REPORT NUMBER: TWG-CAL-09-01

**NEW CAR ASSESSMENT PROGRAM (NCAP)**  
SIDE AIRBAG OUT-OF-POSITION INJURY TESTING

HONDA OF AMERICA MFG.  
2009 ACURA TL  
4-DOOR SEDAN

NHTSA NUMBER: M95304TWG

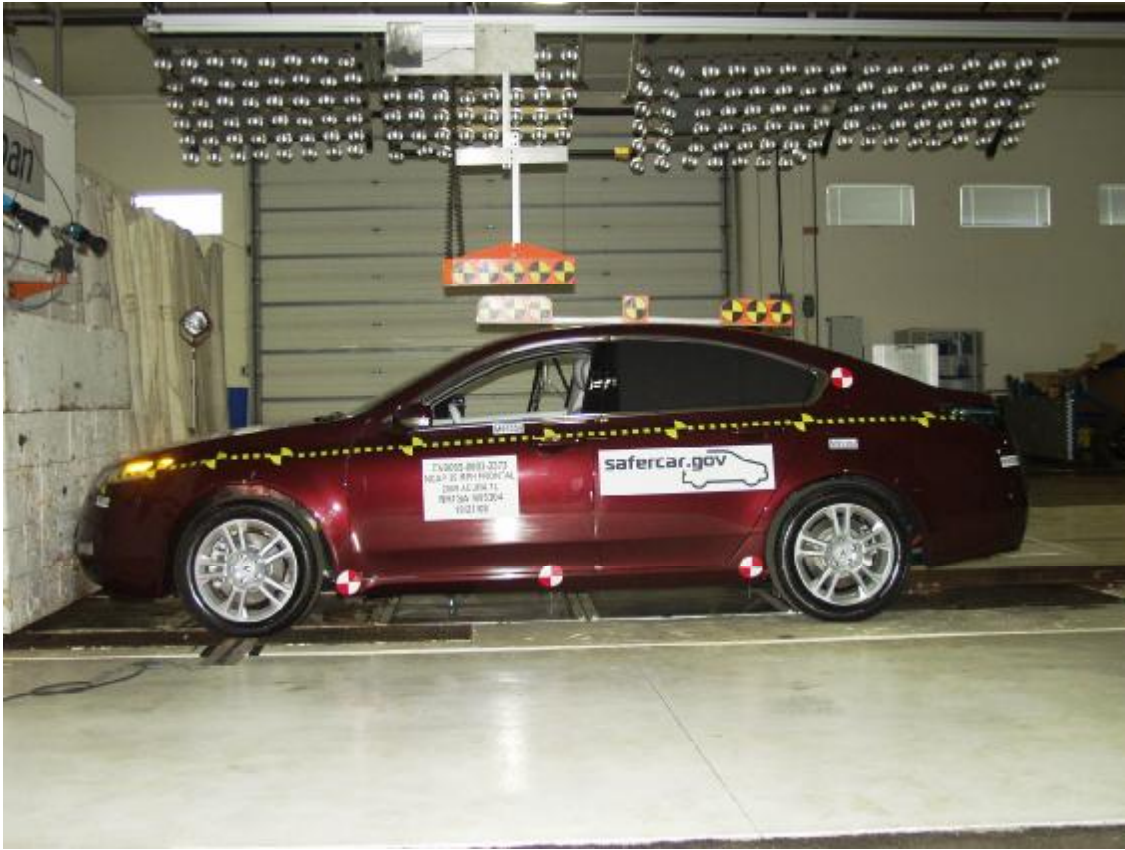
Figure A-1: Pre-Test Vehicle Left Side View

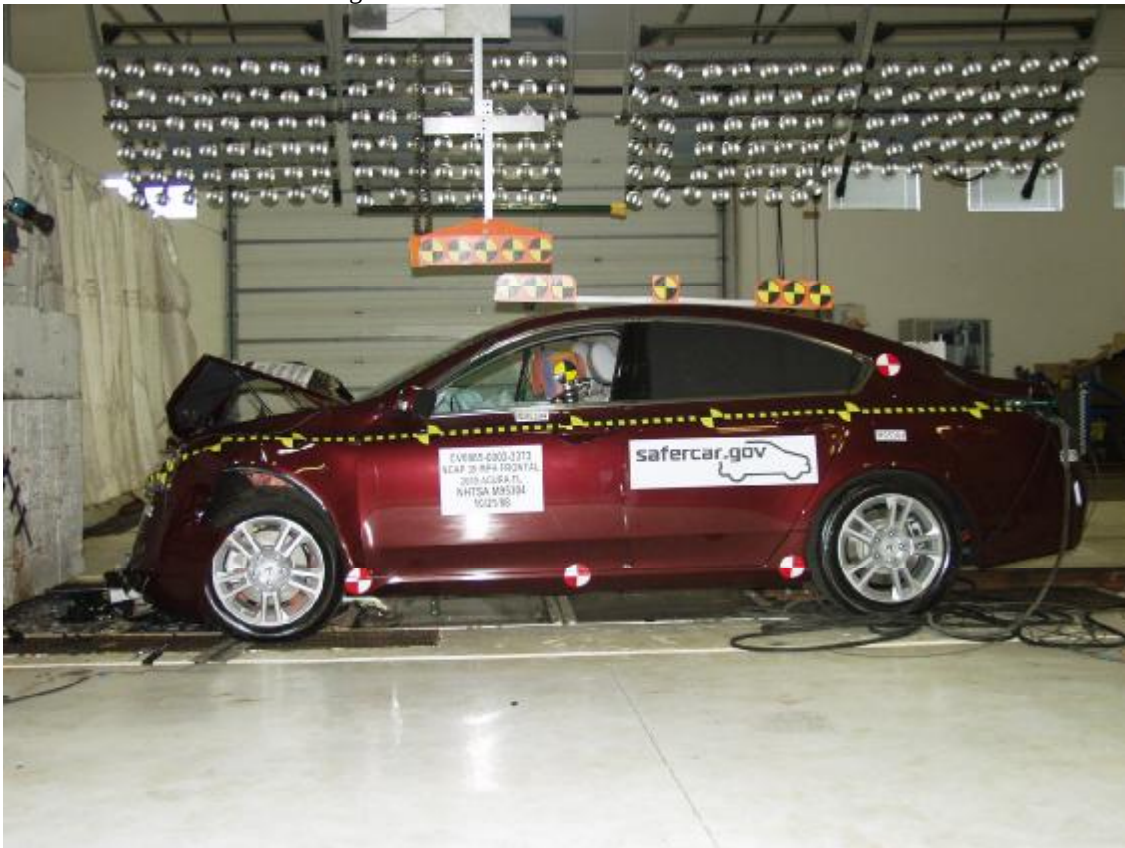
Figure A-2: Post-Test Vehicle Left Side View

‡Vehicle had previously undergone a New Car Assessment Program Barrier Impact Test on October 21, 2008.

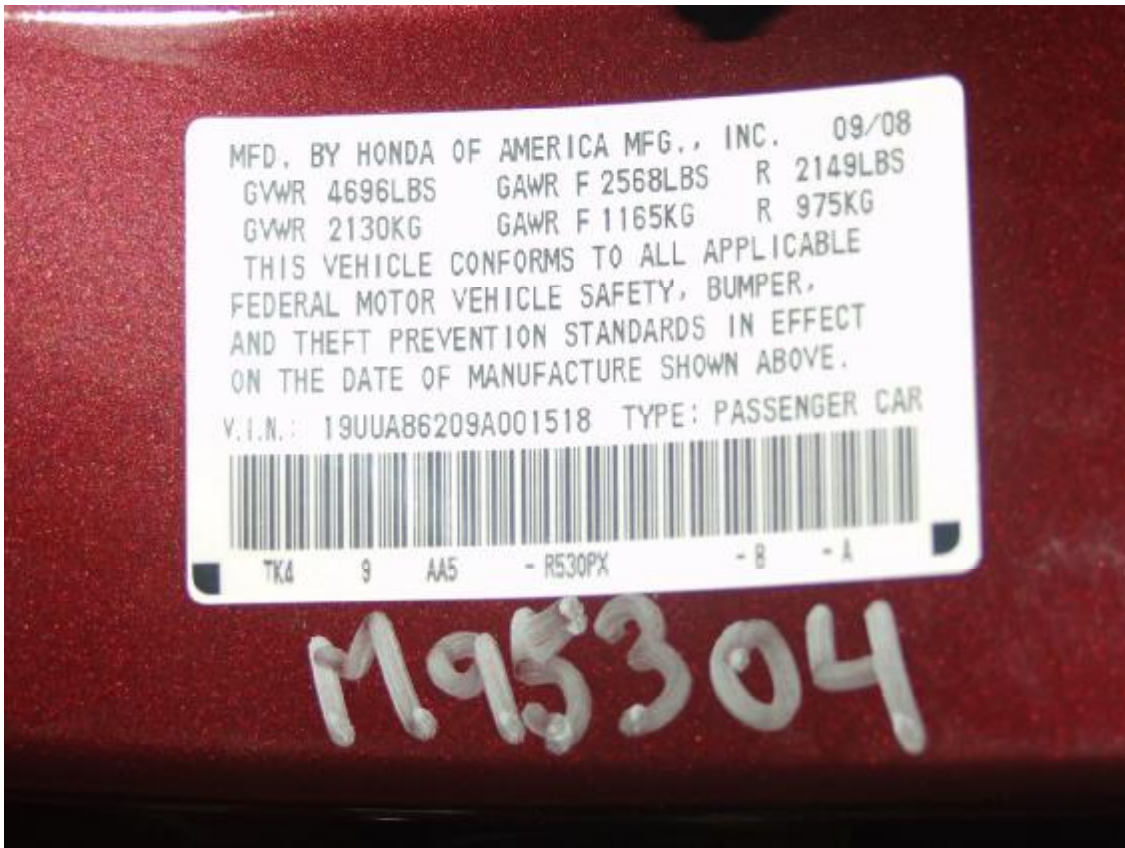
Figure A-3: Vehicle Certification Placard

Vehicle Manufactured by: Honda of America Mfg

Date of Manufacture 09/08

GVWR: 2130 kg; GAWR: 1165 kg FRONT; 975 kg REAR

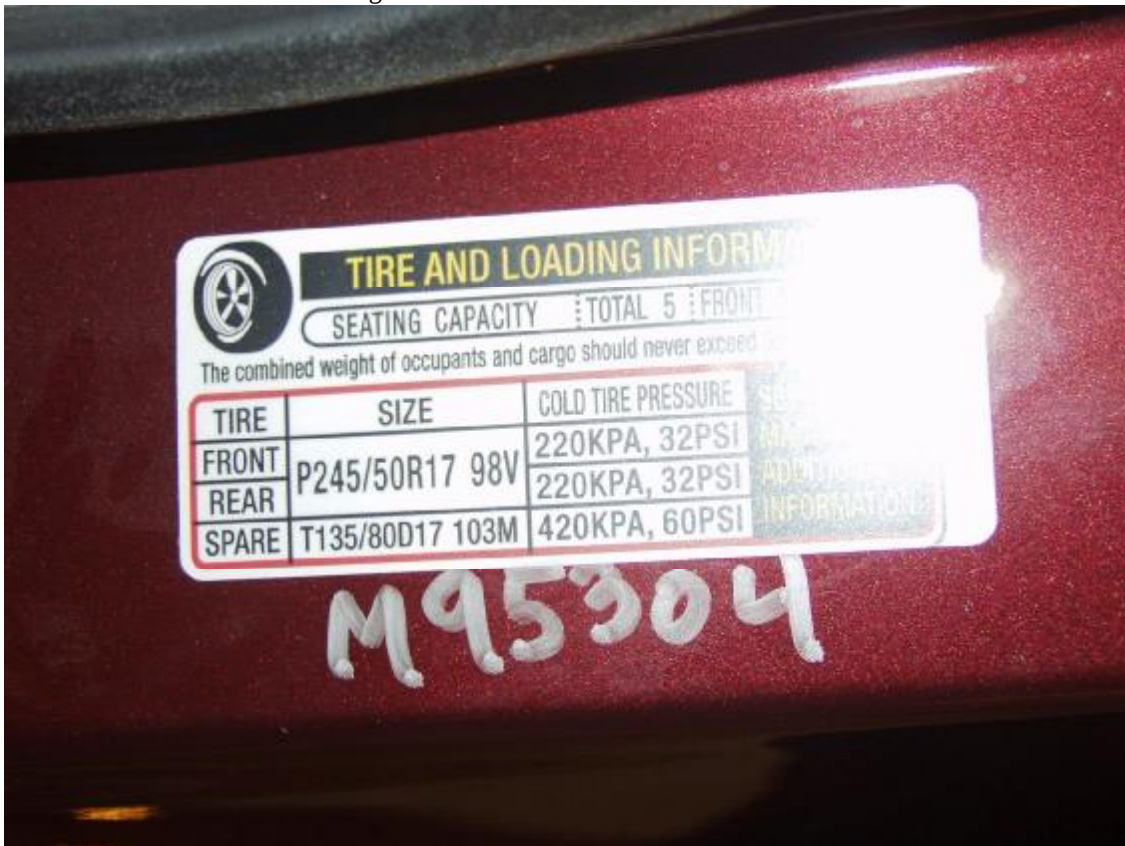
Figure A-4: Vehicle Tire Placard

Recommended Tire Size: P245/50R17

\* Recommended Cold Tire Pressure: 220 kPa FRONT; 220 kPa REAR

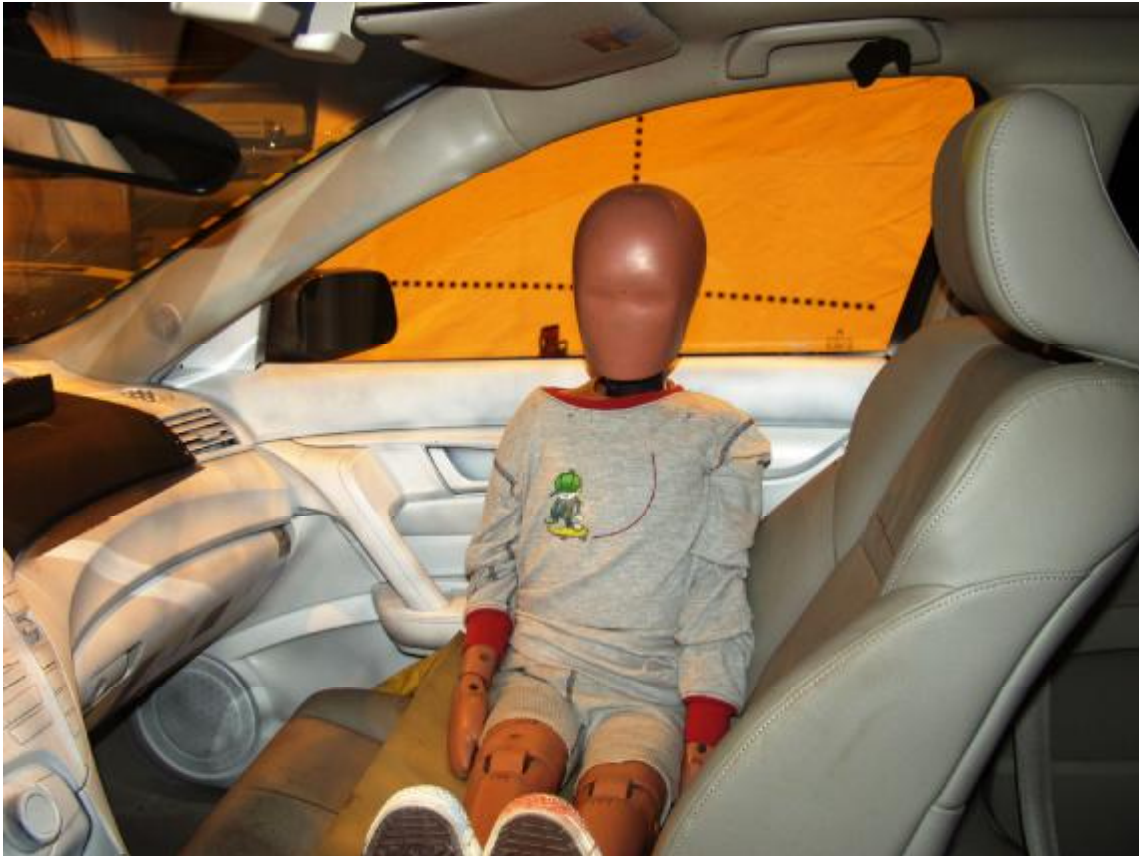
Figure A-5: Pre-Test Frontal View of Dummy

The six-year old child dummy was placed with its arms hanging at its sides on the foam block facing inboard with its legs extended. The seat track was adjusted to 148 mm rearward of full forward to minimize the vertical distance between the dummy's head and the roof-rail module and to maximize the cushion to head interaction. While keeping the head in neutral orientation, the dummy's pelvis was moved outboard until the dummy's back contacted the door trim panel armrest and the center of gravity of the head was centered in the deployment trajectory of the airbag. The dummy was then moved to maintain the vertical plane through the centerline of the dummy's shoulder bolts parallel to the vehicle centerline. The dummy's arms were then bent at the elbow until the fingers contacted the booster seat. This orientation complies with section 3.3.5.1 of the TWG Recommended Procedures for Evaluating Occupant Injury Risk from Deploying Side Airbags as defined by Lund, et al and the Technical Working Group First Revision dated July, 2003.

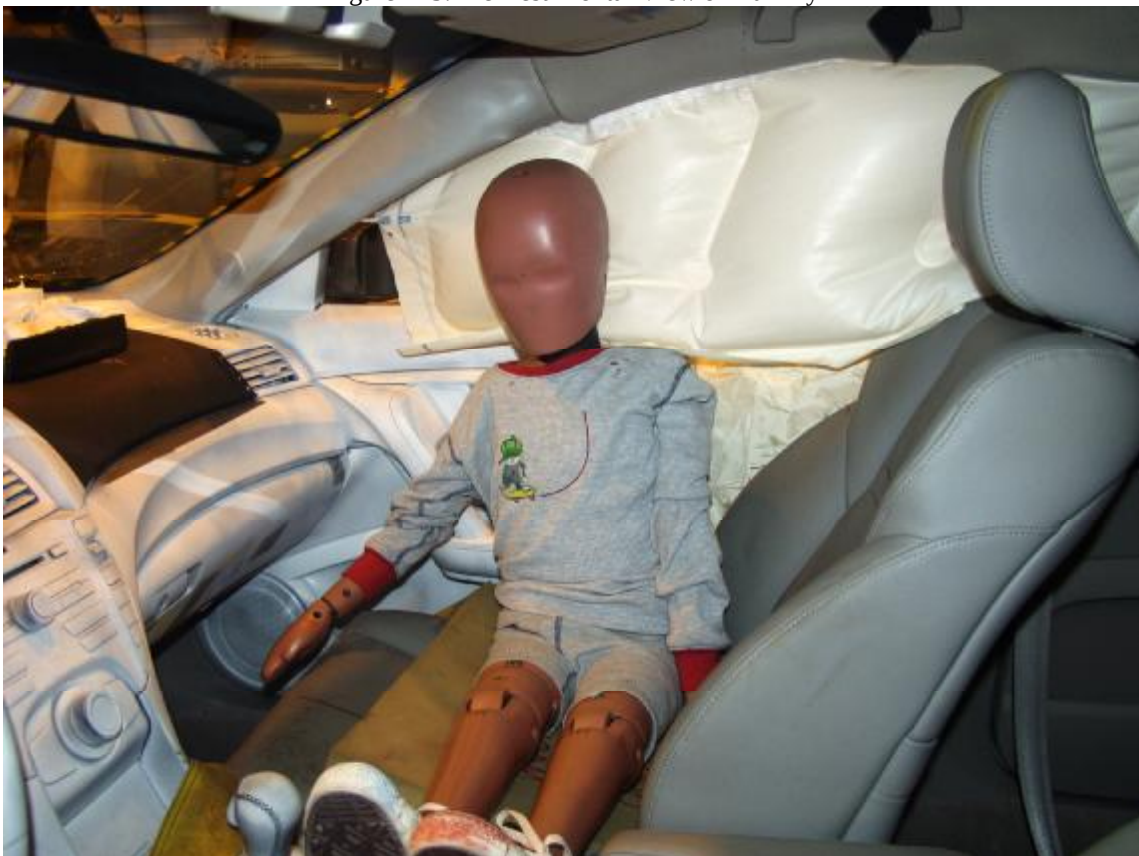
Figure A-6: Post-Test Frontal View of Dummy

| <b>Head Contact:</b> | Side Curtain airbag |
| <b>Upper Torso Contact:</b> | Seat side torso airbag |
| <b>Lower Torso Contact:</b> | Seat side torso airbag |

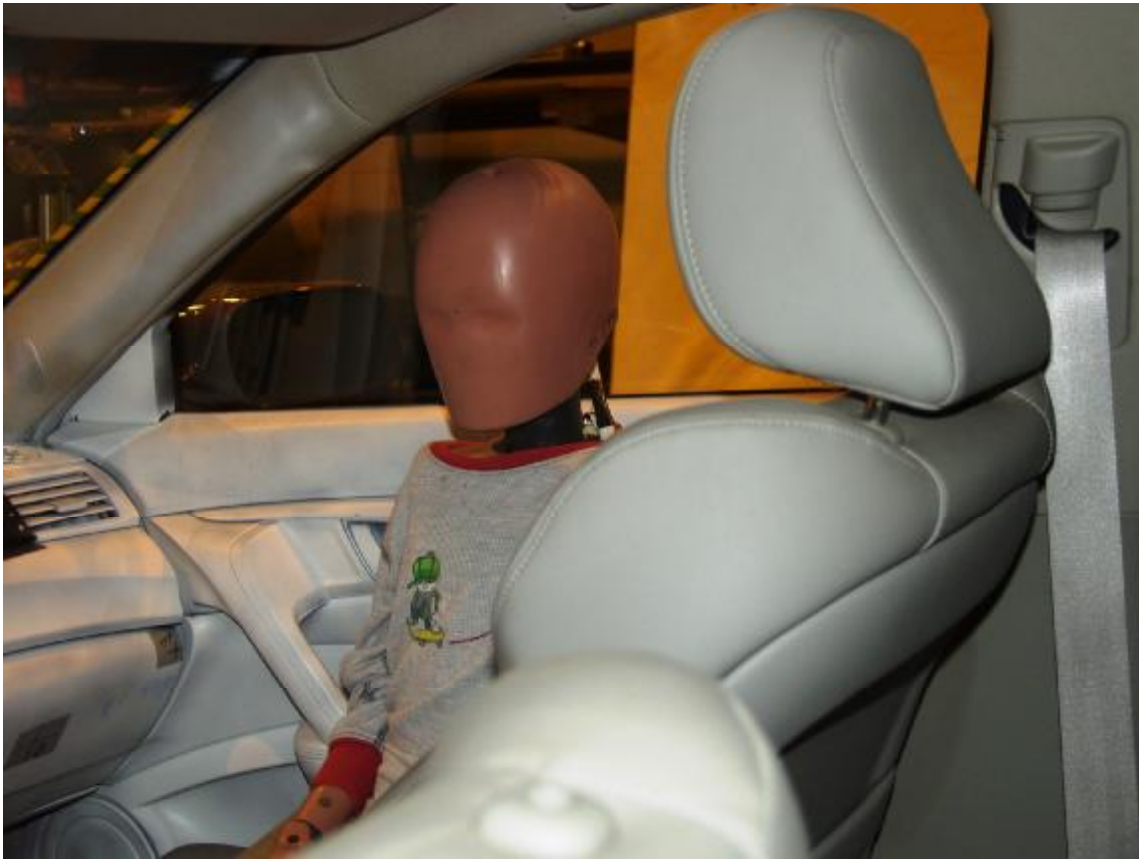
Figure A-7: Pre-Test Left Side View of Dummy

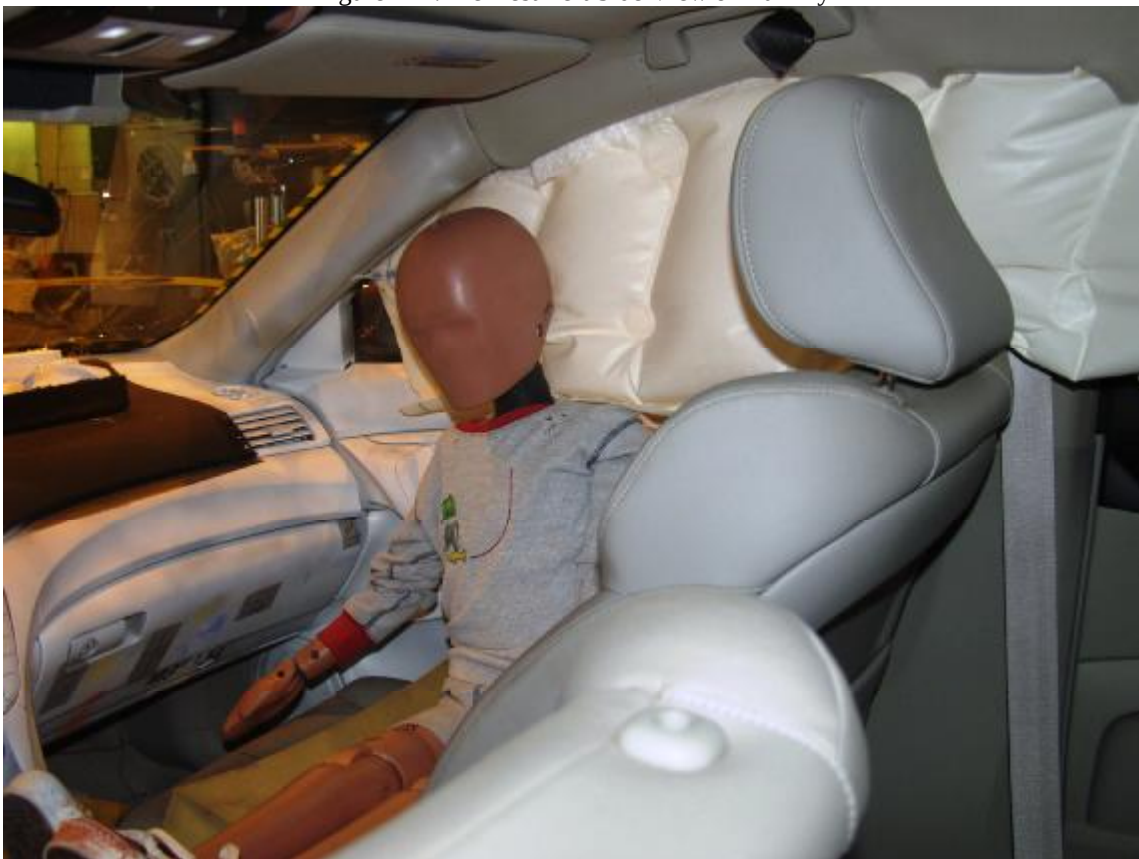
Figure A-8: Post-Test Left Side View of Dummy

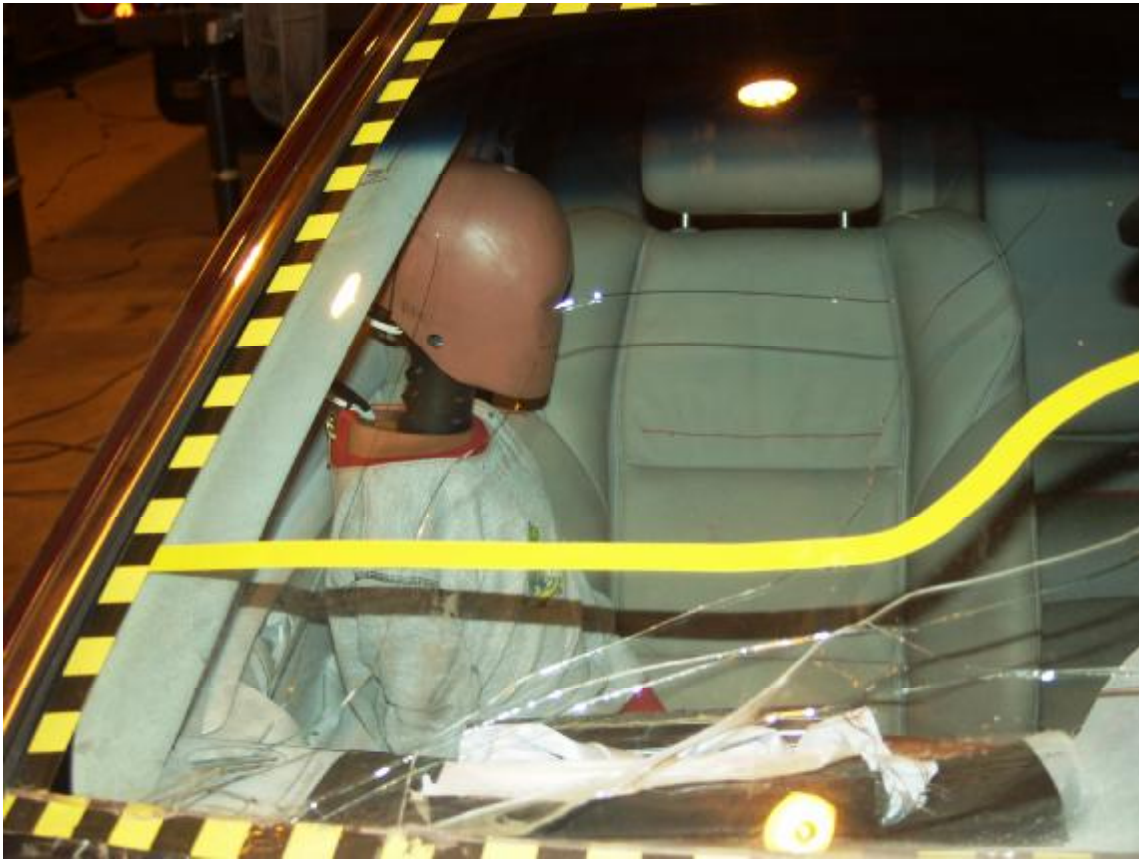
Figure A-9: Pre-Test Right Side View of Dummy

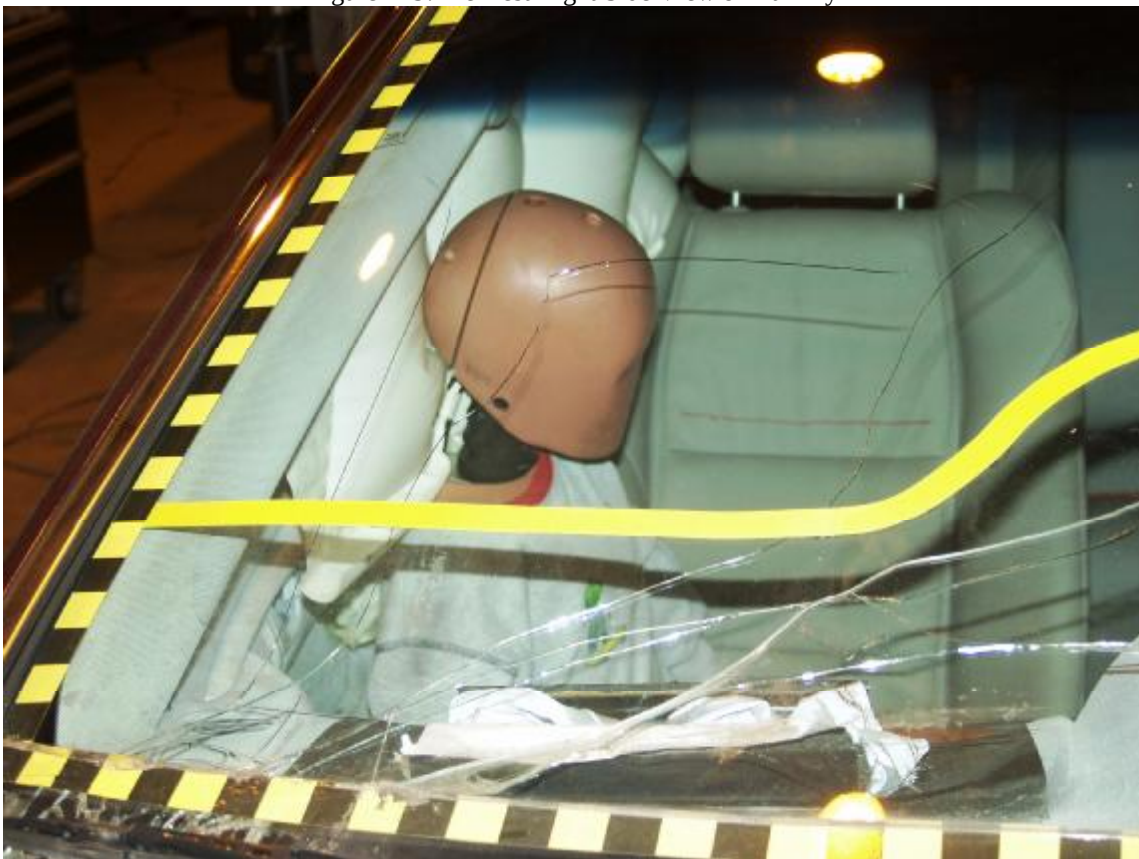
Figure A-10: Post-Test Right Side View of Dummy

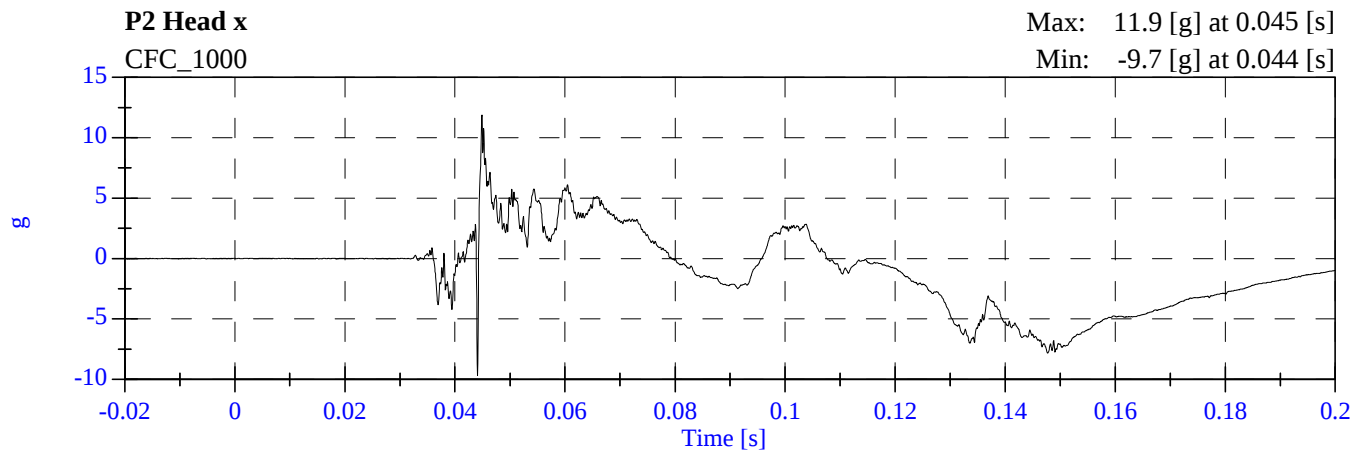
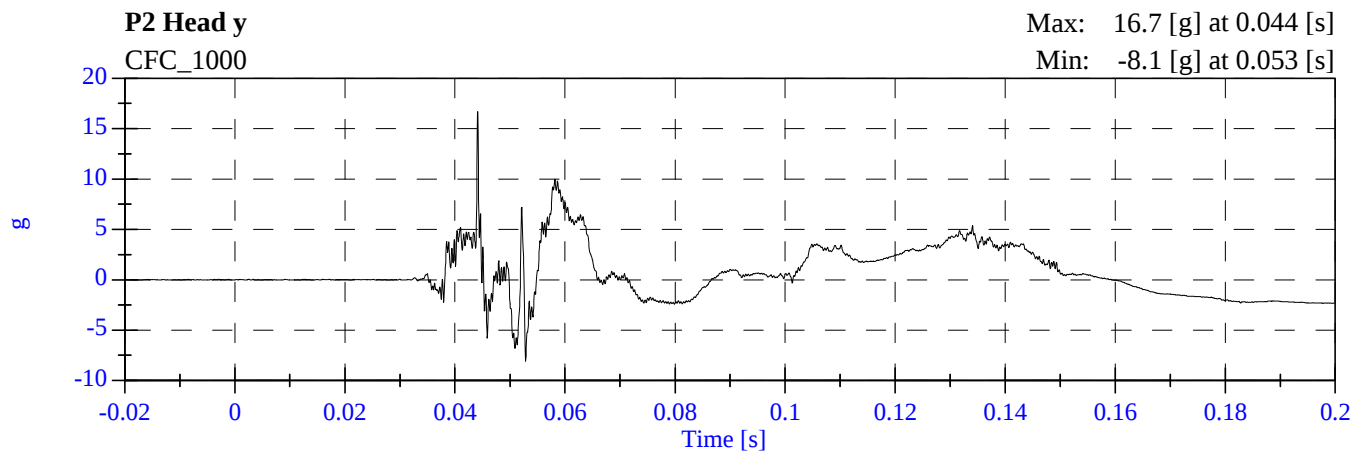
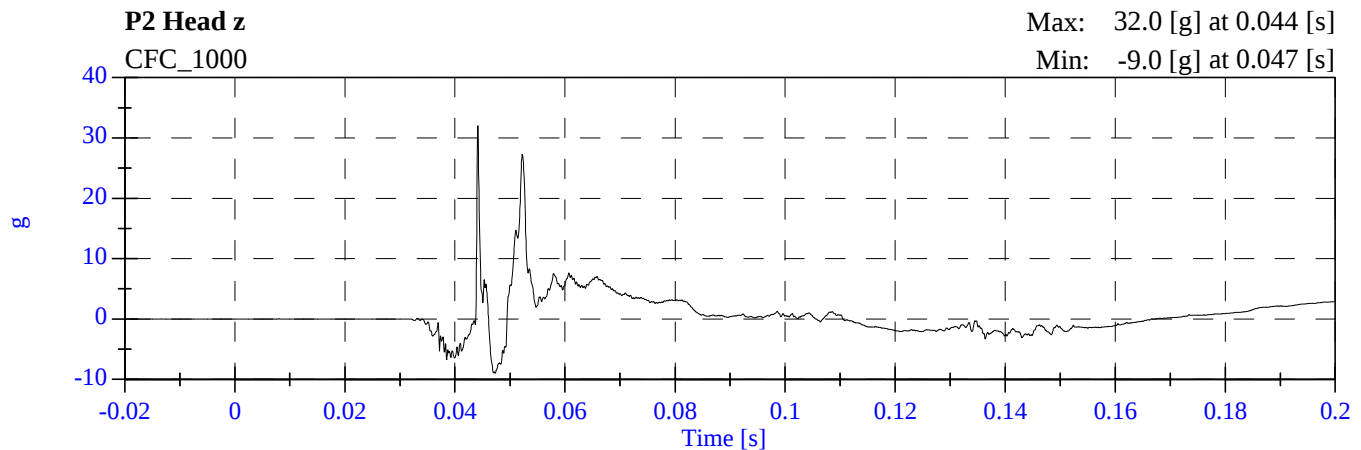
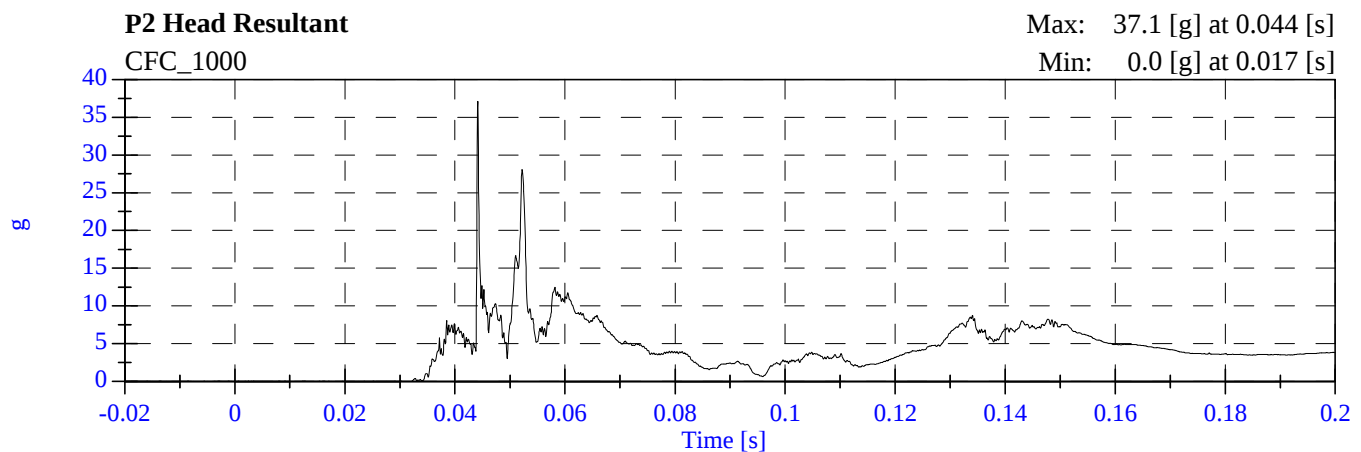
| PLOT | PLOT NAME[UNITS, CHANNEL FILTER CLASS] | PAGE |
|---|---|---|
| 1 | P2 Head x [g, CFC_1000] | B-3 |
| 2 | P2 Head y [g, CFC_1000] | B-3 |
| 3 | P2 Head z [g, CFC_1000] | B-3 |
| 4 | P2 Head Resultant [g, CFC_1000] | B-3 |

| | | MAXIMUM VALUE | | | |
|---|---|---|---|---|---|
| Head X | g | 11.9 | 44.9 | -9.7 | 44.1 |
| Head Y | g | 16.7 | 44.1 | -8.1 | 52.8 |
| Head Z | g | 32.0 | 44.1 | -9.0 | 47.3 |
| Head Resultant | g | 37.1 | 44.1 | 0.0 | 17.4 |

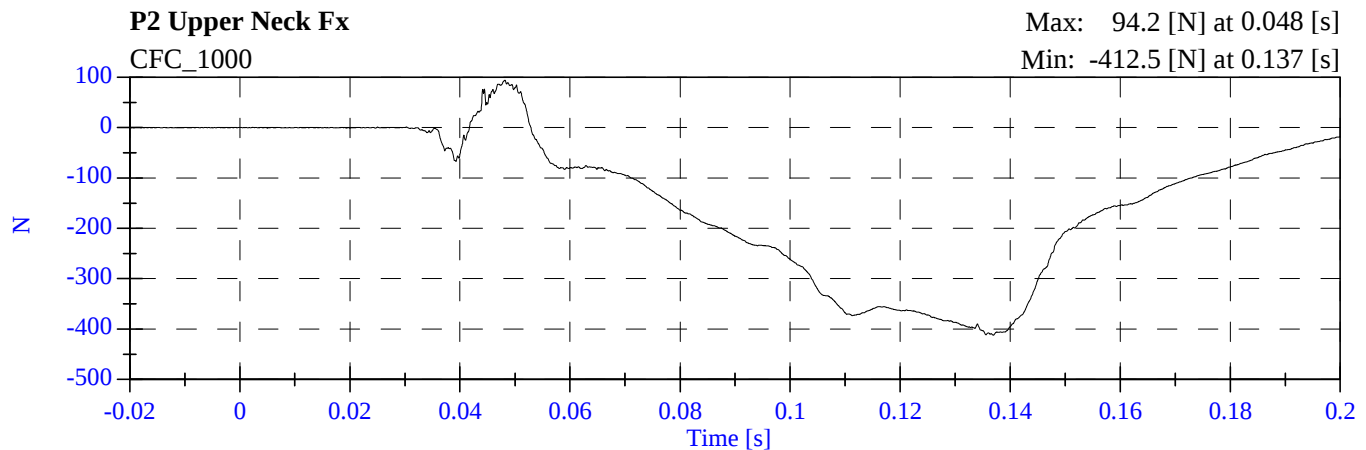
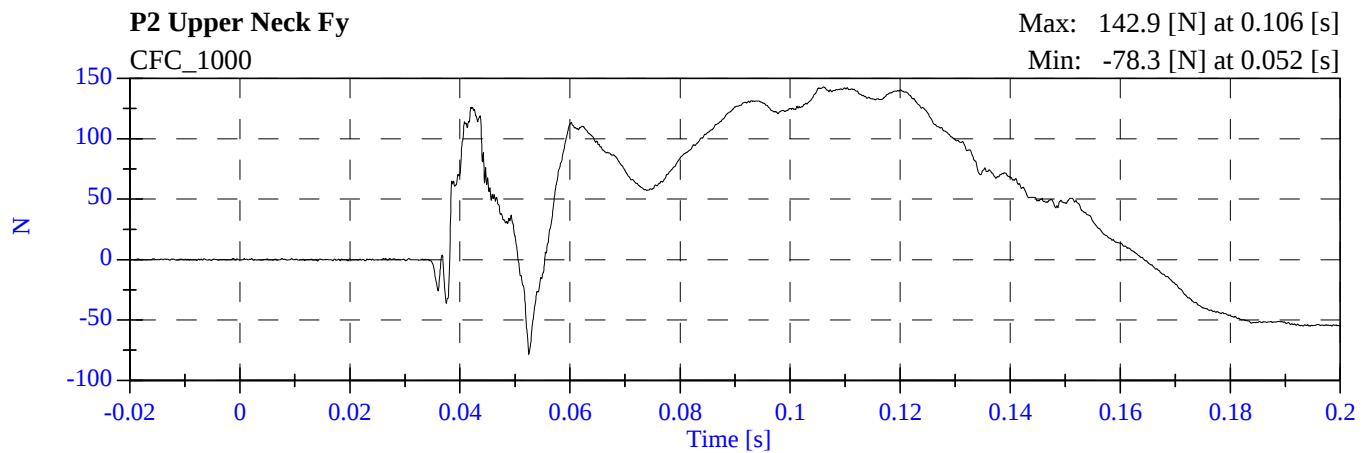
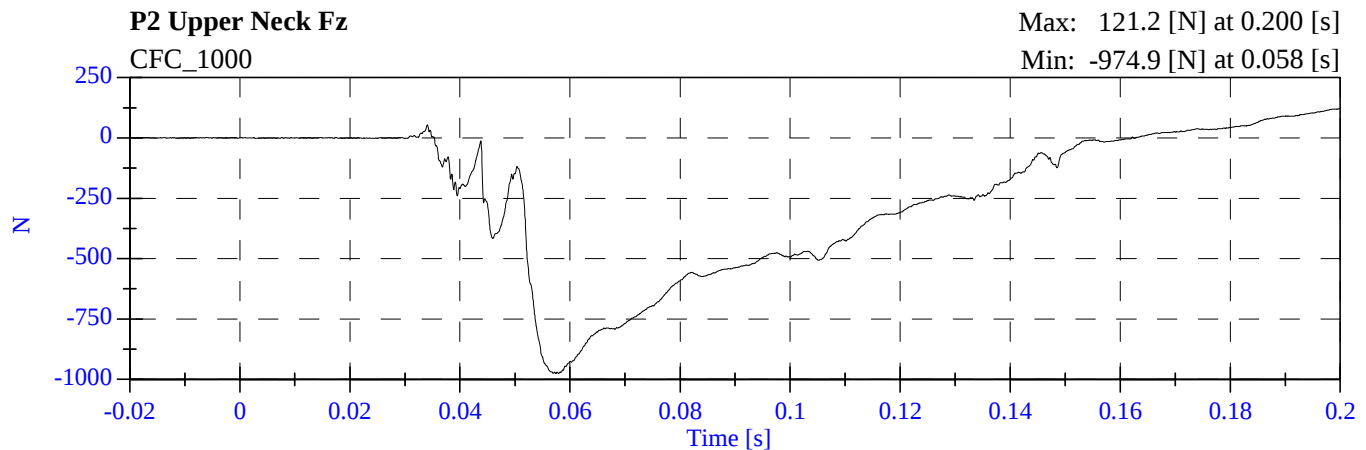
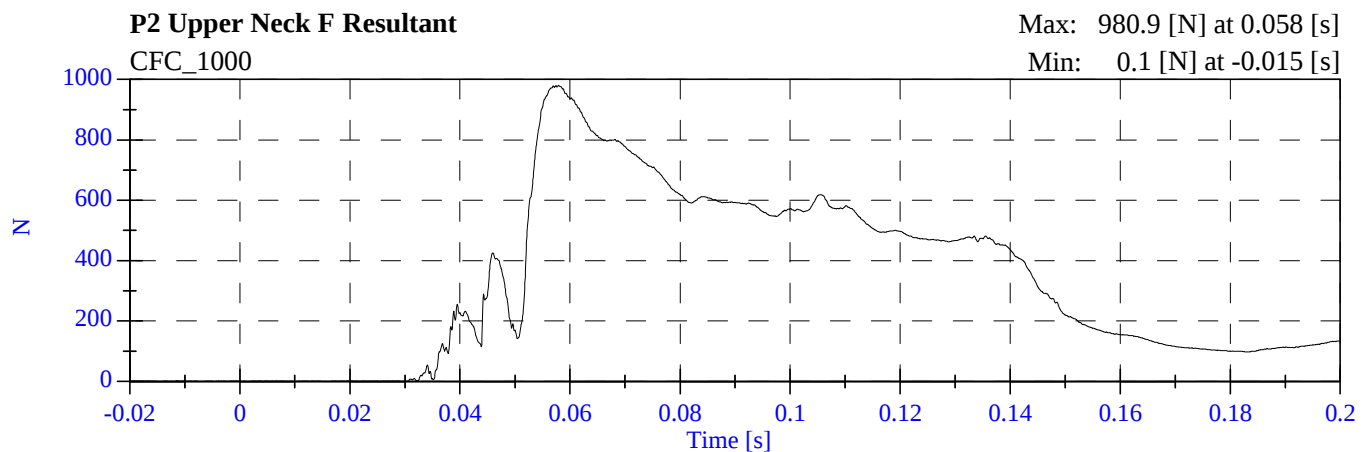
| PLOT | PLOT NAME[UNITS, CHANNEL FILTER CLASS] | PAGE |
|---|---|---|
| 5 | P2 Upper Neck Fx [N, CFC_1000] | B-4 |
| 6 | P2 Upper Neck Fy [N, CFC_1000] | B-4 |
| 7 | P2 Upper Neck Fz [N, CFC_1000] | B-4 |
| 8 | P2 Upper Neck F Resultant [N, CFC_1000] | B-4 |

| | | MAXIMUM VALUE | | | |
|---|---|---|---|---|---|
| Upper Neck Fx | N | 94.2 | 48.2 | -412.5 | 136.9 |
| Upper Neck Fy | N | 142.9 | 106.1 | -78.3 | 52.5 |
| Upper Neck Fz | N | 121.2 | 199.8 | -974.9 | 57.9 |
| Upper Neck F Resultant | N | 980.9 | 57.9 | 0.1 | -14.6 |

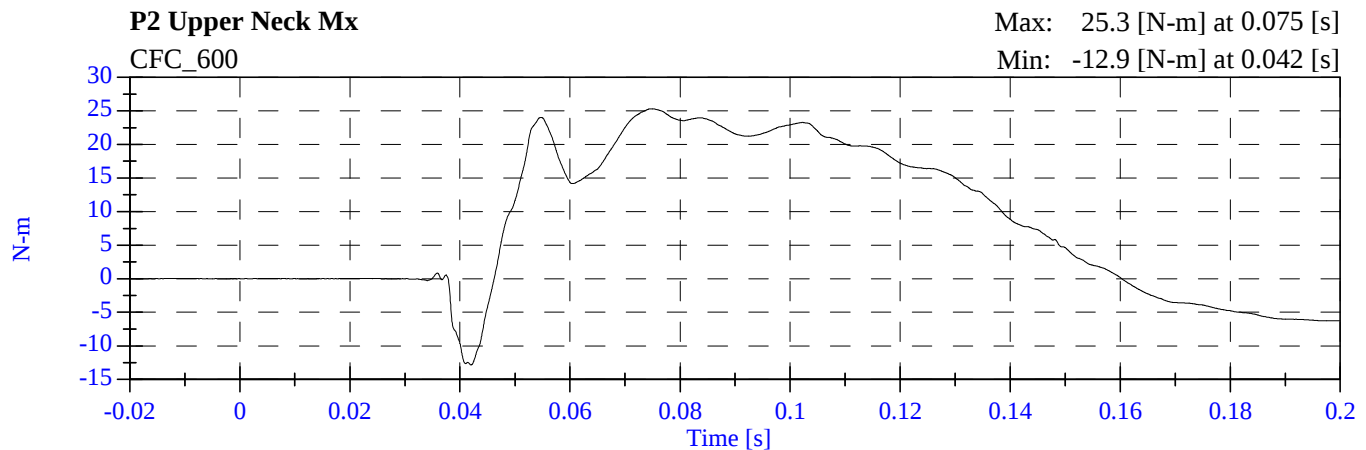
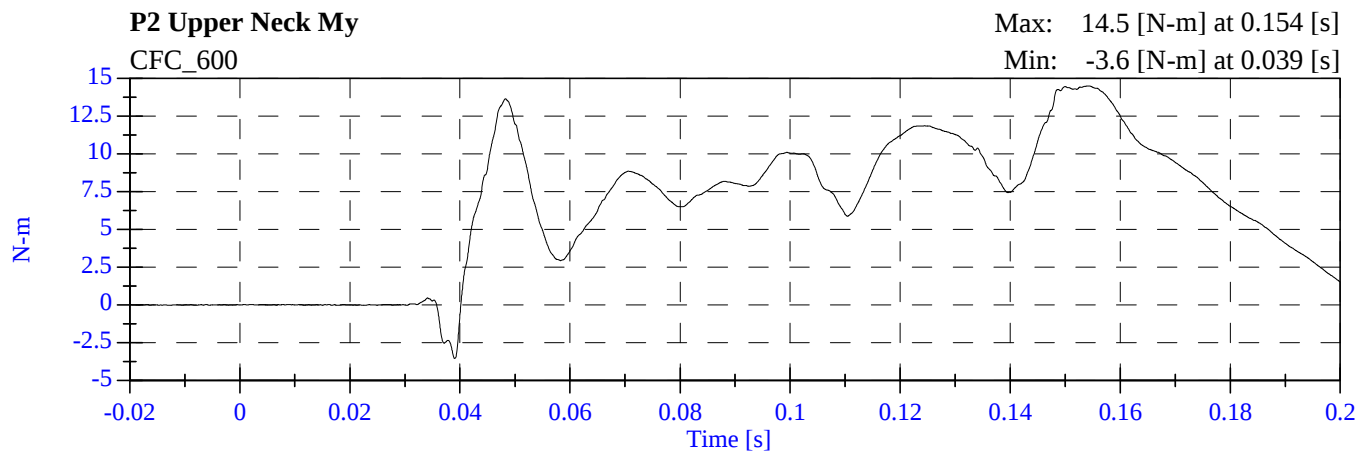
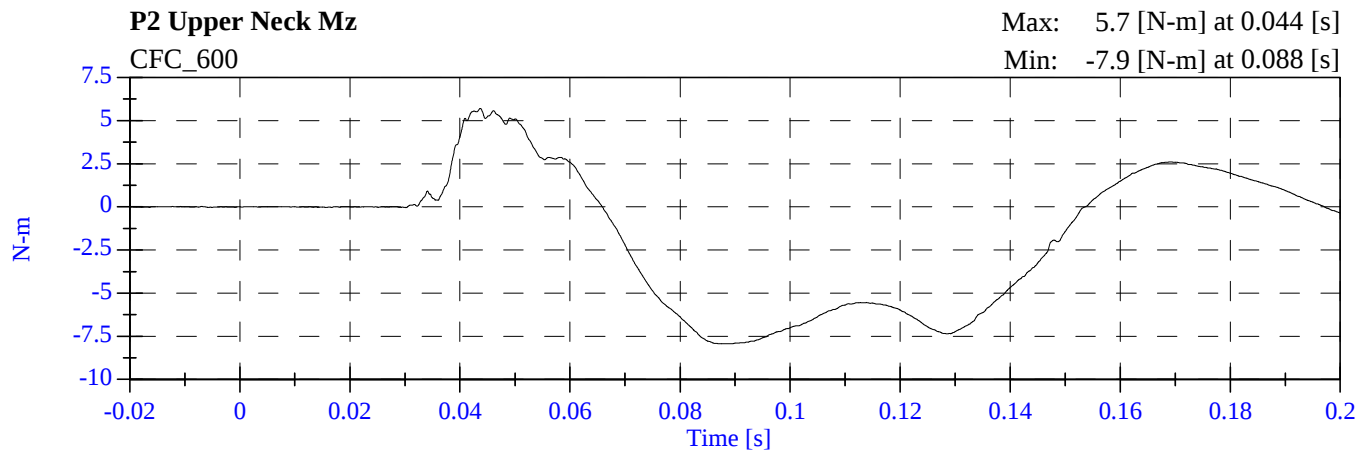
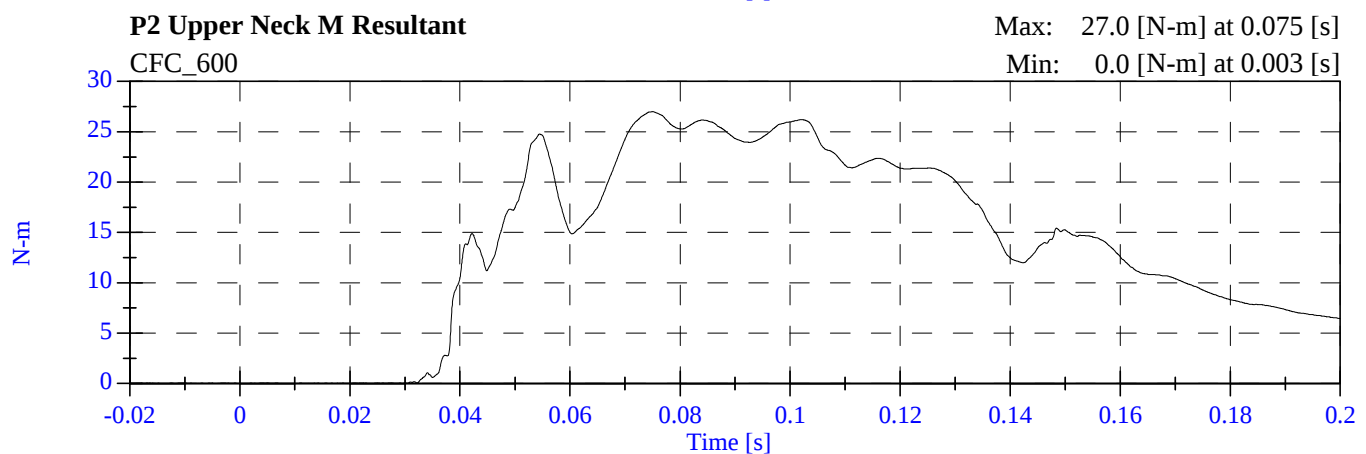
| PLOT | PLOT NAME[UNITS, CHANNEL FILTER CLASS] | PAGE |
|---|---|---|
| 9 | P2 Upper Neck Mx [N-m, CFC_600] | B-5 |
| 10 | P2 Upper Neck My [N-m, CFC_600] | B-5 |
| 11 | P2 Upper Neck Mz [N-m, CFC_600] | B-5 |
| 12 | P2 Upper Neck M Resultant [N-m, CFC_600] | B-5 |

| | | MAXIMUM VALUE | | | |
|---|---|---|---|---|---|
| Upper Neck Mx | N-m | 25.3 | 75.0 | -12.9 | 42.0 |
| Upper Neck My | N-m | 14.5 | 154.2 | -3.6 | 39.0 |
| Upper Neck Mz | N-m | 5.7 | 43.7 | -7.9 | 88.0 |
| Upper Neck M Resultant | N-m | 27.0 | 75.0 | 0.0 | 3.0 |

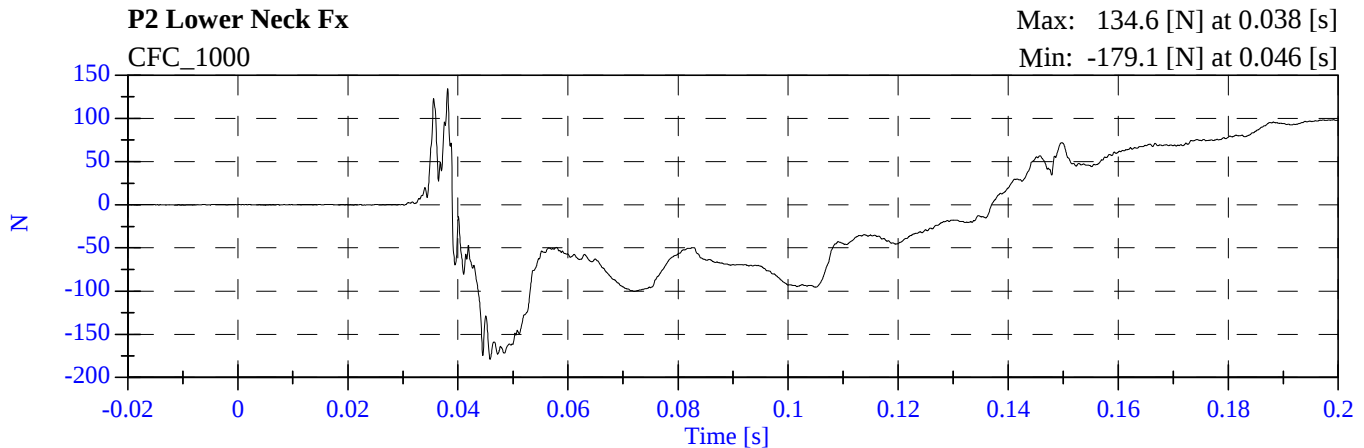
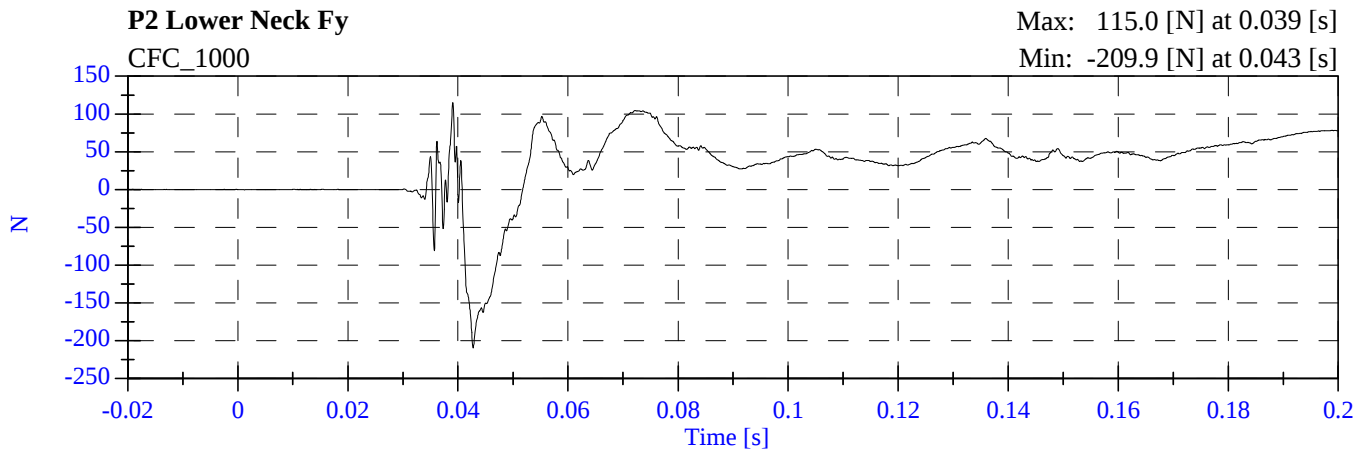
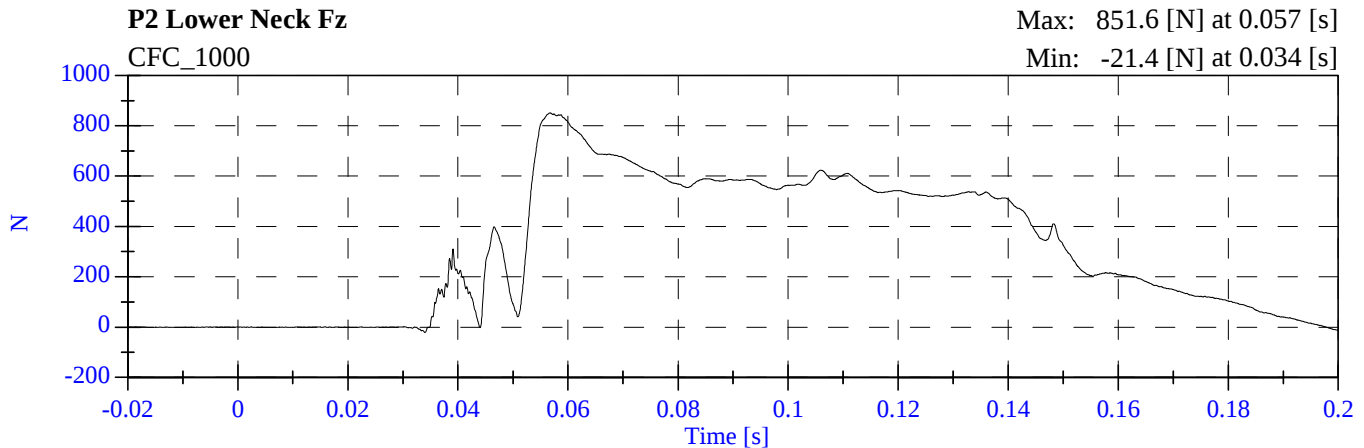
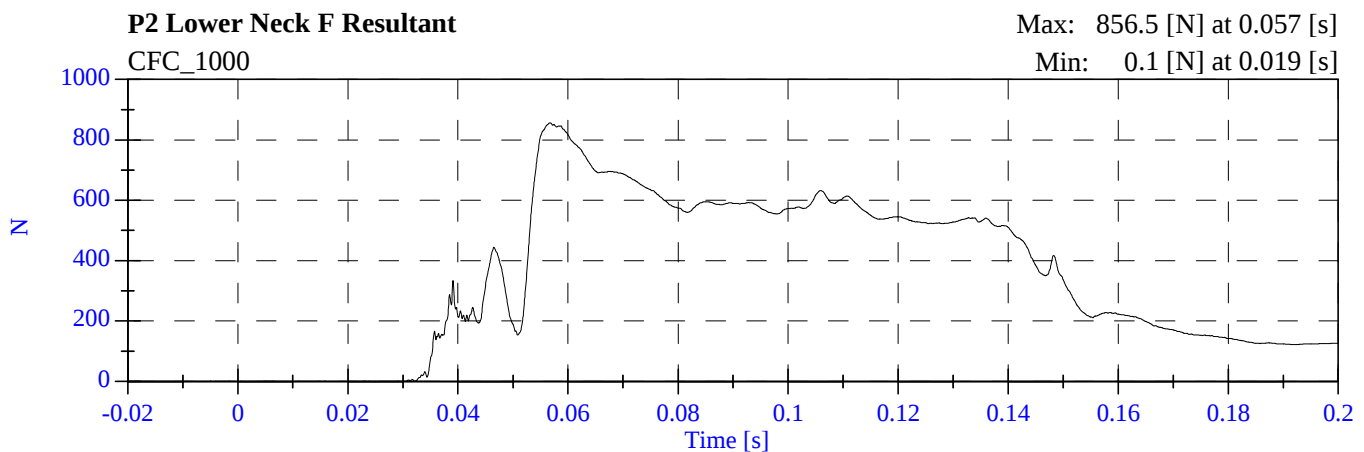
| PLOT | PLOT NAME[UNITS, CHANNEL FILTER CLASS] | PAGE |
|---|---|---|
| 13 | P2 Lower Neck Fx [N, CFC_1000] | B-6 |
| 14 | P2 Lower Neck Fy [N, CFC_1000] | B-6 |
| 15 | P2 Lower Neck Fz [N, CFC_1000] | B-6 |
| 16 | P2 Lower Neck F Resultant [N, CFC_1000] | B-6 |

| | | MAXIMUM VALUE | | | |
|---|---|---|---|---|---|
| Lower Neck Fx | N | 134.6 | 38.1 | -179.1 | 45.9 |
| Lower Neck Fy | N | 115.0 | 39.0 | -209.9 | 42.7 |
| Lower Neck Fz | N | 851.6 | 56.7 | -21.4 | 34.0 |
| Lower Neck F Resultant | N | 856.5 | 56.7 | 0.1 | 18.6 |

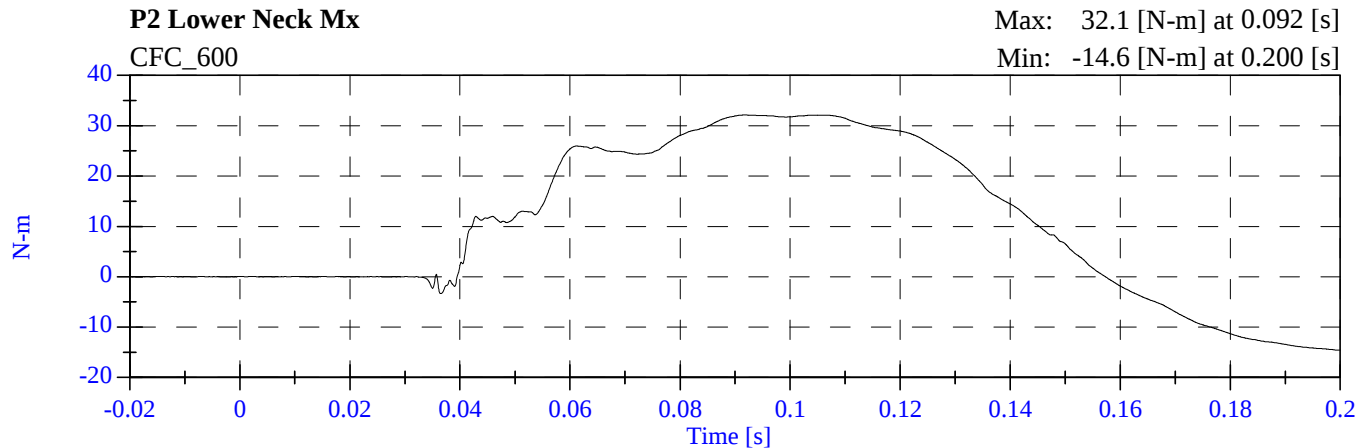
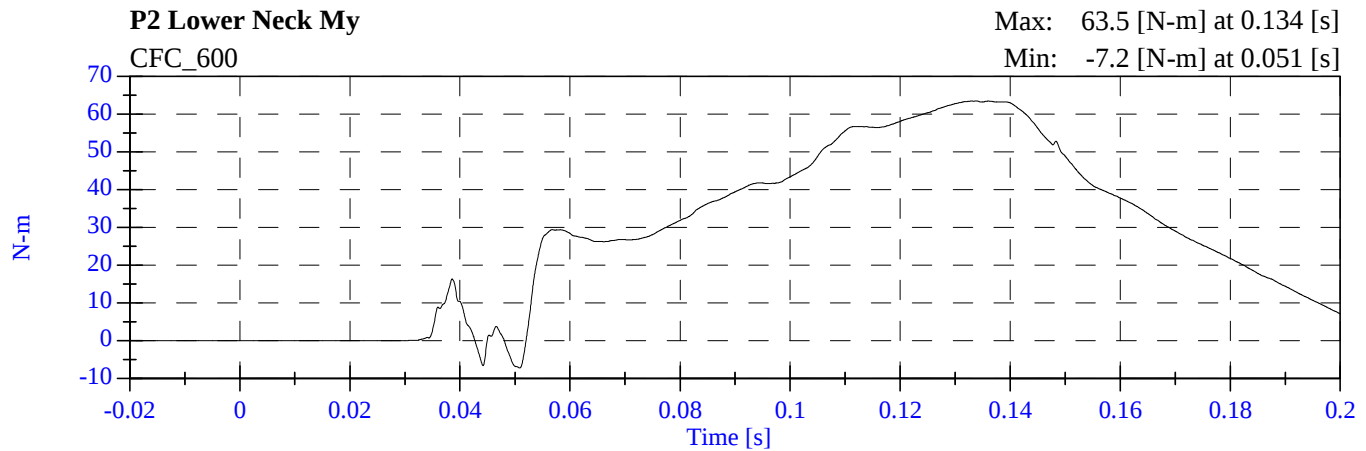
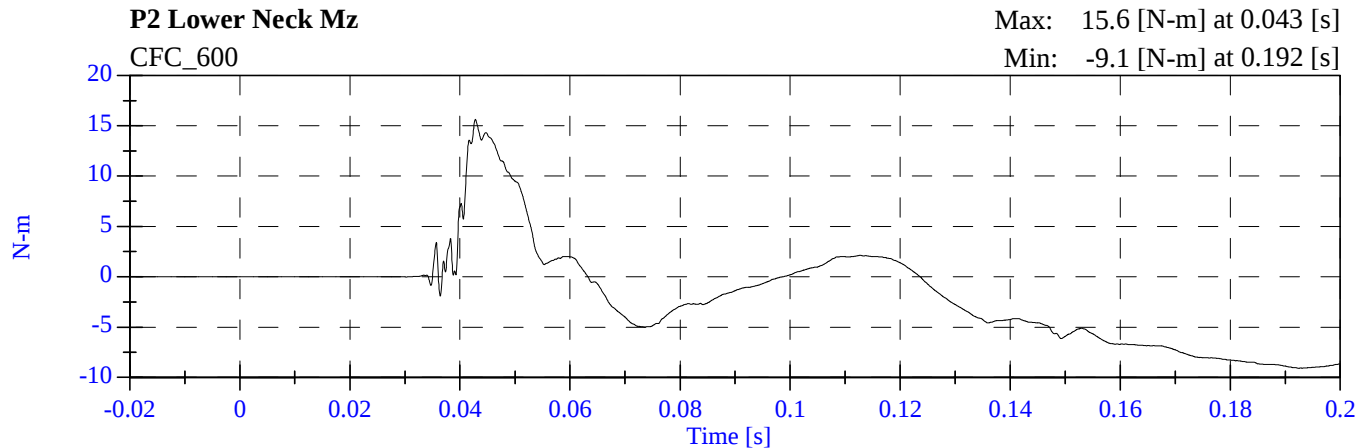
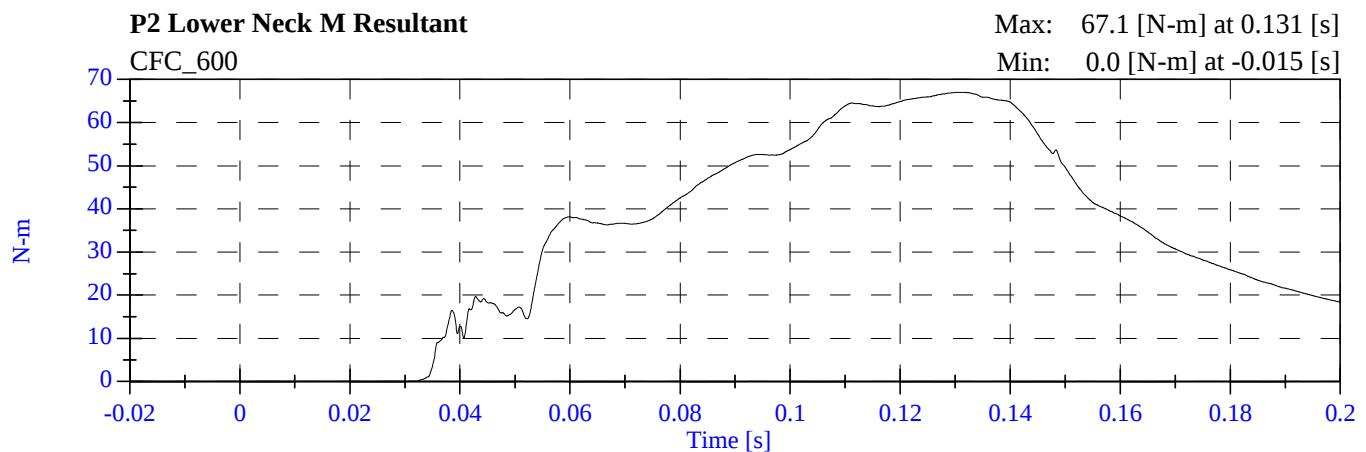
| PLOT | PLOT NAME[UNITS, CHANNEL FILTER CLASS] | PAGE |
|---|---|---|
| 17 | P2 Lower Neck Mx [N-m, CFC_600] | B-7 |
| 18 | P2 Lower Neck My [N-m, CFC_600] | B-7 |
| 19 | P2 Lower Neck Mz [N-m, CFC_600] | B-7 |
| 20 | P2 Lower Neck M Resultant [N-m, CFC_600] | B-7 |

| | | MAXIMUM VALUE | | | |
|---|---|---|---|---|---|
| Lower Neck Mx | N-m | 32.1 | 91.8 | -14.6 | 199.9 |
| Lower Neck My | N-m | 63.5 | 133.8 | -7.2 | 50.8 |
| Lower Neck Mz | N-m | 15.6 | 42.8 | -9.1 | 192.4 |
| Lower Neck M Resultant | N-m | 67.1 | 131.5 | 0.0 | -15.1 |
