REPORT NUMBER: TWG-CAL-09-01

**NEW CAR ASSESSMENT PROGRAM (NCAP)**  
SIDE AIRBAG OUT-OF-POSITION INJURY TESTING

HONDA OF AMERICA MFG.  
2009 ACURA TL  
4-DOOR SEDAN

NHTSA NUMBER: M95304TWG

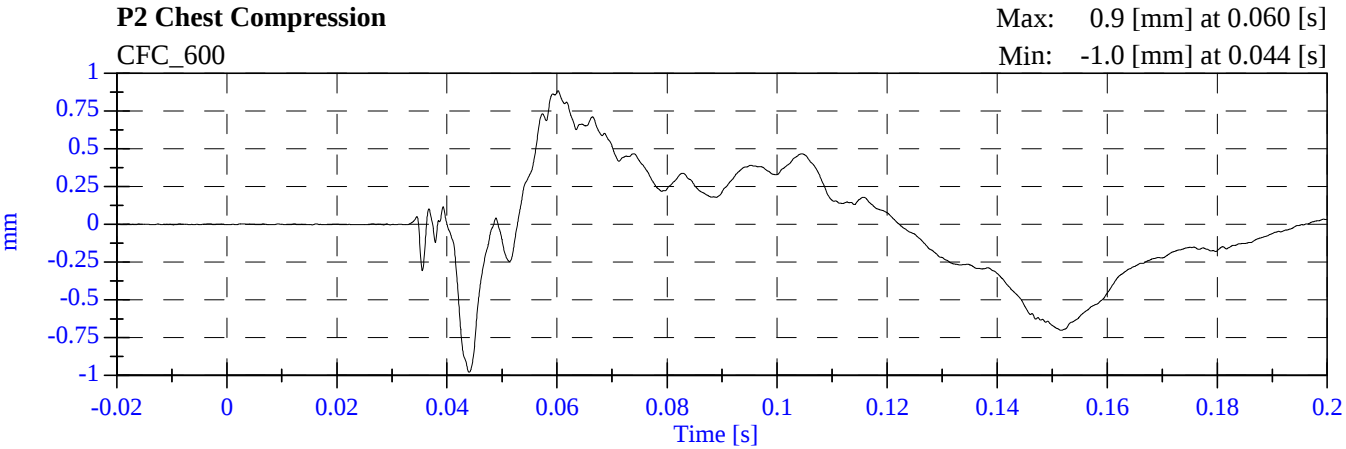
| PLOT | PLOT NAME[UNITS, CHANNEL FILTER CLASS] | PAGE |
|---|---|---|
| 25 | P2 Chest Compression [mm, CFC_600] | B-8 |

| | | MAXIMUM VALUE | | | |
|---|---|---|---|---|---|
| Chest Displacement | g | 0.9 | 60.2 | -1.0 | 44.0 |
