**REPORT NUMBER: TWG-MGA-2009-007**

**SIDE AIRBAG OUT-OF-POSITION INJURY  
TECHNICAL WORKING GROUP**

**CHRYSLER LLC  
2009 DODGE CHALLENGER  
NHTSA NUMBER: M90303TWG2**

**FINAL REPORT**

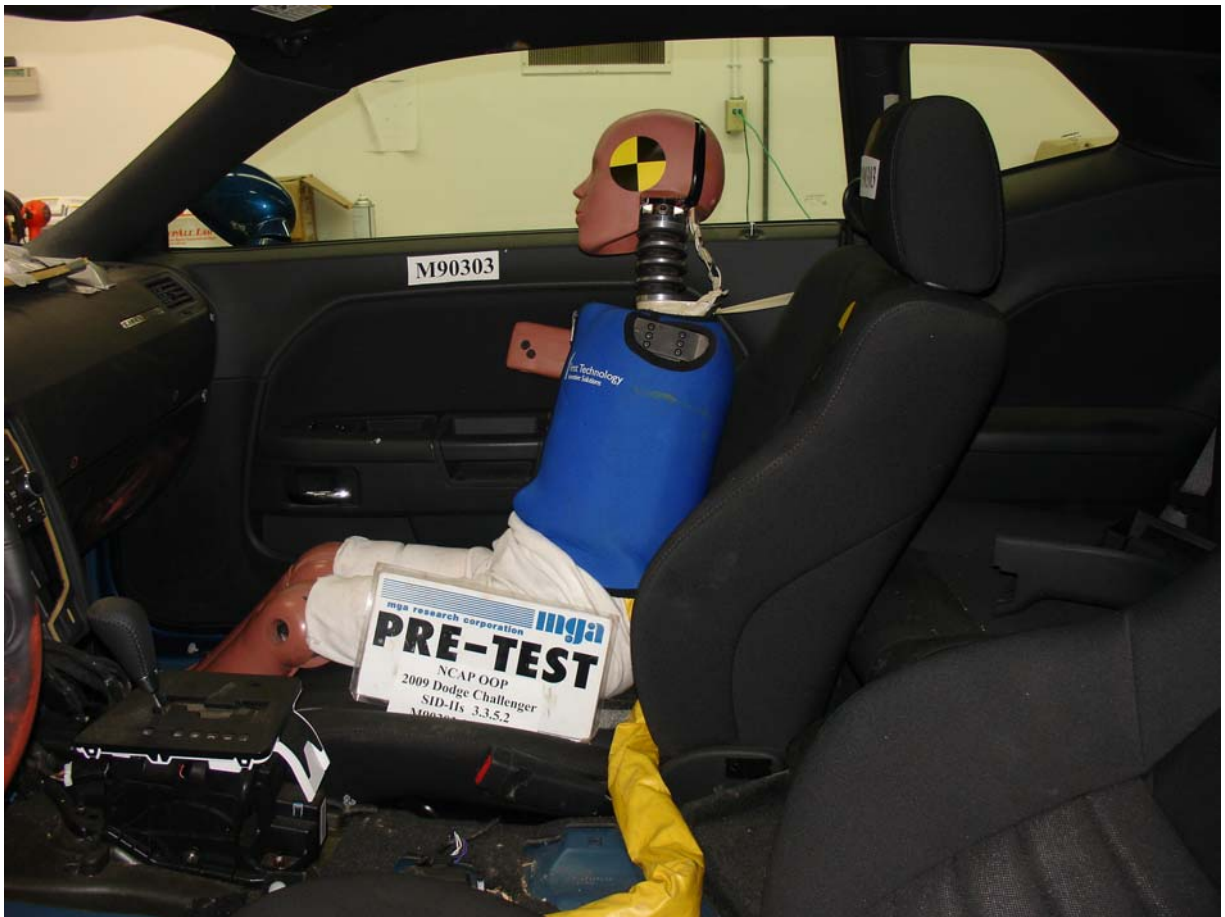
Pre-Test SID-IIs Dummy Left Side View

The SID-IIs dummy was placed in the right front passenger seat facing forward in the center of the seat with its arm rotated horizontal to clear the armrest. The seat track was adjusted forward. The dummy was moved outboard until contact with the door trim panel ensuring that the deployment trajectory of the airbag intersects with the centerline of the top of the head. Masking tape was wrapped around the dummy's neck bracket to hold the dummy in place.

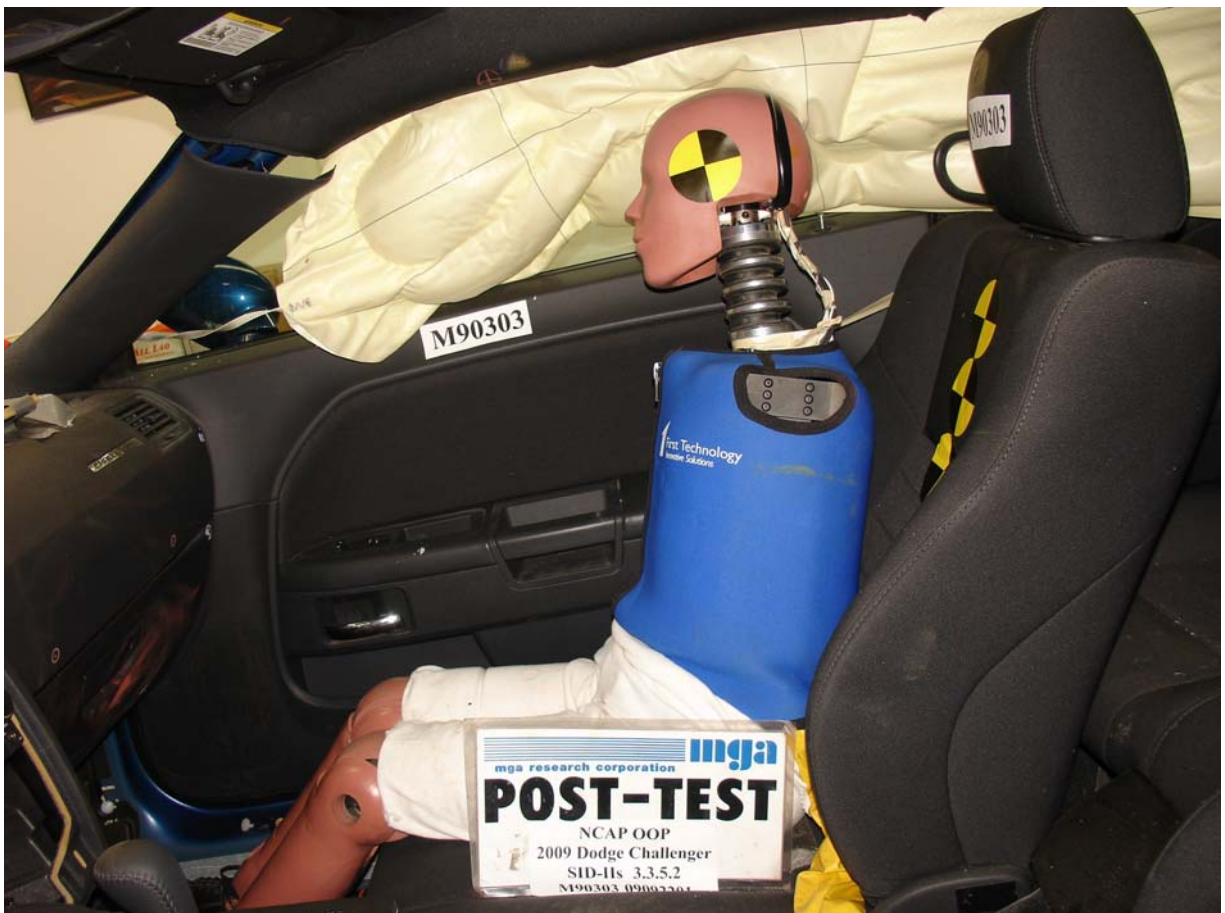
Post-Test SID-IIs Dummy Left Side View

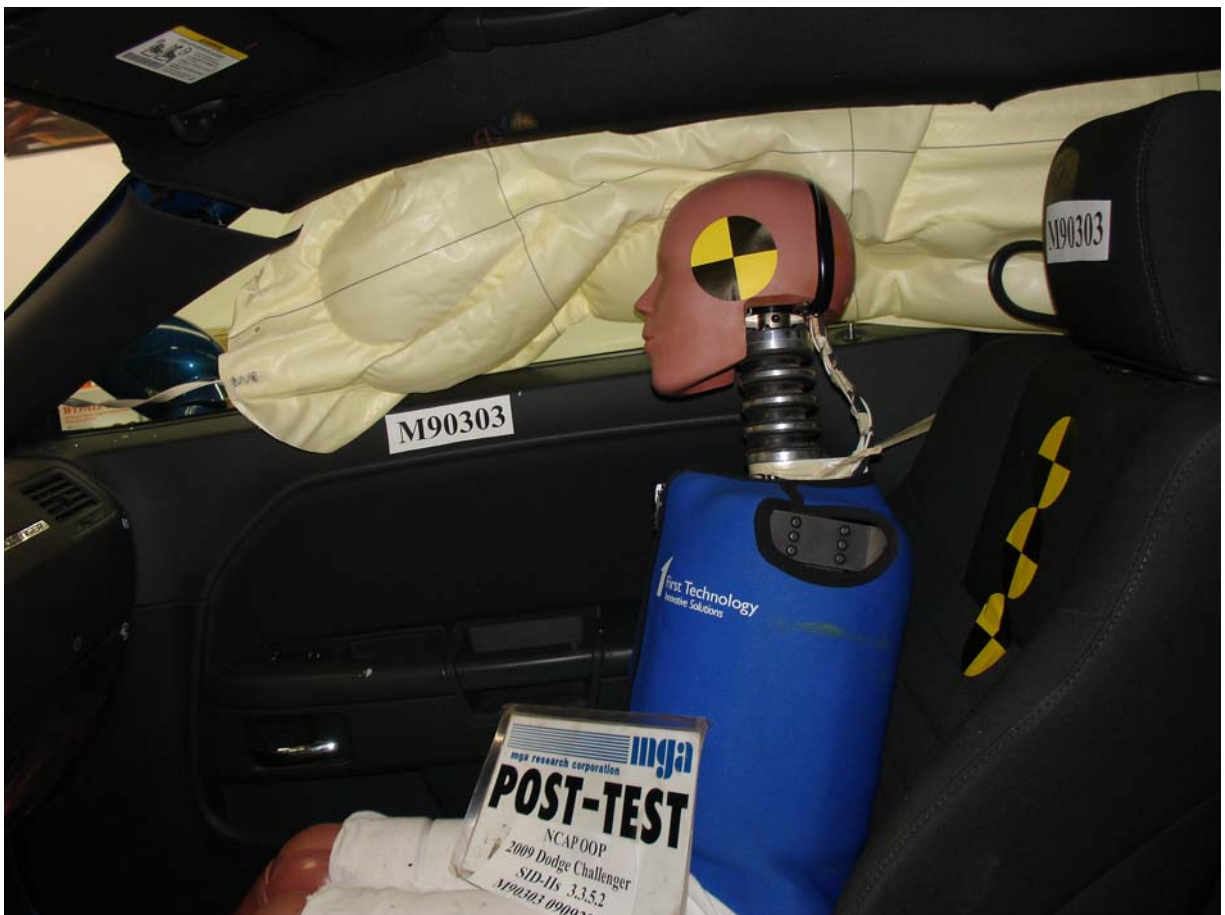
- Curtain airbag to top of head

Post-Test SID-IIs Dummy Left Side Closeup View

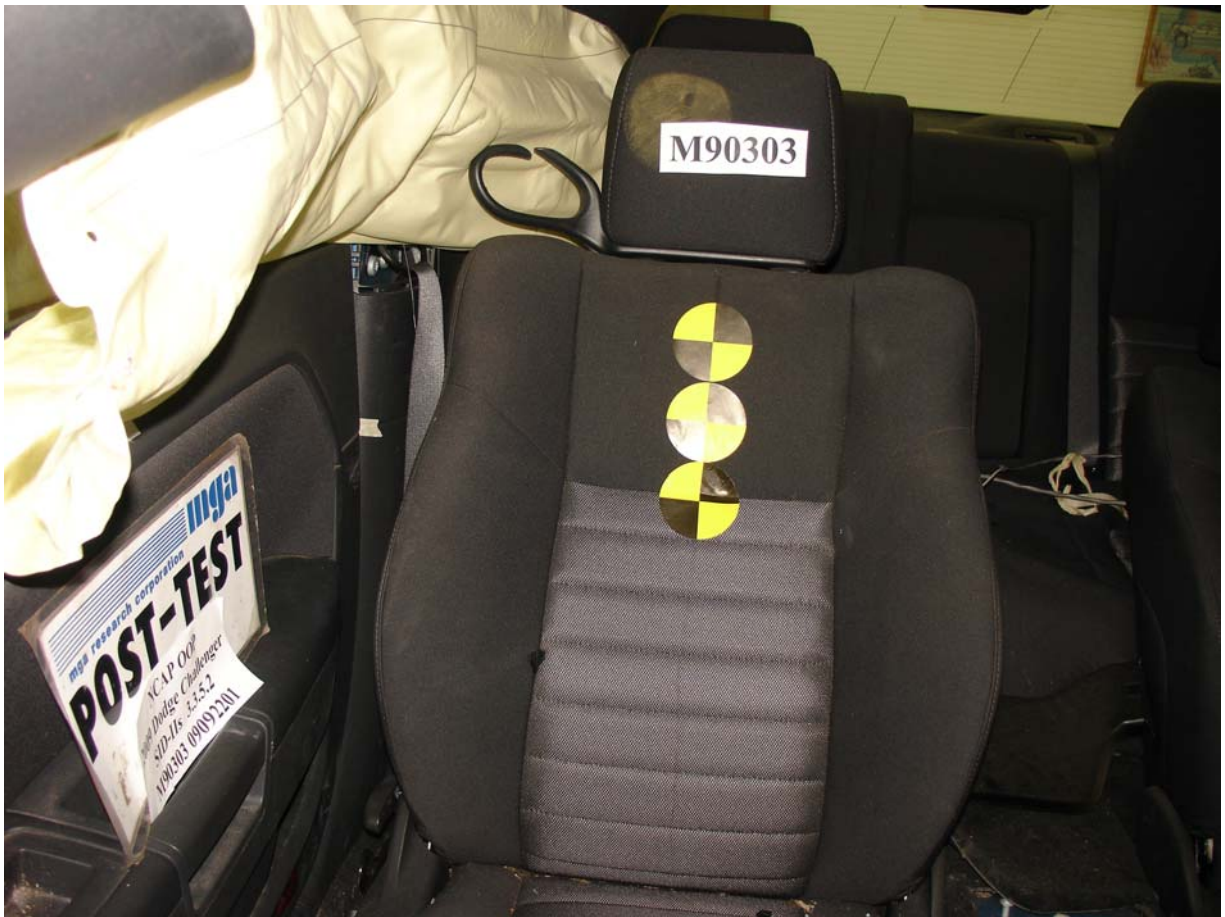
Post-Test Curtain Airbag Front View
