**REPORT NUMBER: TWG-MGA-2009-005**

**SIDE AIRBAG OUT-OF-POSITION INJURY  
TECHNICAL WORKING GROUP**

**CHRYSLER LLC  
2009 DODGE JOURNEY  
NHTSA NUMBER: M90300TWG2**

**FINAL REPORT**

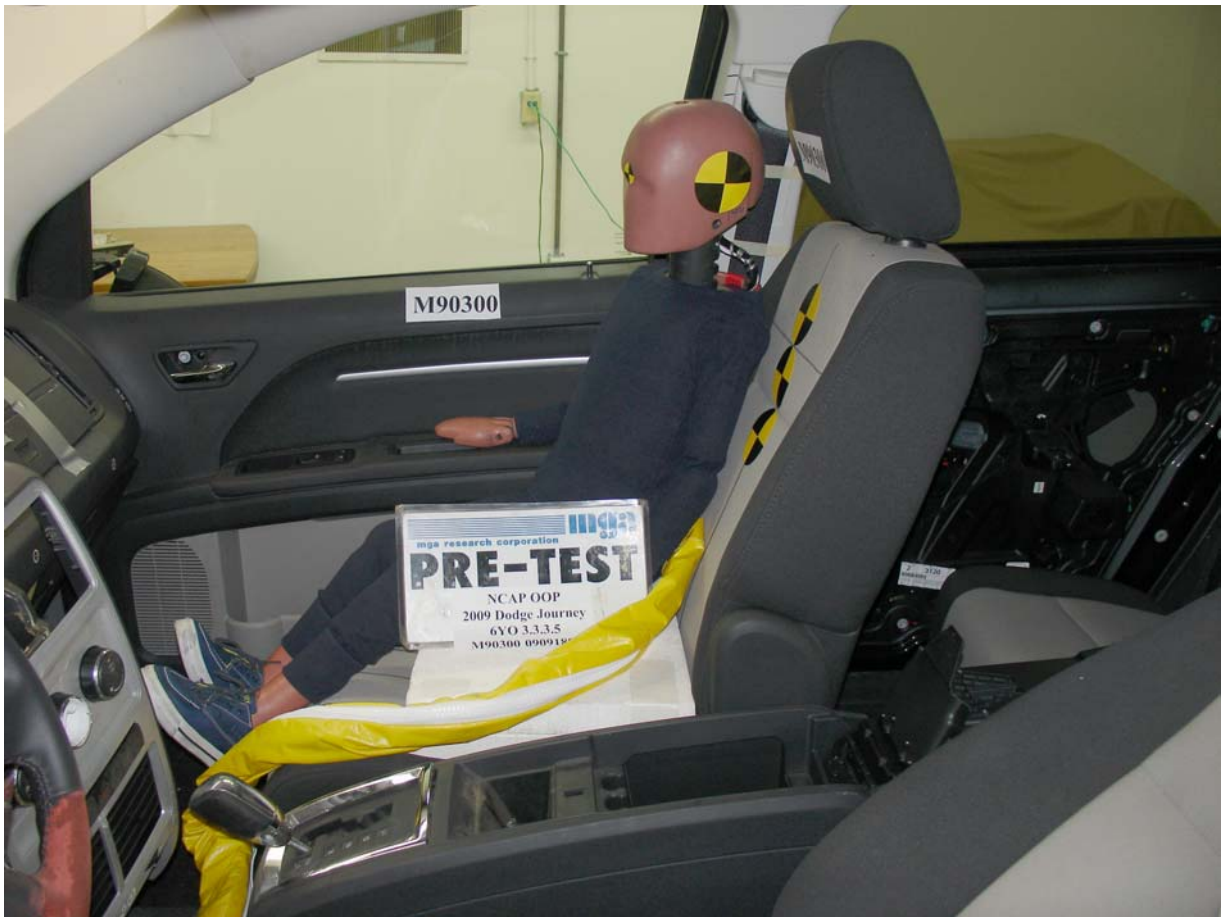
Pre-Test 6-Year-Old Child Dummy Left Side View

The Hybrid III 6-Year-Old child dummy was placed in the right front passenger seat along the outboard edge of the foam block, aligning the upper spine with the deployment trajectory of the airbag. The dummy's head was placed in between the seat bolster and pillar/side trim. The head remained in its neutral orientation. The legs were aligned so that they cross the heel placement points that were previously marked on the seat cushion. The feet were held in place and the pelvis slid forward and parallel to the centerline of the vehicle until the dummy's head/neck junction was aligned vertically with the top edge of the airbag module. The legs were then repositioned so that they cross the heel placement points. With the vehicle door closed, the dummy's outboard arm was raised to clear the armrest and the pelvis and upper torso was slid outboard until the pelvis or torso contacted the door. The outboard arm was placed on the armrest. The inboard arm was flexed so that the upper arm contacted the seat back and the fingertips contacted the foam block.

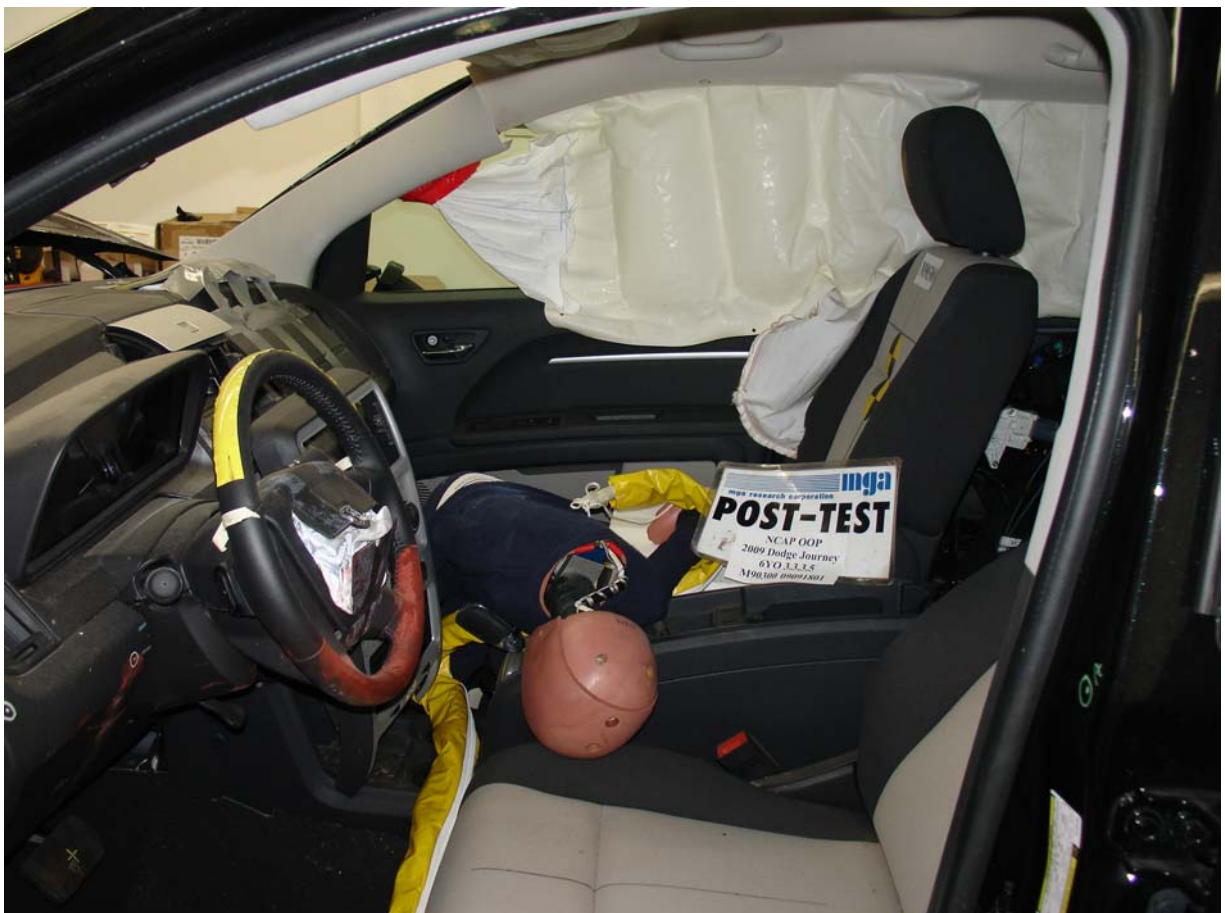
Post-Test 6-Year-Old Child Dummy Left Side View

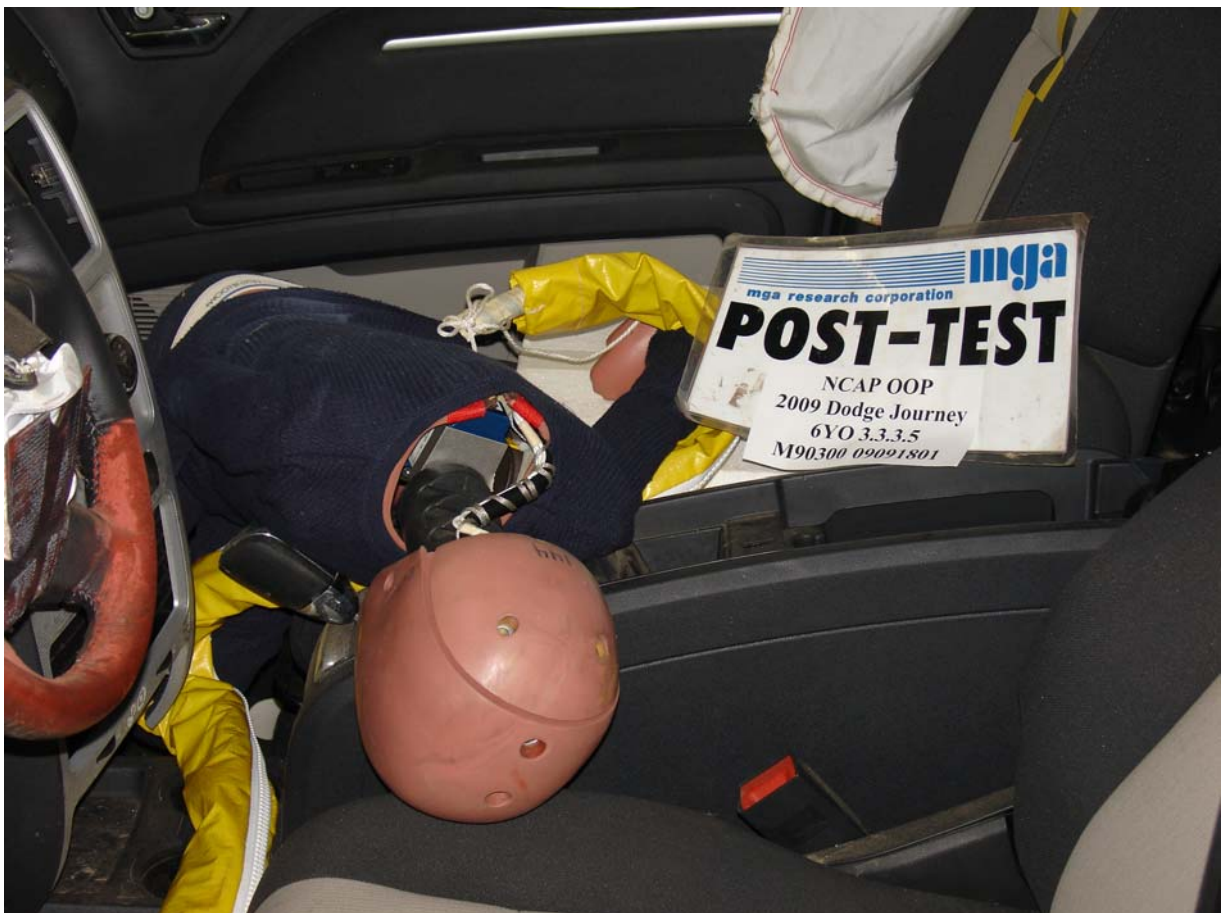
Post-Test 6-Year-Old Child Dummy Left Side Closeup View

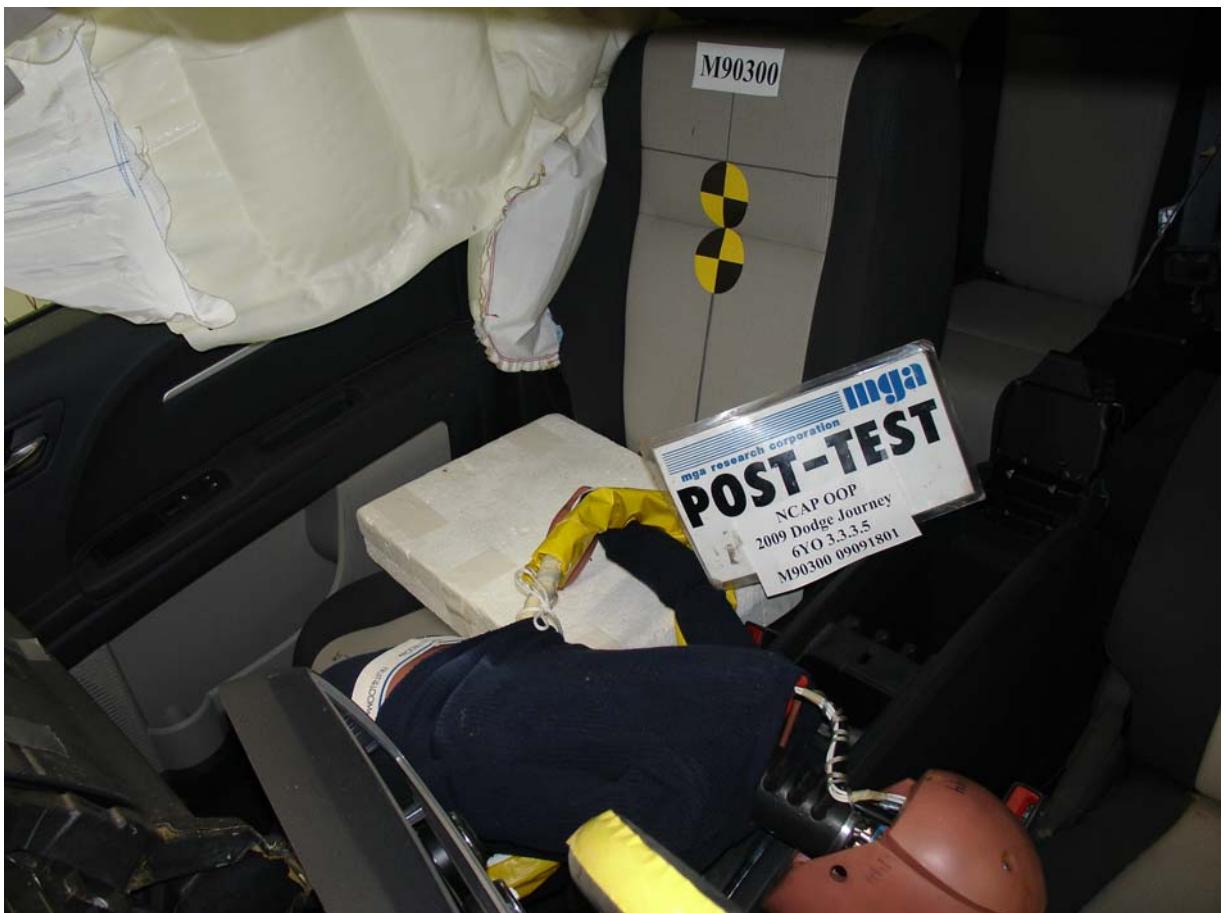
Post-Test 6-Year-Old Child Dummy Left  $\frac{3}{4}$  Front View

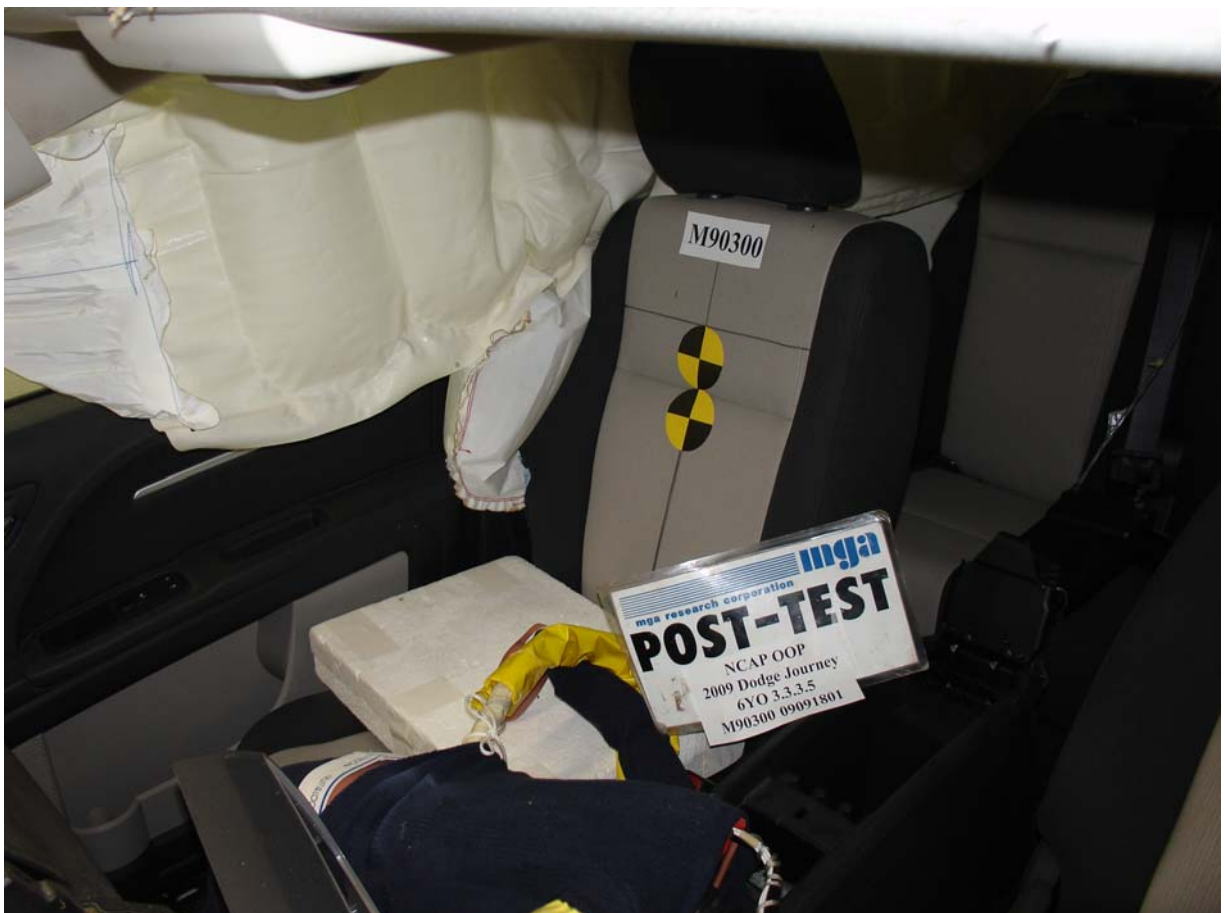
Post-Test 6-Year-Old Child Dummy Left  $\frac{3}{4}$  Front Closeup View

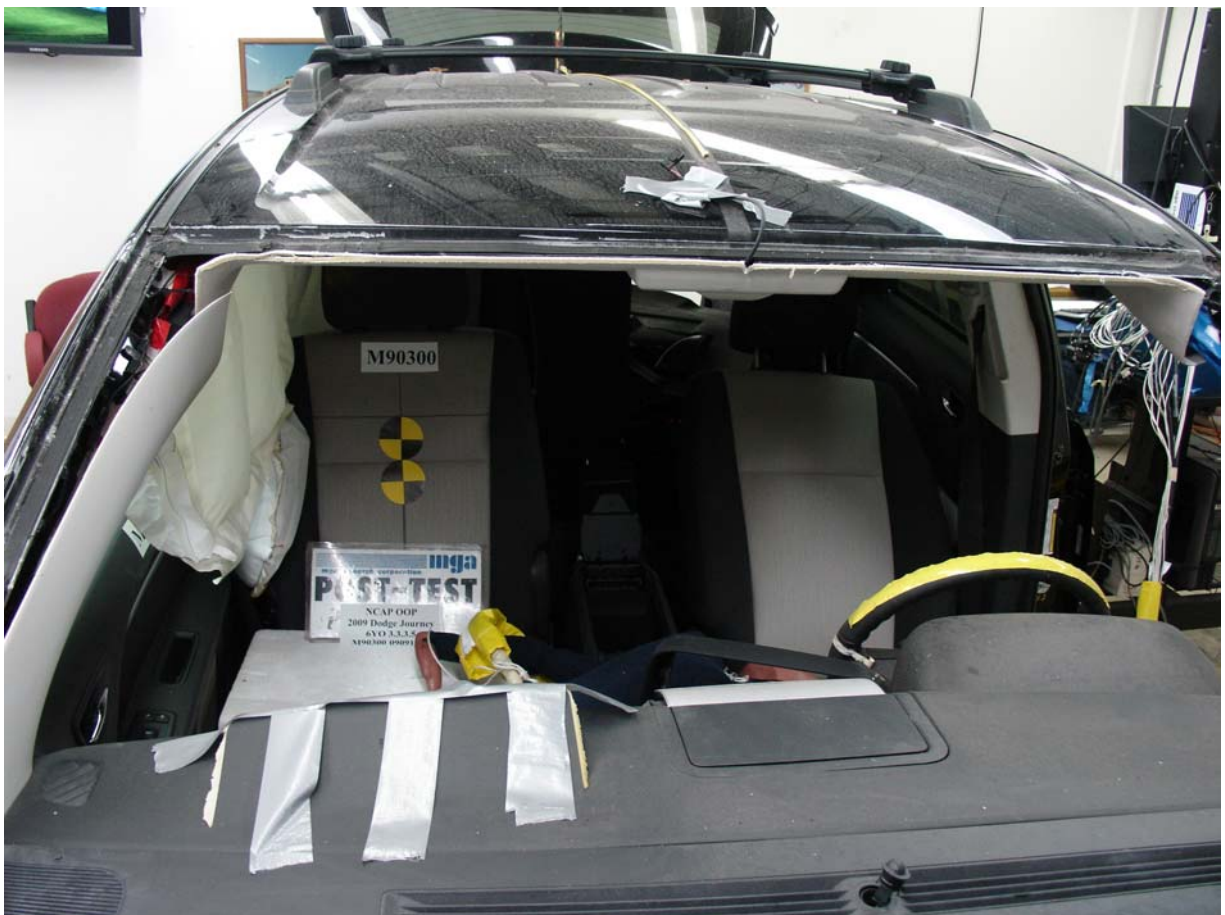
Post-Test 6-Year-Old Child Dummy Front View

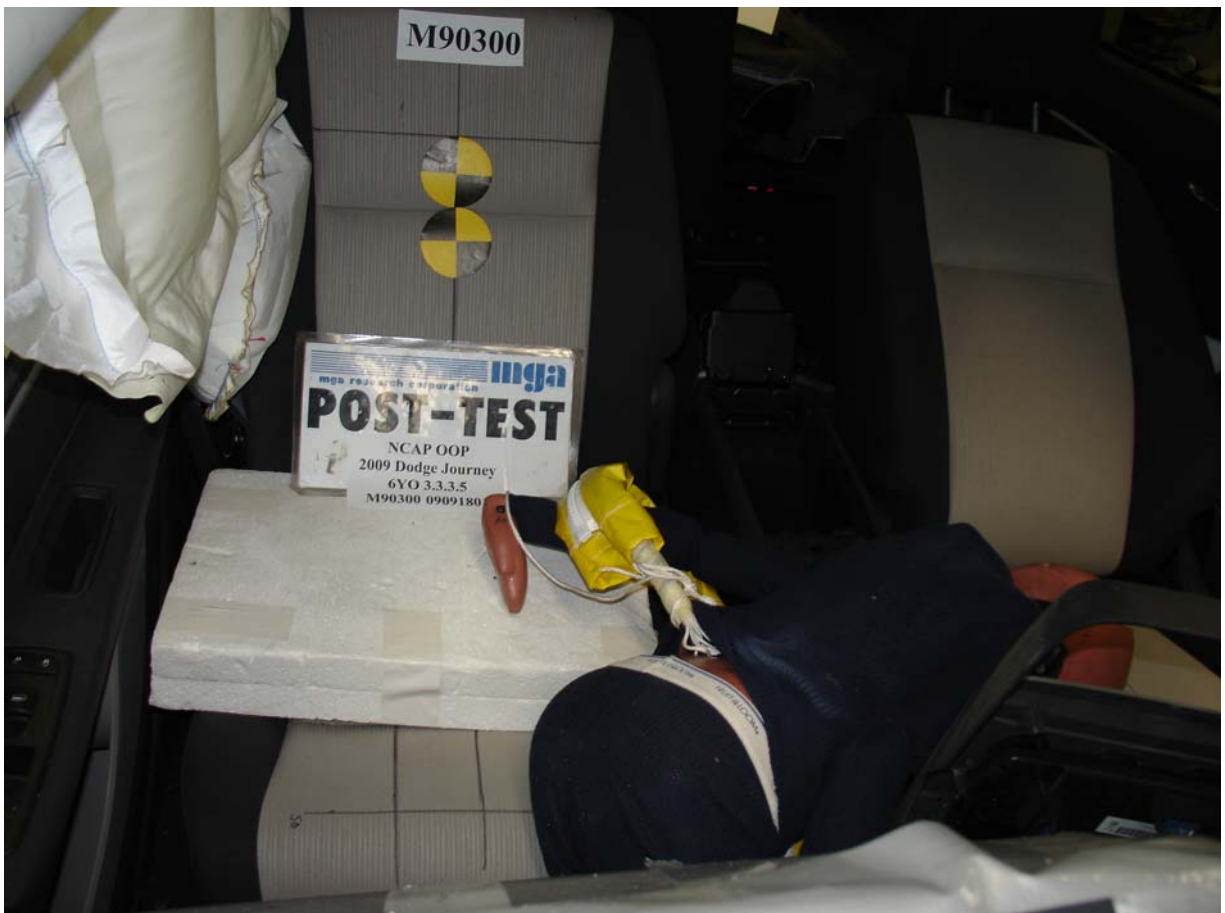
Post-Test 6-Year-Old Child Dummy Front Closeup View

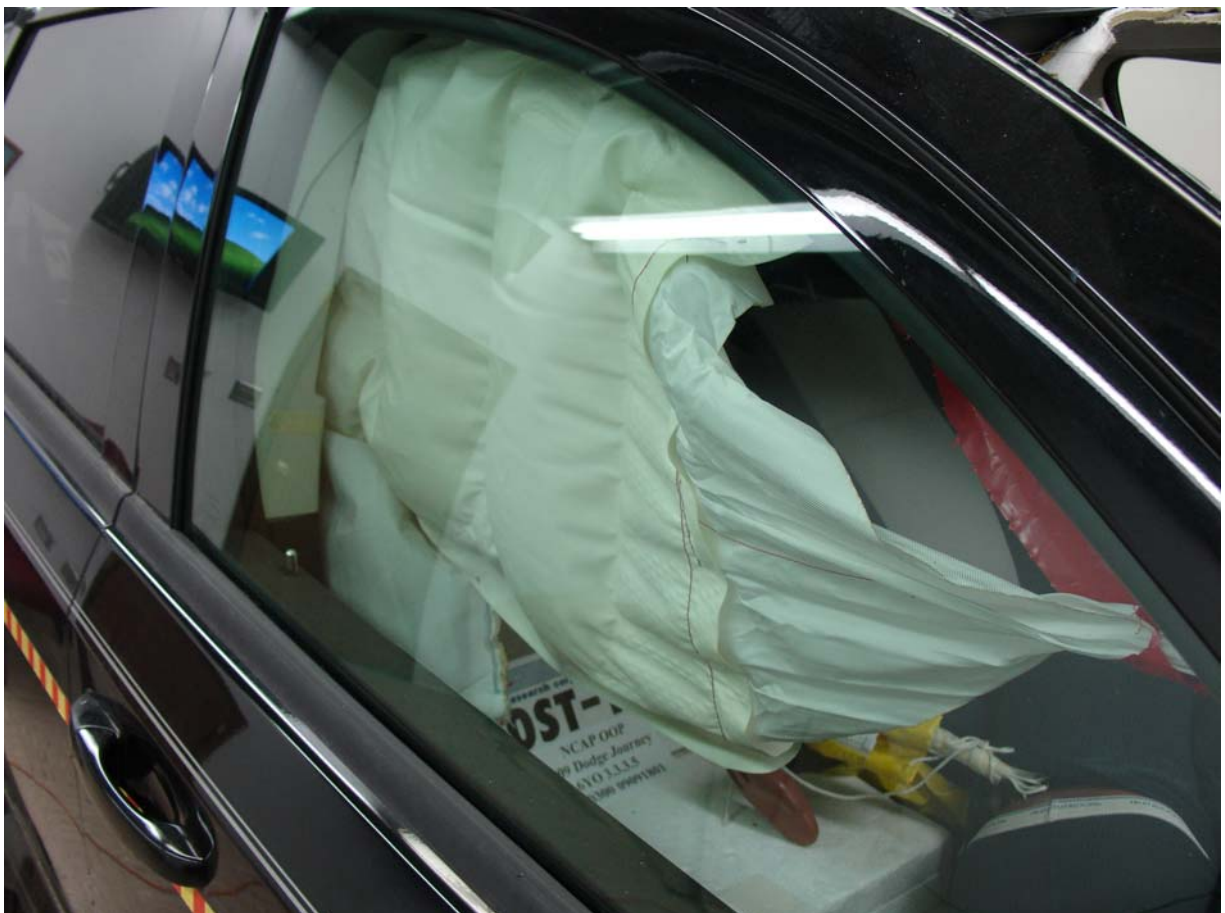
Post-Test 6-Year-Old Child Dummy Right  $\frac{3}{4}$  Front View

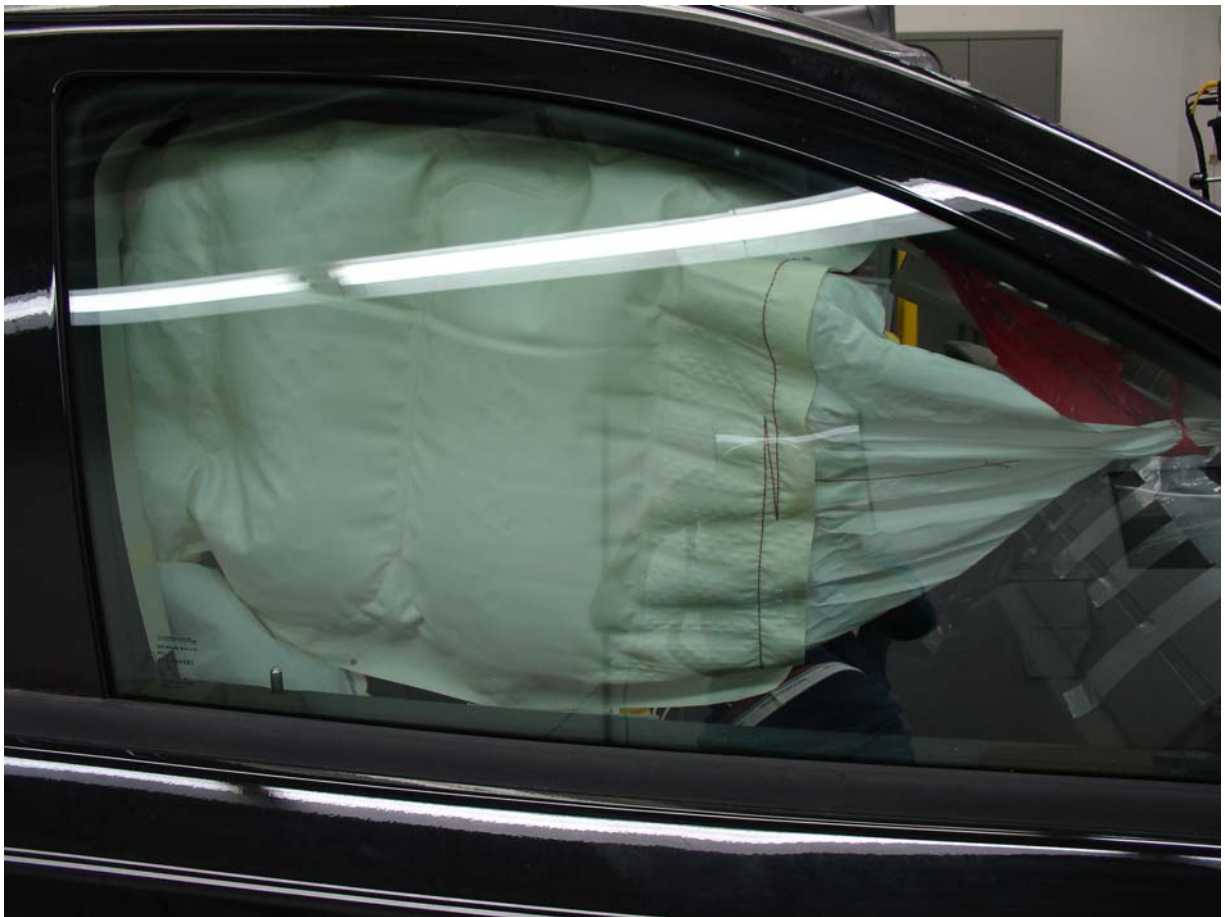
Post-Test 6-Year-Old Child Dummy Right Side Closeup View

- Curtain airbag to right side and back of head.
- Torso bag to right side of torso

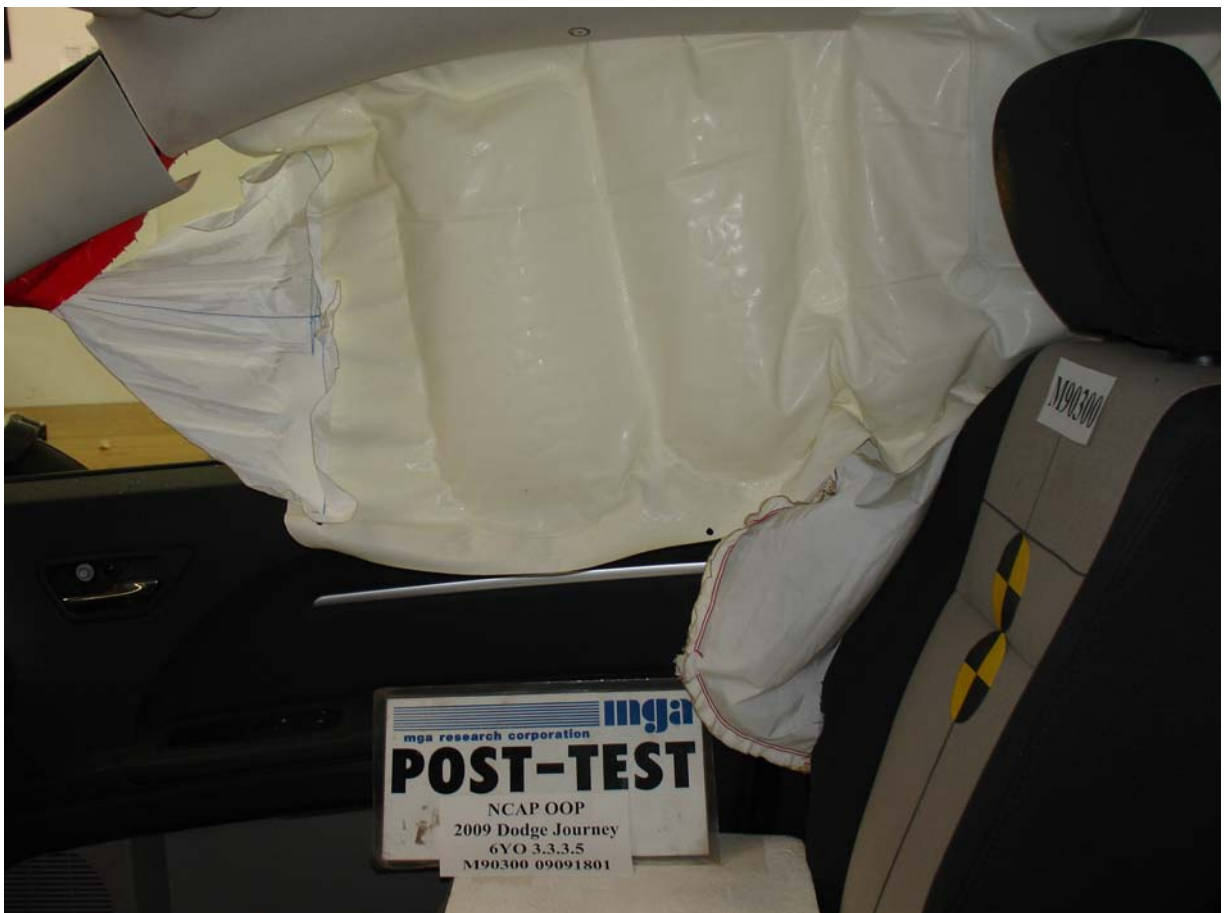
Post-Test Right Front Passenger Compartment View

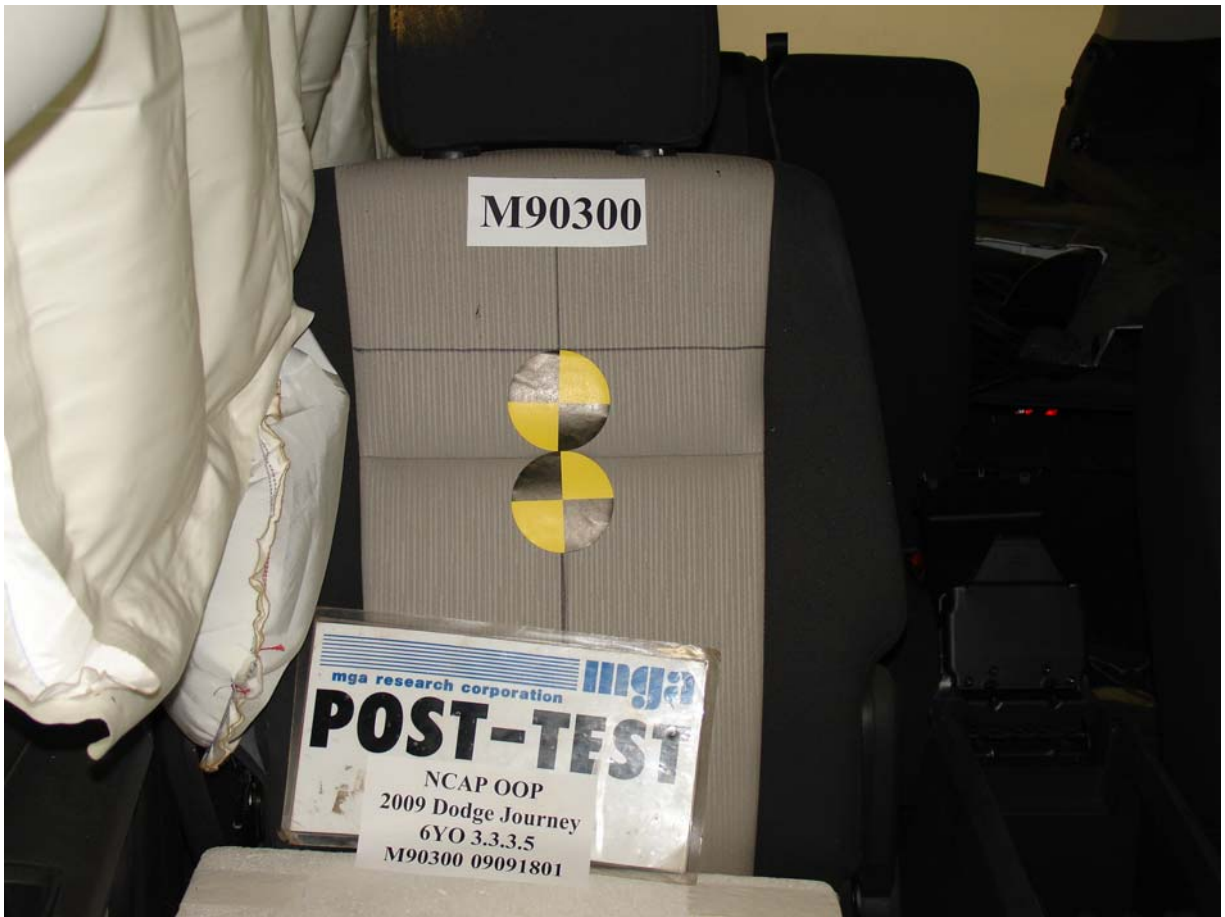
Post-Test Curtain and Torso Airbag Front View

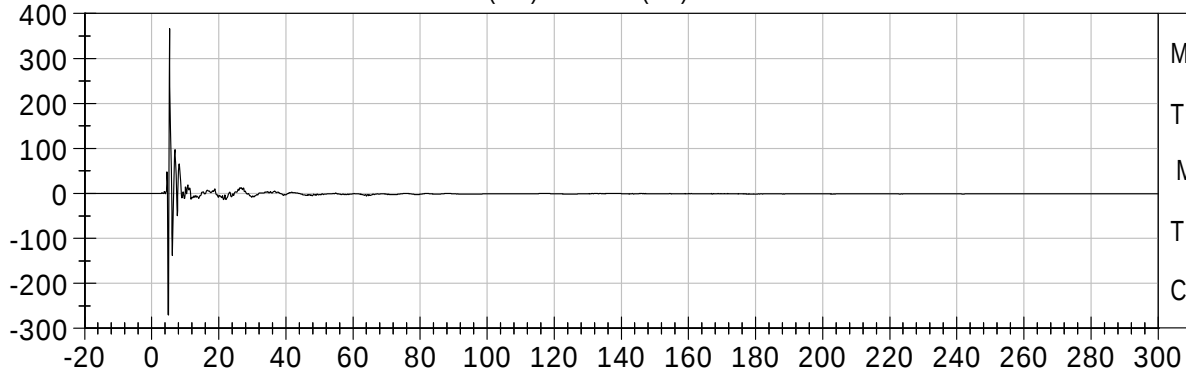
PASSENGER LOWER STERNUM X (G's) vs TIME (ms)

| DESCRIPTION | UNIT | MAXIMUM VALUE | | | |
|---|---|---|---|---|---|
| Lower Sternum X | G | 366.1 | 5.32 | -270.4 | 5.0 |
