REPORT NUMBER: TWG-CAL-09-02

**NEW CAR ASSESSMENT PROGRAM (NCAP)**  
SIDE AIRBAG OUT-OF-POSITION INJURY TESTING

MITSUBISHI MOTORS NORTH AMERICA  
2009 MITSUBISHI GALANT  
4-DOOR SEDAN

FINAL REPORT

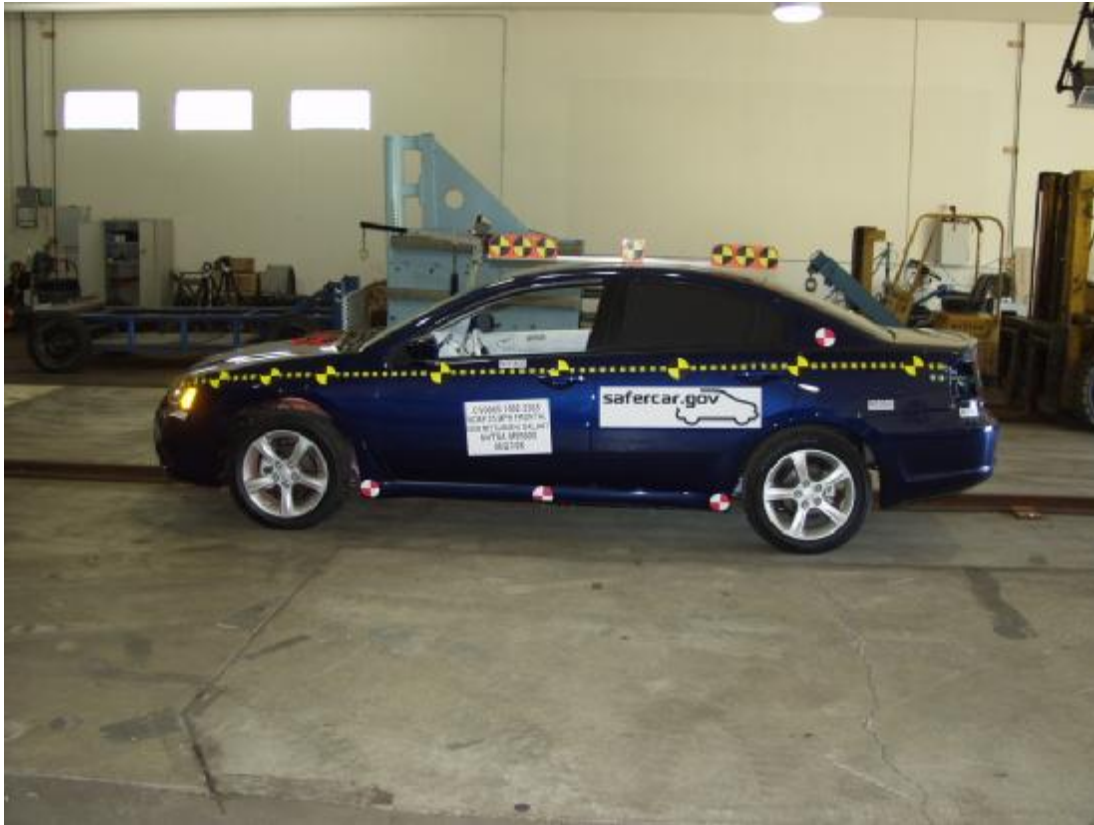
Figure A-1: Pre-Test Vehicle Left Side View

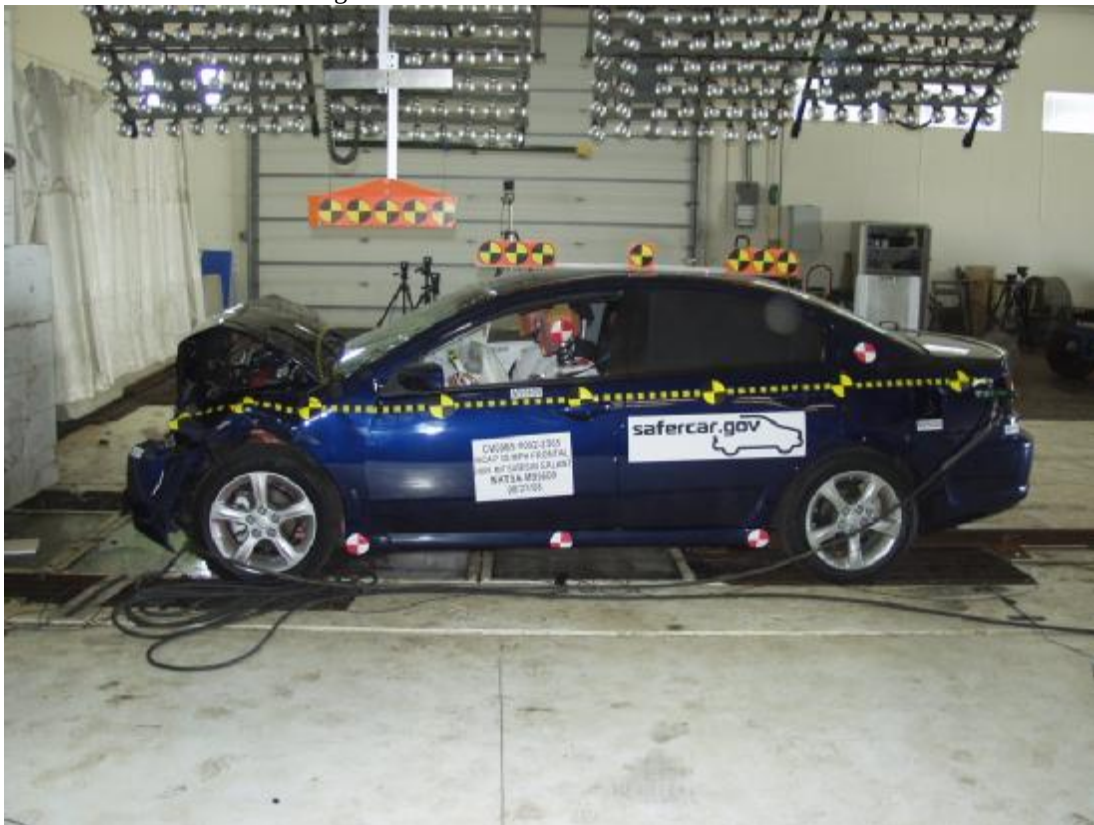
Figure A-2: Post-Test Vehicle Left Side View

‡Vehicle had previously undergone a New Car Assessment Program Barrier Impact Test on August 27, 2008.

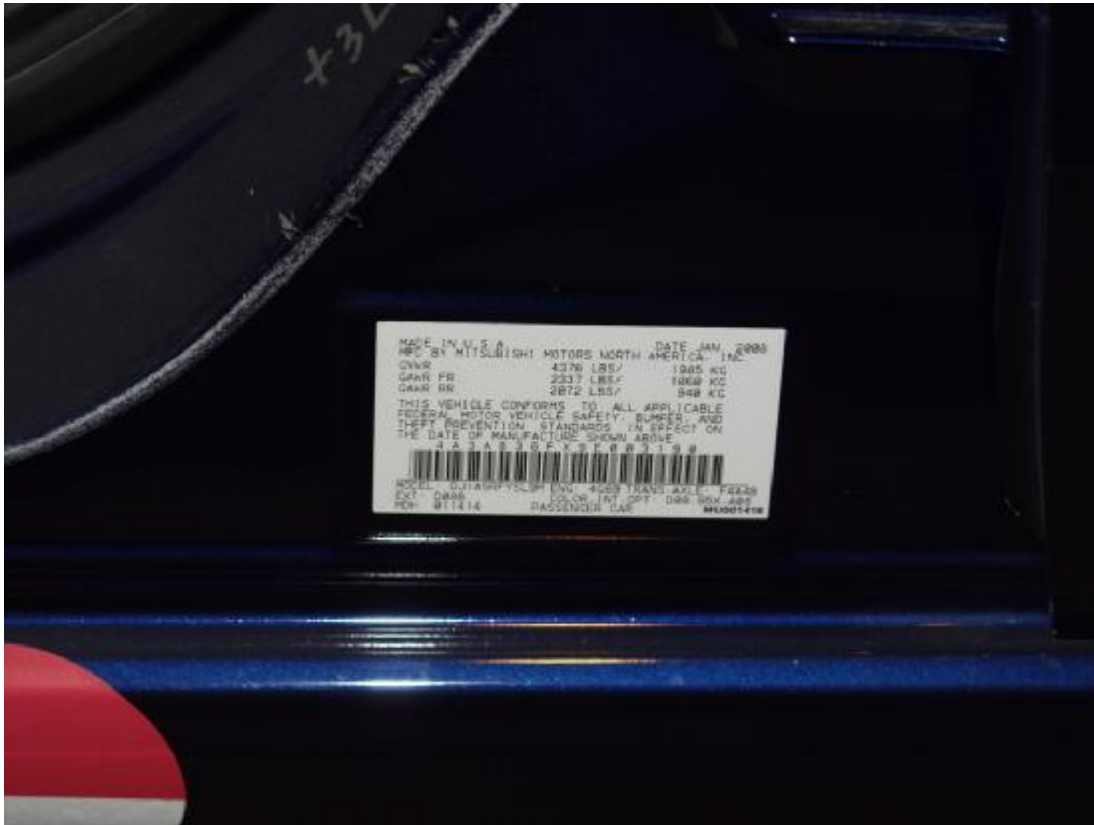
Figure A-3: Vehicle Certification Placard

Vehicle Manufactured by: Mitsubishi Motors North America

Date of Manufacture 01/08

GVWR: 1985 kg; GAWR: 1060 kg FRONT; 940 kg REAR

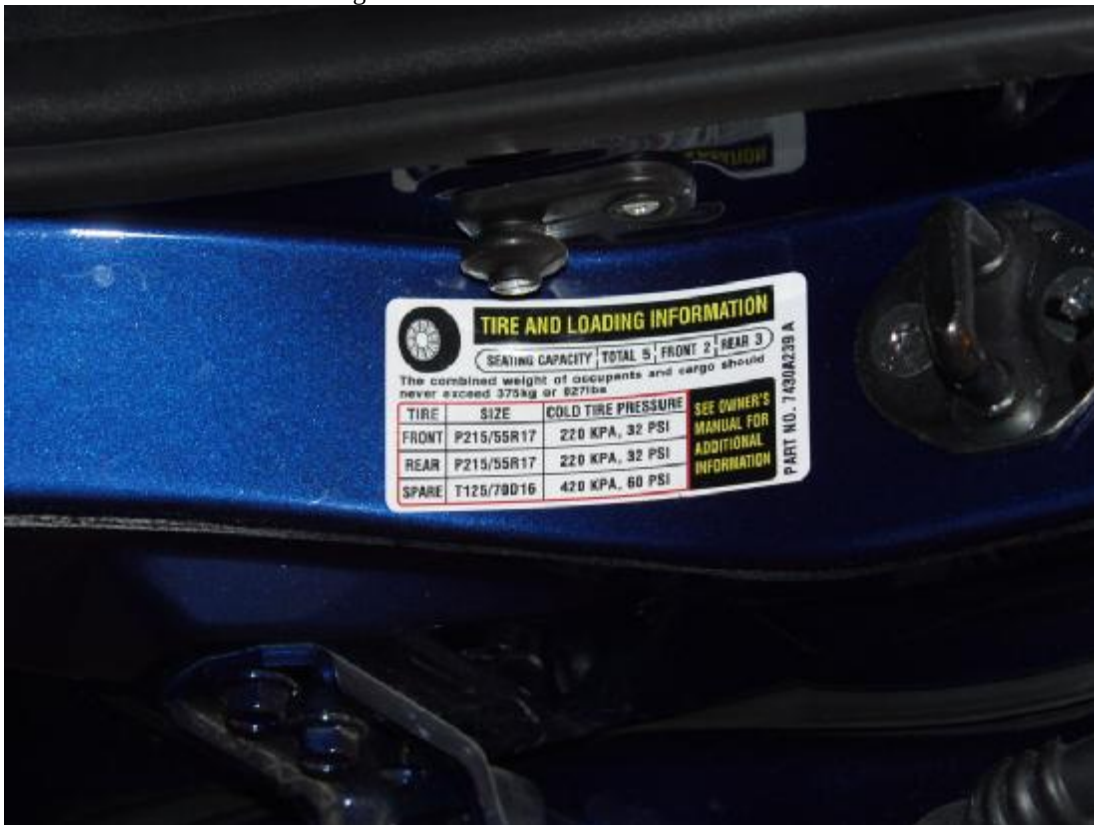
Figure A-4: Vehicle Tire Placard

Recommended Tire Size: P215/55R17

\* Recommended Cold Tire Pressure: 220 kPa FRONT; 220 kPa REAR

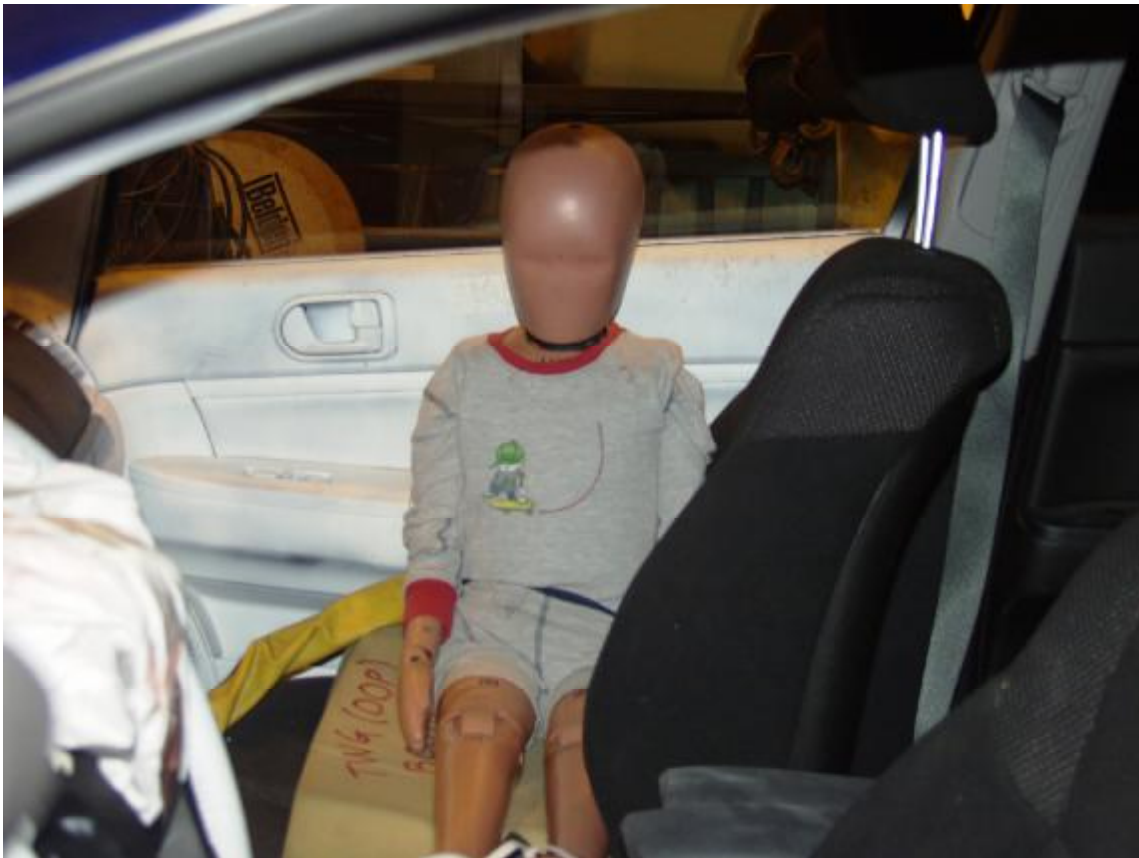
Figure A-5: Pre-Test Frontal View of Dummy

The six-year old child dummy was placed with its arms hanging at its sides on the foam block facing inboard with its legs extended. The seat track was adjusted to 40 mm rearward of full forward to minimize the vertical distance between the dummy's head and the roof-rail module and to maximize the cushion to head interaction. While keeping the head in neutral orientation, the dummy's pelvis was moved outboard until the dummy's back contacted the door trim panel armrest and the center of gravity of the head was centered in the deployment trajectory of the airbag. The dummy was then moved to maintain the vertical plane through the centerline of the dummy's shoulder bolts parallel to the vehicle centerline. The dummy's arms were then bent at the elbow until the fingers contacted the booster seat. This orientation complies with section 3.3.5.1 of the TWG Recommended Procedures for Evaluating Occupant Injury Risk from Deploying Side Airbags as defined by Lund, et al and the Technical Working Group First Revision dated July, 2003.

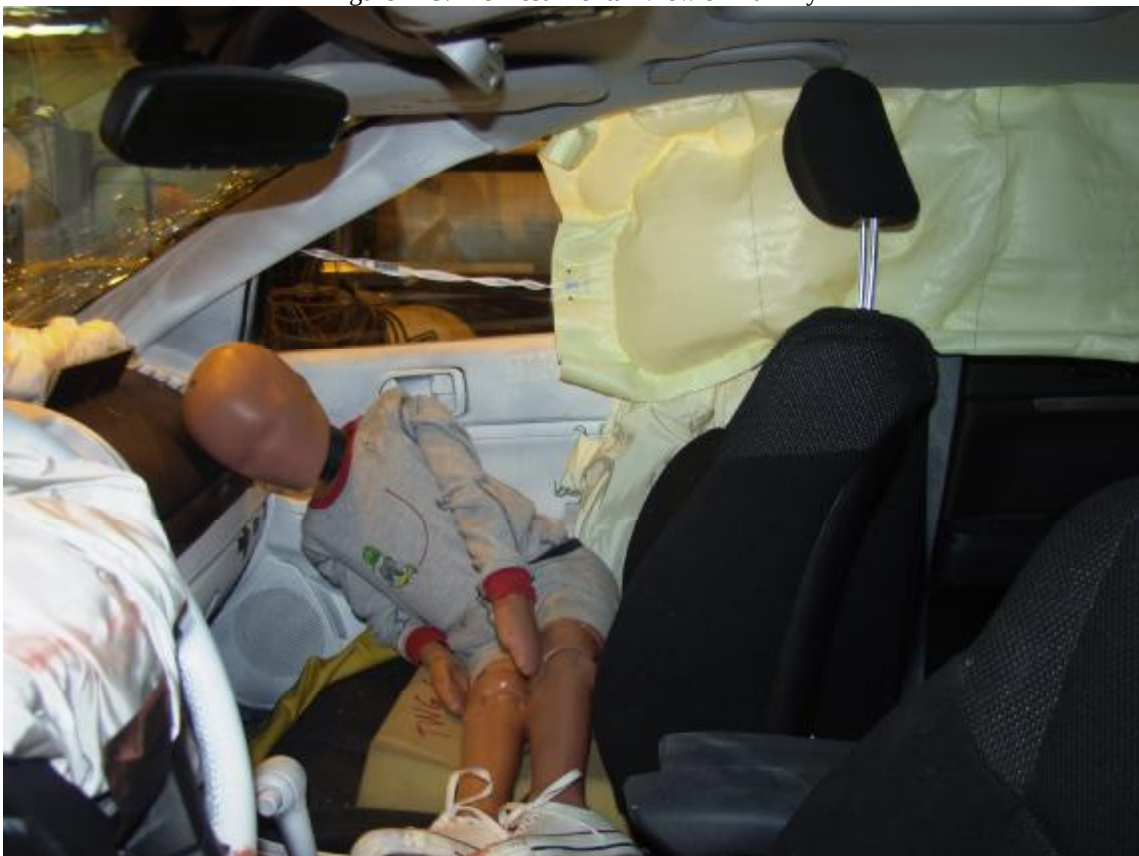
Figure A-6: Post-Test Frontal View of Dummy

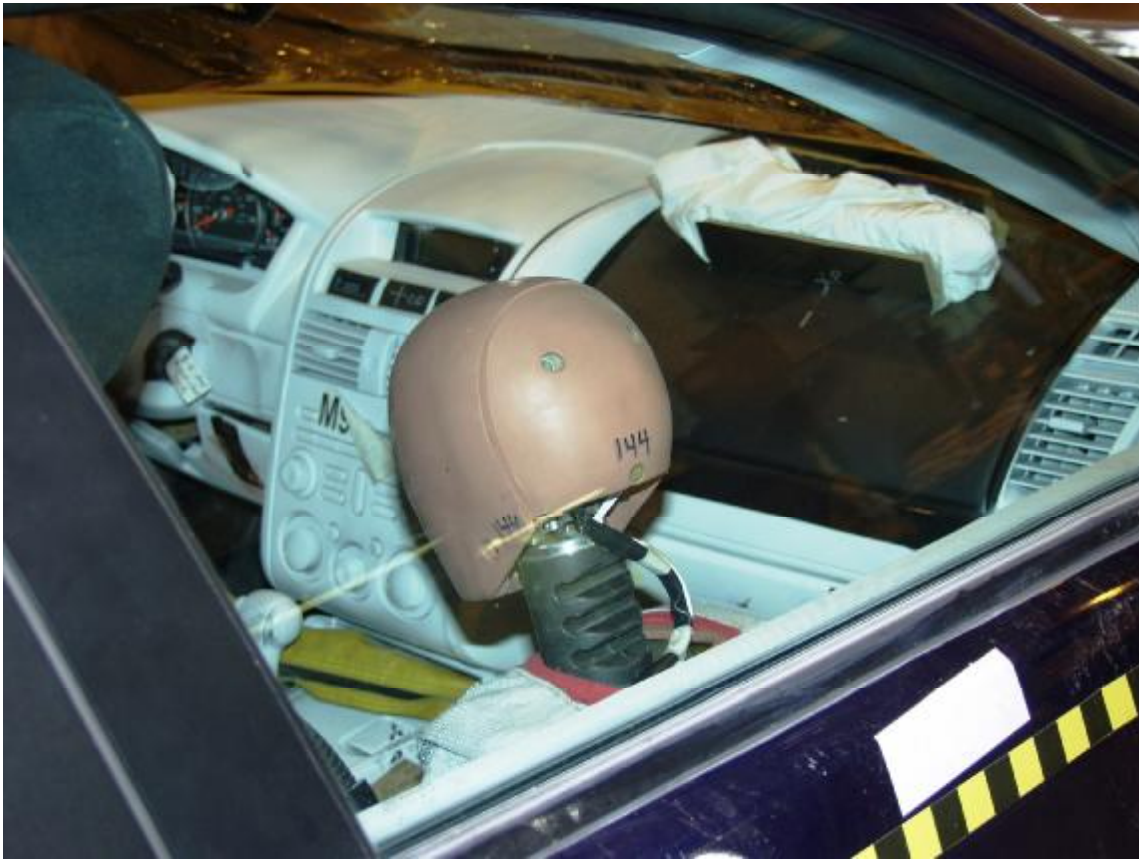
Figure A-7: Pre-Test Left Side View of Dummy

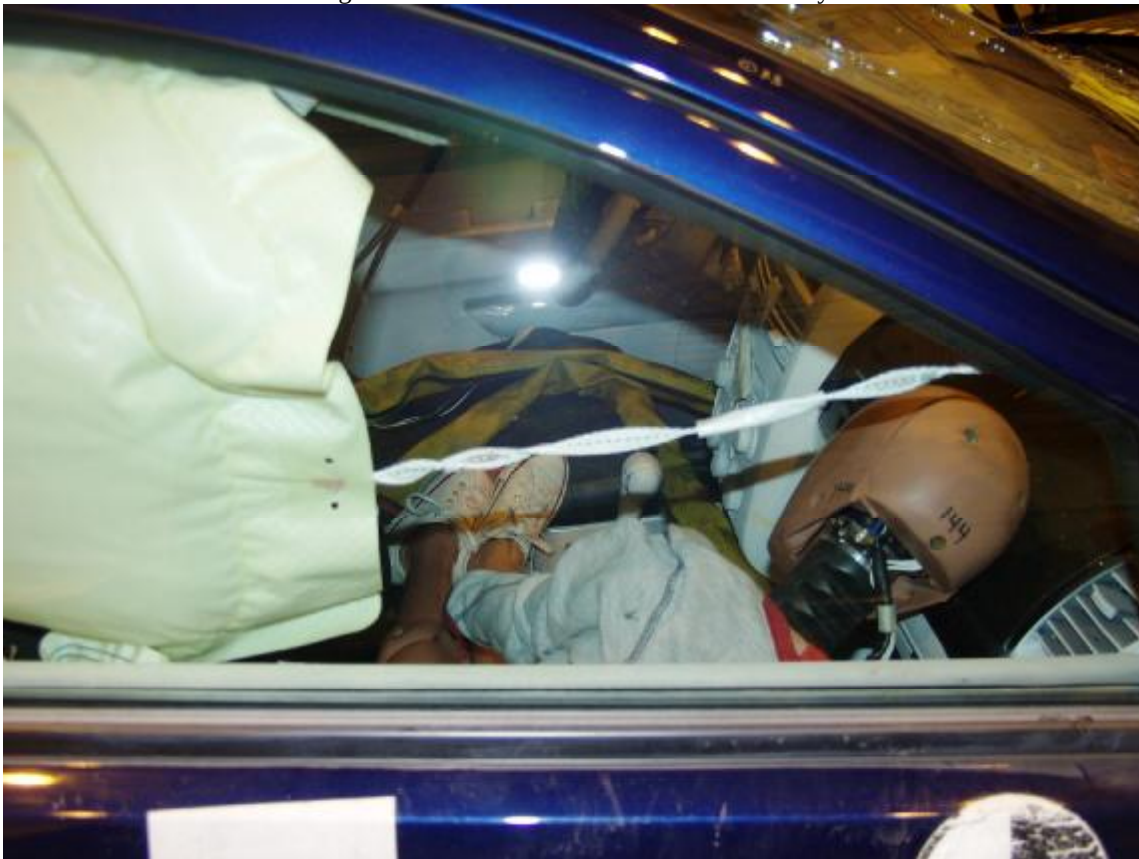
Figure A-8: Post-Test Left Side View of Dummy

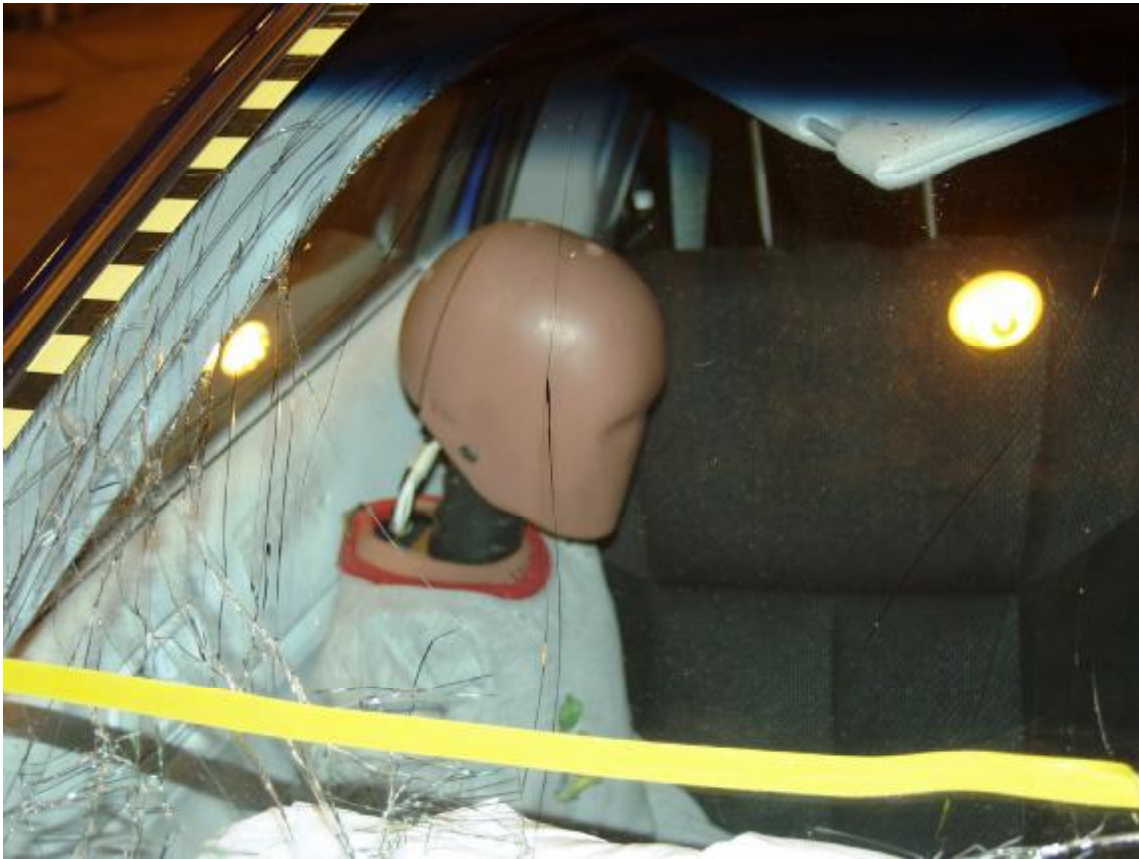
Figure A-9: Pre-Test Right Side View of Dummy

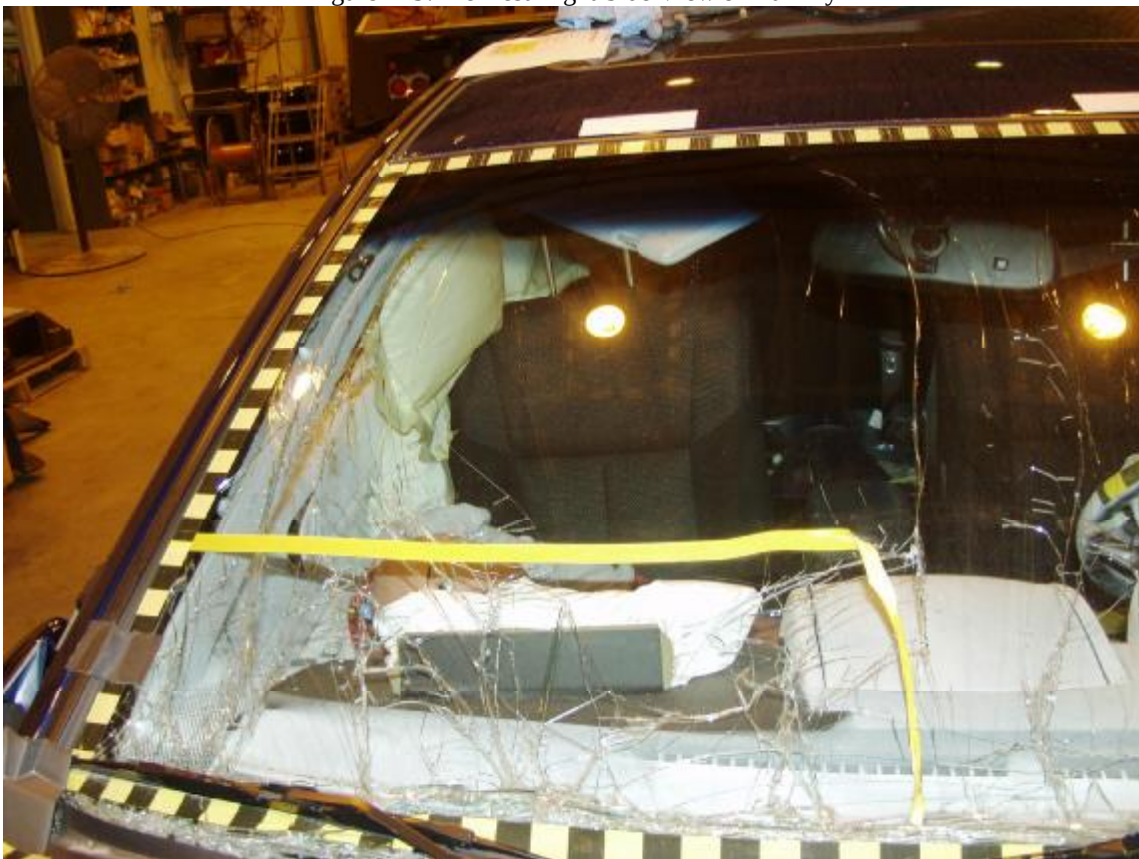
Figure A-10: Post-Test Right Side View of Dummy
