**REPORT NUMBER: NCAP-MGA-2011-001**

**NEW CAR ASSESSMENT PROGRAM (NCAP)  
Frontal Barrier Impact Test**

**HYUNDAI MOTOR MANUFACTURING ALABAMA, LLC  
2011 Hyundai Sonata GLS 4-Dr Sedan  
NHTSA No.: MB5000**

**FINAL REPORT**

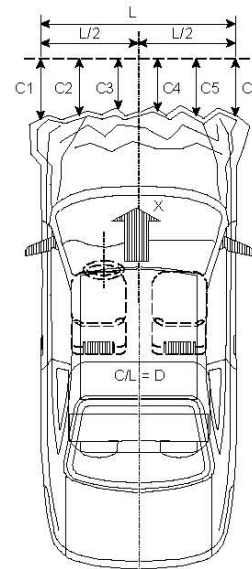
Accelerometer Locations: As per measurements on Page 16  
 Cal. Procedure/Interval: MGA procedure / 6 month  
 Integration Algorithm: Trapezoidal Linearity: > 99%  
 Impact Velocity (km/h): 56.3  
 Velocity Change (km/h): 63.7  
 Time of Separation (msec): 97.7

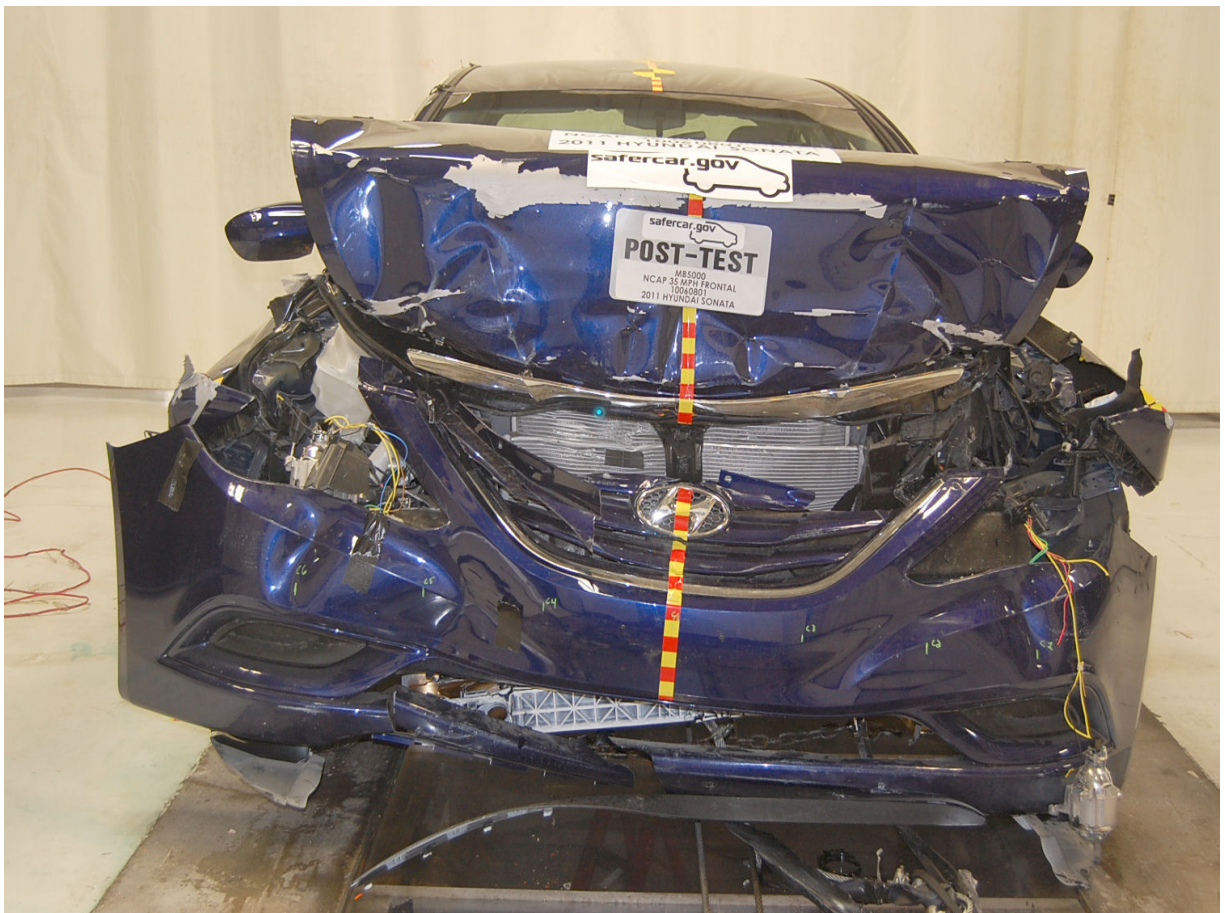
Post-Test Front View

The maximum static crush of the vehicle was 518 mm and both the driver and passenger side doors remained closed during the impact event and were operable after the impact.

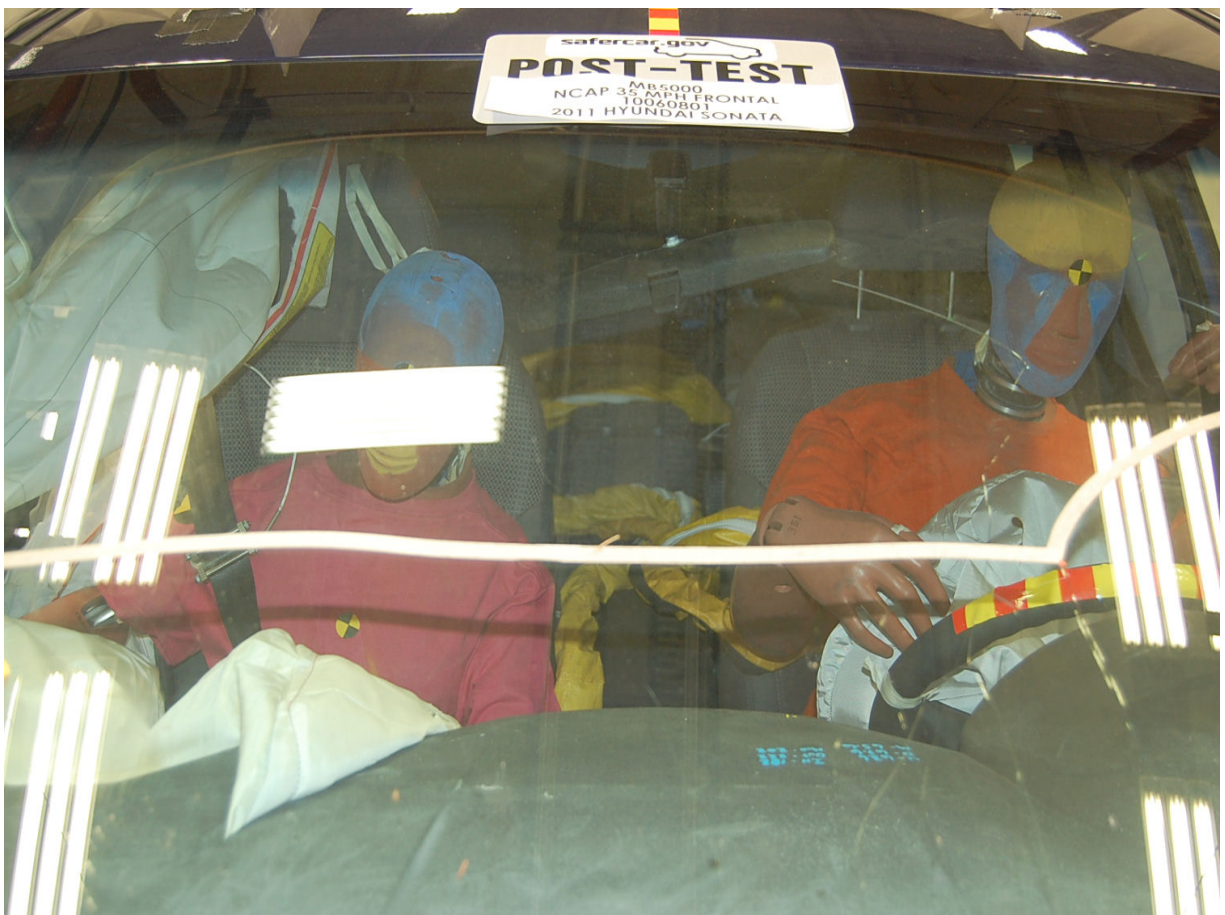
Post-Test Windshield View

There was 100 percent windshield retention and no intrusion into the protected zone of the windshield during the event. There was no Stoddard Solvent leakage after the event or during any phase of the static rollover.

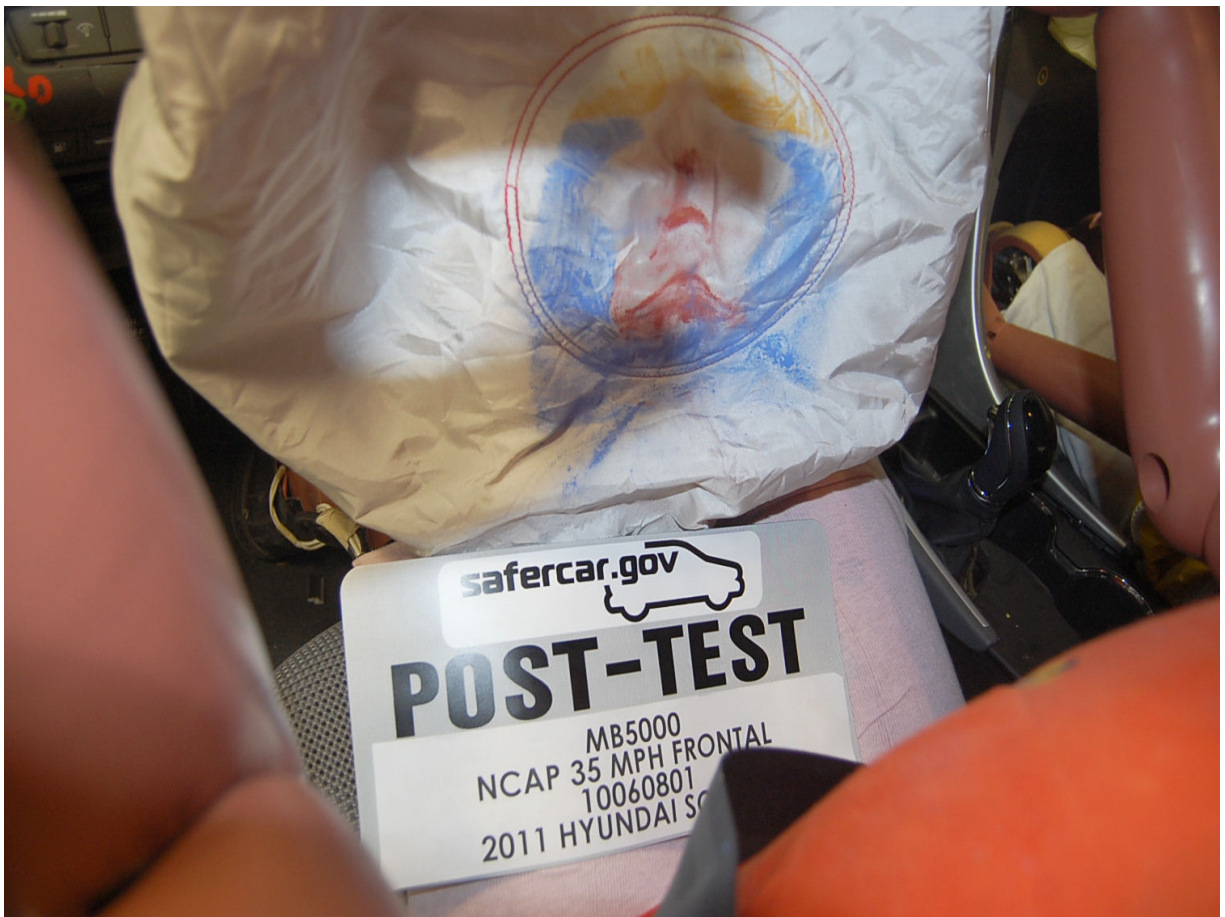
Post-Test Driver Dummy Airbag Contact

The driver's head and chest contacted the airbag. The driver's head also contacted the headrest and headliner. The driver's knees contacted the knee bolster and steering column. The passenger's head and chest contacted the airbag. The passenger's head also contacted the headrest. The passenger's left knee contacted the glove box.

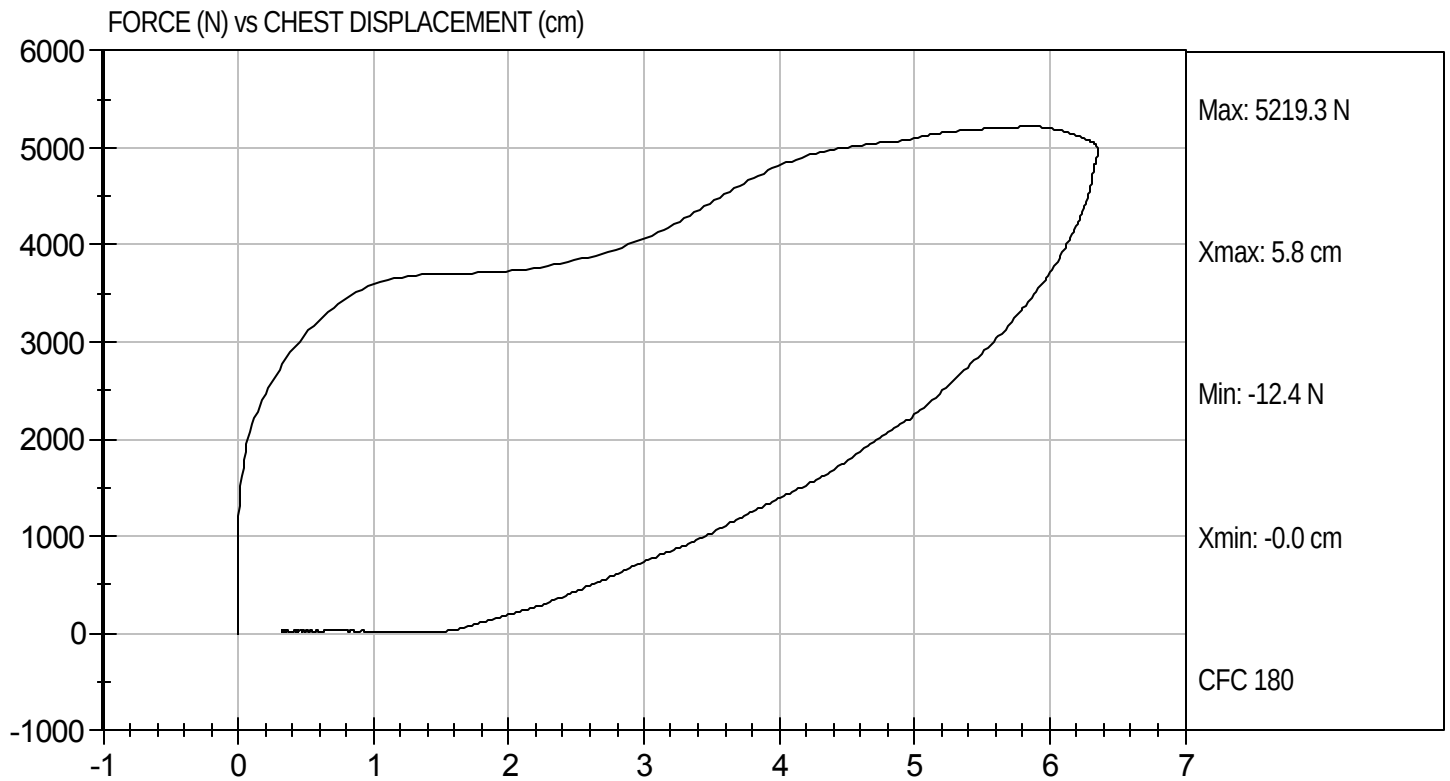
Test Desc: Thorax Impact  
Component ID: D101594

Test Date: 5/26/10  
Velocity: 22.22 ft/s, 6.77 m/s

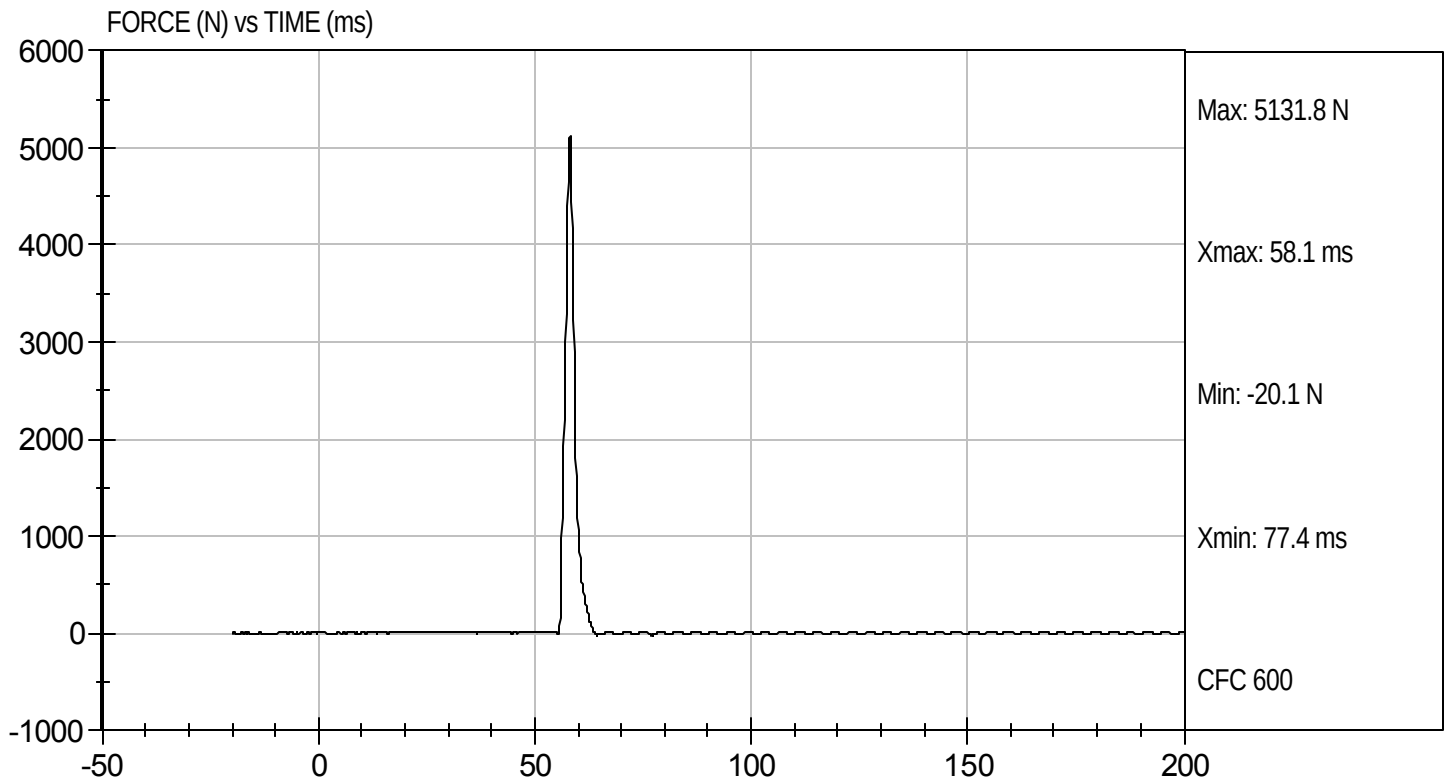
Test Desc: Right Knee  
Component ID: D101595

Test Date: 5/26/10  
Velocity: 6.92 ft/s, 2.11 m/s

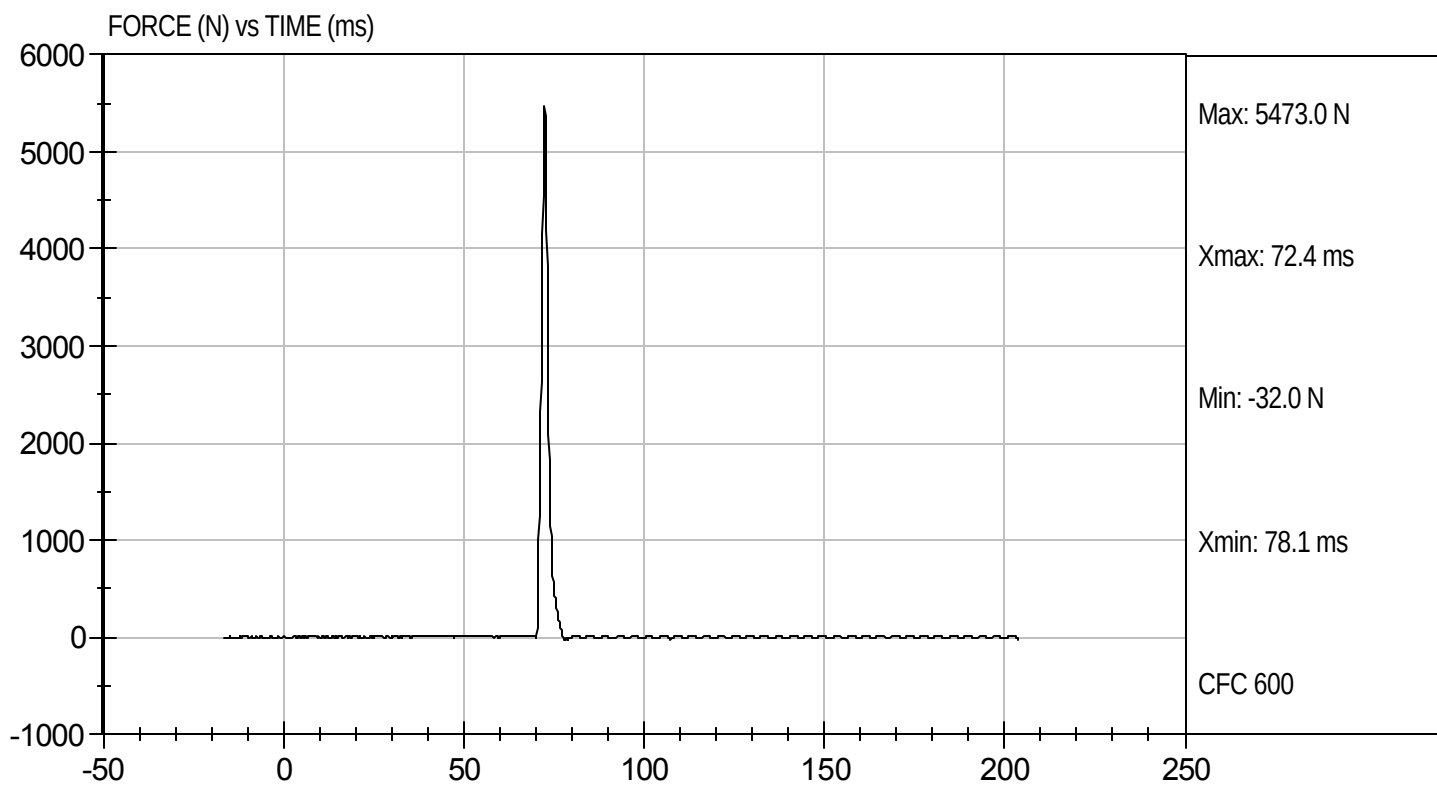
Test Desc: Left Knee  
Component ID: D101596

Test Date: 5/26/10  
Velocity: 6.83 ft/s, 2.08 m/s

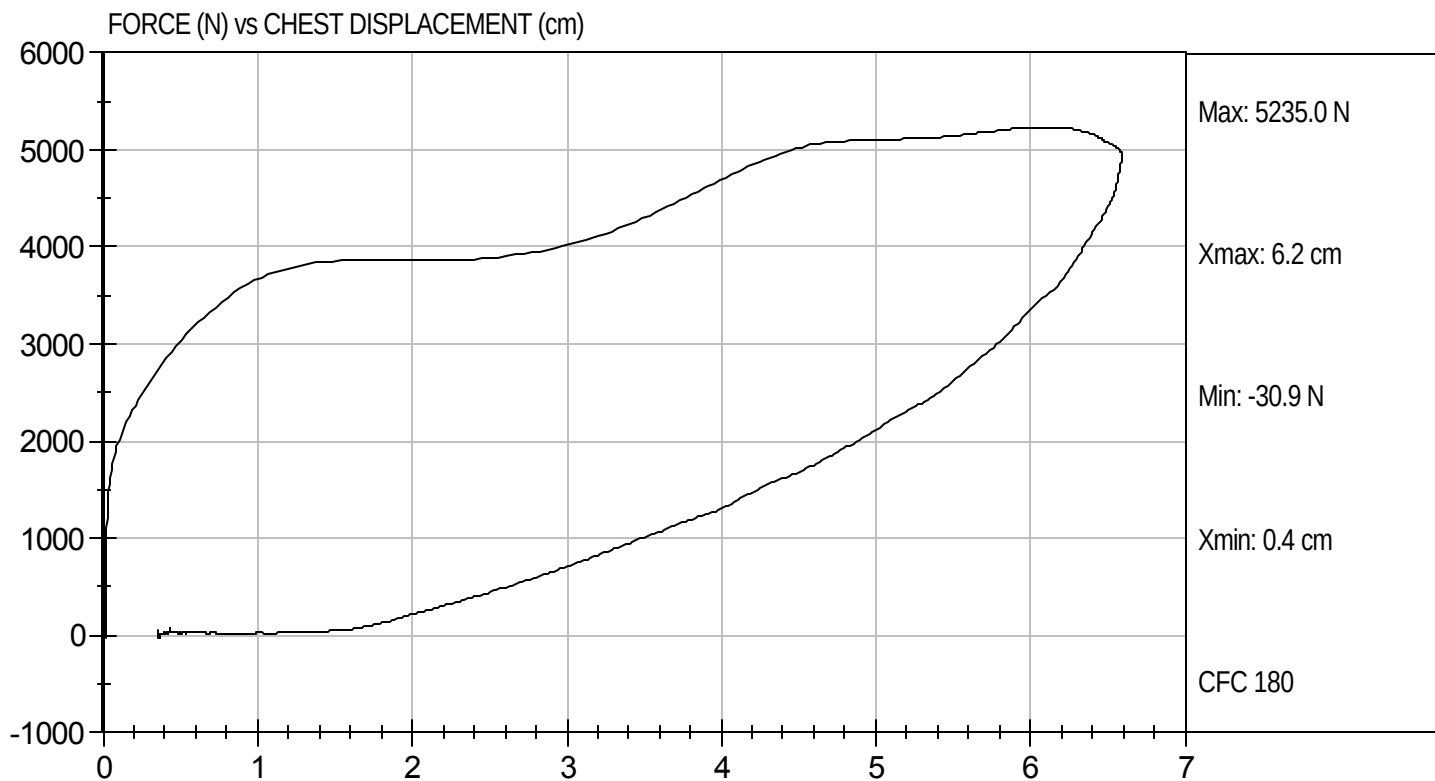
Test Desc: Thorax Impact  
Component ID: D101764

Test Date: 6/9/10  
Velocity: 21.9 ft/s, 6.68 m/s

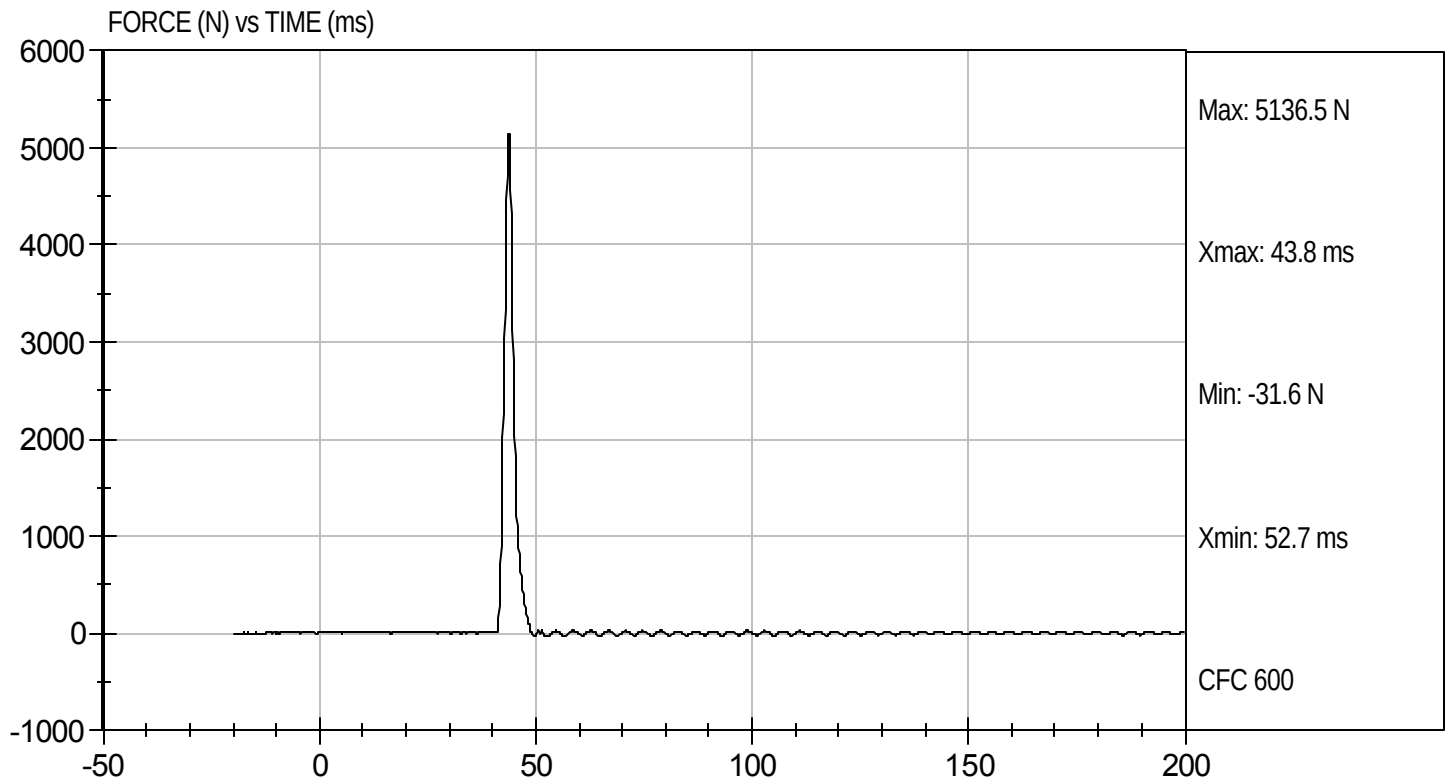
Test Desc: Right Knee  
Component ID: D101765

Test Date: 6/9/10  
Velocity: 6.92 ft/s, 2.11 m/s

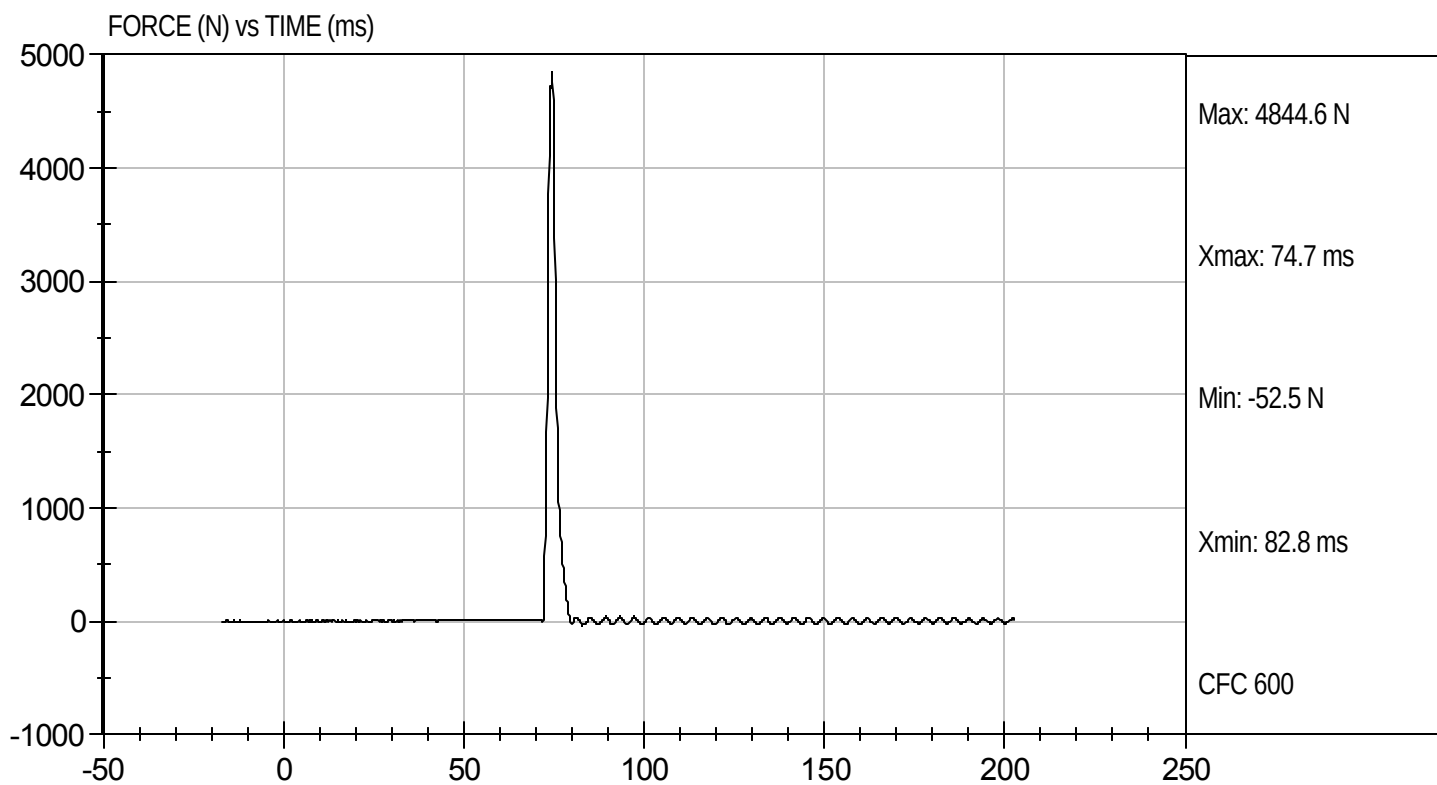
Test Desc: Left Knee  
Component ID: D101766

Test Date: 6/9/10  
Velocity: 6.86 ft/s, 2.09 m/s
