REPORT NUMBER: SPNCAP-MGA-2011-003

**NEW CAR ASSESSMENT PROGRAM (NCAP)
Side Impact Pole Test**

**HYUNDAI MOTOR MANUFACTURING ALABAMA, LLC
2011 Hyundai Sonata GLS 4-Dr Sedan
NHTSA No.: MB5002**

**MGA RESEARCH CORPORATION
5000 Warren Road
Burlington, WI 53105**

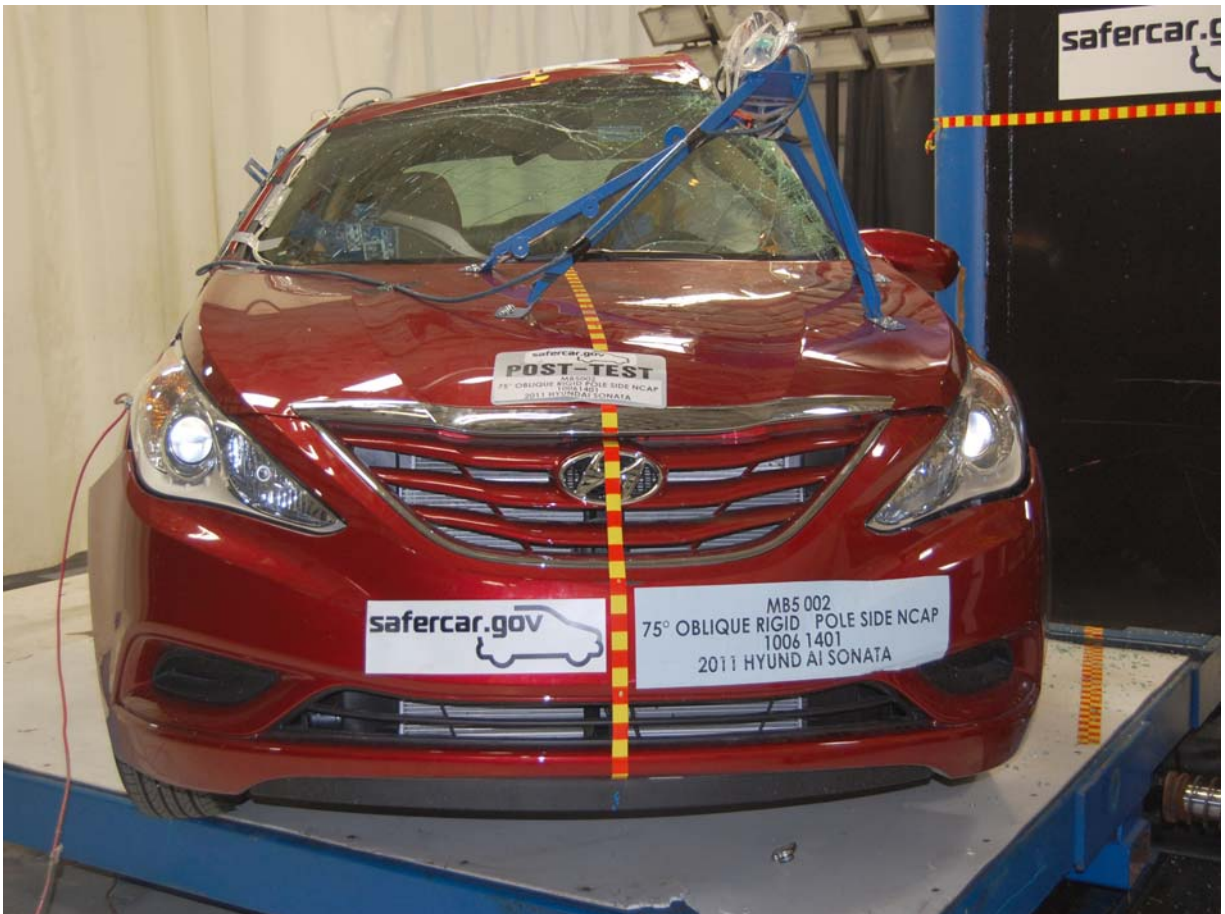
Post-Test Frontal View of Test Vehicle

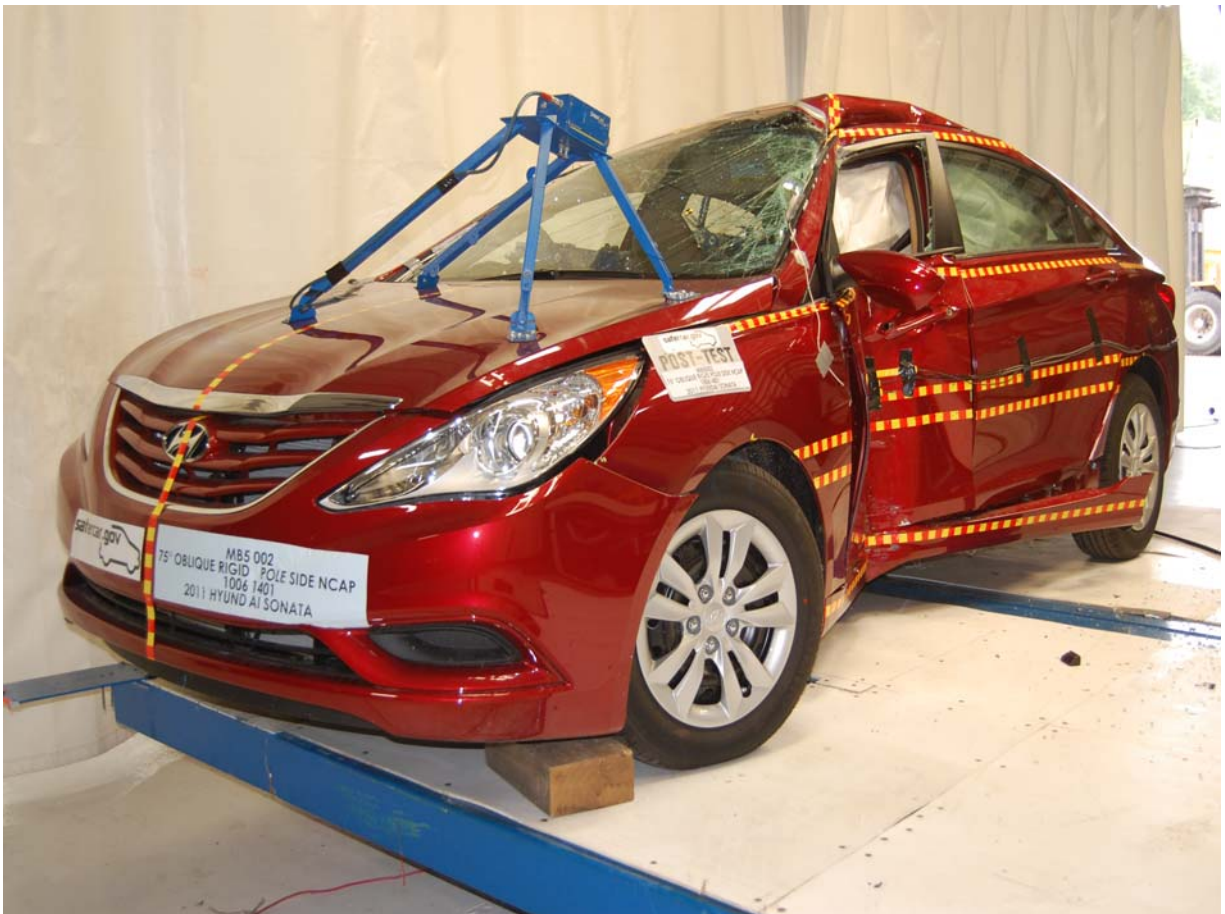
Post-Test Left Front ¾ View of Test Vehicle

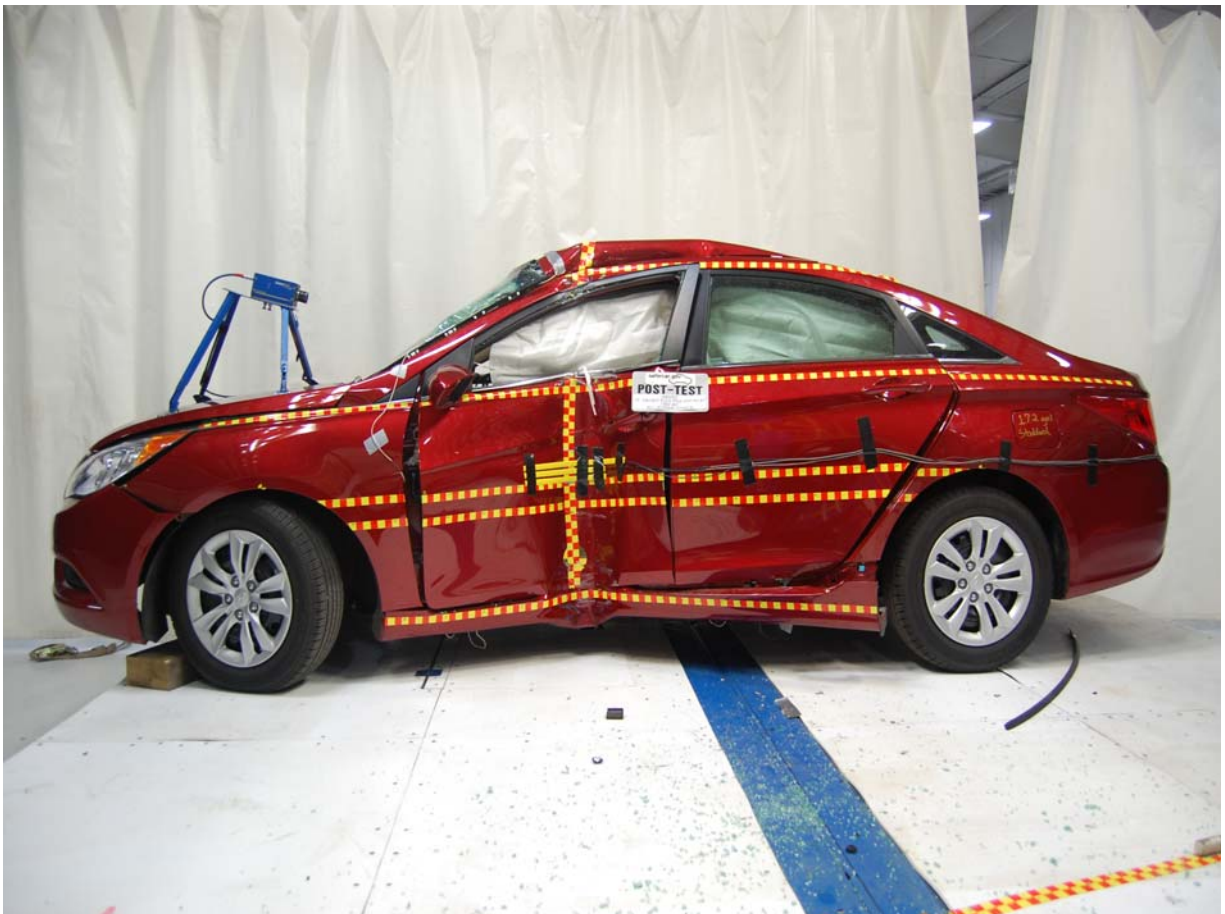
Post-Test Left Side View of Test Vehicle

Description	Front	Rear
Left Side Doors	Remained closed and jammed shut	Remained closed and jammed shut
Right Side Doors	Remained closed and operational	Remained closed and operational
Hatch and Other Doors	Remained closed and operational	Remained closed and operational
Seat Movement	0	0
Seat Back Failure	None	None

Critical Areas of Performance	Observations and Conclusions
Pillar Performance	No Separation
Sill Separation	None
Windshield Damage	Cracked
Window Damage	Left Front Window Broke
Other Notable Effects	None

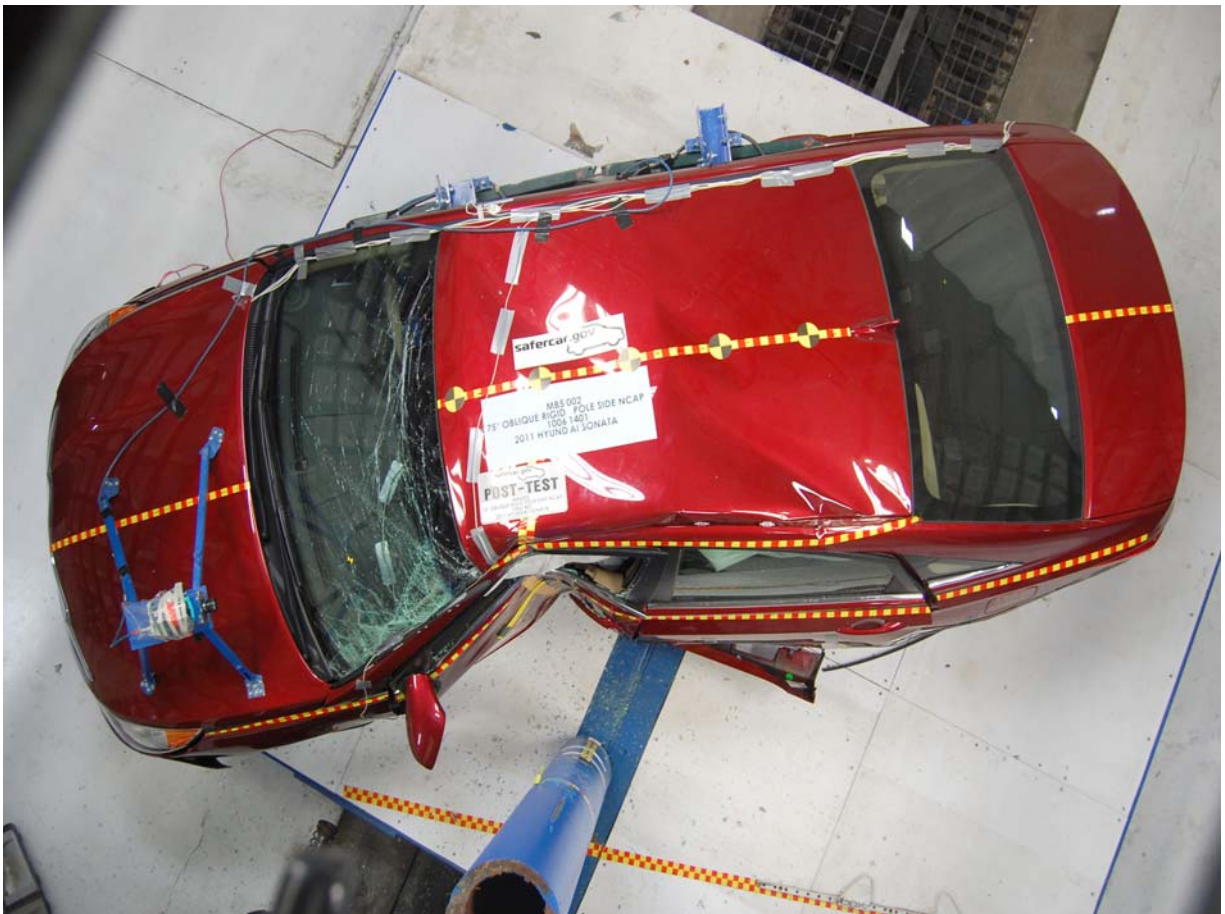
Post-Test Overhead View of Test Vehicle and Pole

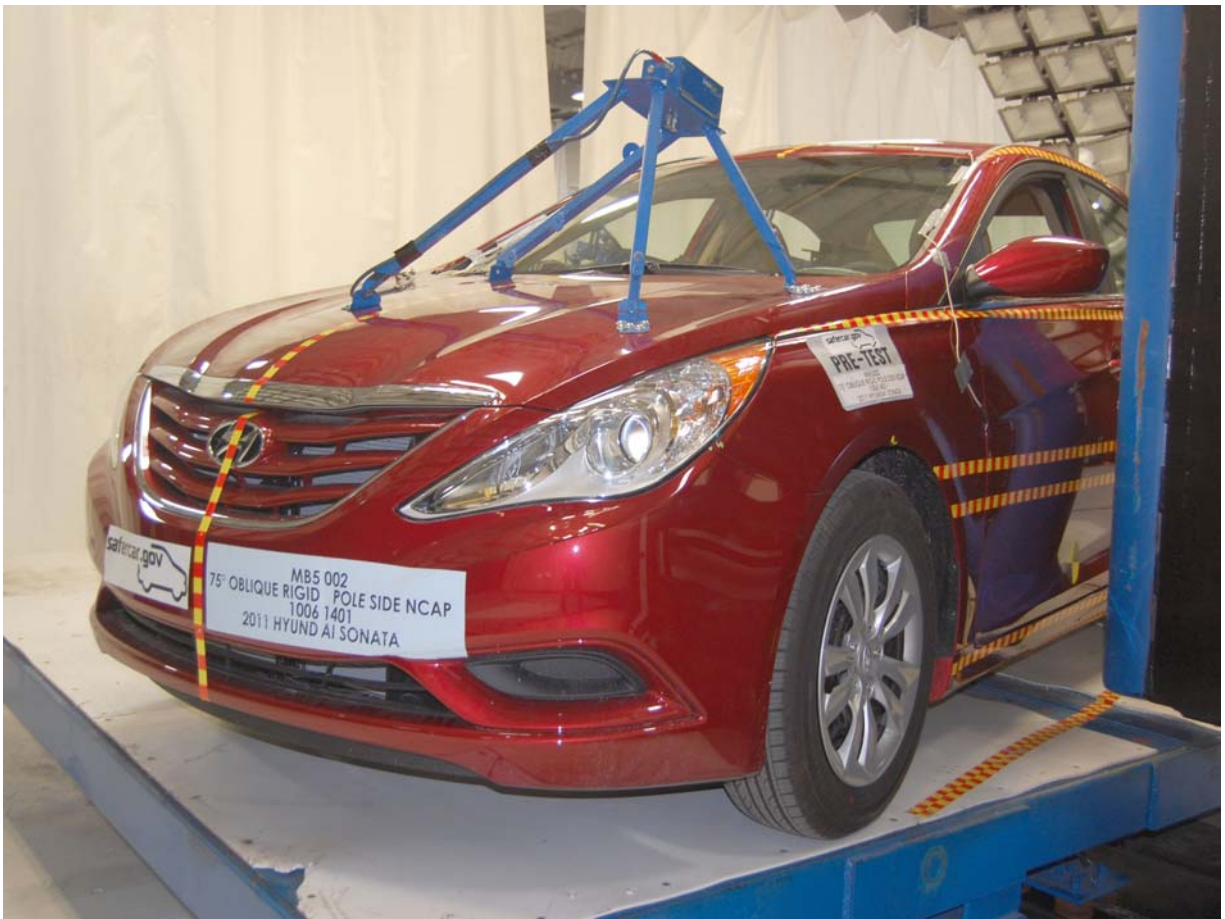
Pre-Test Left Side View of Pole Positioned Against Side of Vehicle at Ideal Impact Point

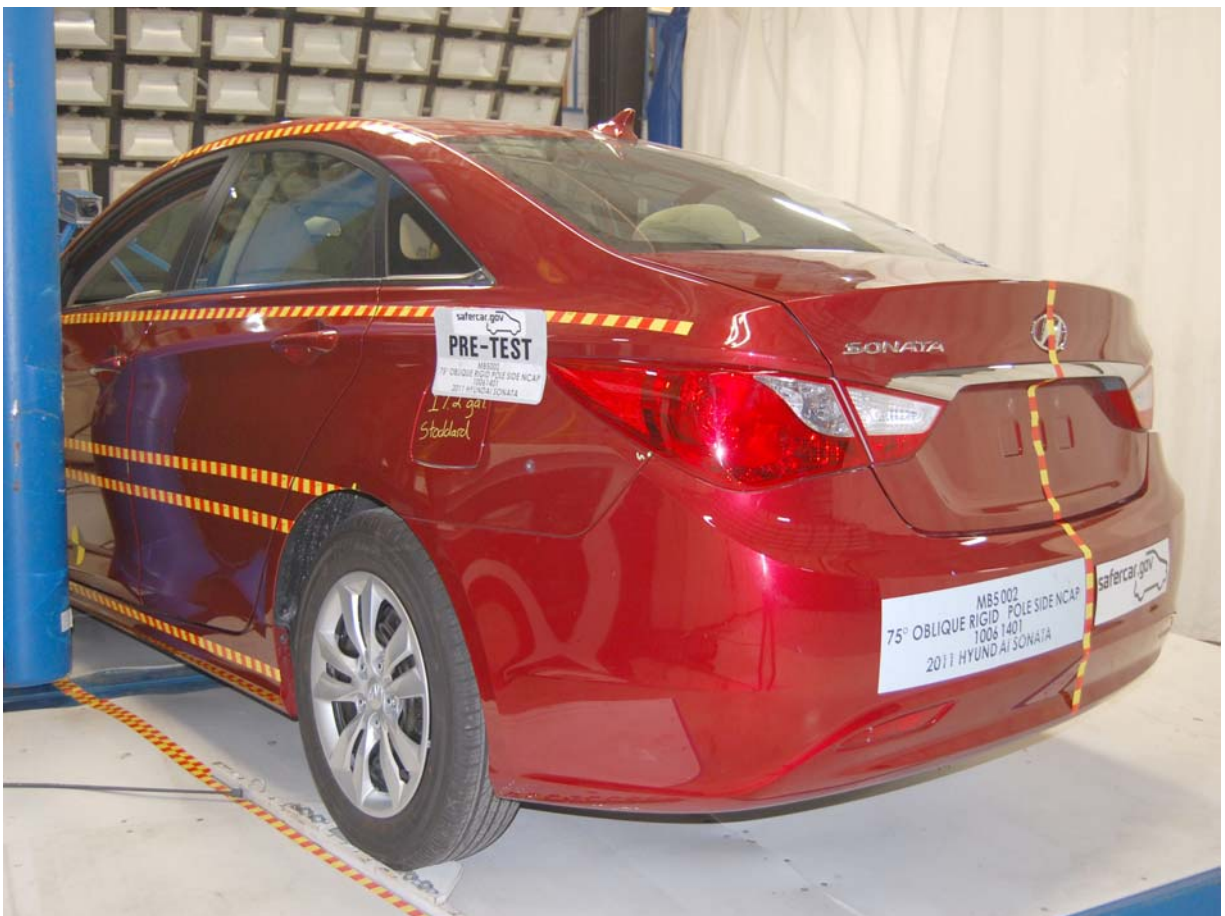
Pre-Test Right Side View of Pole Positioned Against Side of Vehicle at Ideal Impact Point

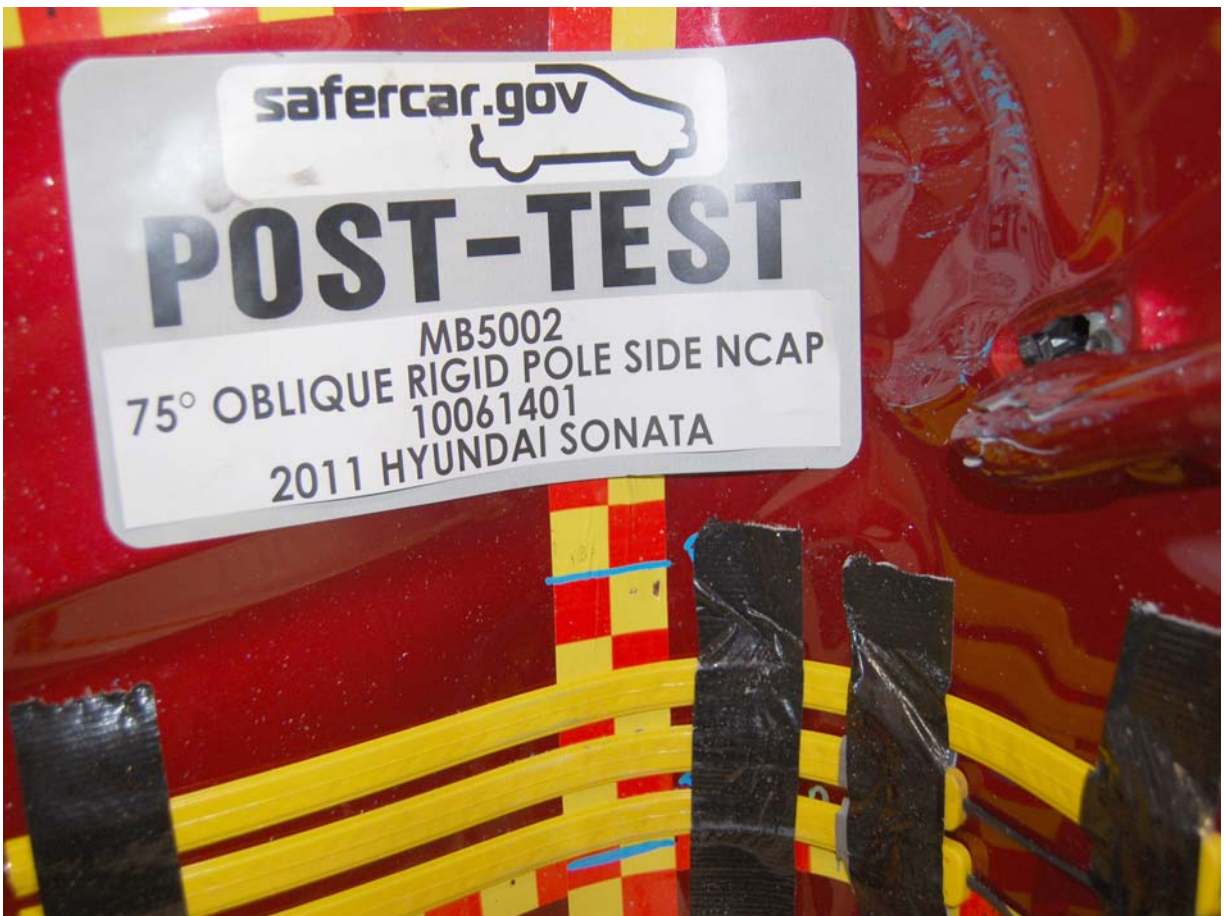
Post-Test Close-Up View of Impact Point Target Showing Impact Location

Measurement Parameter	Units	Value
Vertical Impact Reference Line (Aft of Front Axle)	mm	1182
Actual Impact Point (Aft of Front Axle)	mm	1192
Impact Point Difference (- forward / + rearward)	mm	10

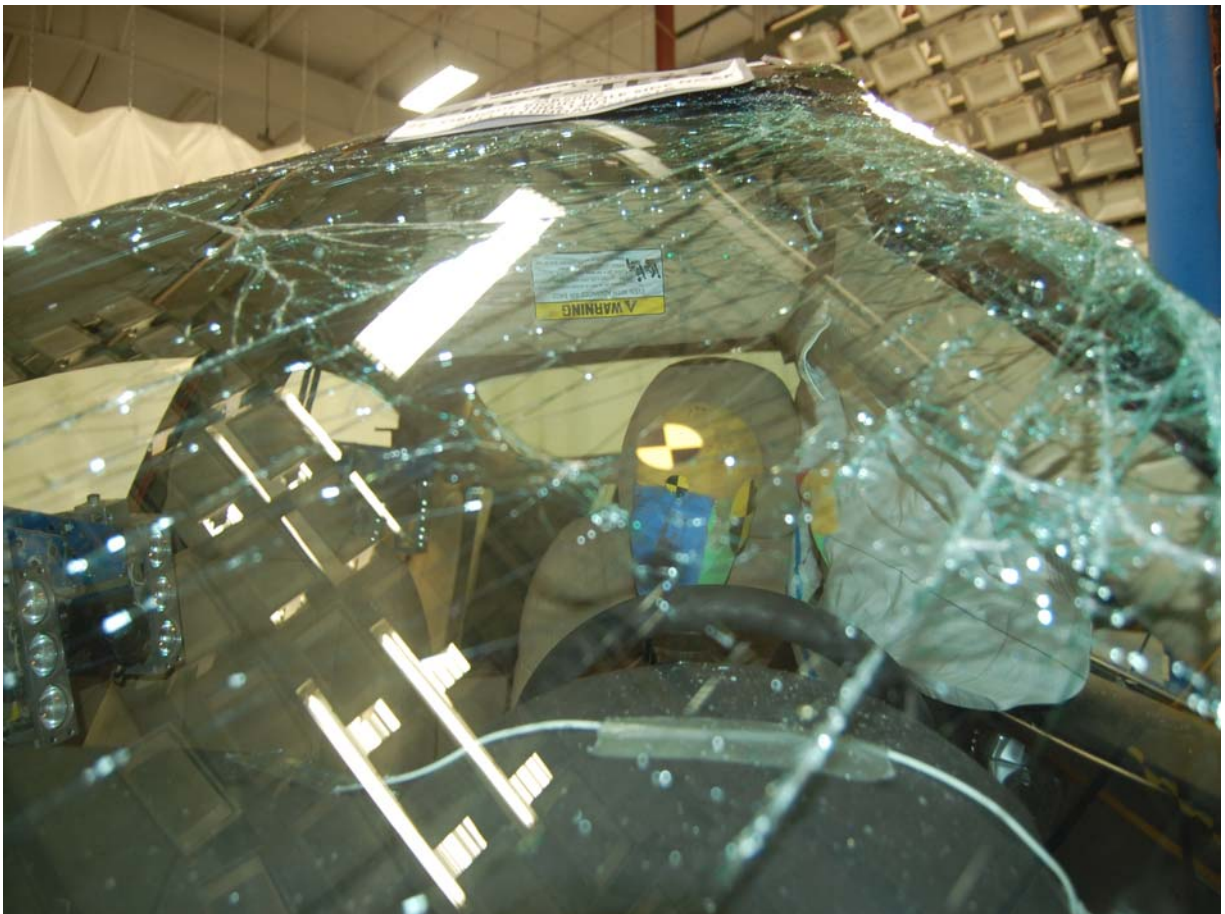
Post-Test Front Close-Up View of Dummy (through front window)

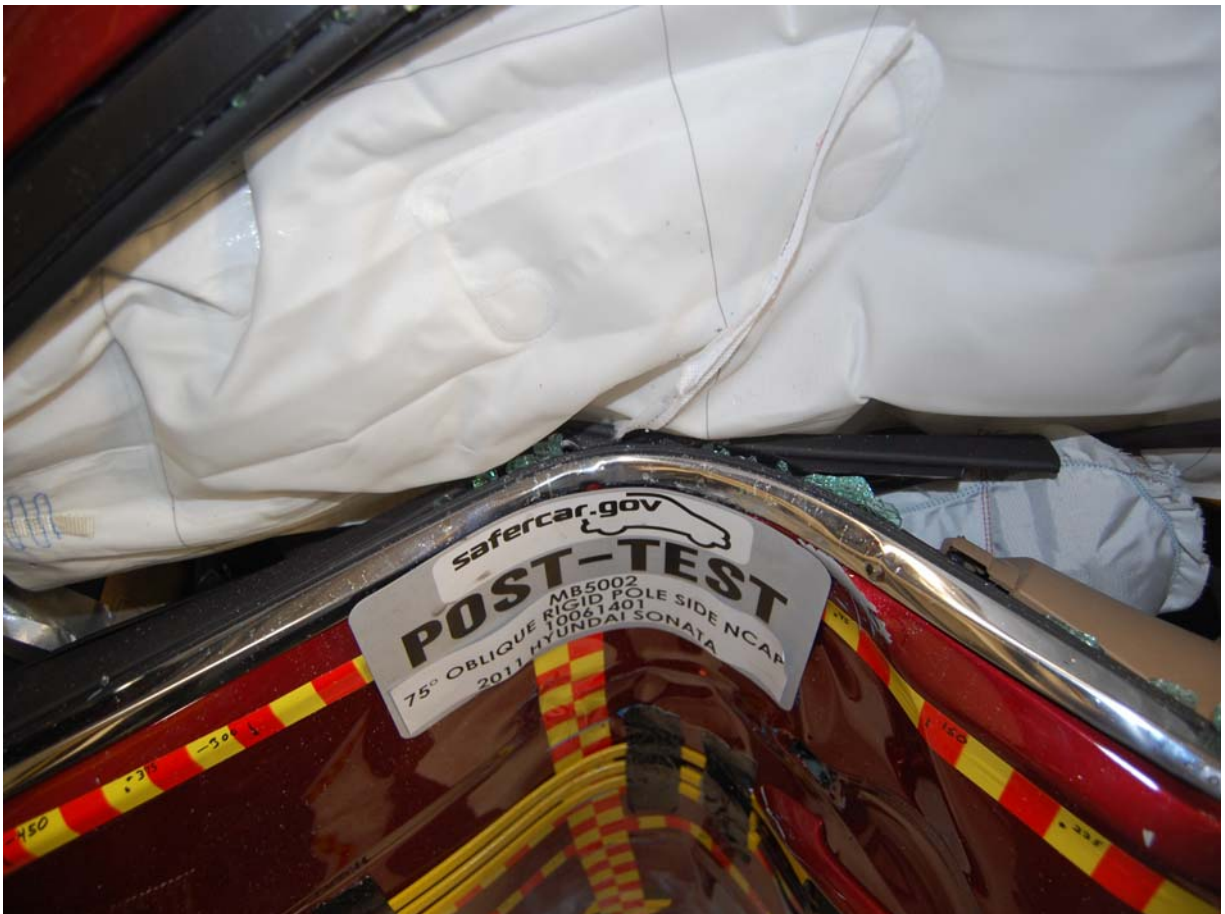
Post-Test Dummy and Door Clearance View

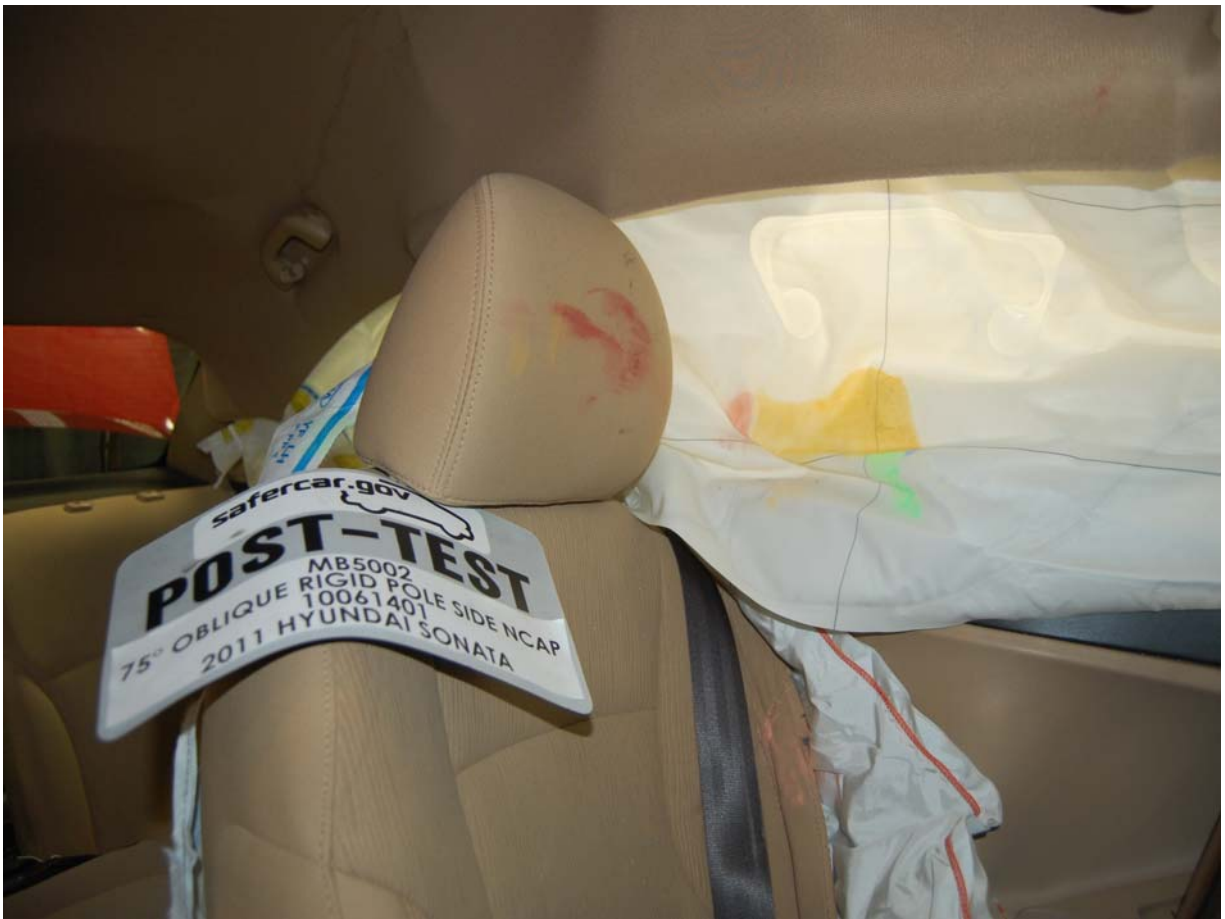
Post-Test Dummy Close-Up Head Contact with Vehicle View

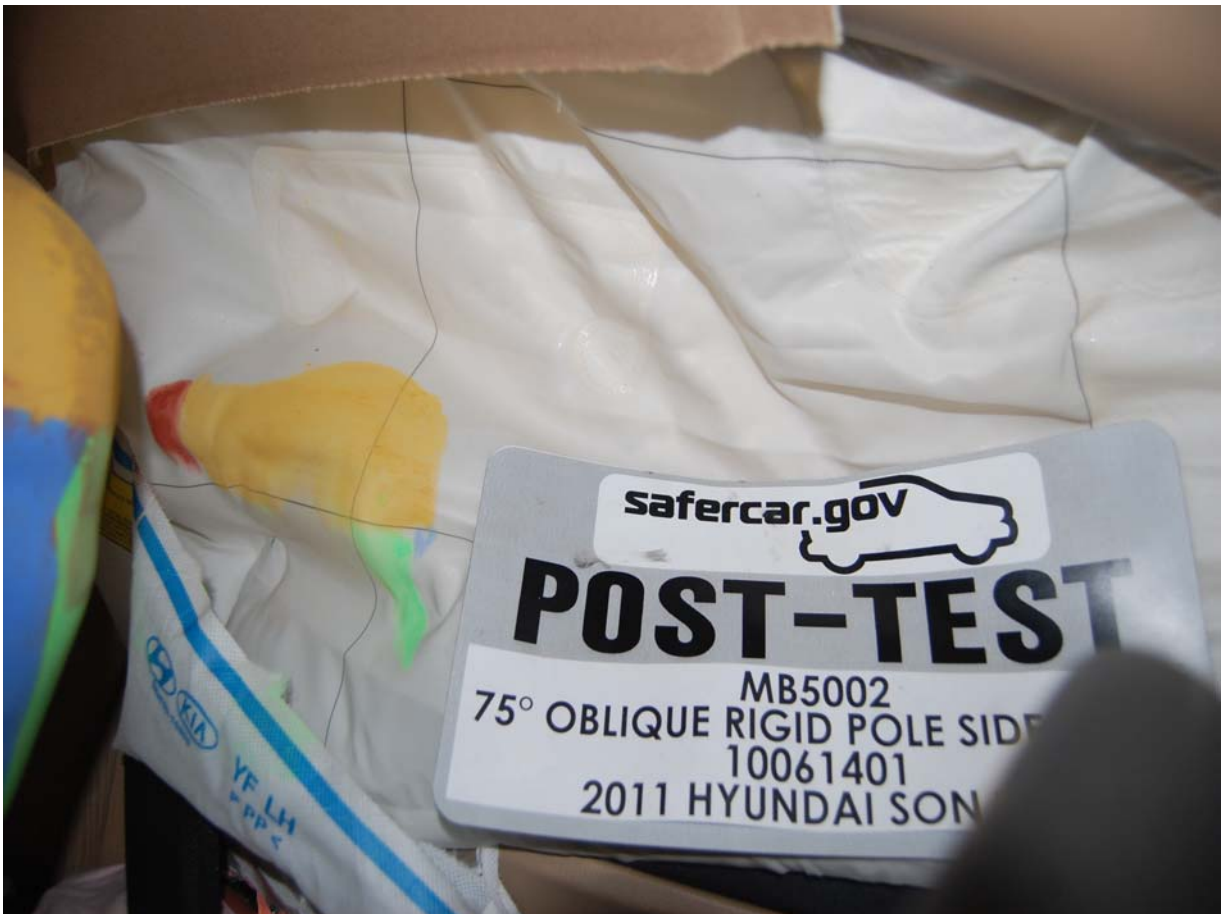
Post-Test Dummy Close-Up Head Contact with Side Airbag View

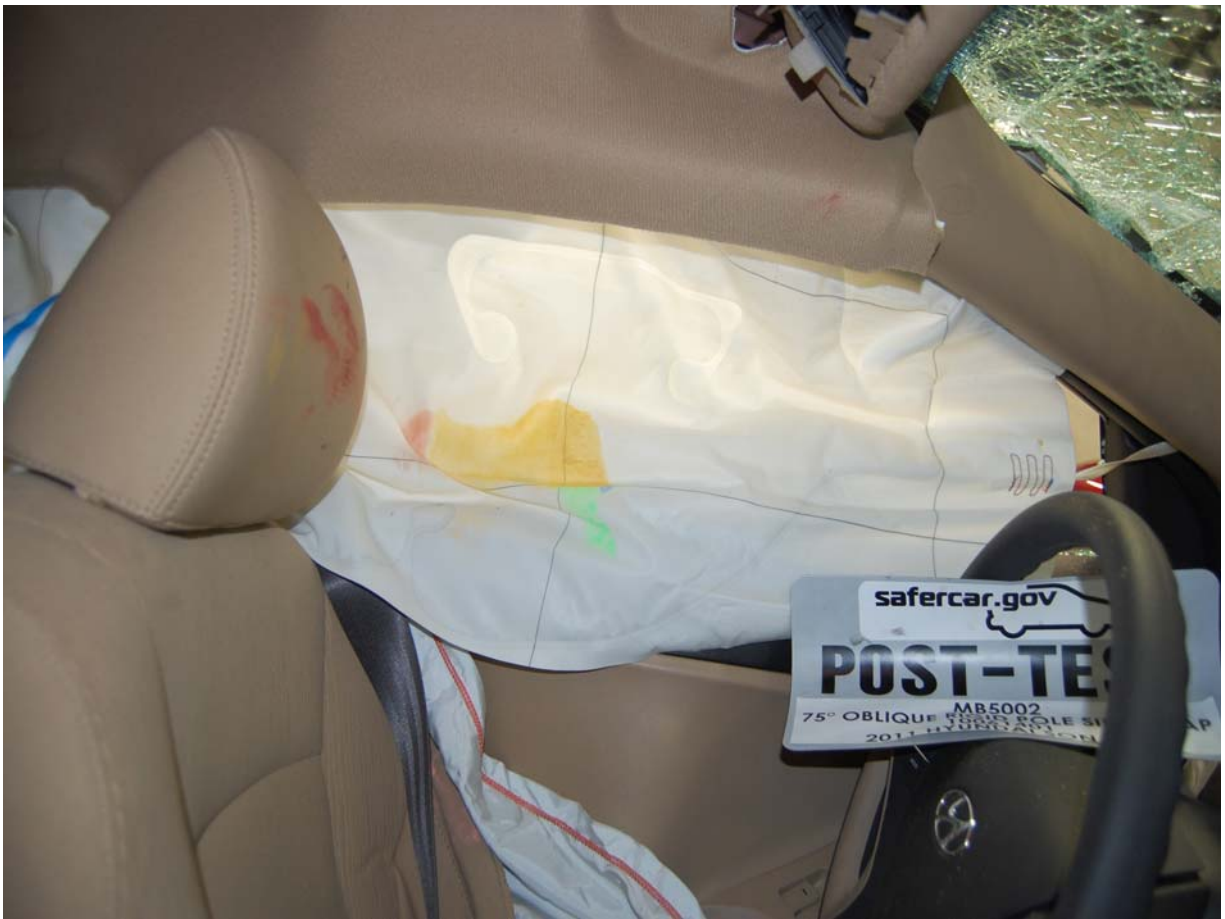
Post-Test Dummy Close-Up Torso Contact with Vehicle Interior View

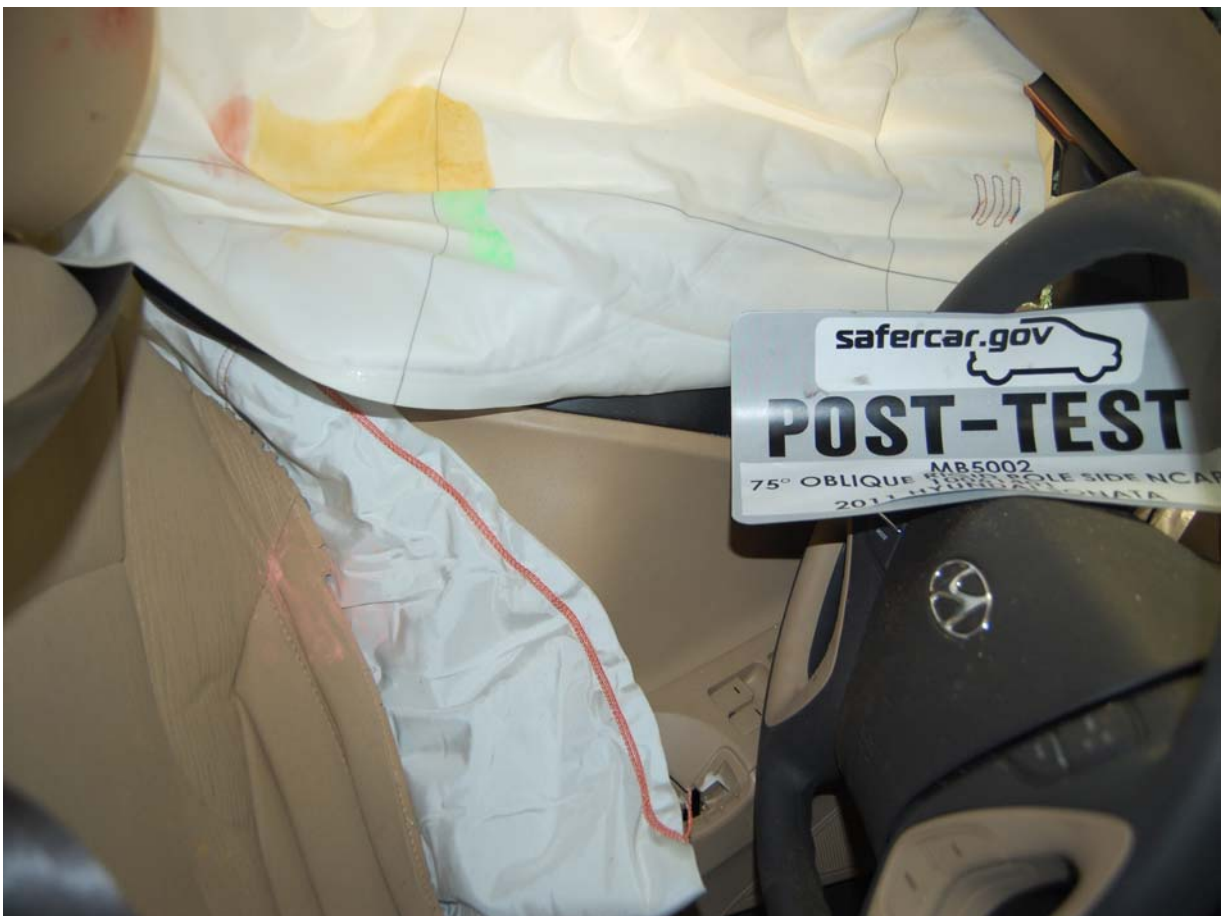
Post-Test Dummy Close-Up Torso Contact with Side Airbag View

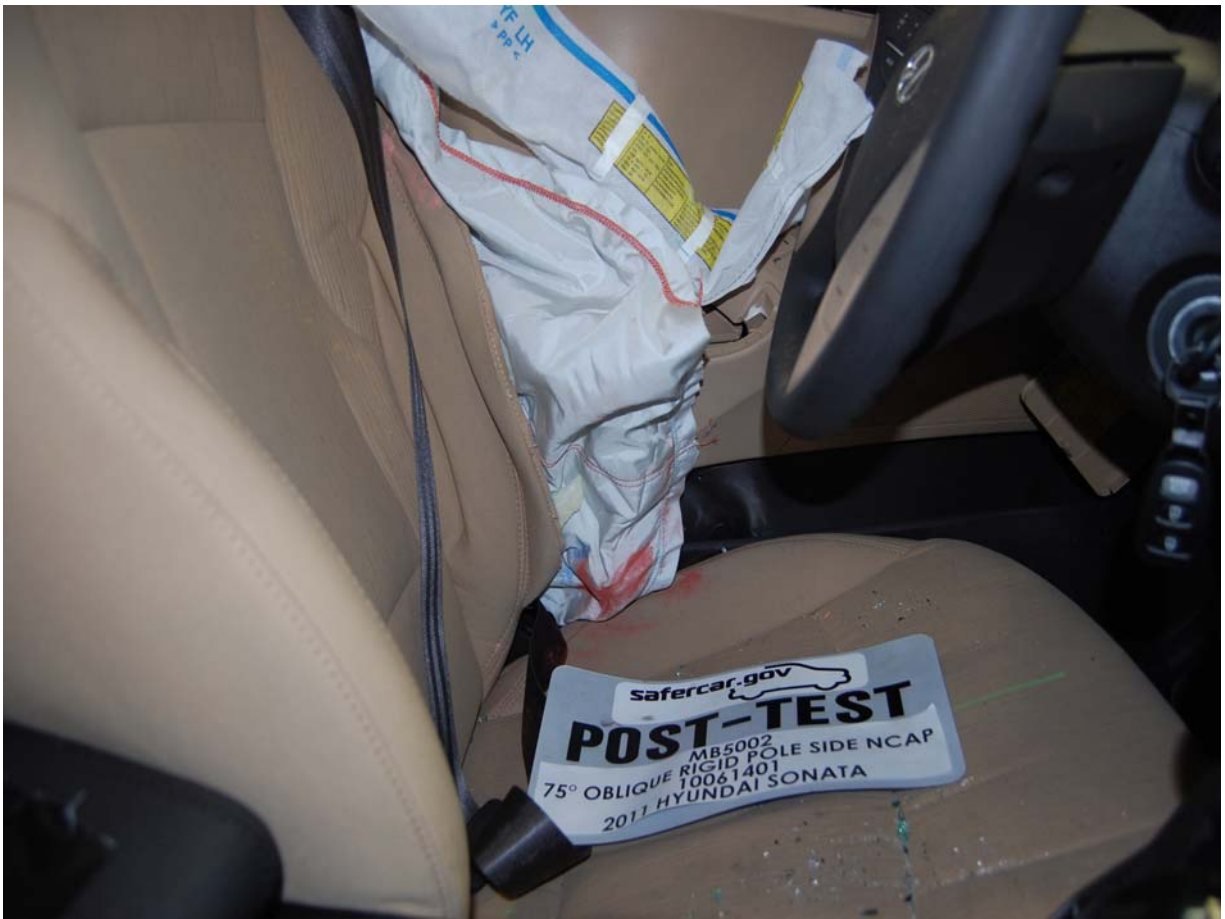
Post-Test Dummy Close-Up Pelvis Contact View

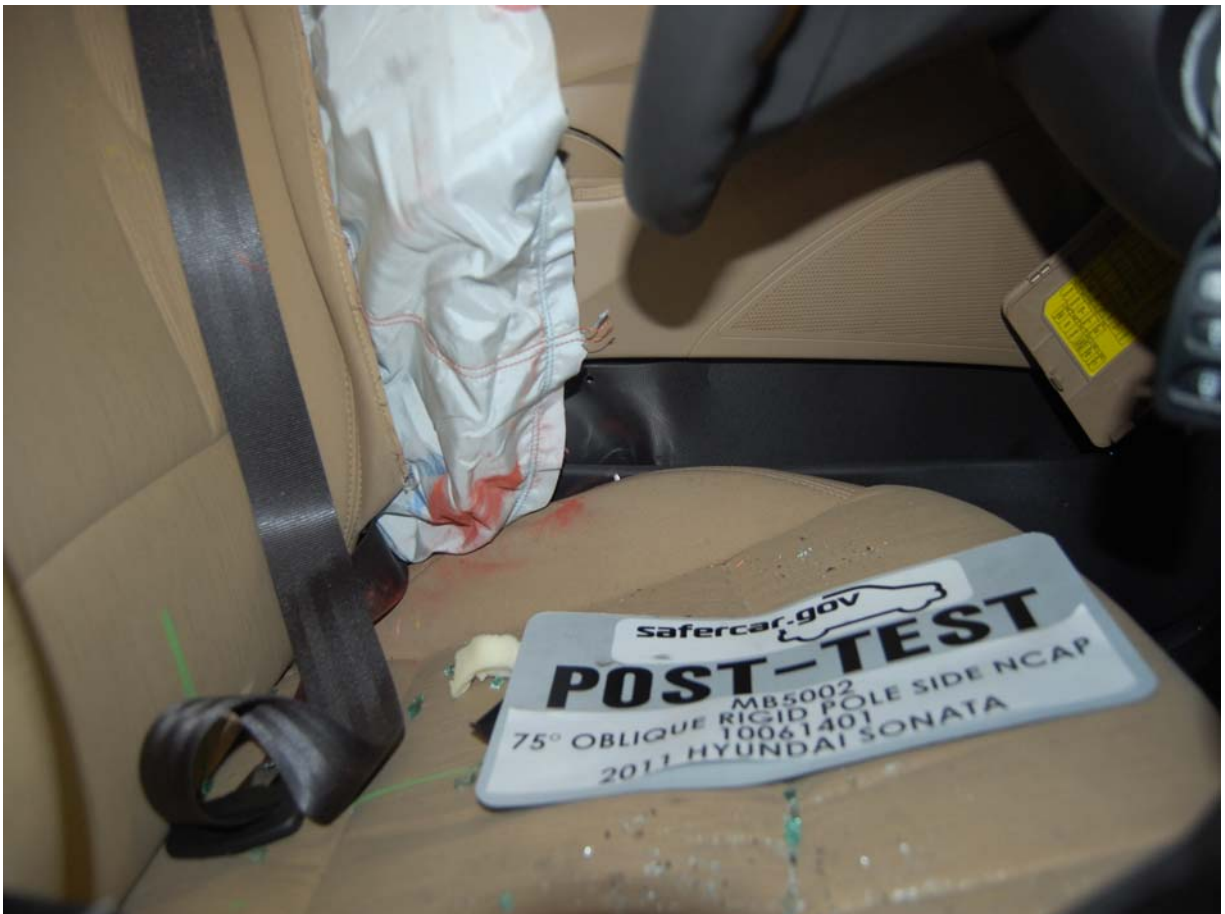
Post-Test Dummy Close-Up Pelvis Contact with Side Airbag View

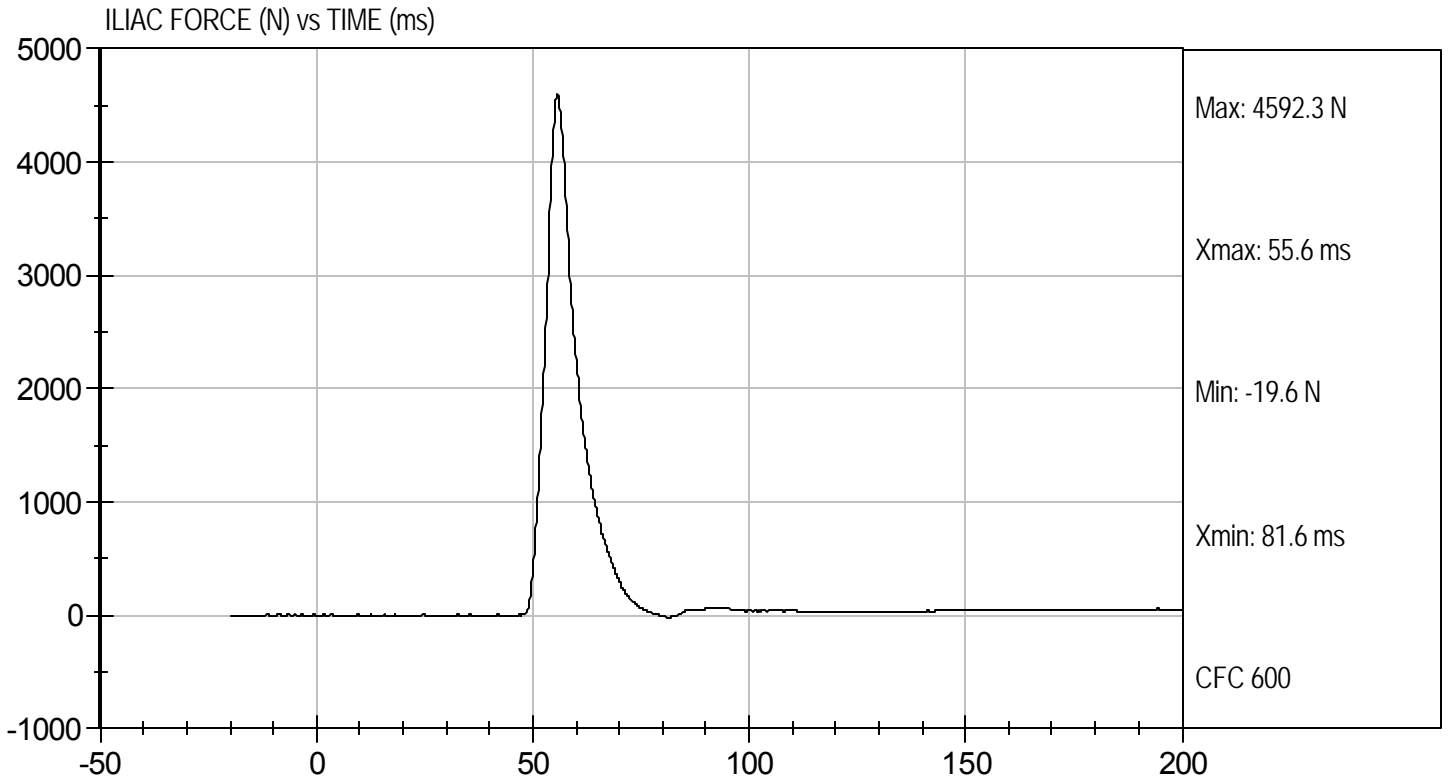
Test Desc: Iliac Impact
Component ID: D101828

Test Date: 6/14/10
Velocity: 14.12 ft/s, 4.30 m/s

Tested Parameter	Units	Specification	Result	Pass/Fail
Temperature	deg C	20.6 to 22.2	21.9	Pass
Humidity	%	10 to 70	55	Pass
Impact Velocity	m/s	4.20 to 4.40	4.30	Pass
Peak Impactor Acceleration	G's	36 to 45	37	Pass
Pelvis Y Acceleration	G's	28 to 39	35	Pass
Peak Pelvis Iliac Force	N	4100 to 5100	4592	Pass
Overall Test Results				Pass
