**REPORT NUMBER: SPNCAP-KAR-11-001**

**NEW CAR ASSESSMENT PROGRAM (NCAP)  
SIDE IMPACT POLE TEST**

**TOYOTA MOTOR MANUFACTURING, KENTUCKY, INC.  
2011 TOYOTA CAMRY LE 4-DOOR SEDAN**

**FINAL REPORT**

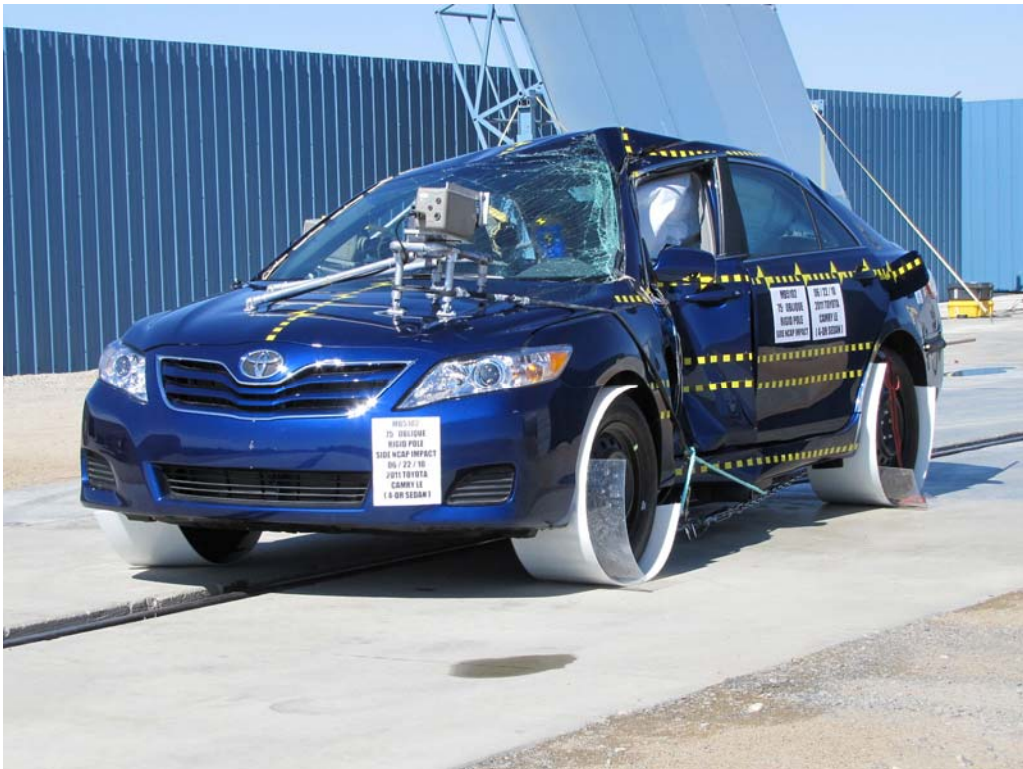
FIGURE 6. Post-Test Left Front  $\frac{3}{4}$  View of Vehicle

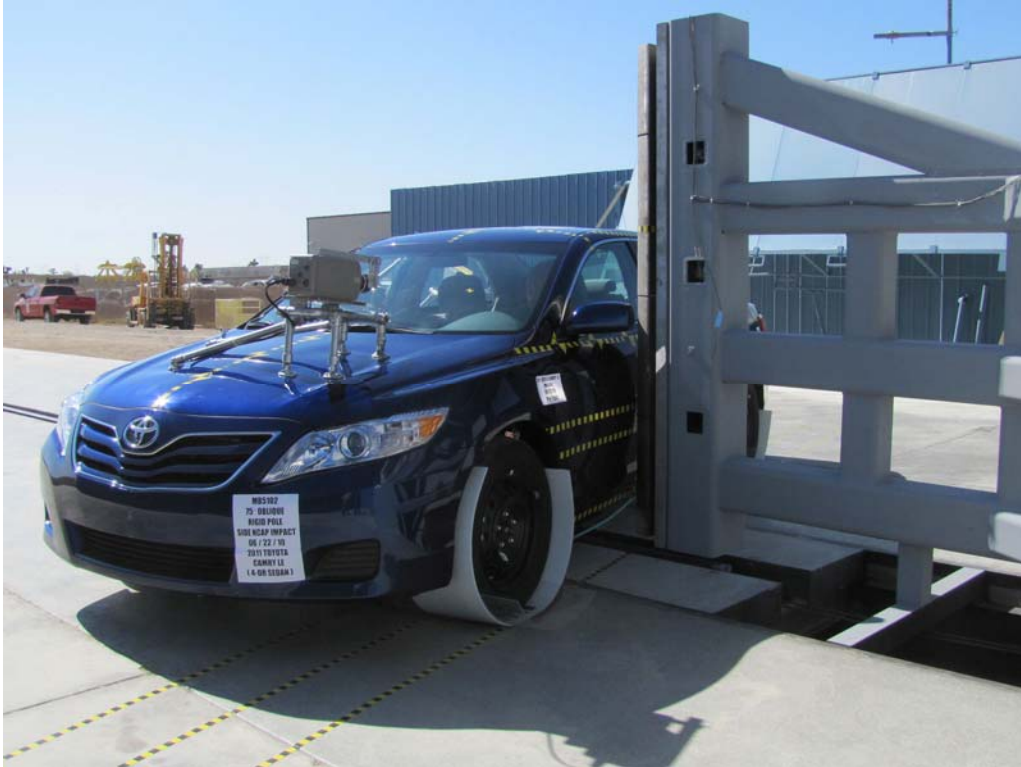
FIGURE 17. Pre-Test Left Side View of Pole Positioned Against Side of Vehicle at Ideal Impact Point

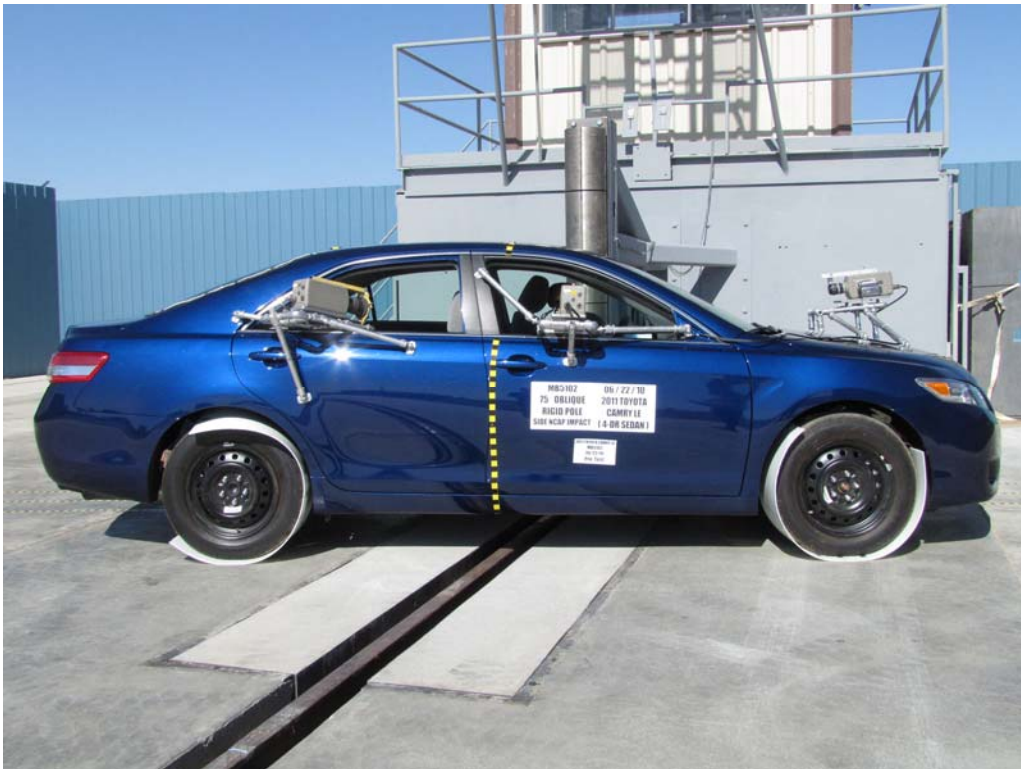
FIGURE 18. Pre-Test Right Side View of Pole Positioned Against Side of Vehicle at Ideal Impact Point

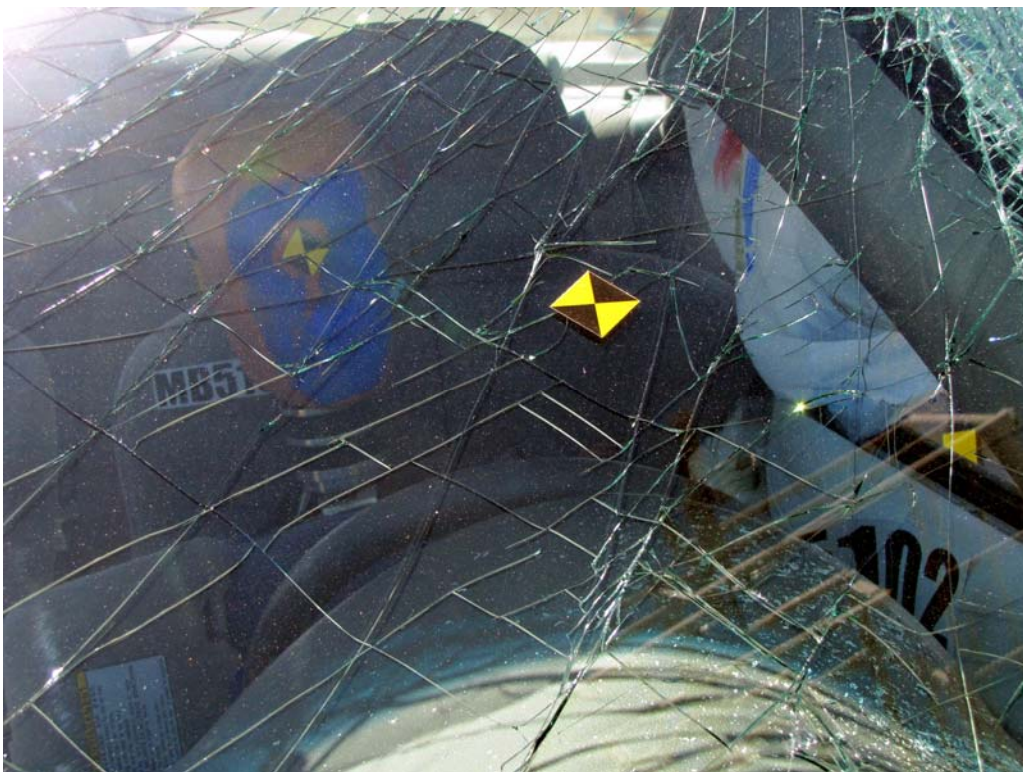
FIGURE 22. Post-Test Front Close-Up View of Dummy

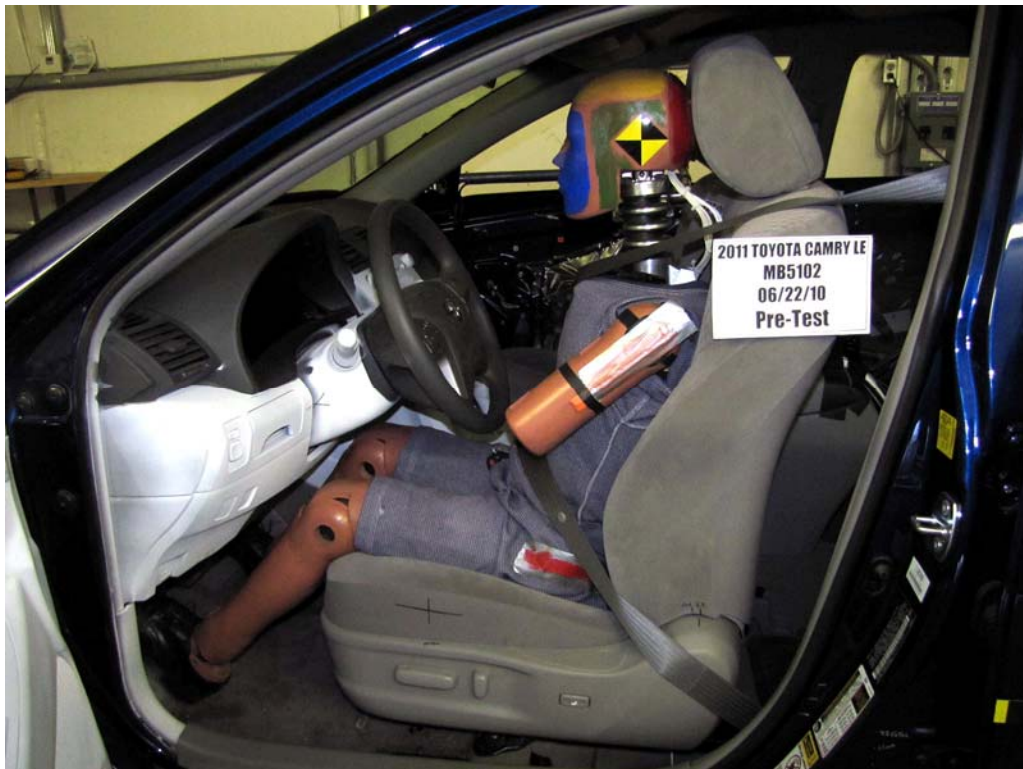
FIGURE 23. Pre-Test Left Side View of Dummy Showing Belt, Chalking, and Contact Switches

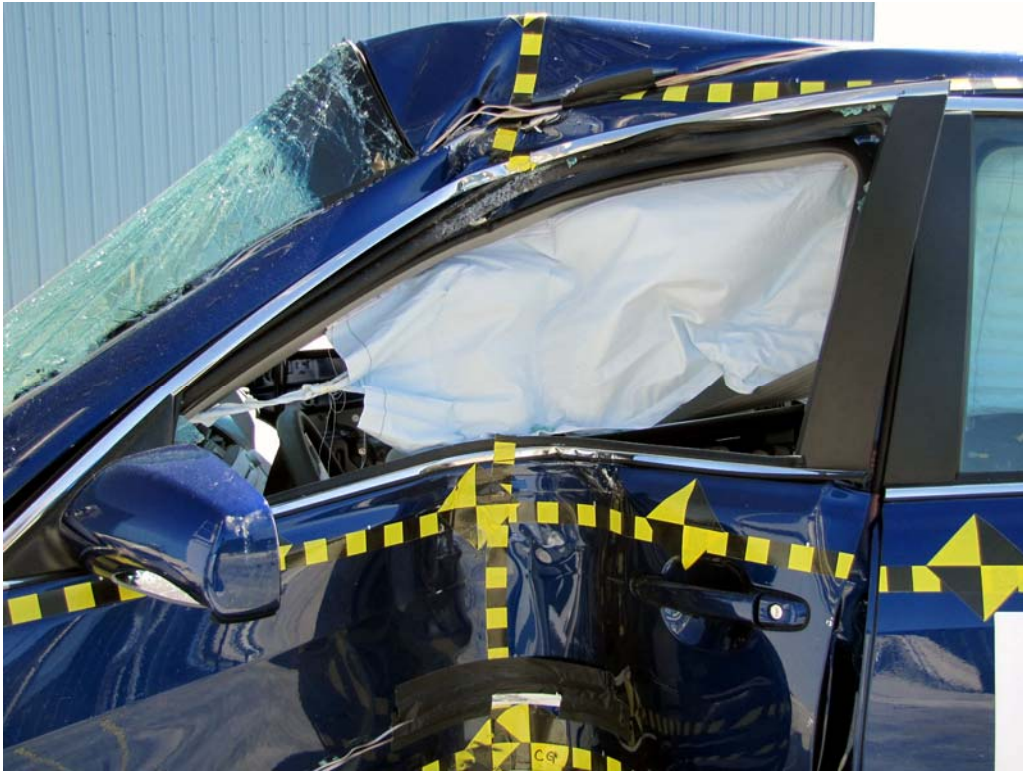
FIGURE 25. Post-Test Left Side View of Dummy Shoulder and Door Top View

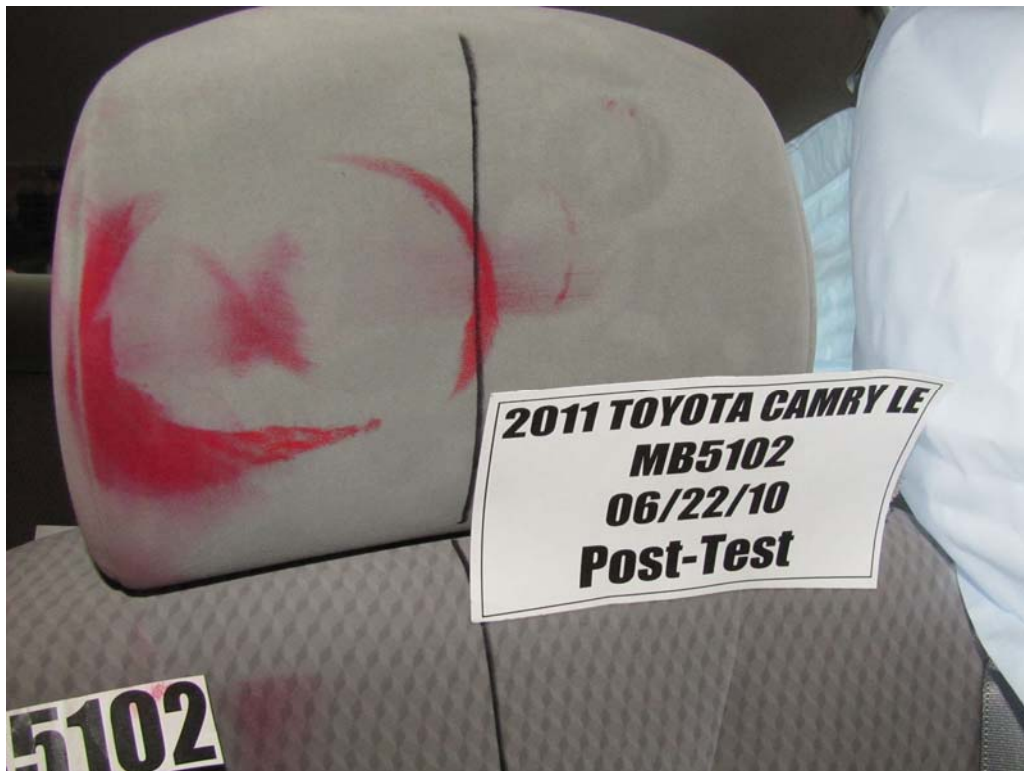
FIGURE 45. Post-Test Dummy Close-Up Head Contact with Vehicle View

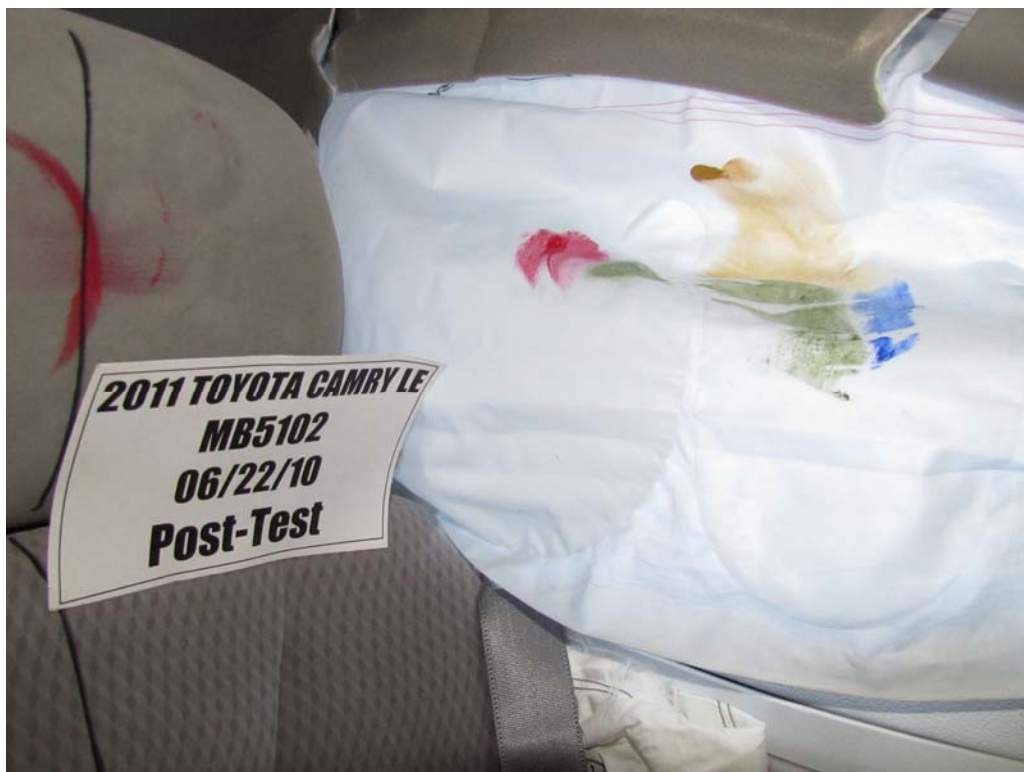
FIGURE 46. Post-Test Dummy Close-Up Head Contact with Side Airbag View

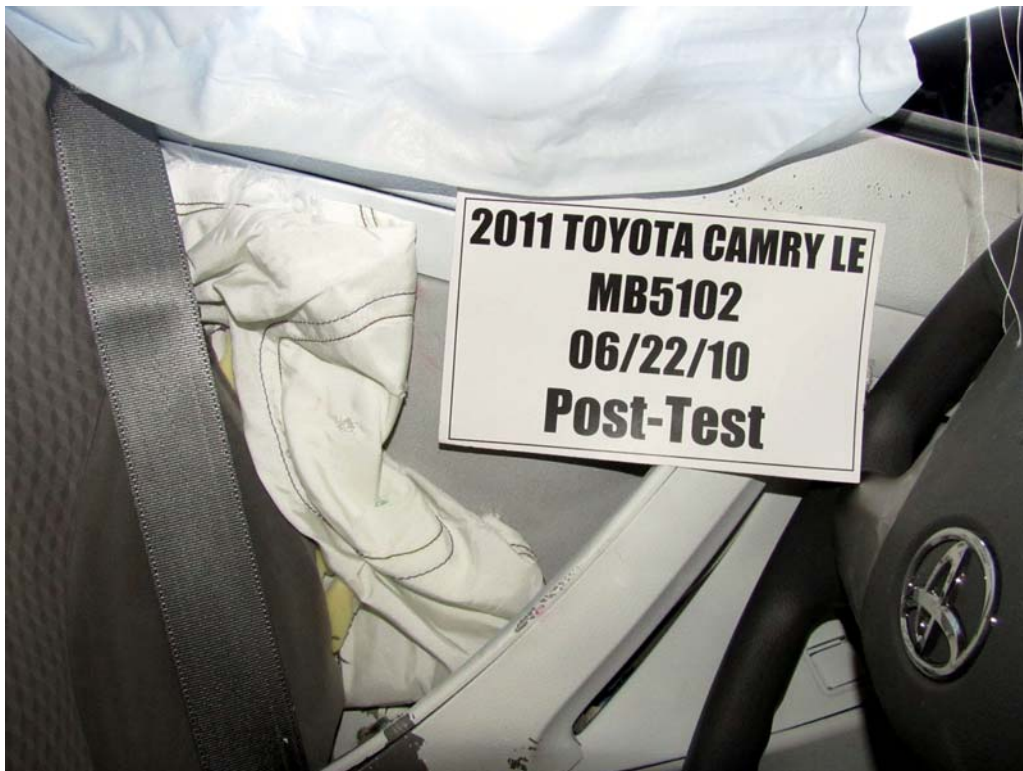
FIGURE 47. Post-Test Dummy Close-Up Torso Contact with Vehicle Interior View

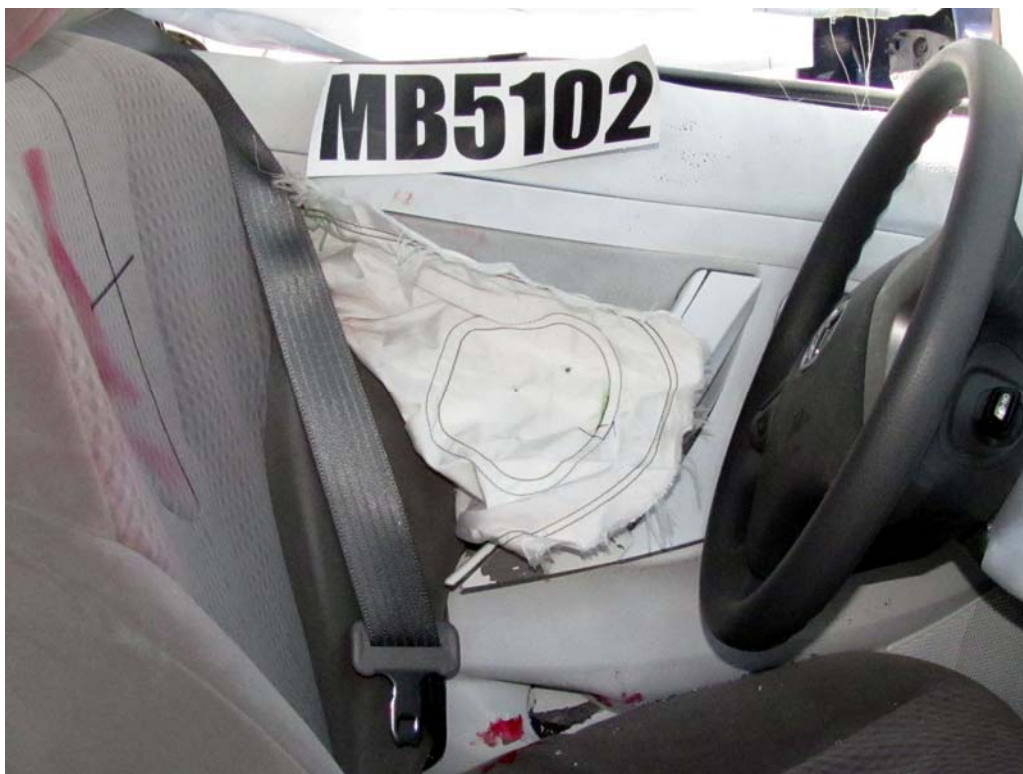
FIGURE 48. Post-Test Dummy Close-Up Torso Contact with Side Airbag View

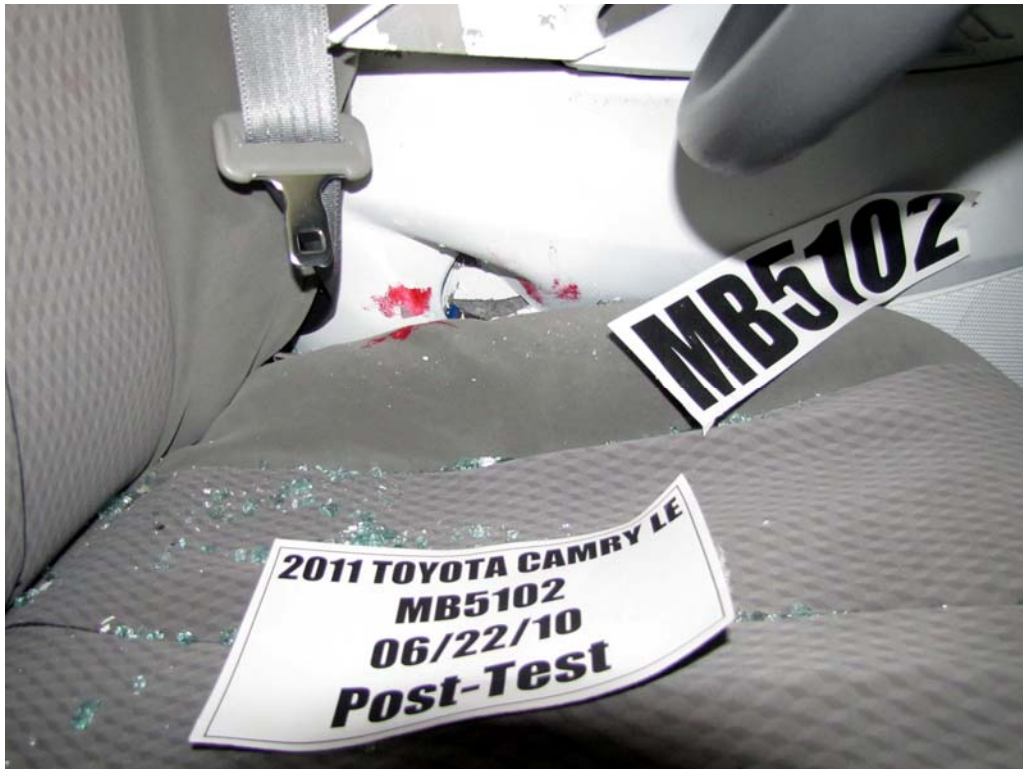
FIGURE 49. Post-Test Dummy Close-Up Pelvis Contact with Vehicle View

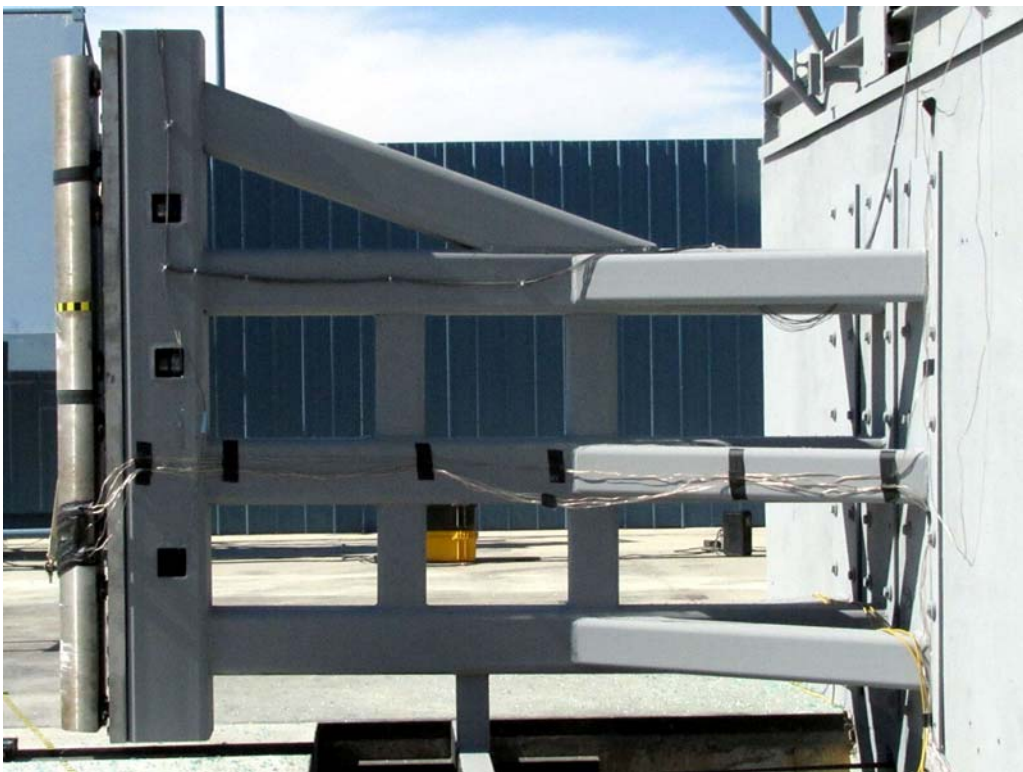
FIGURE 58. Post-Test Pole Barrier Side View

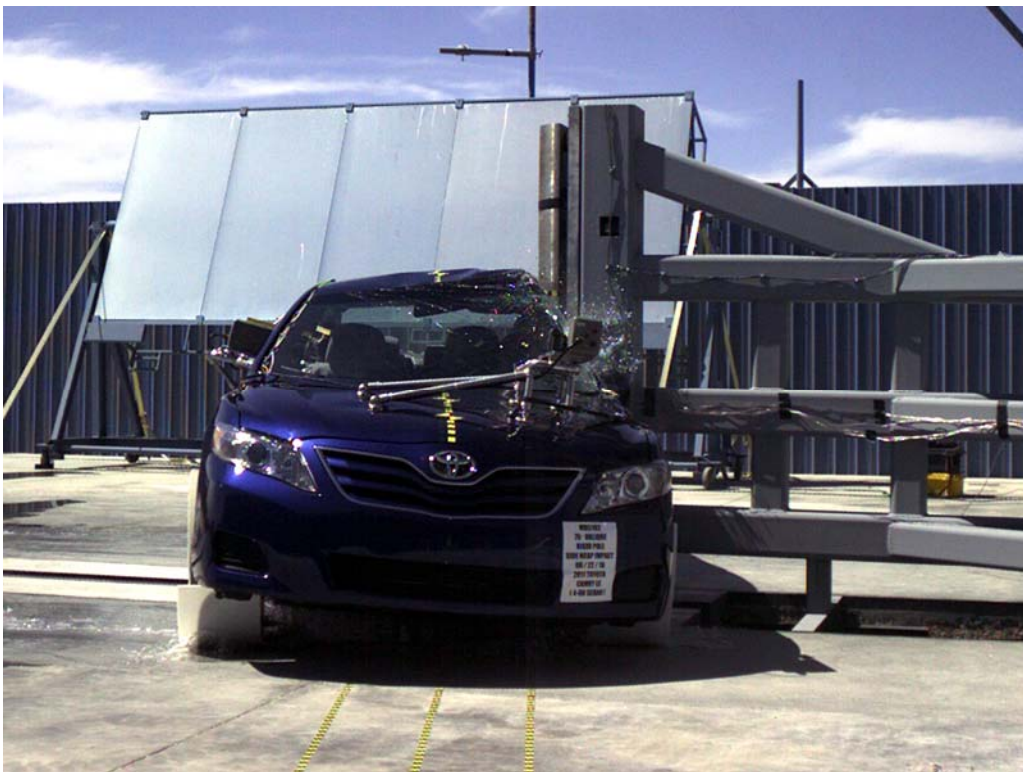
FIGURE 66. Impact Event

Both of the struck side doors of the test vehicle remained closed and latched and were jammed shut after the impact. There was no separation at the hinges or the latches. The non-struck side doors remained closed and latched. There were no driver injury values that exceeded their limits. There was no FMVSS 301 Stoddard solvent spillage as a result of the impact.
