**REPORT NUMBER: NCAP-KAR-11-001**

**NEW CAR ASSESSMENT PROGRAM (NCAP)  
FRONTAL BARRIER IMPACT TEST**

**TOYOTA MOTOR MANUFACTURING, NORTHERN KENTUCKY, INC.  
2011 TOYOTA CAMRY LE 4-DOOR SEDAN**

**FINAL REPORT**

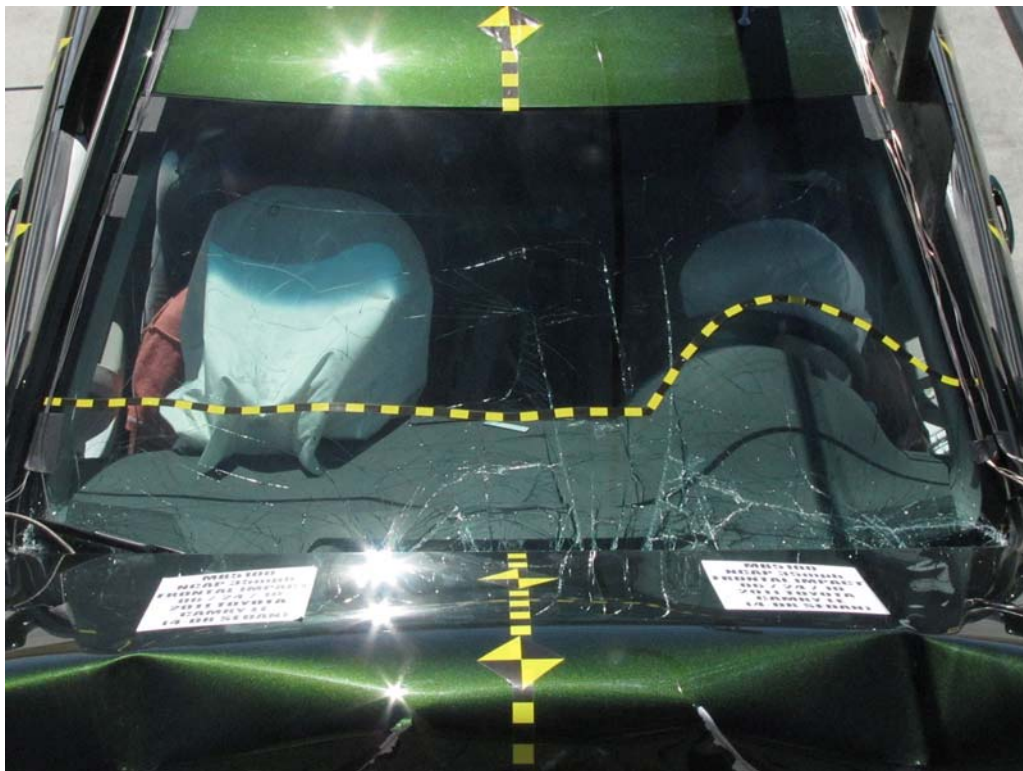
FIGURE 18. Post-Test Windshield View

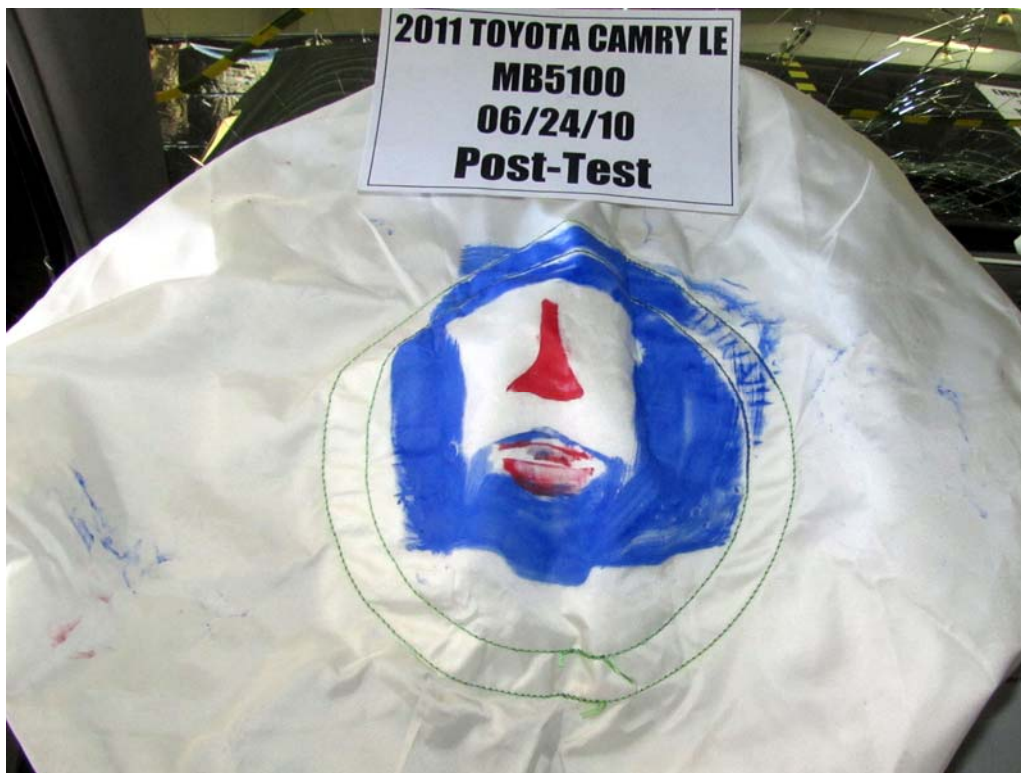
FIGURE 43. Post-Test Driver Dummy Contact With Airbag

The driver's visible contact points were as follows: The driver ATD's head contacted the airbag and the headrest. The upper torso contacted the airbag. Both the left and right knees contacted the knee airbag, with the left knee also contacting the knee bolster.

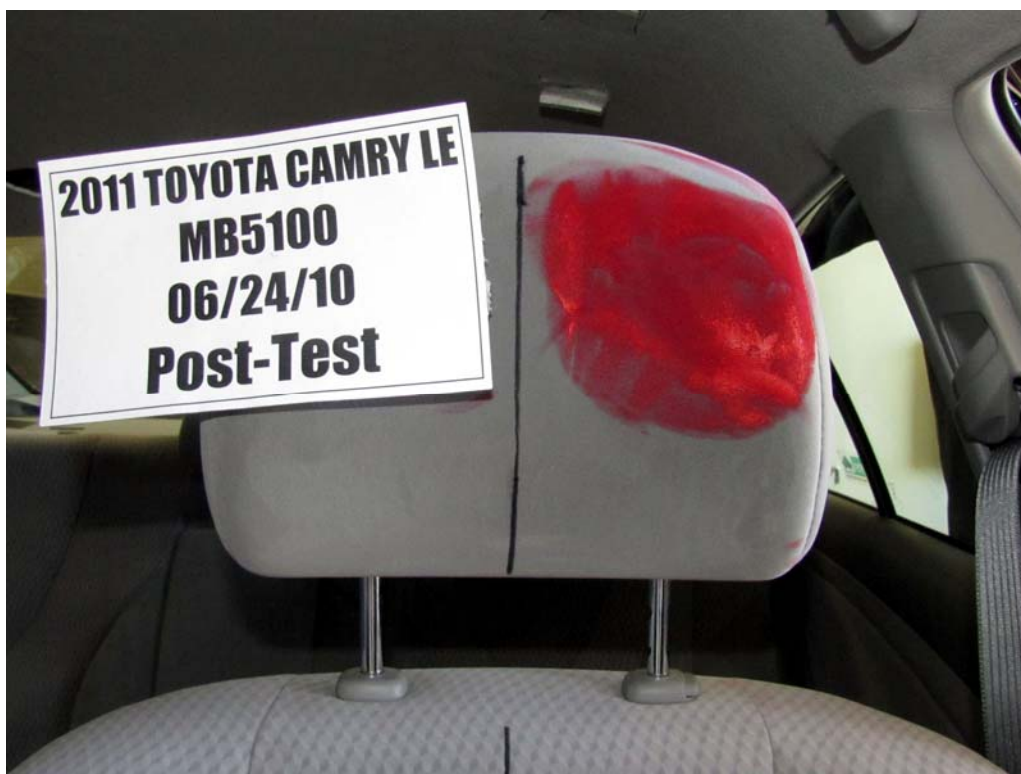
FIGURE 43a. Post-Test Driver Dummy Contact With Headrest

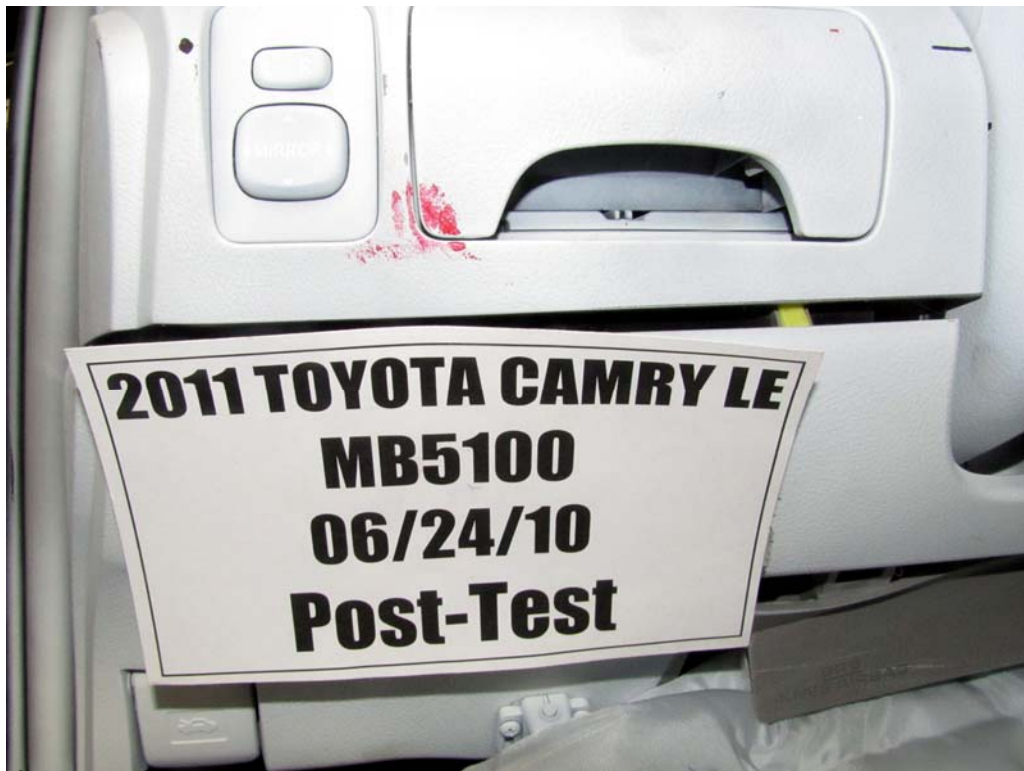
FIGURE 43b. Post-Test Driver Dummy Contact With Knee Bolster

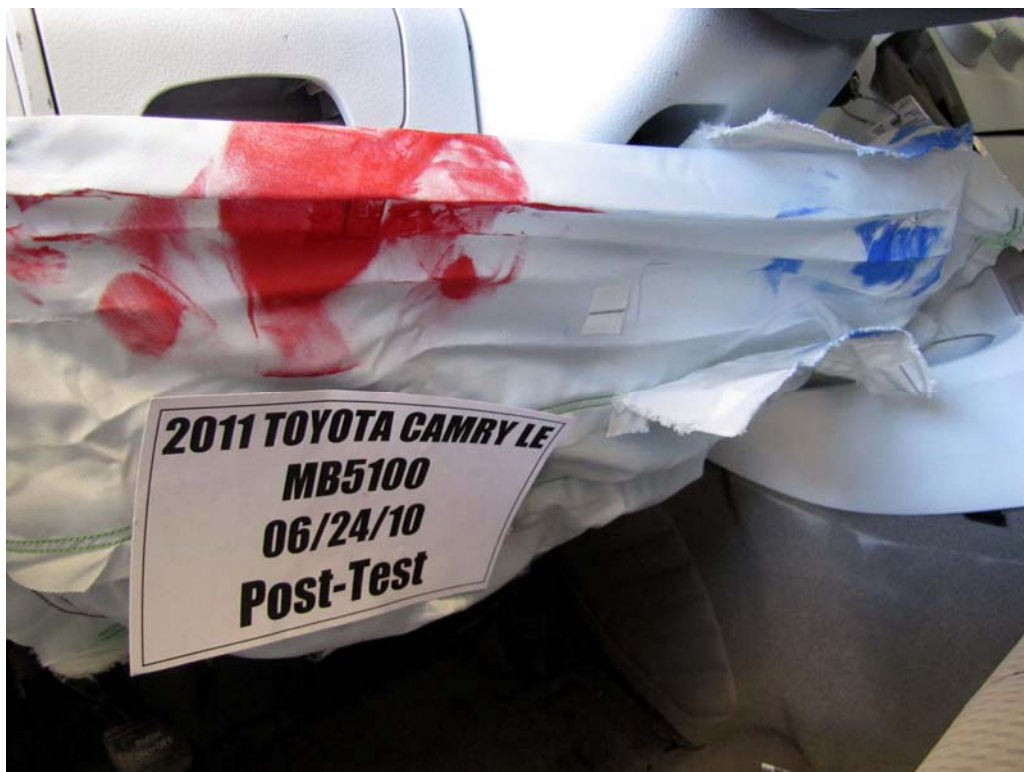
FIGURE 43c. Post-Test Driver Dummy Contact With Airbag

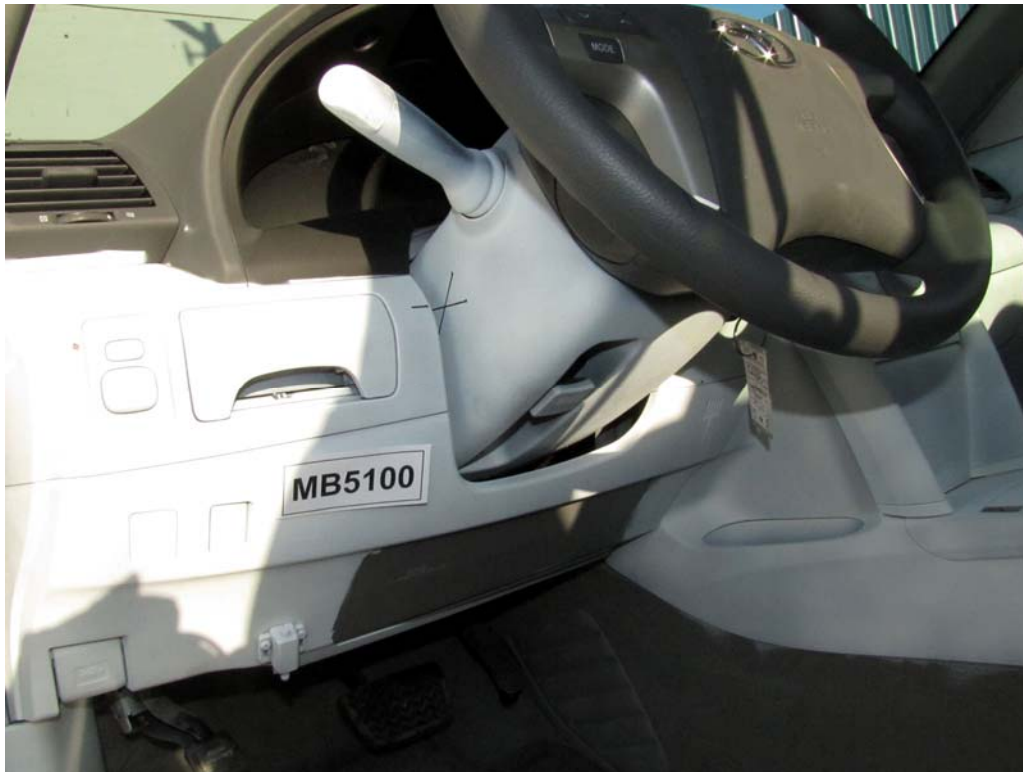
FIGURE 44. Pre-Test View of Steering Column Shear Capsule

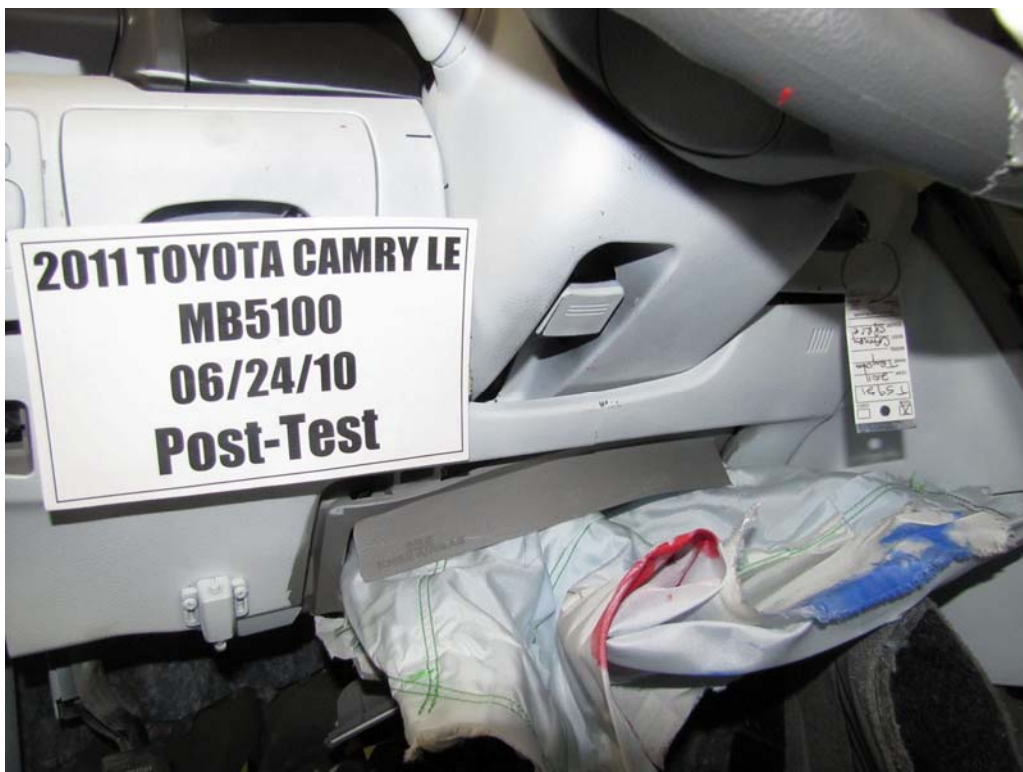
FIGURE 45. Post-Test View of Steering Column Shear Capsule

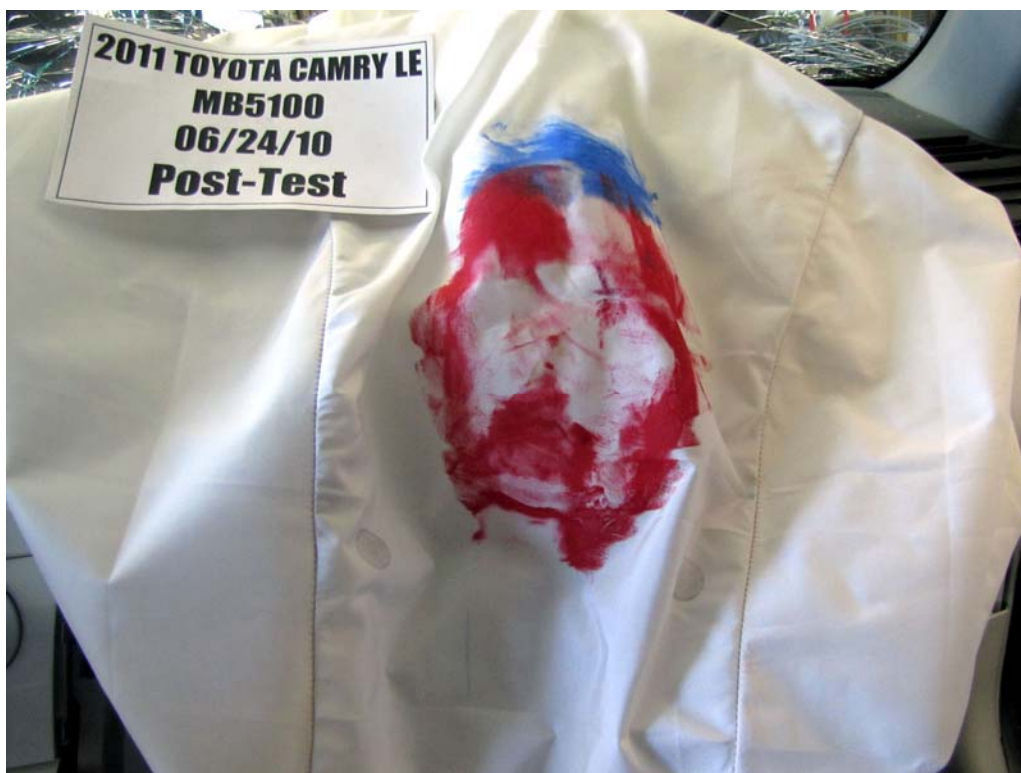
FIGURE 60. Post-Test Passenger Dummy Contact With Airbag

The passenger's visible contact points were as follows: The passenger ATD's head contacted the airbag and headrest. The upper torso contacted the airbag. Both the left and right knees contacted the glovebox.

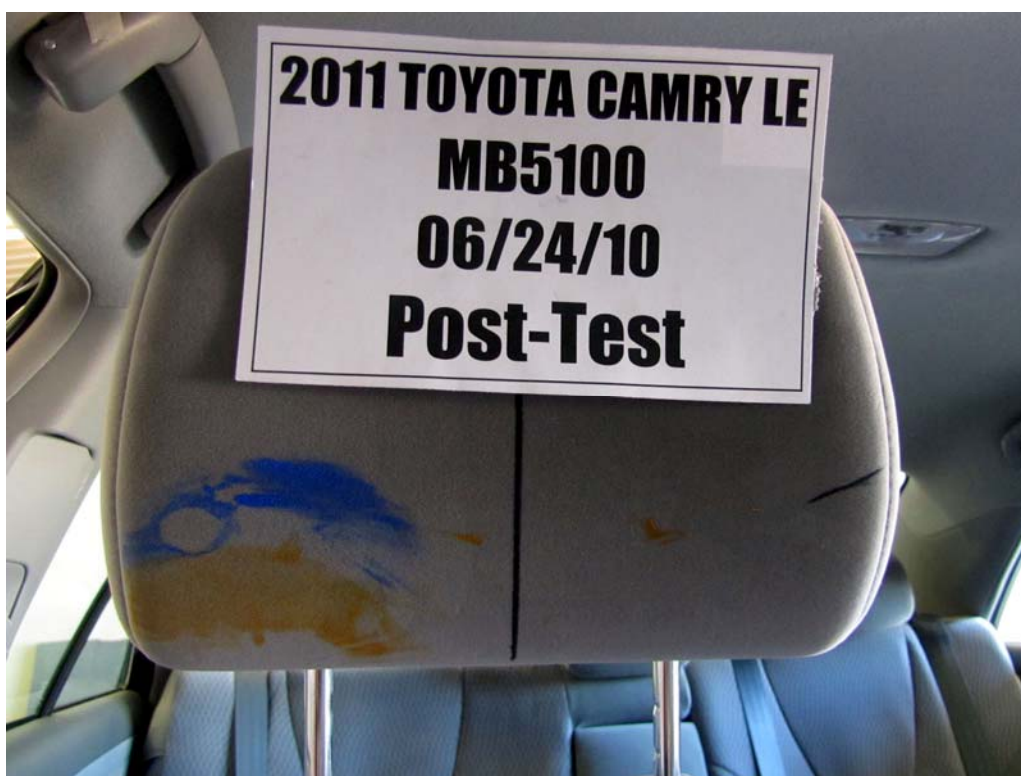
FIGURE 60a. Post-Test Passenger Dummy Contact With Headrest

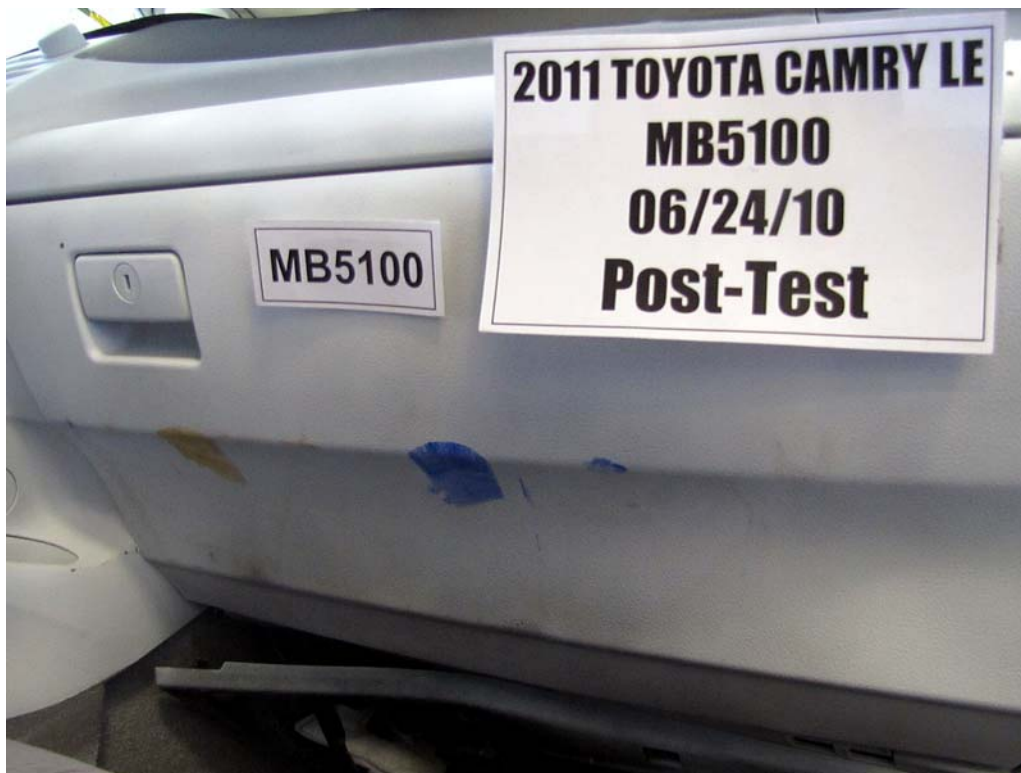
FIGURE 60b. Post-Test Passenger Dummy Contact With Knee Bolster

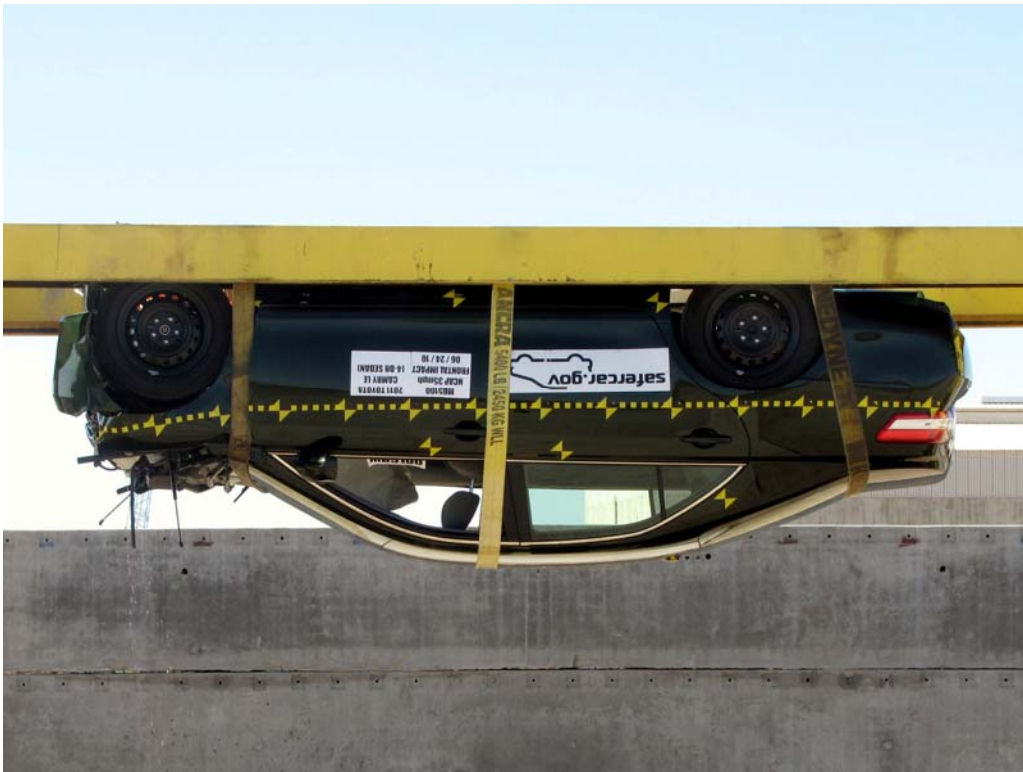
FIGURE 66. Vehicle at 180°on Static Rollover Device

There was 100% windshield retention and no intrusion into the protected zone of the windshield during the event. There was no Stoddard solvent leakage after the event or during any phase of the static rollover.
