**Vehicle Research and Test Center
FMVSS 208 Dynamic Rollover
of a 2007 Ford Expedition
TRC Inc. Test Number 091022**

**Prepared By:
Transportation Research Center Inc.
10820 State Route 347
P. O. Box B-67
East Liberty, OH 43319**

**Final Report
October 2009 – March 2010**

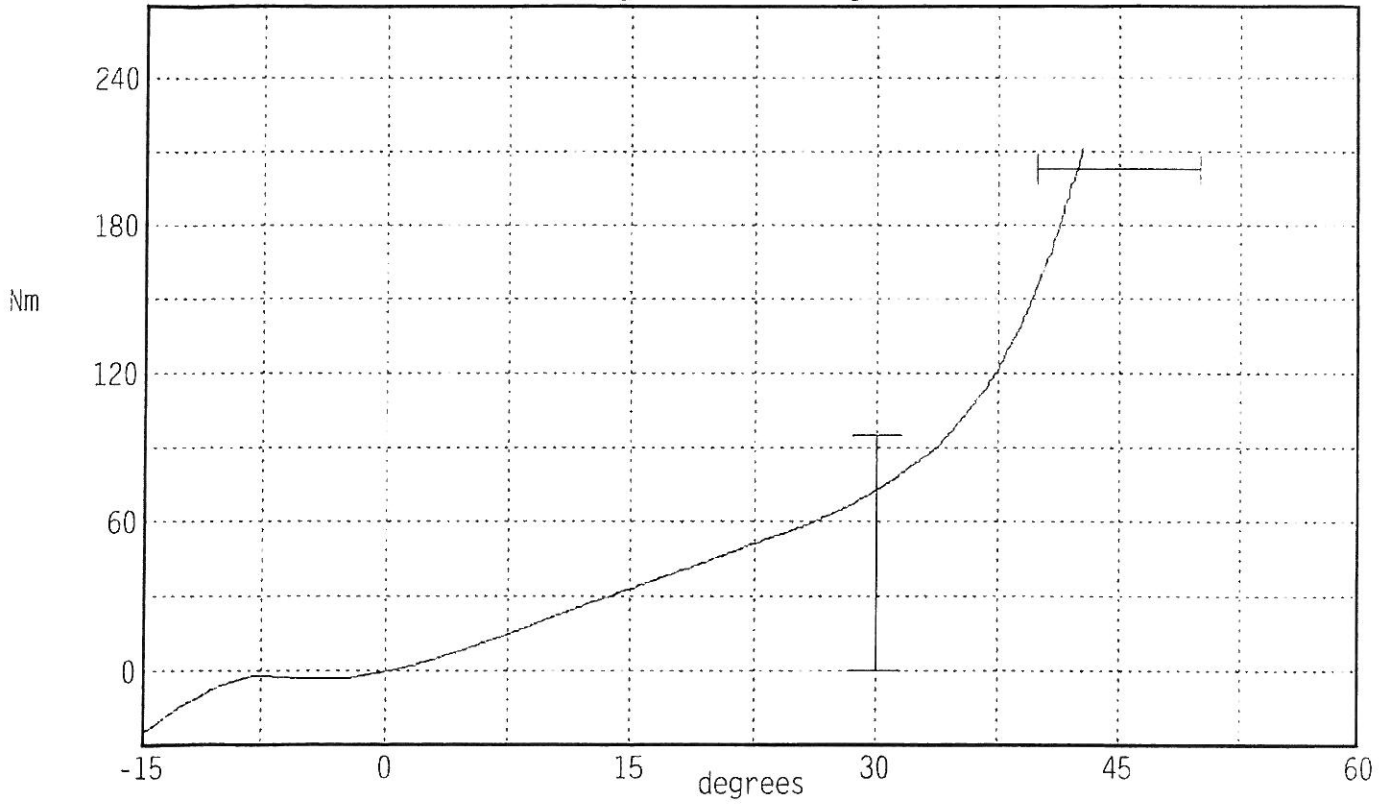
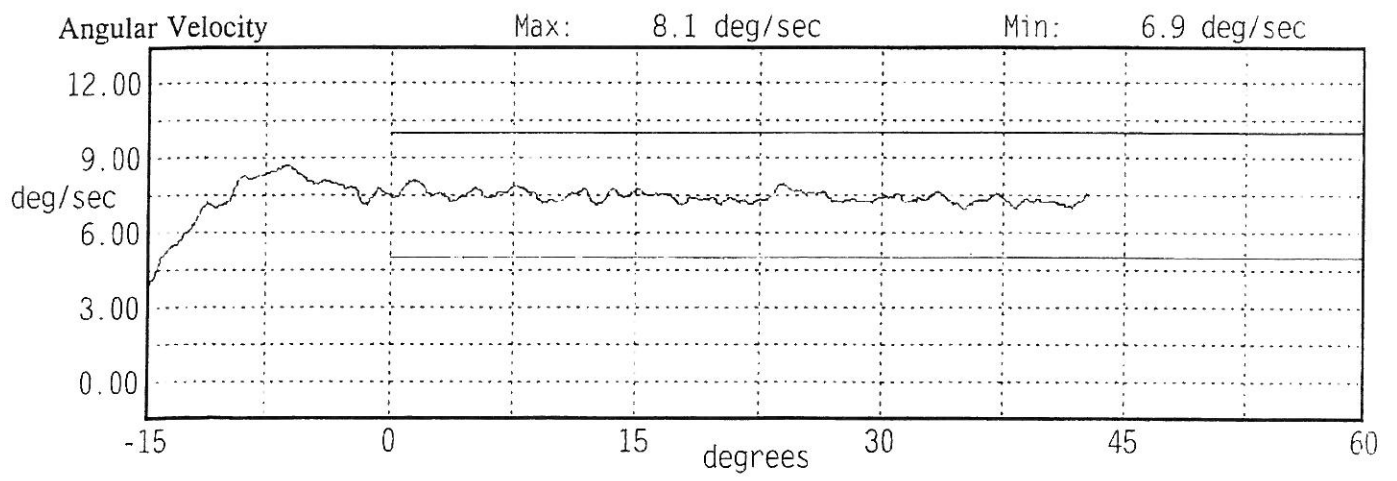
Hybrid III Hip Range of Motion

TEST PARAMETER	SPECIFICATION	TEST RESULTS	
Temperature	18.9 - 25.6	21.1 °C	Pass
Humidity	10 - 70	24 %	Pass
Moment at 30 deg	<= 94.9	73.2 Nm	Pass
Angle at 203 Nm	40.0 - 50.0	42.5 deg	Pass
Average Velocity	5.0 - 10.0	7.4 deg/sec	Pass

Moment About H-Point
 Peak Moment: 211.7 Nm at 42.7 deg
 Peak Angle: 42.7 deg at 211.7 Nm

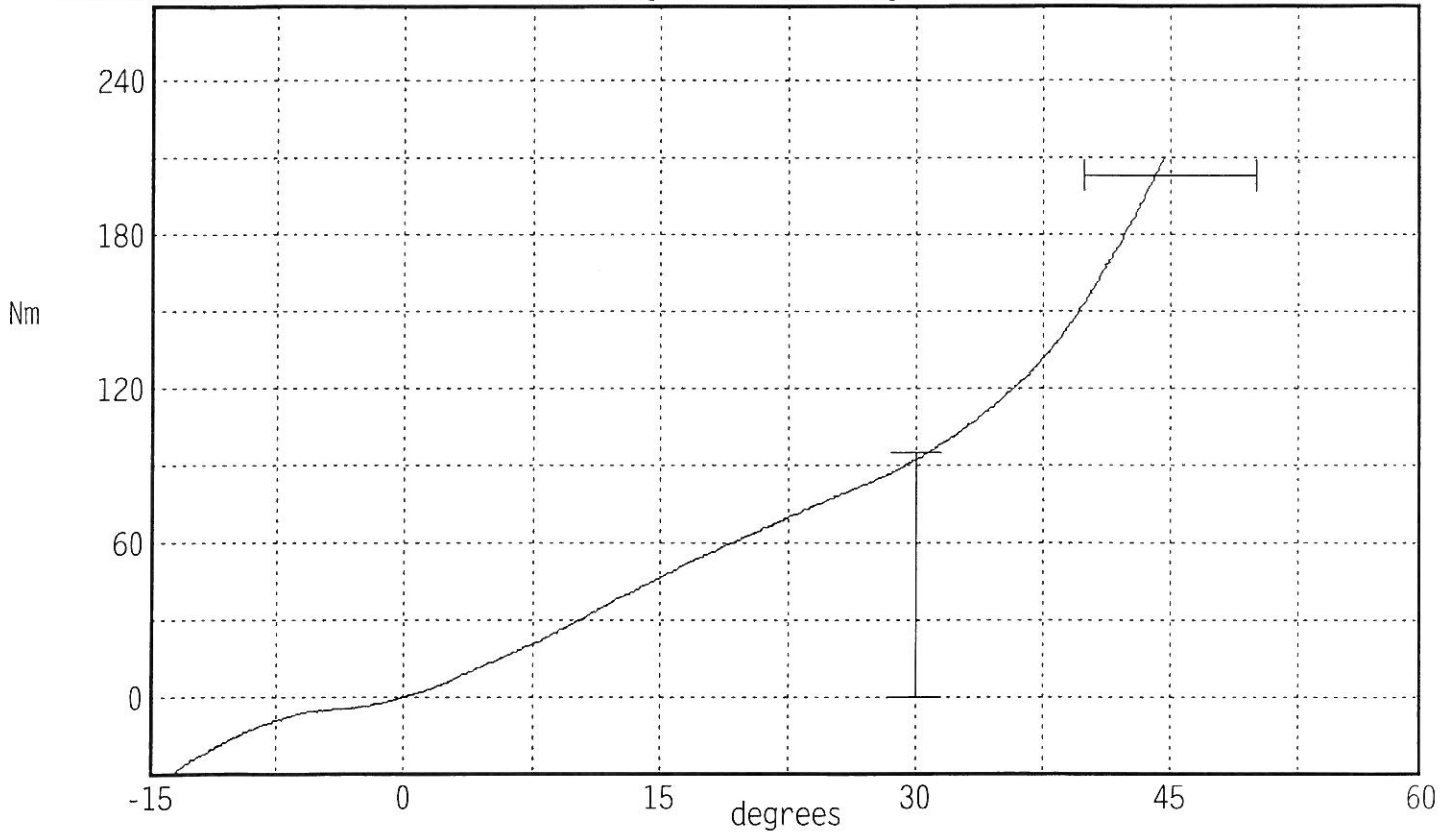
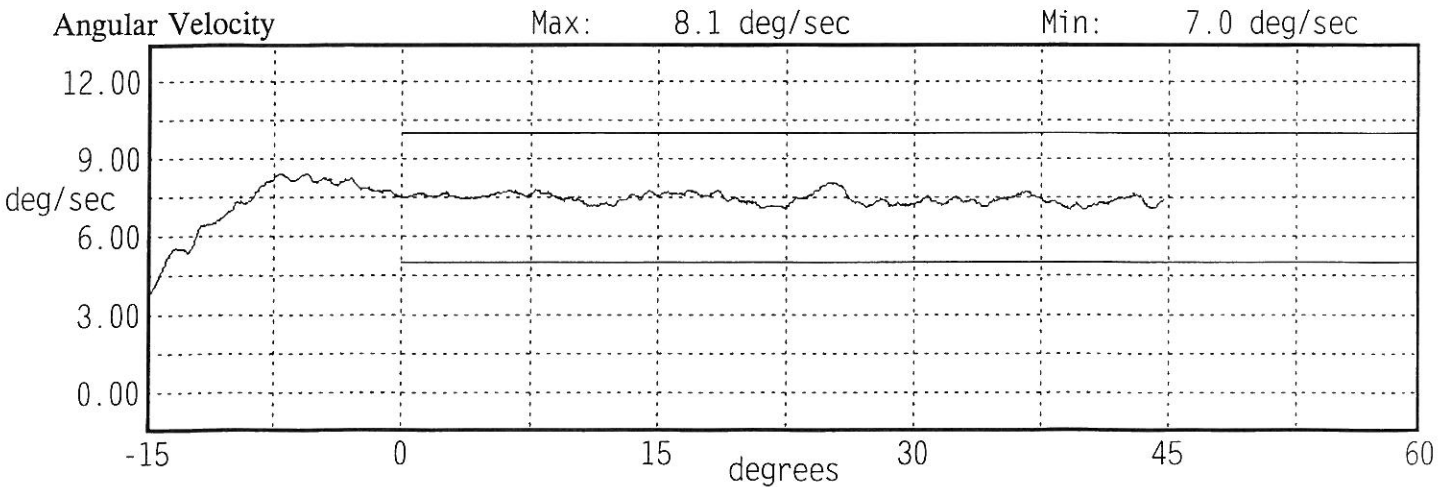
Hybrid III Hip Range of Motion

TEST PARAMETER	SPECIFICATION	TEST RESULTS
Temperature	18.9 - 25.6	21.3 °C Pass
Humidity	10 - 70	45 % Pass
Moment at 30 deg	<= 94.9	92.2 Nm Pass
Angle at 203 Nm	40.0 - 50.0	44.1 deg Pass
Average Velocity	5.0 - 10.0	7.4 deg/sec Pass

Moment About H-Point
Peak Moment: 210.1 Nm at 44.7 deg
Peak Angle: 44.7 deg at 210.1 Nm

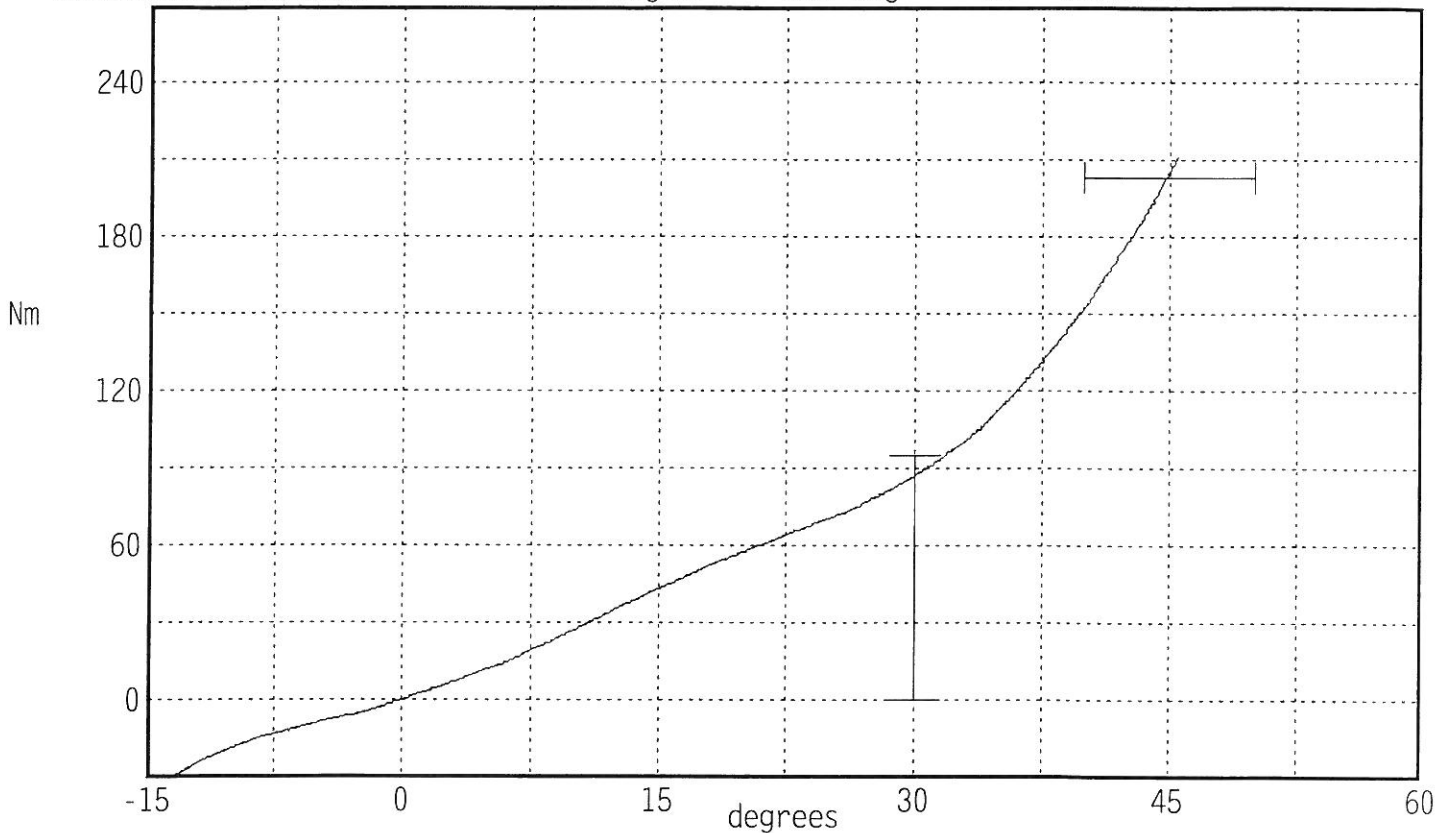
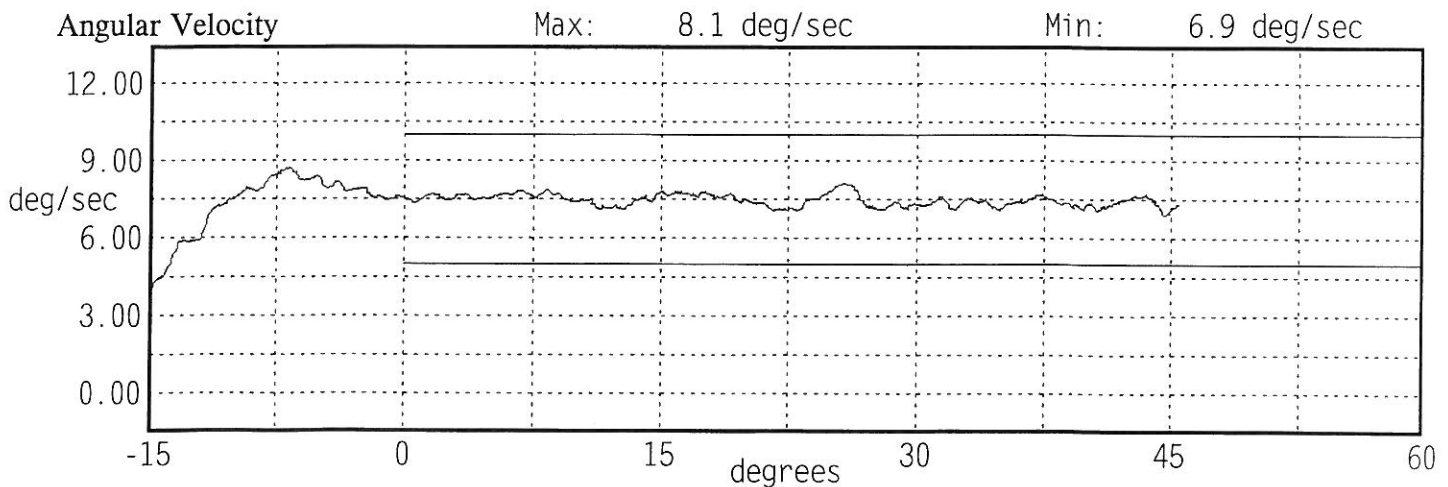
TEST PARAMETER	SPECIFICATION	TEST RESULTS
Temperature	18.9 - 25.6	21.3 °C Pass
Humidity	10 - 70	45 % Pass
Moment at 30 deg	<= 94.9	87.4 Nm Pass
Angle at 203 Nm	40.0 - 50.0	44.8 deg Pass
Average Velocity	5.0 - 10.0	7.4 deg/sec Pass

Moment About H-Point
Peak Moment: 211.0 Nm at 45.5 deg
Peak Angle: 45.5 deg at 211.0 Nm

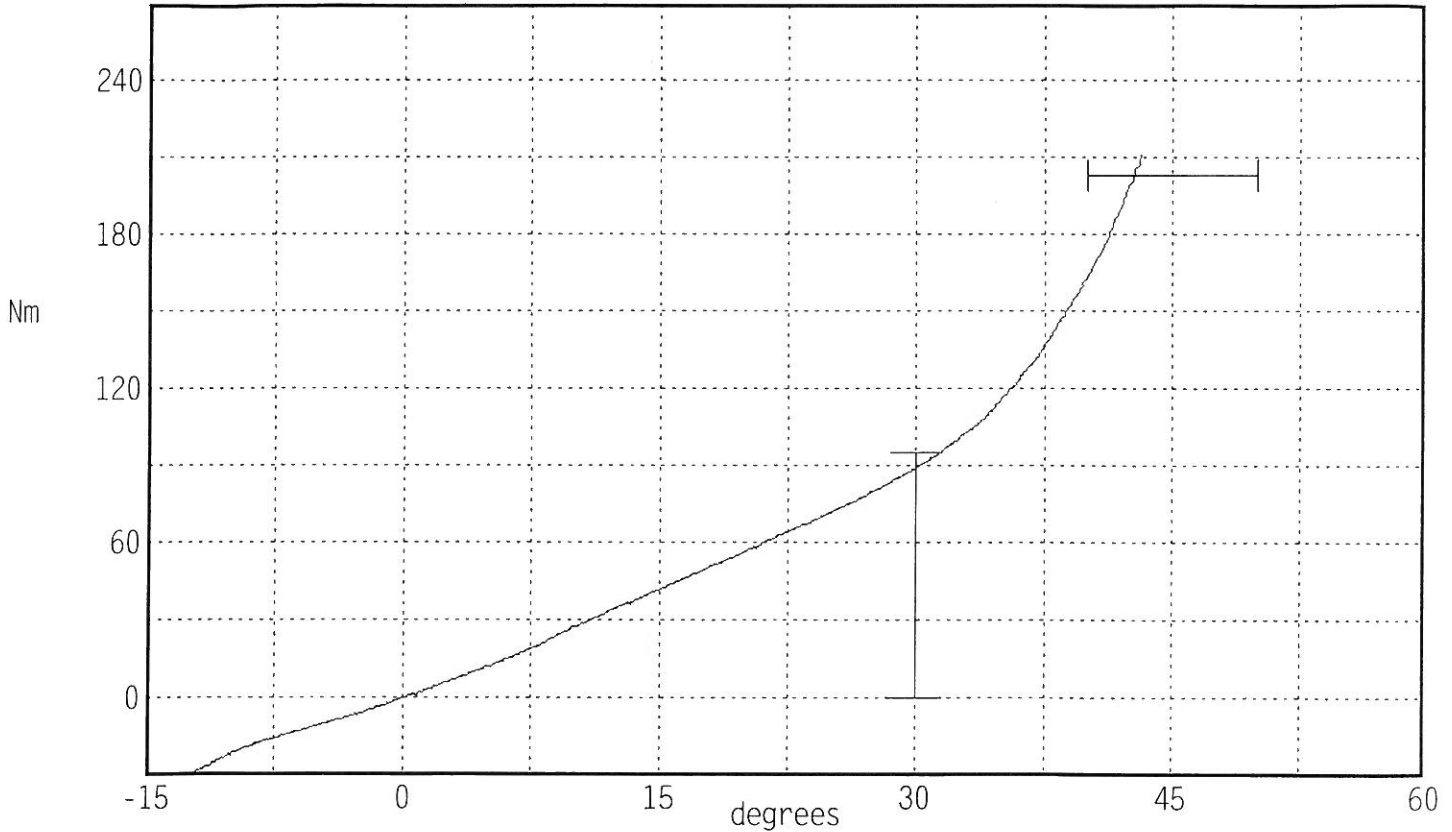
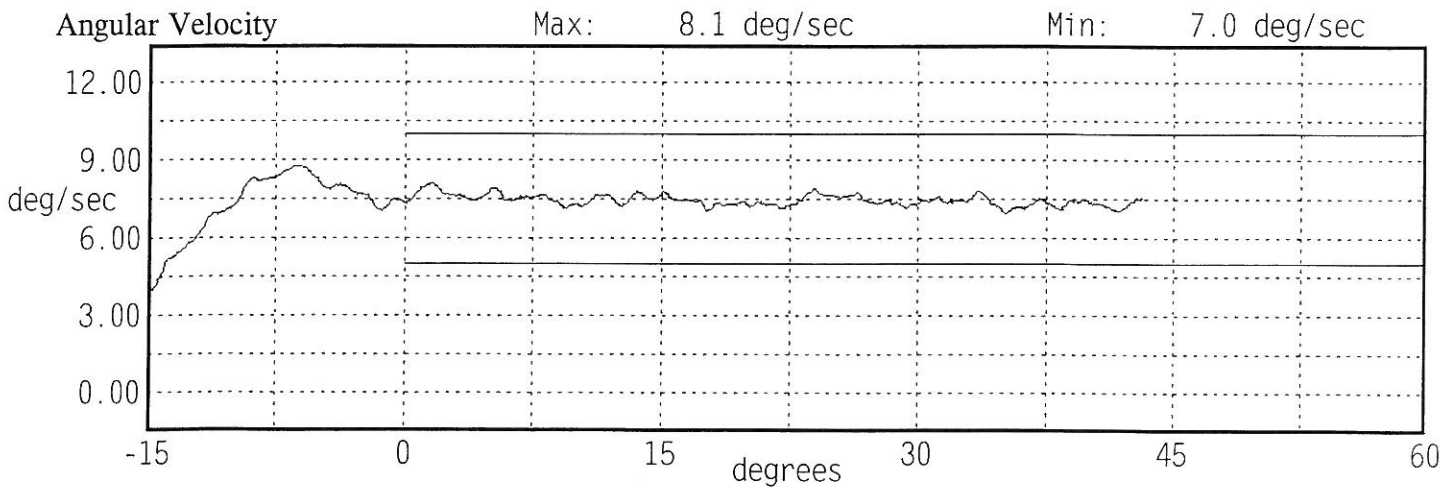
Hybrid III Hip Range of Motion

TEST PARAMETER	SPECIFICATION	TEST RESULTS
Temperature	18.9 - 25.6	21.2 °C Pass
Humidity	10 - 70	20 % Pass
Moment at 30 deg	<= 94.9	89.6 Nm Pass
Angle at 203 Nm	40.0 - 50.0	42.7 deg Pass
Average Velocity	5.0 - 10.0	7.4 deg/sec Pass

Moment About H-Point
Peak Moment: 211.2 Nm at 43.2 deg
Peak Angle: 43.2 deg at 211.2 Nm

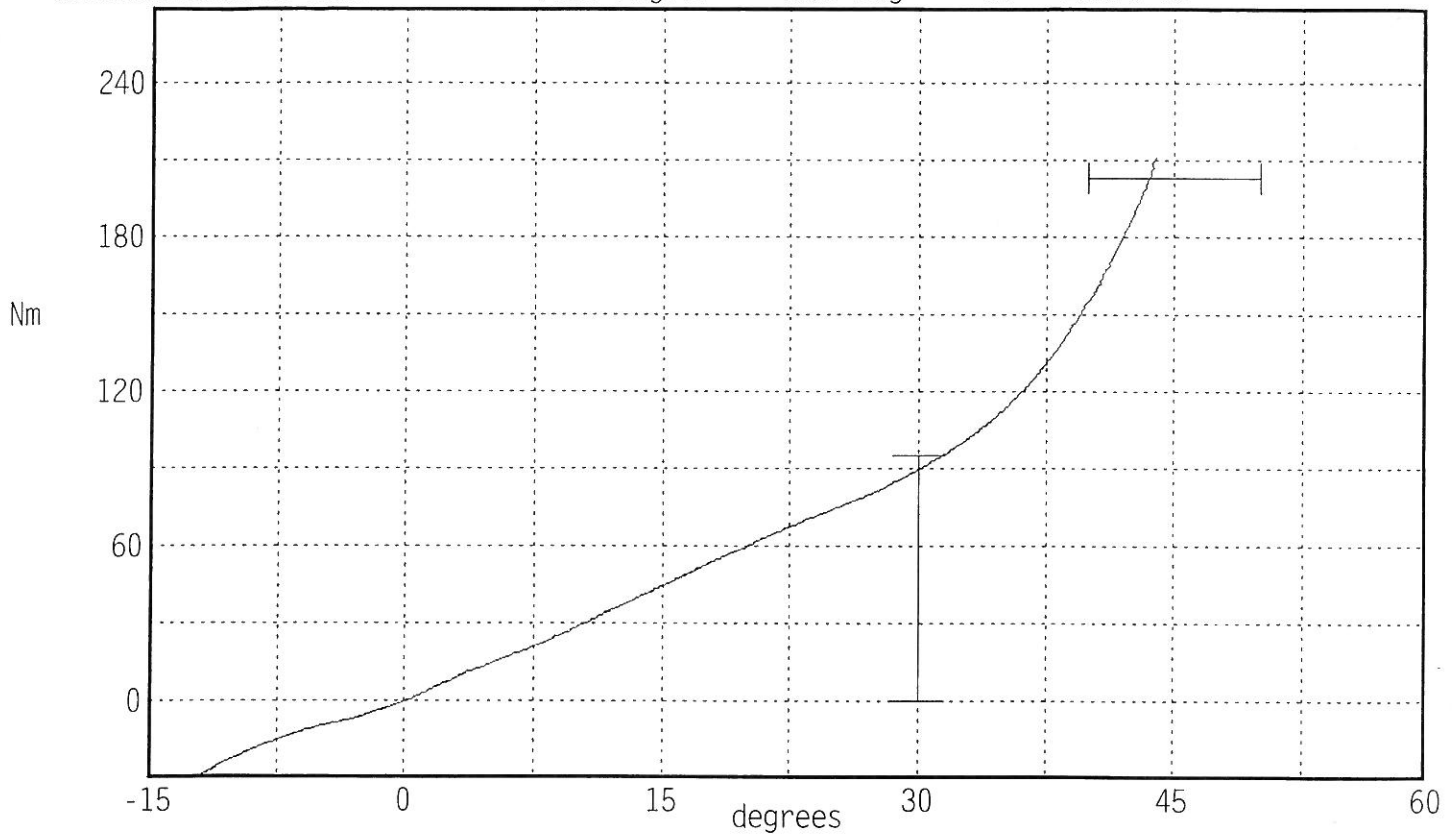
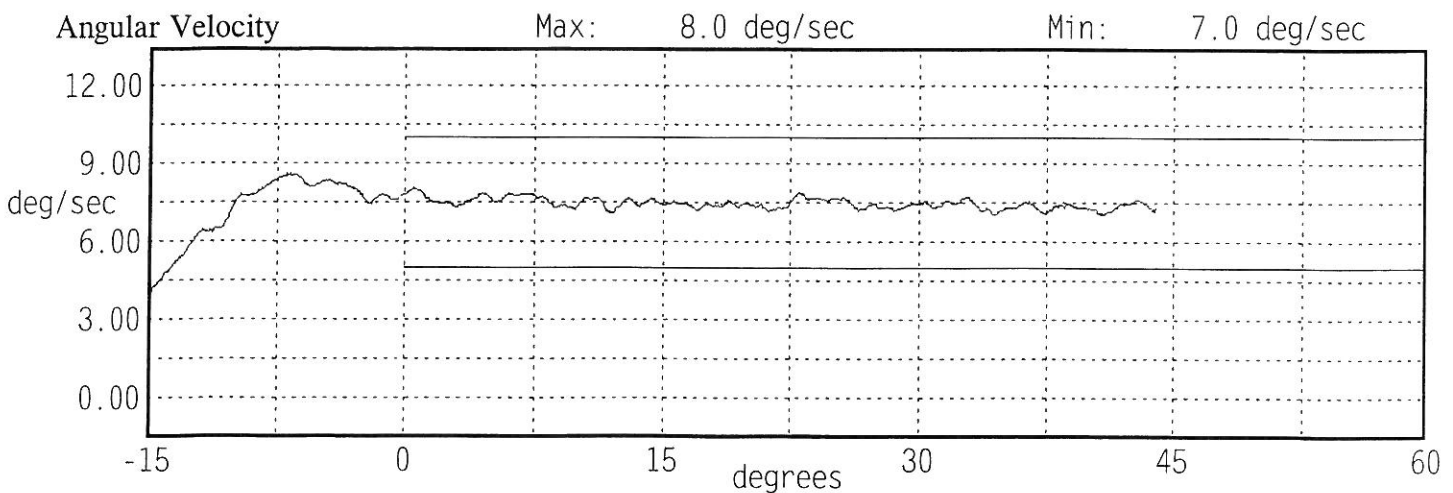
TEST PARAMETER	SPECIFICATION	TEST RESULTS
Temperature	18.9 - 25.6	21.2 °C Pass
Humidity	10 - 70	21 % Pass
Moment at 30 deg	<= 94.9	89.6 Nm Pass
Angle at 203 Nm	40.0 - 50.0	43.6 deg Pass
Average Velocity	5.0 - 10.0	7.5 deg/sec Pass

Moment About H-Point
Peak Moment: 211.0 Nm at 43.9 deg
Peak Angle: 43.9 deg at 211.0 Nm
