REPORT NUMBER: NCAP-CAL-11-005

**NEW CAR ASSESSMENT PROGRAM (NCAP)
Moving Deformable Barrier Side Impact Test**

**Ford Motor Company
2011 Ford Taurus SEL
4-Door Sedan**

NHTSA NUMBER: MB0222

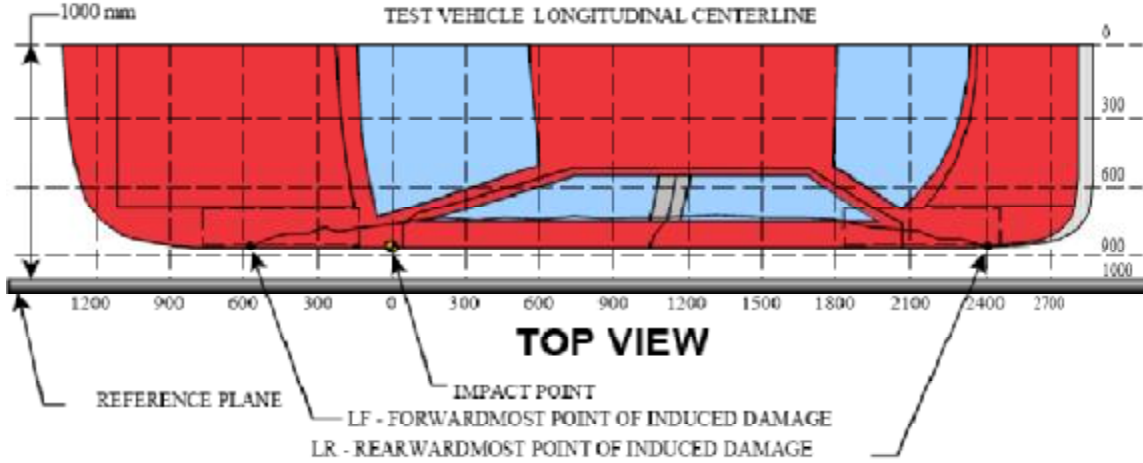
**DATA SHEET NO. 13
VEHICLE DAMAGE PROFILE DISTANCES**

DAMAGE PROFILE DISTANCES

DPD	Distance From Impact Point (mm)	Level	Pre-Test (mm)	Post-Test (mm)	Maximum Static Crush (mm)
1	2400	4	100	104	4
2	1920	3	52	192	140
3	1440	3	54	307	253
4	960	3	53	273	220
5	0	3	57	262	205
6	0	2	47	64	17
