**REPORT NUMBER: SINCAP-MGA-2011-004**

**NEW CAR ASSESSMENT PROGRAM  
SIDE IMPACT TEST**

**DAIMLER AG STUTTGART  
2010 MERCEDES-BENZ E350 4-DR SEDAN  
NHTSA NUMBER: EA0500**

**PREPARED BY:  
MGA RESEARCH CORPORATION  
5000 WARREN ROAD  
BURLINGTON, WI 53105**

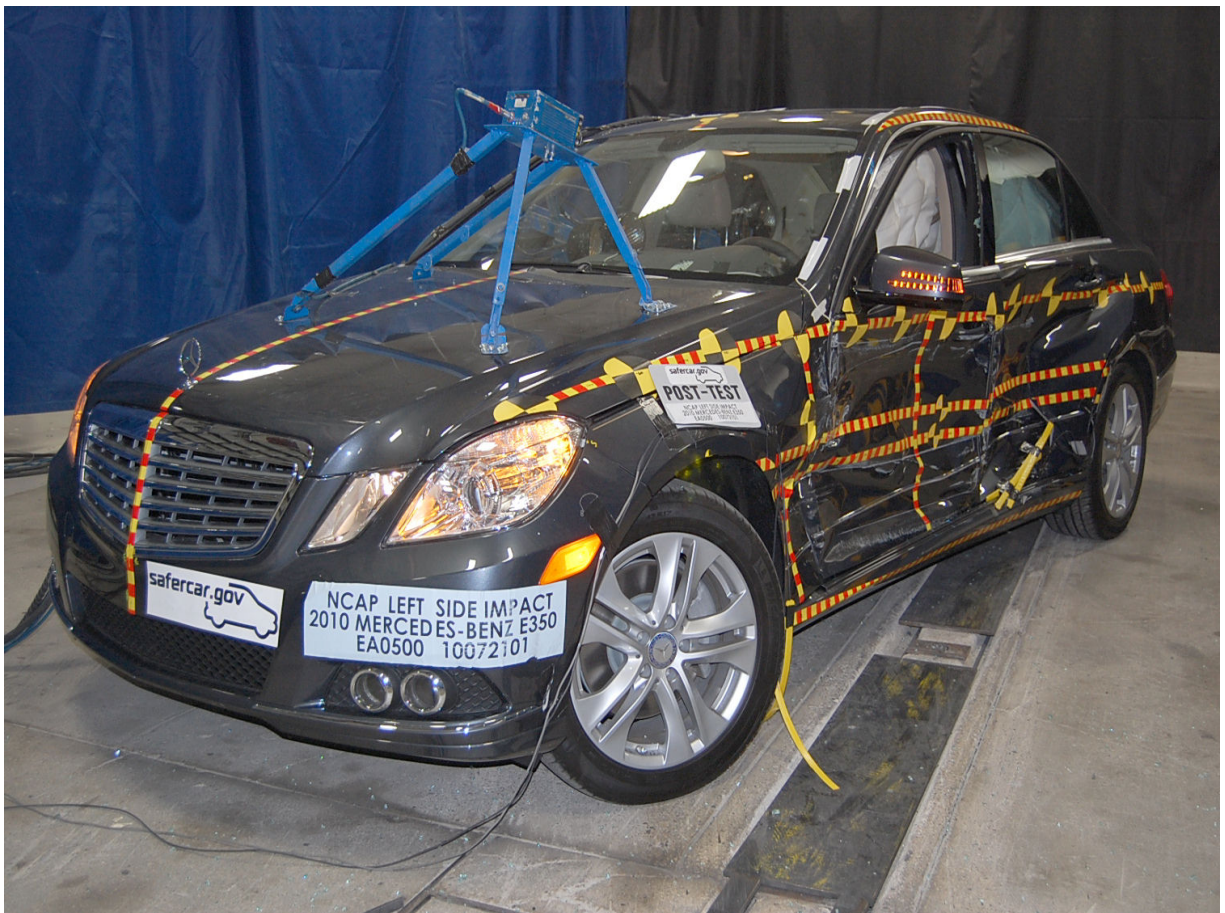
Post-Test Left Front  $\frac{3}{4}$  View

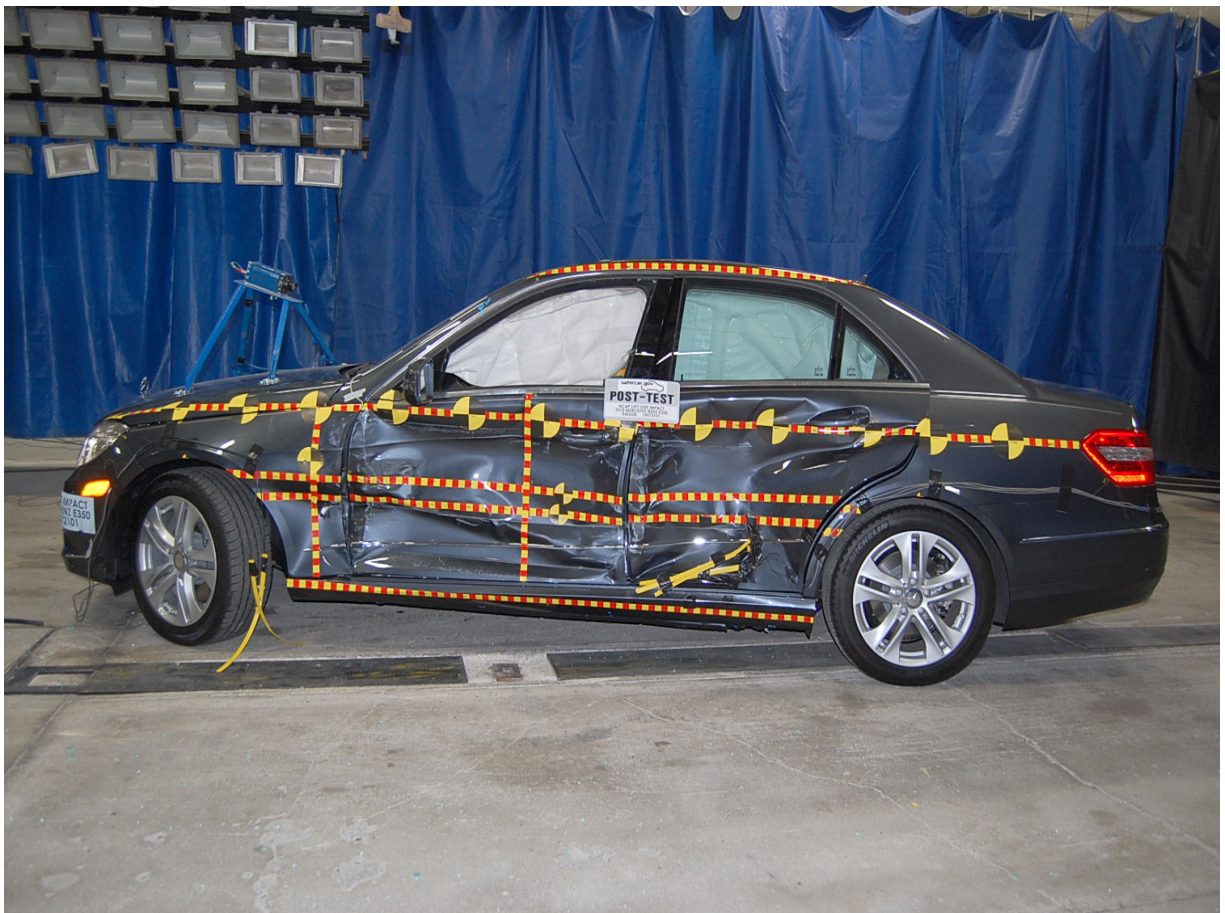
Post-Test Left Side View

The test vehicle sustained a maximum static crush of 167 mm at level 3, 1650 mm rearward of the vertical impact point. The driver and passenger SID/HIIIs, Serial Nos. 271 and 272 respectively, were calibrated just prior to this test.

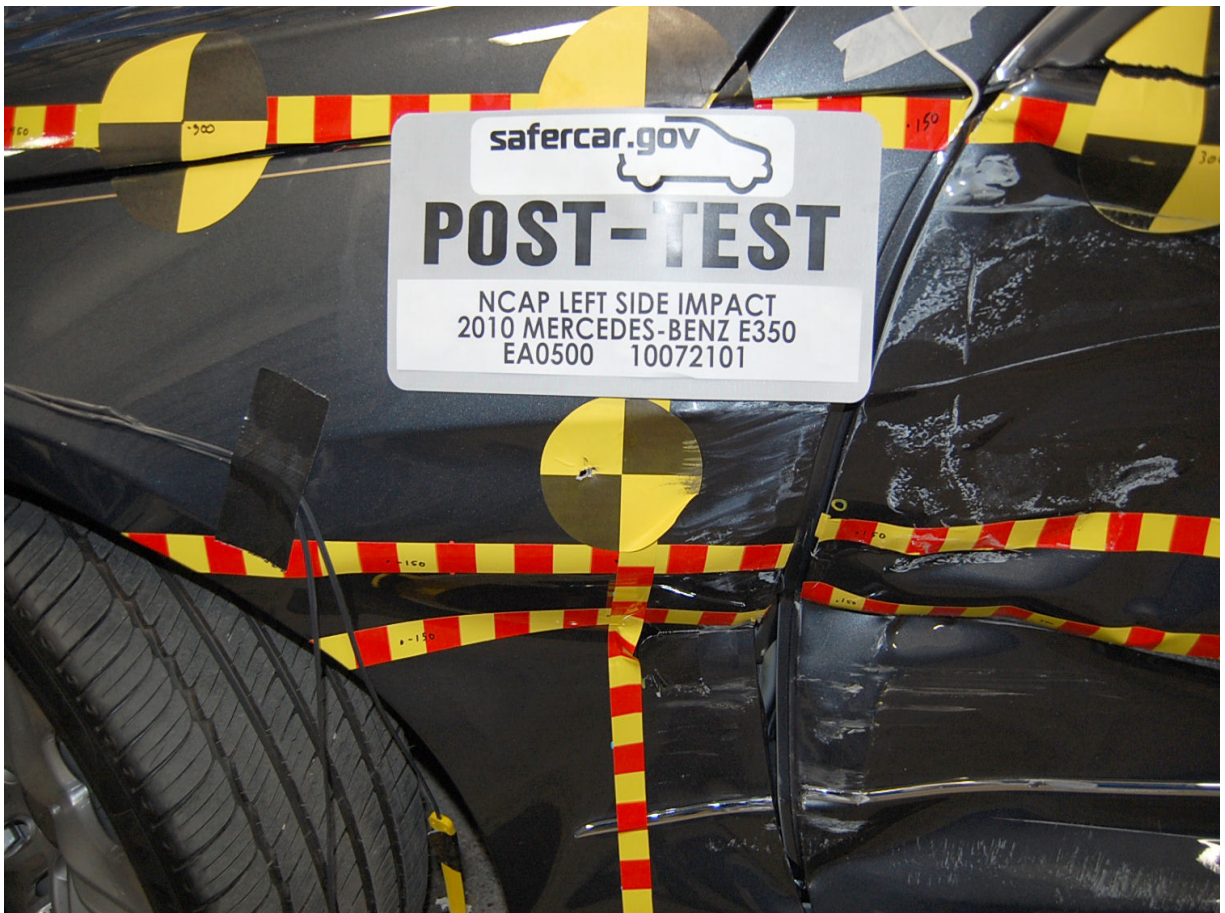
Post-Test Left Impact Point

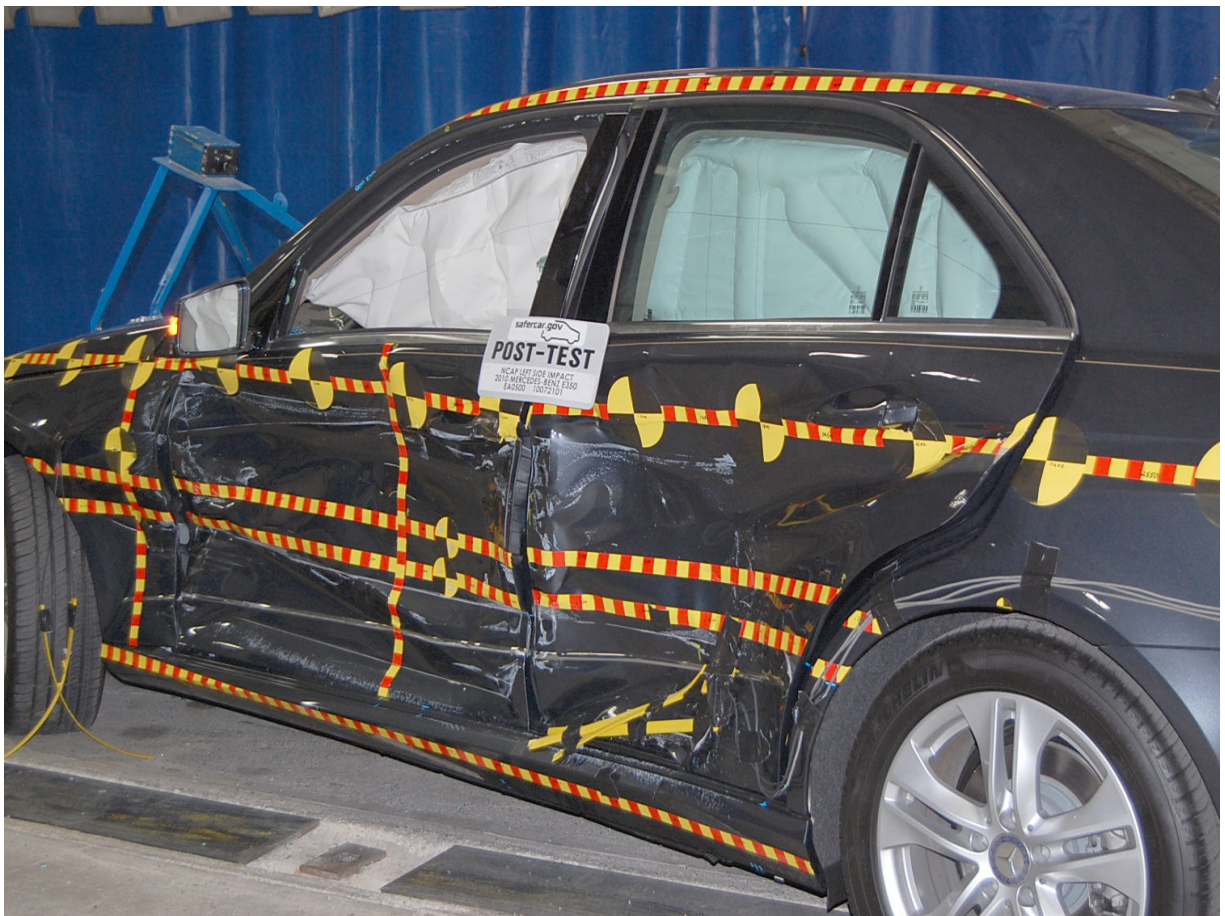
Post-Test Rear  $\frac{3}{4}$  View of Left Side Doors

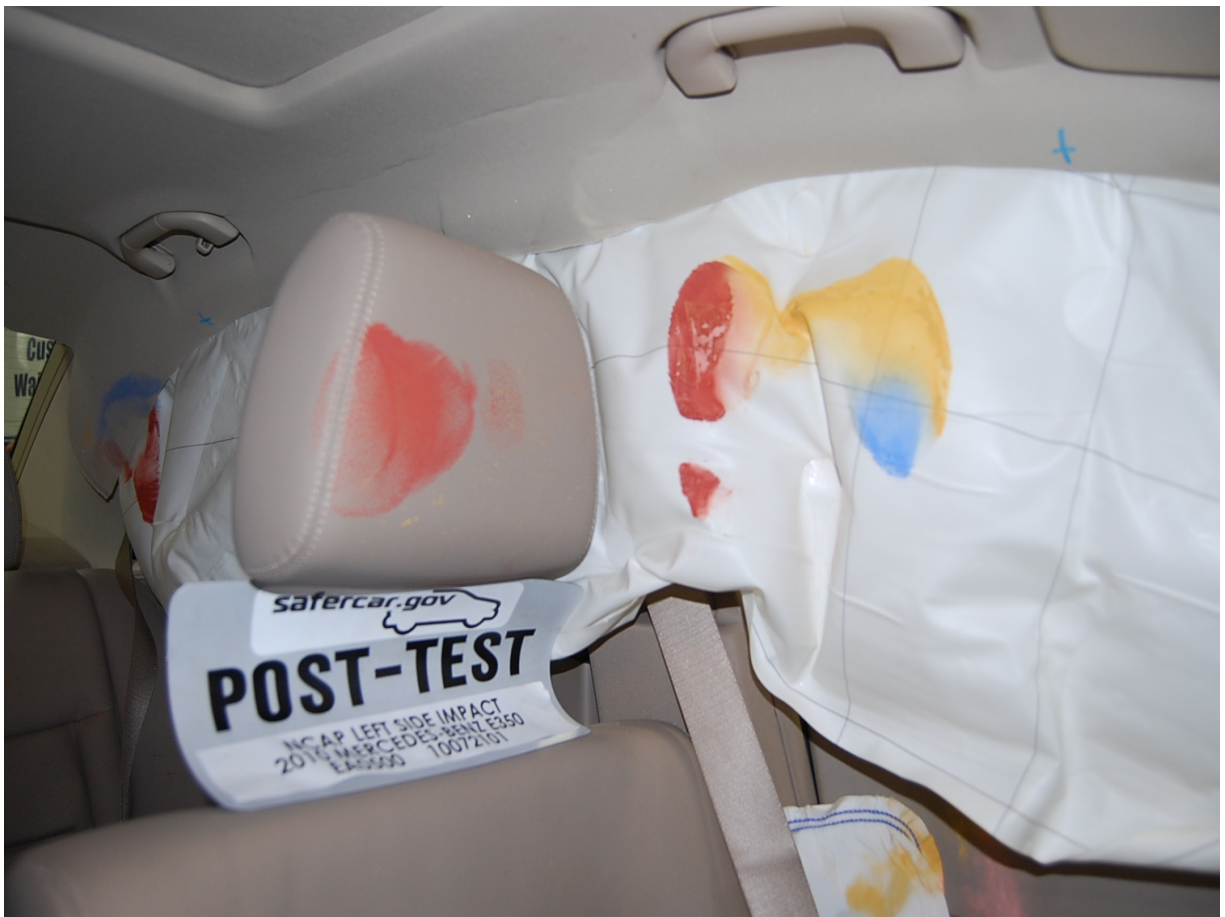
Post-Test Driver Dummy Head Contact View

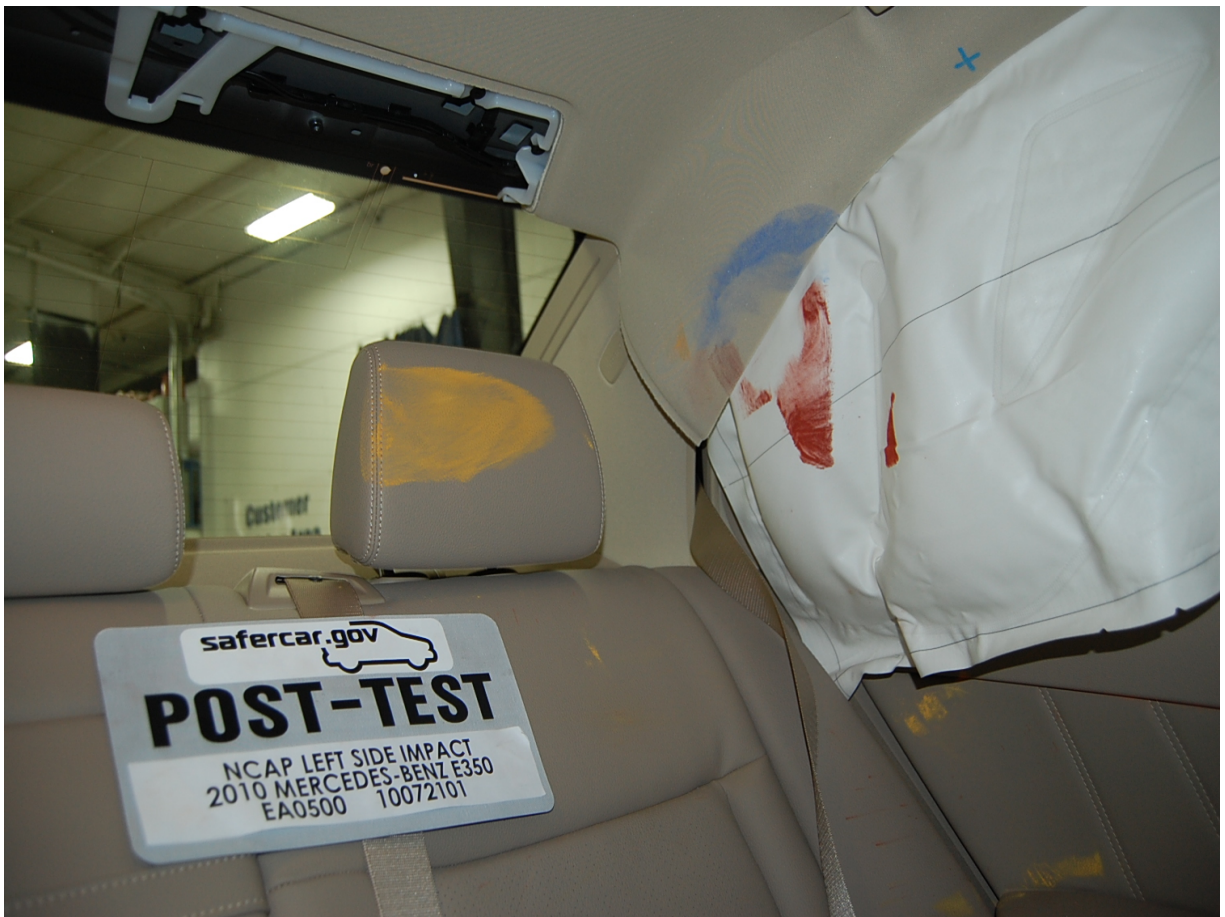
Post-Test Passenger Dummy Head Contact View
