**REPORT NUMBER: SINCAP-MGA-2011-005**

**NEW CAR ASSESSMENT PROGRAM (NCAP)  
Moving Deformable Barrier Side Impact Test**

**KIA MOTORS MANUFACTURING GEORGIA, INC.  
2011 Kia Sorento LX FWD  
NHTSA No.: MB0504**

**MGA RESEARCH CORPORATION  
5000 Warren Road  
Burlington, WI 53105**

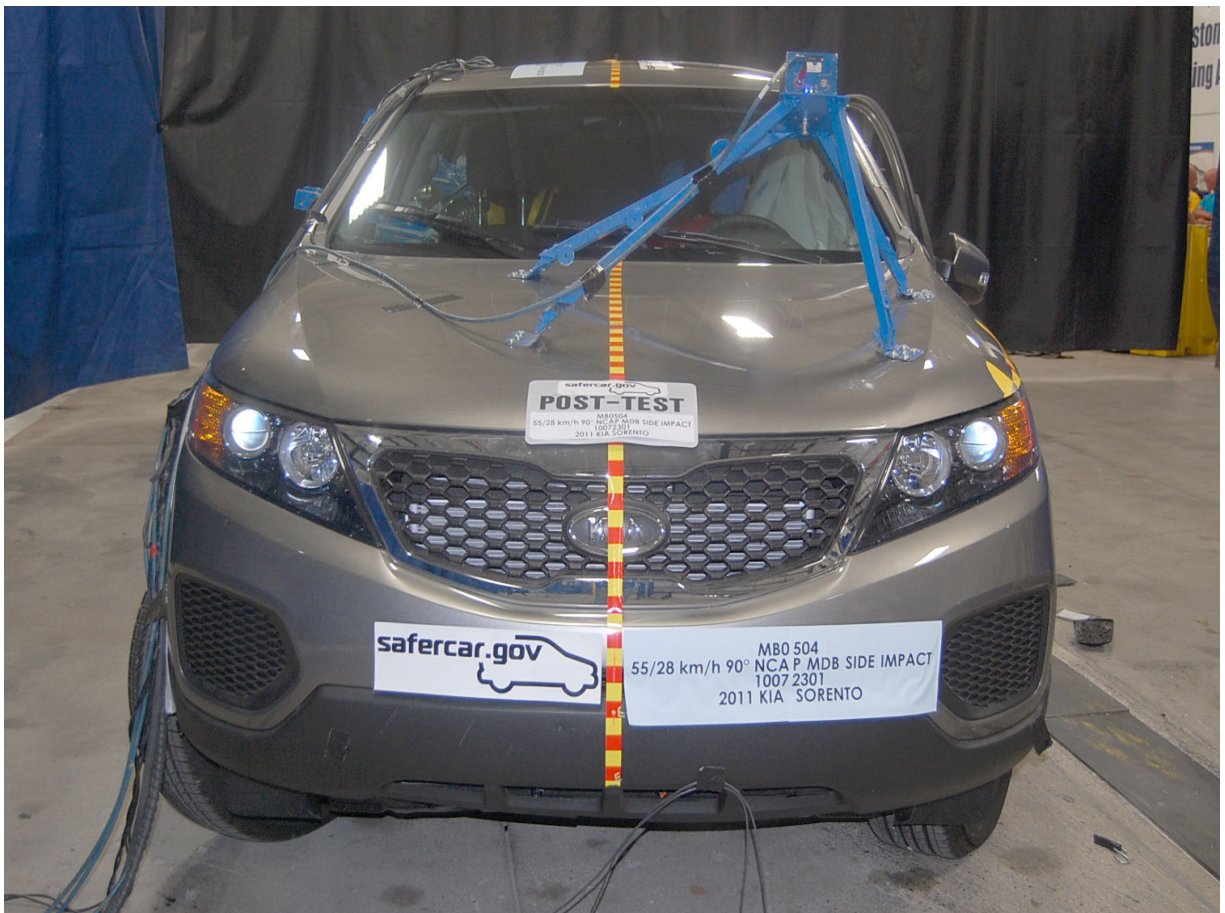
Post-Test Frontal View of Test Vehicle

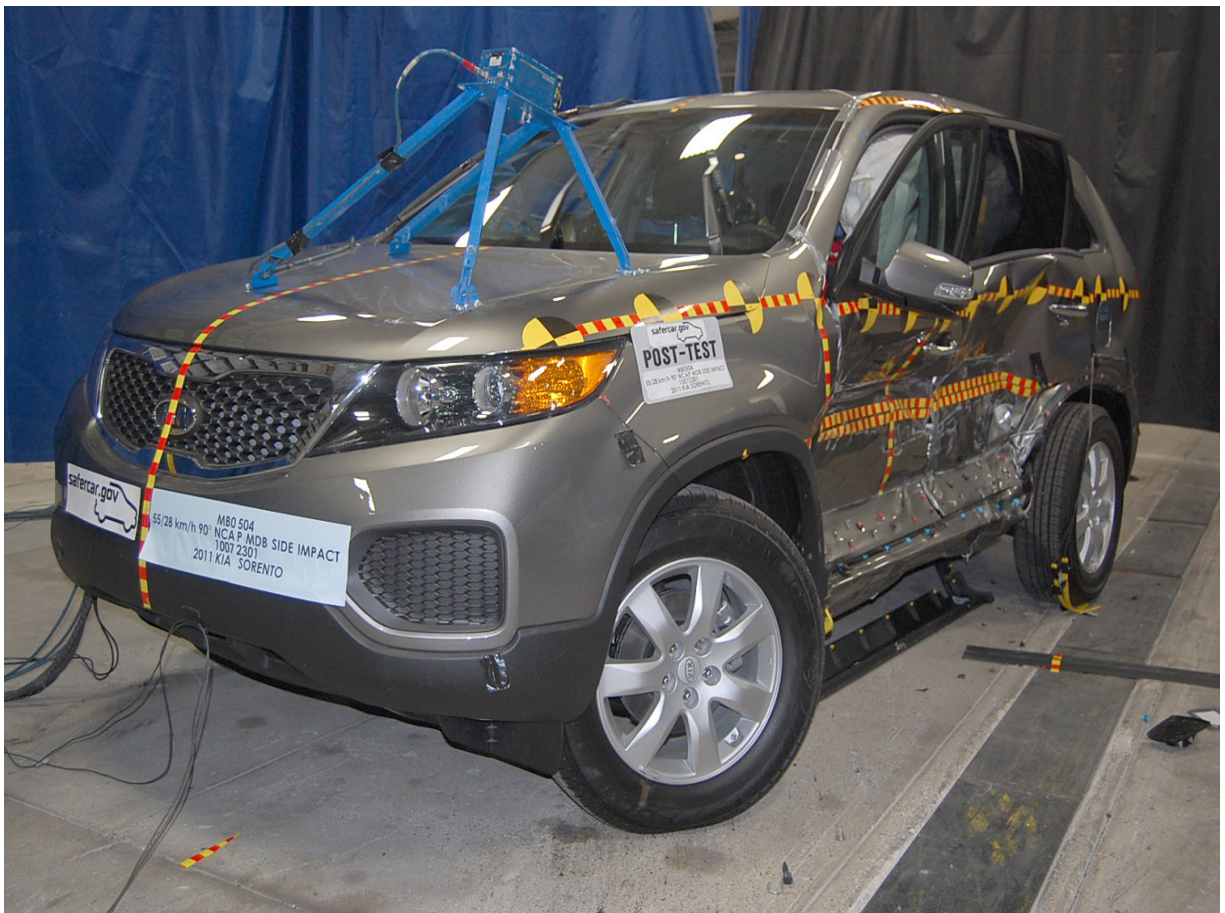
Post-Test Left  $\frac{3}{4}$  Front View of Test Vehicle

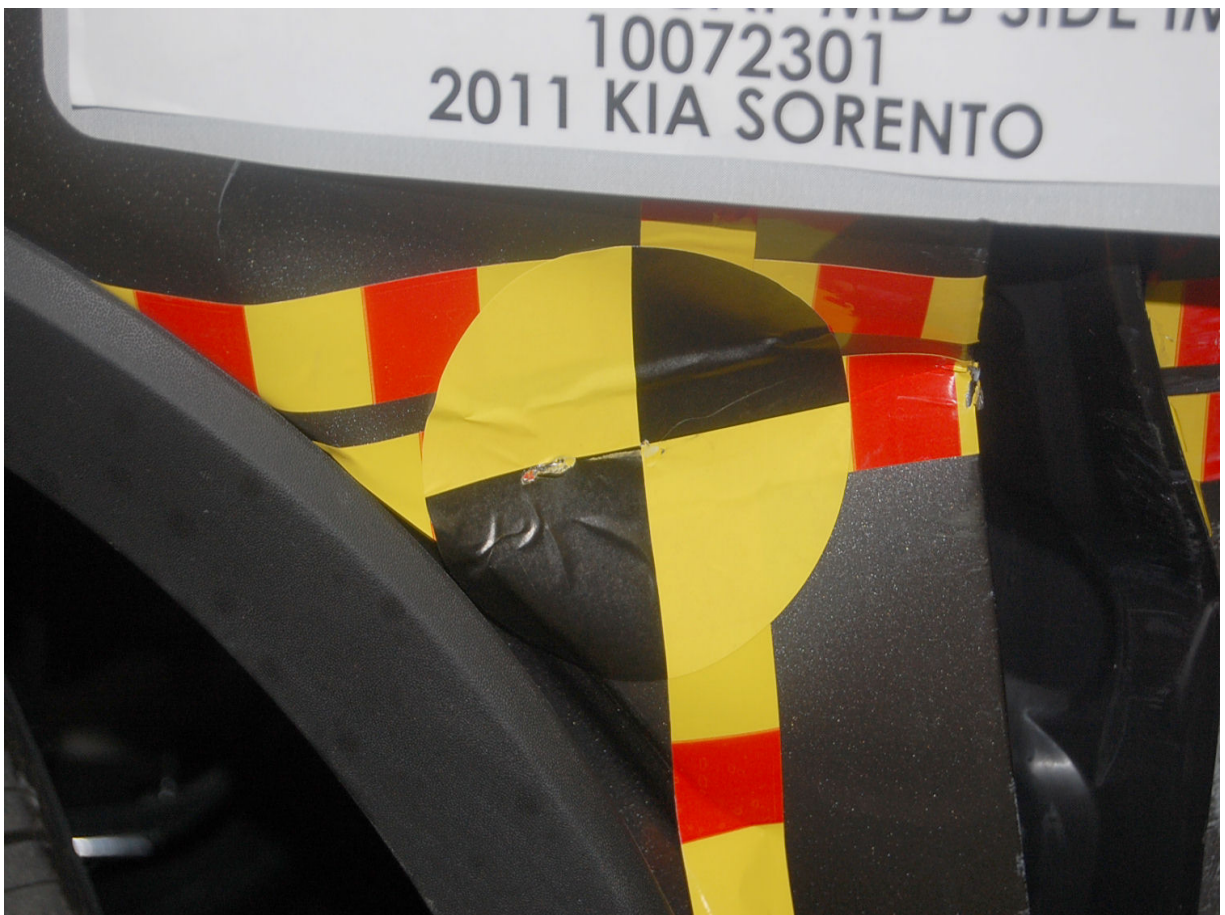
Post-Test Close-Up View of Impact Point Target Showing Impact Point Location

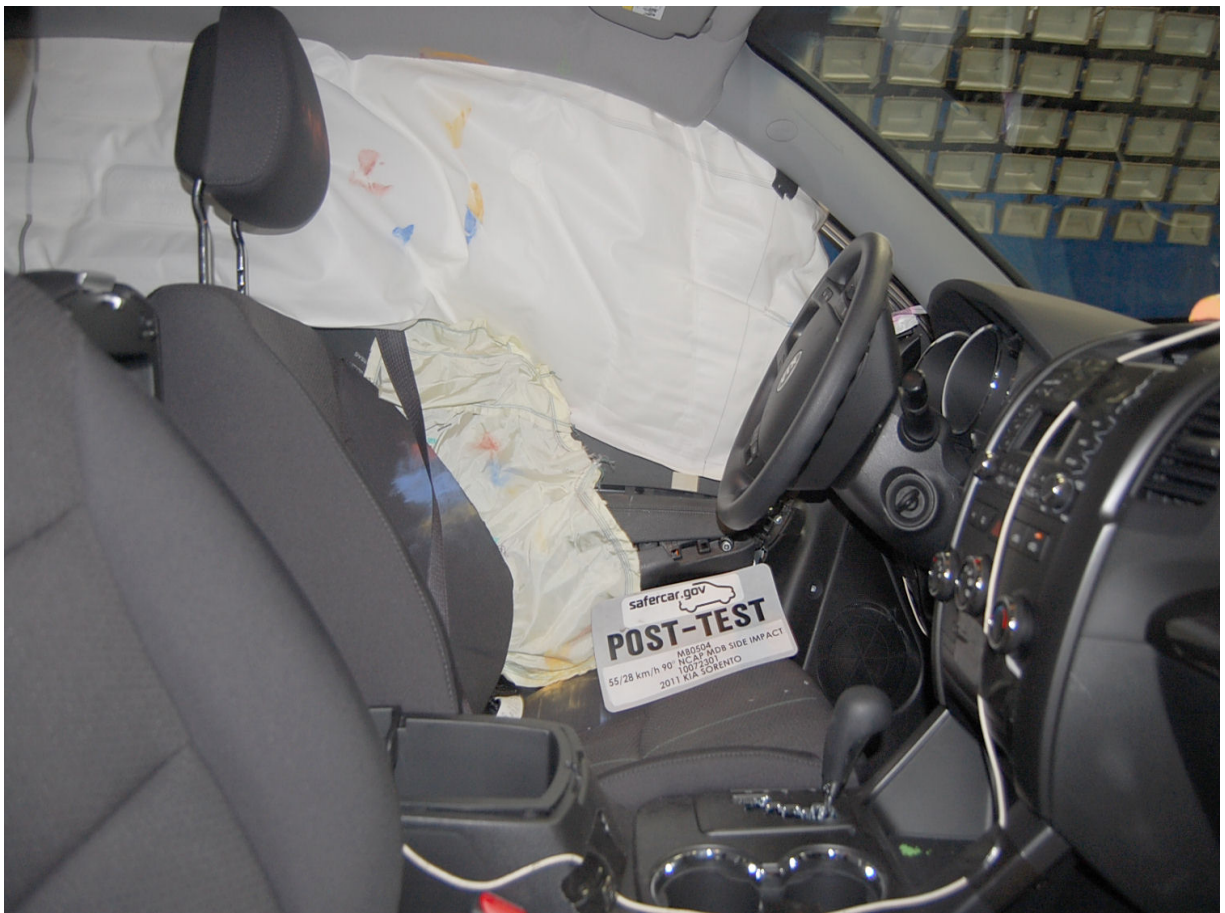
Post-Test Driver Inner Door Panel View Showing Driver Dummy Contact Locations

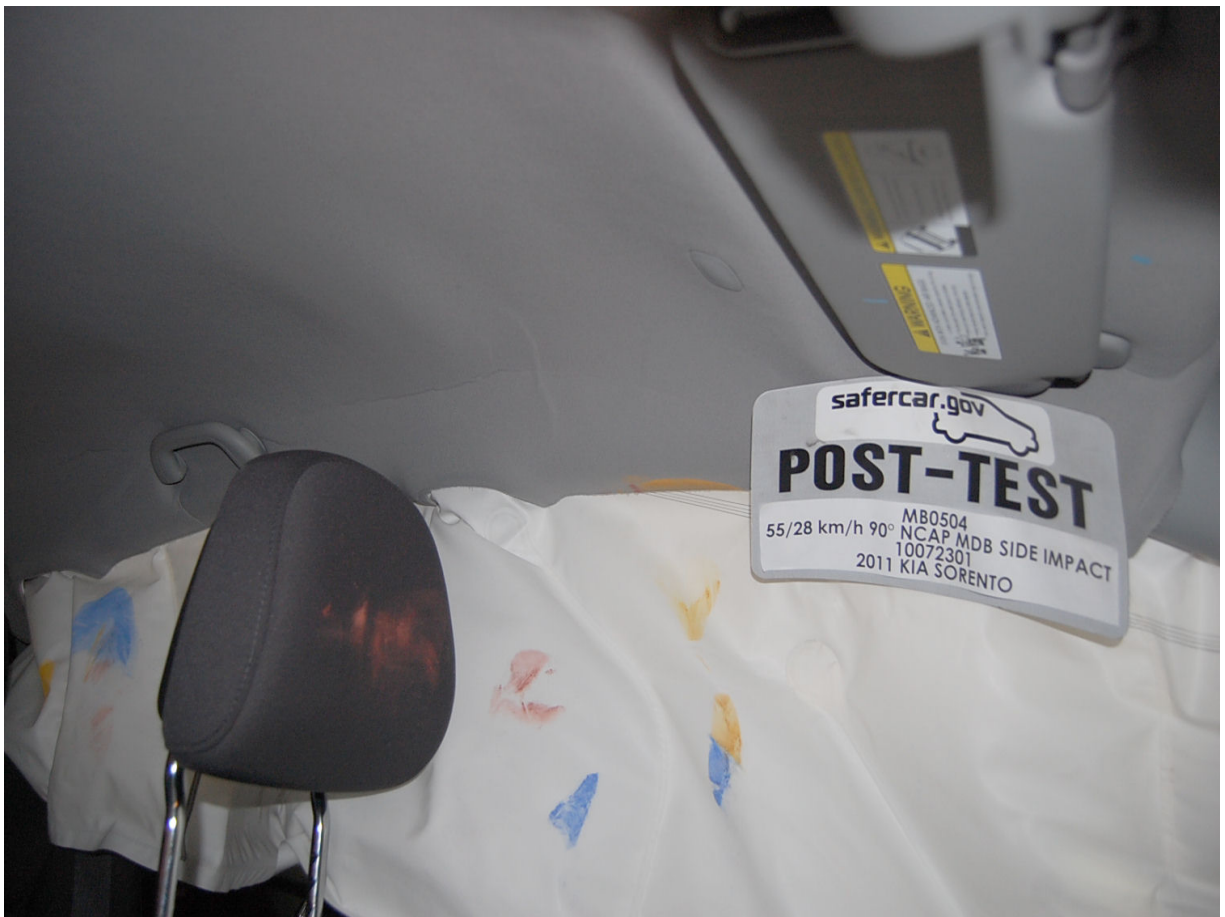
Post-Test Driver Dummy Close-up Head Contact with Vehicle View

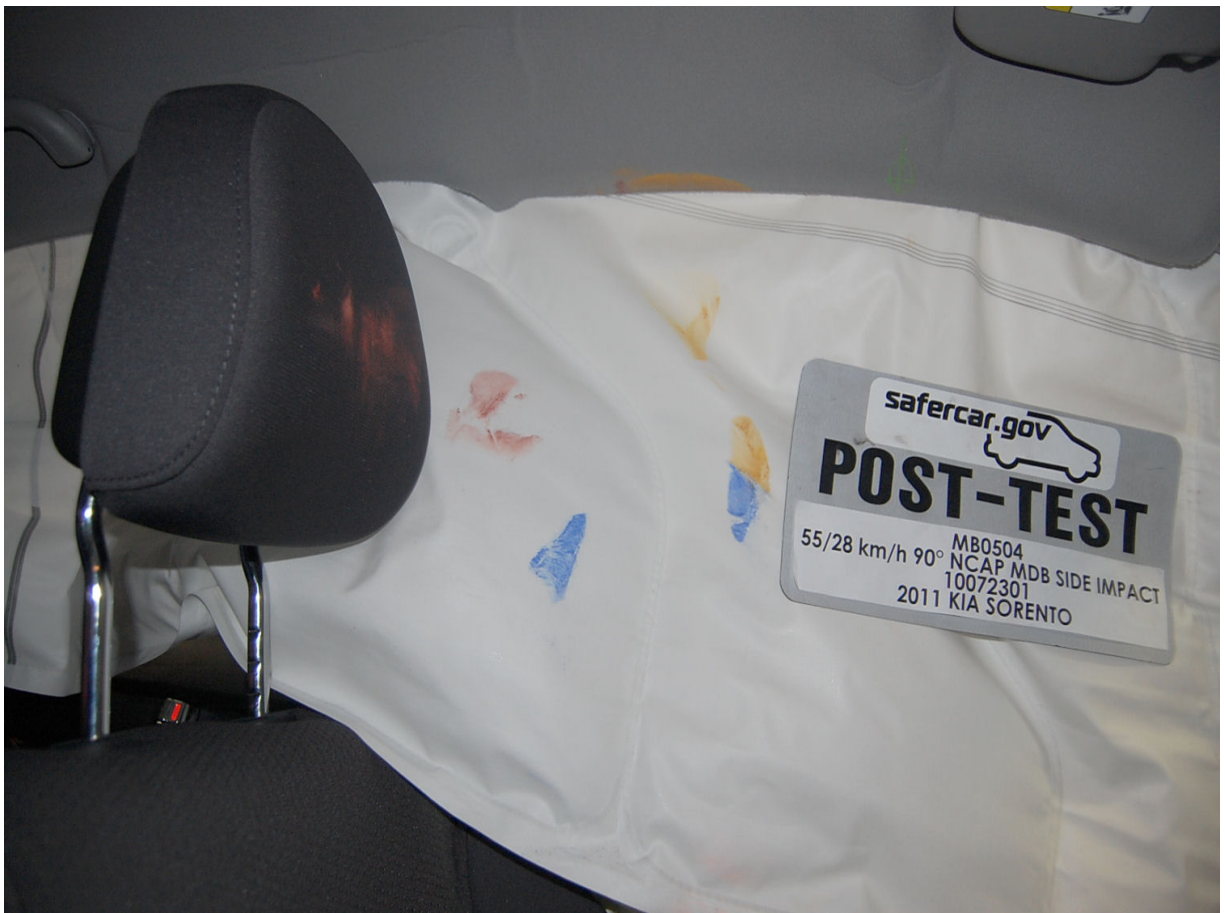
Post-Test Driver Dummy Close-up Head Contact with Side Airbag View

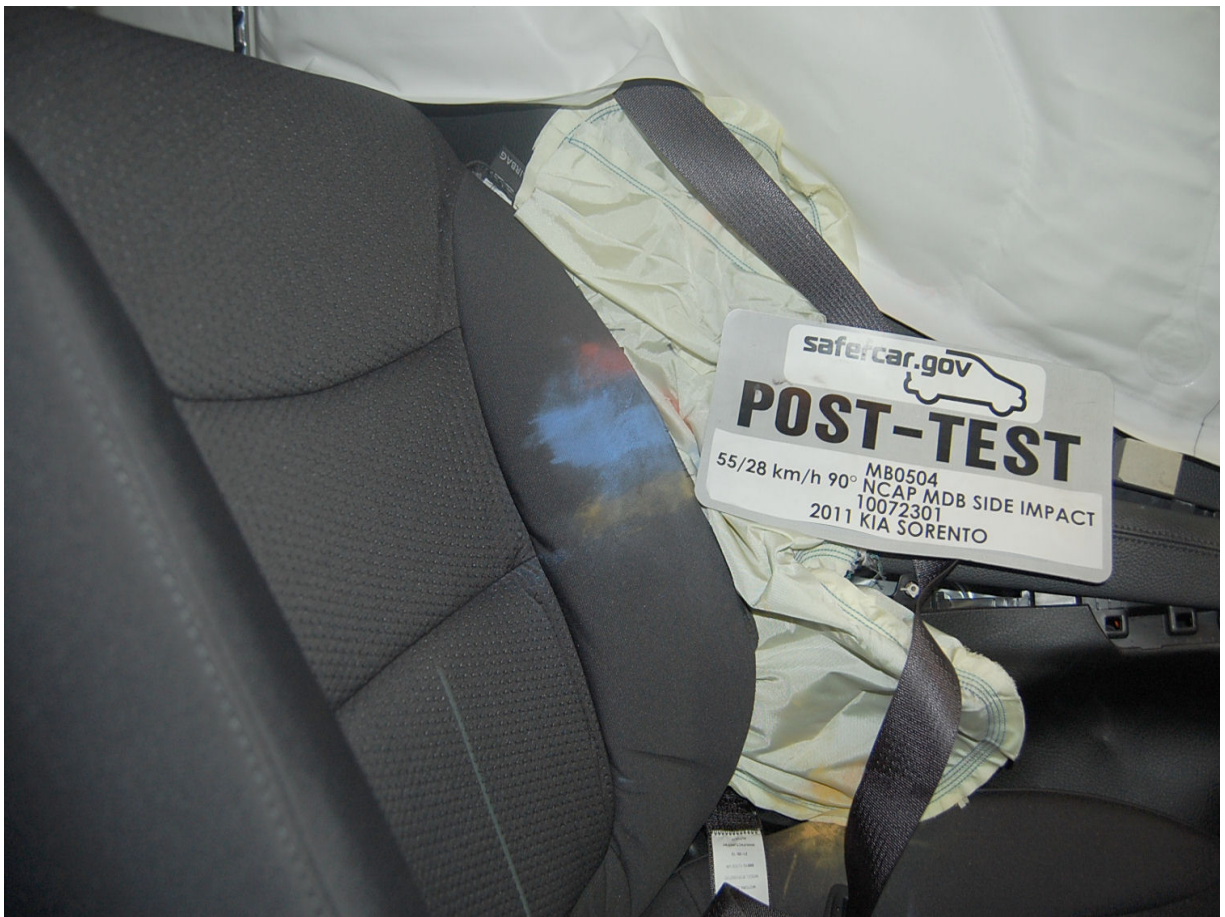
Post-Test Driver Dummy Close-up Torso Contact with Vehicle View

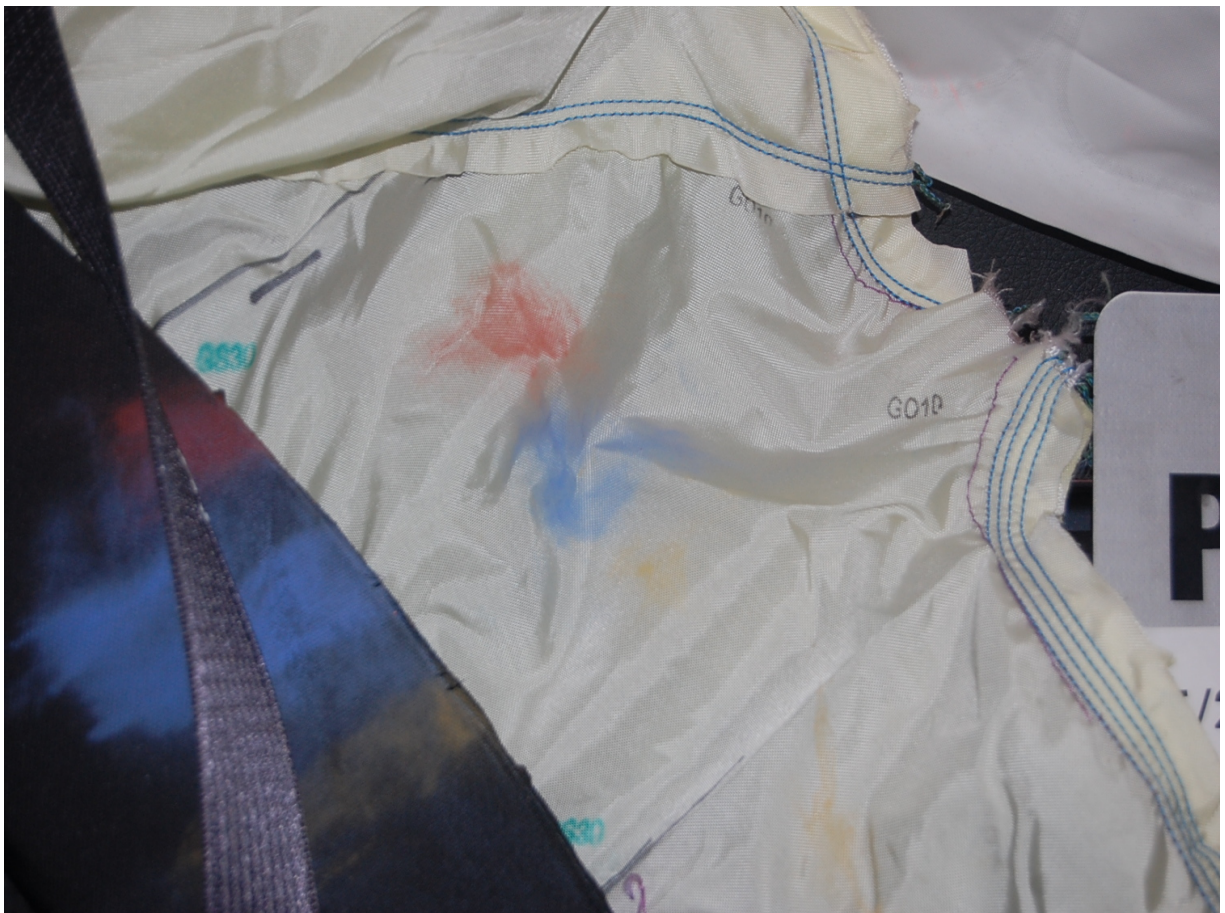
Post-Test Driver Dummy Close-up Torso Contact with Side Airbag View

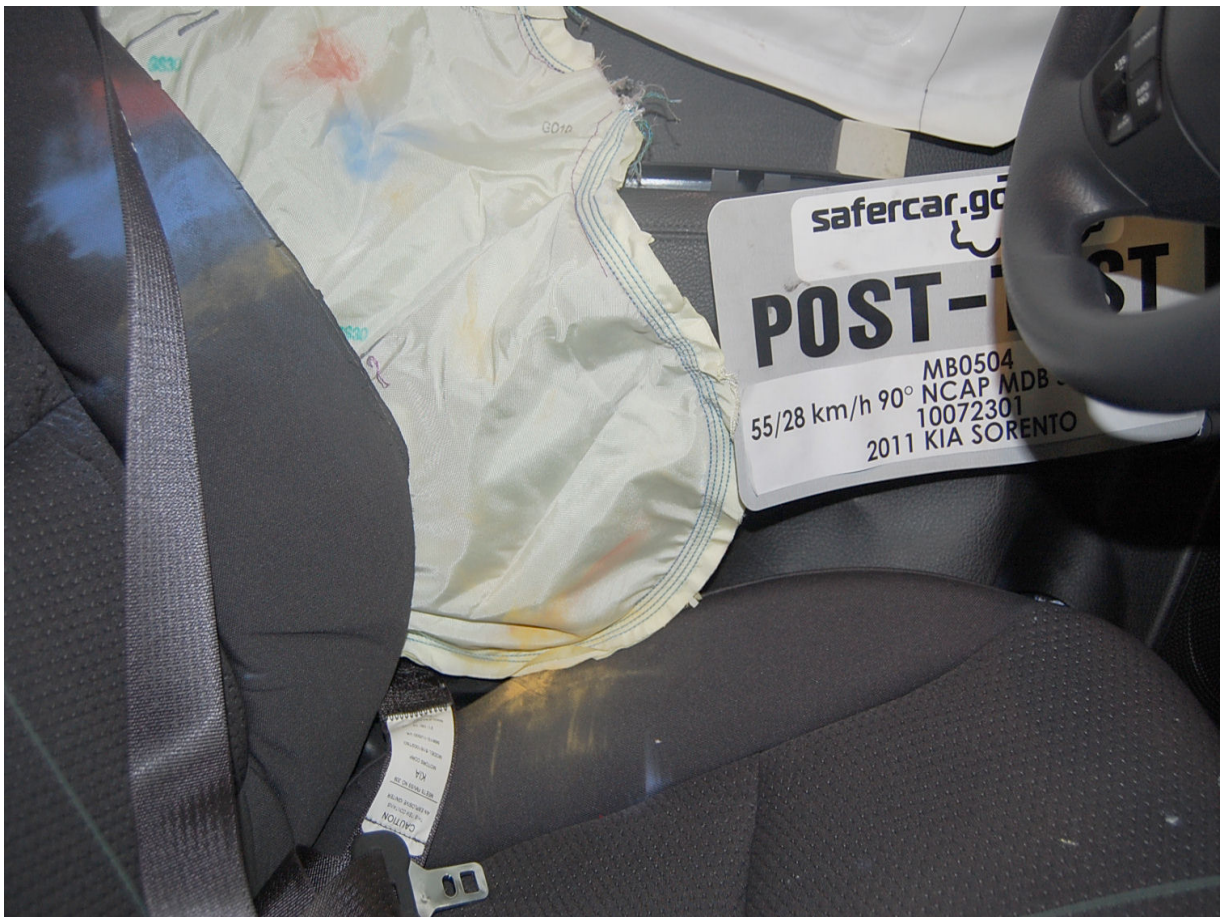
Post-Test Driver Dummy Close-up Pelvis Contact View

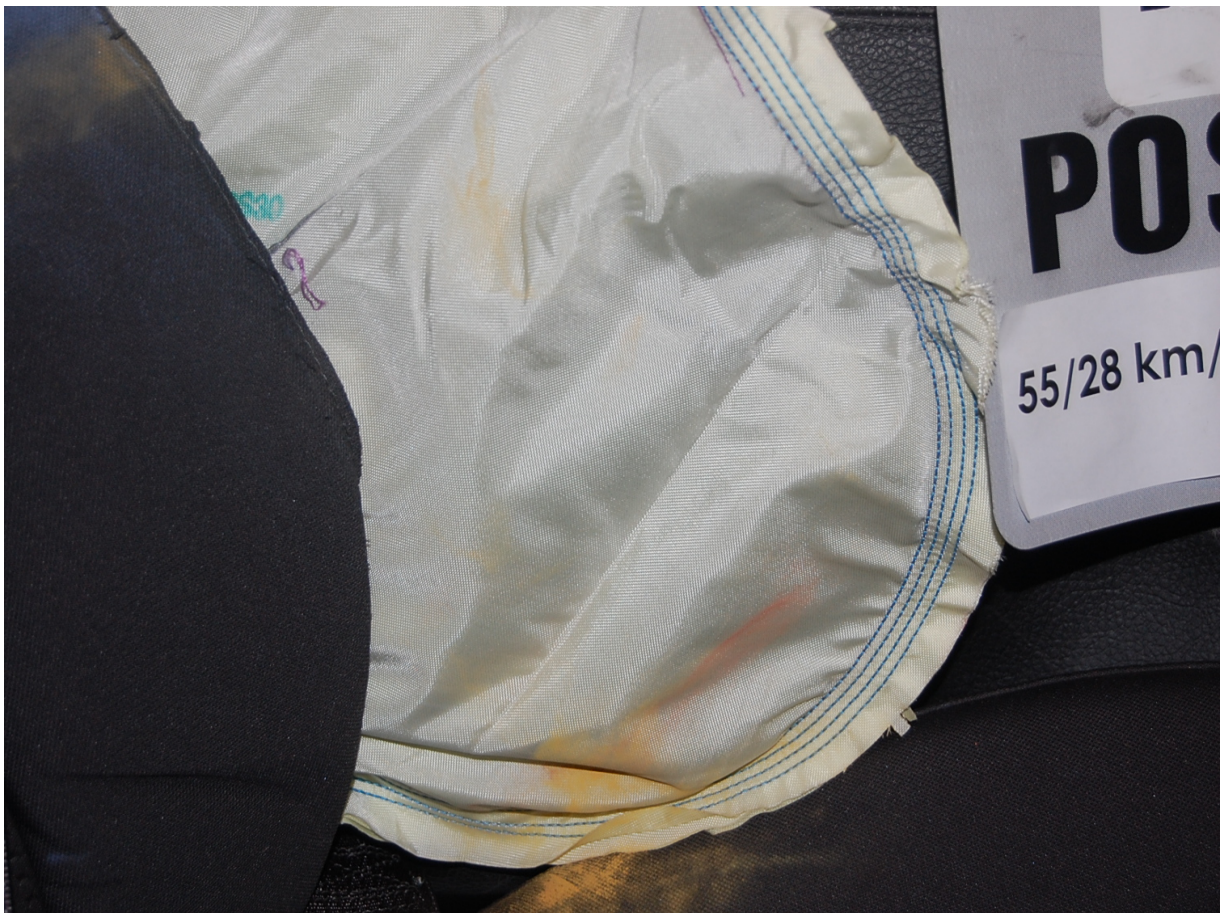
Post-Test Driver Dummy Close-up Pelvis Contact with Side Airbag View

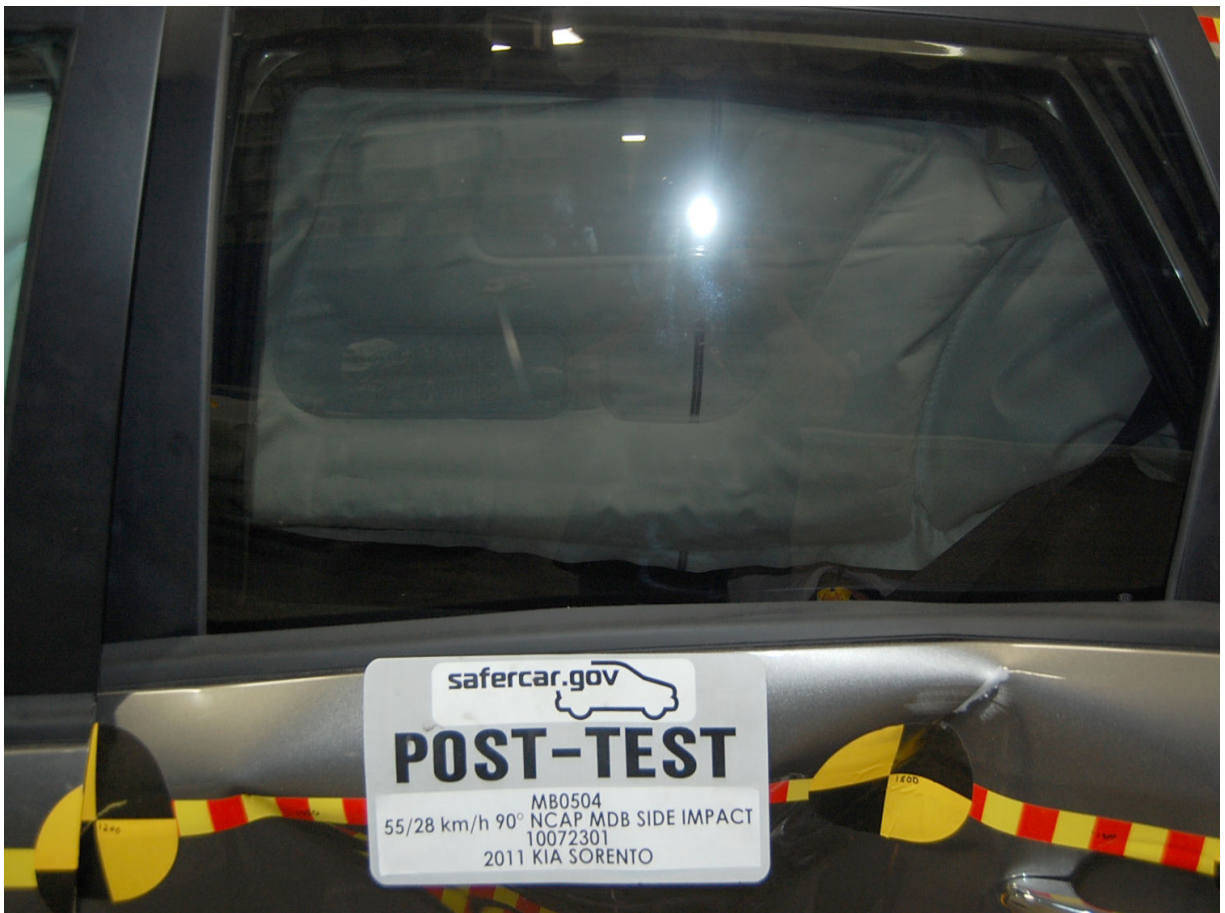
Post-Test Left Side View of Rear Passenger Dummy Shoulder and Door Top View

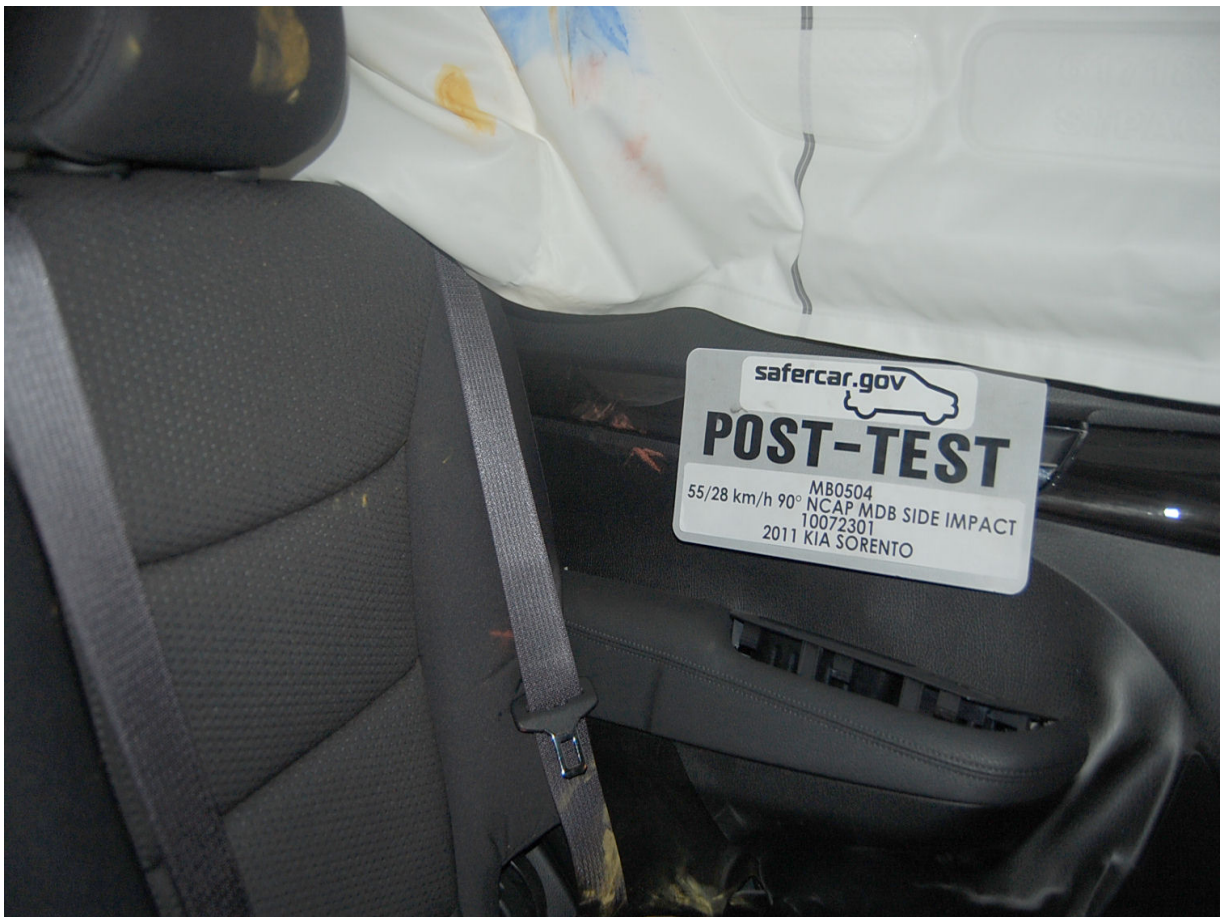
Post-Test Rear Passenger Dummy Close-up Torso Contact with Vehicle View

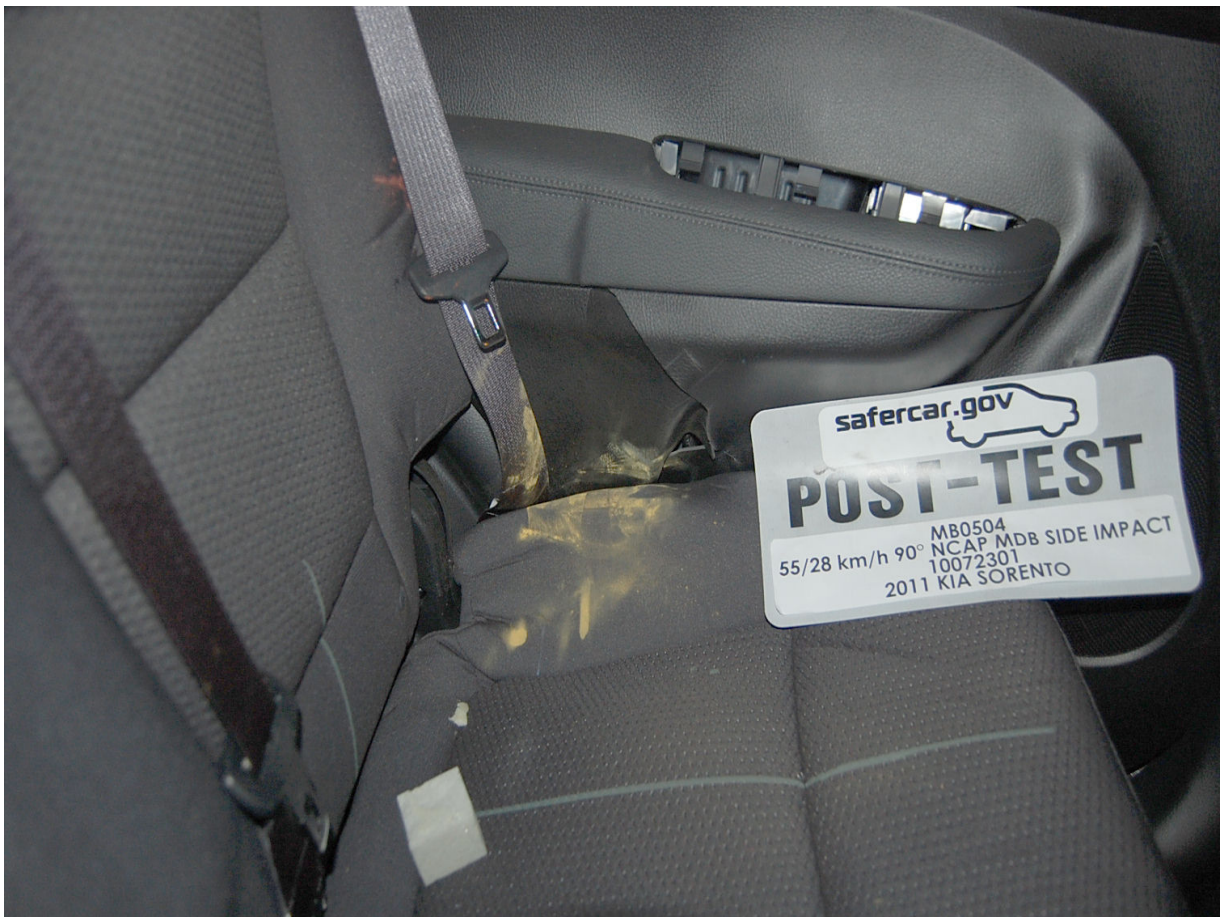
Post-Test Rear Passenger Dummy Close-up Pelvis Contact with Vehicle Interior View

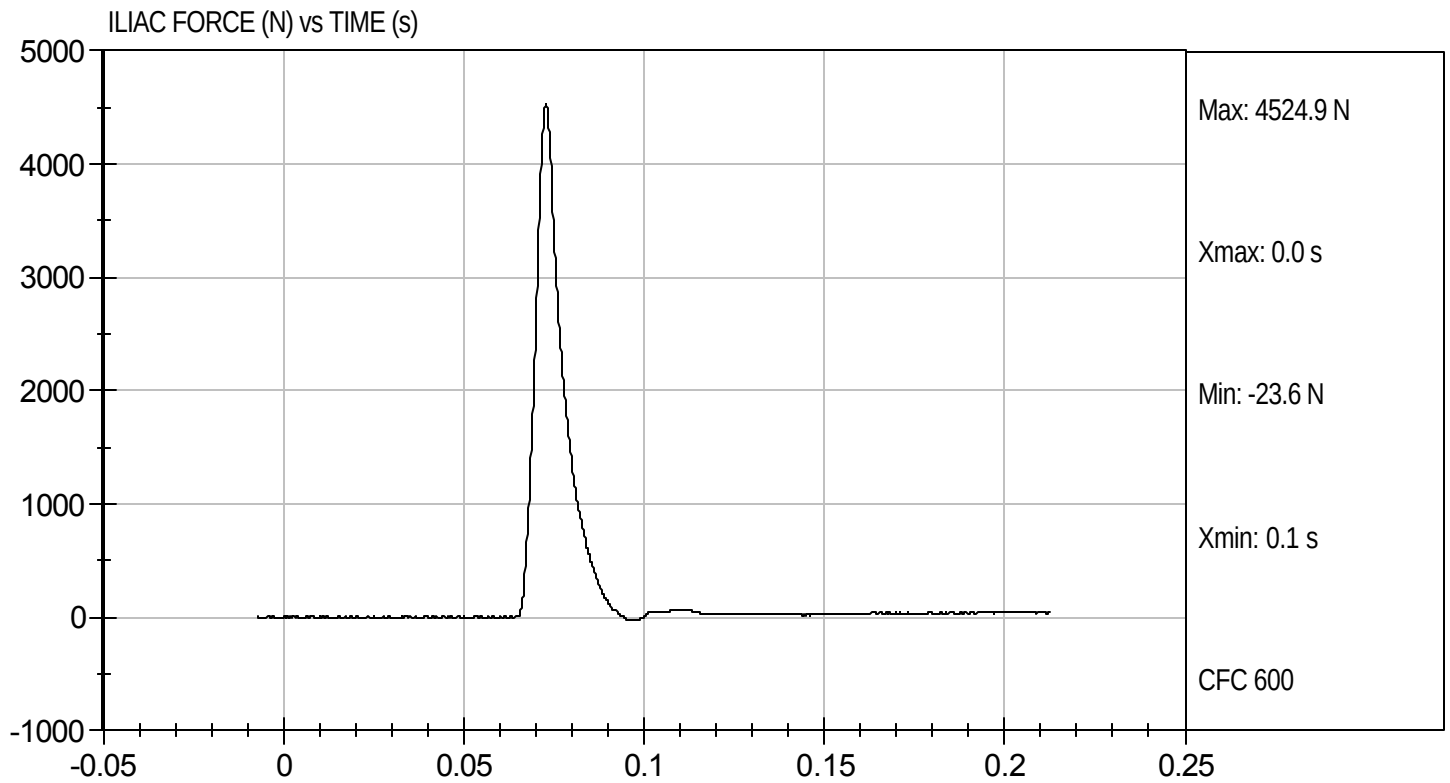
Test Desc: Iliac Impact  
Component ID: D102378

Test Date: 7/26/10  
Velocity: 14.24 ft/s, 4.34 m/s
