**REPORT NUMBER: SINCAP-MGA-2011-007**

**NEW CAR ASSESSMENT PROGRAM (NCAP)  
Moving Deformable Barrier Side Impact Test**

**HONDA MFG. OF ALABAMA, LLC  
2011 Honda Pilot LX 2WD  
NHTSA No.: MB5301**

**MGA RESEARCH CORPORATION  
5000 Warren Road  
Burlington, WI 53105**

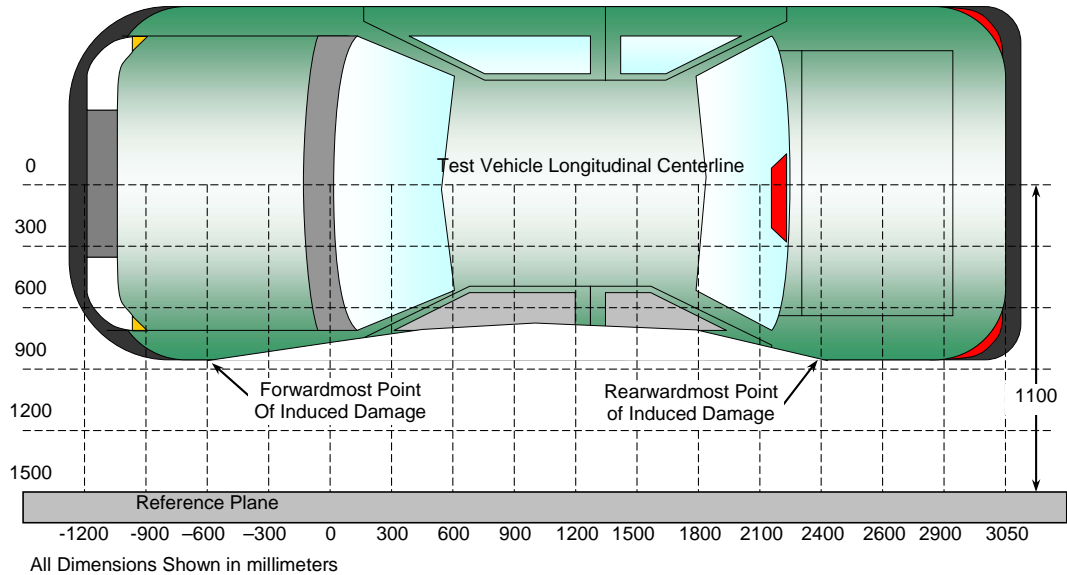
**DATA SHEET NO. 13**  
**VEHICLE DAMAGE PROFILE DISTANCES**

**TOP VIEW**

**DAMAGE PROFILE DISTANCES**

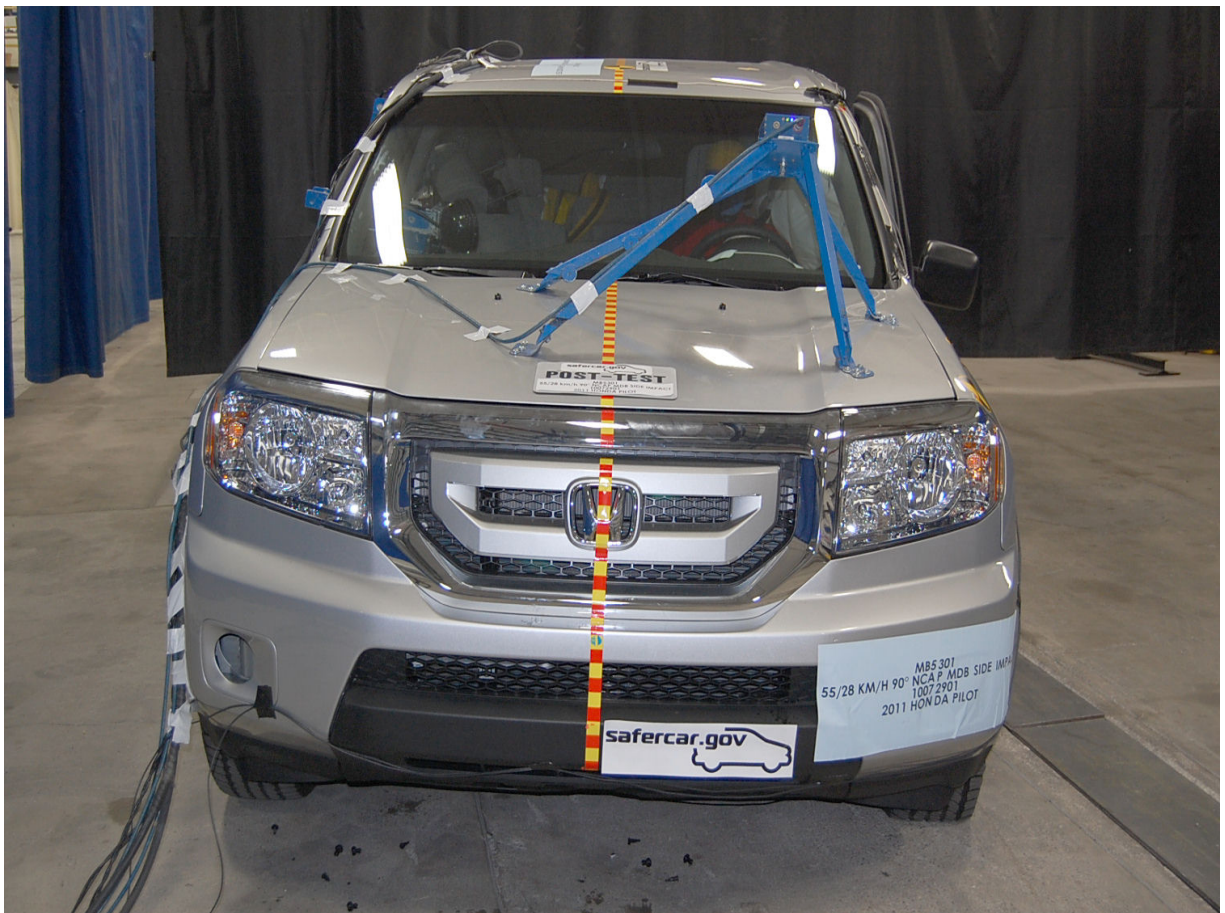
Post-Test Frontal View of Test Vehicle

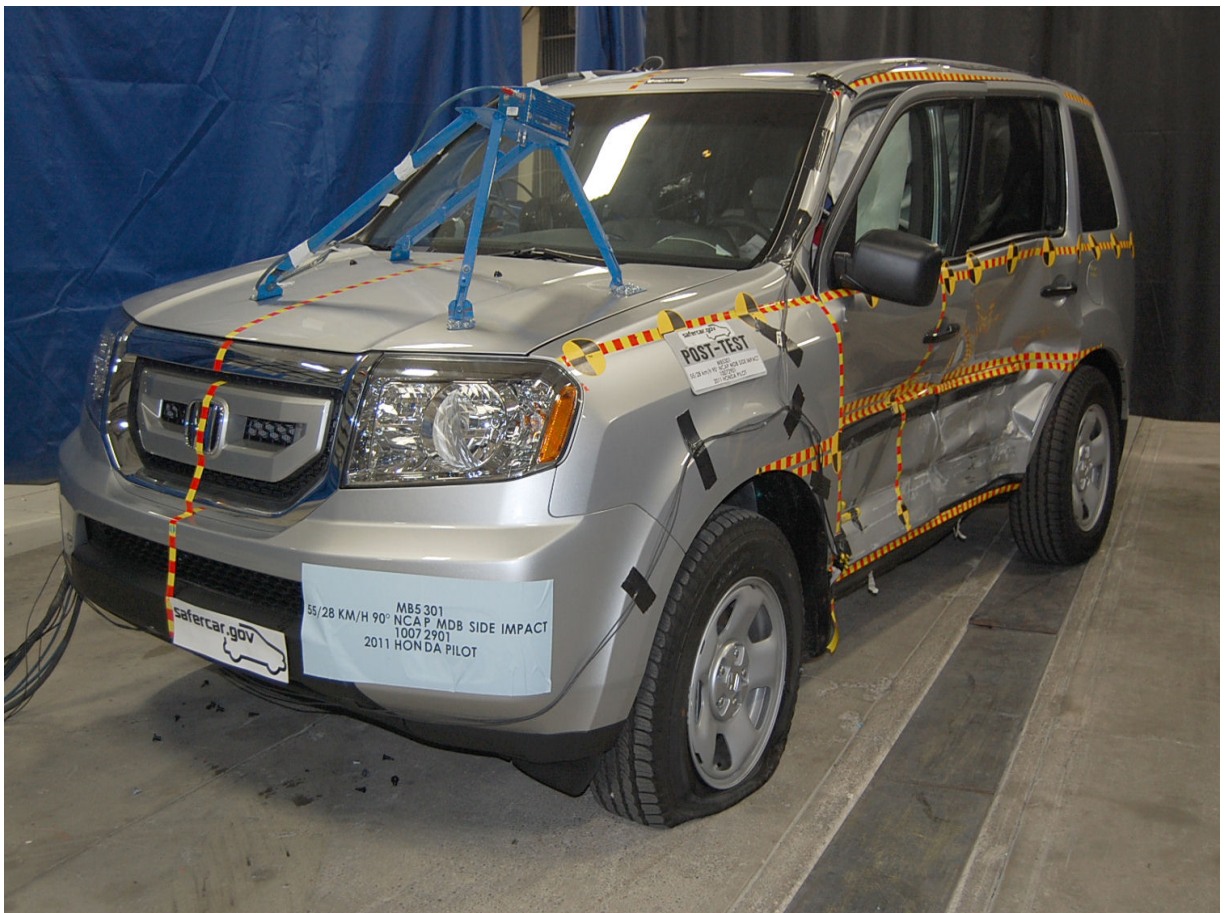
Post-Test Left  $\frac{3}{4}$  Front View of Test Vehicle

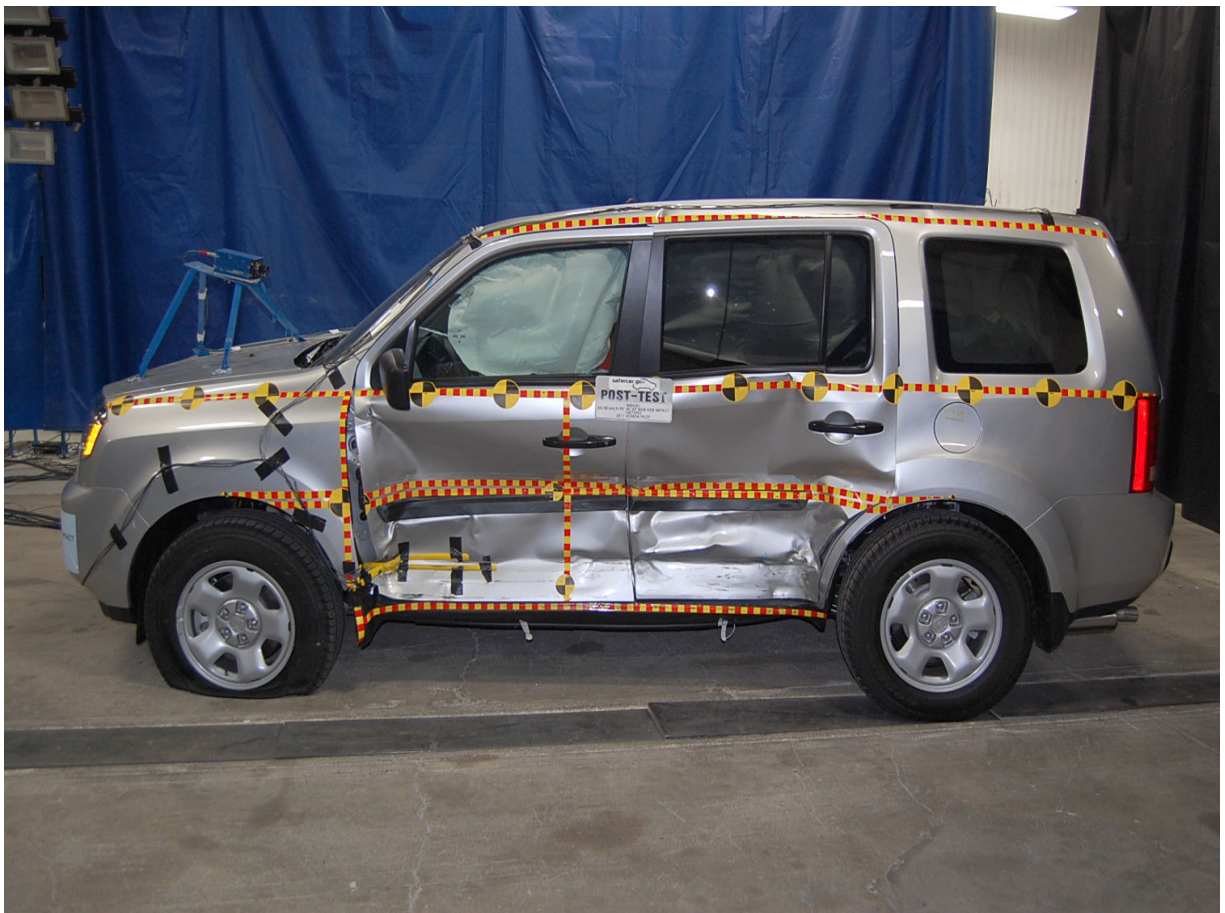
Post-Test Left Side View of Test Vehicle

Description	Front	Rear
Left Side Doors	Remained closed and jammed shut	Remained closed and jammed shut
Right Side Doors	Remained closed and operational	Remained closed and operational
Hatch and Other Doors	Remained closed and operational	Remained closed and operational
Seat Movement	0	0
Seat Back Failure	None	None

Critical Areas of Performance	Observations and Conclusions
Pillar Performance	No Separation
Sill Separation	None
Windshield Damage	None
Window Damage	None
Other Notable Effects	None

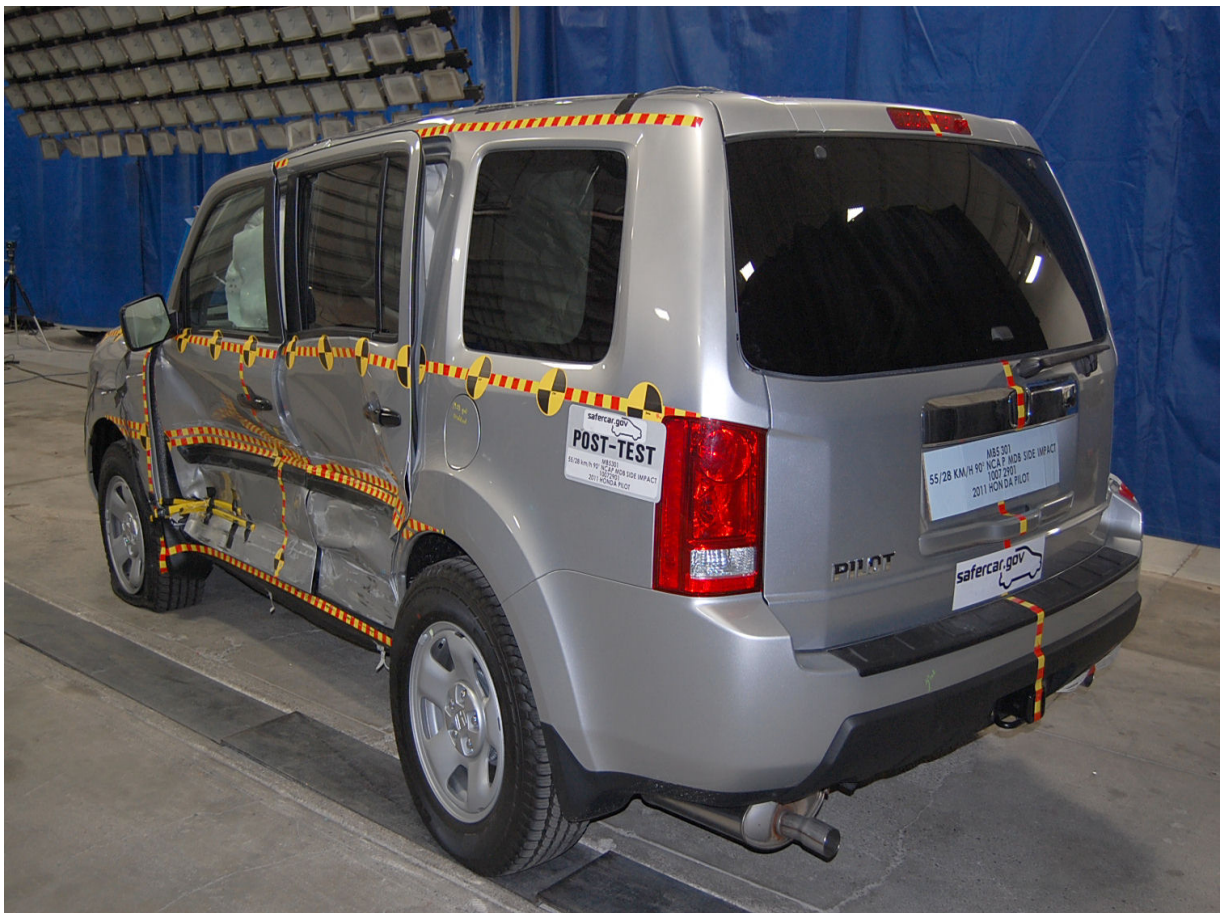
Post-Test Left  $\frac{3}{4}$  Rear View of Test Vehicle

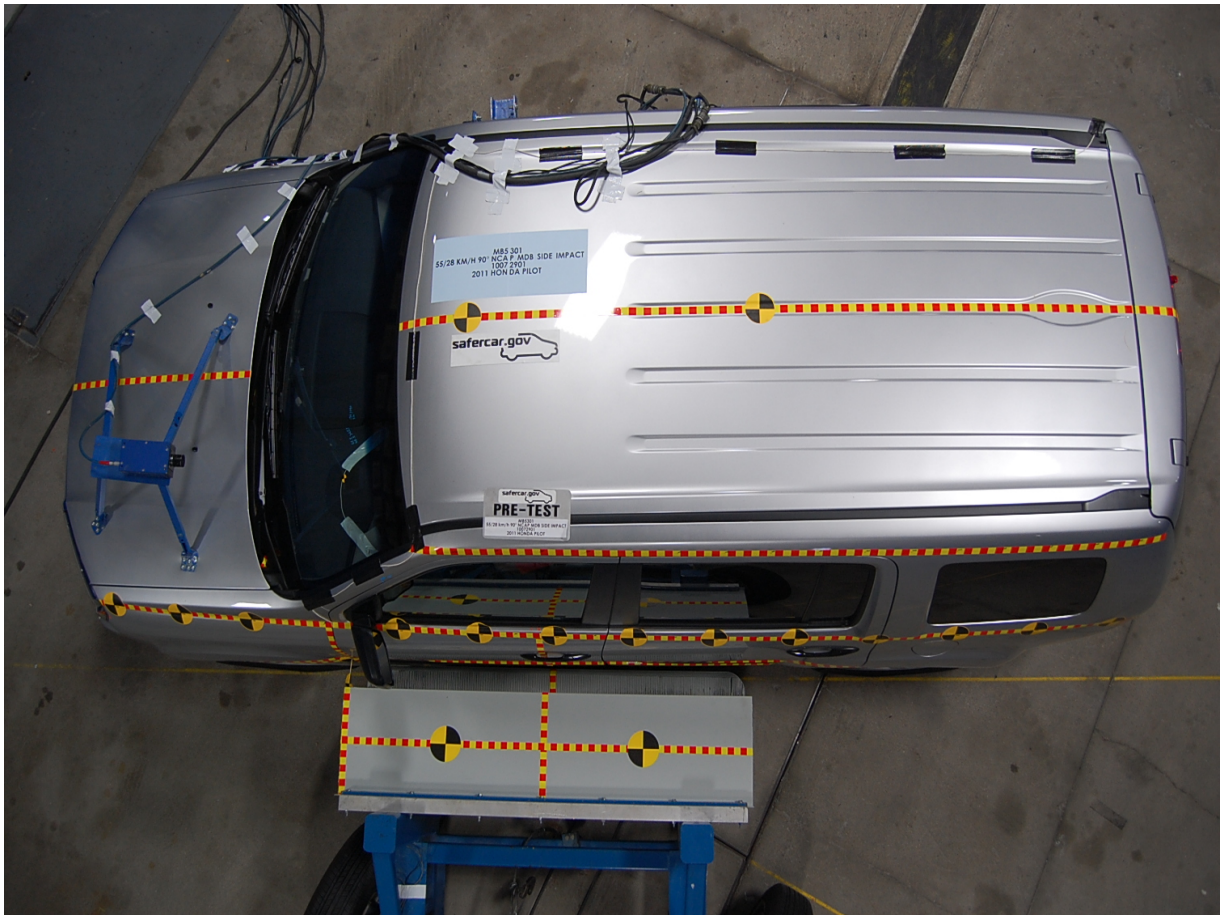
Pre-Test Overhead View of Test Vehicle with MDB Positioned Against Side of Target Vehicle at Ideal Impact Point

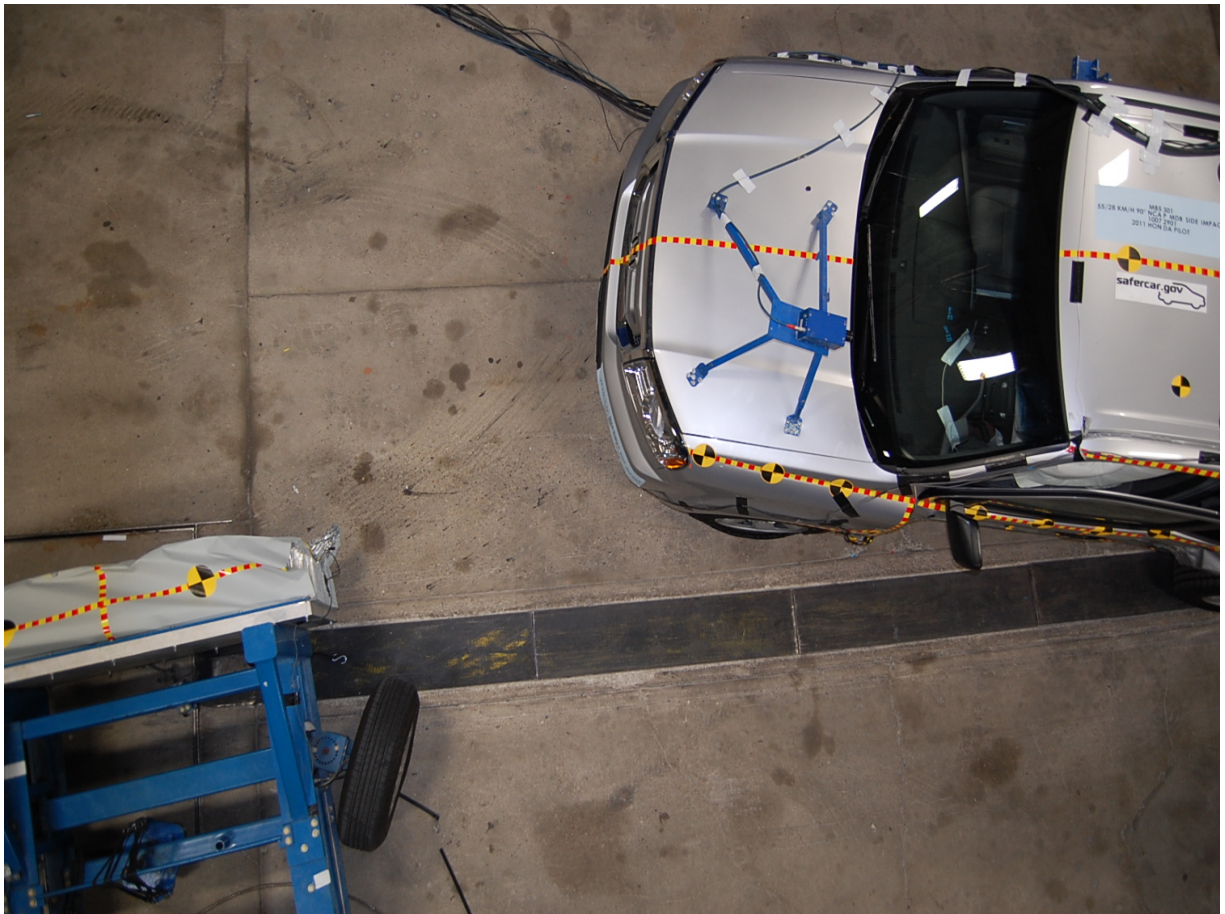
Post-Test Overhead View of Test Vehicle and MDB

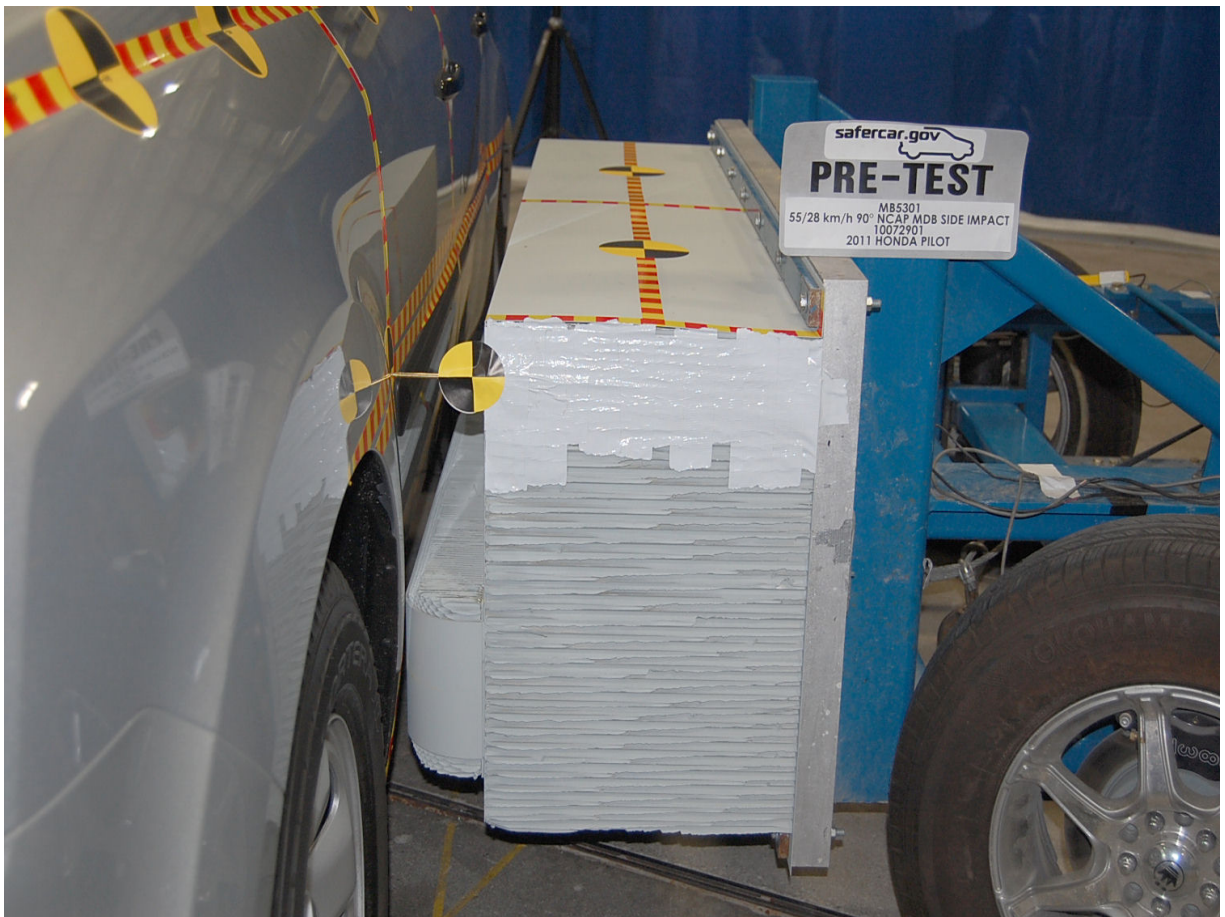
Pre-Test Left Side View of MDB Positioned Against Side of Target Vehicle at Ideal Impact Point

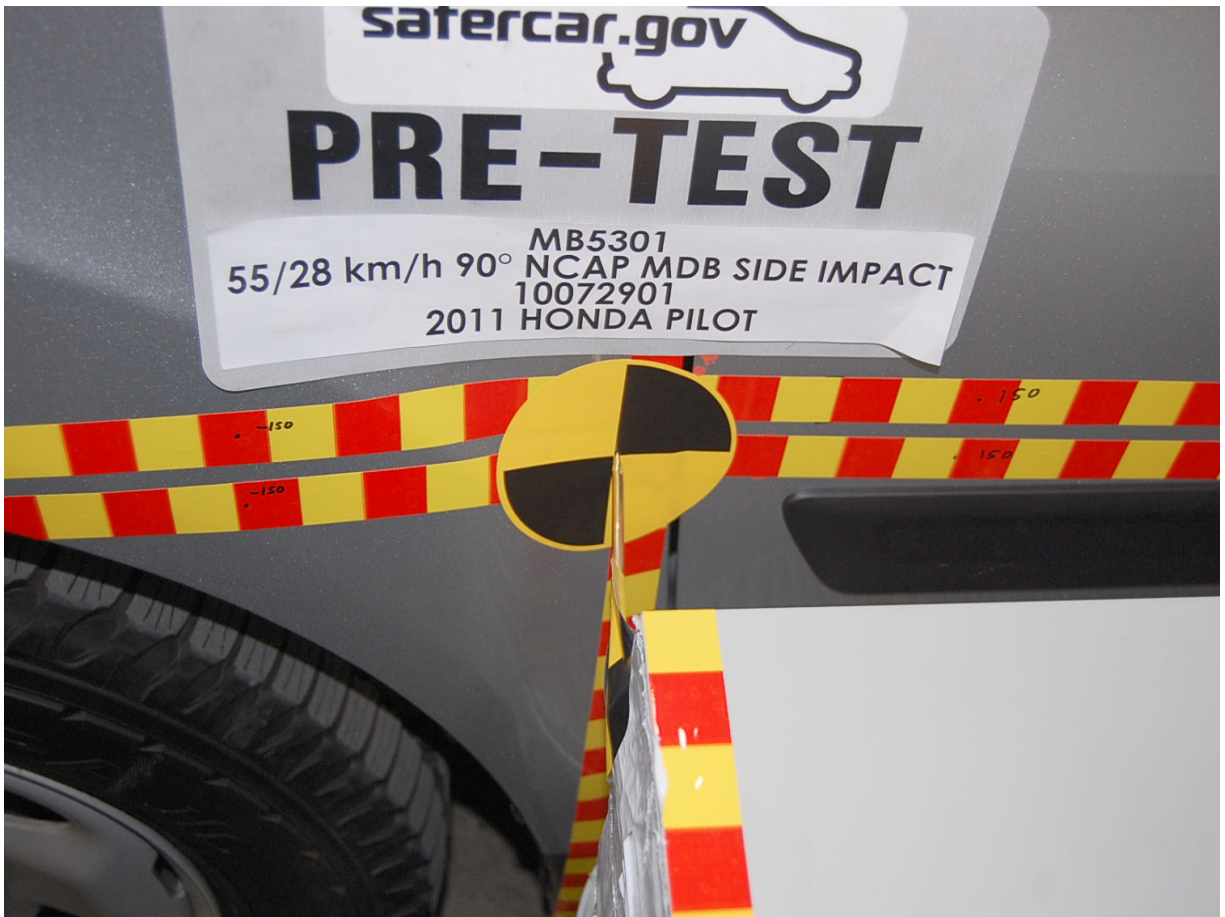
Pre-Test Close-Up View of Impact Point Target

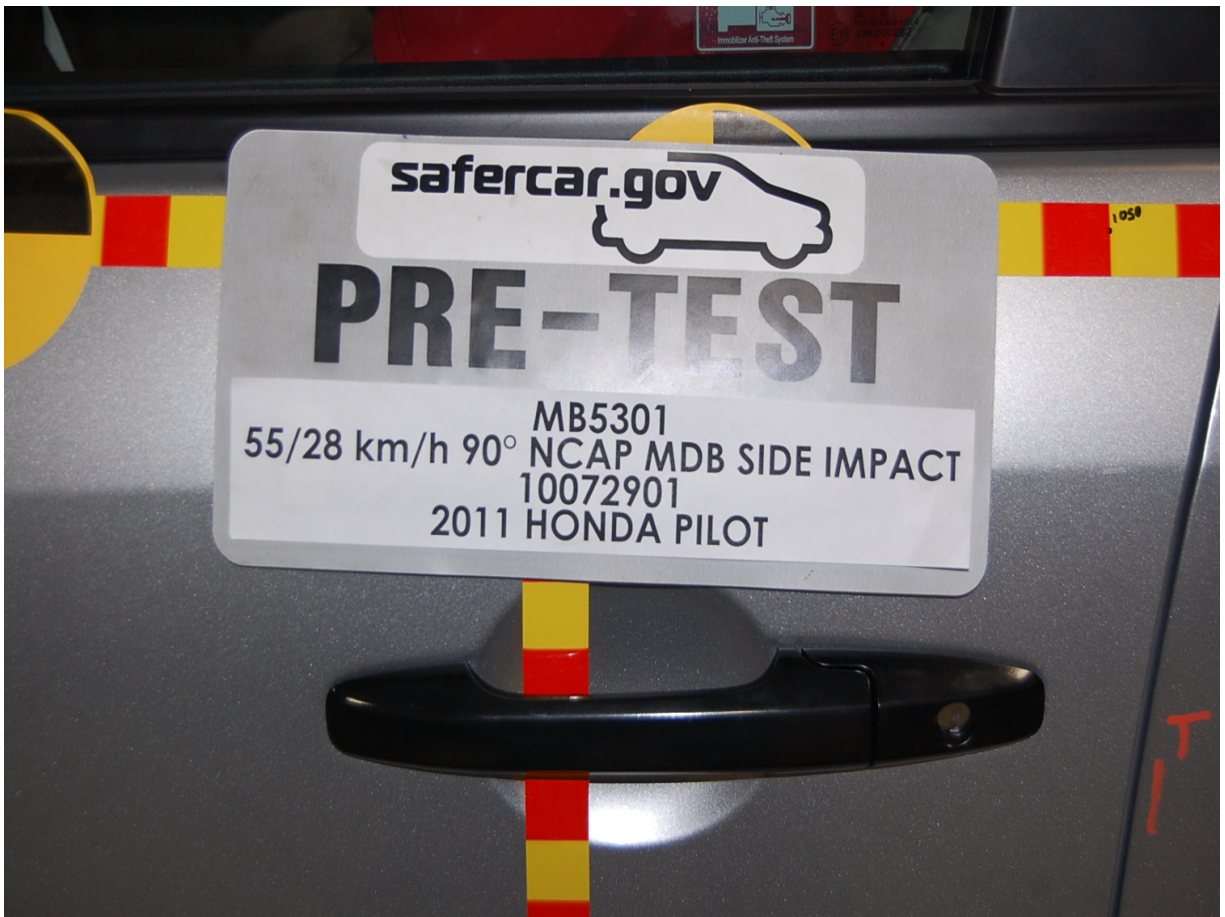
Pre-Test Left Front Door Latch Close-Up

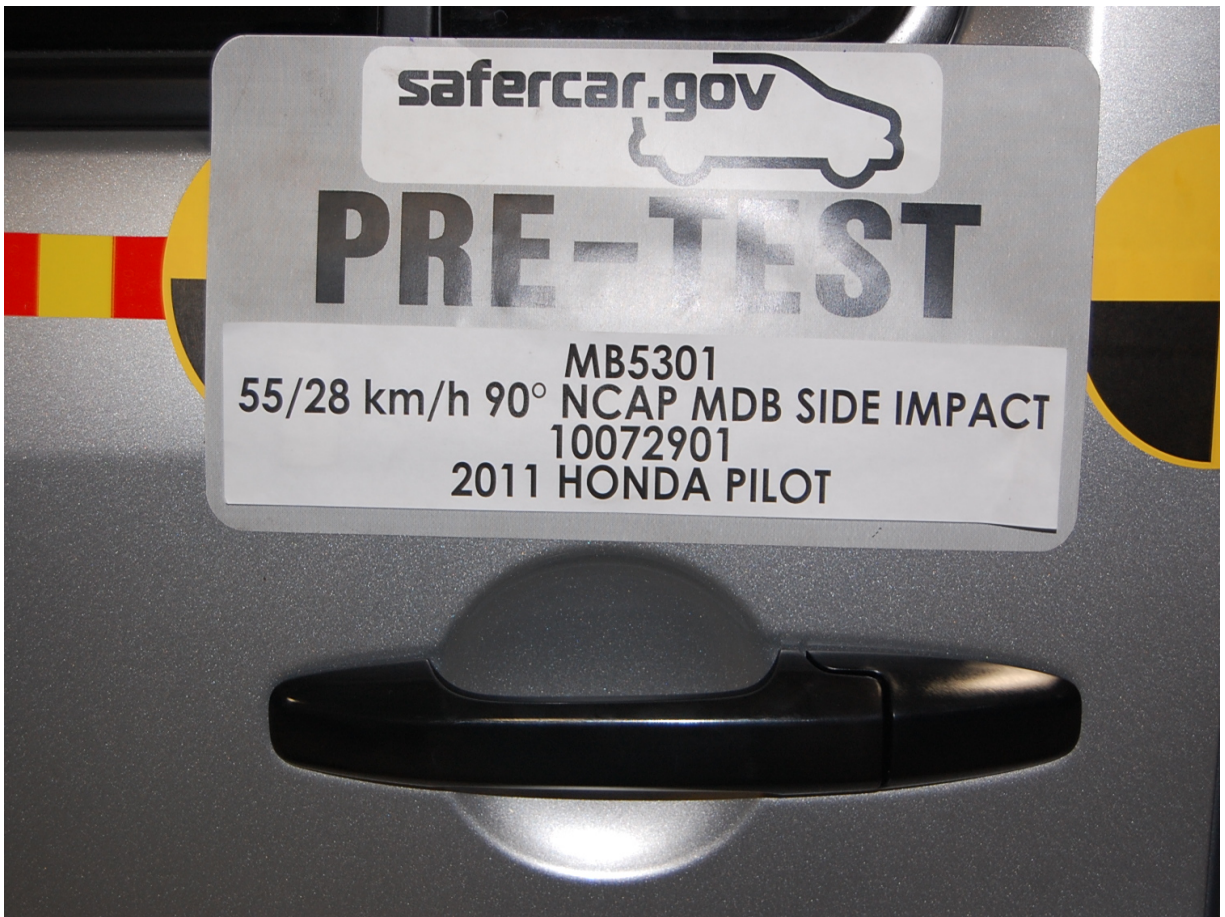
Pre-Test Left Rear Door Latch Close-Up

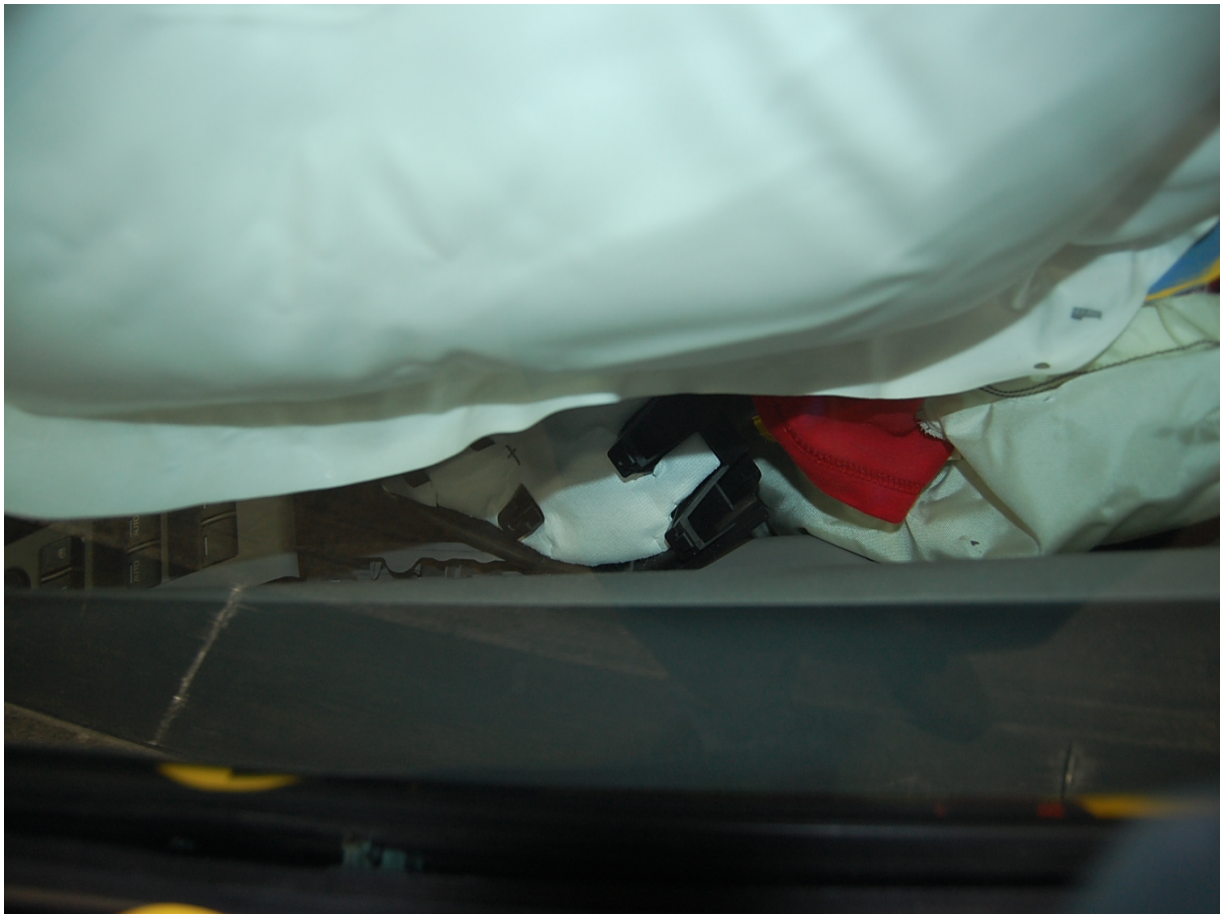
Post-Test Driver Dummy and Door Clearance View

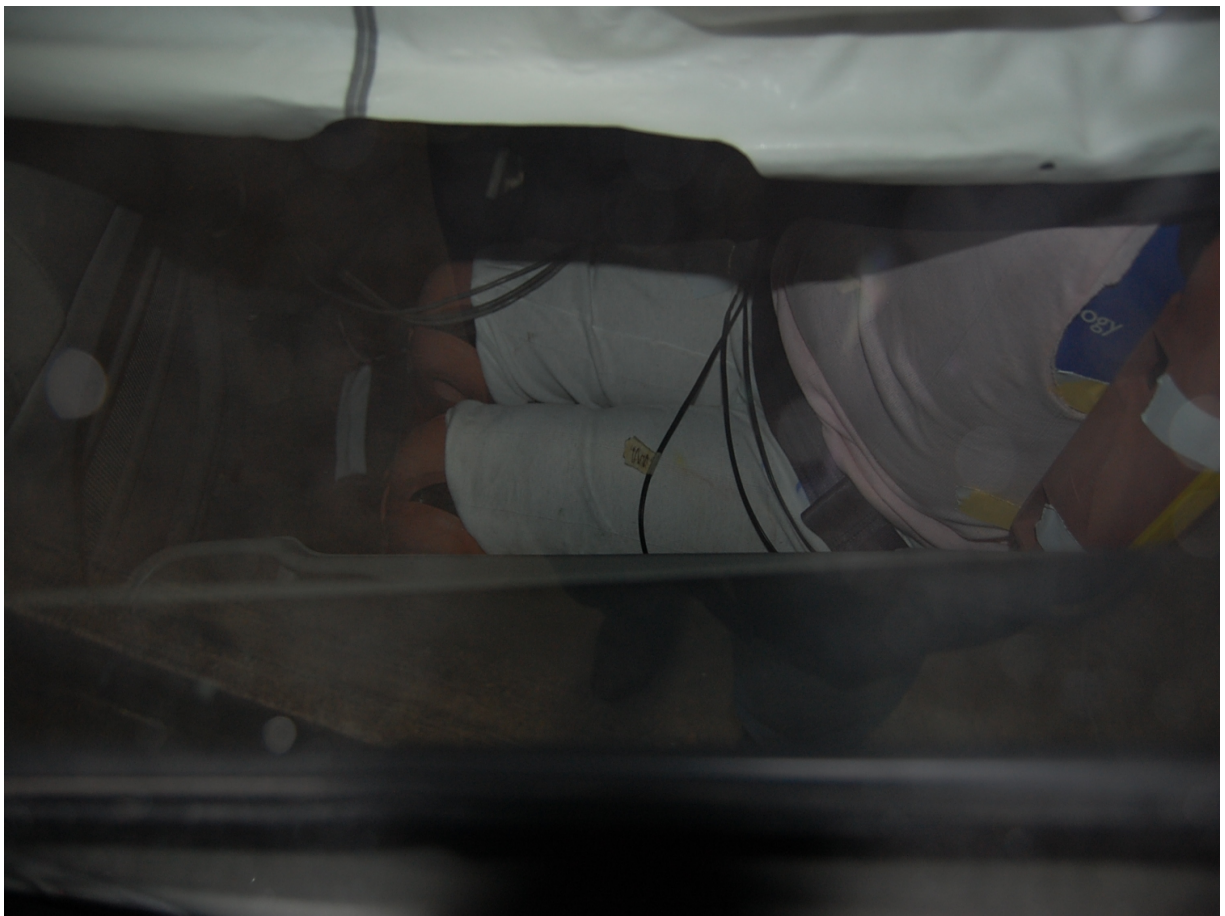
Post-Test Rear Passenger Dummy and Door Clearance View

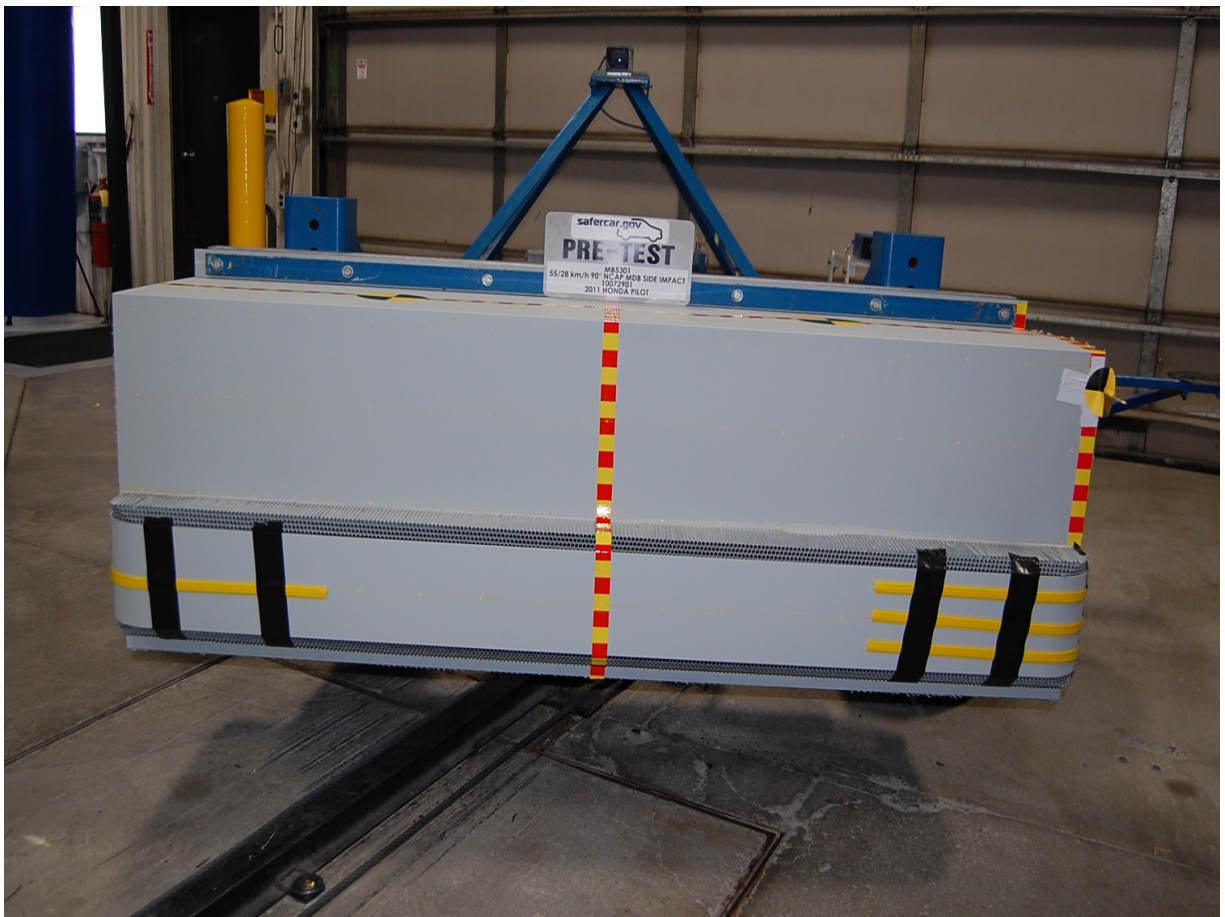
Pre-Test Front View of MDB Impactor Face

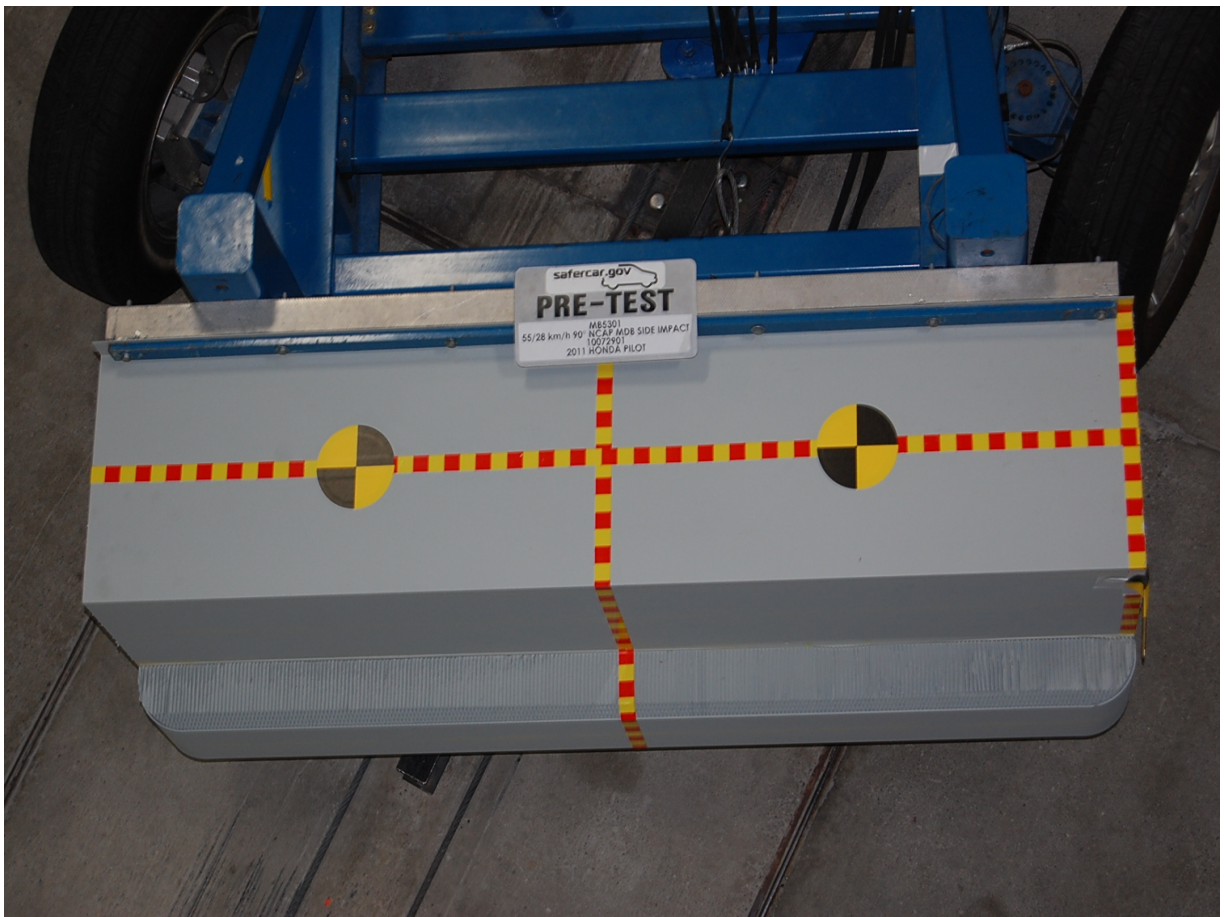
Pre-Test Top View of MDB Impactor Face

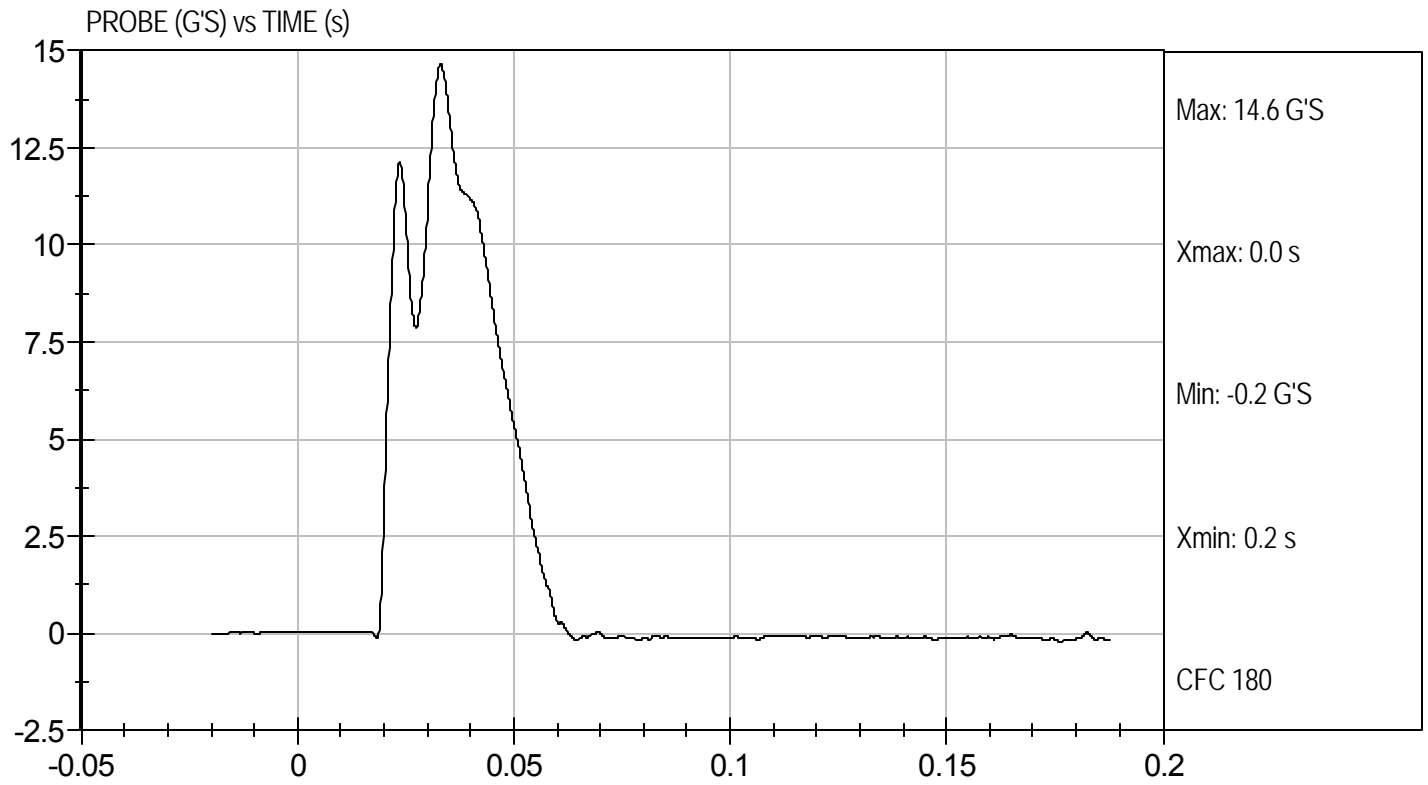
Test Desc: Shoulder Impact  
Component ID: D102373

Test Date: 7/26/10  
Velocity: 14.0 ft/s, 4.27 m/s

Tested Parameter	Units	Specification	Result	Pass/Fail
Laboratory Temperature	deg C	20.6 to 22.2	20.9	Pass
Laboratory Relative Humidity	%	10 to 70	53	Pass
Impact Velocity	m/s	4.20 to 4.40	4.27	Pass
Maximum Probe Acceleration	G's	13 to 18	15	Pass
Shoulder Displacement	mm	28 to 37	32	Pass
Upper Spine (T1) Y Acceleration	G's	17 to 22	19	Pass
Overall Test Results				Pass

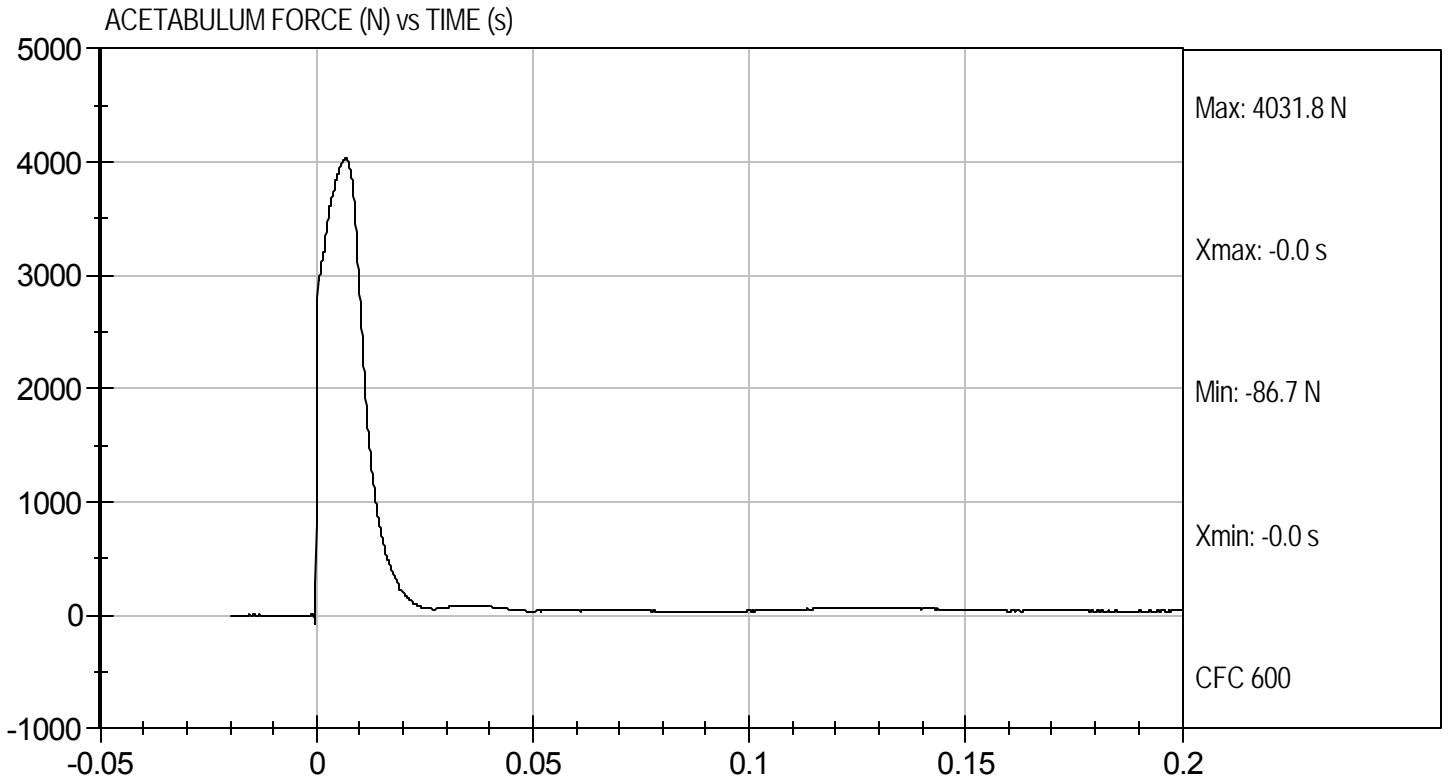
Test Desc: Pelvis Impact  
Component ID: D102377

Test Date: 7/26/10  
Velocity: 21.9 ft/s, 6.68 m/s

Tested Parameter	Units	Specification	Result	Pass/Fail
Temperature	deg C	20.6 to 22.2	20.9	Pass
Humidity	%	10 to 70	53	Pass
Impact Velocity	m/s	6.60 to 6.80	6.68	Pass
Peak Impactor Acceleration	G's	38 to 47	42	Pass
Pelvis Y Acceleration after 6 ms	G's	34 to 42	40	Pass
Peak Acetabulum Force	N	3600 to 4300	4032	Pass
Overall Test Results				Pass

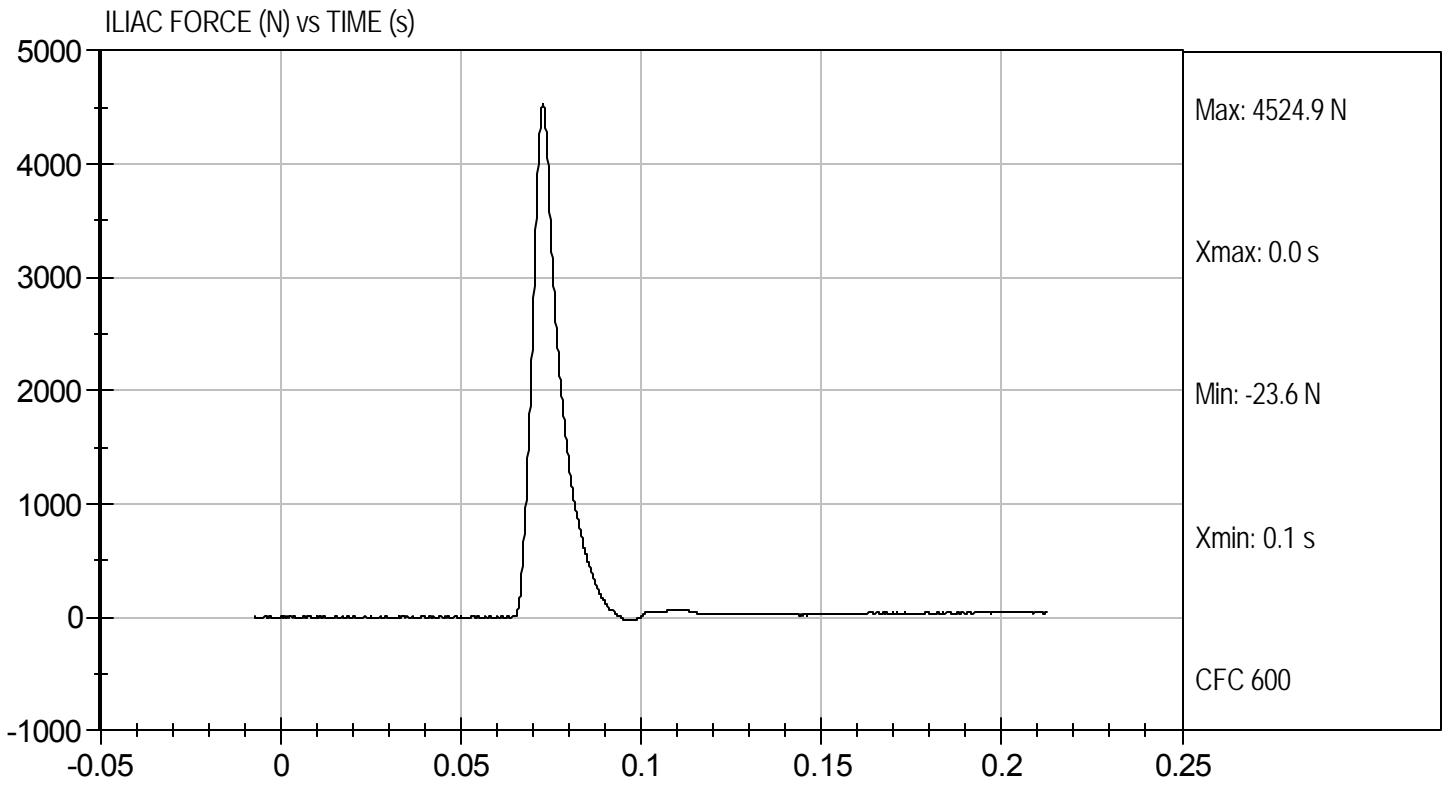
Test Desc: Iliac Impact  
Component ID: D102378

Test Date: 7/26/10  
Velocity: 14.24 ft/s, 4.34 m/s

Tested Parameter	Units	Specification	Result	Pass/Fail
Temperature	deg C	20.6 to 22.2	20.9	Pass
Humidity	%	10 to 70	53	Pass
Impact Velocity	m/s	4.20 to 4.40	4.34	Pass
Peak Impactor Acceleration	G's	36 to 45	36	Pass
Pelvis Y Acceleration	G's	28 to 39	35	Pass
Peak Pelvis Iliac Force	N	4100 to 5100	4525	Pass
			Overall Test Results	Pass

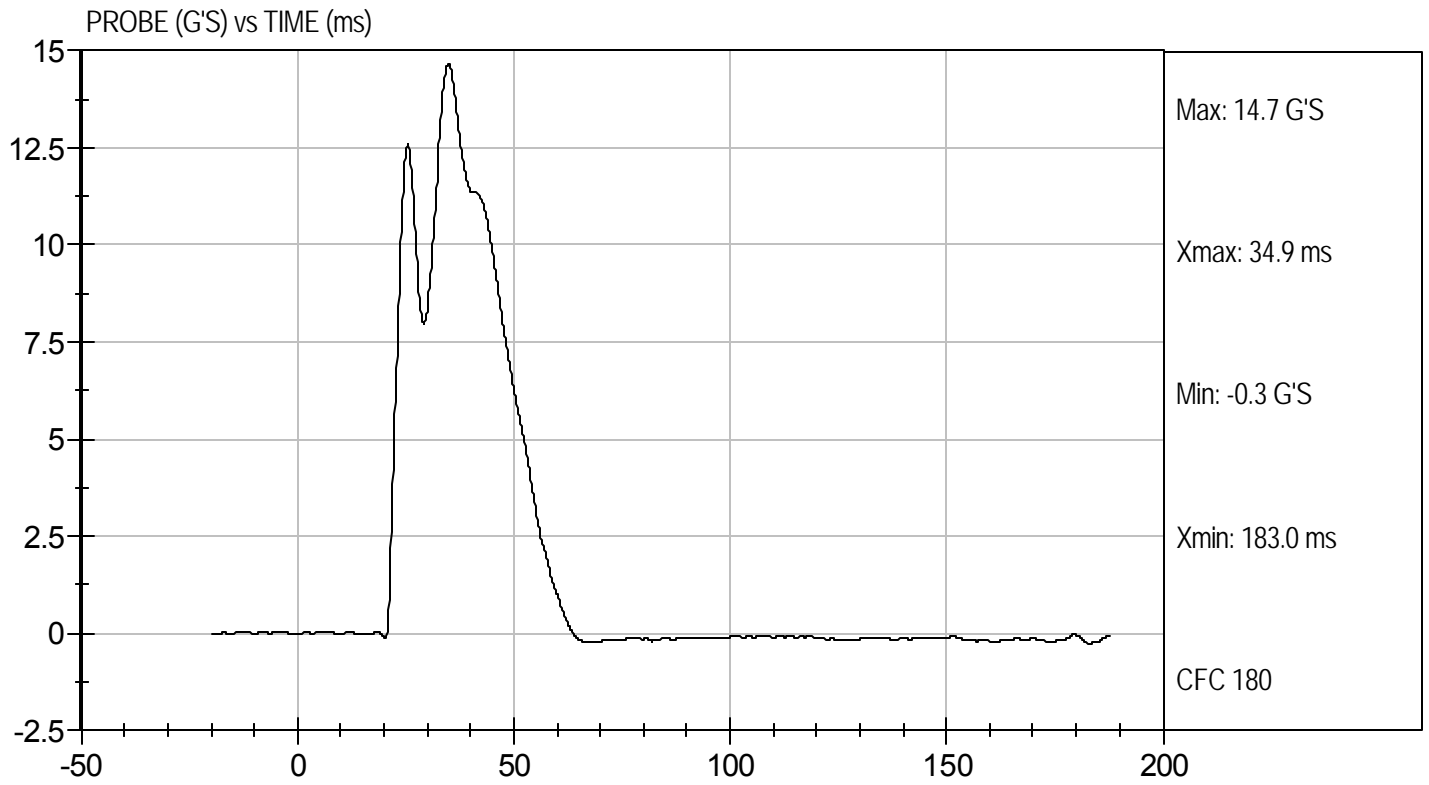
Test Desc: Shoulder Impact  
Component ID: D102463

Test Date: 7/29/10  
Velocity: 14.0 ft/s, 4.27 m/s

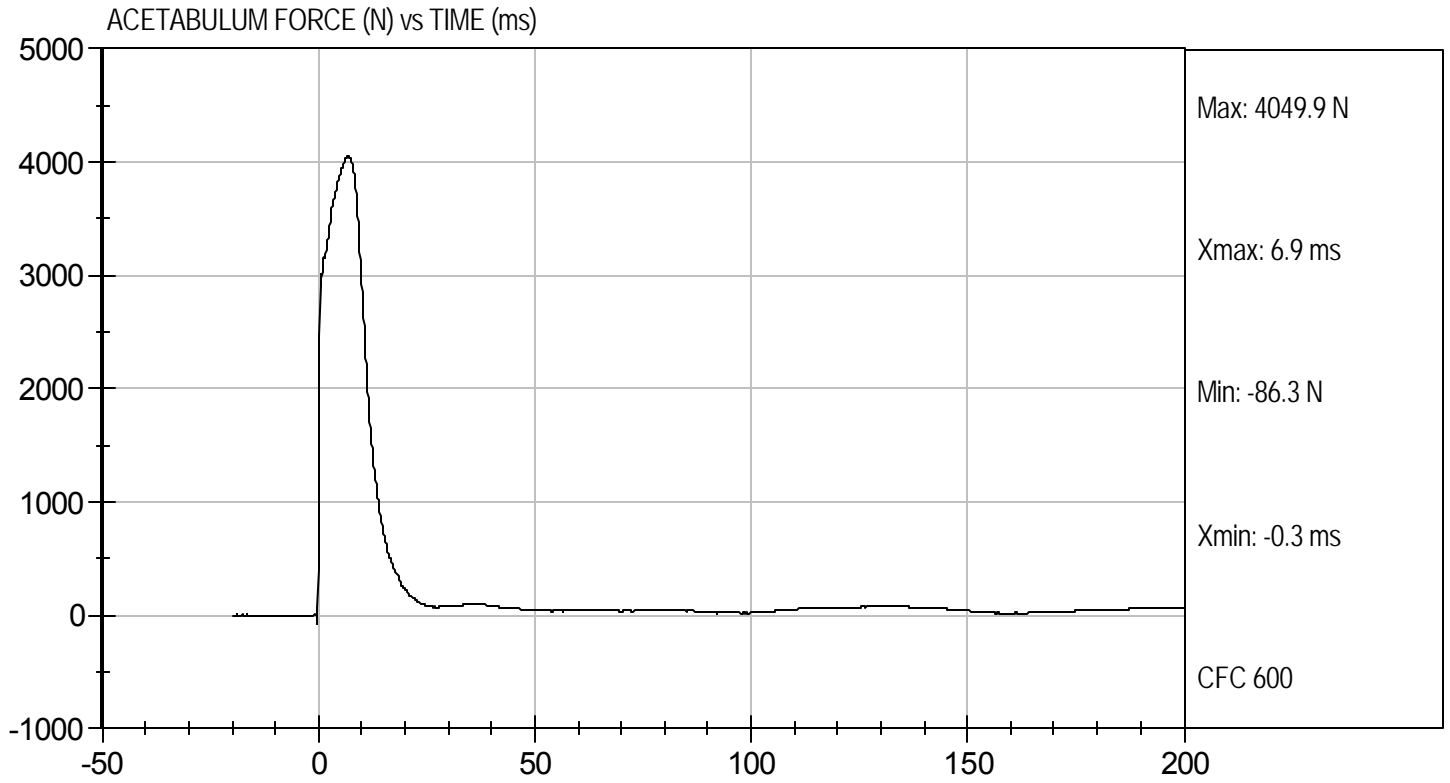
Test Desc: Pelvis Impact  
Component ID: D102467

Test Date: 7/29/10  
Velocity: 22.22 ft/s, 6.77 m/s
