**REPORT NUMBER: SINCAP-MGA-2011-007**

**NEW CAR ASSESSMENT PROGRAM (NCAP)  
Moving Deformable Barrier Side Impact Test**

**HONDA MFG. OF ALABAMA, LLC  
2011 Honda Pilot LX 2WD  
NHTSA No.: MB5301**

**MGA RESEARCH CORPORATION  
5000 Warren Road  
Burlington, WI 53105**

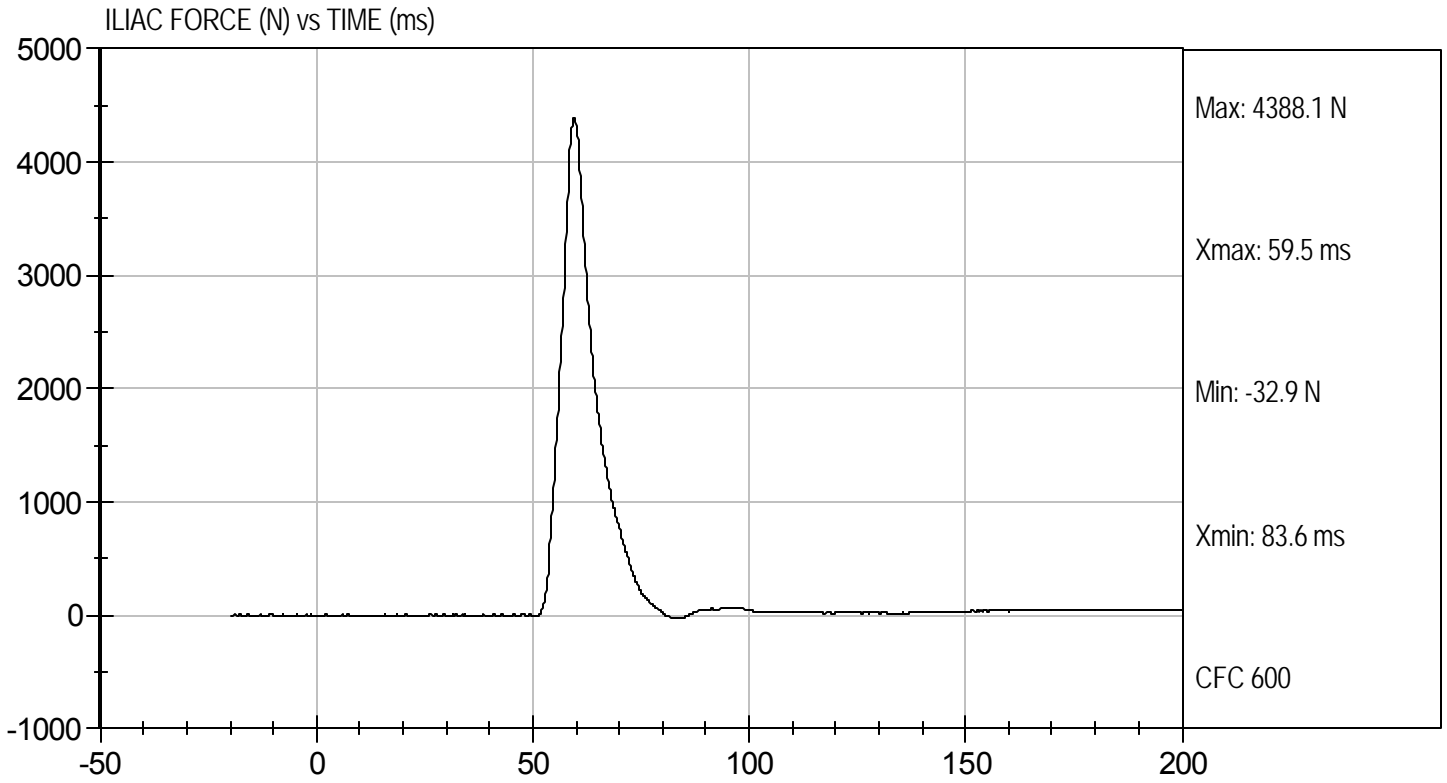
Test Desc: Iliac Impact  
Component ID: D102468

Test Date: 7/29/10  
Velocity: 14.2 ft/s, 4.33 m/s
