**REPORT NUMBER: SPNCAP-MGA-2011-010**

**NEW CAR ASSESSMENT PROGRAM (NCAP)  
Side Impact Pole Test**

**KIA MOTORS MANUFACTURING GEORGIA, INC.  
2011 Kia Sorento LX FWD  
NHTSA No.: MB0505**

**MGA RESEARCH CORPORATION  
5000 Warren Road  
Burlington, WI 53105**

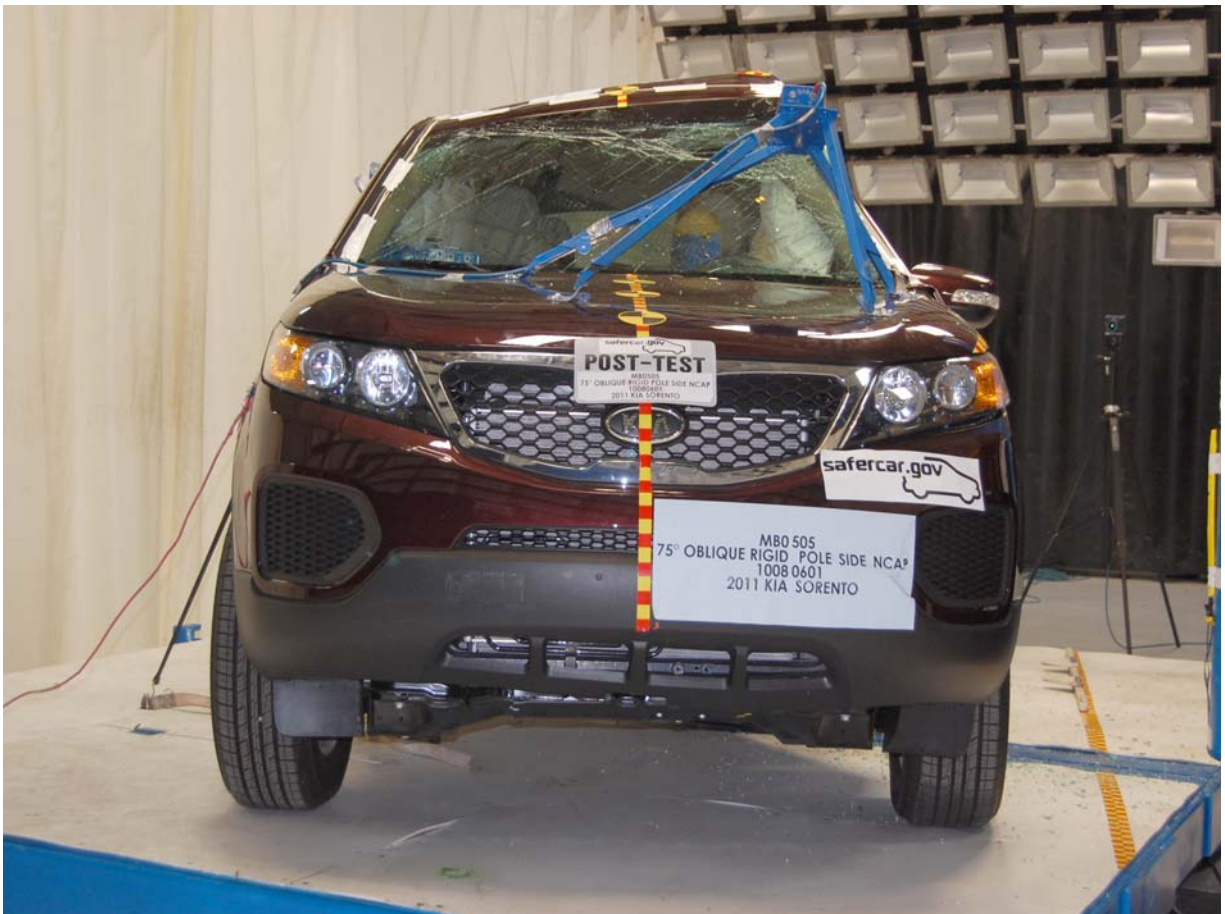
Post-Test Frontal View of Test Vehicle

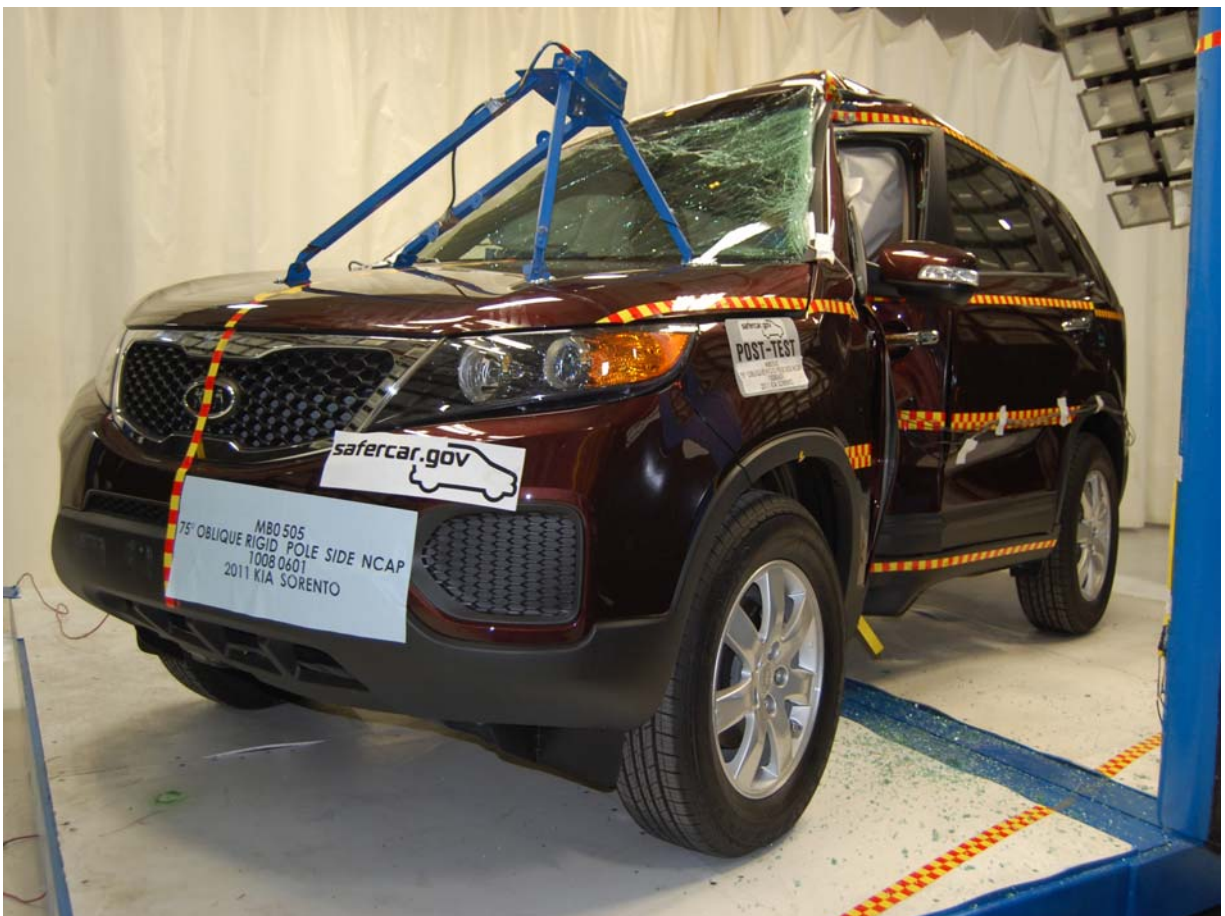
Post-Test Left Front  $\frac{3}{4}$  View of Test Vehicle

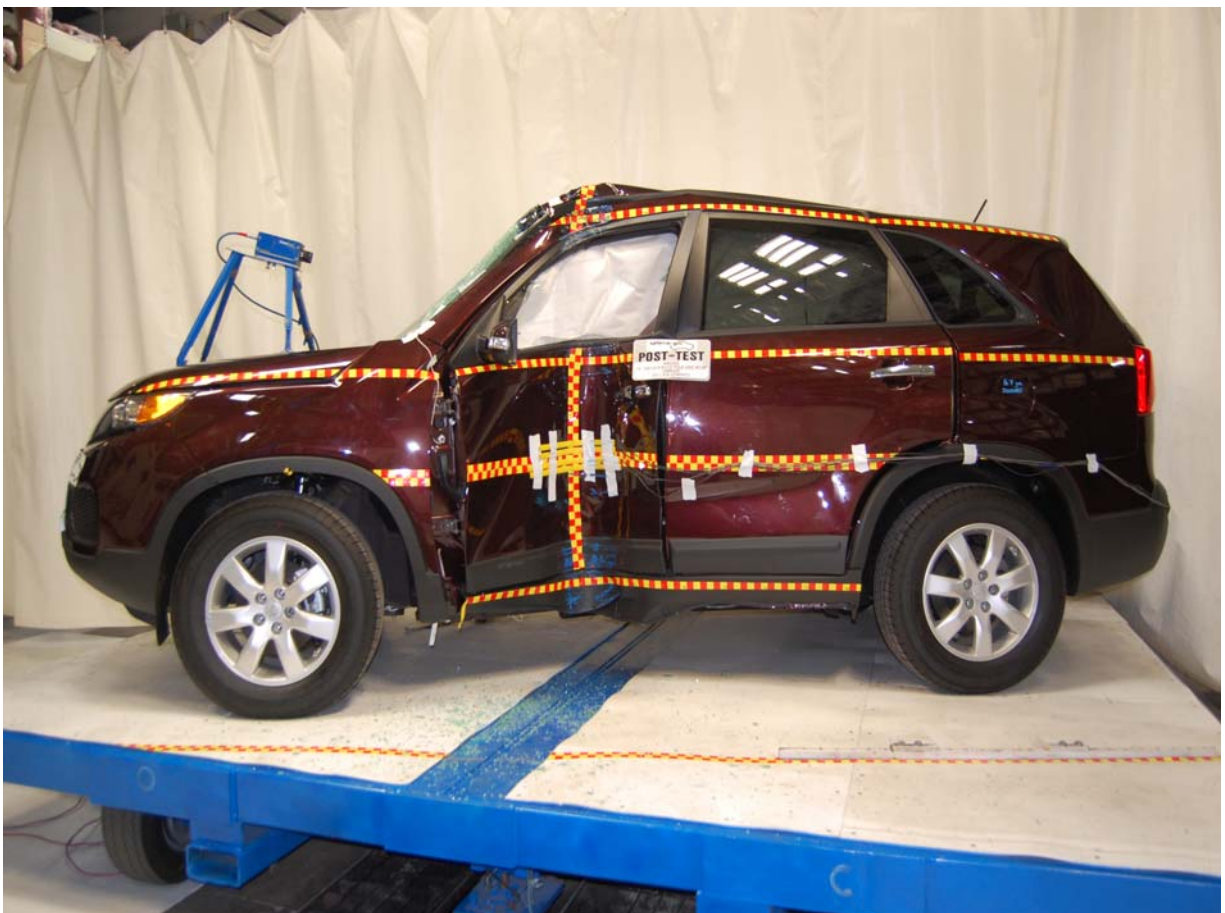
Post-Test Left Side View of Test Vehicle

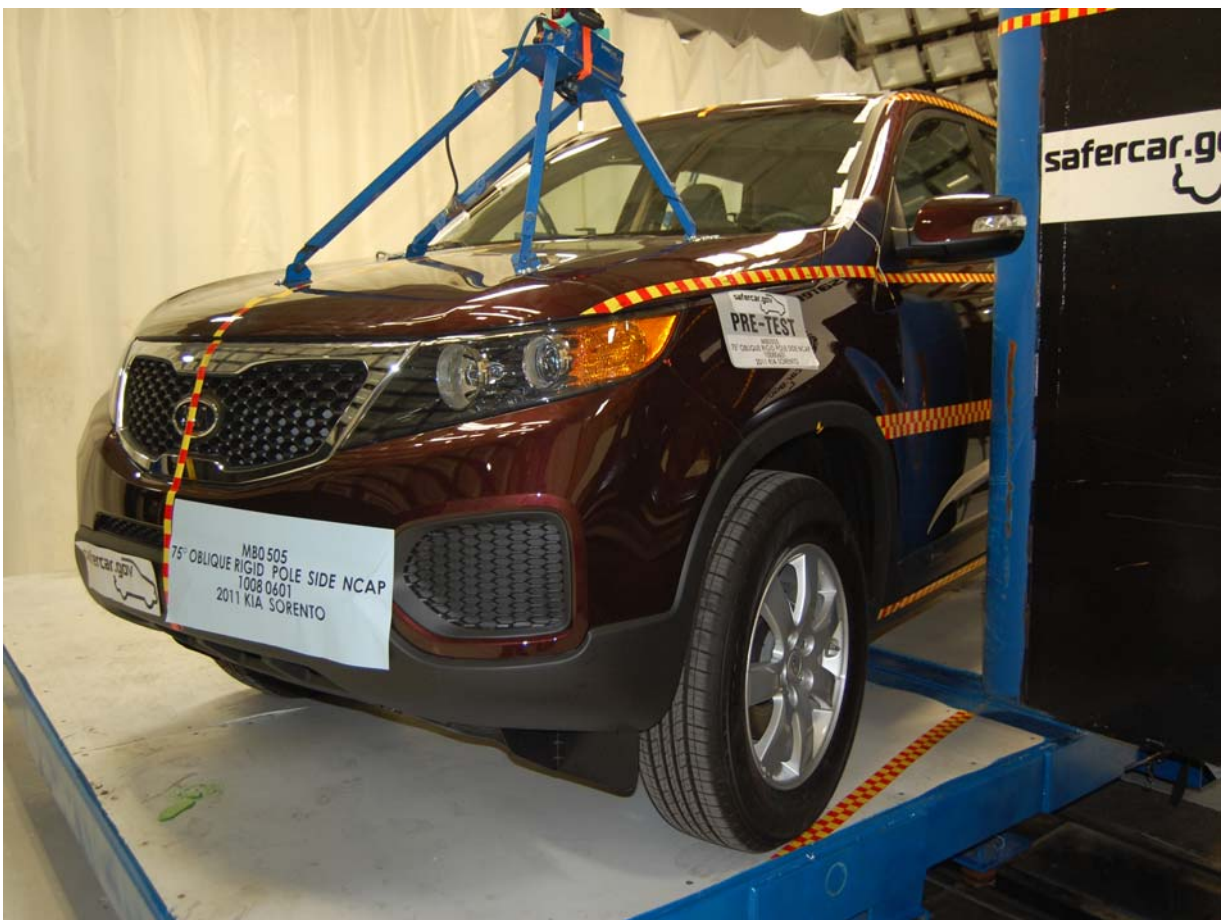
Pre-Test Left Side View of Pole Positioned Against Side of Vehicle at Ideal Impact Point

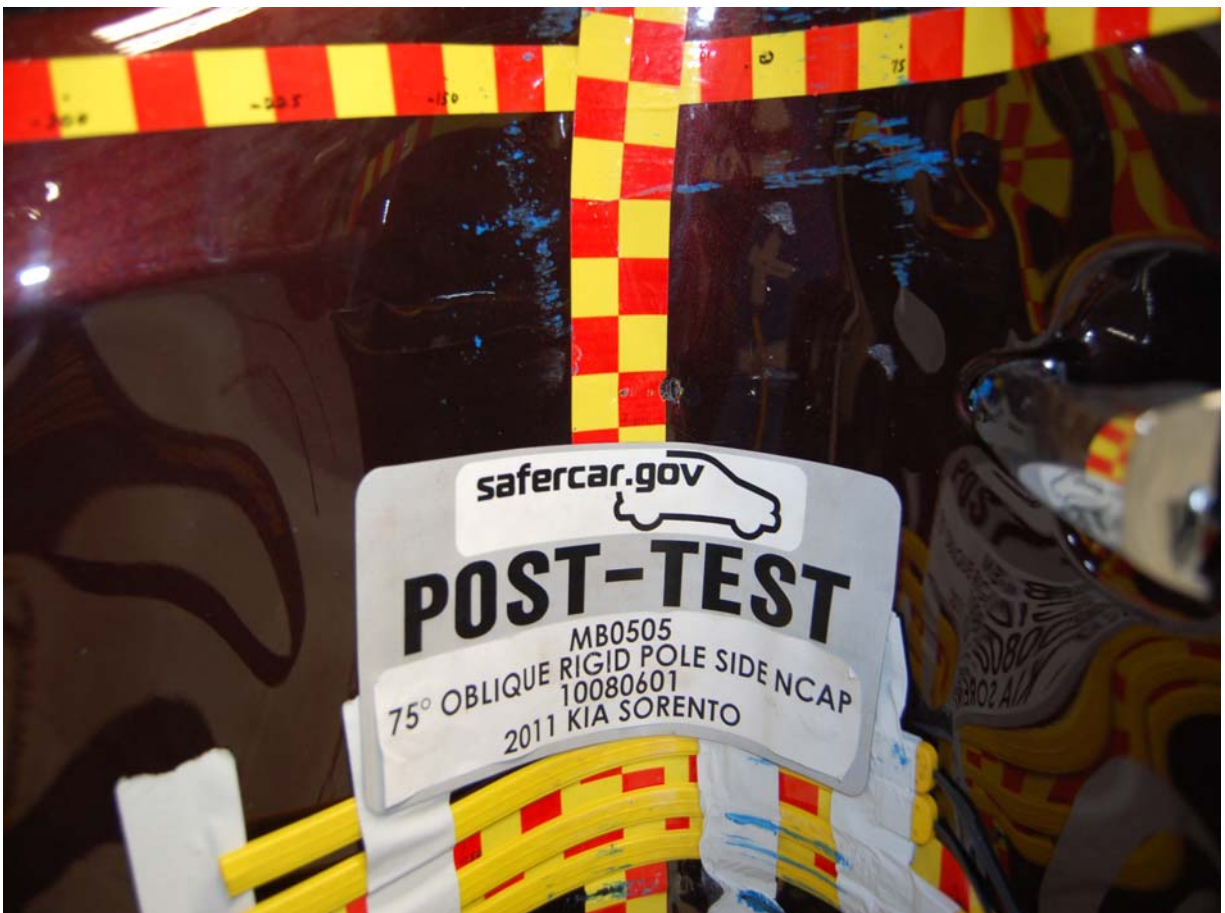
Post-Test Close-Up View of Impact Point Target Showing Impact Location

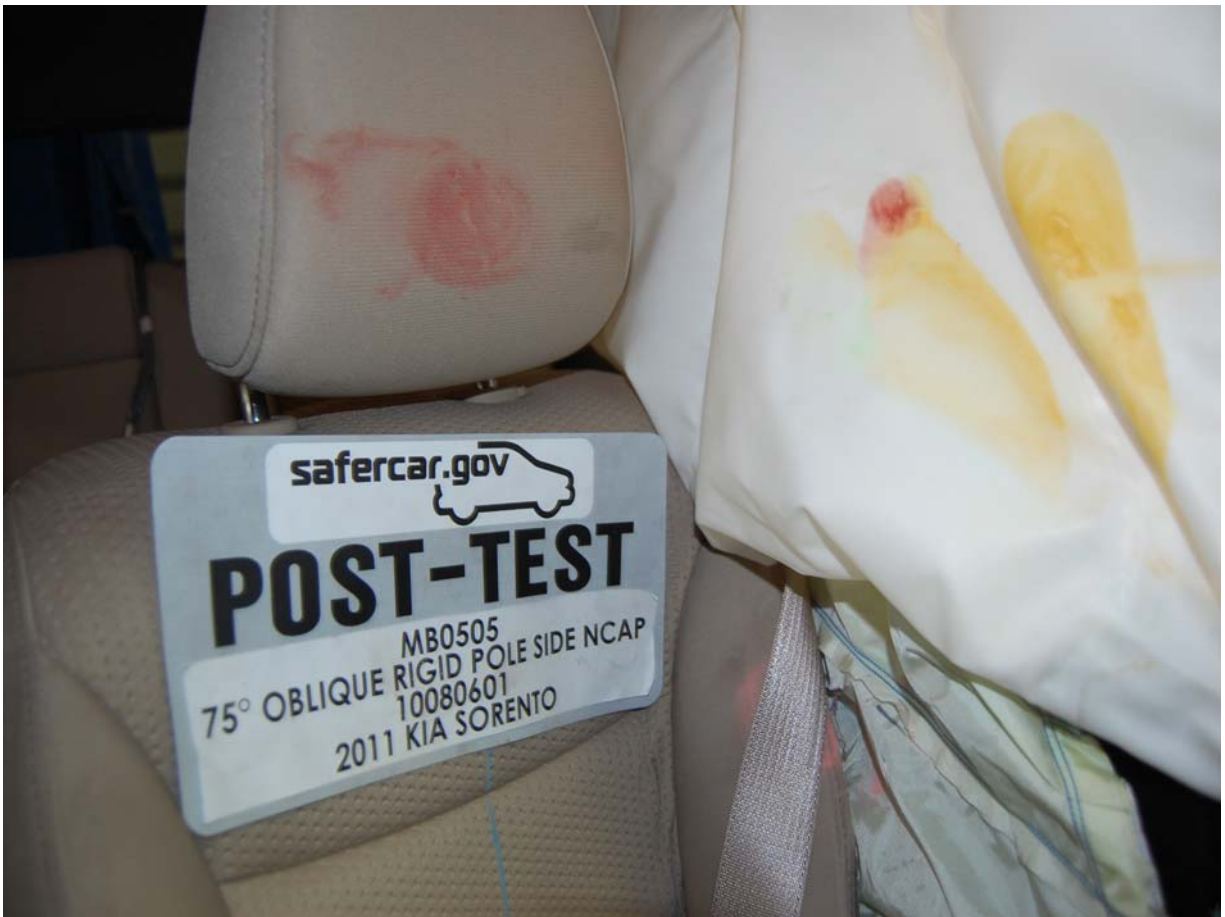
Post-Test Dummy Close-Up Head Contact with Vehicle View

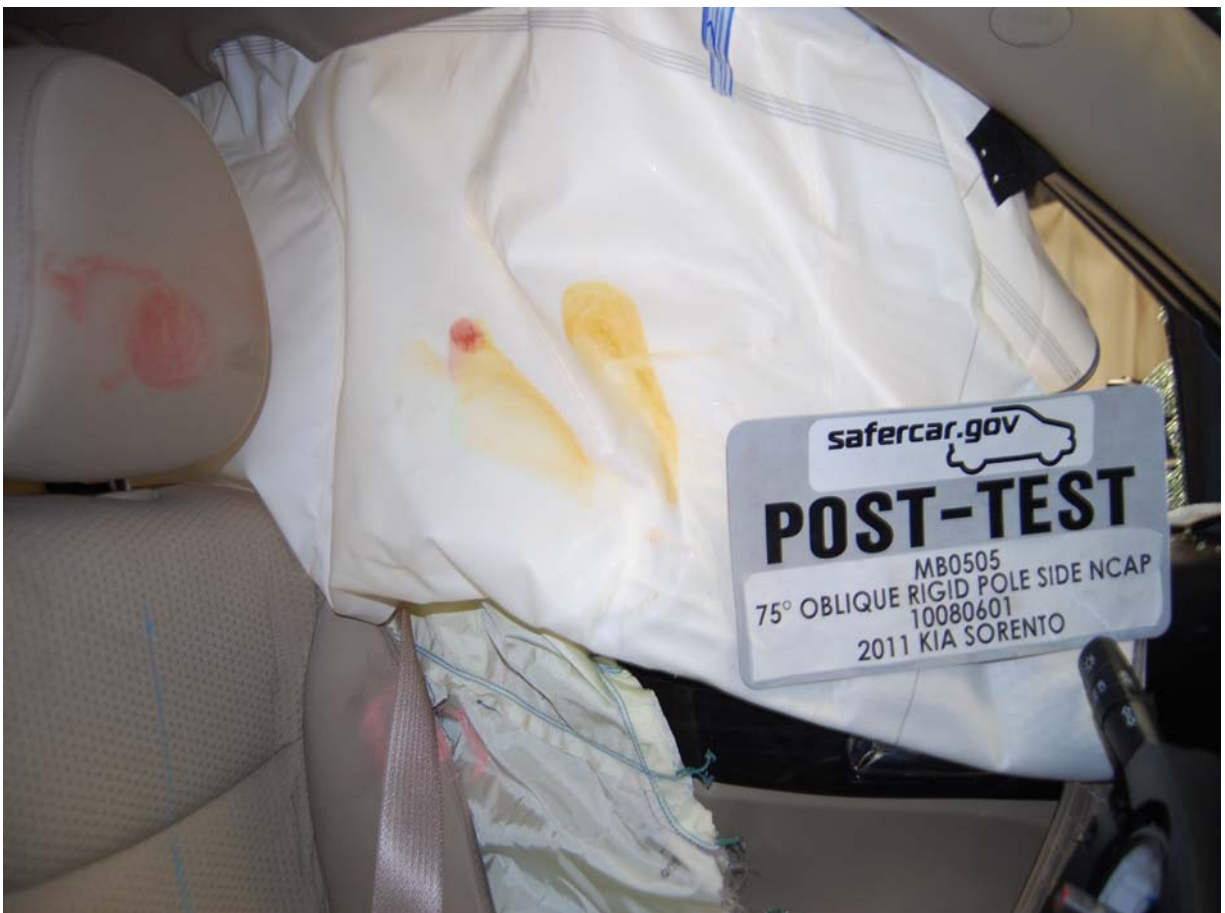
Post-Test Dummy Close-Up Head Contact with Side Airbag View

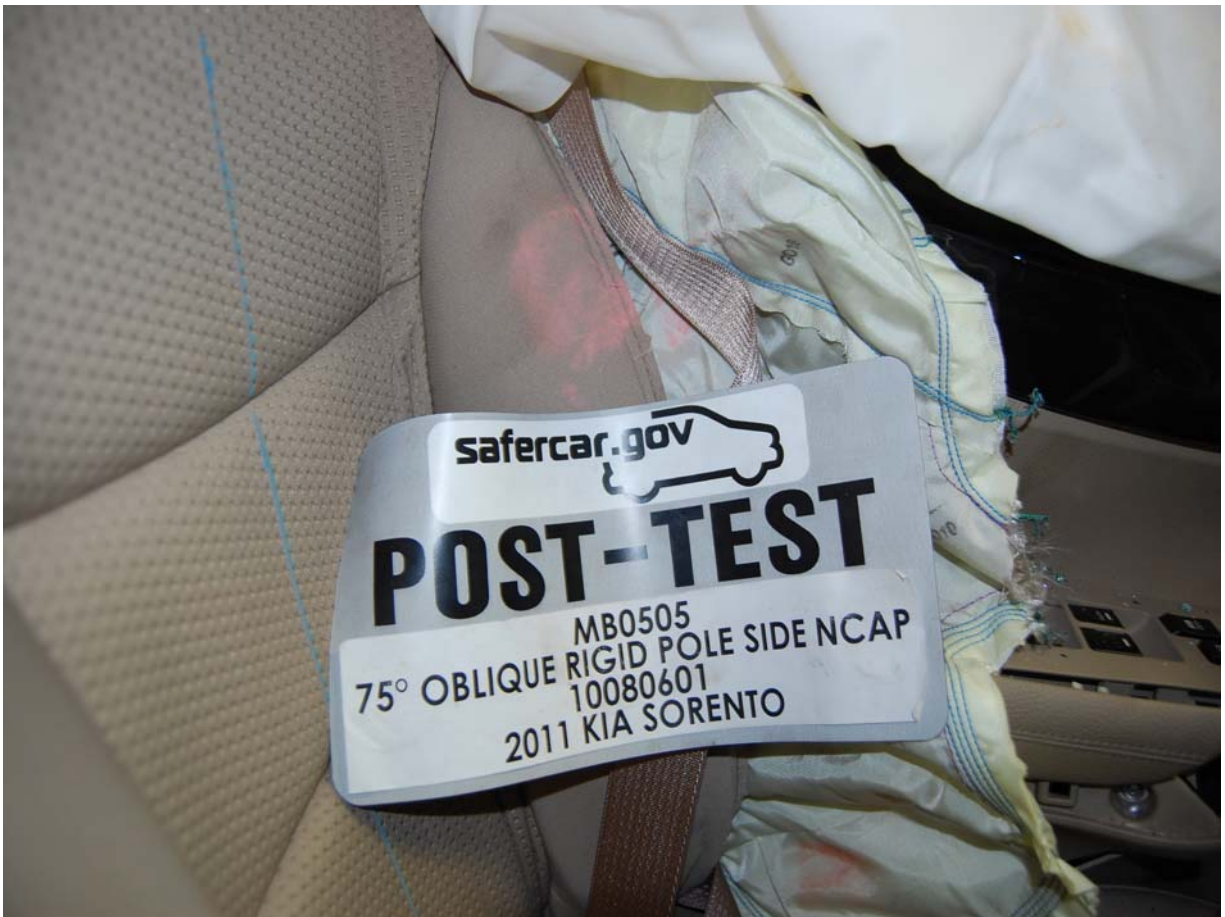
Post-Test Dummy Close-Up Torso Contact with Vehicle Interior View

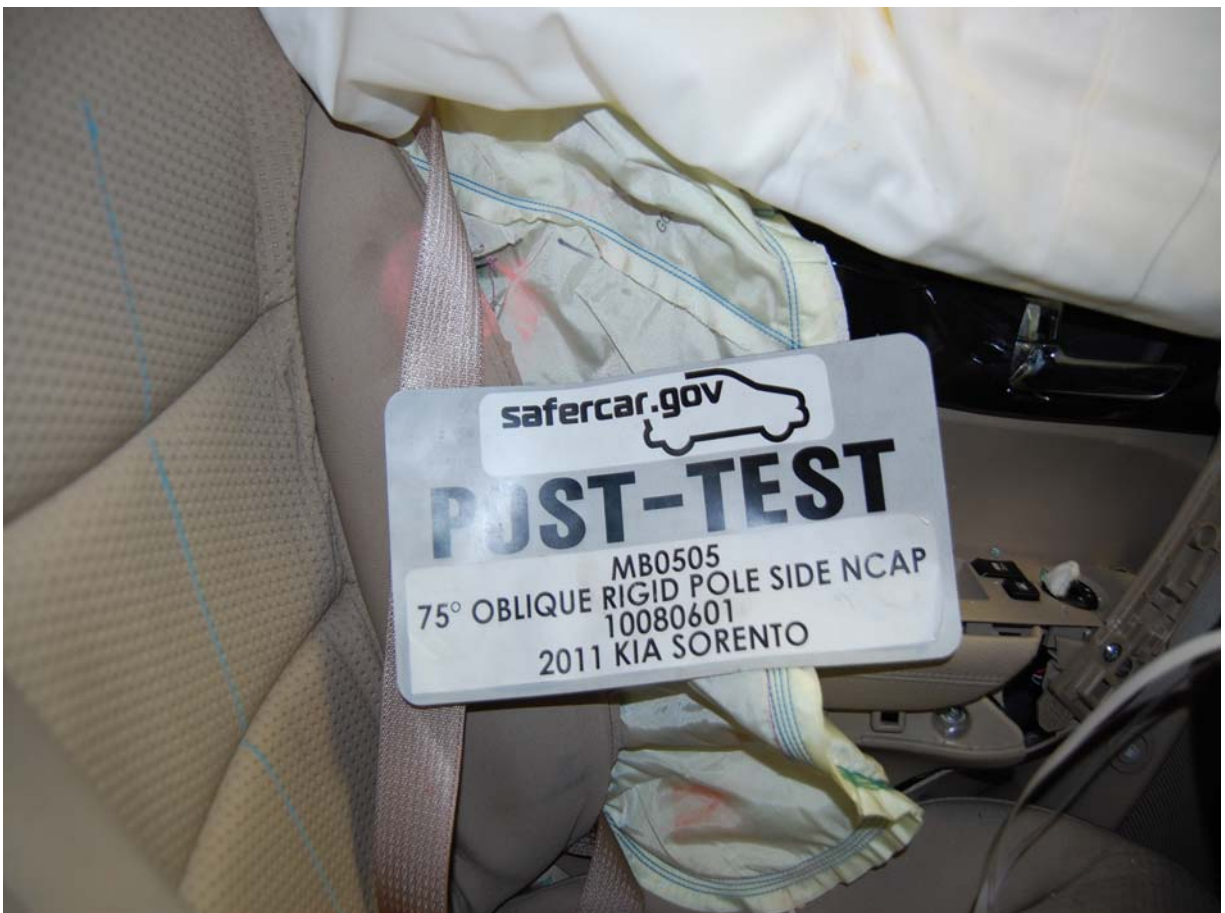
Post-Test Dummy Close-Up Torso Contact with Side Airbag View

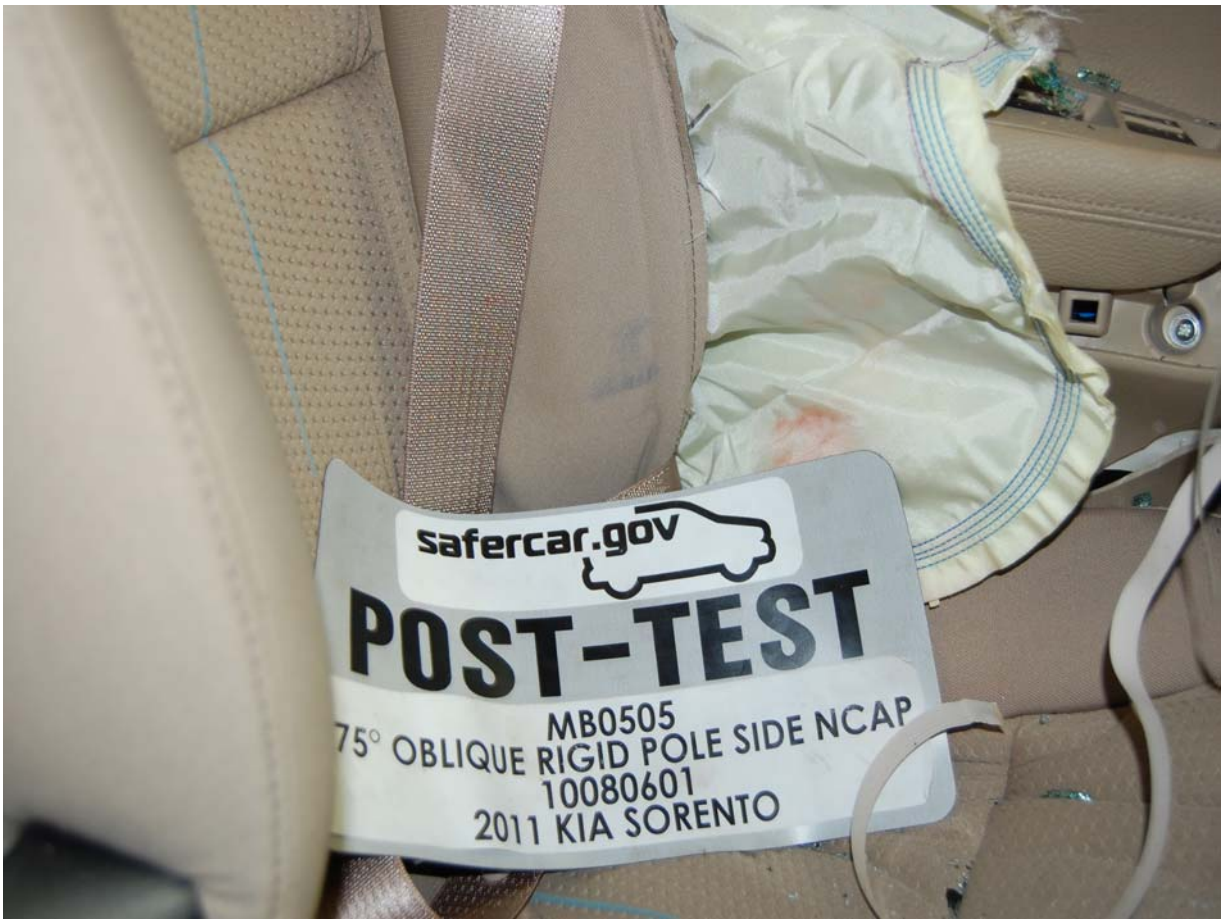
Post-Test Dummy Close-Up Pelvis Contact View

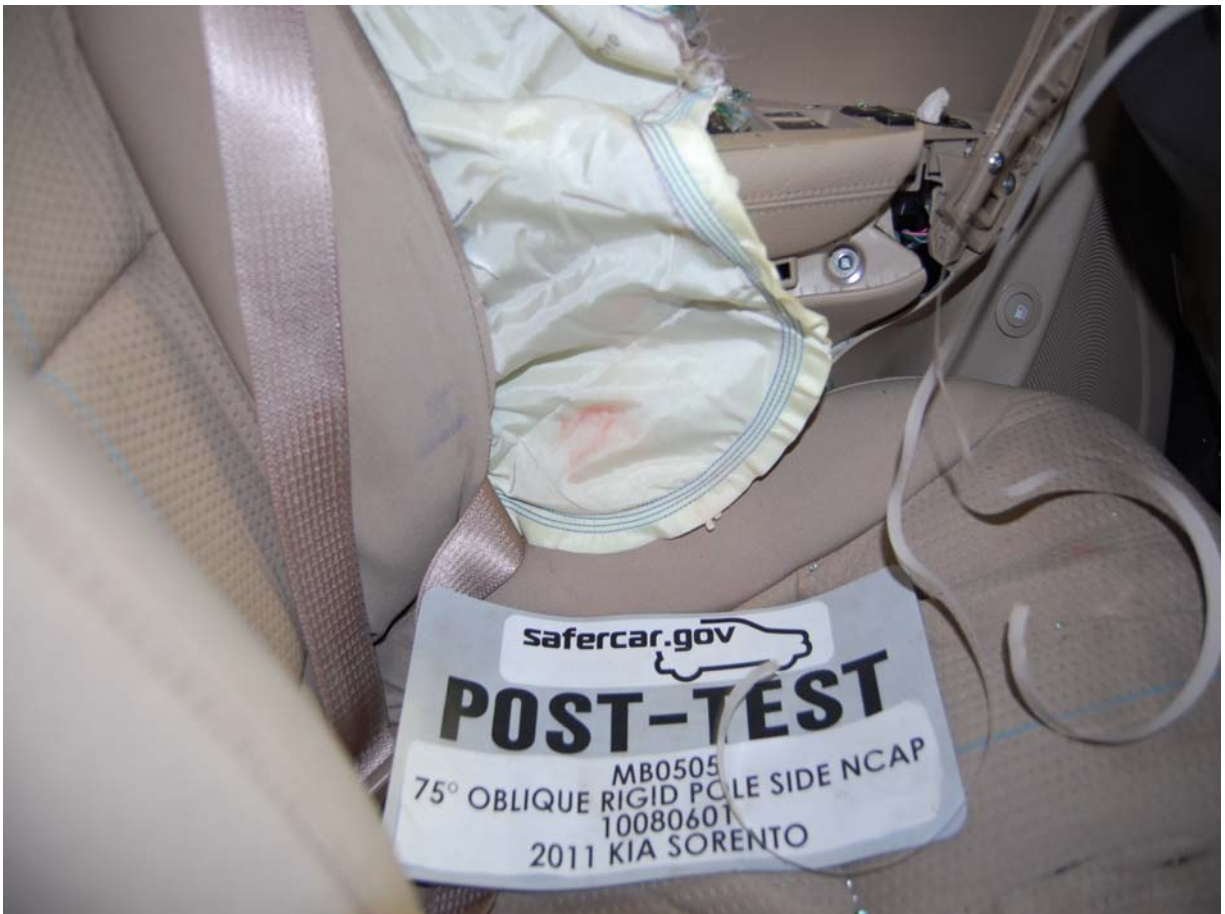
Post-Test Dummy Close-Up Pelvis Contact with Side Airbag View

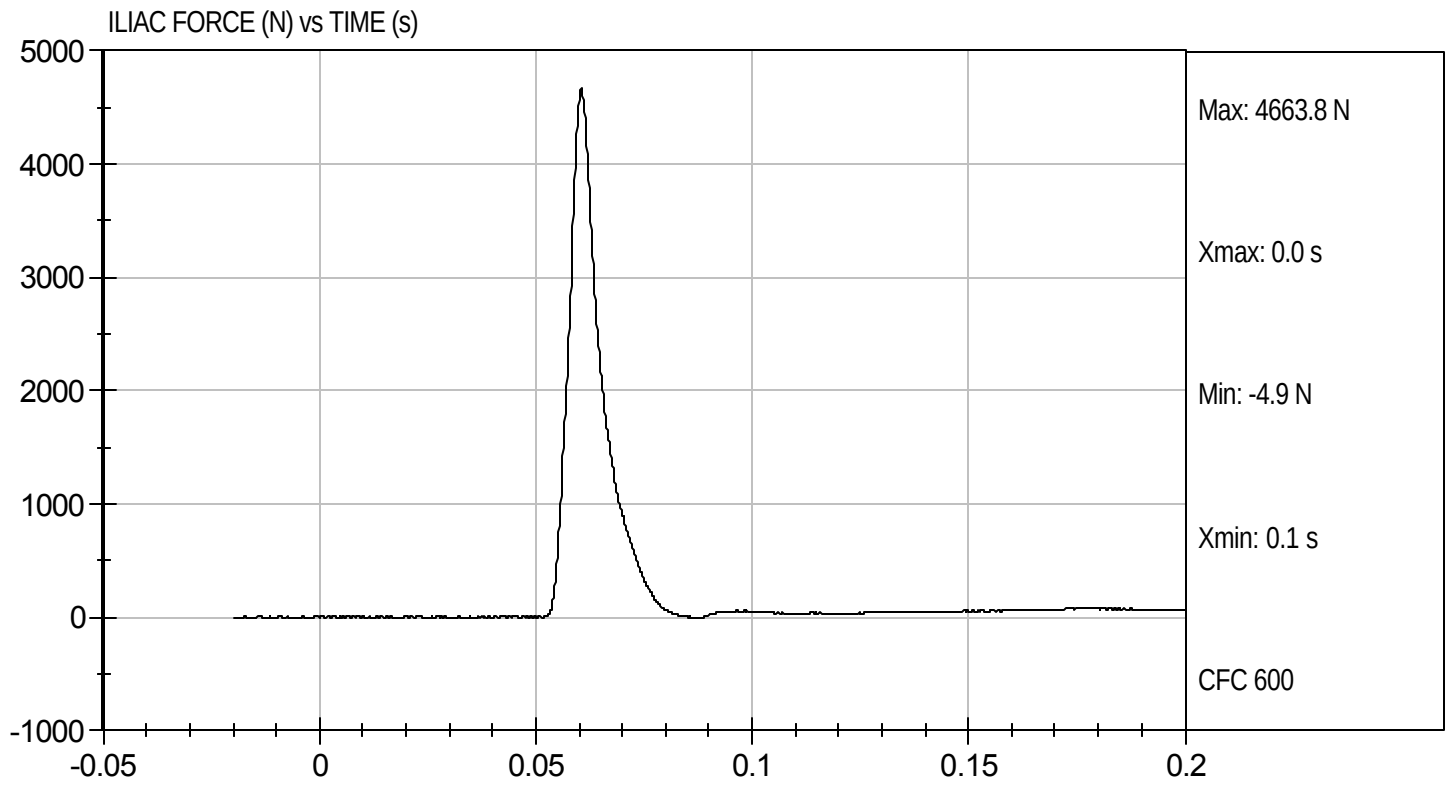
Test Desc: Iliac Impact  
Component ID: D102558

Test Date: 8/9/10  
Velocity: 14.37 ft/s, 4.38 m/s
