**REPORT NUMBER: SPNCAP-CAL-11-007**

**NEW CAR ASSESSMENT PROGRAM (NCAP)  
SIDE IMPACT POLE TEST**

**General Motors LLC  
2011 Chevrolet Traverse LS  
4-Door SUV**

**FINAL REPORT**

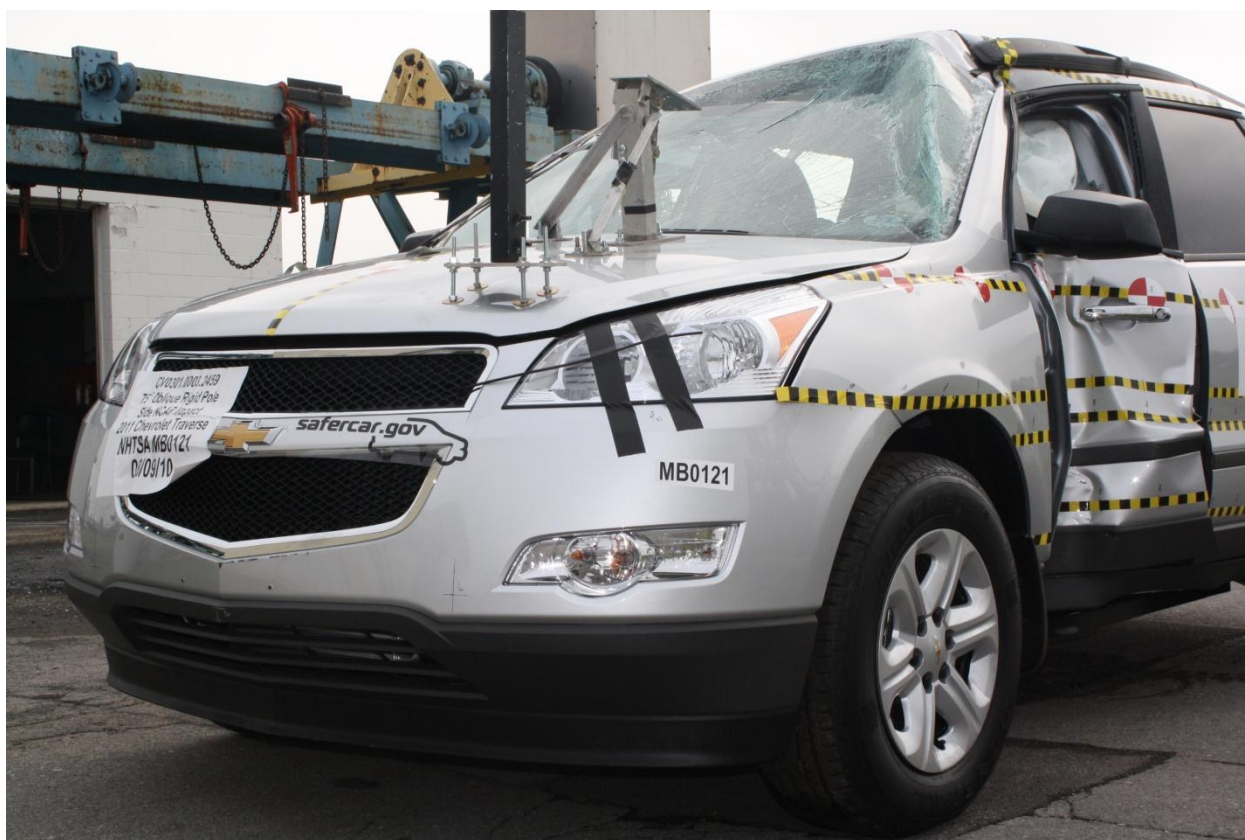
**Figure A-6: Post-Test Left Front  $\frac{3}{4}$  View of Test Vehicle**

| Critical Areas of Performance | Observations and Conclusions |
|---|---|
| Windshield Damage | Severe cracking on left side of windshield |
| Window Damage | Left front window shattered during impact |

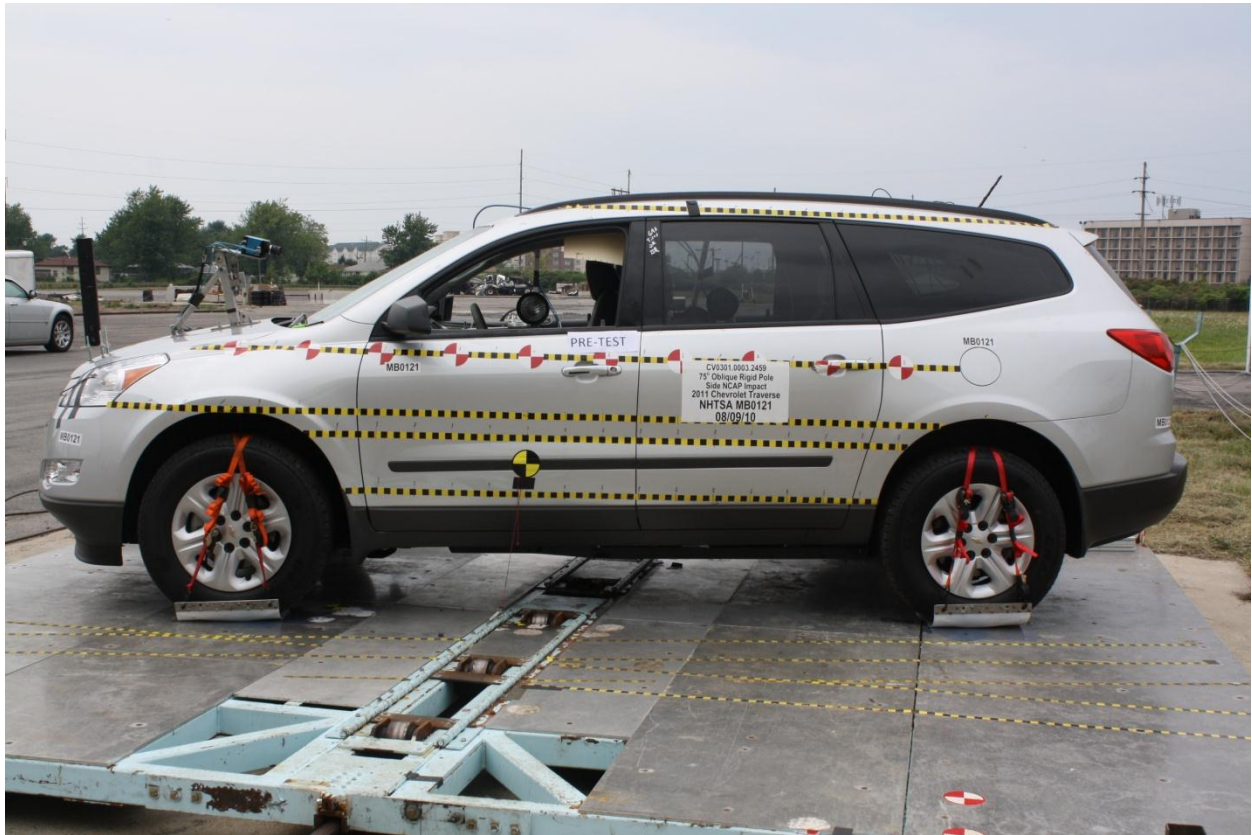
**Figure A-8: Post-Test Left Side View of Test Vehicle**

| Critical Areas of Performance | Observations and Conclusions |
|---|---|
| Pillar Performance | B-Pillar Intrusion caused by pole impact |
