**REPORT NUMBER: SNCAP-CAL-11-008**

**NEW CAR ASSESSMENT PROGRAM (NCAP)  
Moving Deformable Barrier Side Impact Test**

**General Motors LLC  
2011 Chevrolet Traverse FWD LS  
4-Door SUV**

**FINAL REPORT**

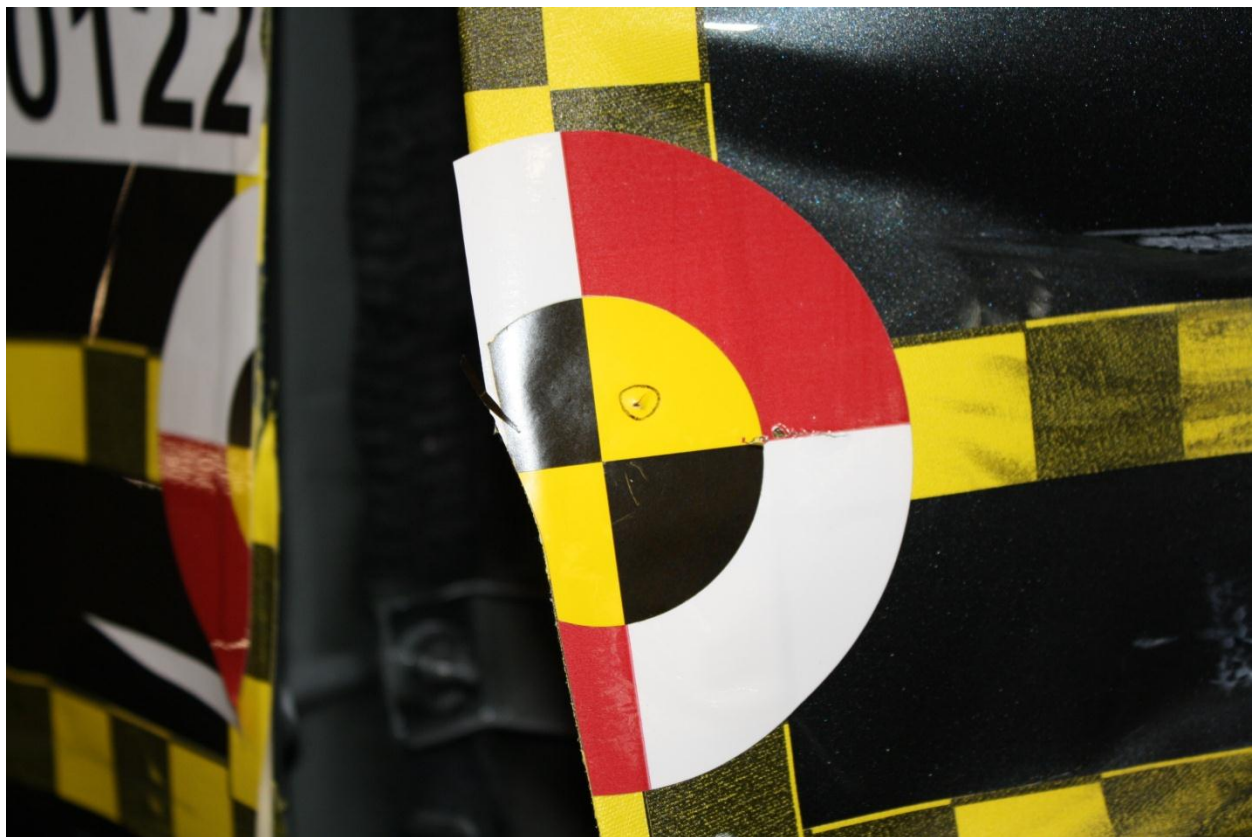
**Figure A-19: Pre-Test Close-up View of Impact Point Target**

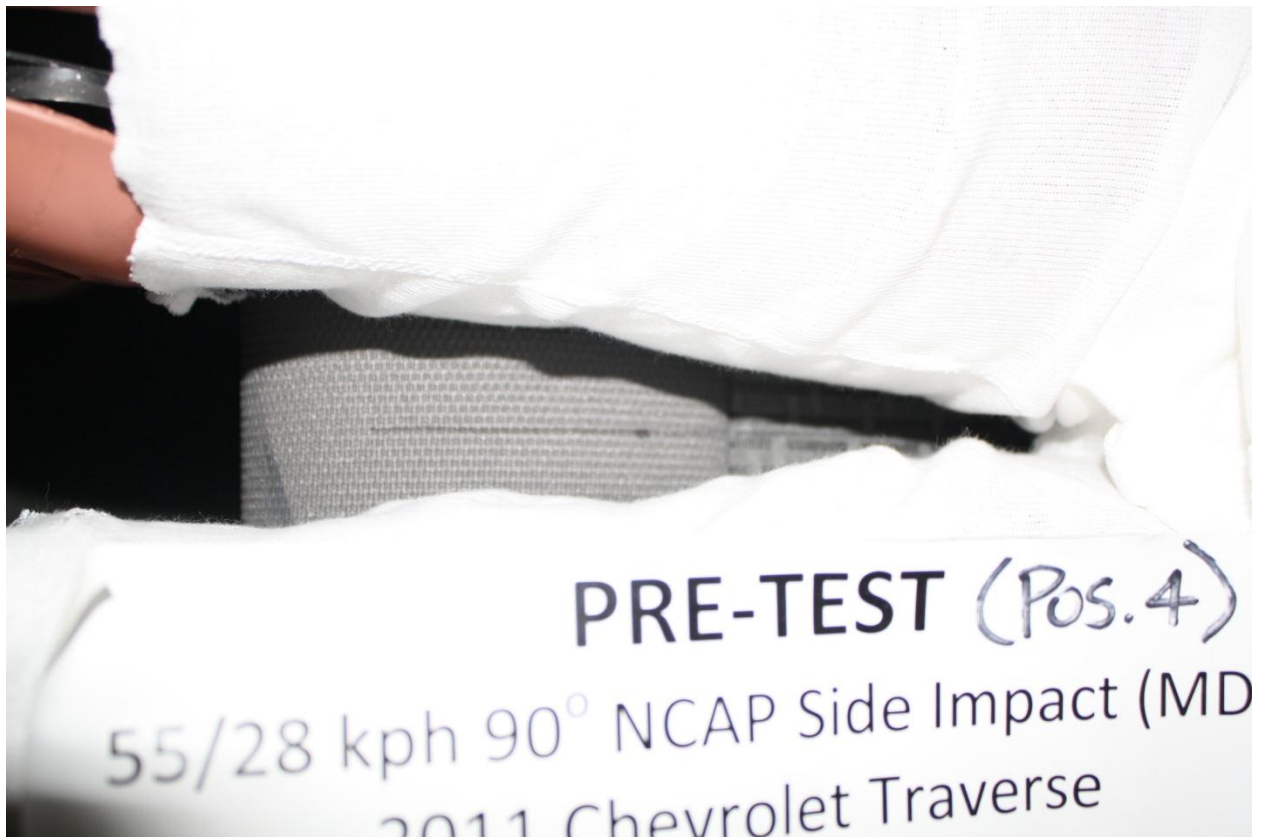
**Figure A-58: Pre-Test Overhead View of Rear Passenger Seat Pan Prior to Dummy Positioning**
