**REPORT NUMBER: SPNCAP-MGA-2011-011**

**NEW CAR ASSESSMENT PROGRAM (NCAP)  
Side Impact Pole Test**

**FORD MOTOR COMPANY  
2011 Ford Fiesta S 4-Dr Sedan  
NHTSA No.: MB0212**

**FINAL REPORT**

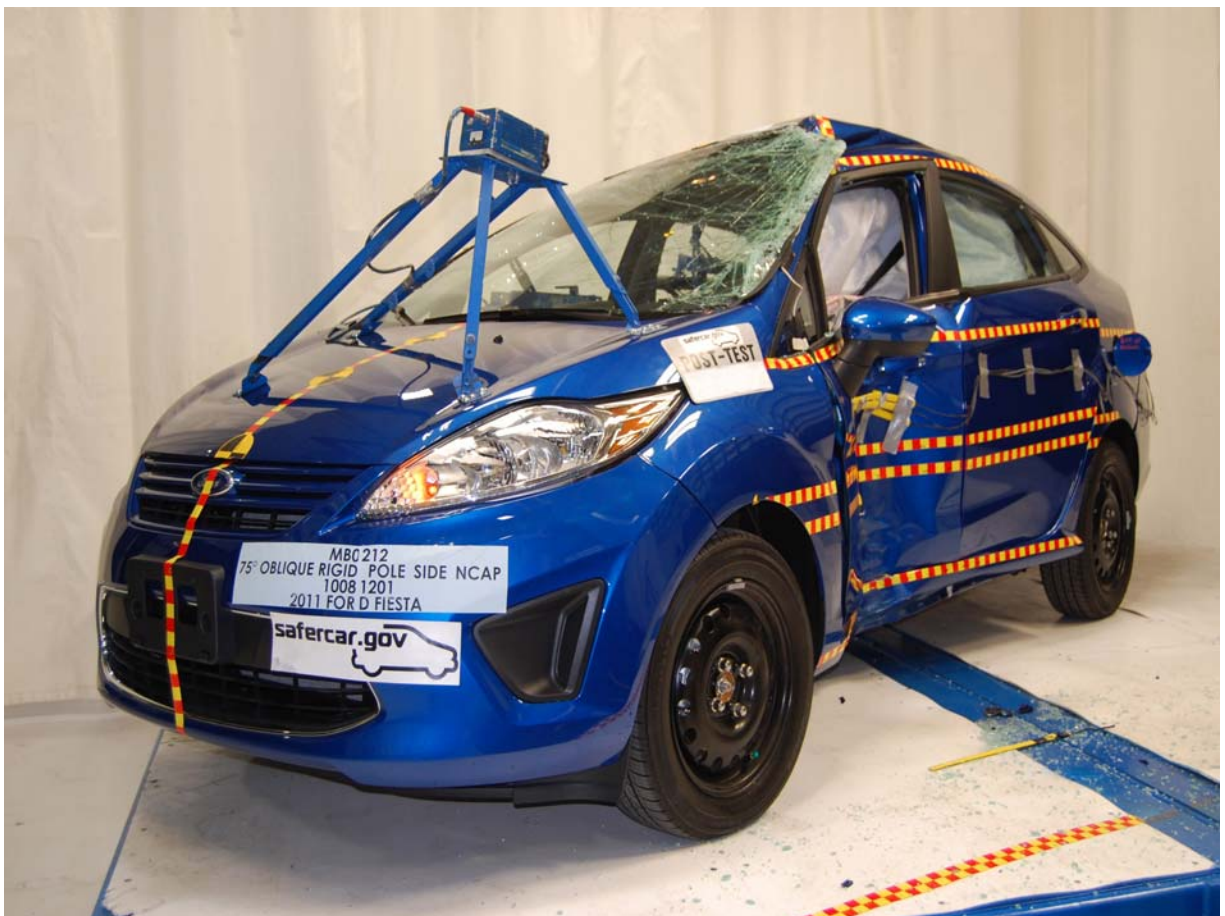
Post-Test Left Front  $\frac{3}{4}$  View of Test Vehicle

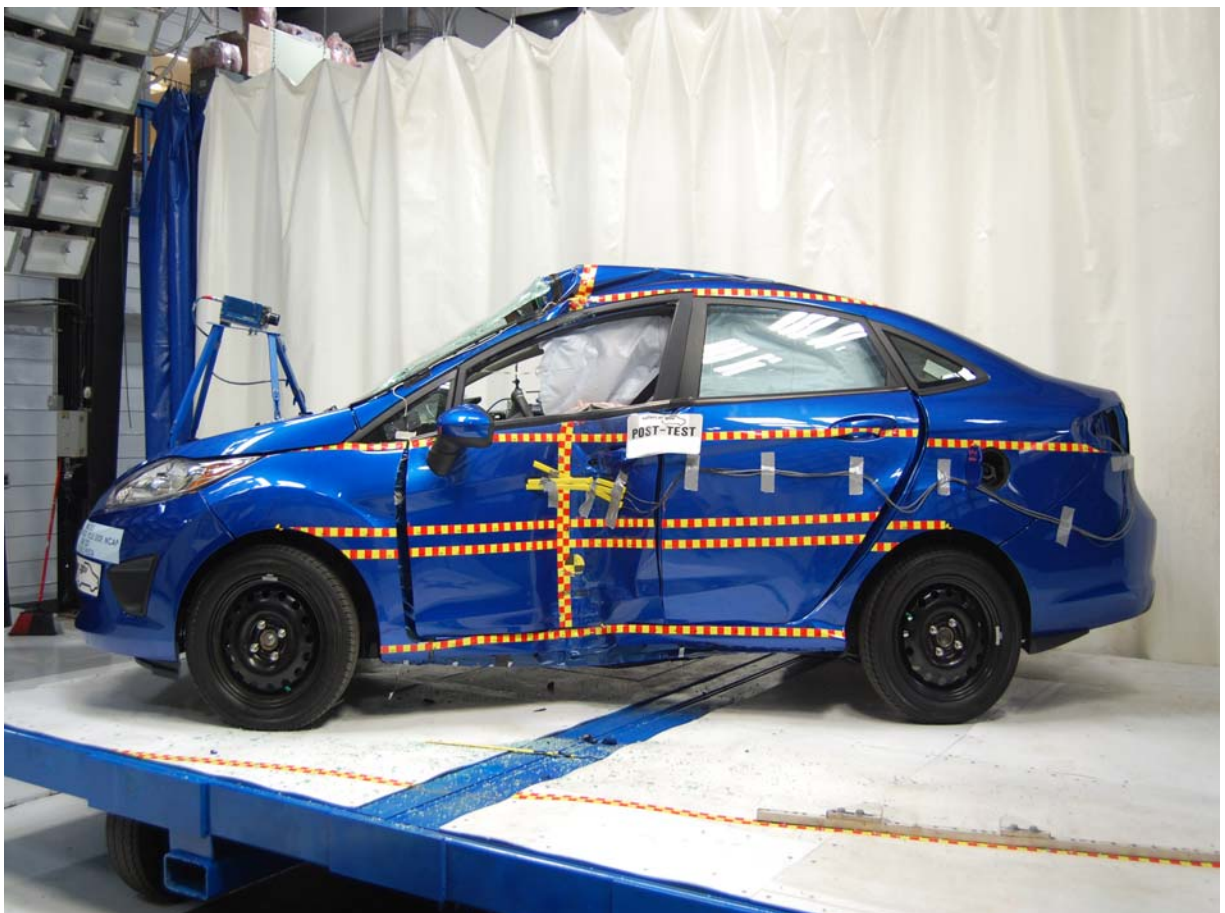
Post-Test Left Side View of Test Vehicle

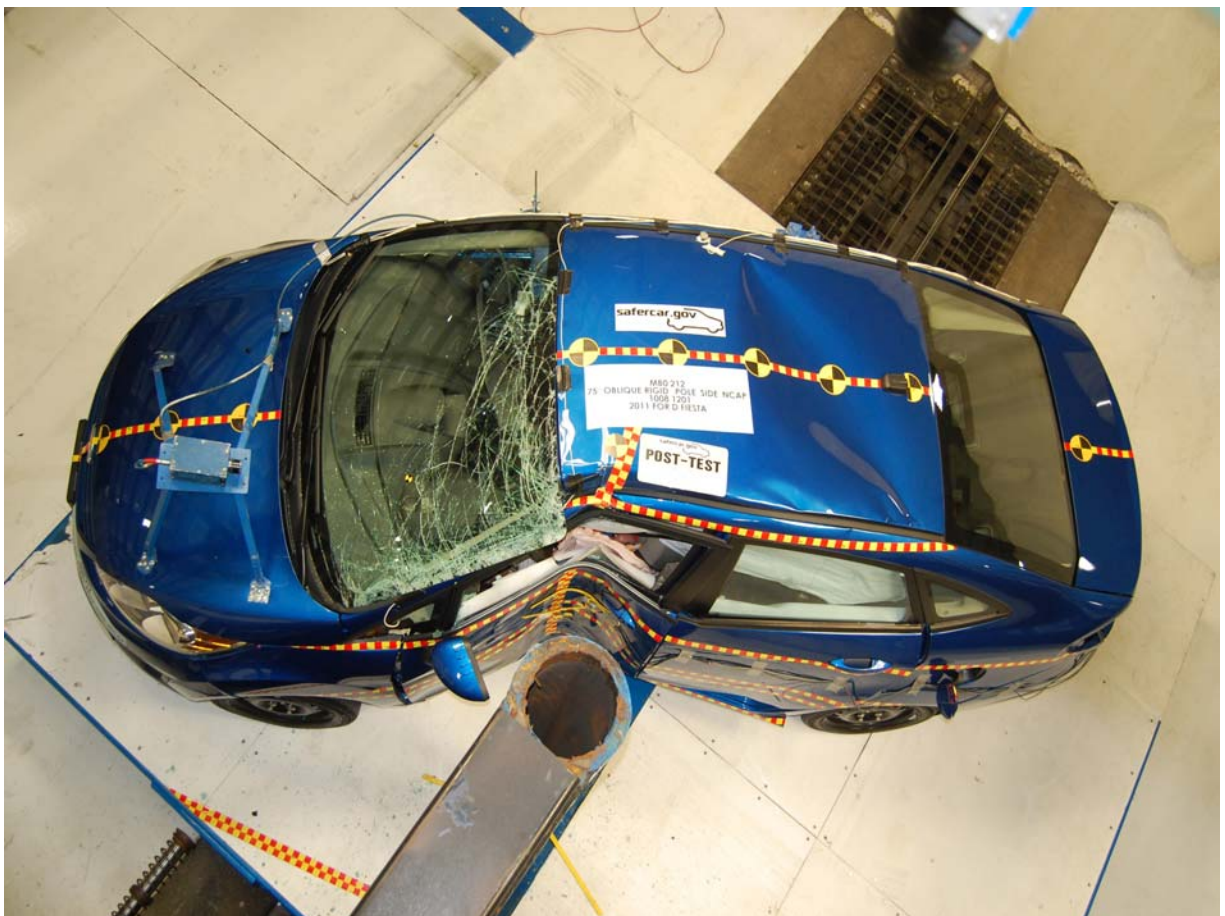
Post-Test Overhead View of Test Vehicle and Pole

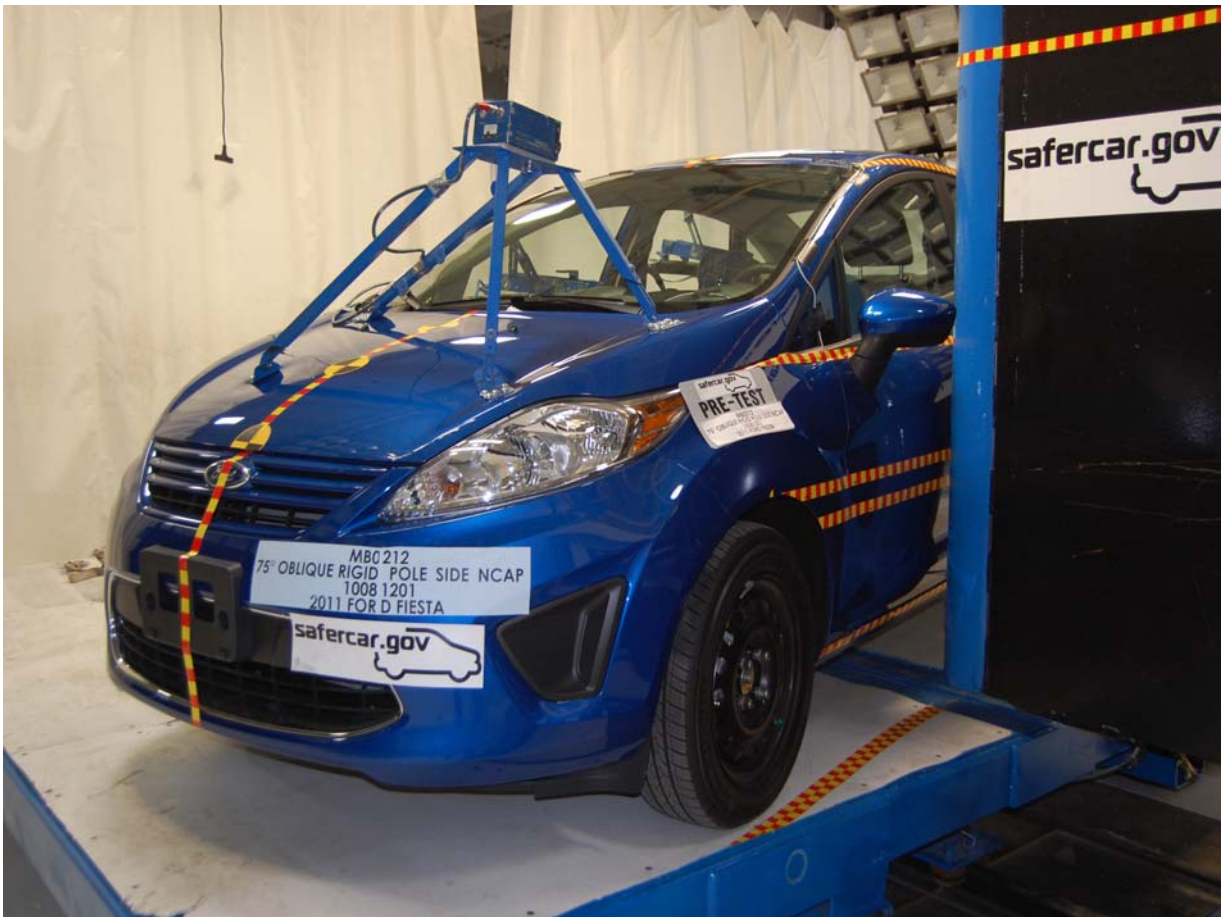
Pre-Test Left Side View of Pole Positioned Against Side of Vehicle at Ideal Impact Point

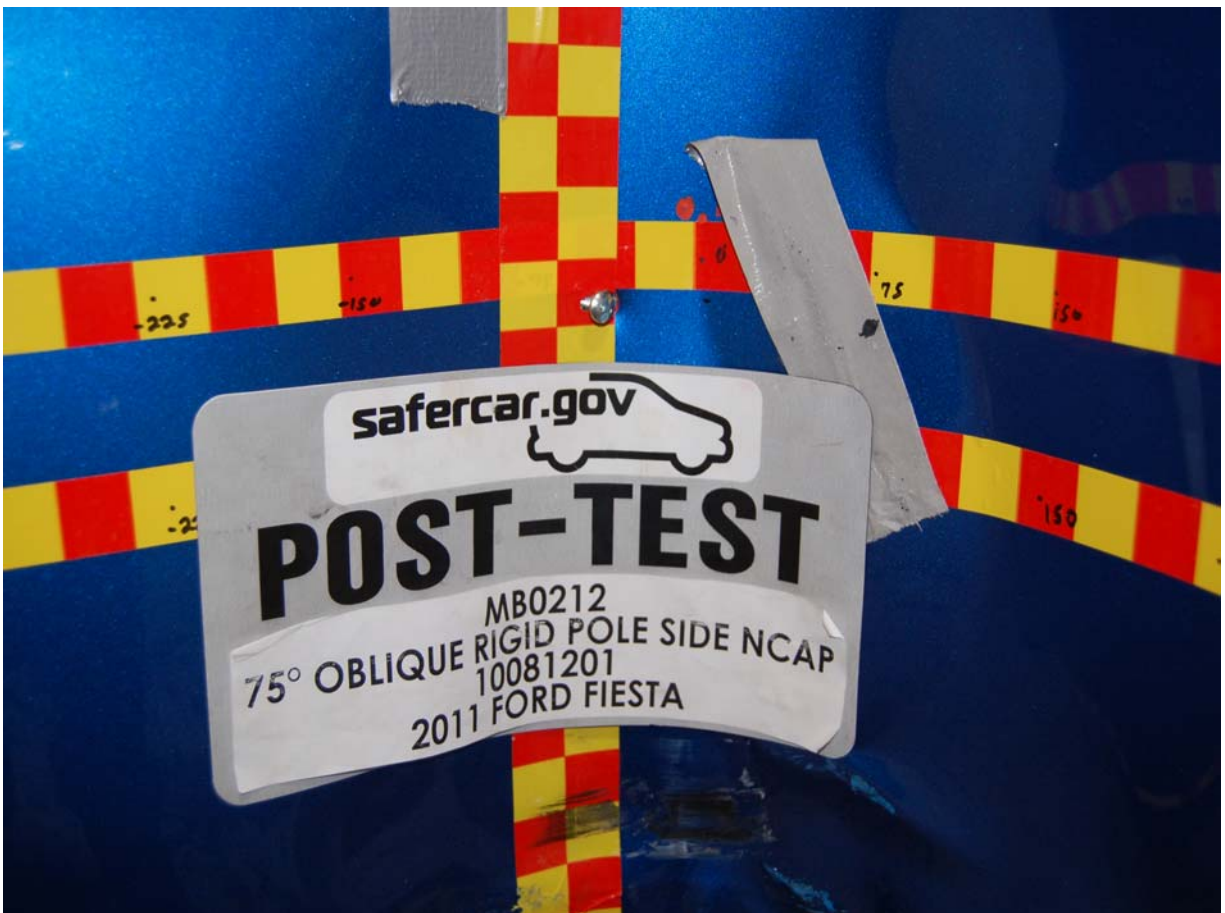
Post-Test Close-Up View of Impact Point Target Showing Impact Location

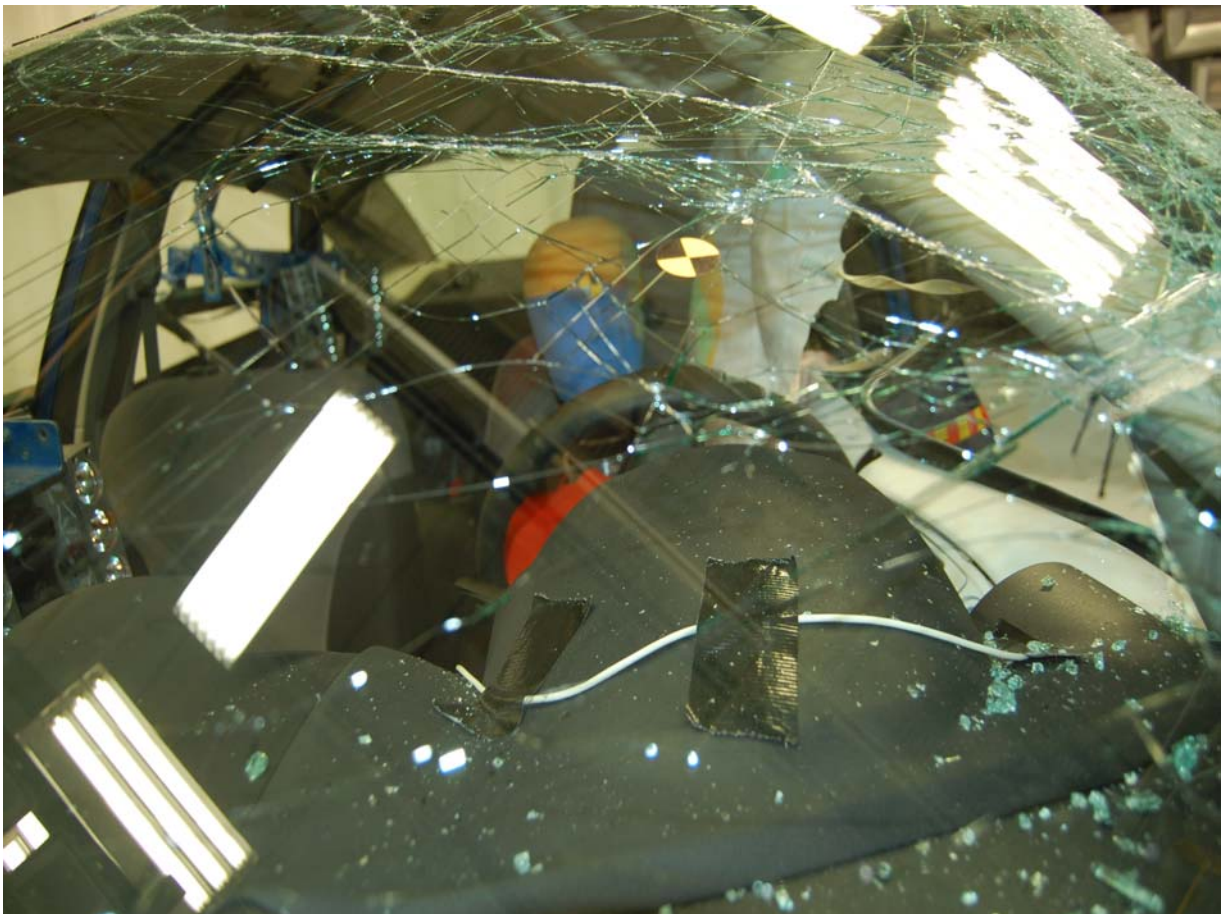
Post-Test Front Close-Up View of Dummy

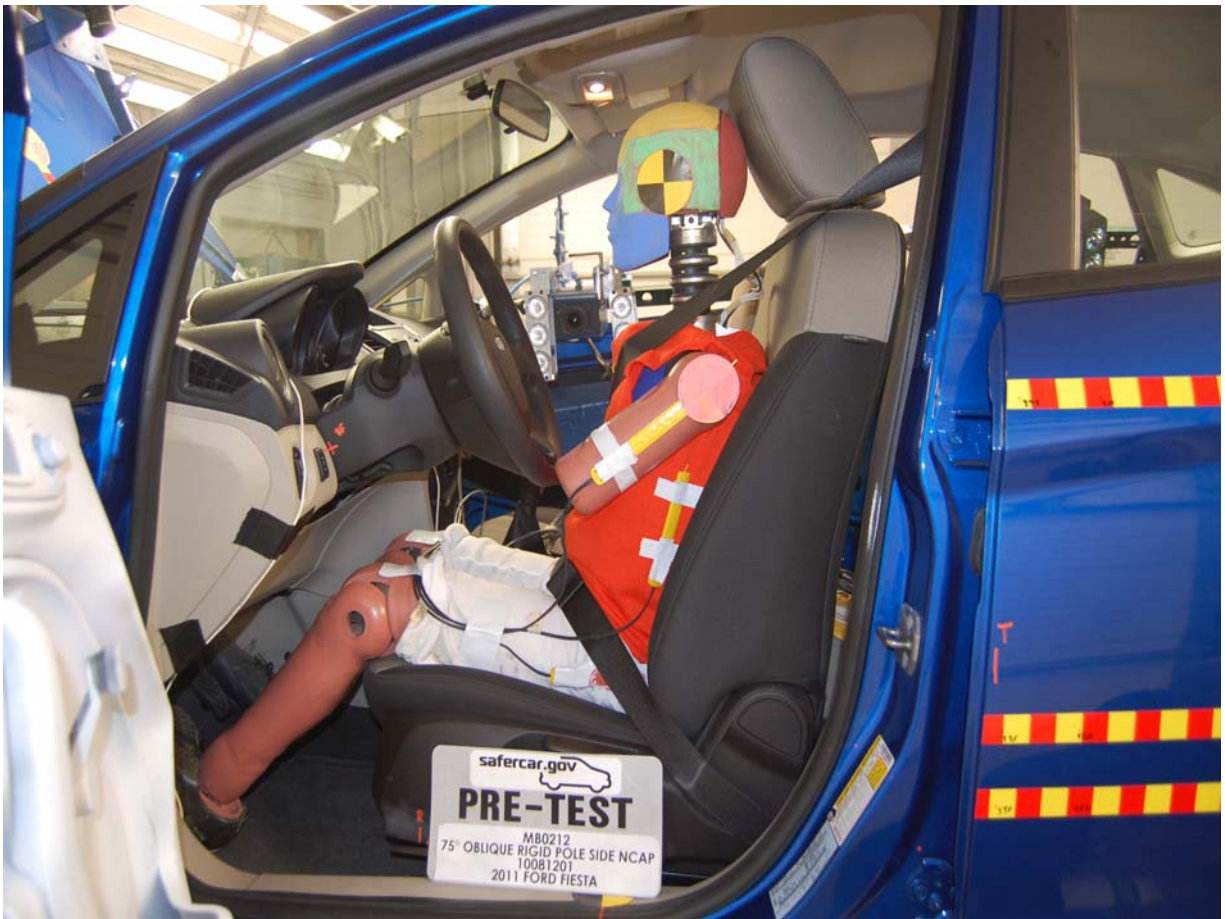
Pre-Test Left Side View of Dummy Showing Belts, Chalking, and Contact Switches (Door Open)

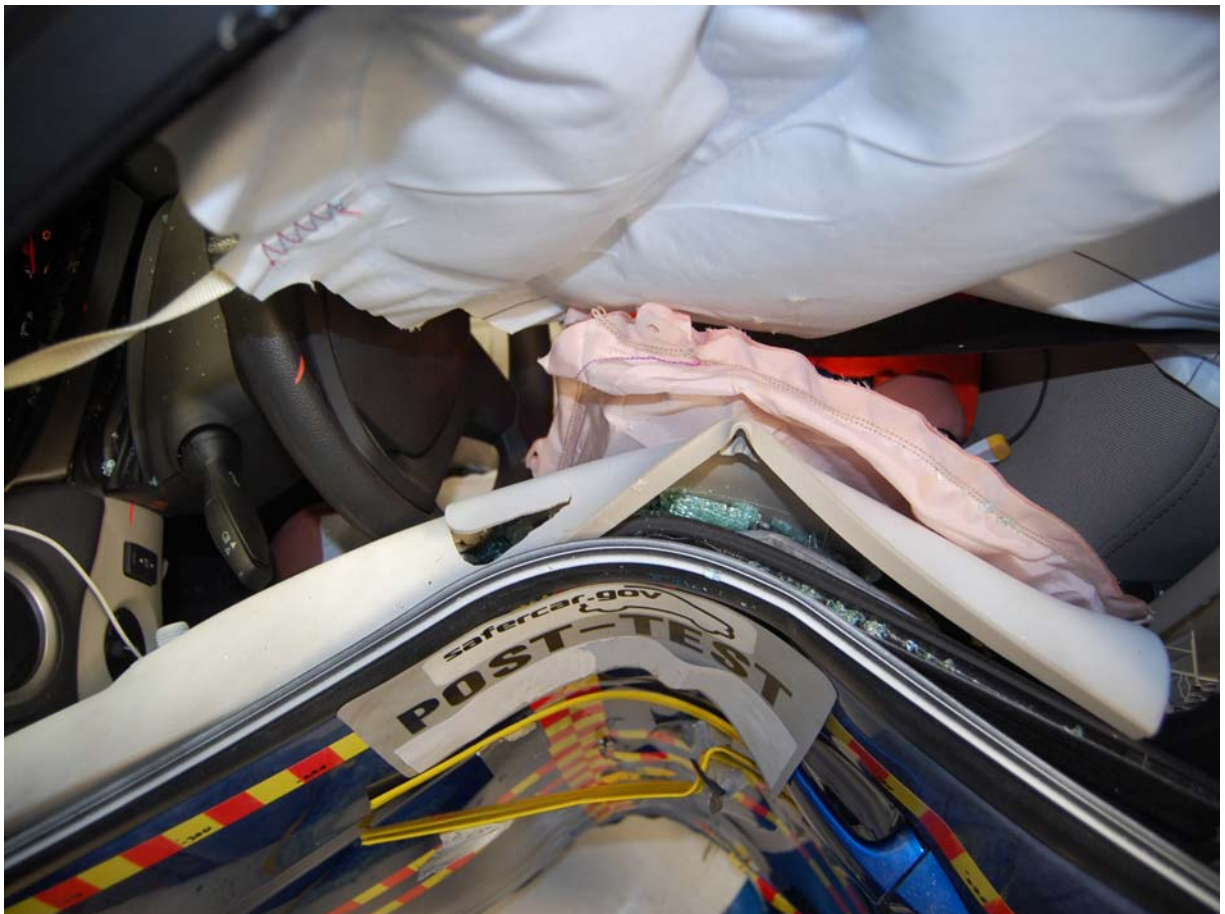
Post-Test Dummy and Door Clearance View

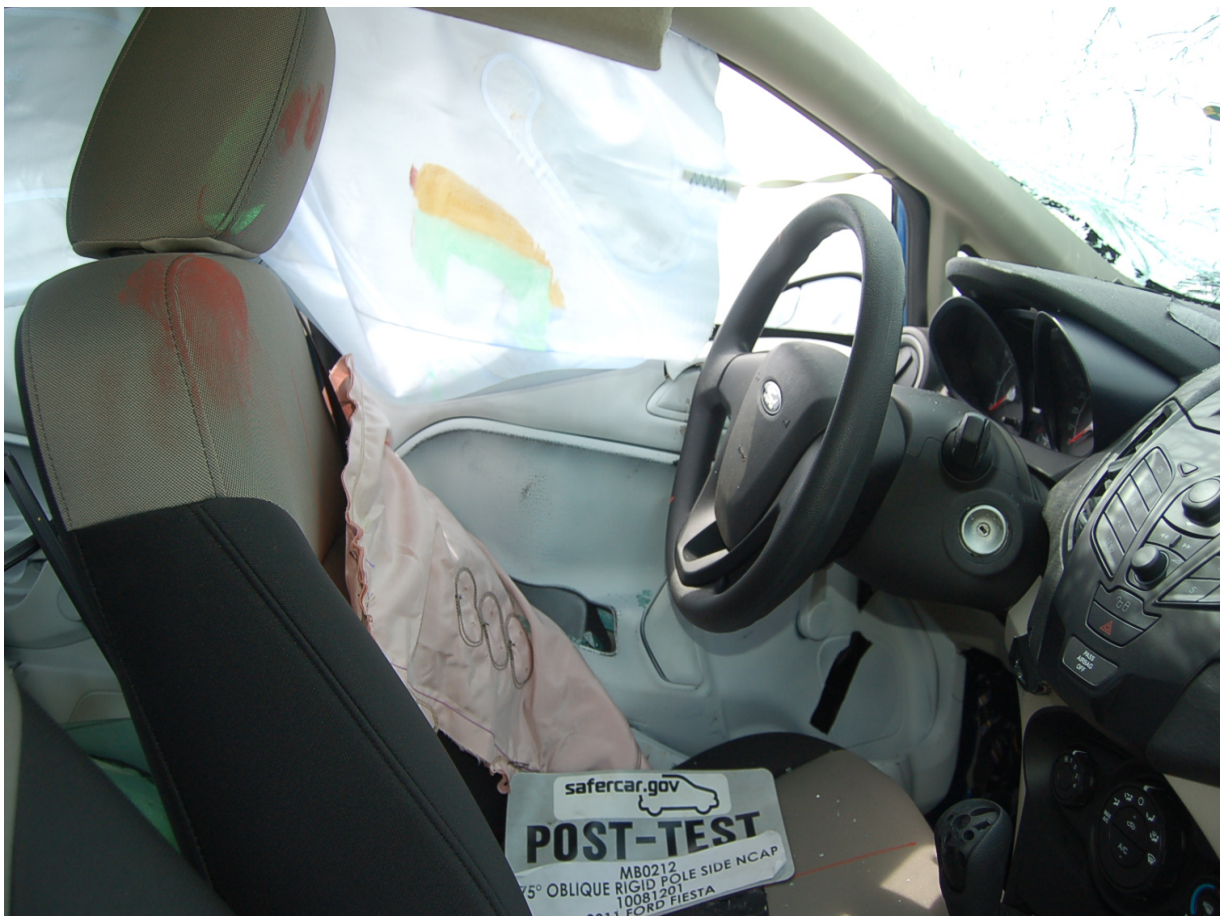
Post-Test Inner Door Panel View Showing Dummy Contact Location

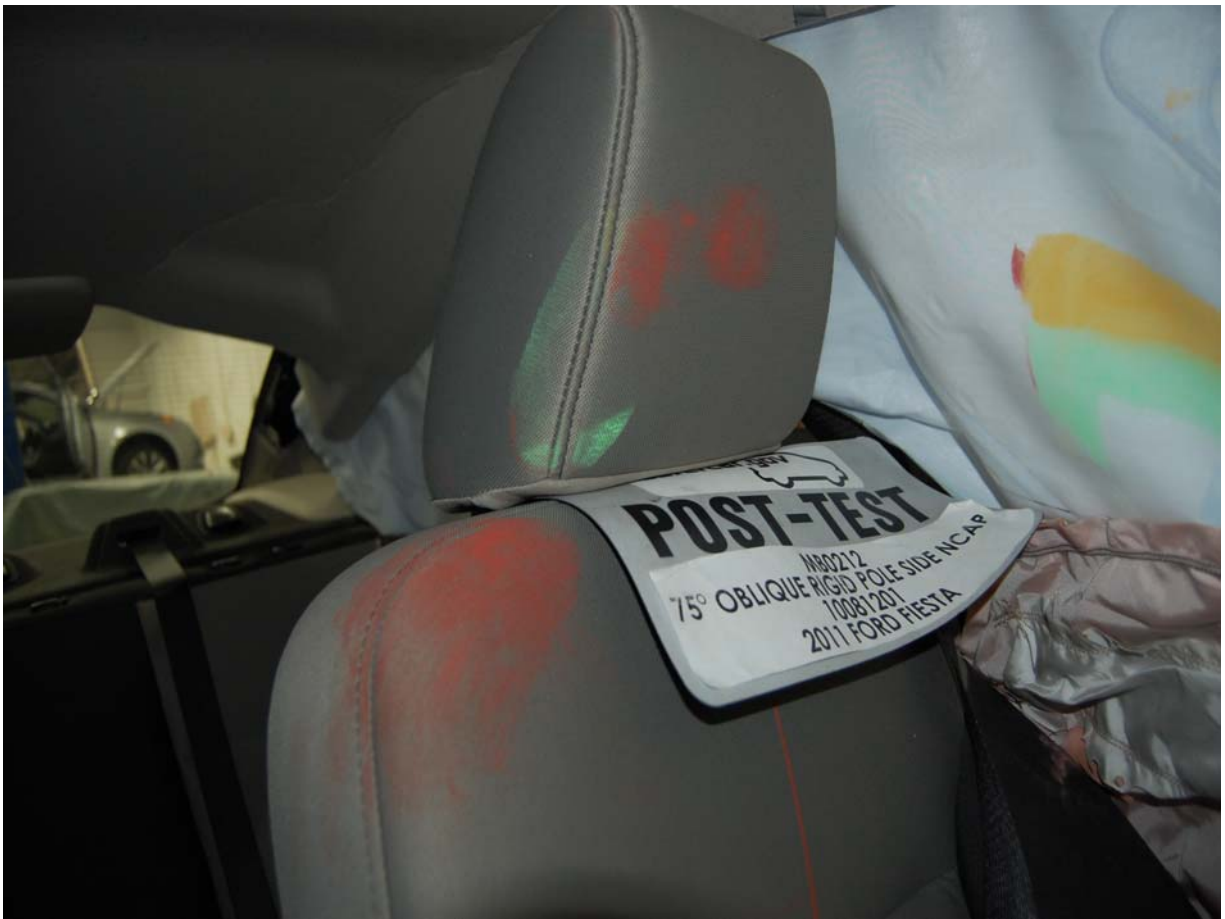
Post-Test Dummy Close-Up Head Contact with Vehicle View

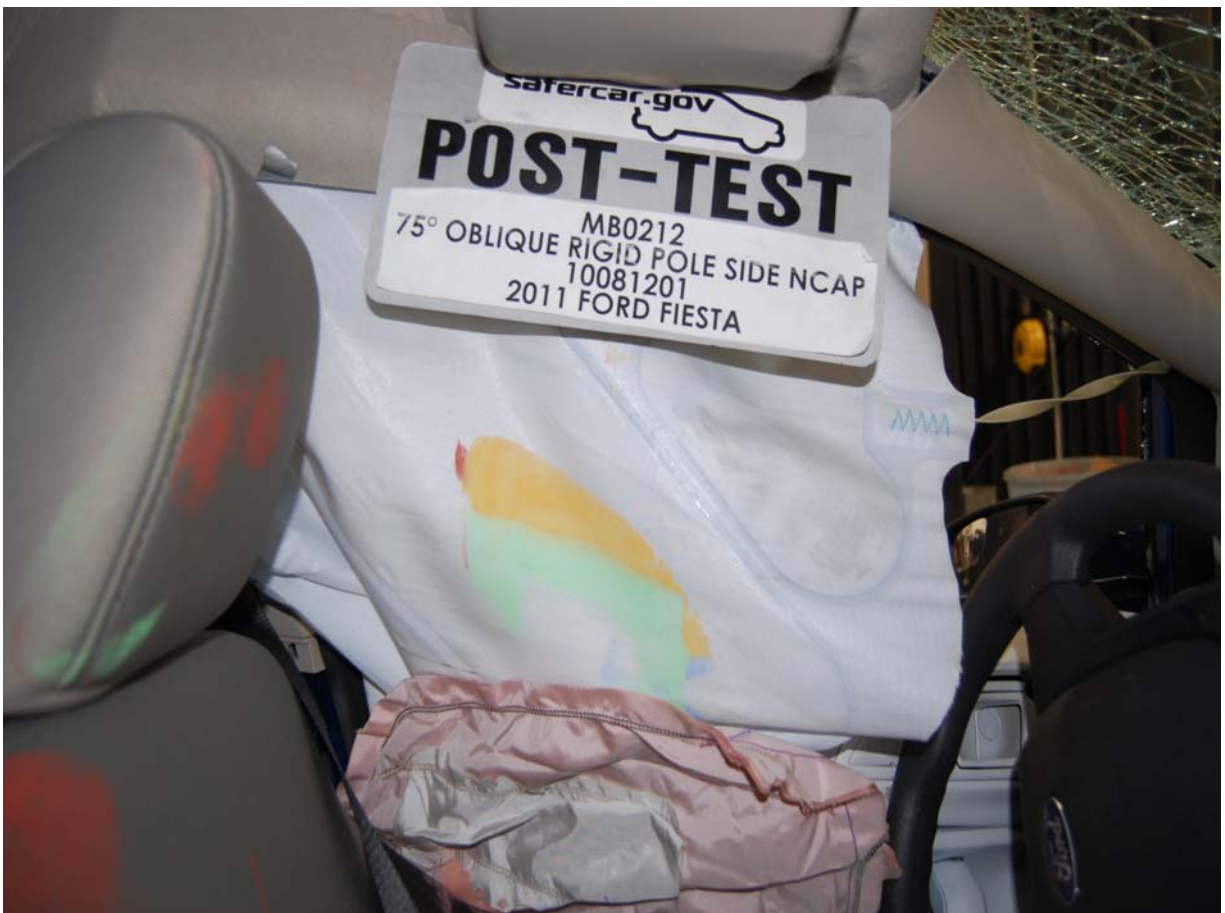
Post-Test Dummy Close-Up Head Contact with Side Airbag View

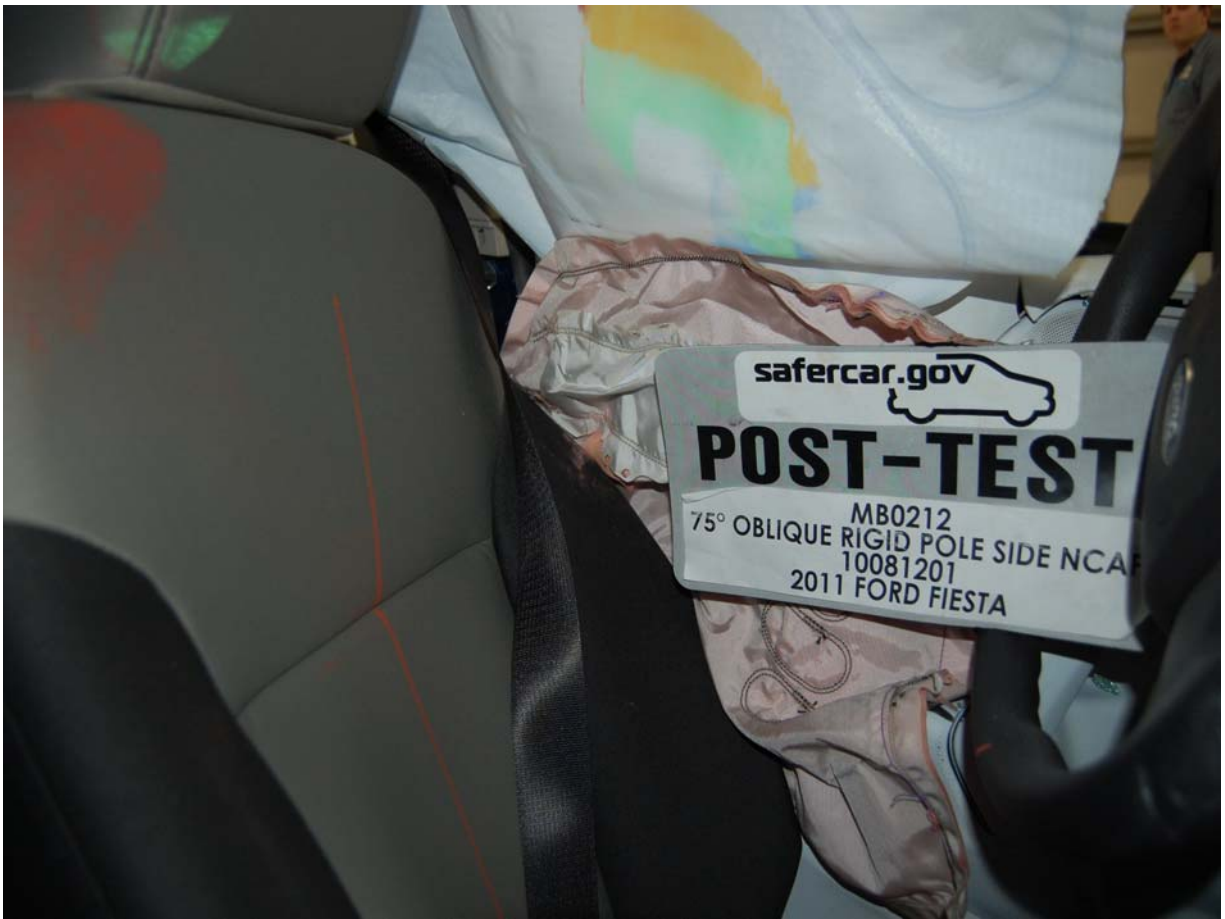
Post-Test Dummy Close-Up Torso Contact with Vehicle Interior View

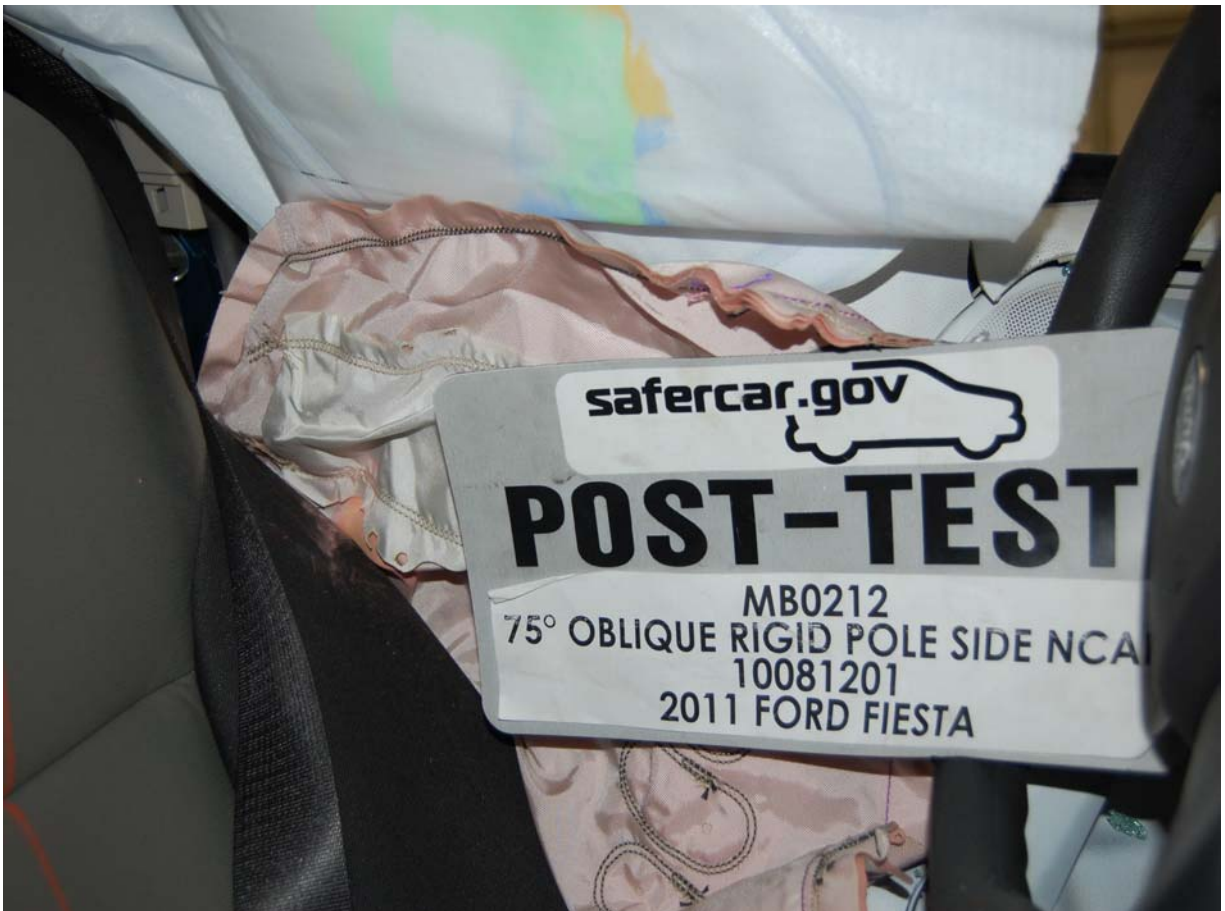
Post-Test Dummy Close-Up Torso Contact with Side Airbag View

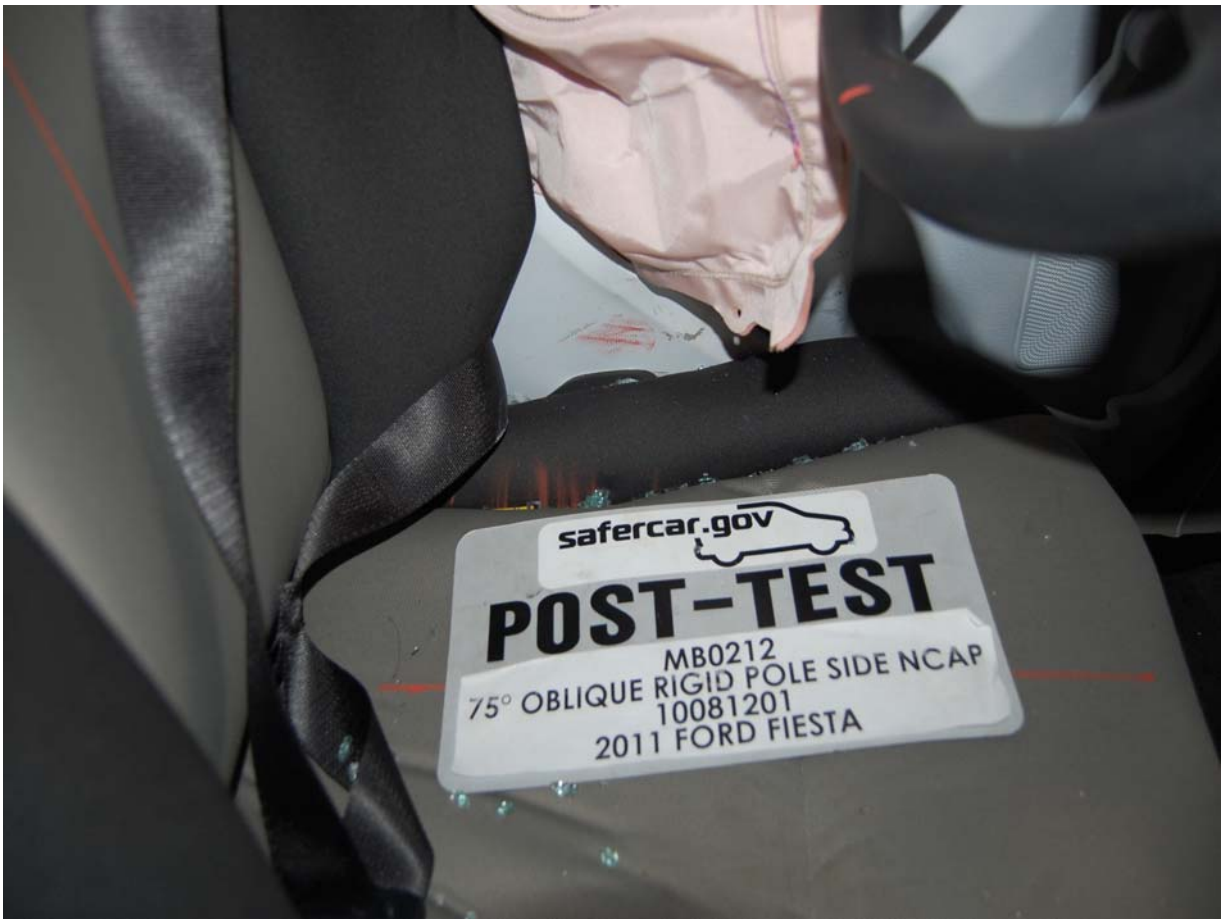
Post-Test Dummy Close-Up Pelvis Contact View

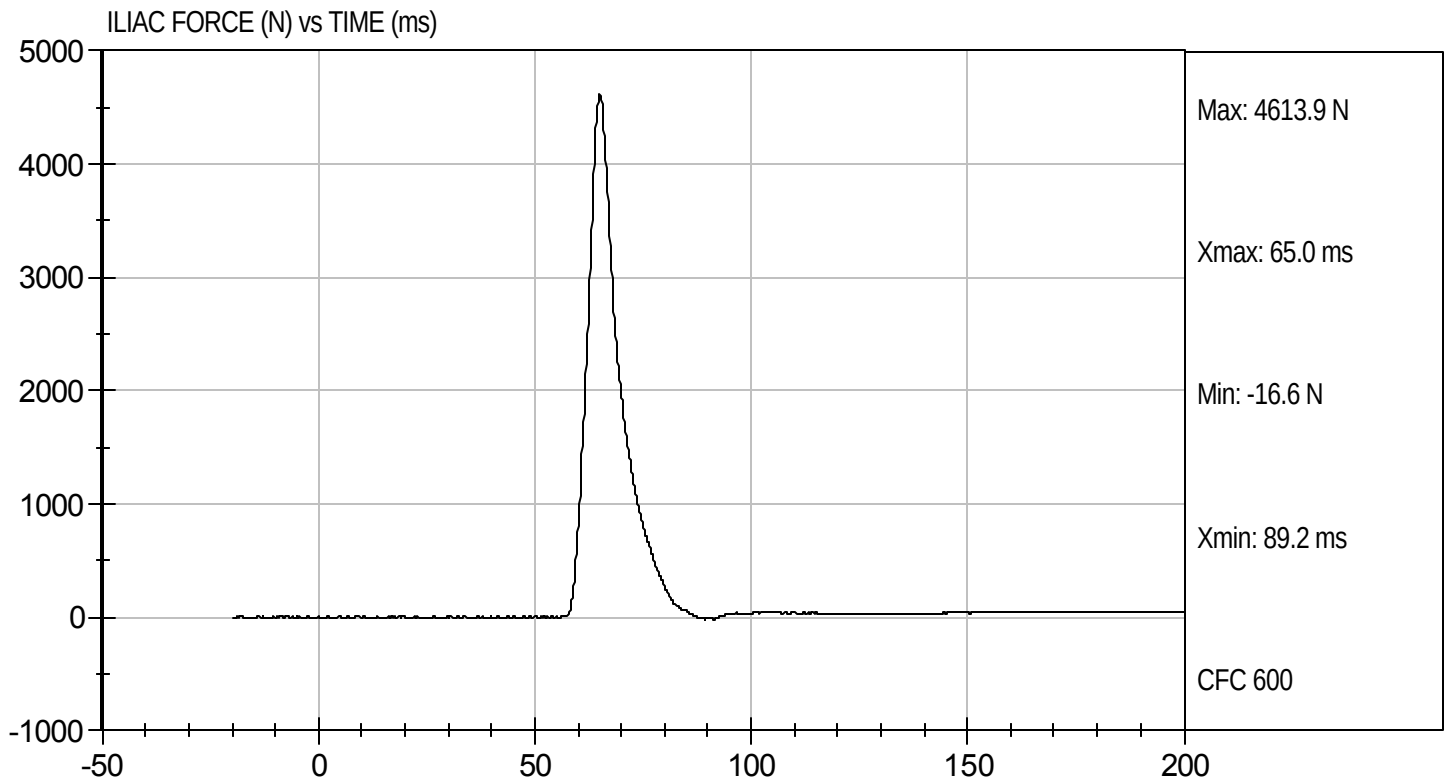
Test Desc: Iliac Impact  
Component ID: D102568

Test Date: 8/12/10  
Velocity: 14.3 ft/s, 4.36 m/s
