**REPORT NUMBER: NCAP-KAR-11-008**

**NEW CAR ASSESSMENT PROGRAM (NCAP)  
FRONTAL BARRIER IMPACT TEST**

**FUI HEAVY INDUSTRIES  
2011 SUBARU OUTBACK 2.5I AWD 5-DOOR MPV**

**FINAL REPORT**

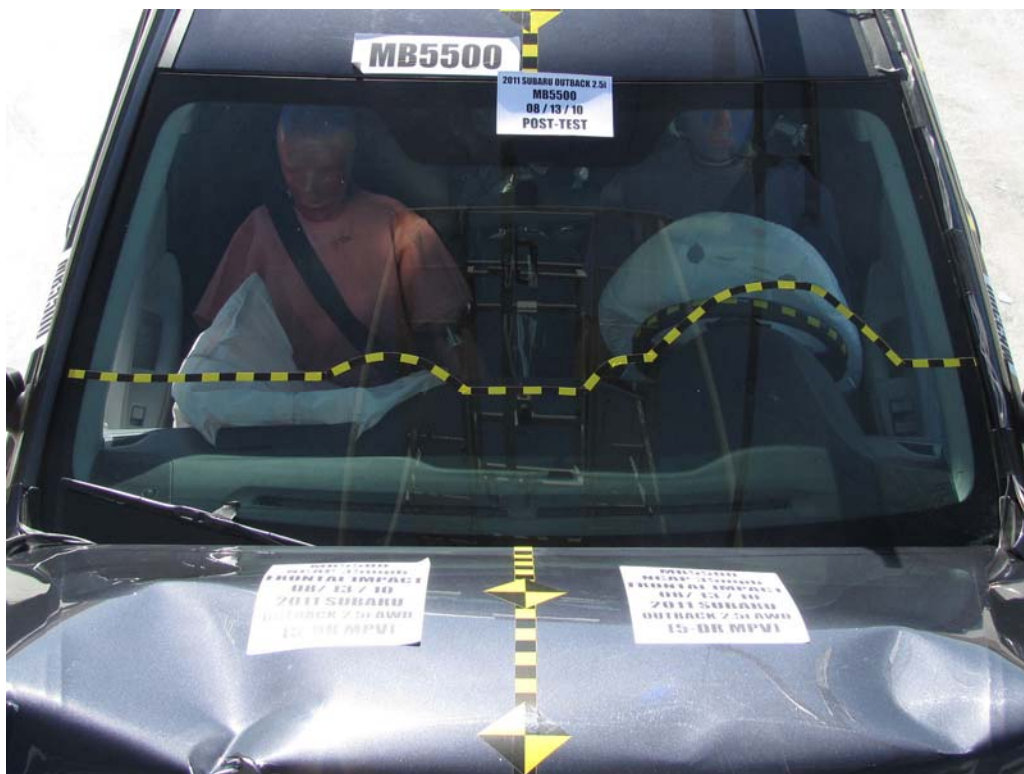
FIGURE 18. Post-Test Windshield View

There was 100% windshield retention and no intrusion into the protected zone of the windshield during the event. There was no Stoddard solvent leakage after the event or during any phase of the static rollover.

| Critical Areas of Performance | Observations and Conclusions |
|---|---|
| Windshield Damage | Cracked |

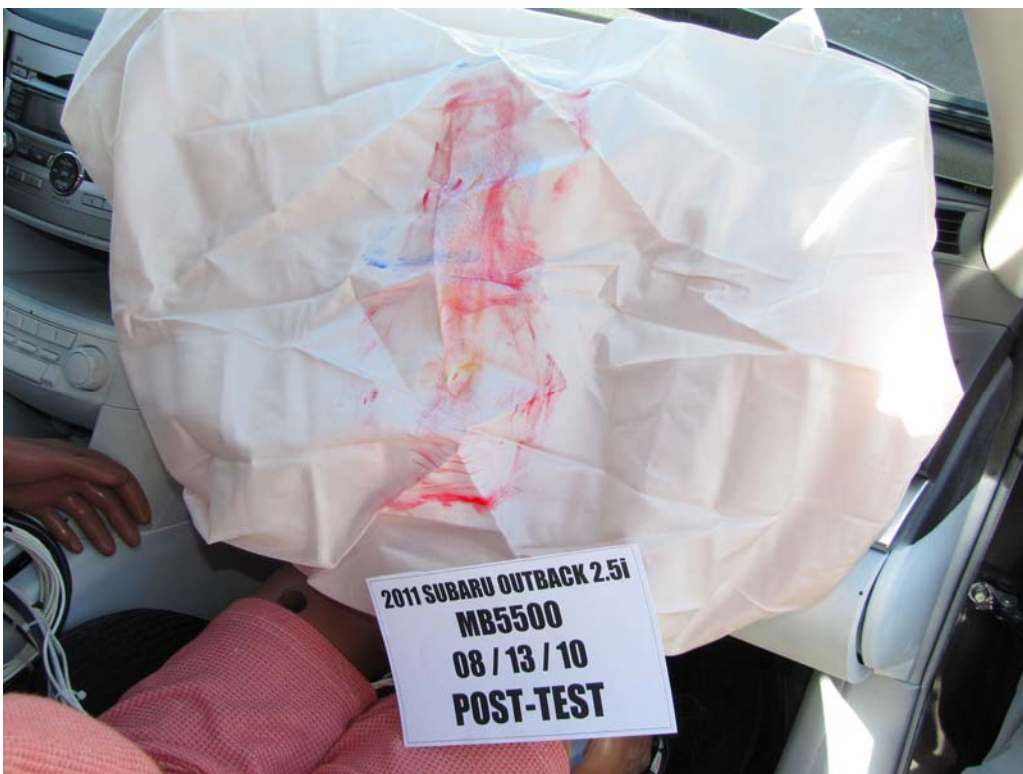
FIGURE 60. Post-Test Passenger Dummy Contact With Airbag

The passenger's visible contact points were as follows: The passenger ATD's head contacted the airbag and headrest. The upper torso contacted the airbag. Both the left and right knees contacted the glovebox.
