REPORT NUMBER: NCAP-MGA-2011-012

**NEW CAR ASSESSMENT PROGRAM (NCAP)
Frontal Barrier Impact Test**

**NISSAN MOTOR COMPANY, LTD.
2011 Infiniti M37X AWD
NHTSA No.: MB5205**

**MGA RESEARCH CORPORATION
5000 Warren Road
Burlington, WI 53105**

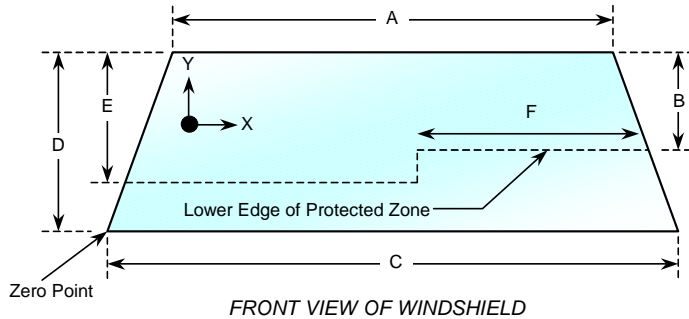
WINDSHIELD PERIPHERY MEASUREMENTS

Measurement	Pre-Test (mm)	Post-Test (mm)	% of Retention
Left Side	2152	2152	100
Right Side	2152	2152	100
Total	4304	4304	100

Item	Units	Value
A	mm	1231
B	mm	367
C	mm	1409
D	mm	832
E	mm	458
F	mm	525

AREA OF PROTECTED ZONE FAILURES - NONE

There was 100 percent windshield retention and no intrusion into the protected zone of the windshield during the event. There was no Stoddard Solvent leakage after the event or during any phase of the static rollover.

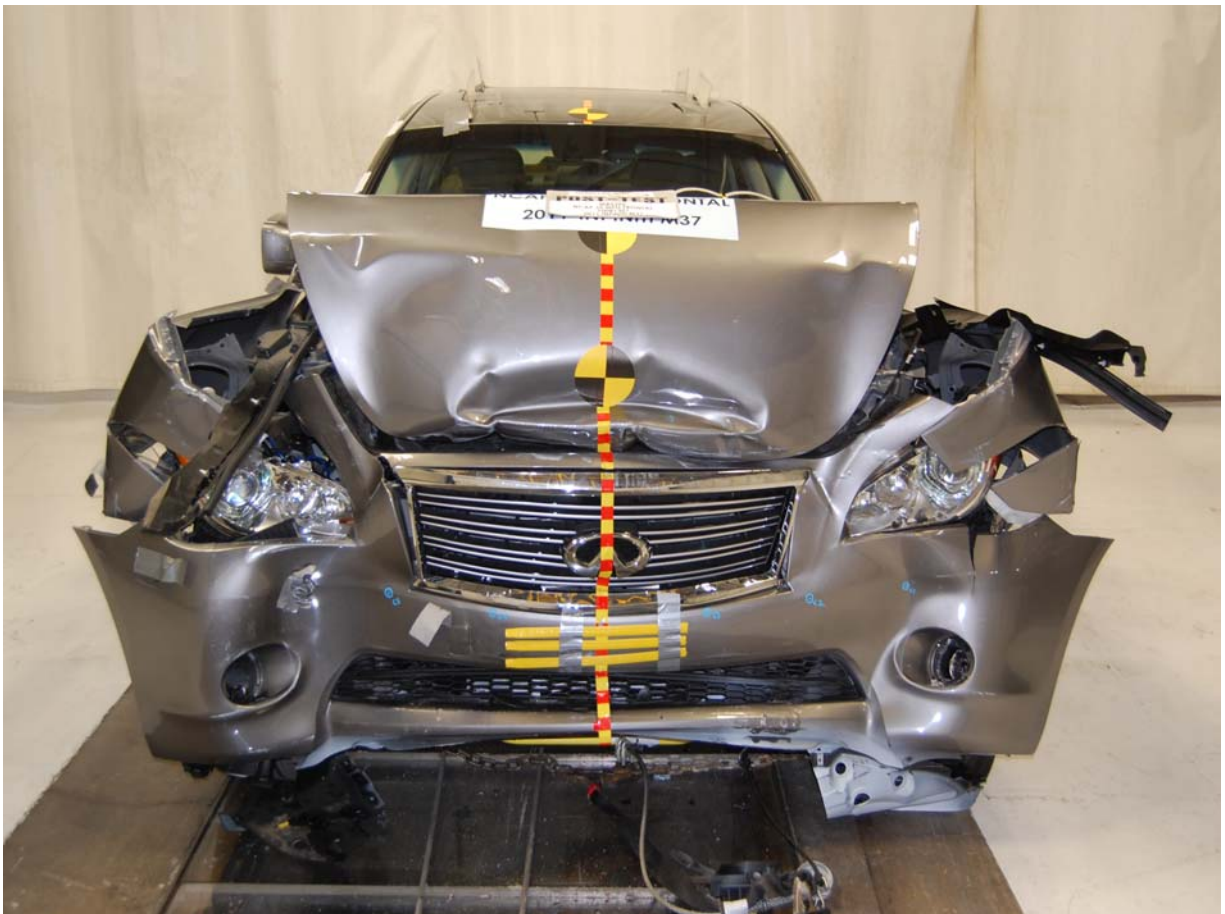
Post-Test Front View

The maximum static crush of the vehicle was 492 mm and both the driver and passenger side doors remained closed during the impact event and were operable after the impact.

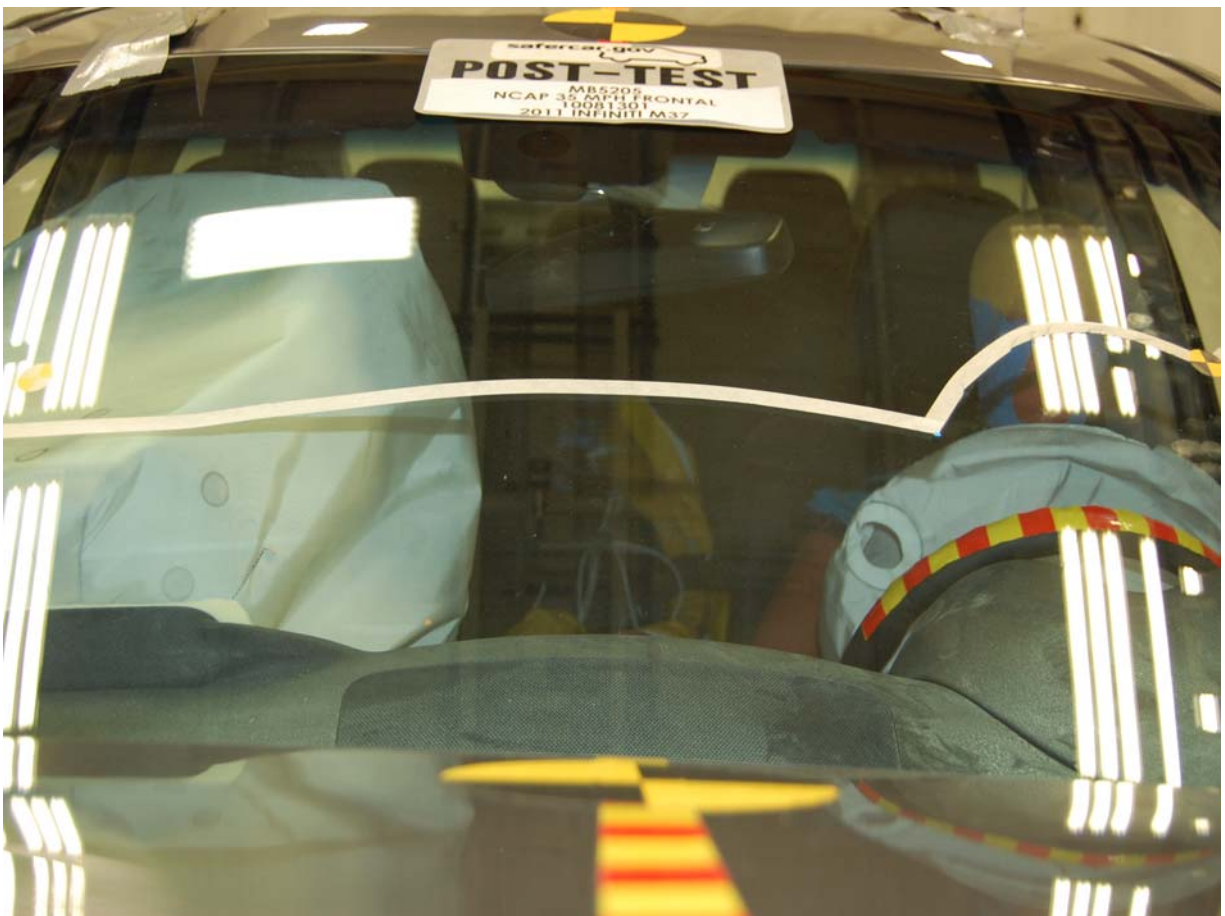
Post-Test Windshield View

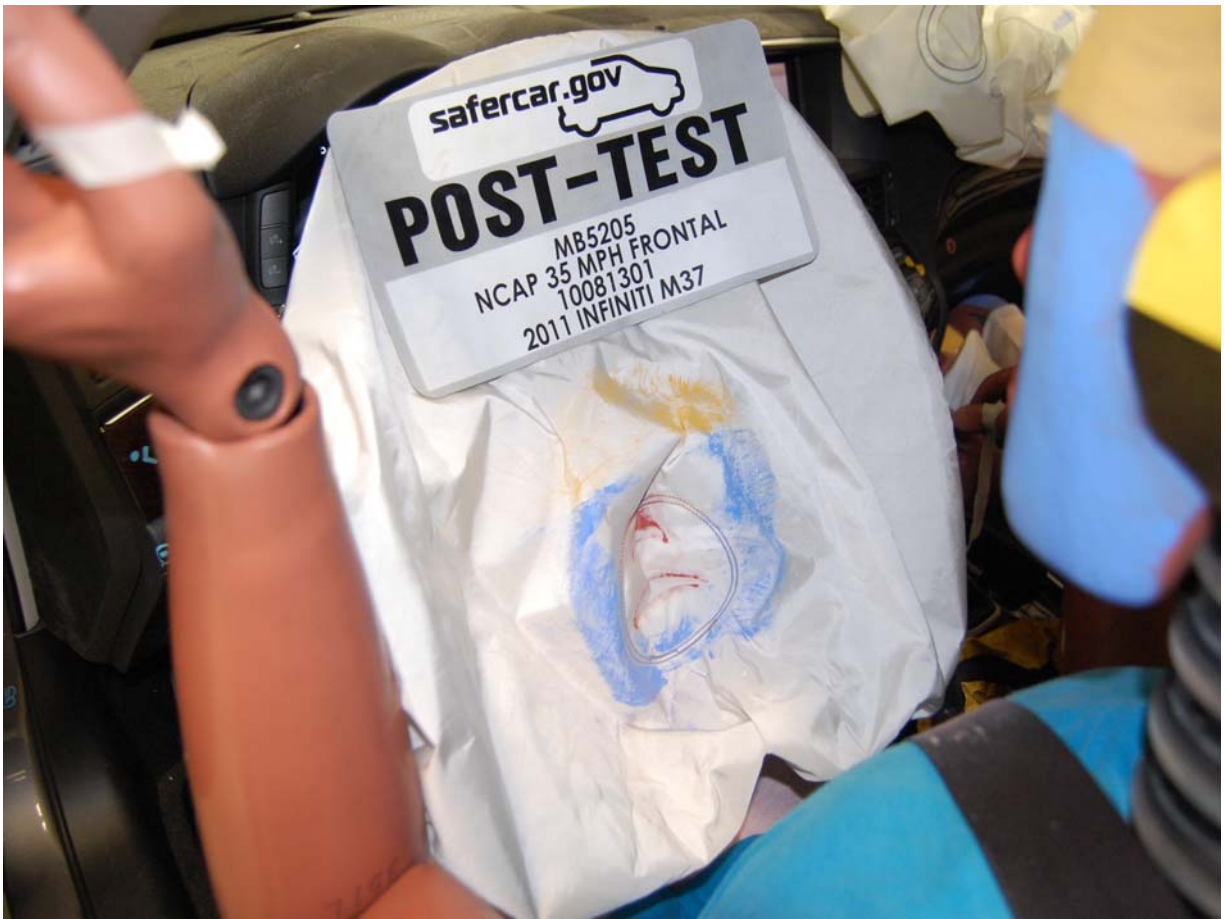
Post-Test Driver Dummy Airbag Contact

The driver's head and chest contacted the airbag. The driver's head also contacted the side header and headrest. The driver's knees contacted the knee bolster. The passenger's head and chest contacted the airbag. The passenger's head also contacted the headrest. The passenger's knees contacted the glove box.

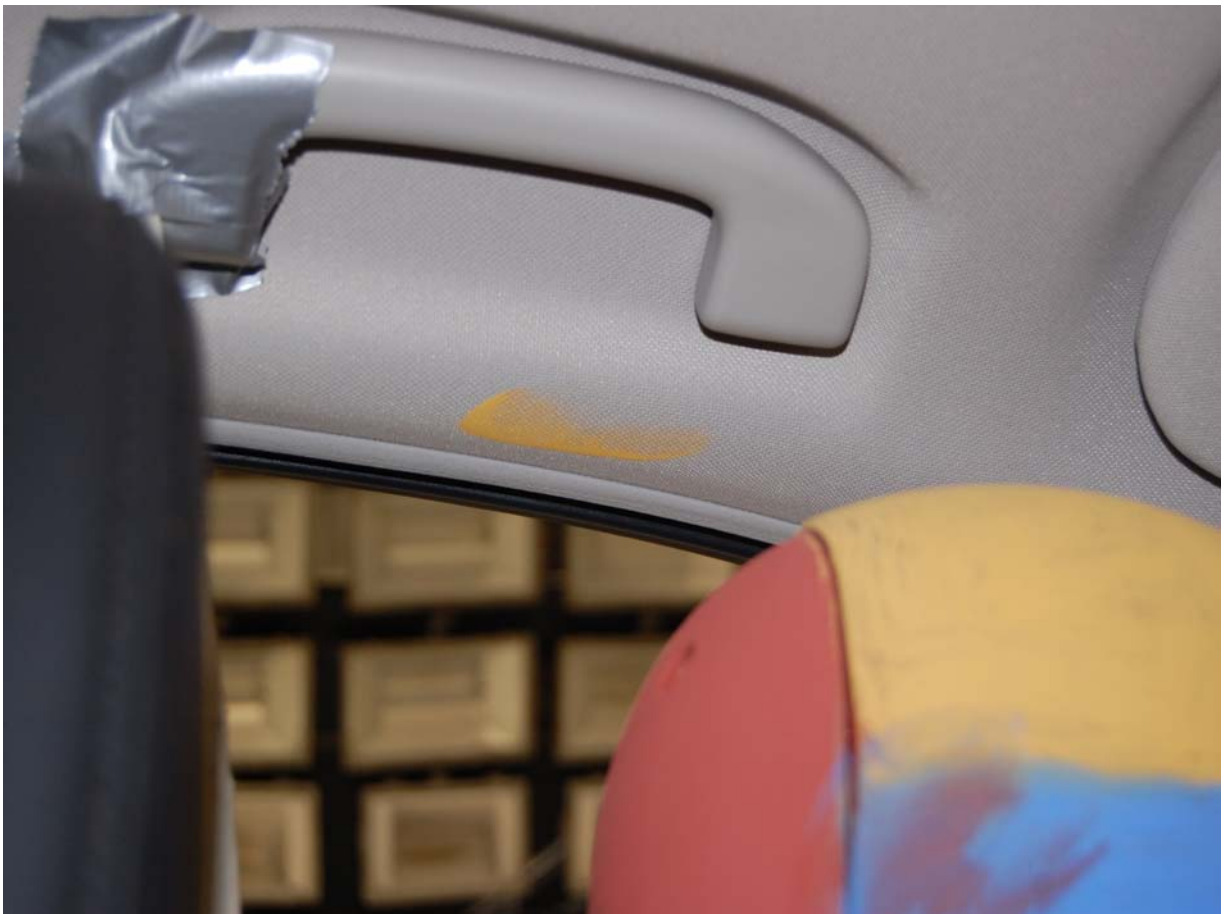
Post-Test Driver Dummy Side Header Contact

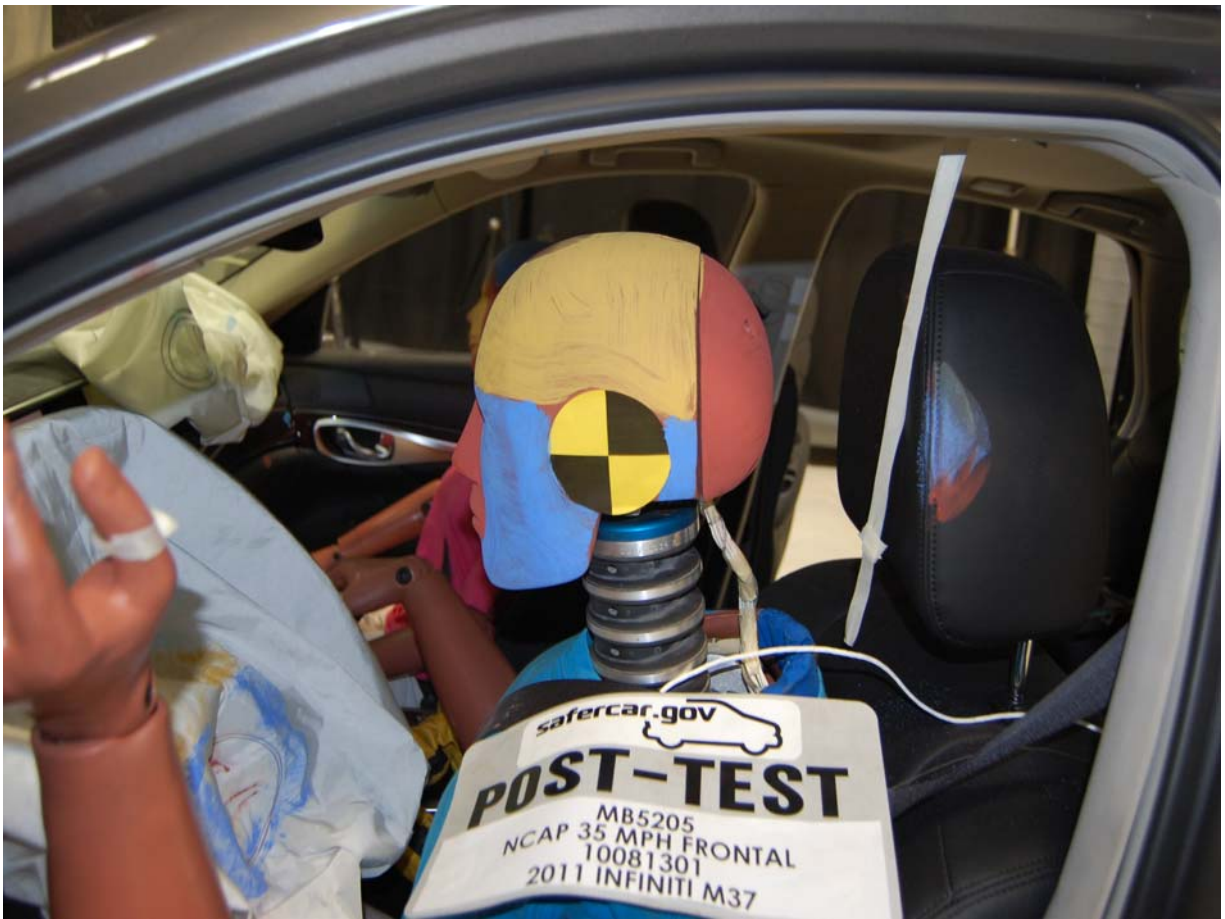
Post-Test Driver Dummy Headrest Contact

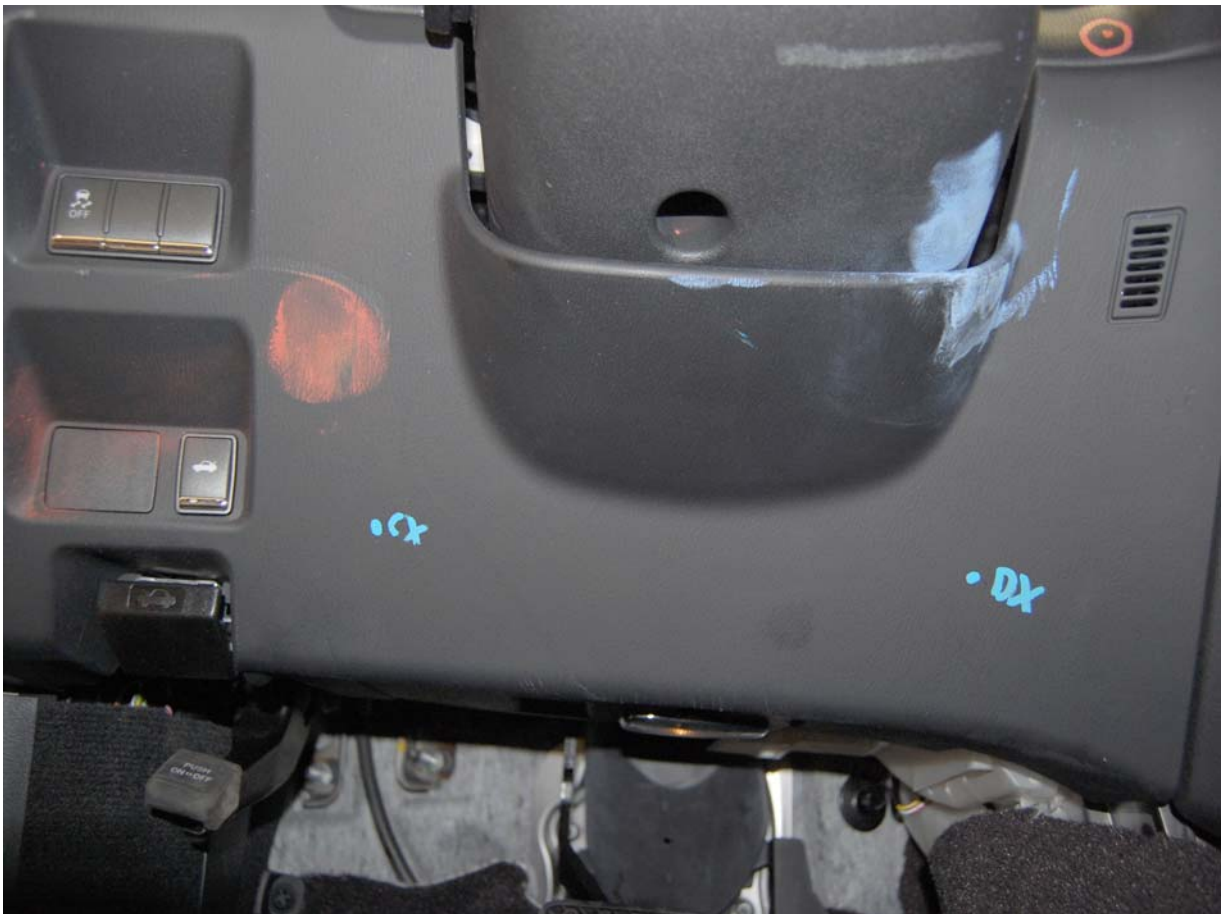
Post-Test Driver Dummy Knee Bolster Contact

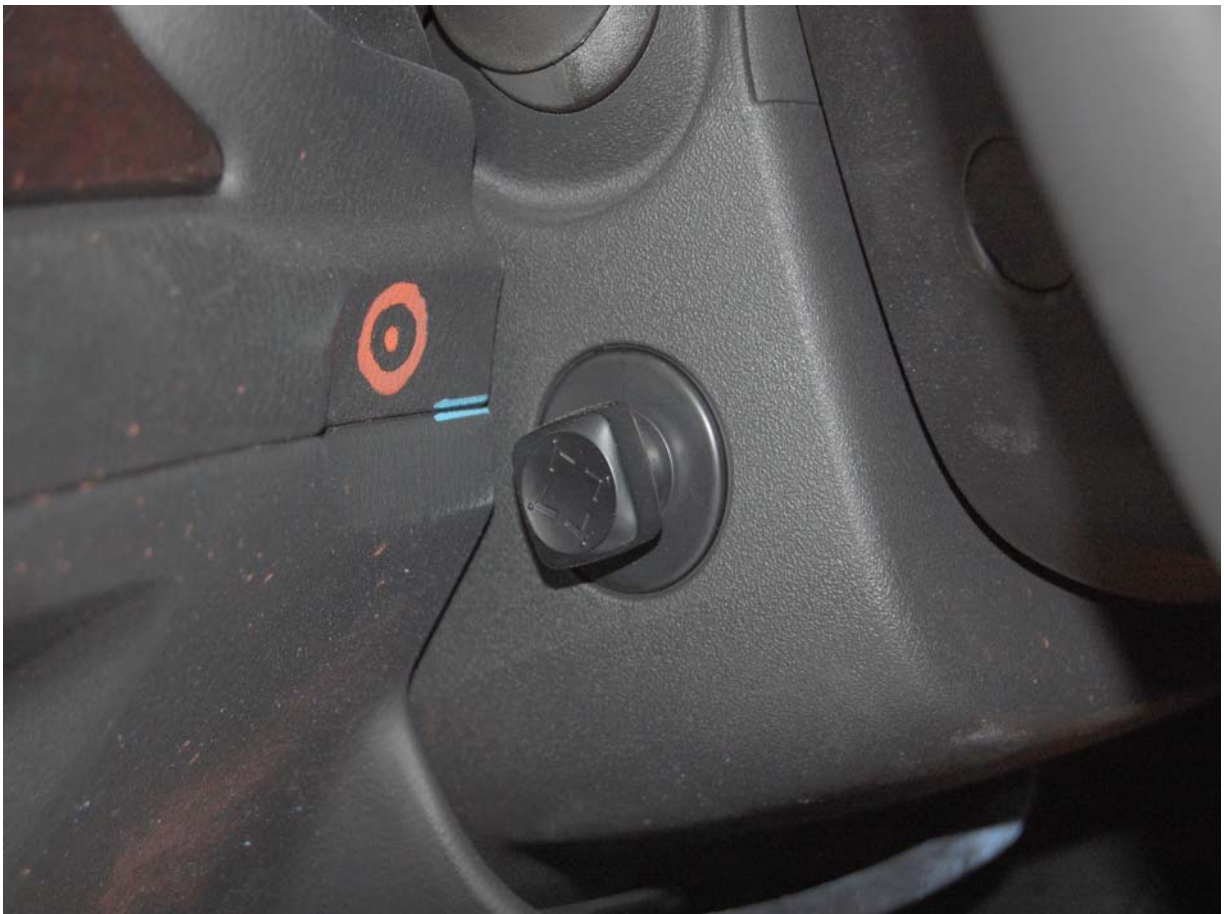
Post-Test View of Steering Column Shear Capsule

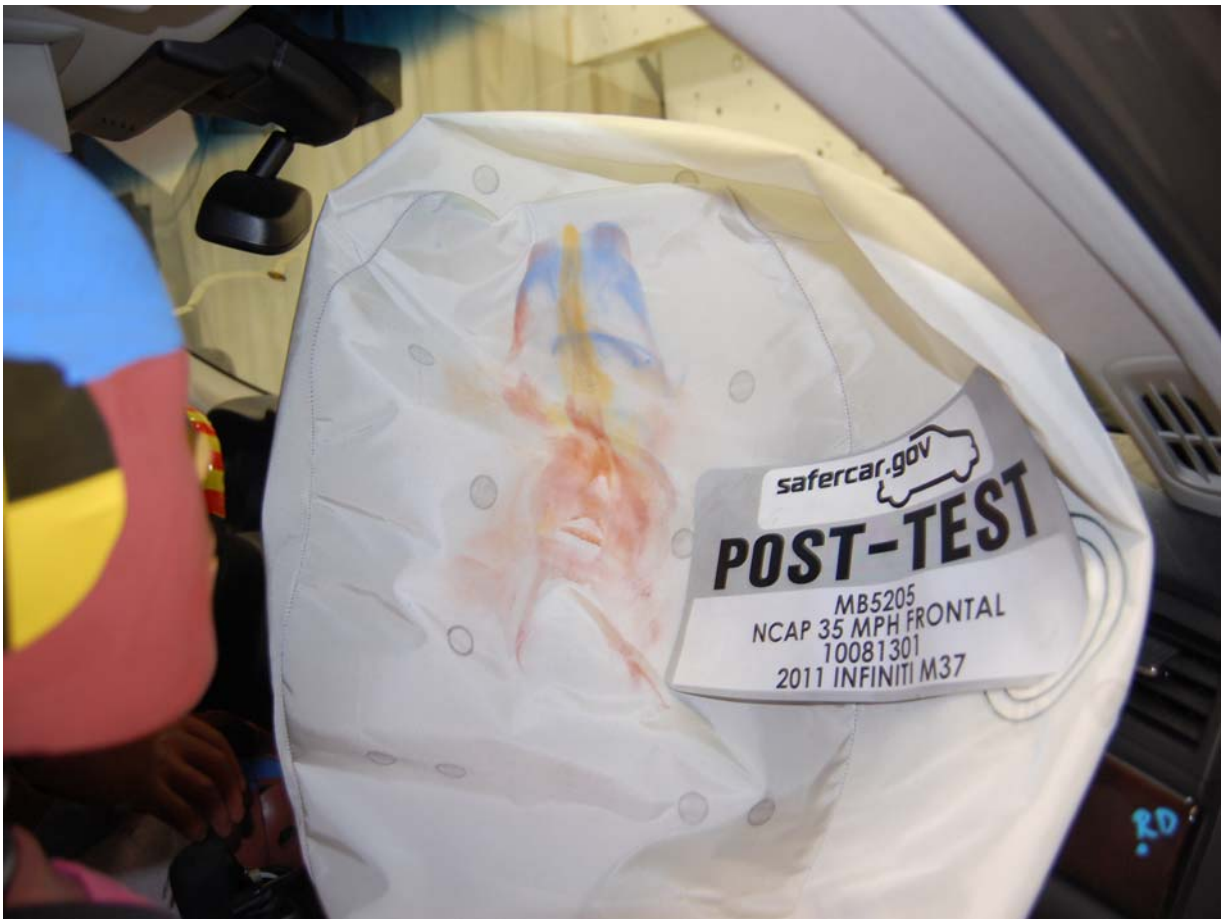
Post-Test Passenger Dummy Airbag Contact

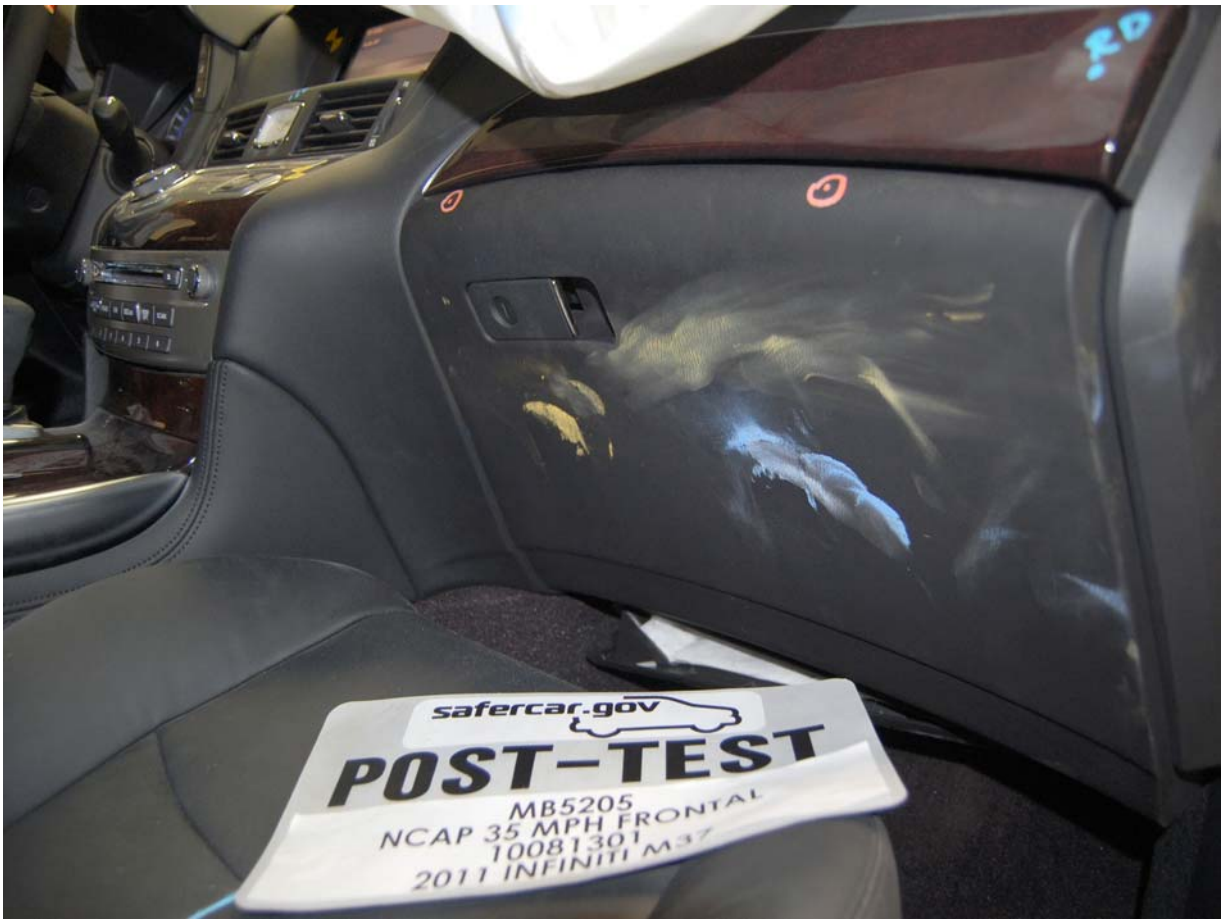
Post-Test Passenger Dummy Glovebox Contact
