**REPORT NUMBER: NCAP-KAR-11-009**

**NEW CAR ASSESSMENT PROGRAM (NCAP)  
FRONTAL BARRIER IMPACT TEST**

**NISSAN MOTOR CO., LTD.  
2011 NISSAN VERSA 4-DOOR SEDAN**

**FINAL REPORT**

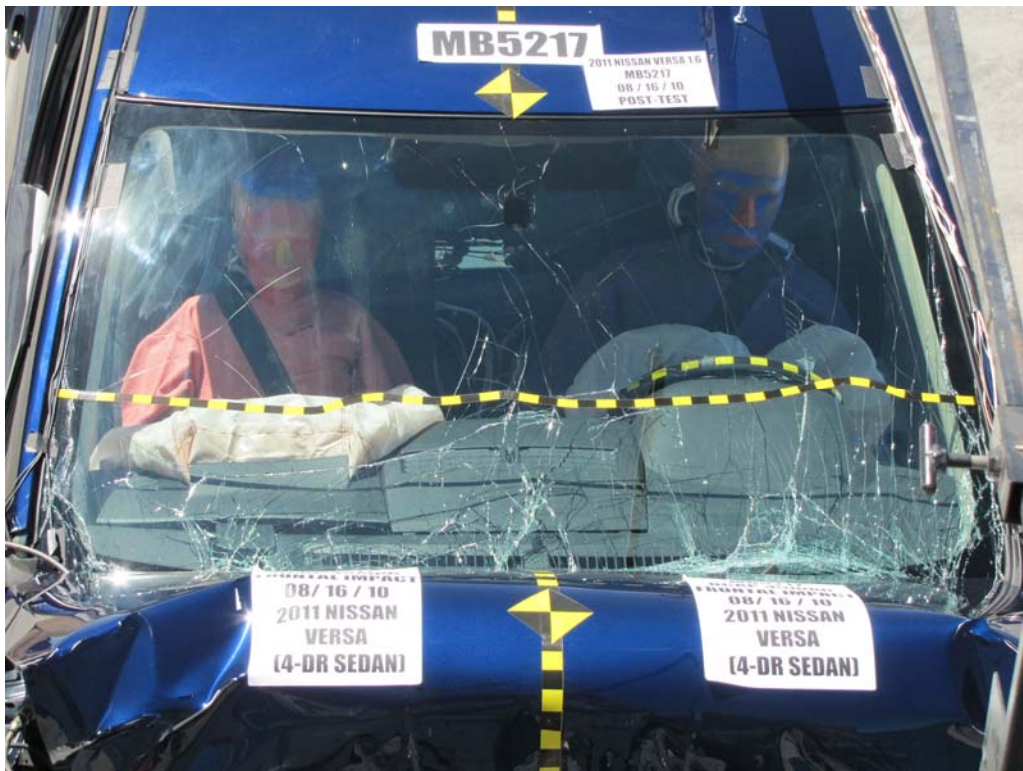
FIGURE 18. Post-Test Windshield View

There was 100% windshield retention and no intrusion into the protected zone of the windshield during the event. There was no Stoddard solvent leakage after the event or during any phase of the static rollover.

| Critical Areas of Performance | Observations and Conclusions |
|---|---|
| Windshield Damage | Broken, Lower Separation |

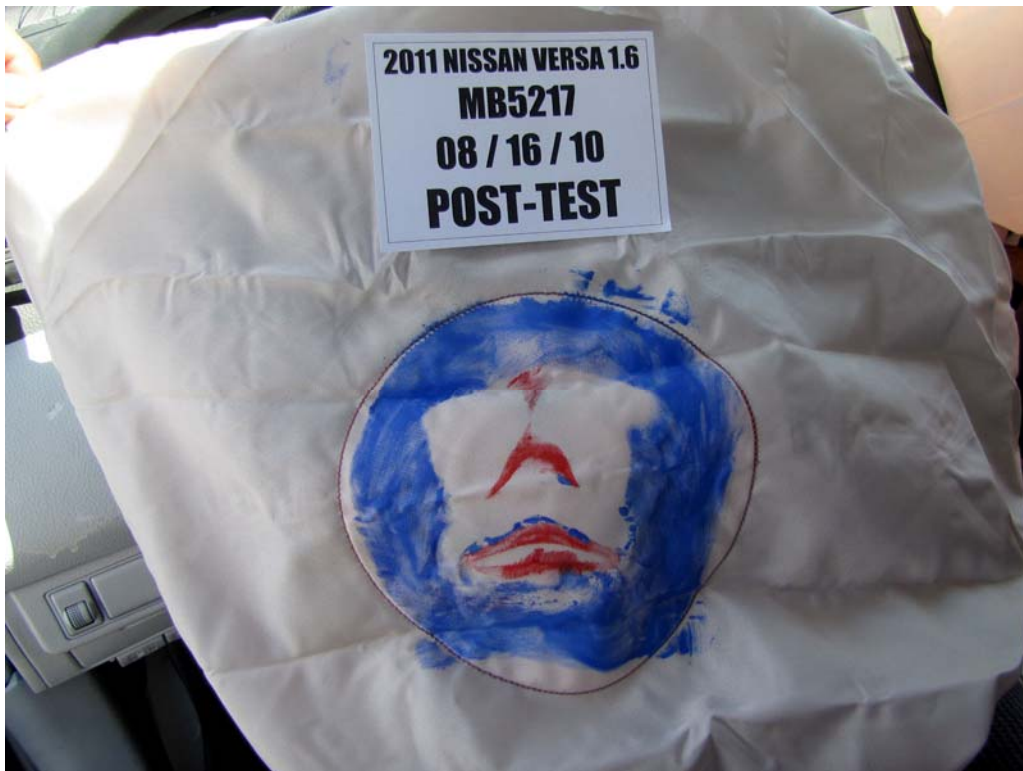
FIGURE 43. Post-Test Driver Dummy Contact With Airbag

The driver's visible contact points were as follows: The driver ATD's head contacted the airbag and the headrest. The upper torso contacted the airbag. Both the left and right knees contacted the knee bolster.

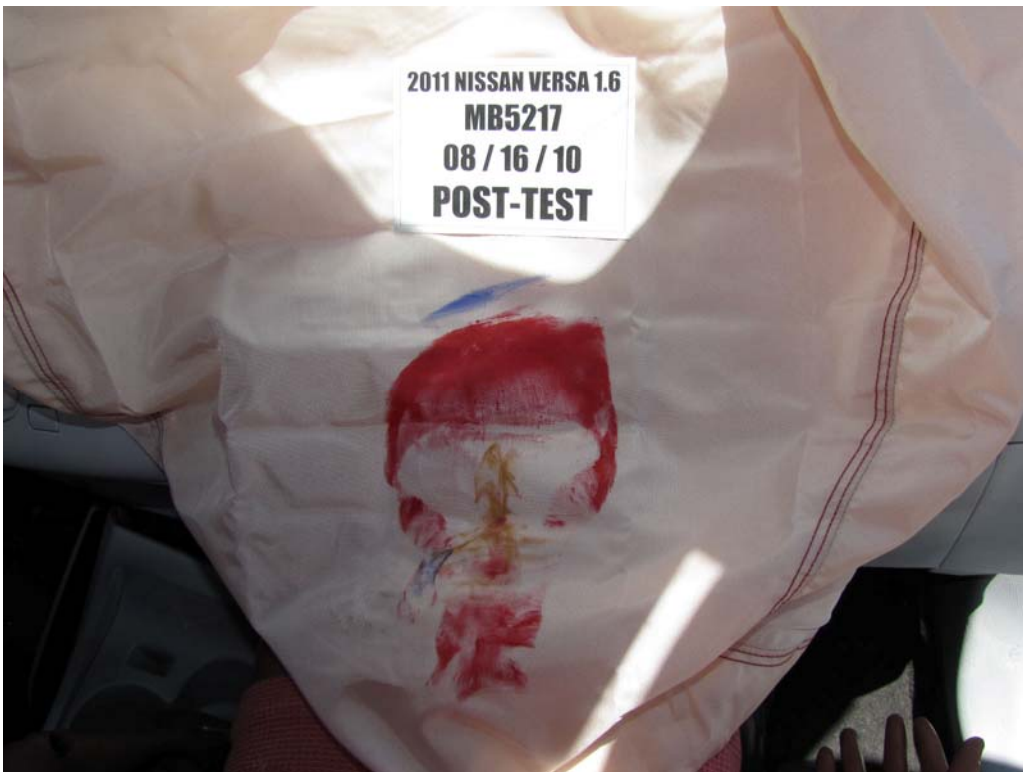
FIGURE 60. Post-Test Passenger Dummy Contact With Airbag

The passenger's visible contact points were as follows: The passenger ATD's head contacted the airbag and headrest. The upper torso contacted the airbag. Both the left and right knees contacted the glovebox.

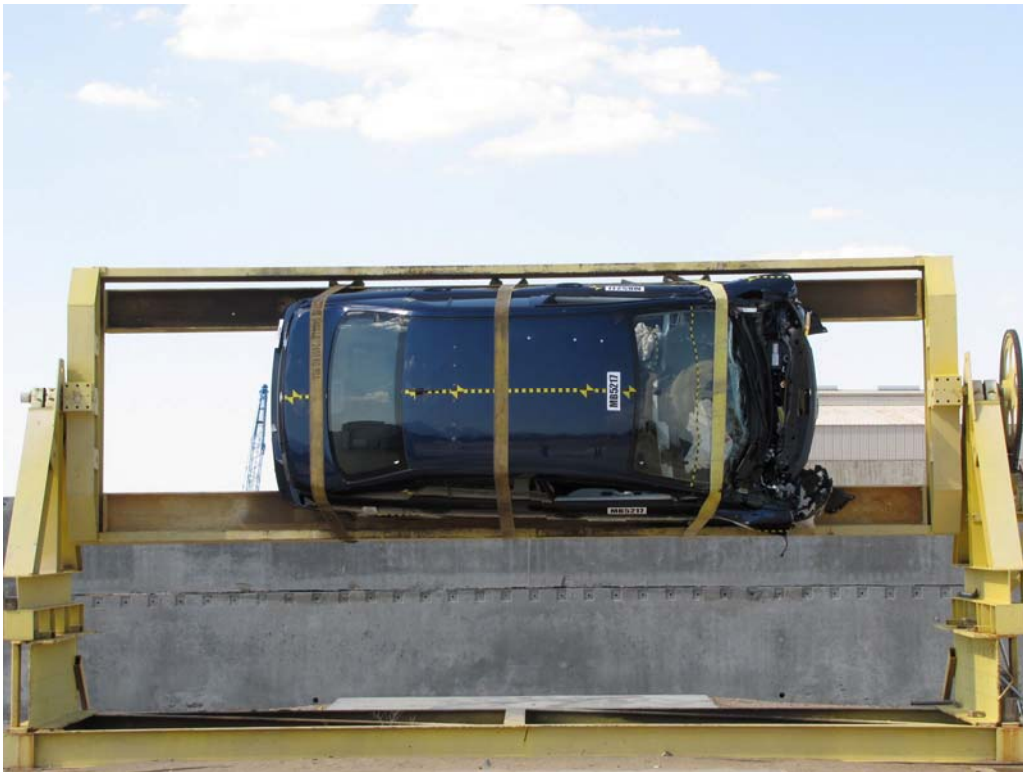
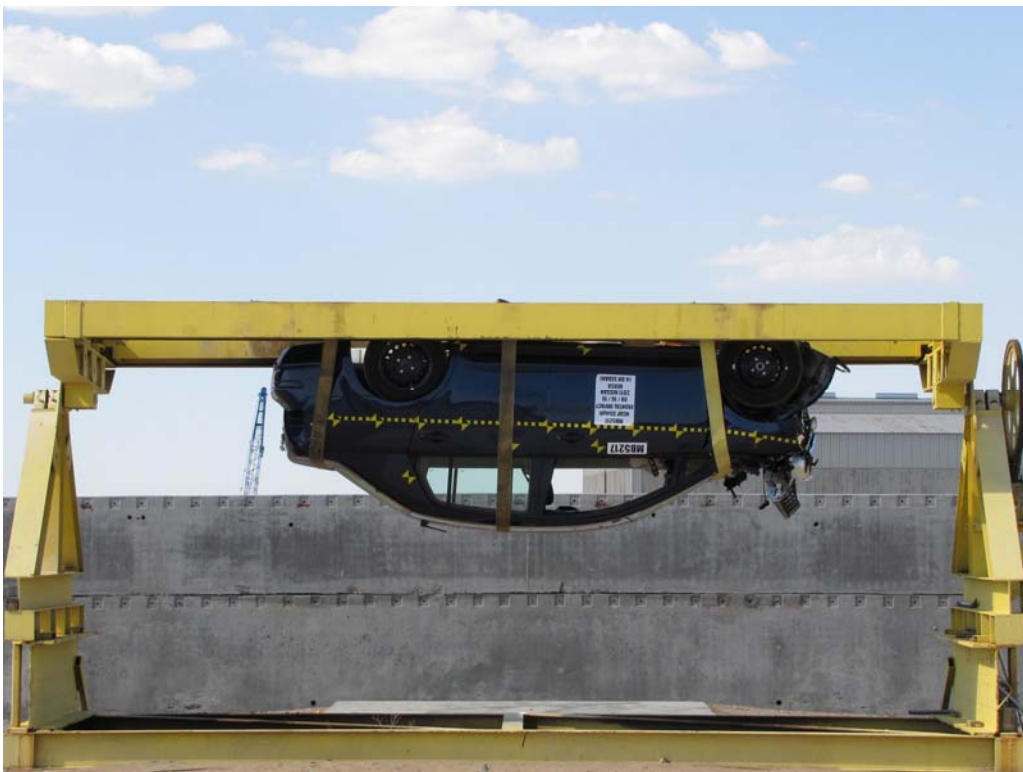
FIGURE 64. Vehicle at 0° on Static Rollover Device

FIGURE 65. Vehicle at 90°on Static Rollover Device

FIGURE 66. Vehicle at 180°on Static Rollover Device

FIGURE 67. Vehicle at 270°on Static Rollover Device

FIGURE 68. Vehicle at 360°on Static Rollover Device
