**REPORT NUMBER: NCAP-CAL-11-011**

**NEW CAR ASSESSMENT PROGRAM (NCAP)  
FRONTAL BARRIER IMPACT TEST**

**General Motors Corp.  
2011 Chevrolet Malibu 1LS  
4-Door Sedan**

**FINAL REPORT**

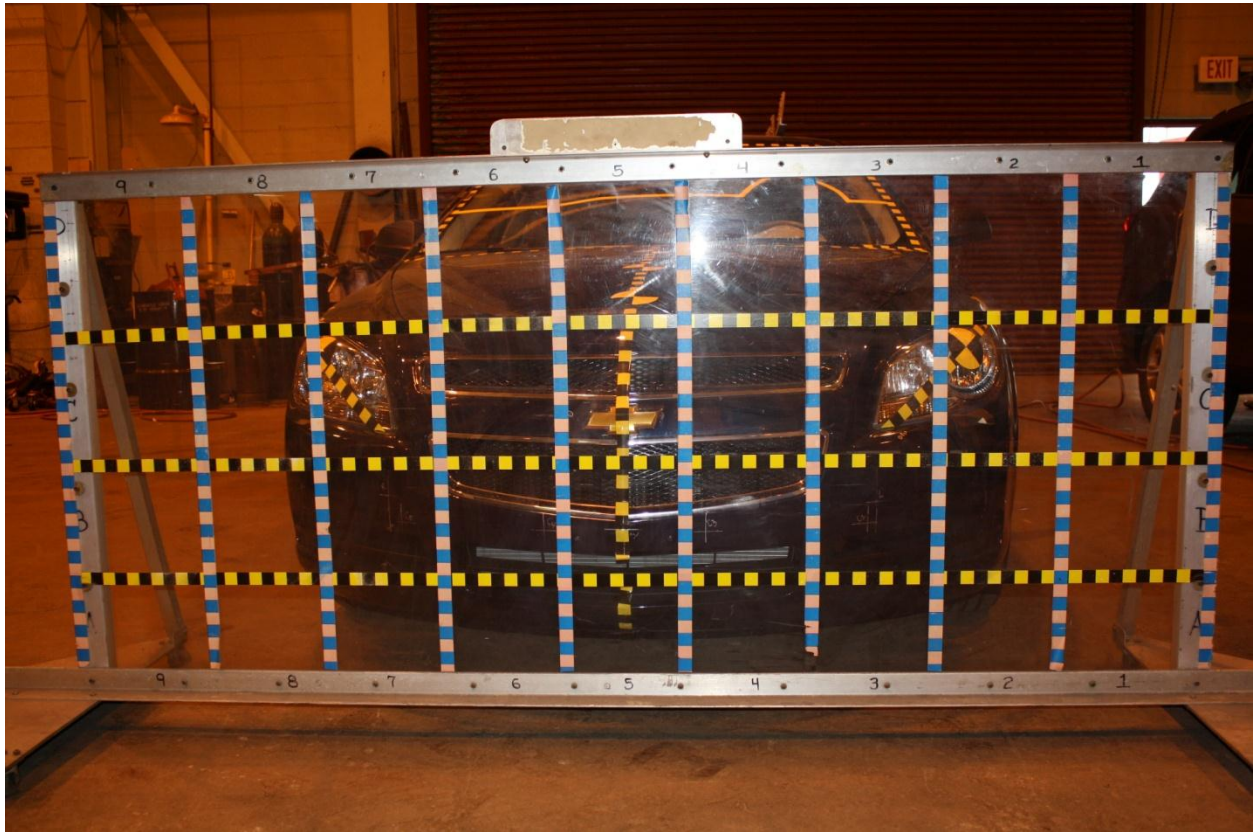
**Figure A-1: Load Cell Location**

A load cell barrier consisting of 36 load cells was impacted by a 2011 Chevrolet Malibu 4-Door Sedan at a velocity of 56.5 kph. The test was performed at Calspan on August 25, 2010. Pre- and post-test photographs of the vehicle and dummies can be found in Appendix A.

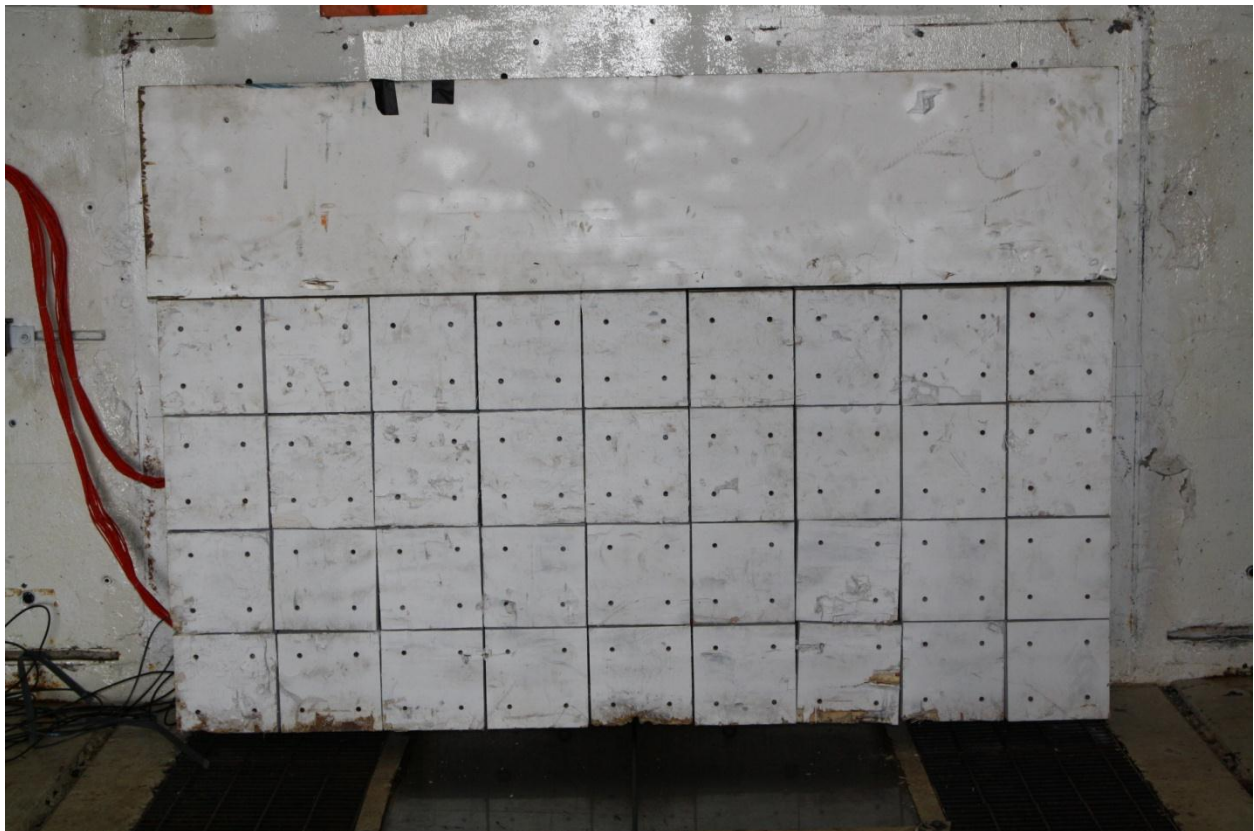
**Figure A-2: Load Cell Wall**

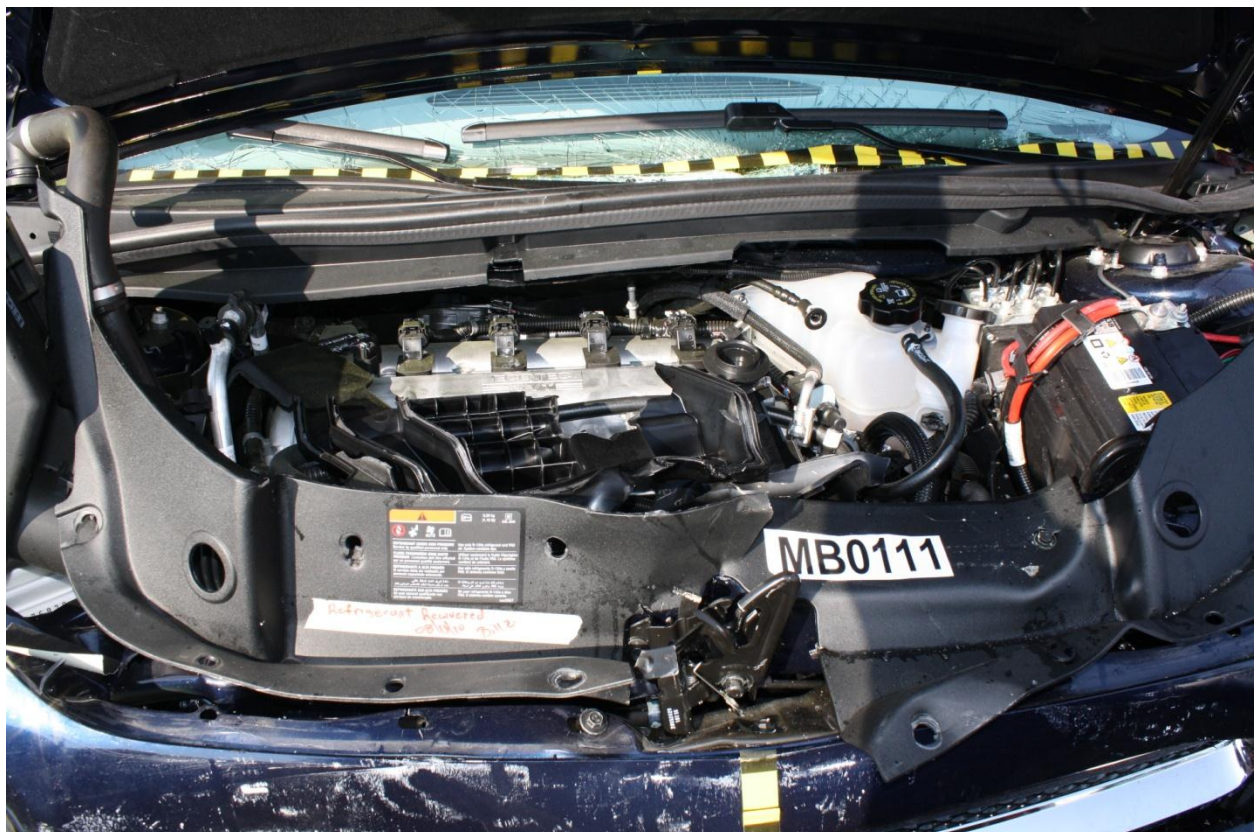
**Figure A-20: Post-Test Engine Compartment View**

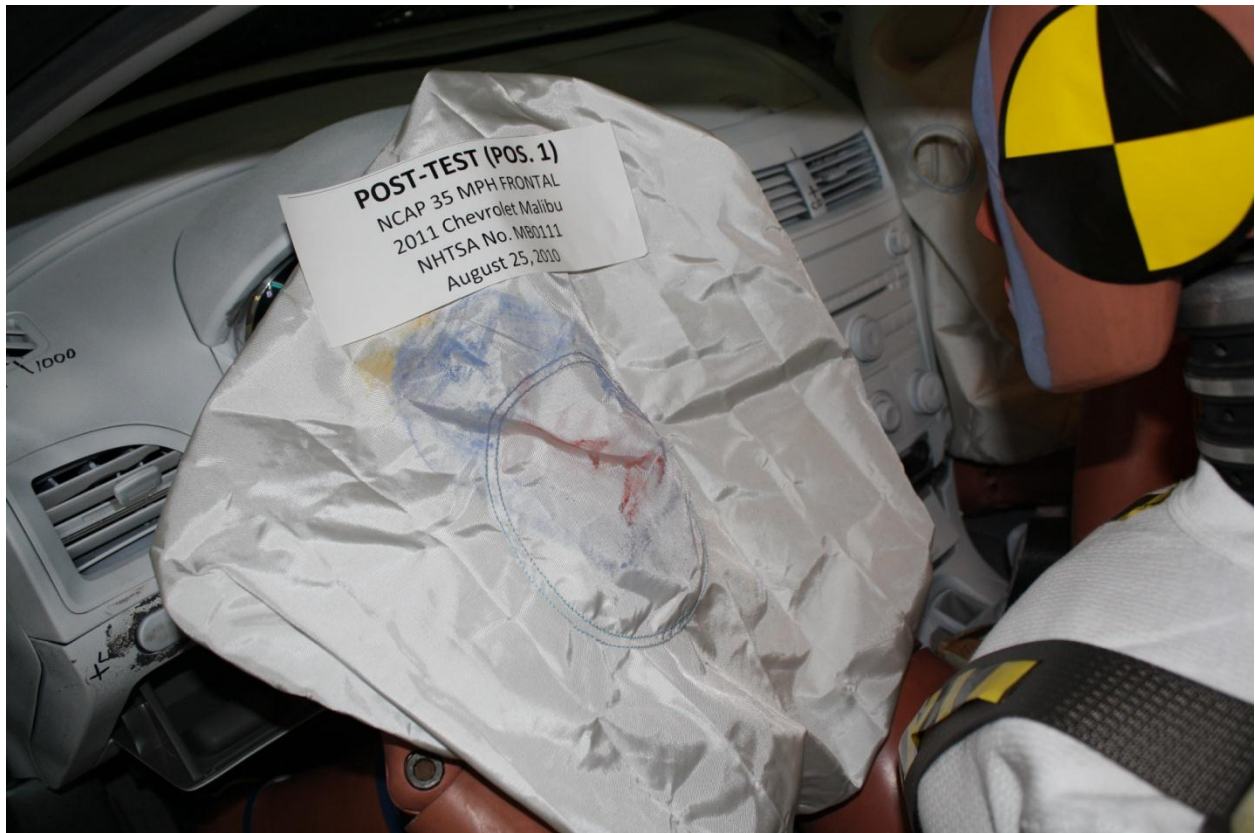
**Figure A-43: Post-Test Driver Dummy Contact with Airbag**

The driver's visible contact points were as follows: Face and Upper Torso with Frontal airbag with the back of head with the head restraint; both knees contacted the knee bolster. The passenger's visible contact points were as follows: Face and Upper Torso with Frontal airbag with the back of head with the head restraint; both knees contacted the glovebox door.

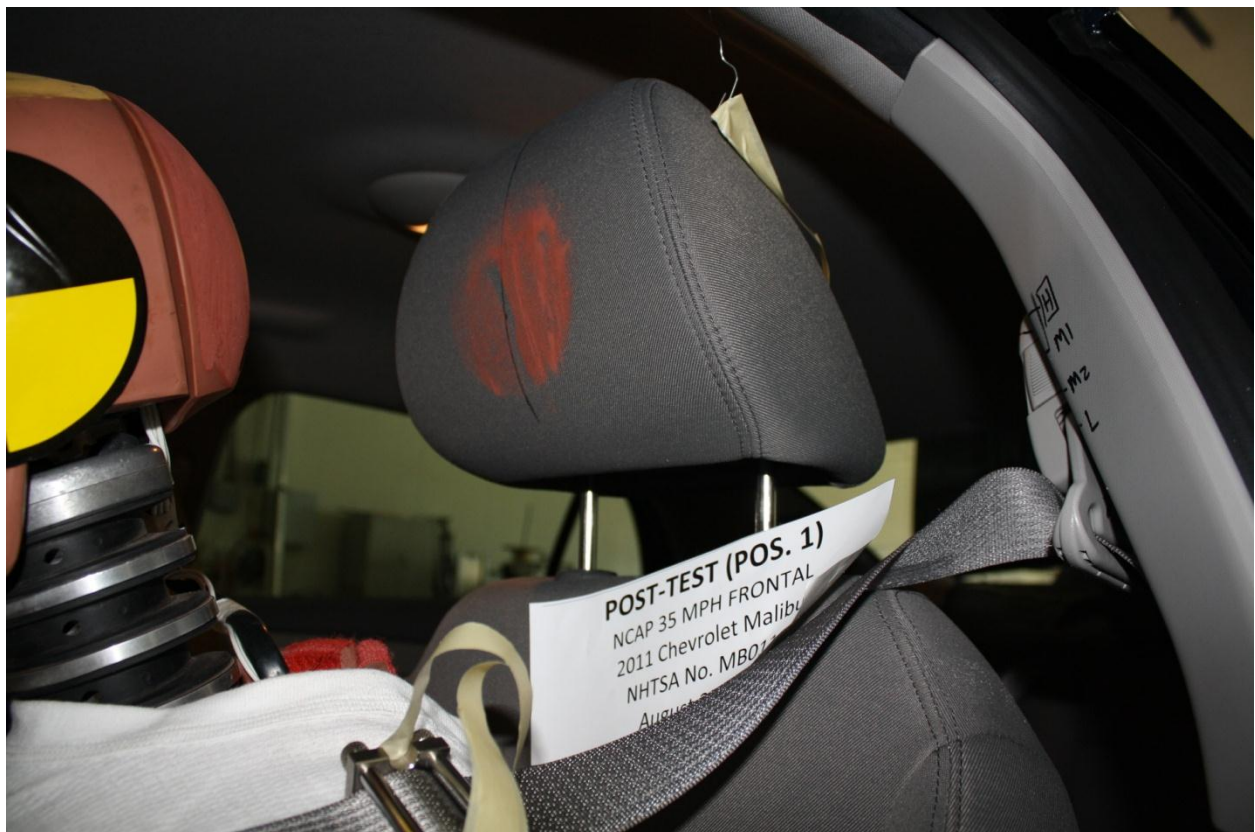
**Figure A-43a: Post-Test Driver Dummy Contact with Head Restraint**

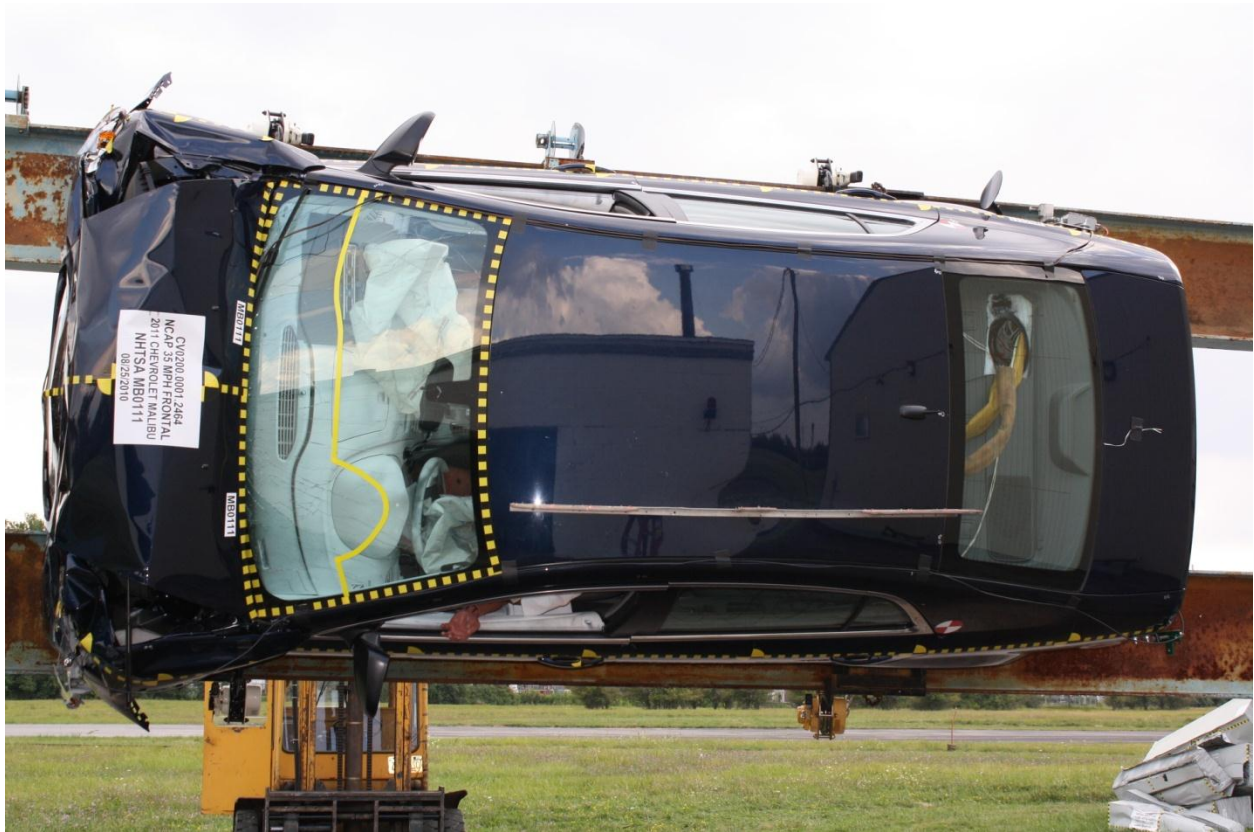
**Figure A-65: Vehicle at 90° on Static Rollover Device**

There was 100 percent windshield retention and no intrusion into the protected zone of the windshield during the event. There was no Stoddard solvent leakage after the event or during any phase of the static rollover.

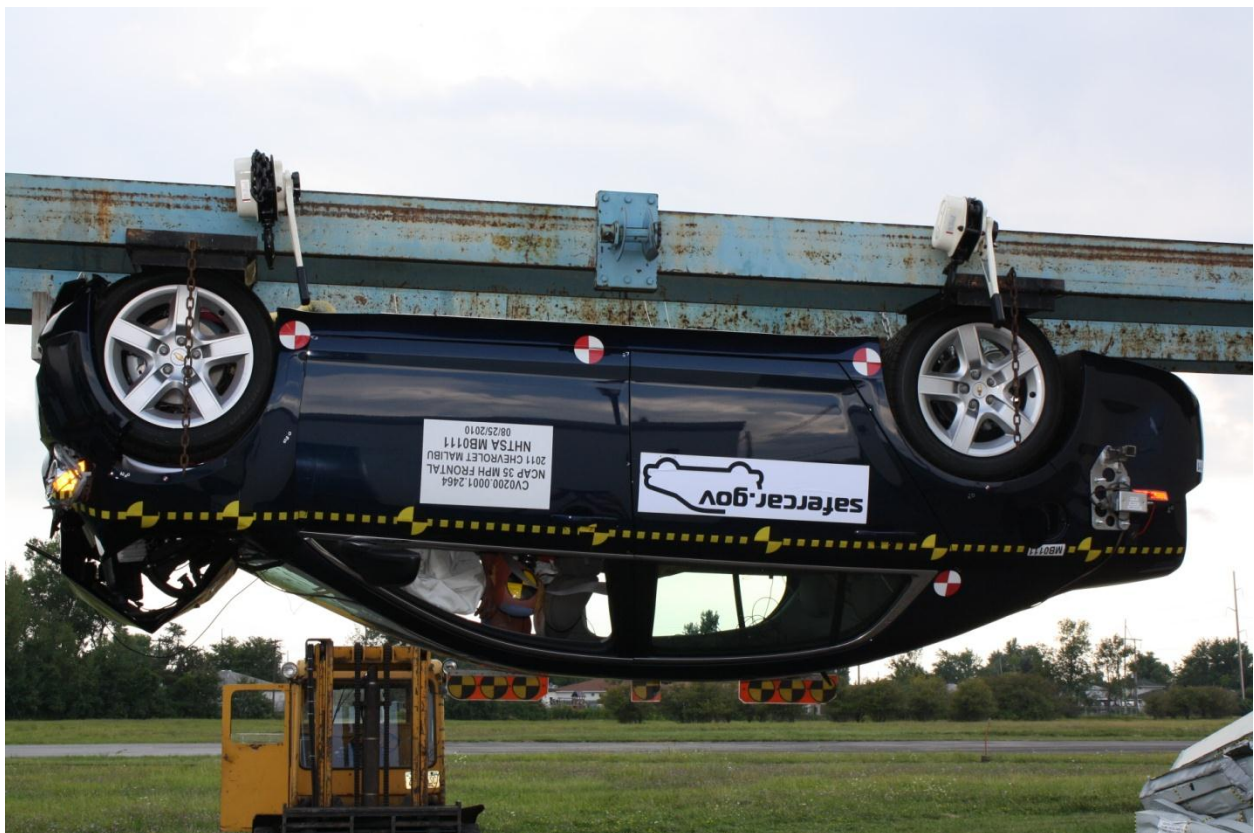
**Figure A-66: Vehicle at 180° on Static Rollover Device**

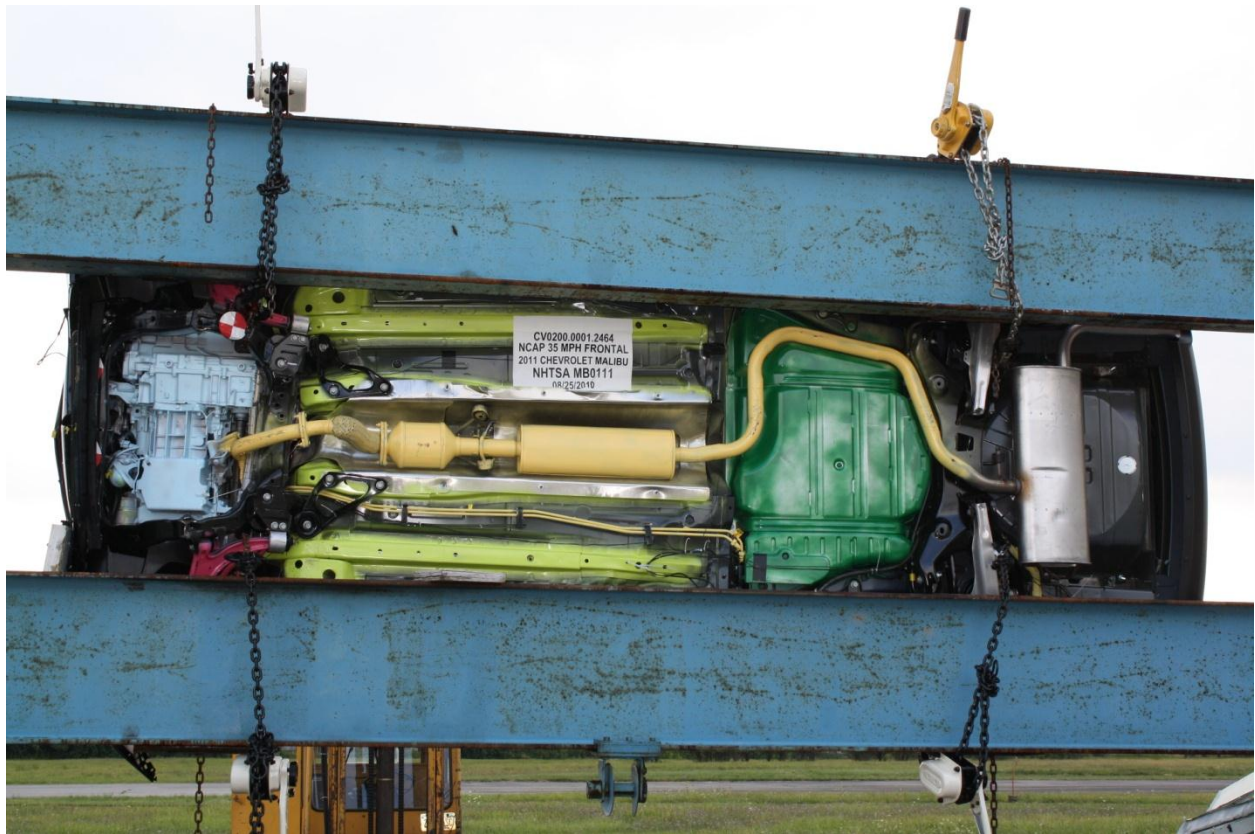
**Figure A-67: Vehicle at 270° on Static Rollover Device**

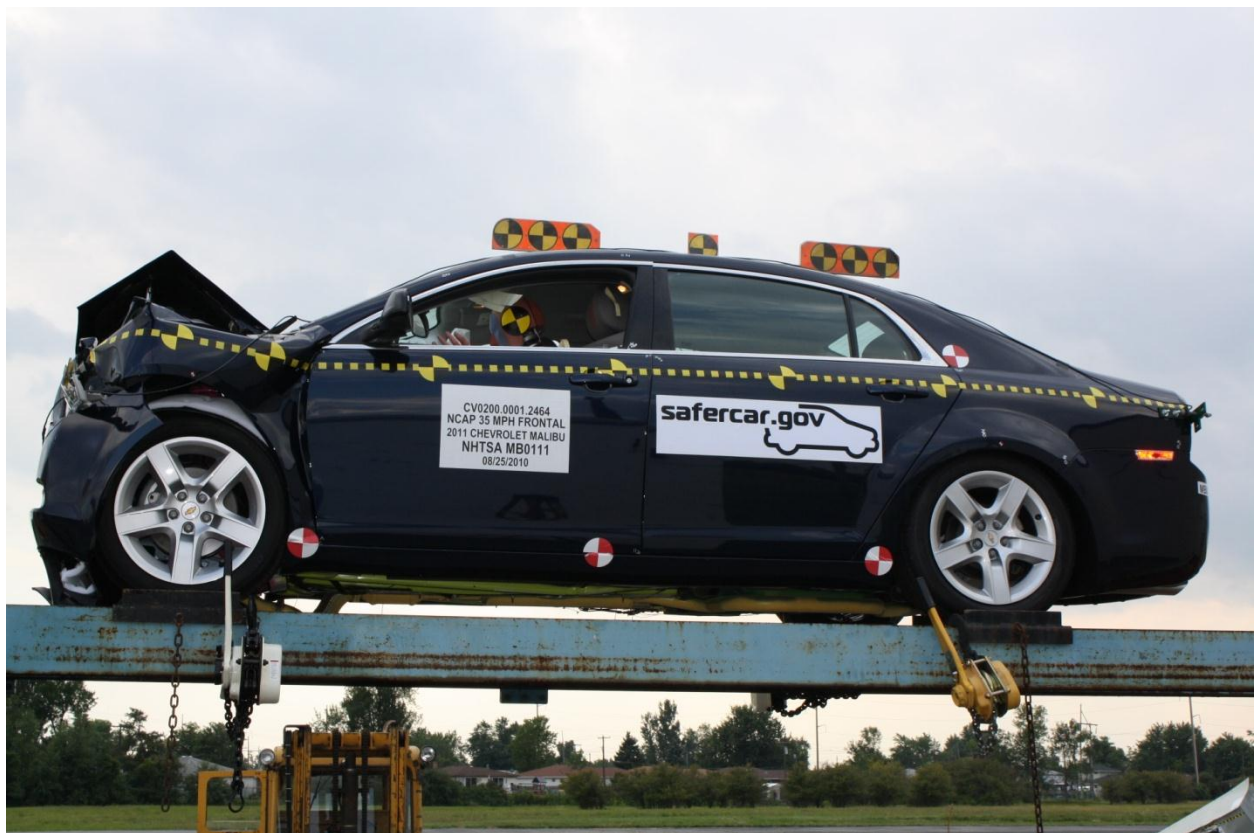
**Figure A-68: Vehicle at 360° on Static Rollover Device**
