**REPORT NUMBER: NCAP-MGA-2011-014**

**NEW CAR ASSESSMENT PROGRAM (NCAP)  
Frontal Barrier Impact Test**

**CHRYSLER GROUP LLC  
2011 Jeep Grand Cherokee Laredo 4X4  
NHTSA No.: MB0311**

**MGA RESEARCH CORPORATION  
5000 Warren Road  
Burlington, WI 53105**

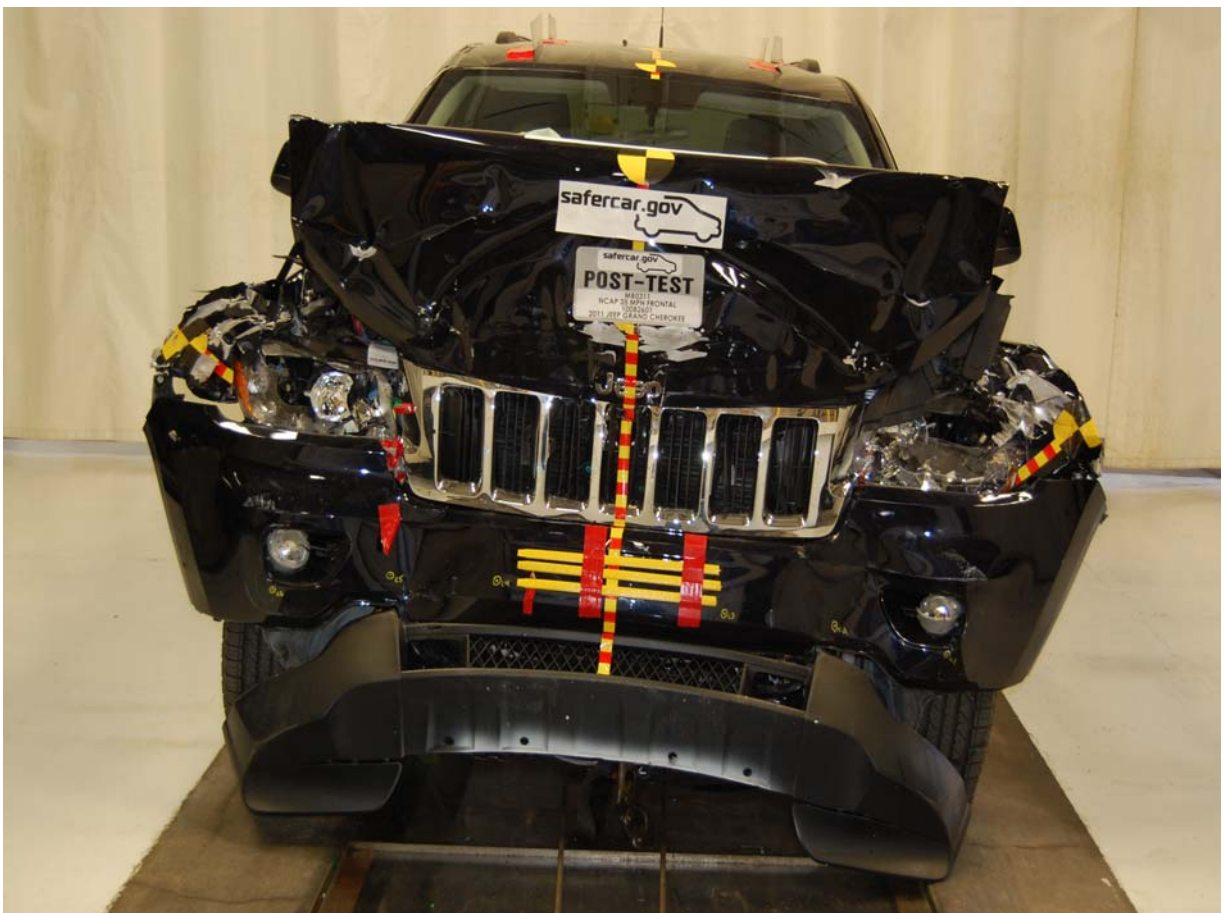
Post-Test Front View

The maximum static crush of the vehicle was 521 mm and both the driver and passenger side doors remained closed during the impact event and were operable after the impact.

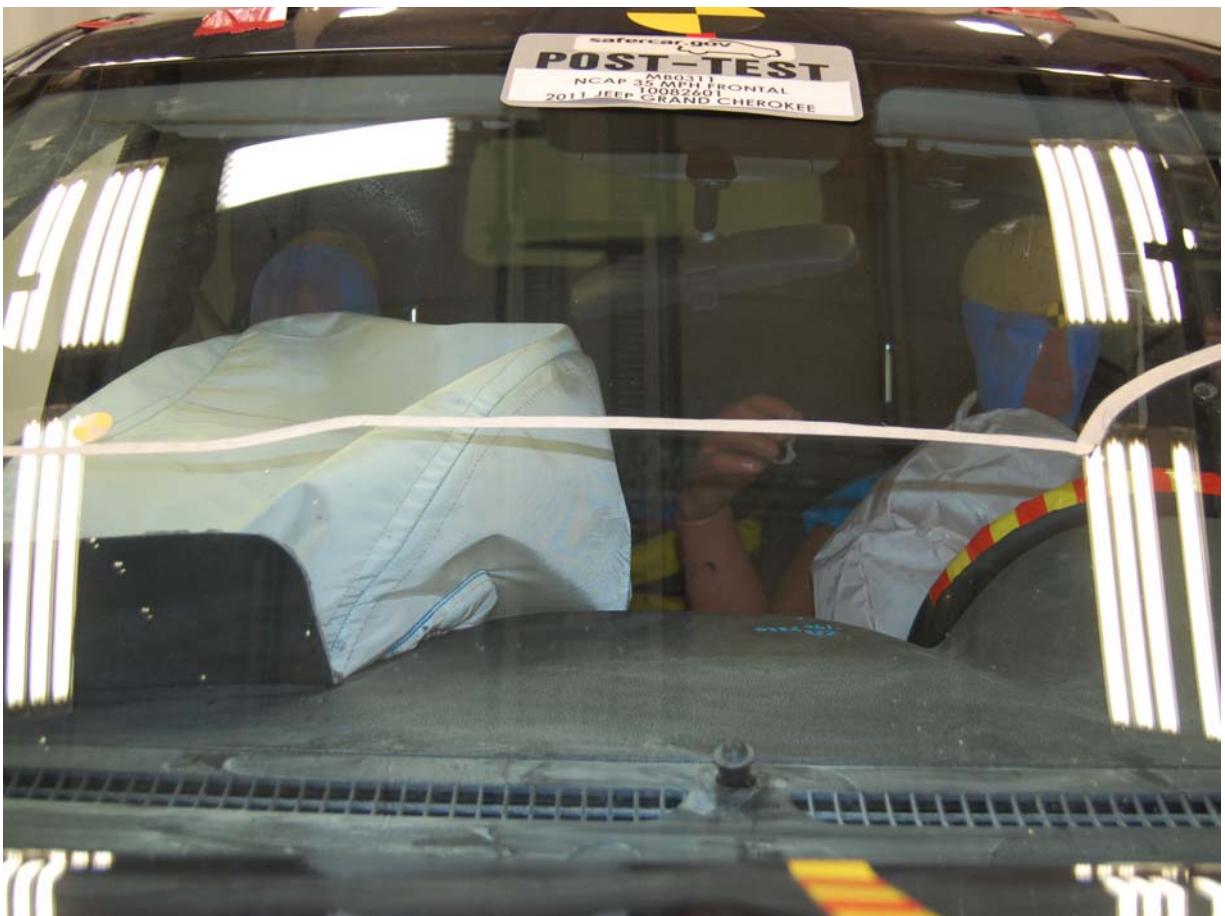
Post-Test Windshield View

There was 100 percent windshield retention and no intrusion into the protected zone of the windshield during the event. There was no Stoddard Solvent leakage after the event or during any phase of the static rollover.

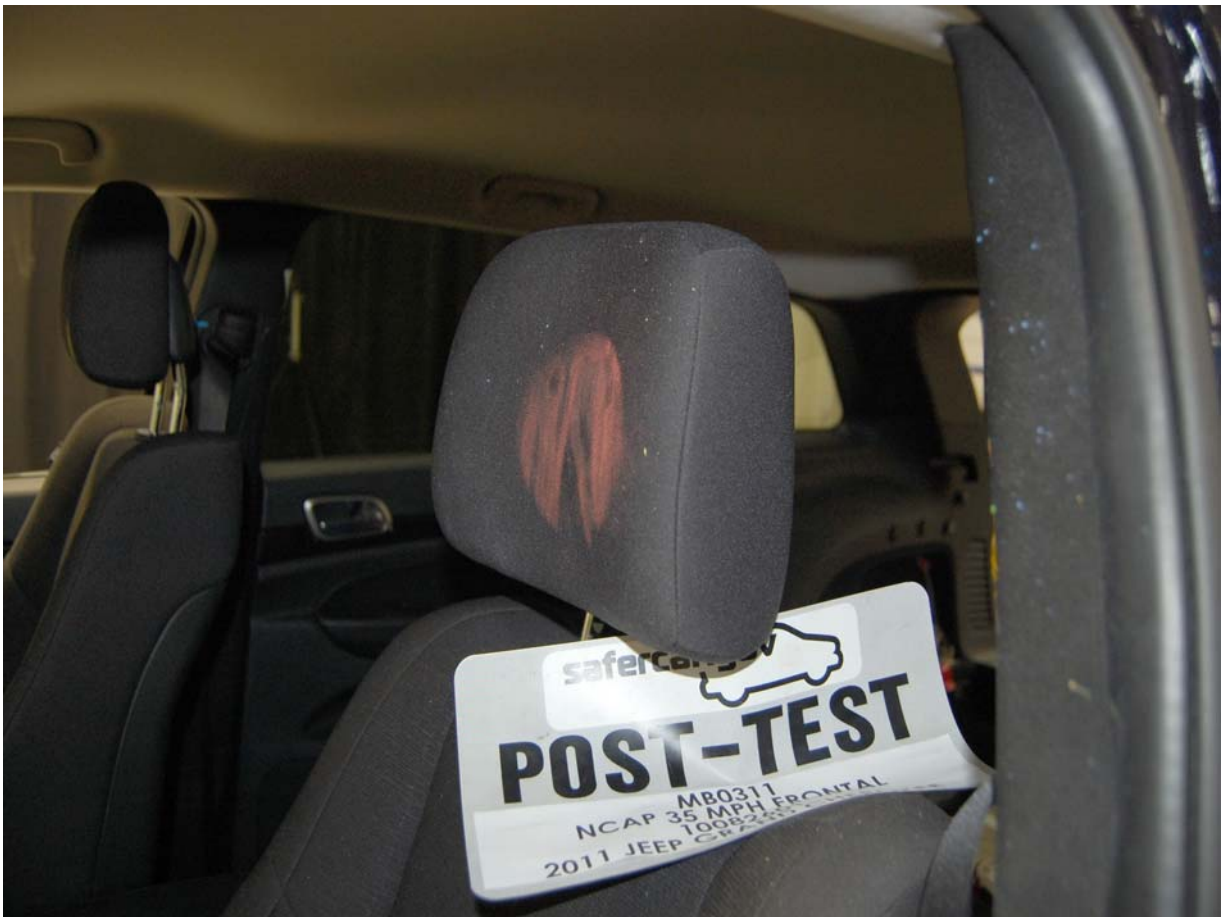
Post-Test Driver Dummy Contact with Headrest

The driver's head and chest contacted the airbag. The driver's head also contacted headrest. The driver's knees contacted the knee bolster. The passenger's head and chest contacted the airbag. The passenger's head also contacted the headrest. The passenger's knees contacted the glove box.

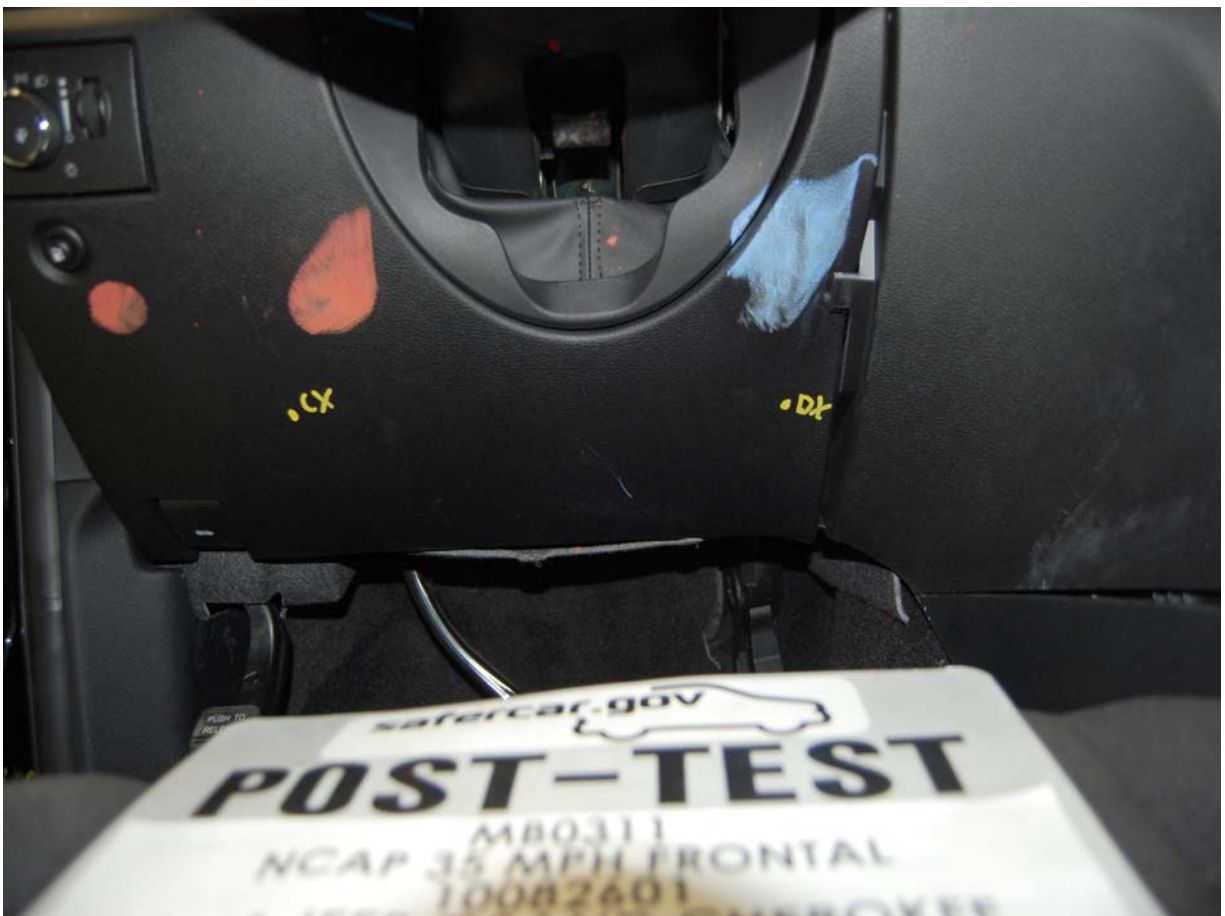
Post-Test Driver Dummy Contact with Knee Bolster

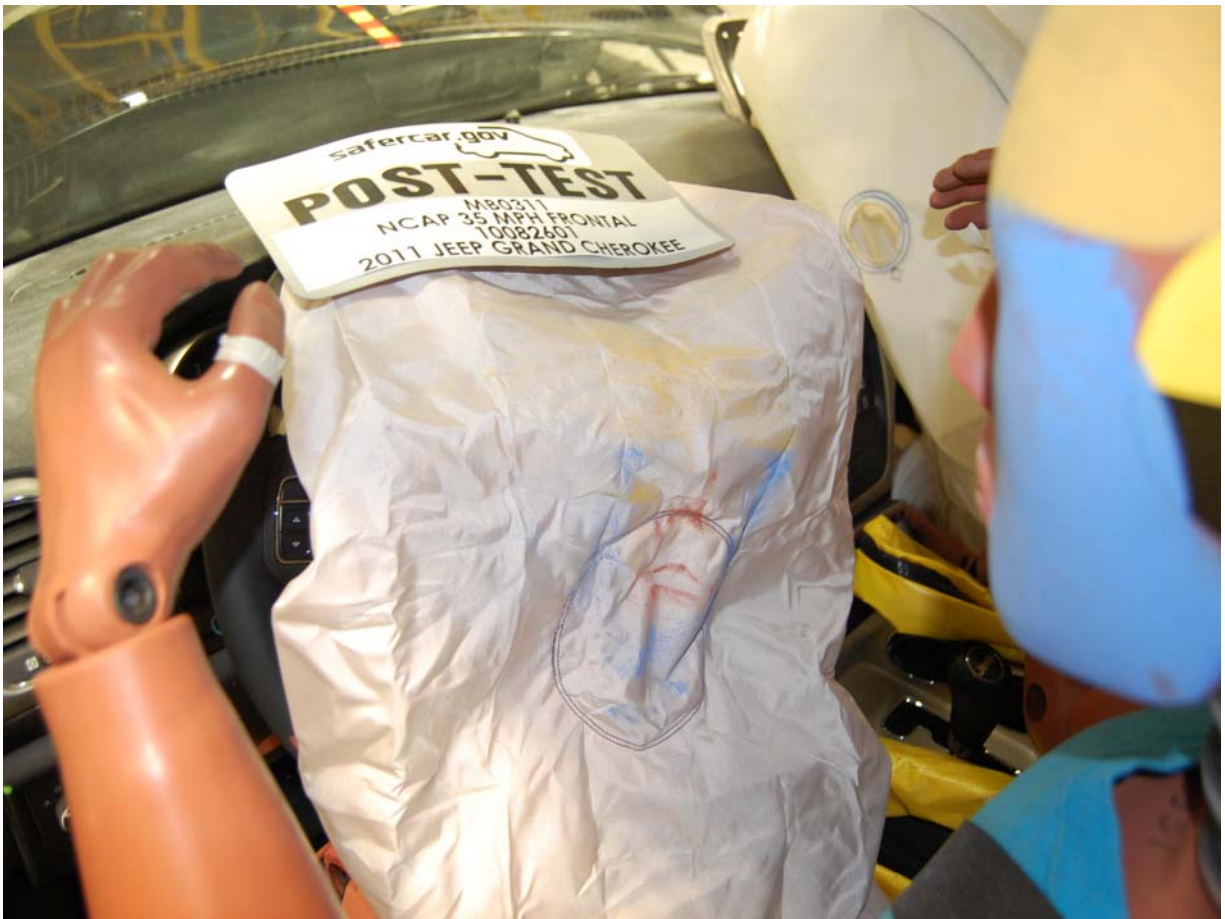
Post-Test Driver Dummy Contact with Airbag

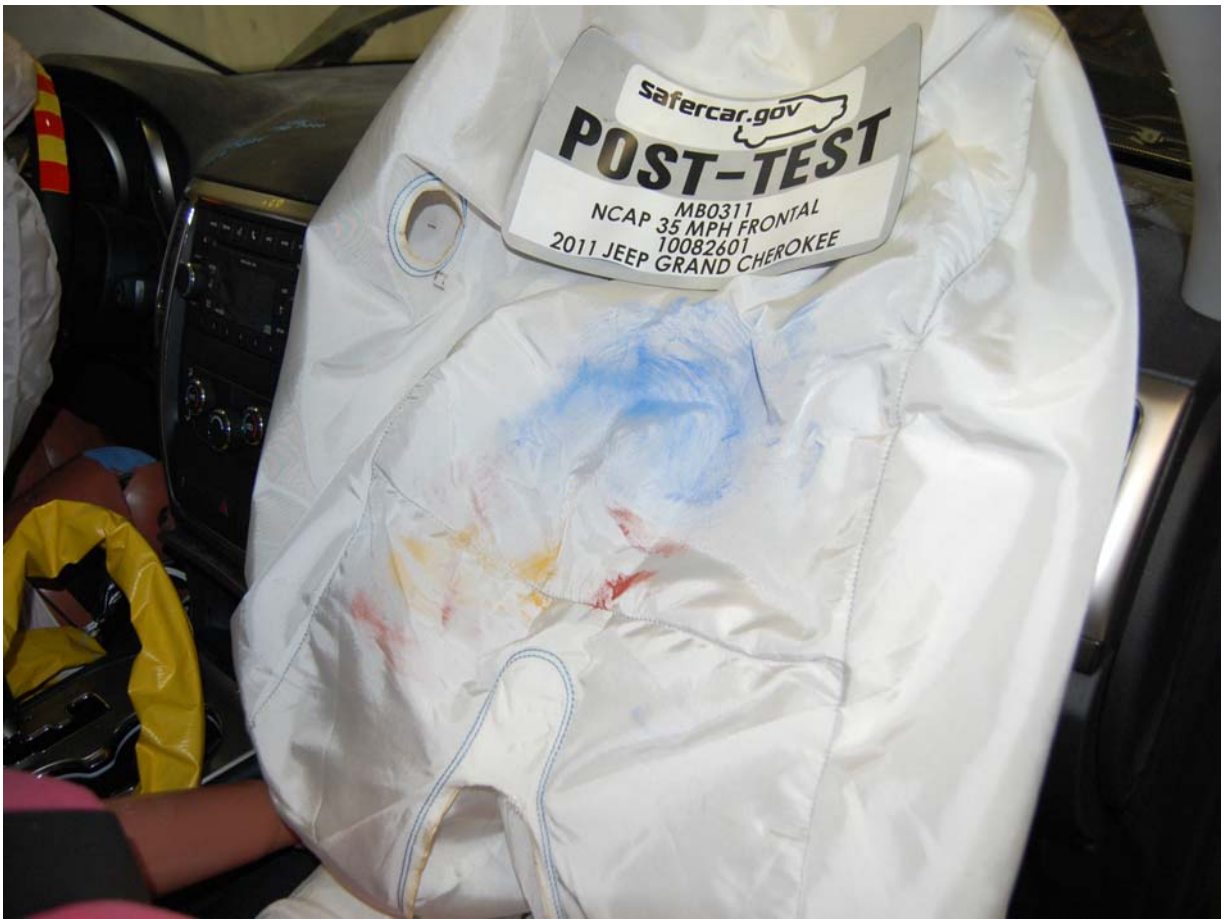
Post-Test Passenger Dummy Contact with Airbag
