**REPORT NUMBER: NCAP-MGA-2011-015**

**NEW CAR ASSESSMENT PROGRAM (NCAP)  
Frontal Barrier Impact Test**

**HYUNDAI MOTOR MANUFACTURING ALABAMA, LLC  
2011 Hyundai Sonata GLS 4-Dr Sedan  
NHTSA No.: UB0500**

**MGA RESEARCH CORPORATION  
5000 Warren Road  
Burlington, WI 53105**

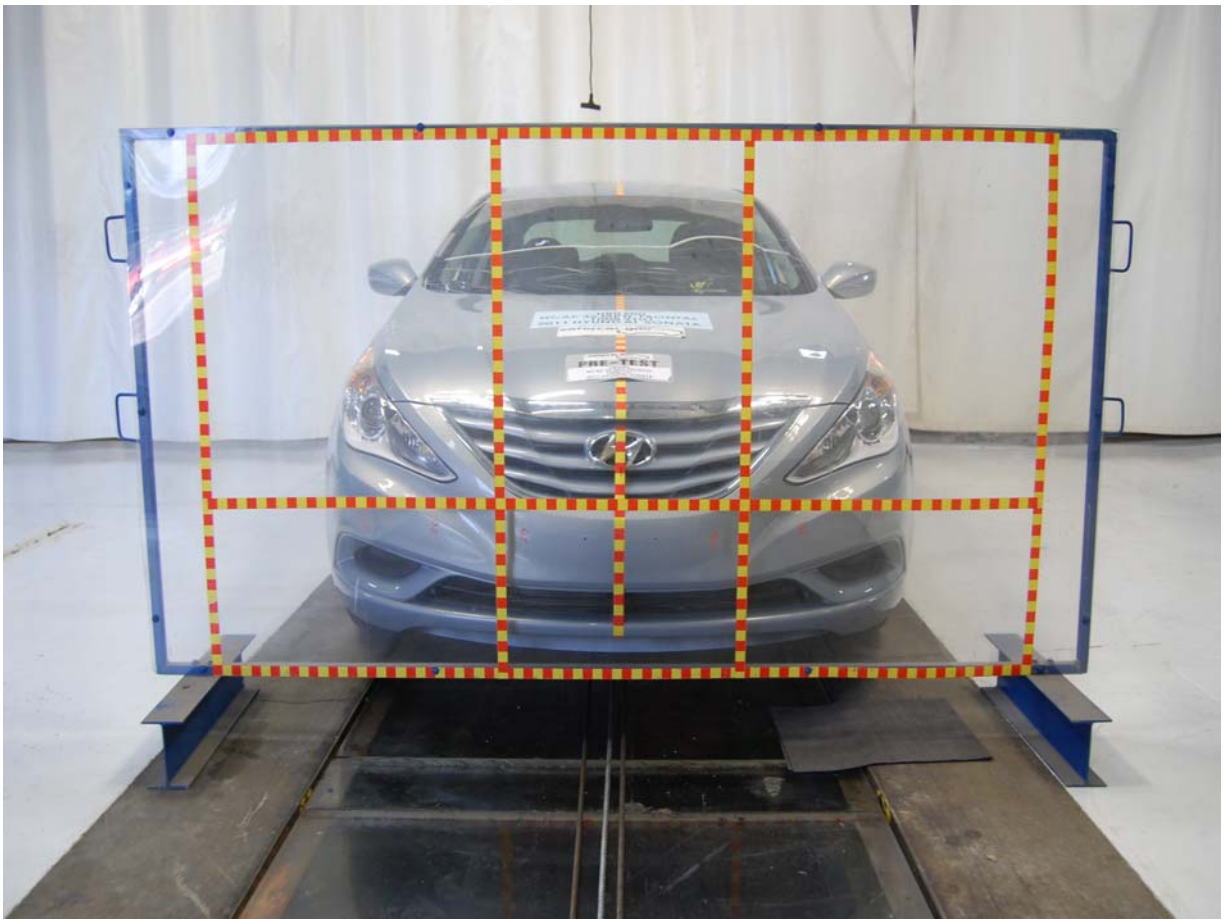
Load Cell Location

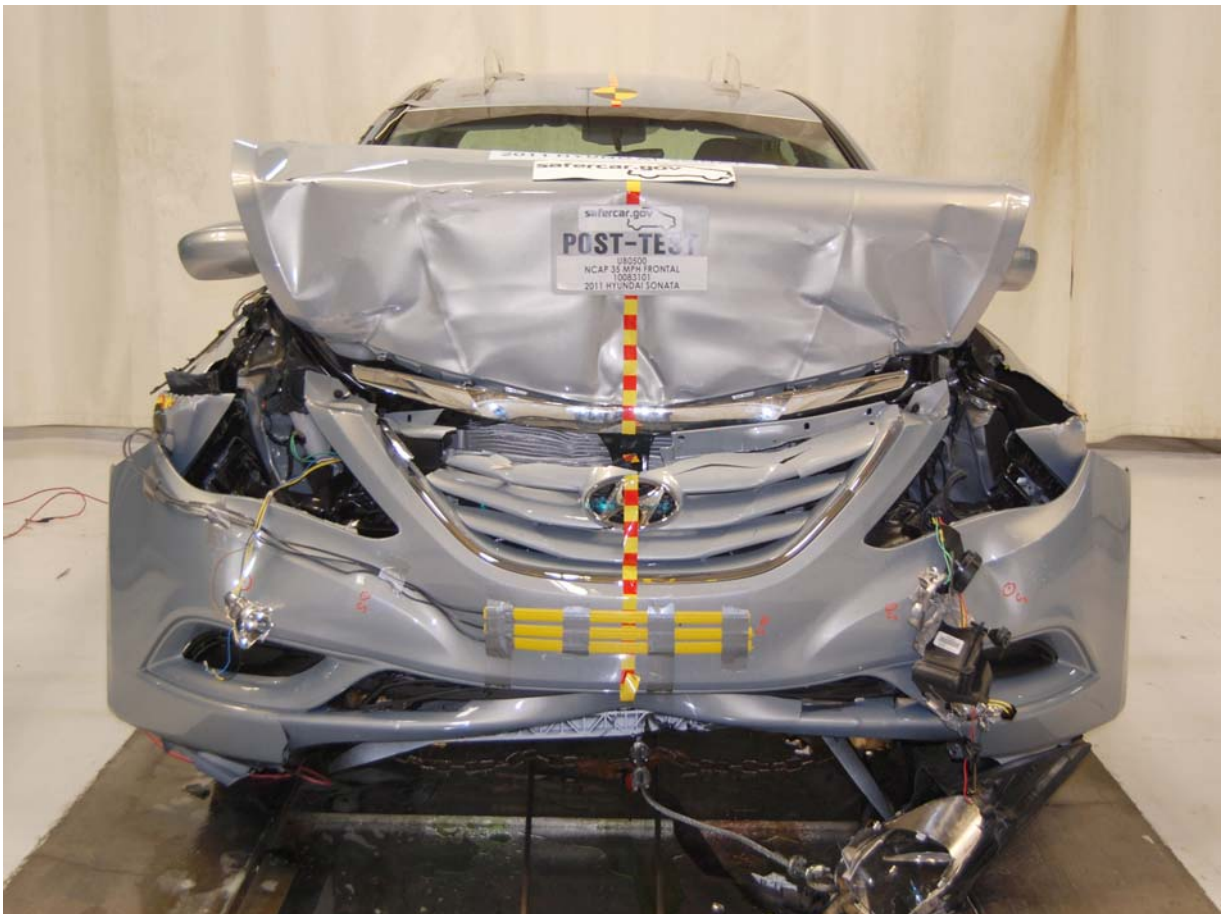
Post-Test Front View

The maximum static crush of the vehicle was 385 mm and both the driver and passenger side doors remained closed during the impact event and were operable after the impact.

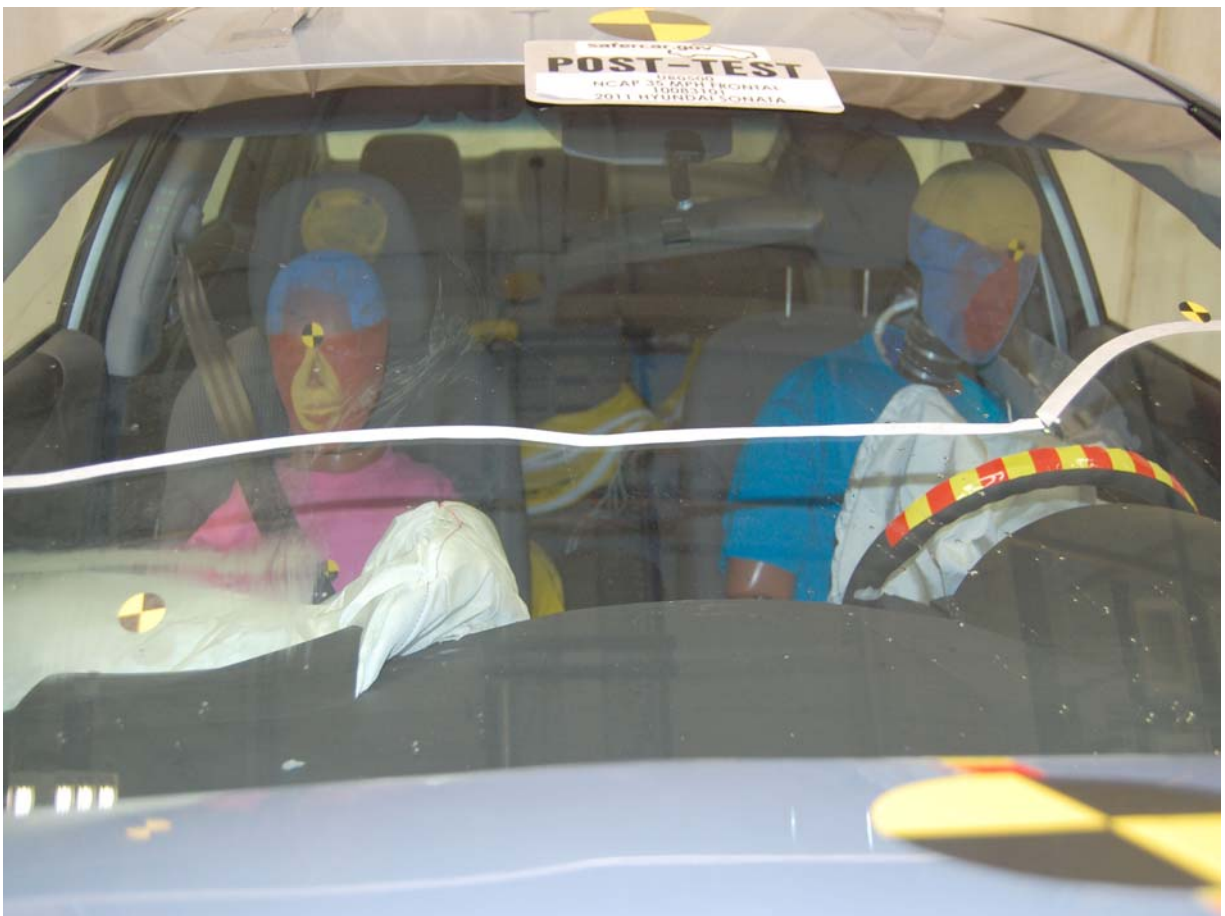
### Post-Test Windshield View

There was 100 percent windshield retention and no intrusion into the protected zone of the windshield during the event. There was no Stoddard Solvent leakage after the event or during any phase of the static rollover.

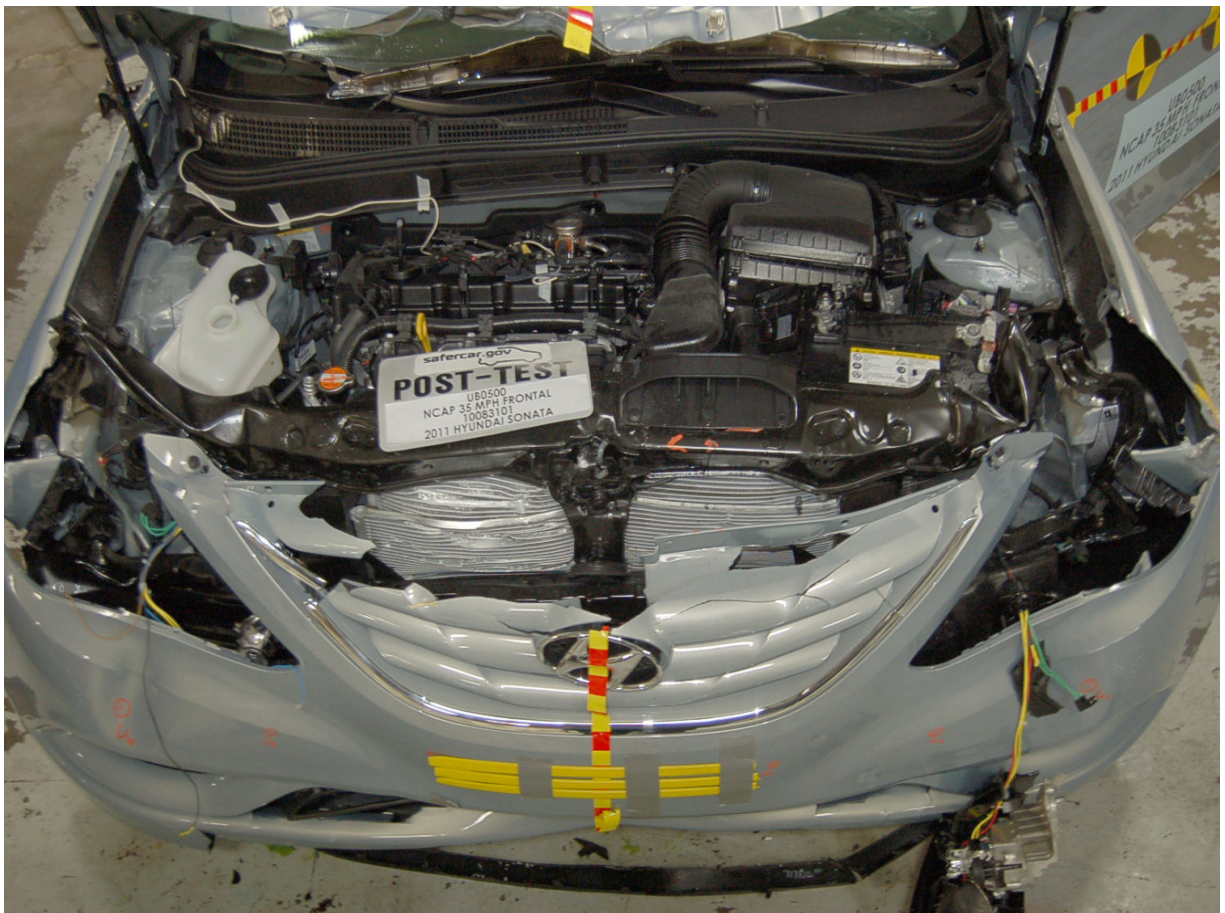
Post-Test Engine Compartment View

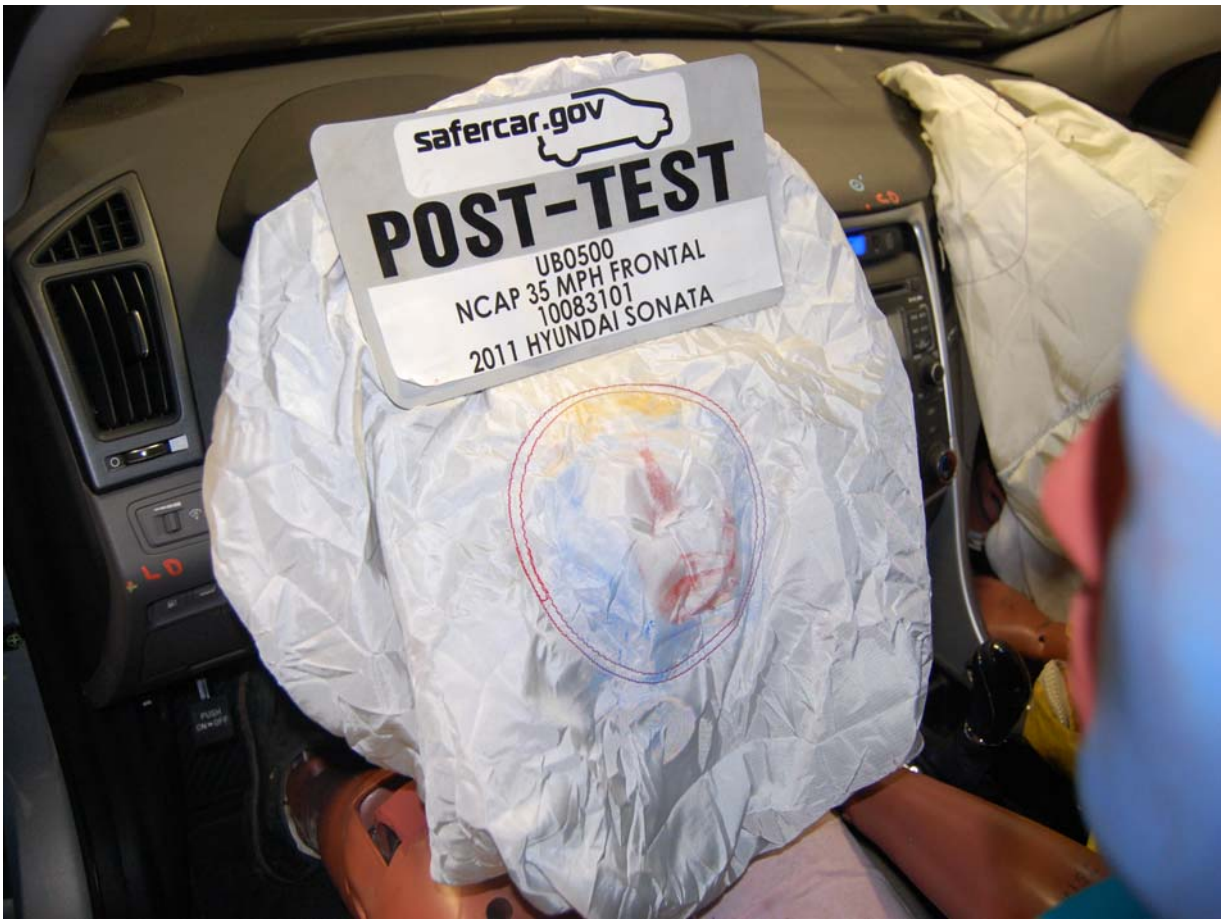
Post-Test Driver Dummy Contact with Airbag

The driver's head and chest contacted the airbag. The driver's head also contacted headrest. The driver's knees contacted the knee bolster. The passenger's head and chest contacted the airbag. The passenger's head also contacted the headrest. There was no contact to the glove box from the passenger's knees.

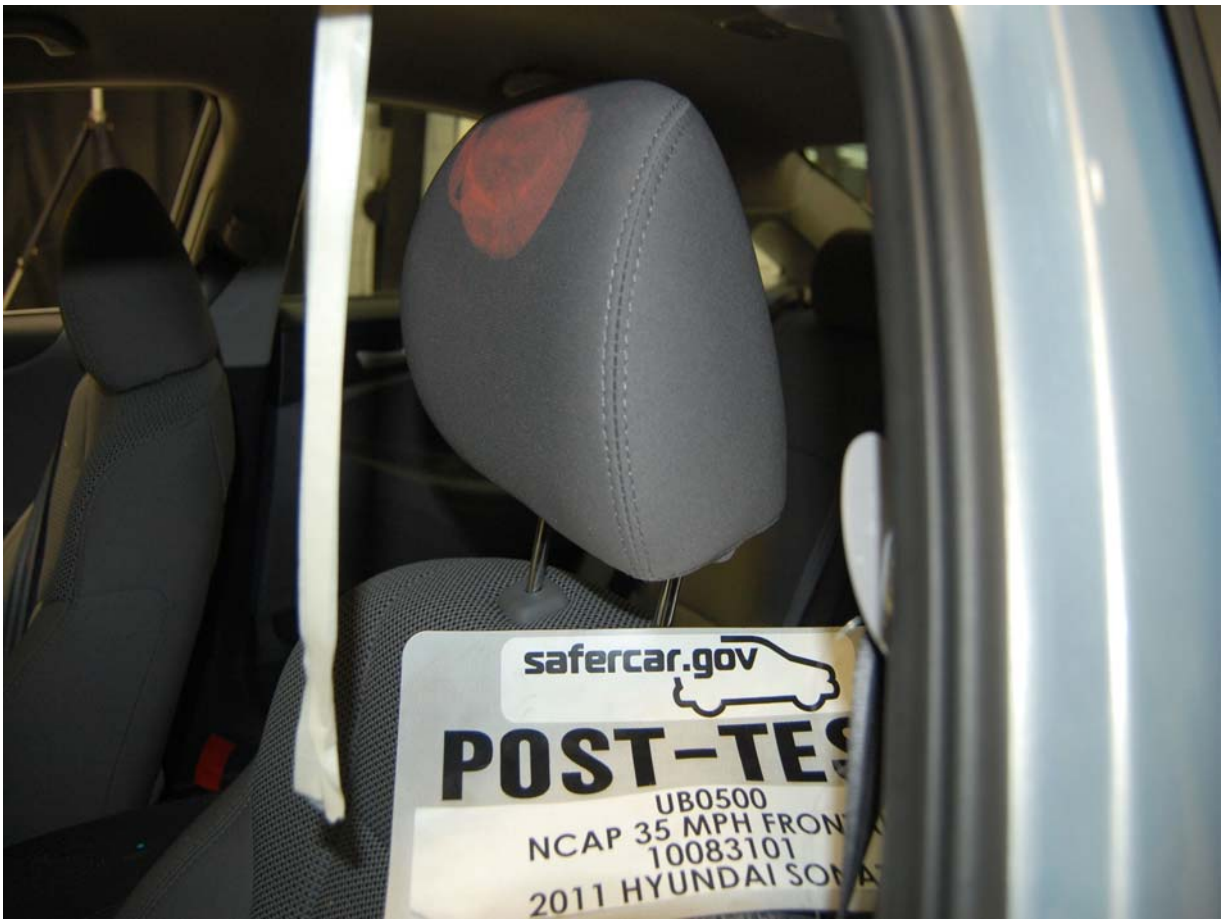
Post-Test Driver Dummy Contact with Headrest

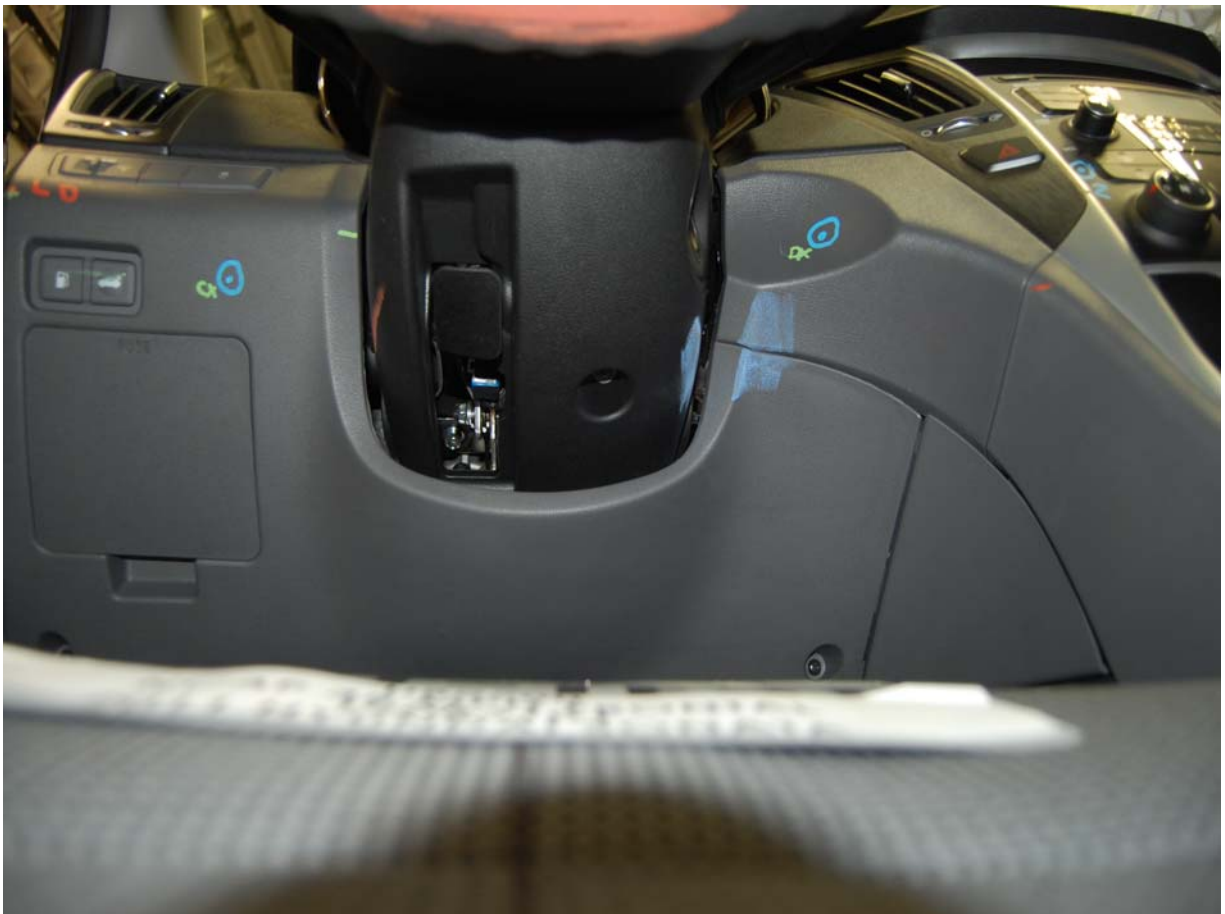
Post-Test Driver Dummy Contact with Knee Bolster

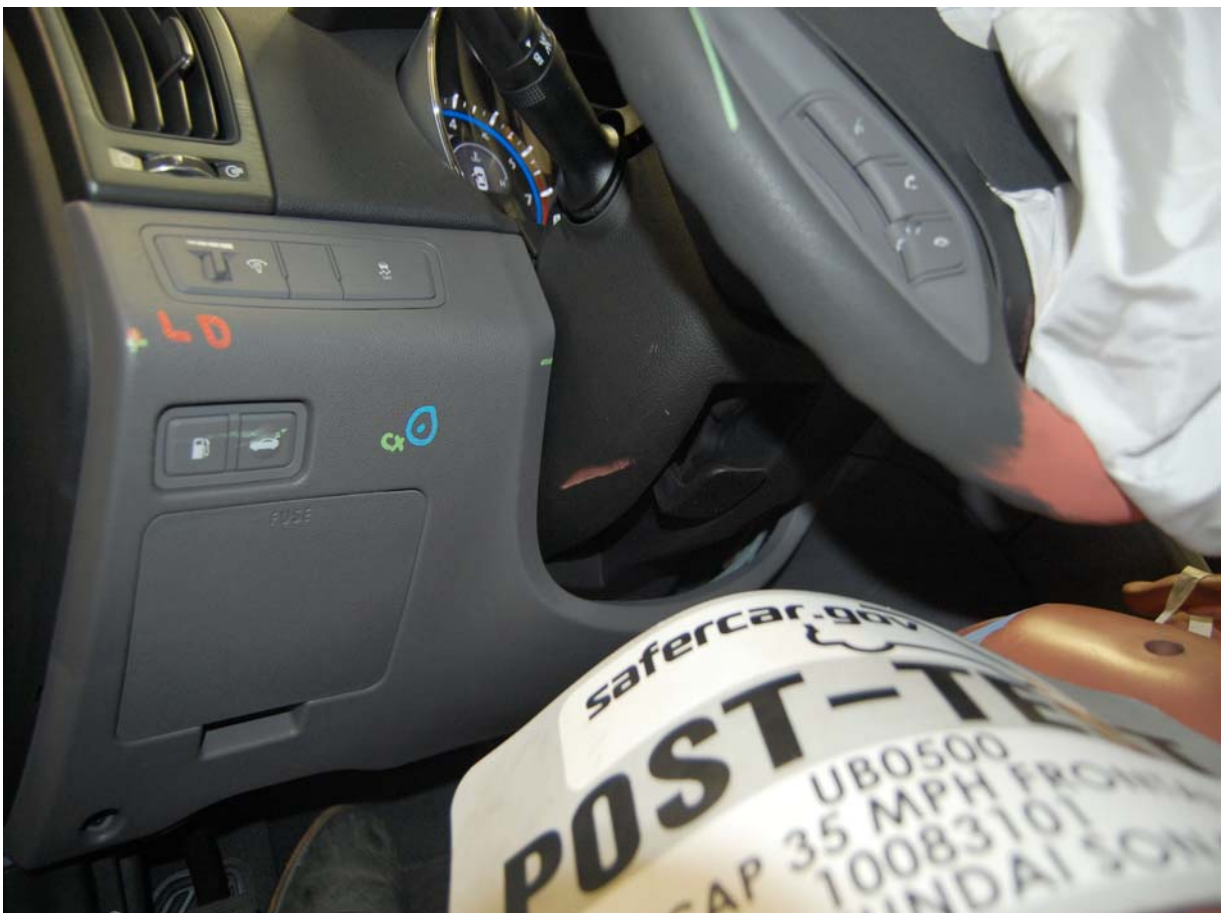
Post-Test View of Steering Column Shear Capsule

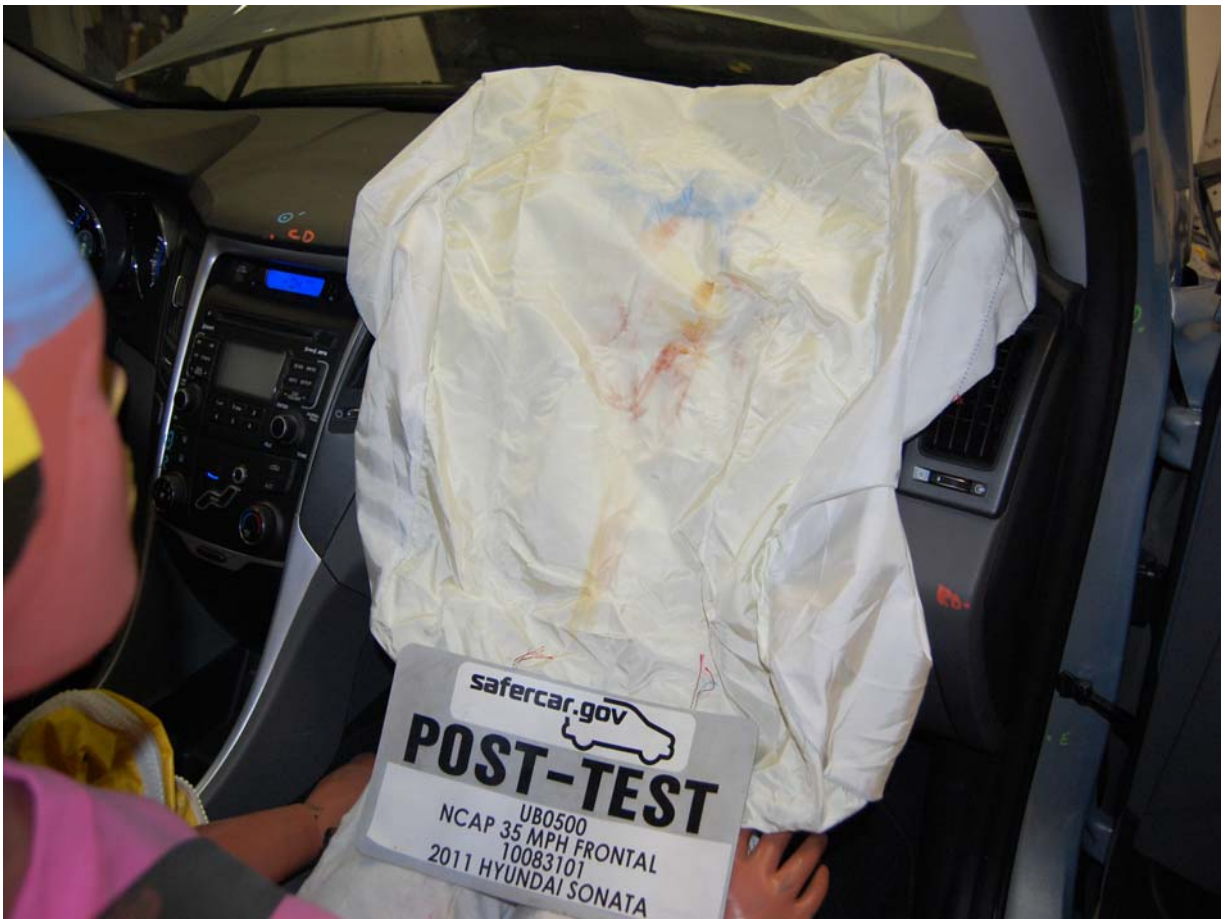
Post-Test Passenger Dummy Contact with Airbag

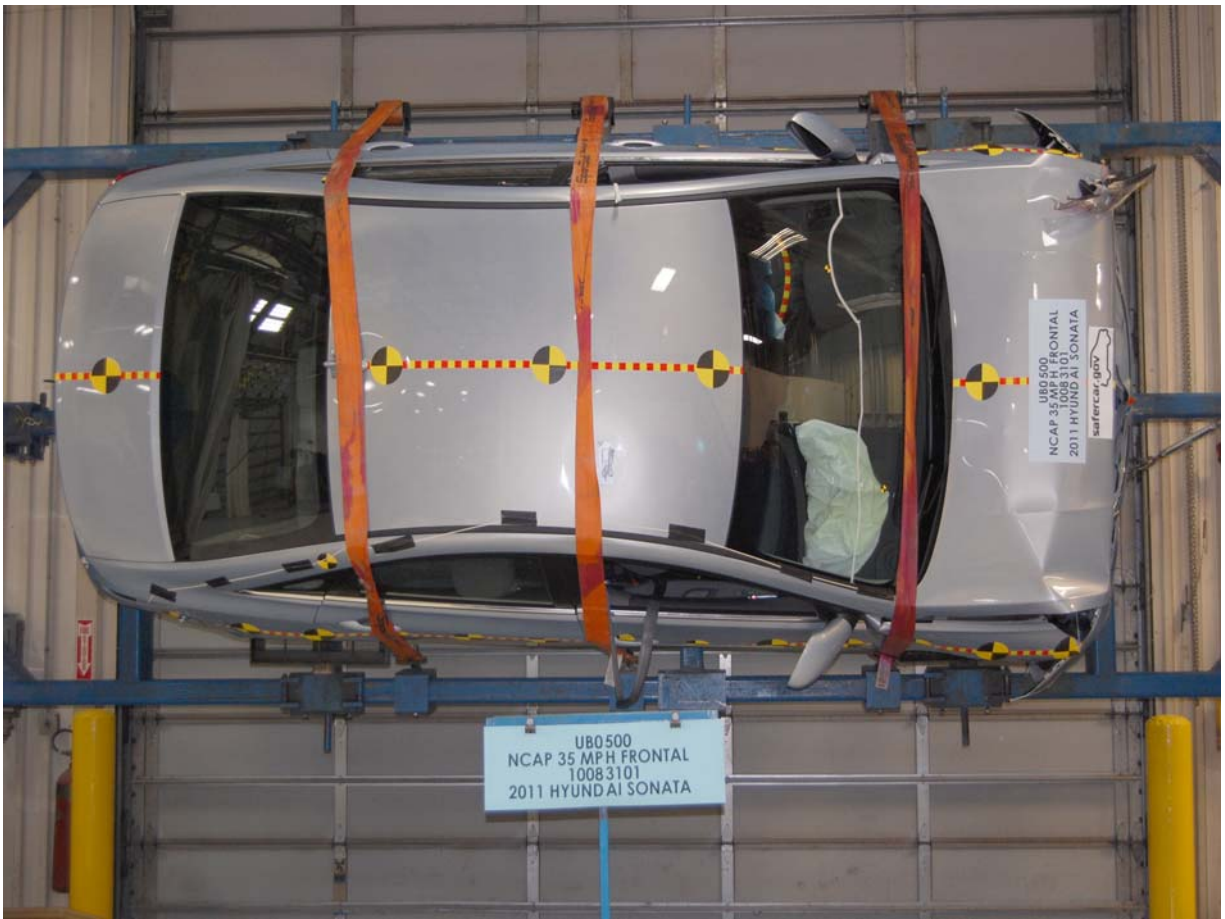
Vehicle at 270 Degrees on Static Rollover Device
