**REPORT NUMBER: NCAP-MCW-11-002**

**NEW CAR ASSESSMENT PROGRAM (NCAP)  
MOVING DEFORMABLE BARRIER SIDE IMPACT TEST**

**GENERAL MOTORS CORPORATION  
2011 CHEVROLET TAHOE SPORT UTILITY VEHICLE  
NHTSA NUMBER: MB 0119**

**FINAL REPORT**

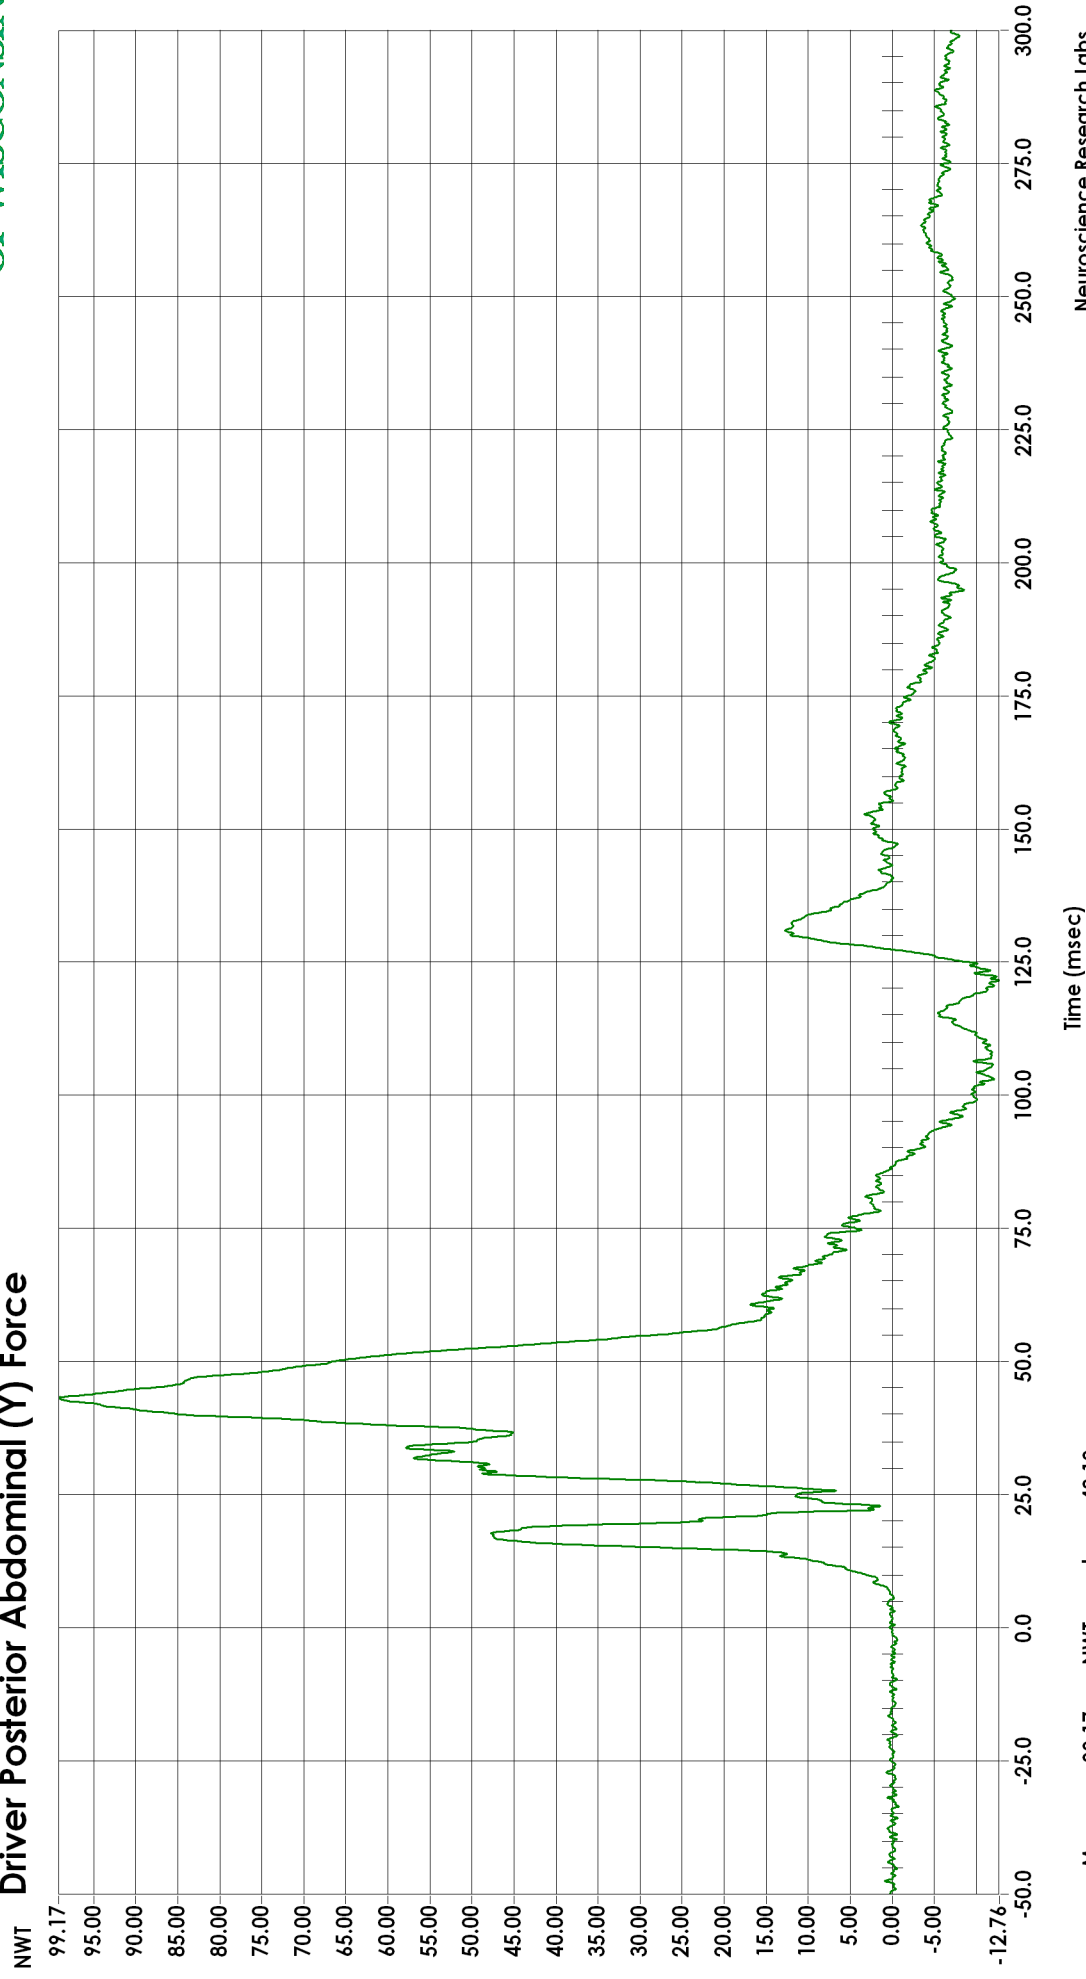
## Driver Posterior Abdominal (Y) Force

| <b>Max</b> | 99.17 | <b>NWT</b> | at | 43.12 | <b>msec</b> |
| <b>Min</b> | -12.76 | <b>NWT</b> | at | 121.52 | <b>msec</b> |
