REPORT NUMBER: NCAP-KAR-11-014

**NEW CAR ASSESSMENT PROGRAM (NCAP)
FRONTAL BARRIER IMPACT TEST**

**BAYERISCHE MOTORENWERKE AG
2011 BMW 535I 4-DOOR SEDAN**

**PREPARED BY:
KARCO ENGINEERING, LLC.
9270 HOLLY ROAD
ADELANTO, CA 92301**

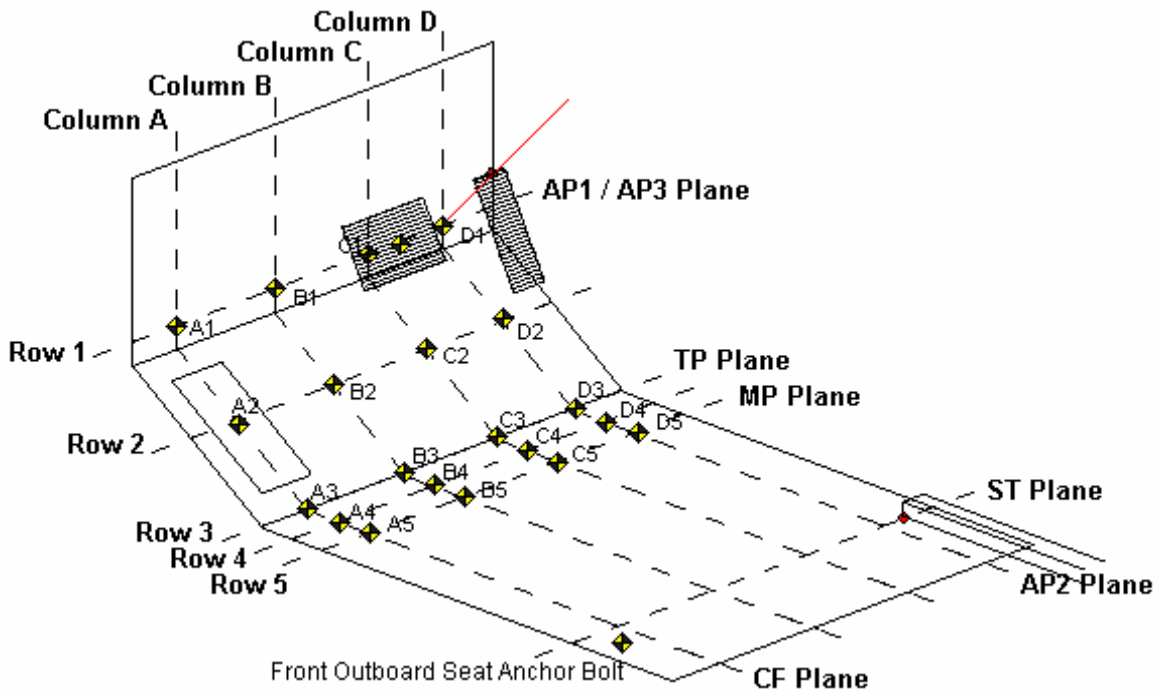
DATA SHEET NO. 14 ... (CONTINUED)
VEHICLE INTRUSION MEASUREMENTS

- AP1: Y-Z Plane passing through D1
- AP2: X-Z Plane passing through D1
- AP3: X-Y plane passing through D1
- MP: Y-Z plane, halfway between the ST plane and AP1 plane
- CF Plane: X-Z plane passes through center of footrest.
- BP Plane: X-Z plane passes through center of brake pedal
- TP Plane: Y-Z plane, intersection of BP Plane and the intersection of the toe pan and floorboard
- Column A: intersection of vehicle and CF plane
- Column D: Intersection of vehicle and AP2 plane
- Row 1: intersection of the vehicle and the AP3 Plane
- Row 3: intersection of the vehicle and TP plane
- Row 5: intersection of the vehicle and MP plane
- Row 2: evenly spaced between row 1 and 3
- Row 4: evenly spaced between row 3 and 5

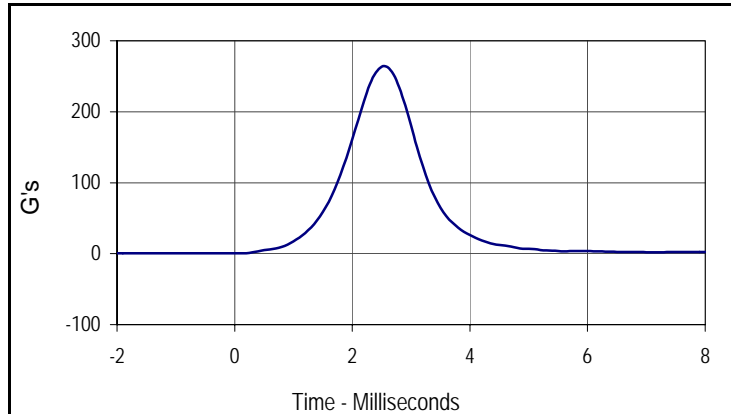
Tested Parameter	Units	Specification	Result	Pass/Fail
Laboratory Temperature	°C	18.9 to 25.6	21.1	Pass
Laboratory Relative Humidity	%	10 to 70	30	Pass
Peak Resultant Acceleration	G's	250.0 to 300.0	263.6	Pass
Peak Lateral Acceleration	G's	≤15.0	4.5	Pass
Is Acceleration Unimodal?	Yes/No	Yes	Yes	Pass
Overall Test Results			Pass

Curve Description			
Head Resultant			
CURNO	Type	SAE Class	Units
001	RES	1000	G's
Max	Time	Min	Time
263.6	2.5	0.4	-1.3
