**REPORT NUMBER: SPNCAP-MGA-2011-016**

**NEW CAR ASSESSMENT PROGRAM (NCAP)  
Side Impact Pole Test**

**GENERAL MOTORS LLC  
2011 Chevrolet Tahoe LS 2WD  
NHTSA No.: MB0118**

**FINAL REPORT**

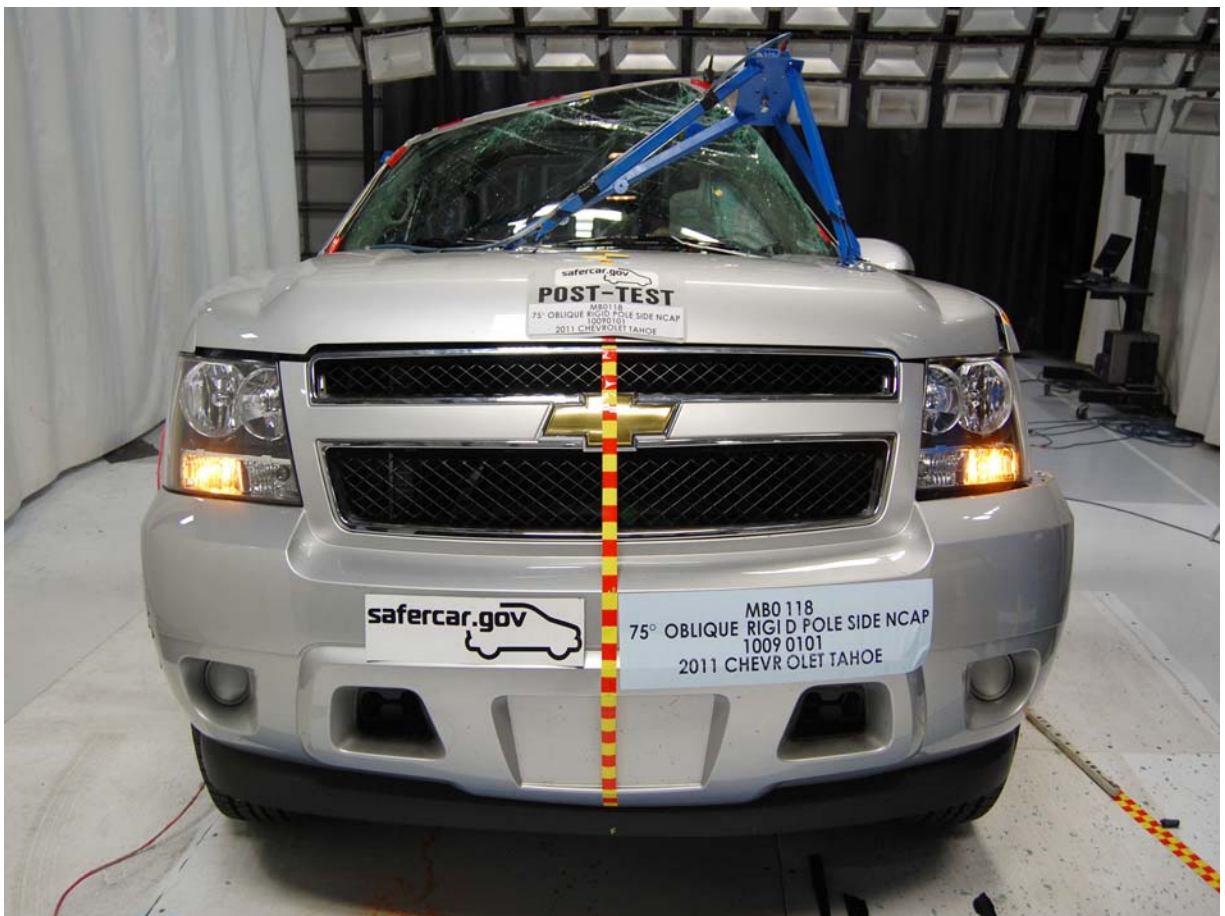
Post-Test Frontal View of Test Vehicle

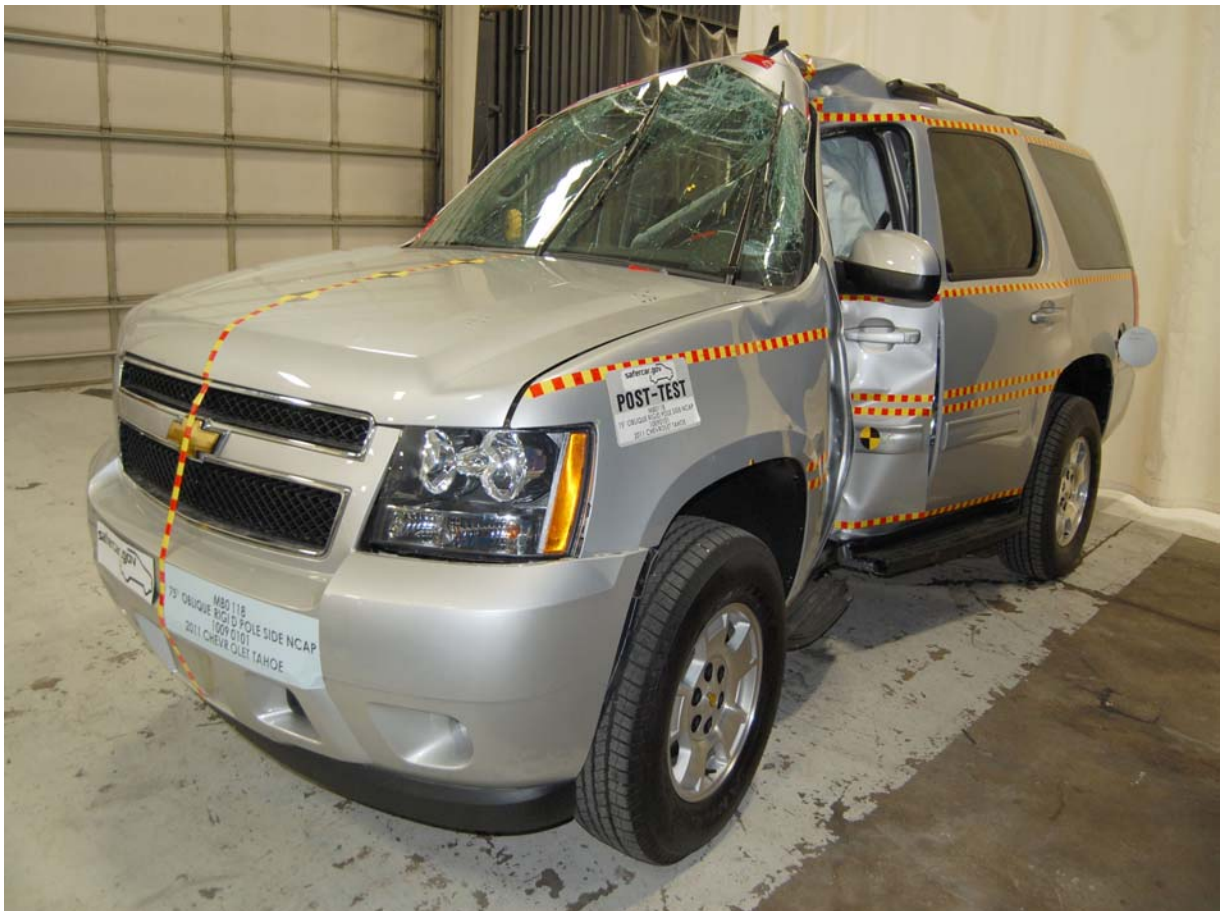
Post-Test Left Front  $\frac{3}{4}$  View of Test Vehicle

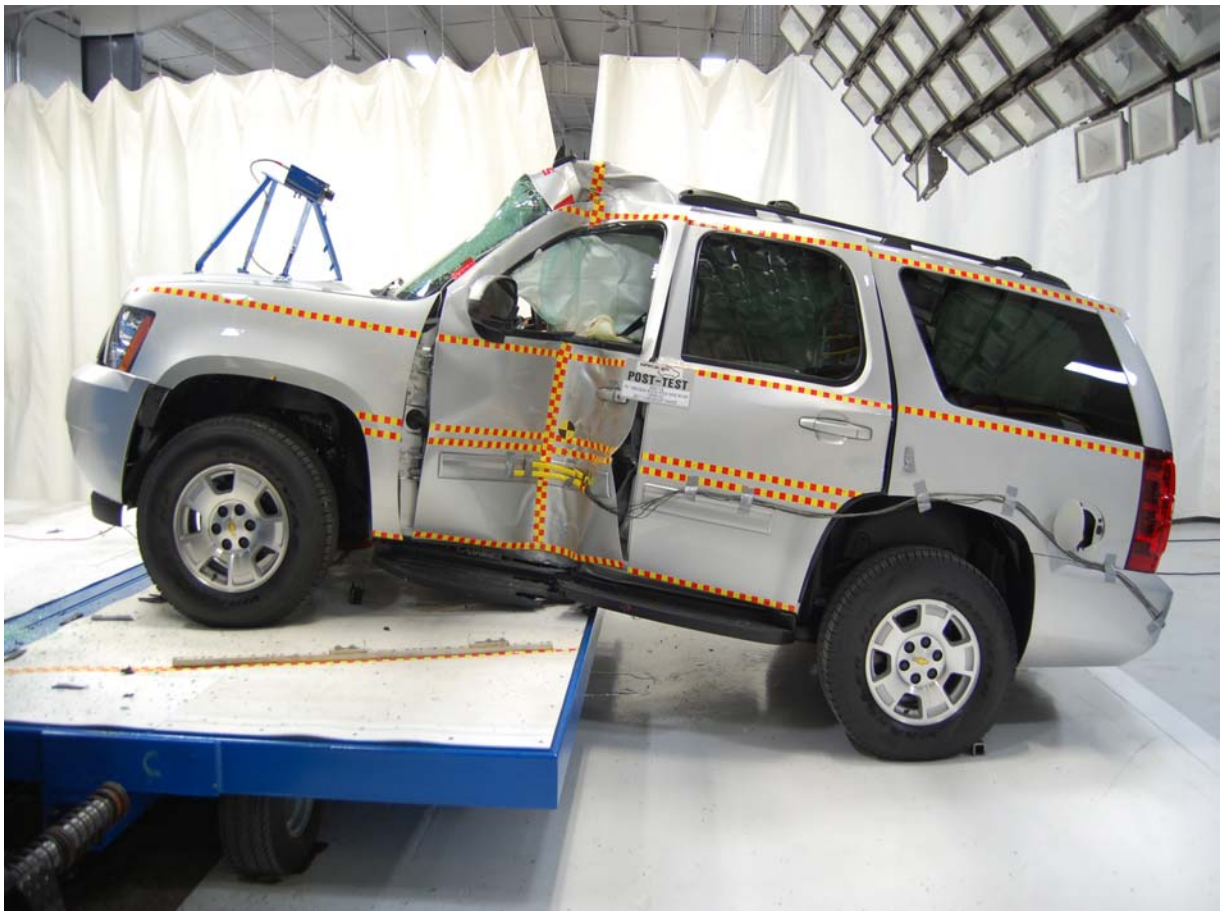
Post-Test Left Side View of Test Vehicle

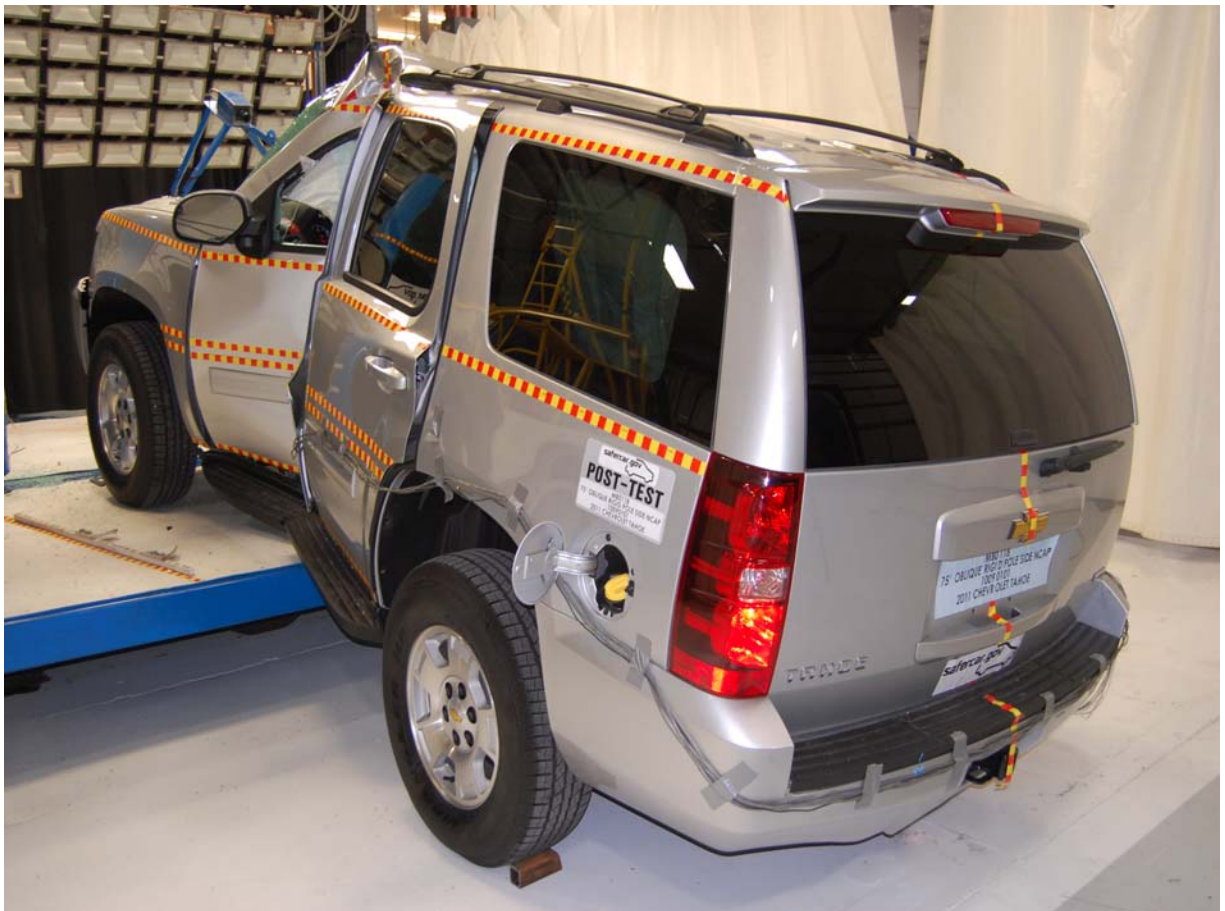
Post-Test Left Rear  $\frac{3}{4}$  View of Test Vehicle

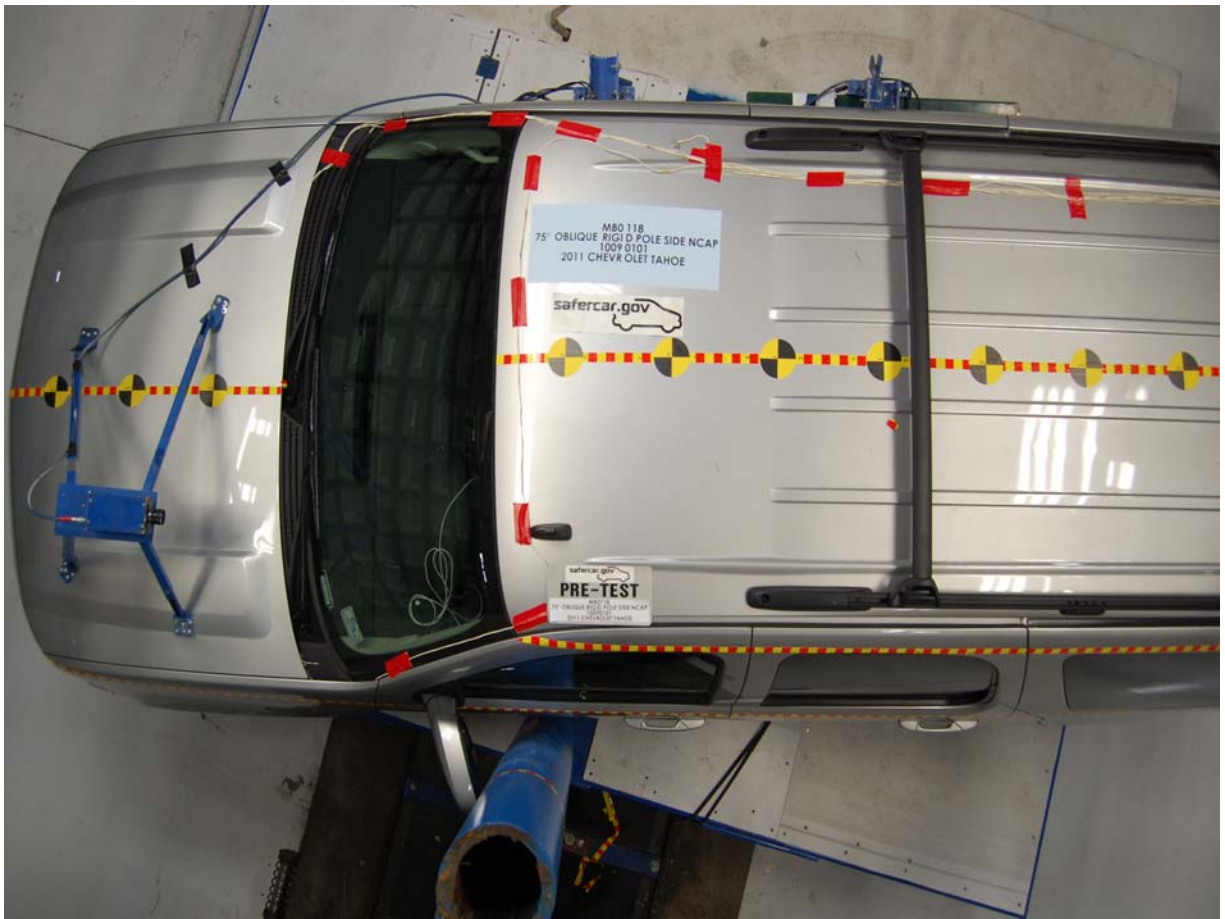
Pre-Test Overhead View of Test Vehicle and Pole

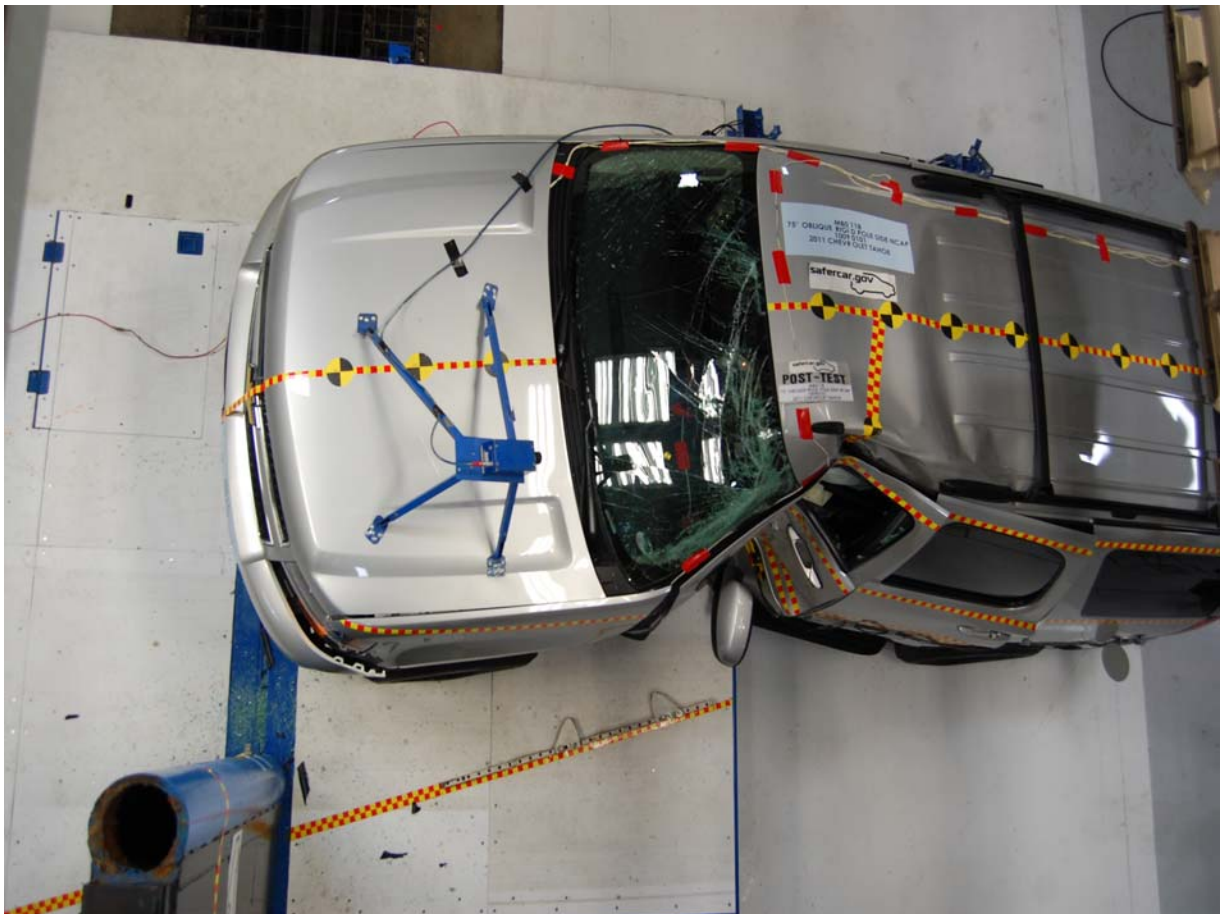
Post-Test Overhead View of Test Vehicle and Pole

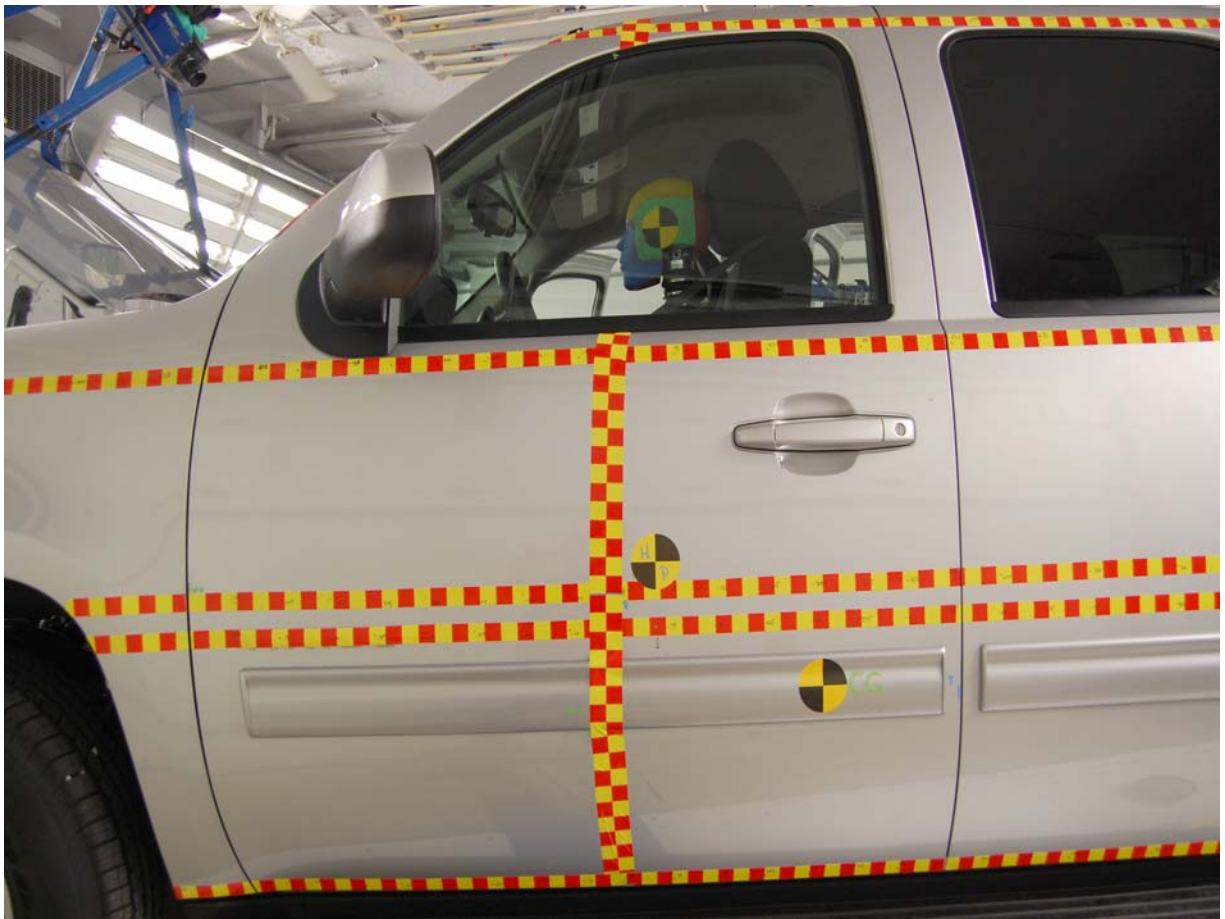
Pre-Test Close-Up View of Impact Point Target

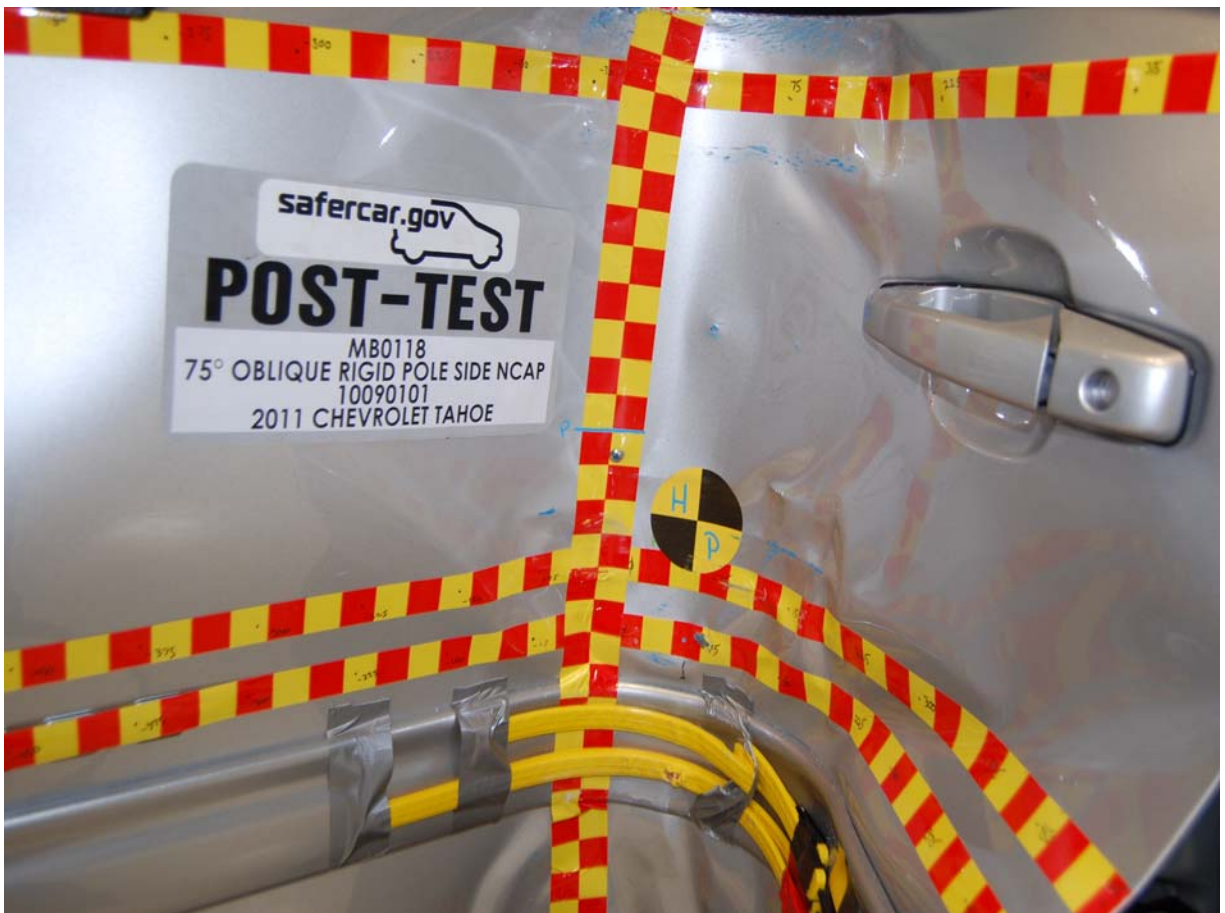
Post-Test Close-Up View of Impact Point Target

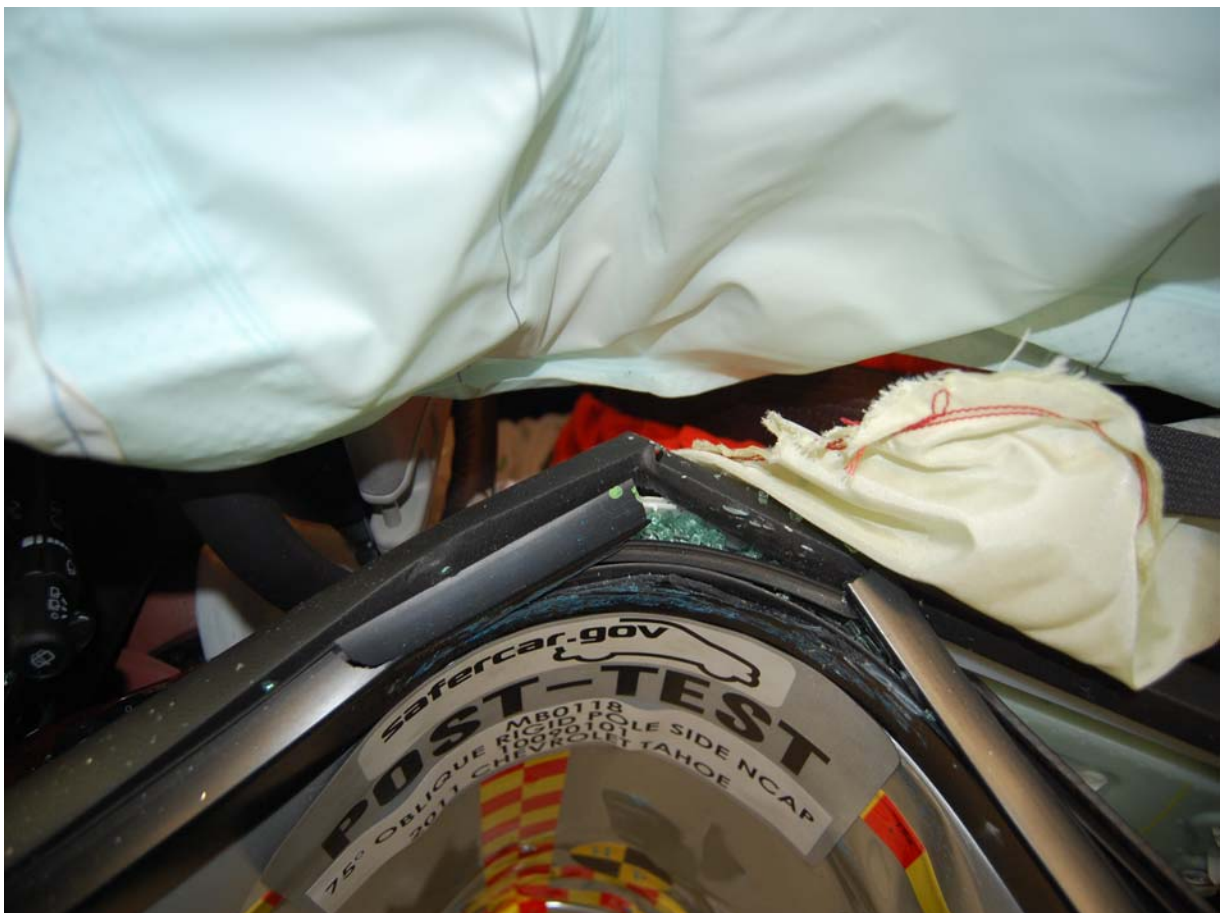
Post-Test Dummy and Door Clearance View

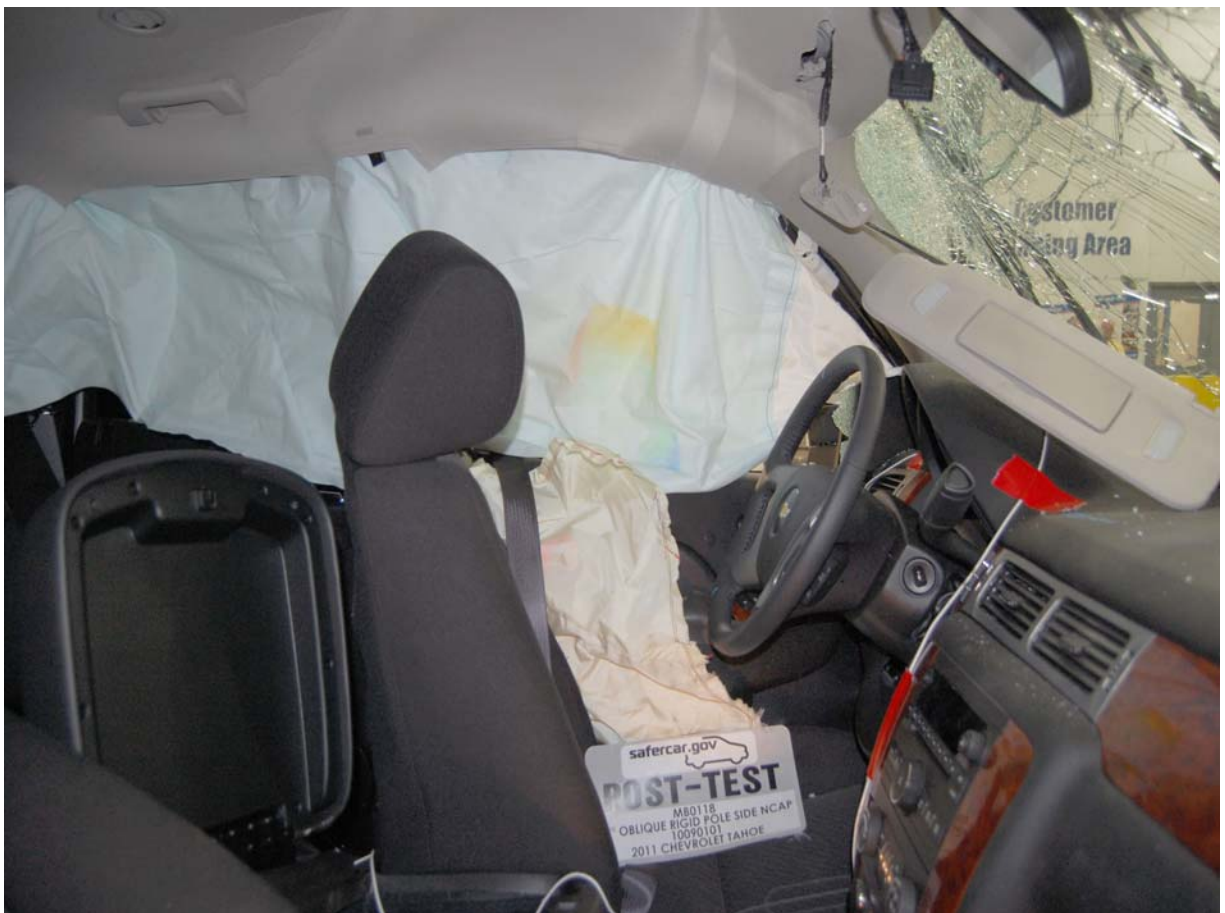
Post-Test Inner Door Panel View Showing Dummy Contact Location

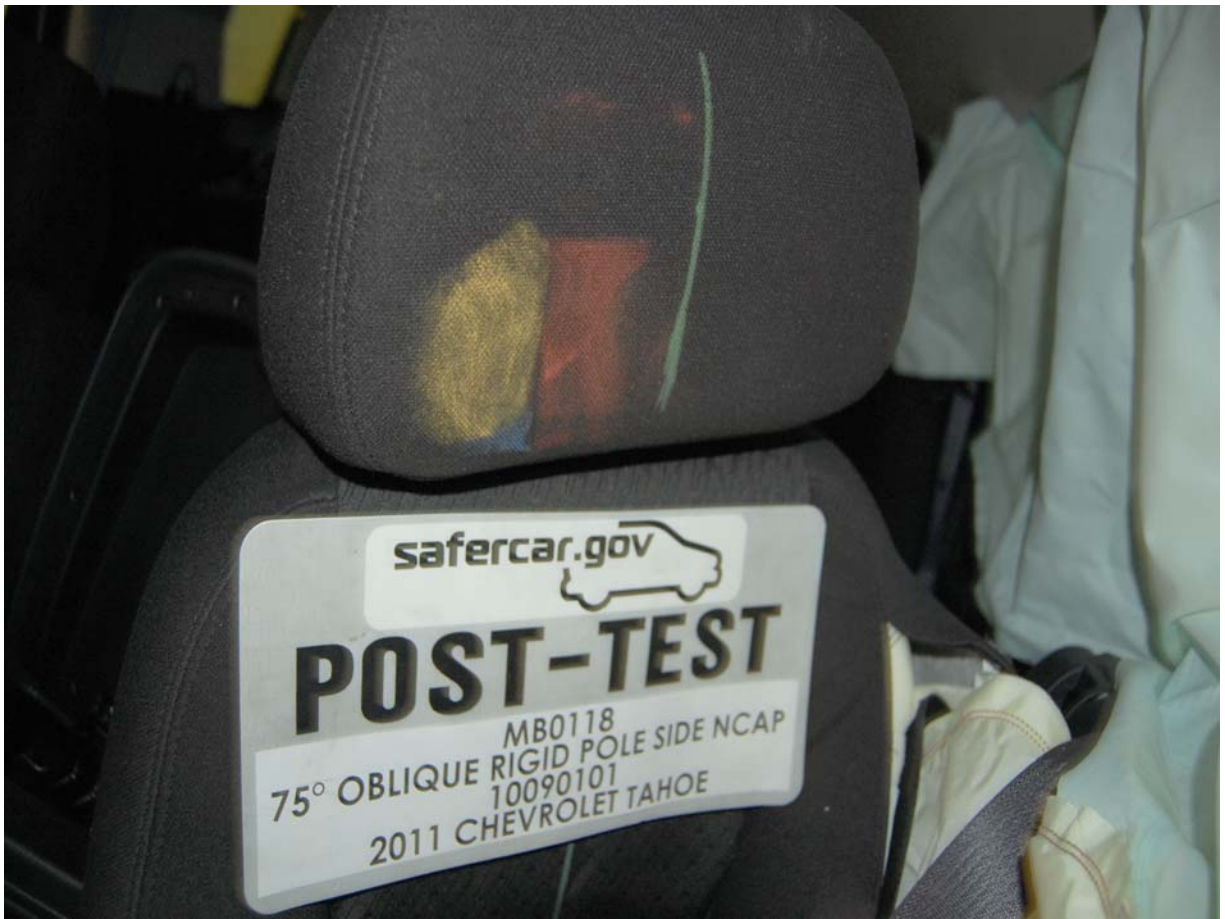
Post-Test Dummy Close-Up Head Contact with Vehicle View

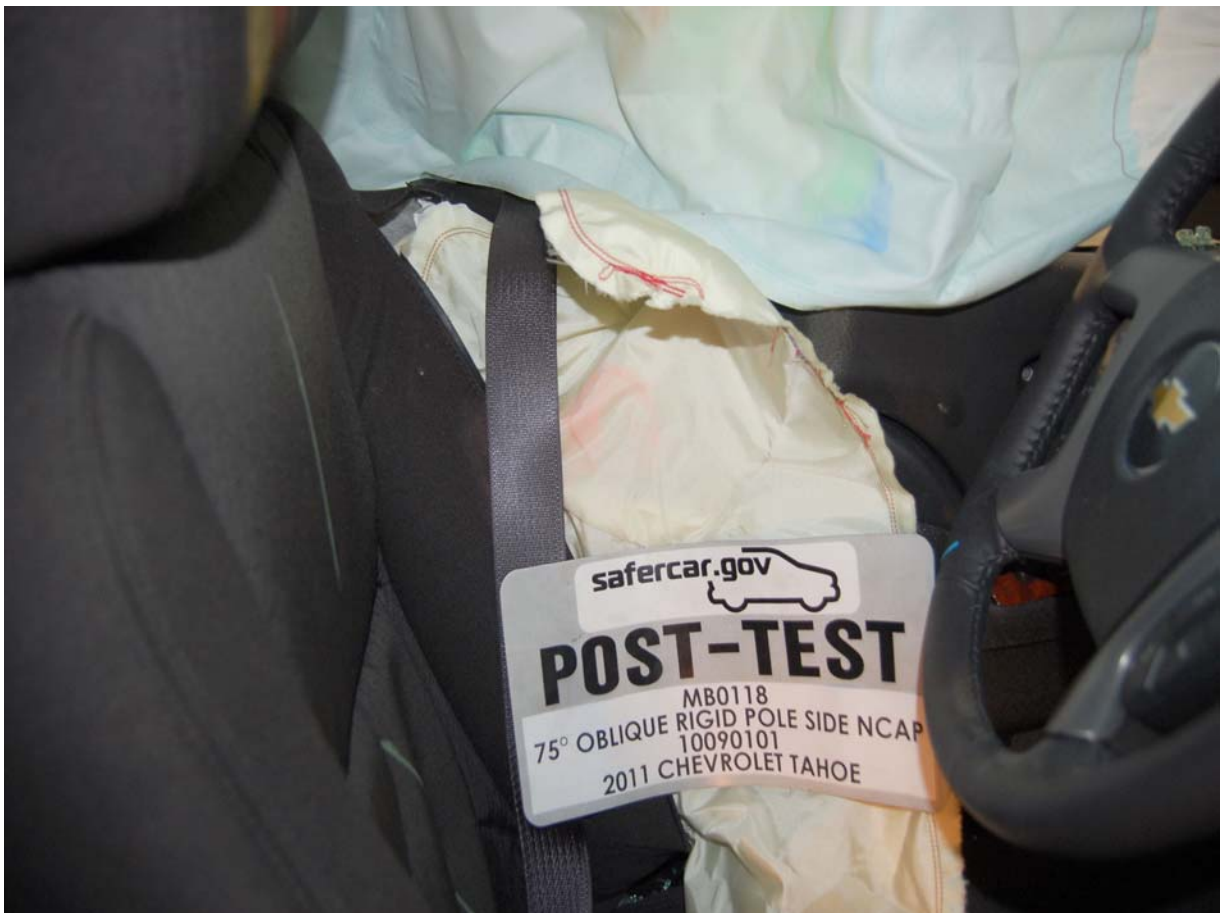
Post-Test Dummy Close-Up Torso Contact with Side Airbag View

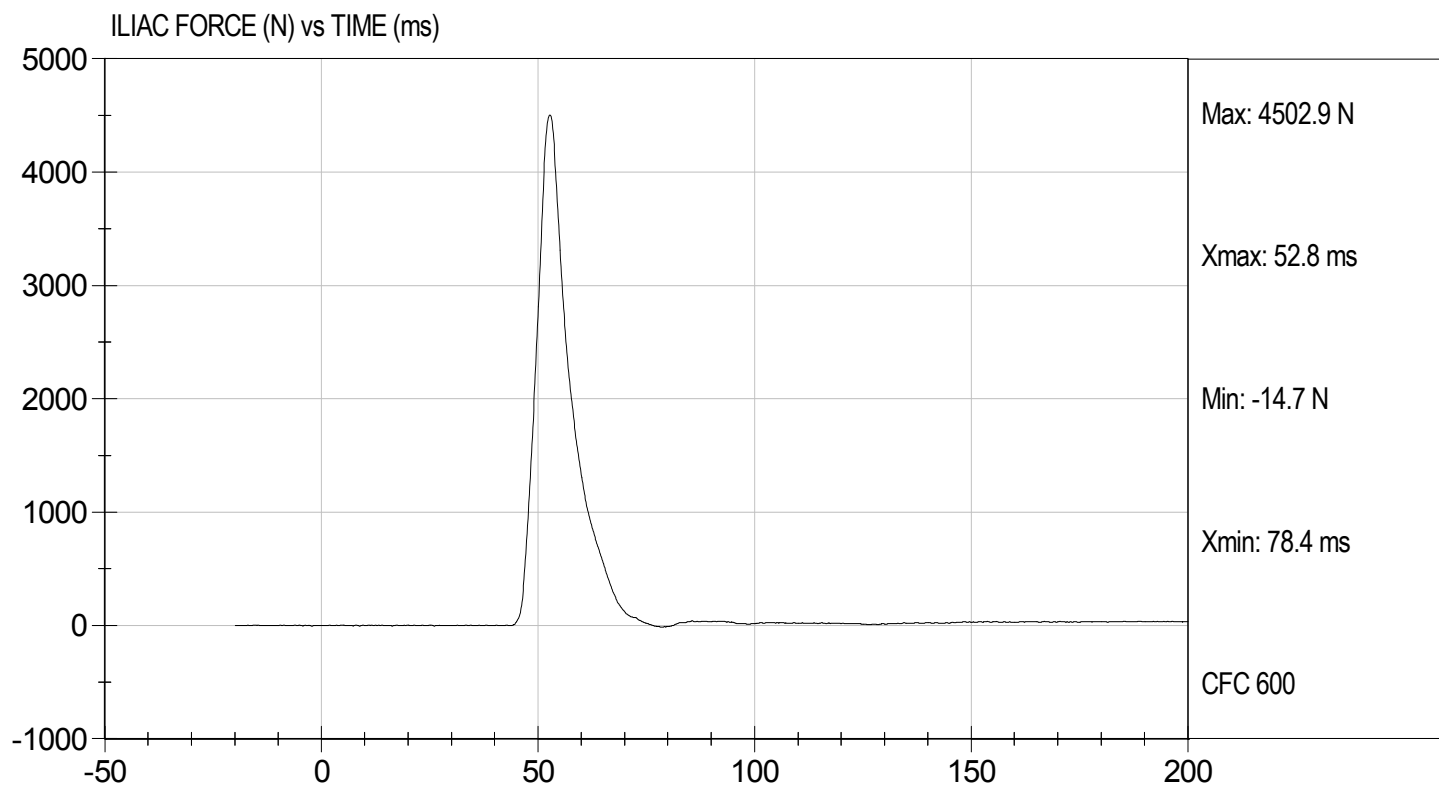
Test Desc: Iliac Impact  
Component ID: D102858

Test Date: 9/2/10  
Velocity: 14.2 ft/s, 4.33 m/s
