**REPORT NUMBER: NCAP-MGA-2011-017**

**NEW CAR ASSESSMENT PROGRAM (NCAP)  
Frontal Barrier Impact Test**

**GENERAL MOTORS LLC  
2011 Chevrolet Tahoe LS 4WD  
NHTSA No.: MB0120**

**FINAL REPORT**

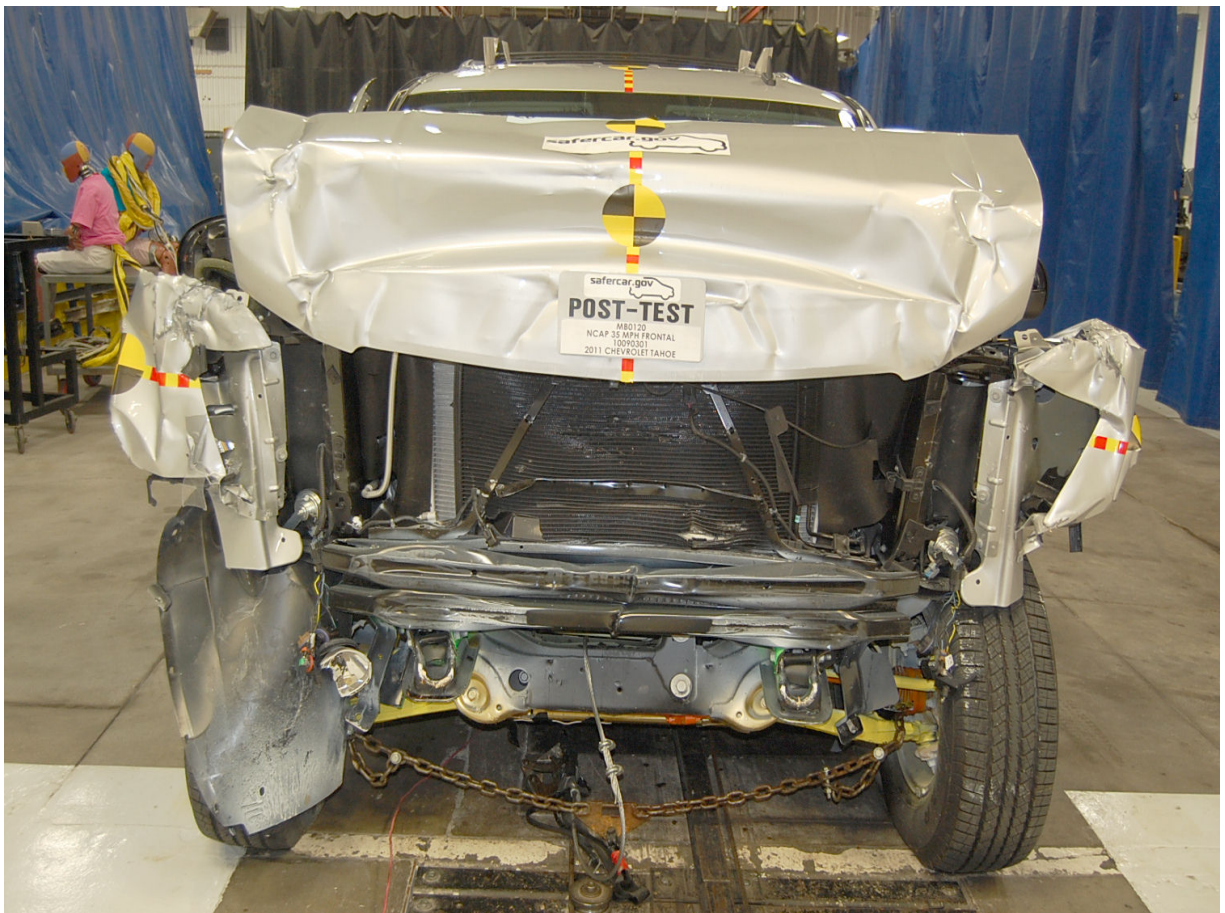
Post-Test Front View

The maximum static crush of the vehicle was 698 mm and both the driver and passenger side doors remained closed during the impact event and were operable after the impact.

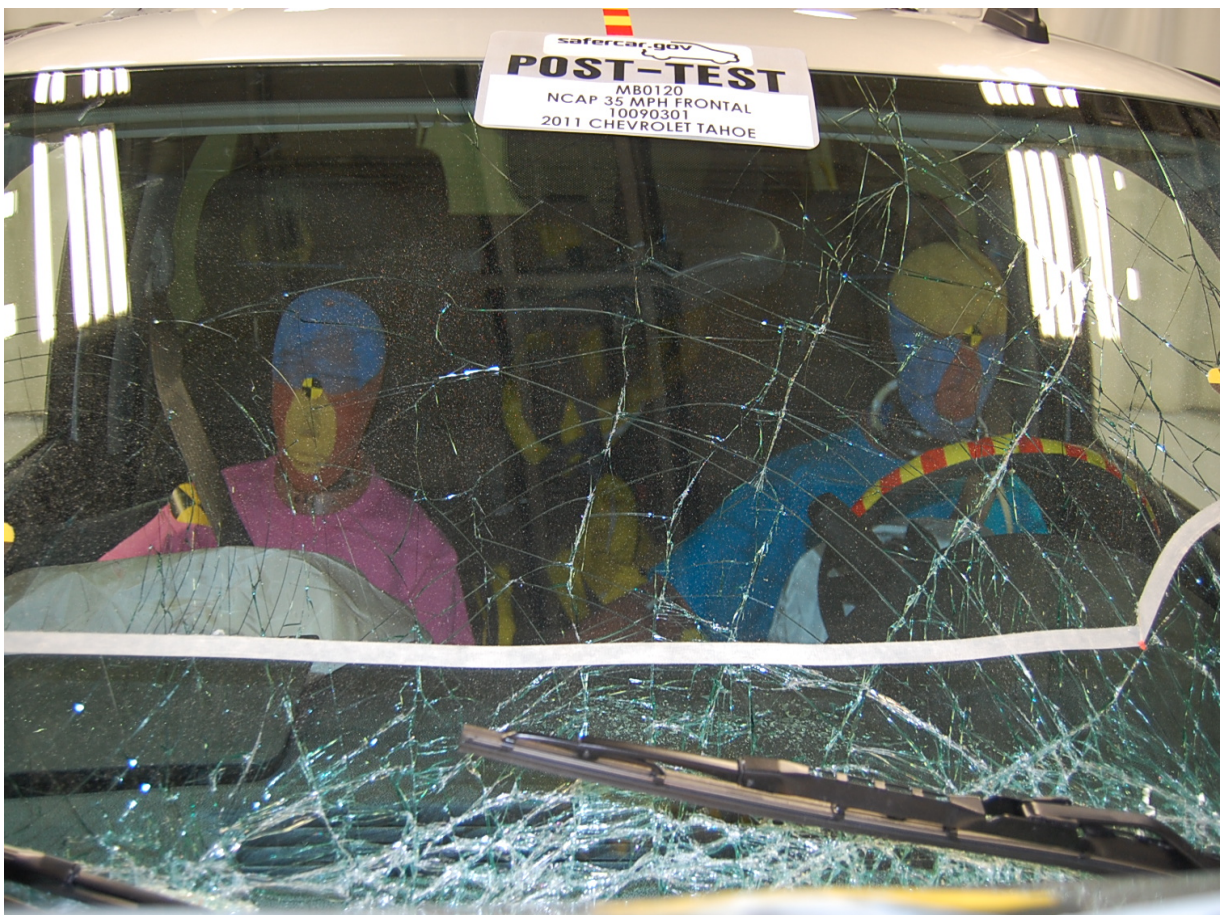
Post-Test Windshield View

There was 100 percent windshield retention and no intrusion into the protected zone of the windshield during the event. There was no Stoddard Solvent leakage after the event or during any phase of the static rollover.

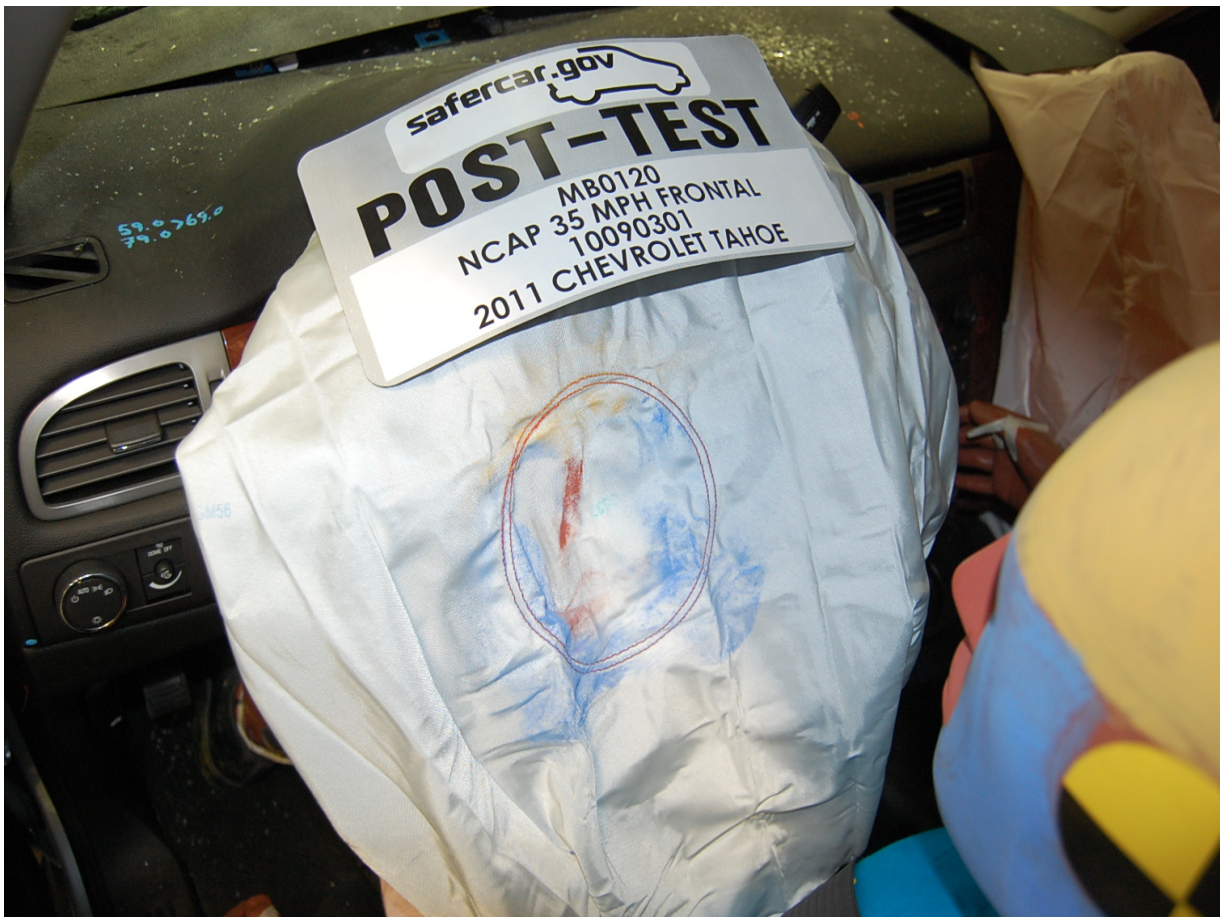
Post-Test Driver Dummy Contact with Airbag

The driver's head and chest contacted the airbag. The driver's head also contacted headrest. The driver's knees contacted the knee bolster. The passenger's head and chest contacted the airbag. The passenger's head also contacted the headrest. The passenger's knees contacted the glovebox.

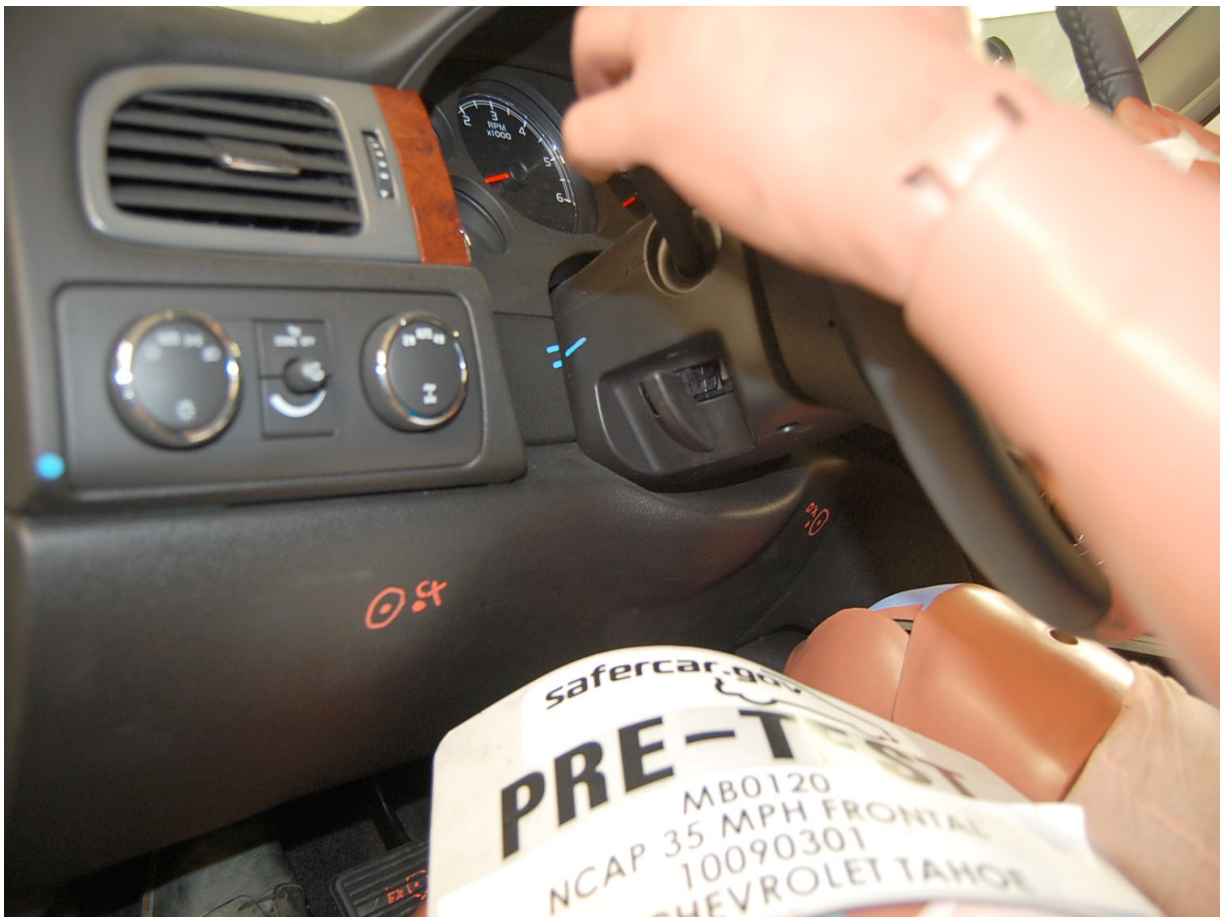
Post-Test Driver Dummy Contact with Knee Bolster

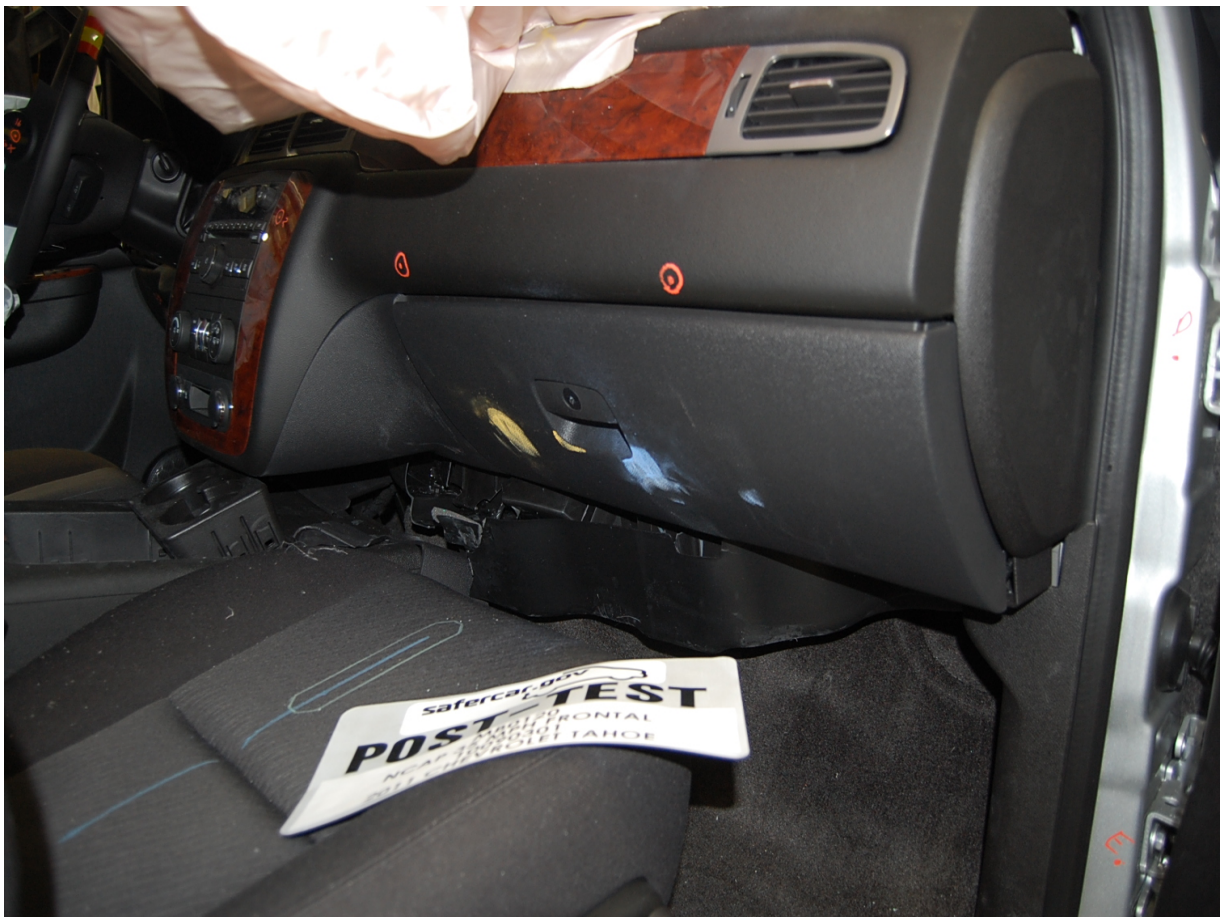
Post-Test Passenger Dummy Contact with Glovebox
