REPORT NUMBER: SINCAP-MGA-2011-022

**NEW CAR ASSESSMENT PROGRAM (NCAP)
Moving Deformable Barrier Side Impact Test**

**CAMI AUTOMOTIVE INC.
2011 Chevrolet Equinox 1LT FWD
NHTSA No.: MB0104**

**MGA RESEARCH CORPORATION
5000 Warren Road
Burlington, WI 53105**

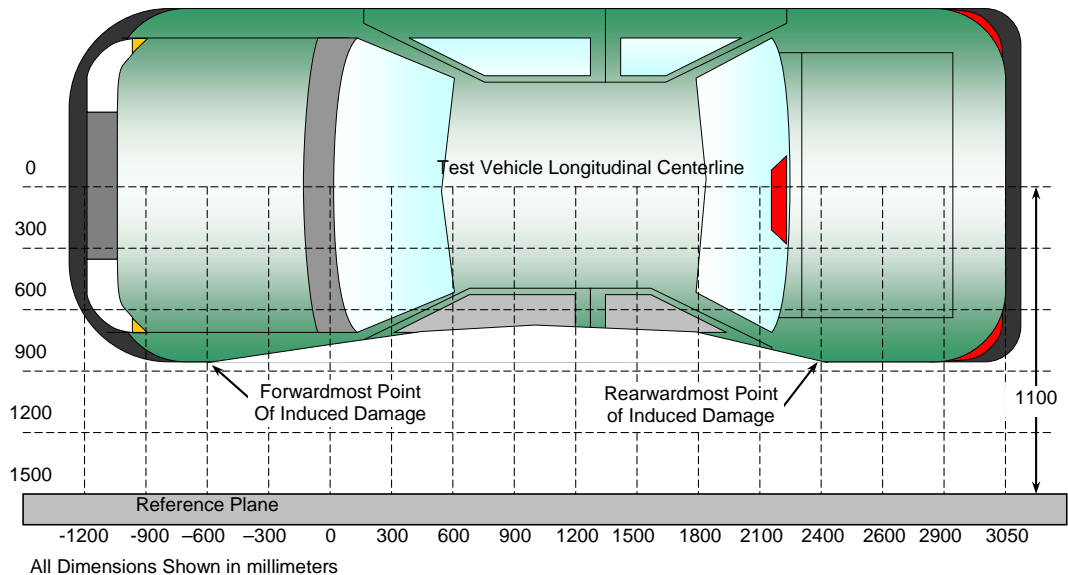
DATA SHEET NO. 13
VEHICLE DAMAGE PROFILE DISTANCES

TOP VIEW

DAMAGE PROFILE DISTANCES

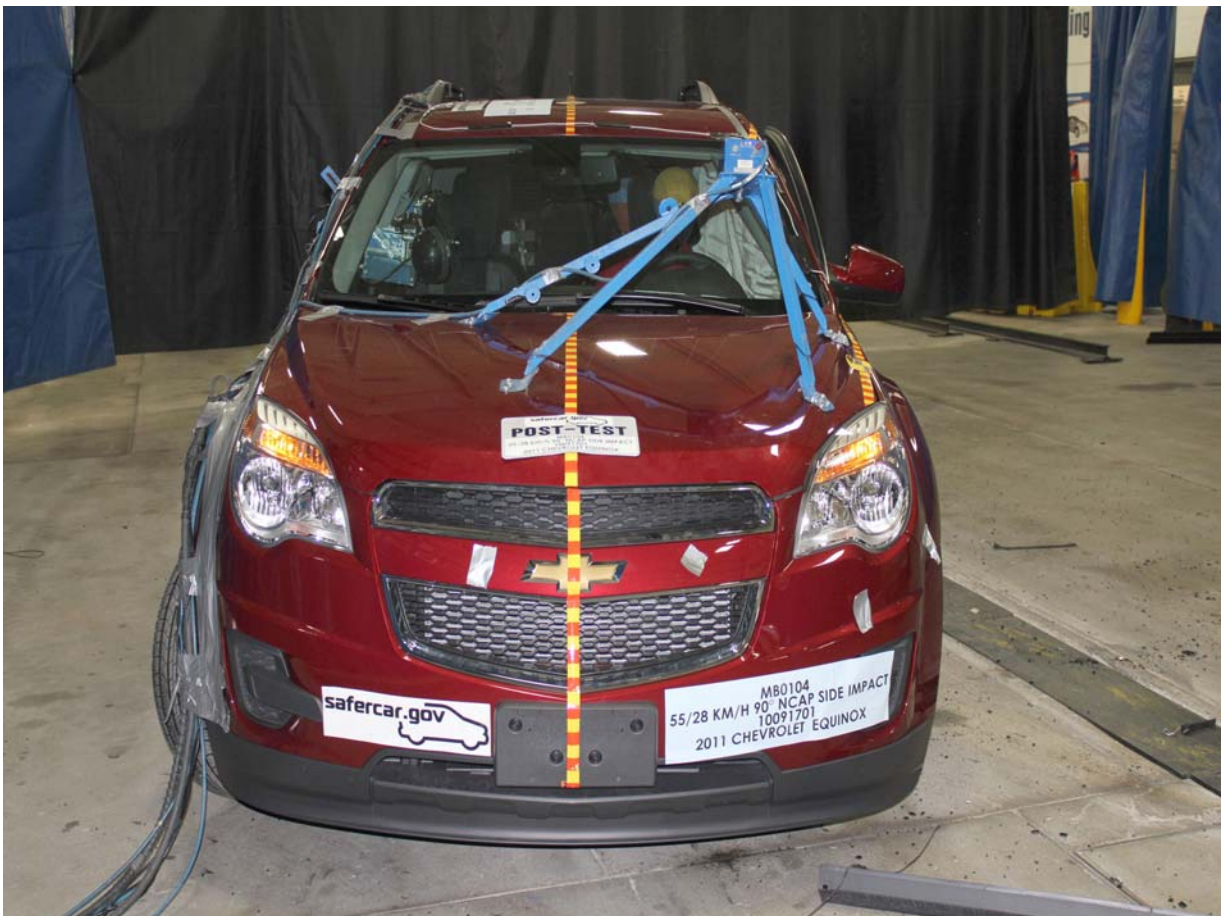
Post-Test Frontal View of Test Vehicle

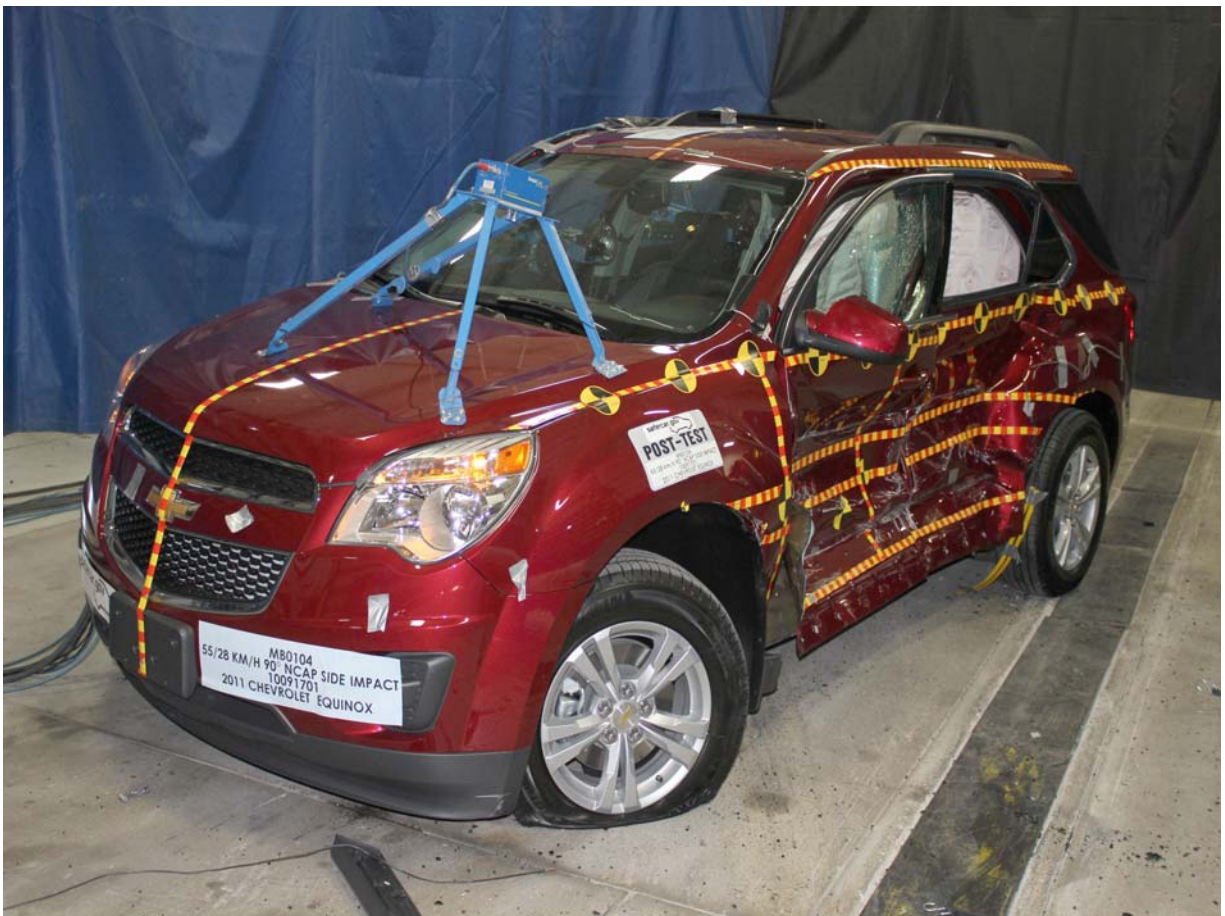
Post-Test Left Three-Quarter Front View of Test Vehicle

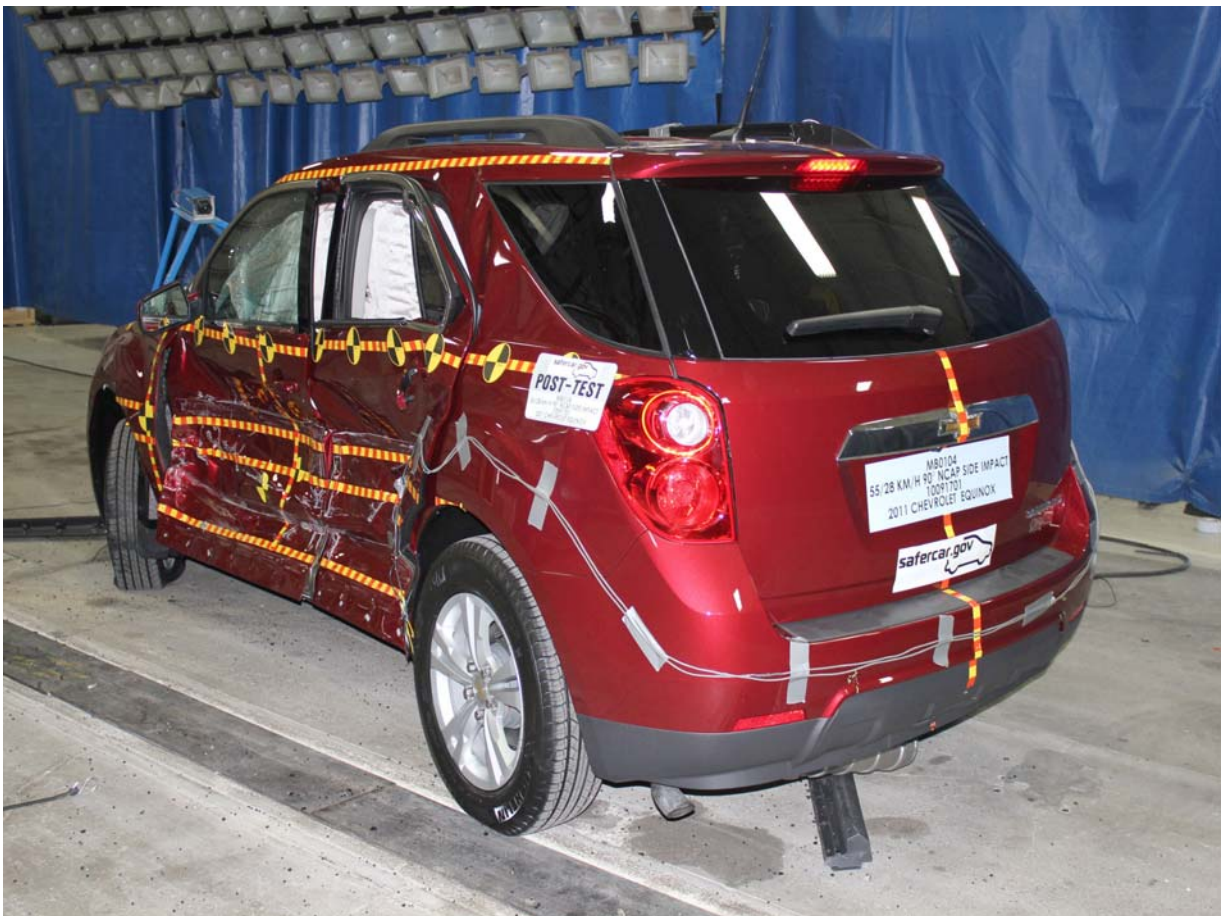
Post-Test Left Three-Quarter Rear View of Test Vehicle

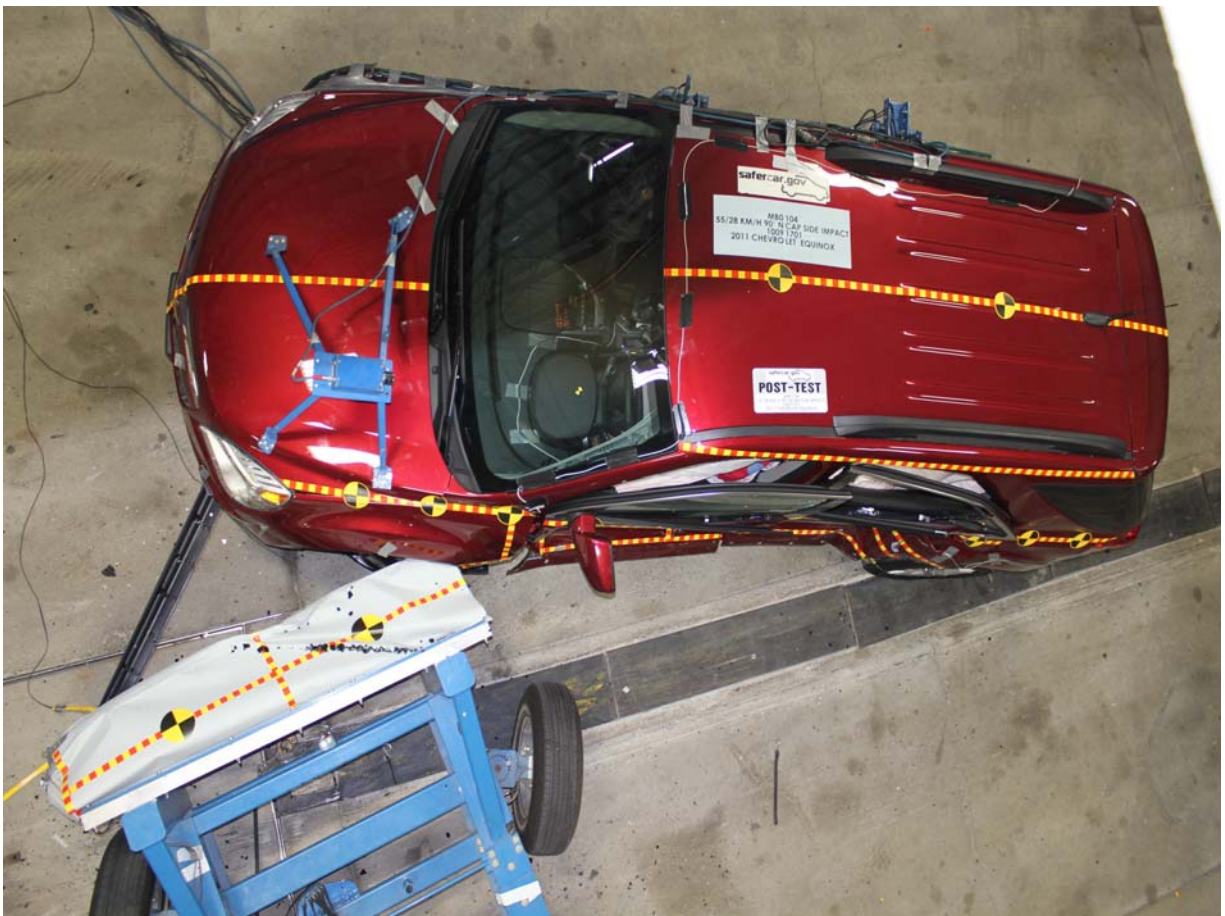
Post-Test Overhead View of Test Vehicle and MDB

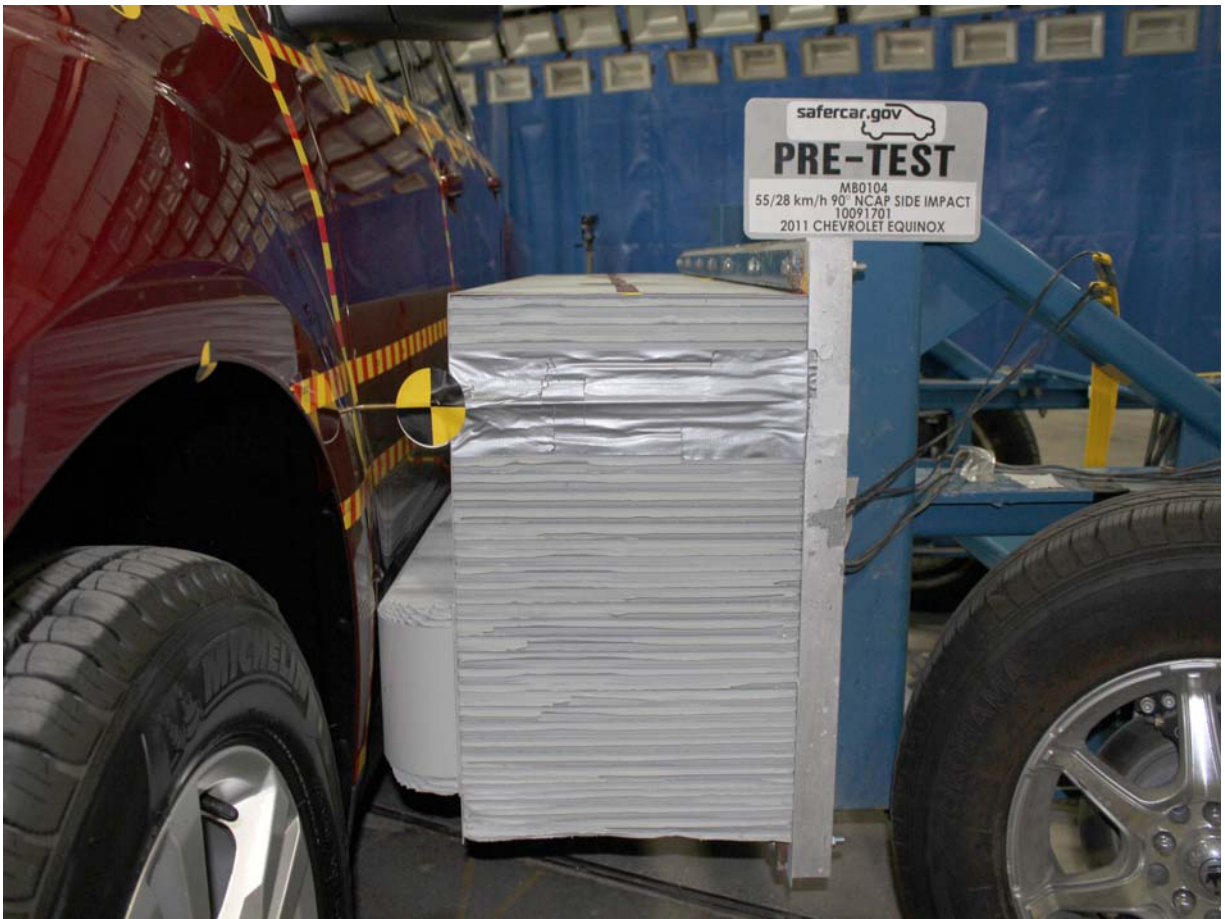
Pre-Test Left Side View of MDB Positioned Against Side of Test Vehicle

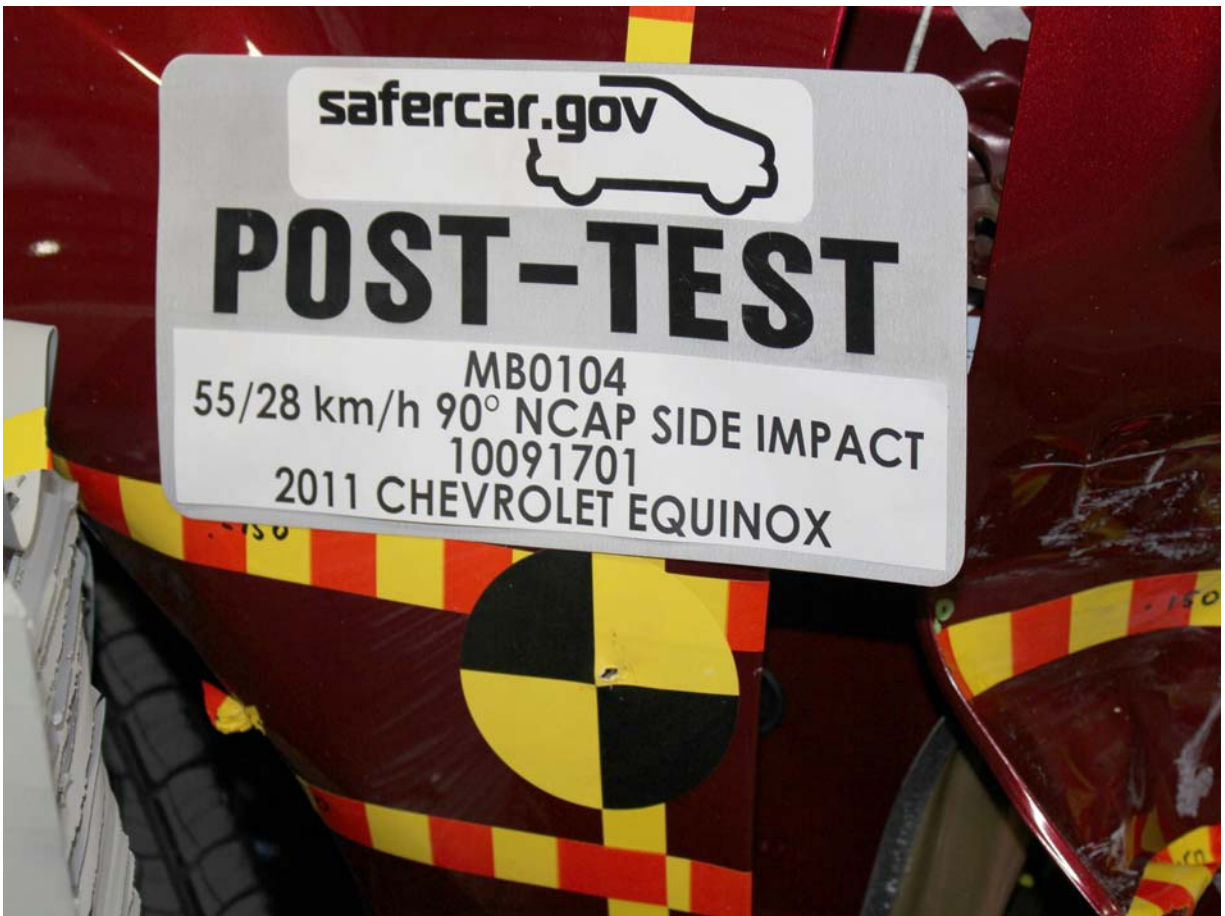
Post-Test Close-Up View of Impact Point Target

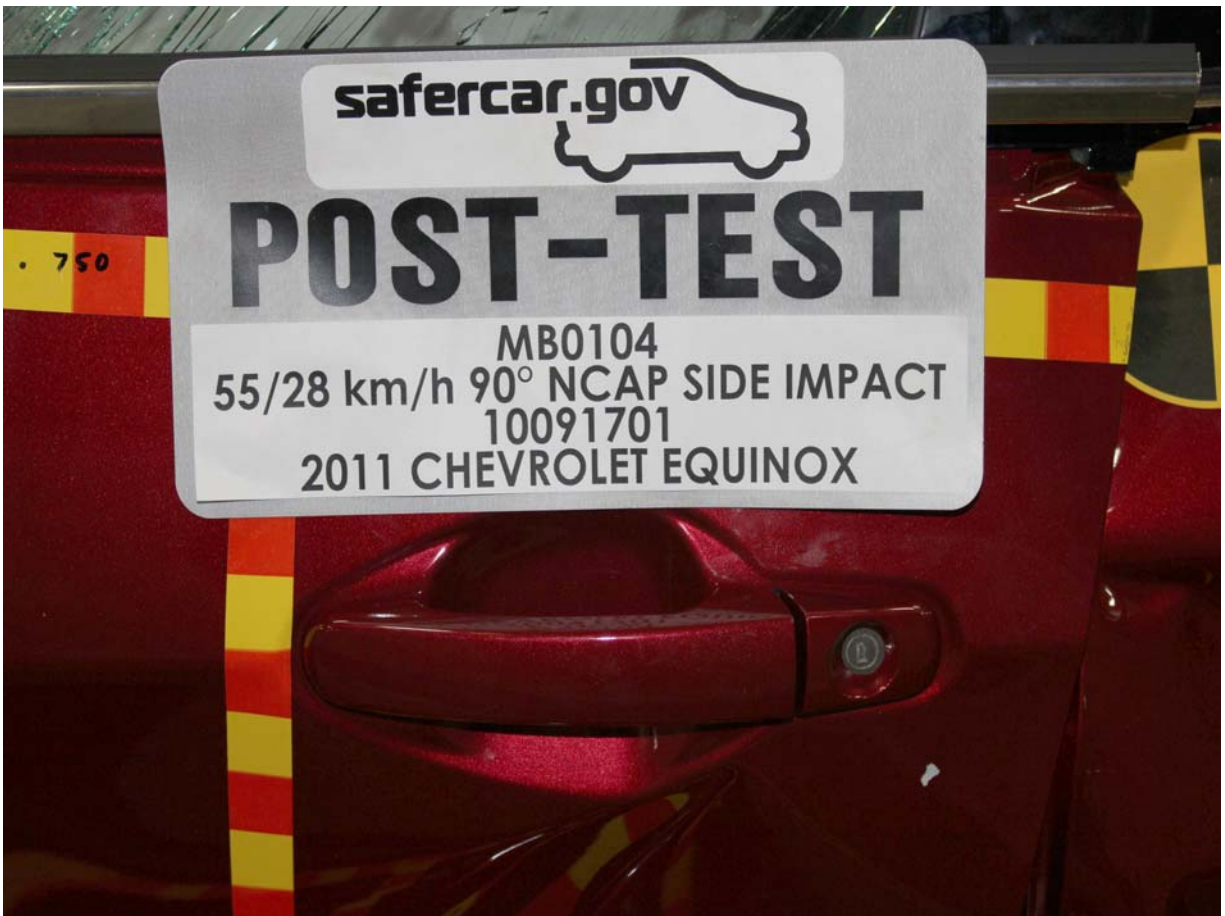
Post-Test Left Front Door Latch Close-Up

The two doors on the struck side of the vehicle did not separate from the body at the hinges or latches and the opposite doors did not open during the side impact event.

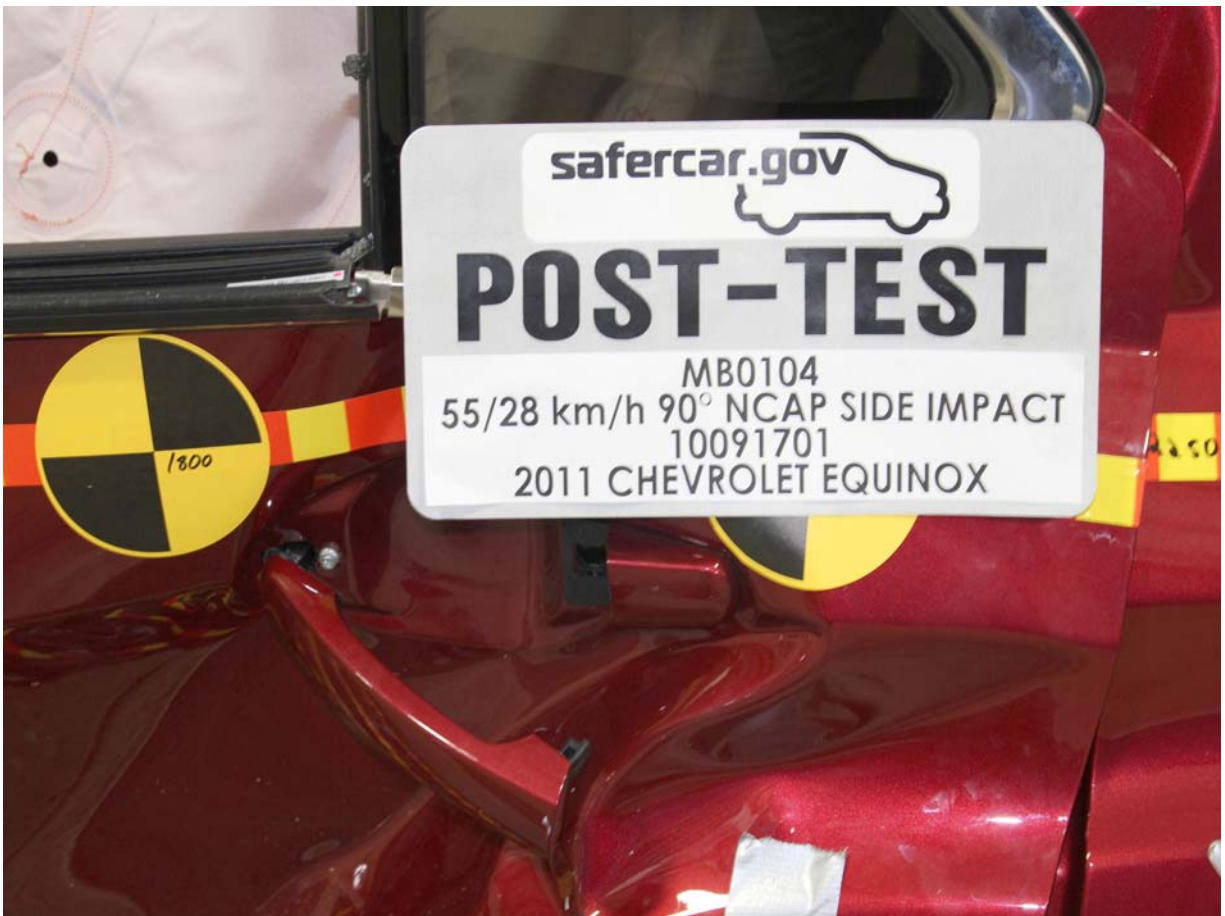
Post-Test Left Rear Door Latch Close-Up

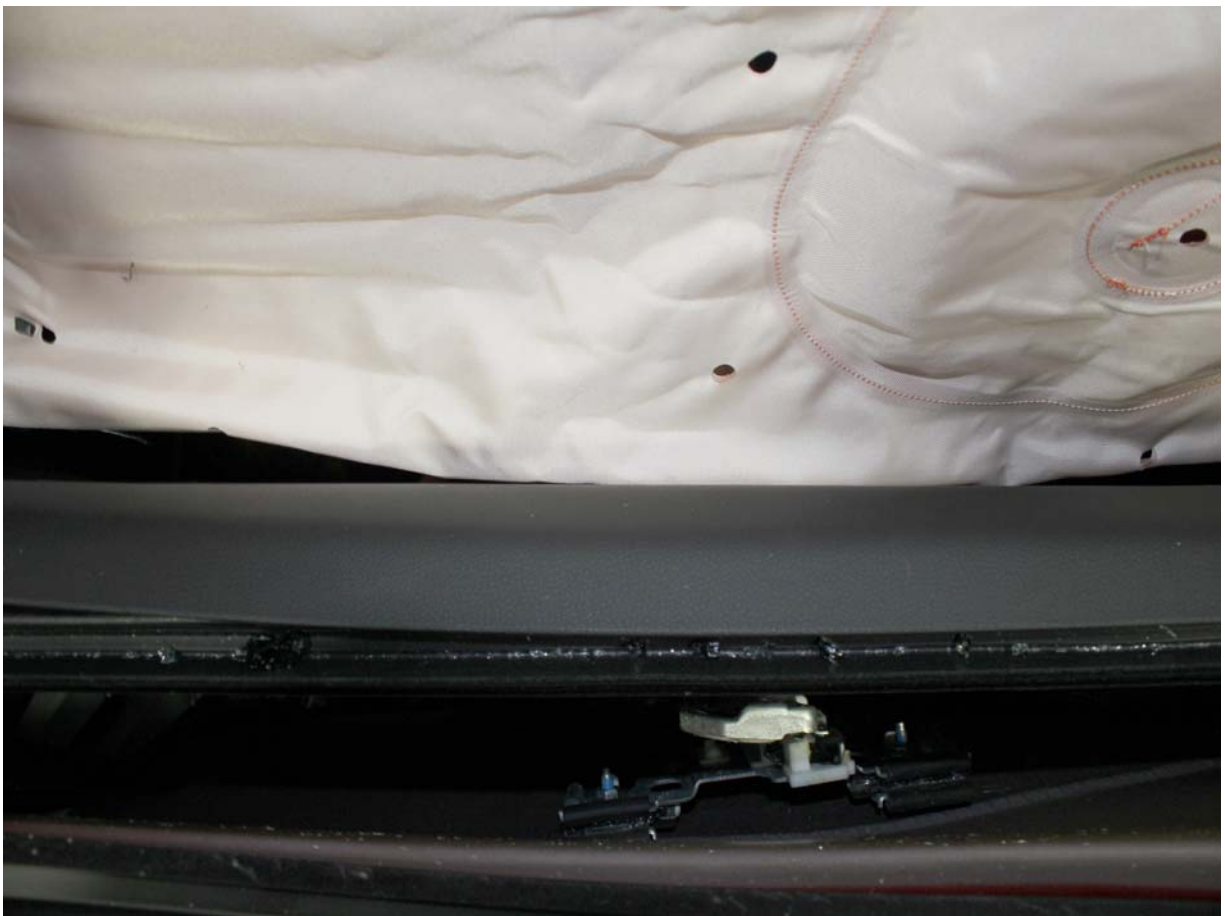
Post-Test Driver Dummy and Door Clearance View

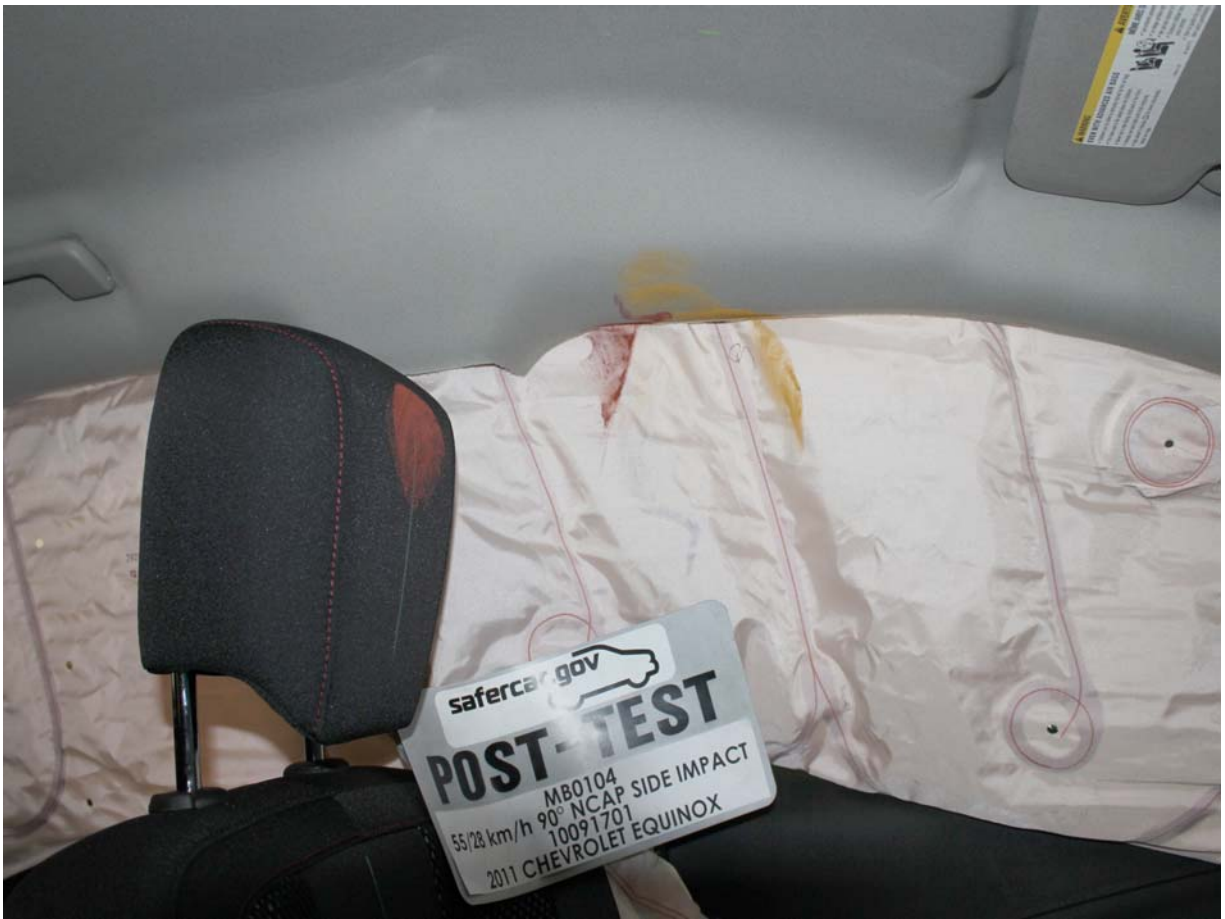
Post-Test Driver Dummy Close-up Head Contact with Vehicle View

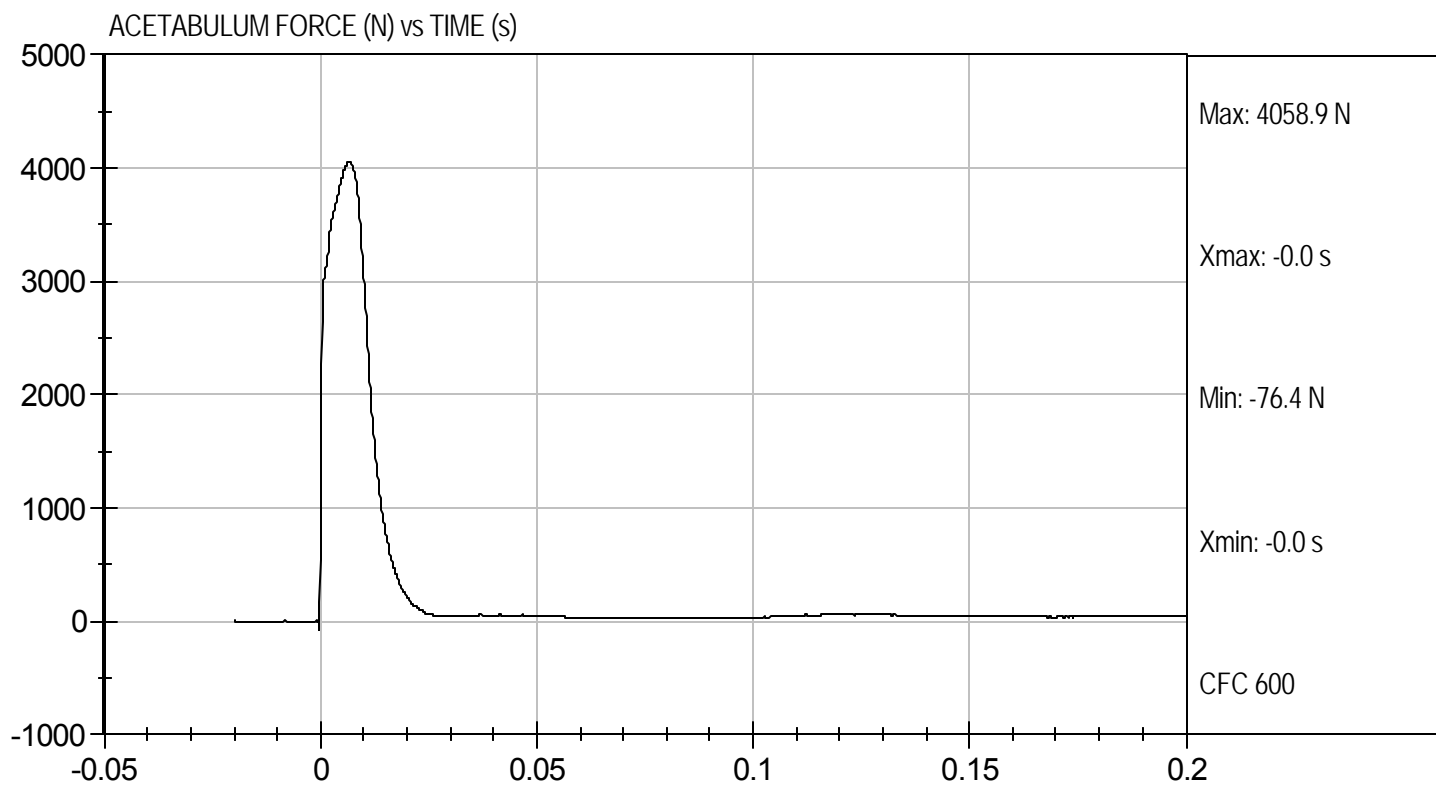
Test Desc: Pelvis Impact
Component ID: D102997

Test Date: 9/14/10
Velocity: 22.01 ft/s, 6.71 m/s

Tested Parameter	Units	Specification	Result	Pass/Fail
Temperature	deg C	20.6 to 22.2	21.8	Pass
Humidity	%	10 to 70	52	Pass
Impact Velocity	m/s	6.60 to 6.80	6.71	Pass
Peak Impactor Acceleration	G's	38 to 47	41	Pass
Pelvis Y Acceleration after 6 ms	G's	34 to 42	37	Pass
Peak Acetabulum Force	N	3600 to 4300	4059	Pass
Overall Test Results				Pass

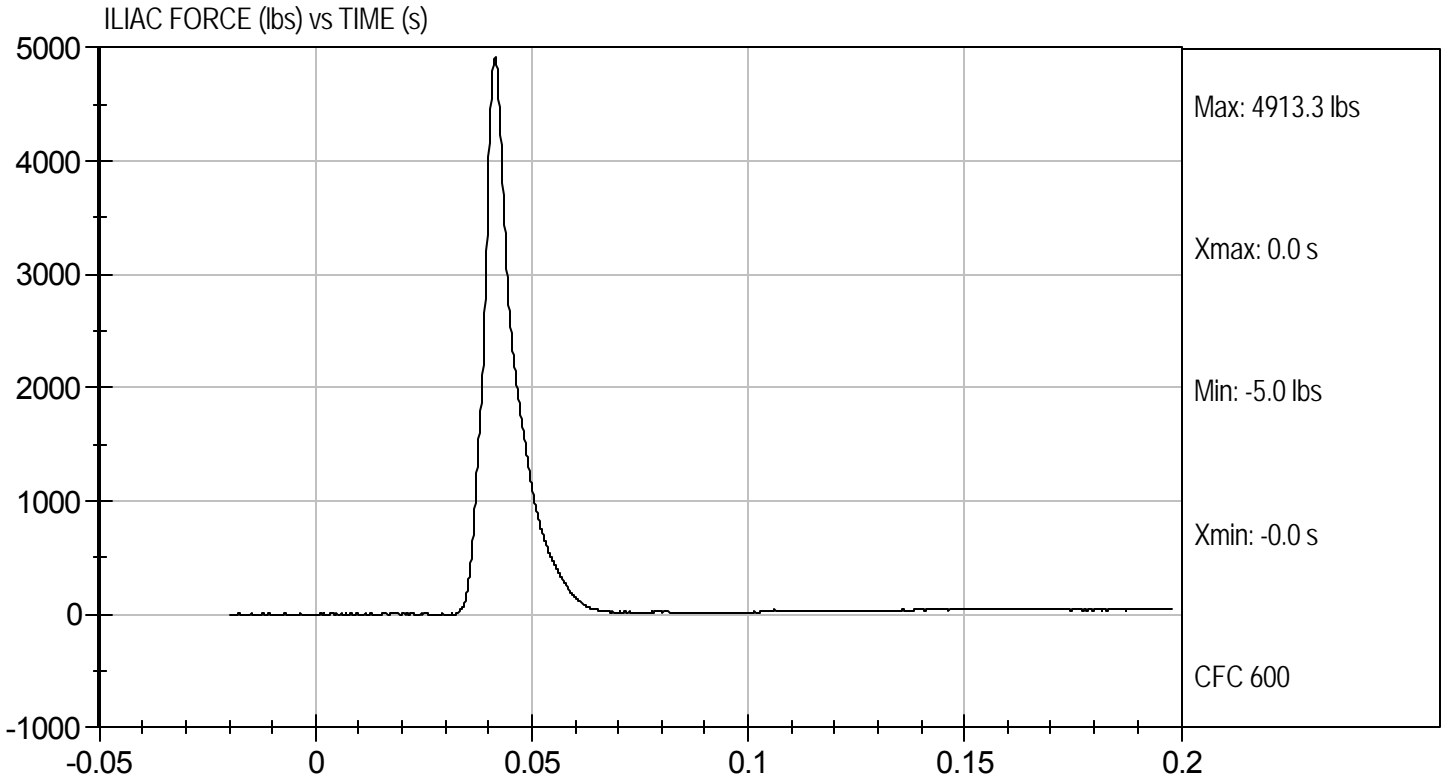
Test Desc: Iliac Impact
Component ID: D102998

Test Date: 9/14/10
Velocity: 14.37 ft/s, 4.38 m/s

Tested Parameter	Units	Specification	Result	Pass/Fail
Temperature	deg C	20.6 to 22.2	21.9	Pass
Humidity	%	10 to 70	54	Pass
Impact Velocity	m/s	4.20 to 4.40	4.38	Pass
Peak Impactor Acceleration	G's	36 to 45	39	Pass
Pelvis Y Acceleration	G's	28 to 39	29	Pass
Peak Pelvis Iliac Force	N	4100 to 5100	4913	Pass
Overall Test Results				Pass

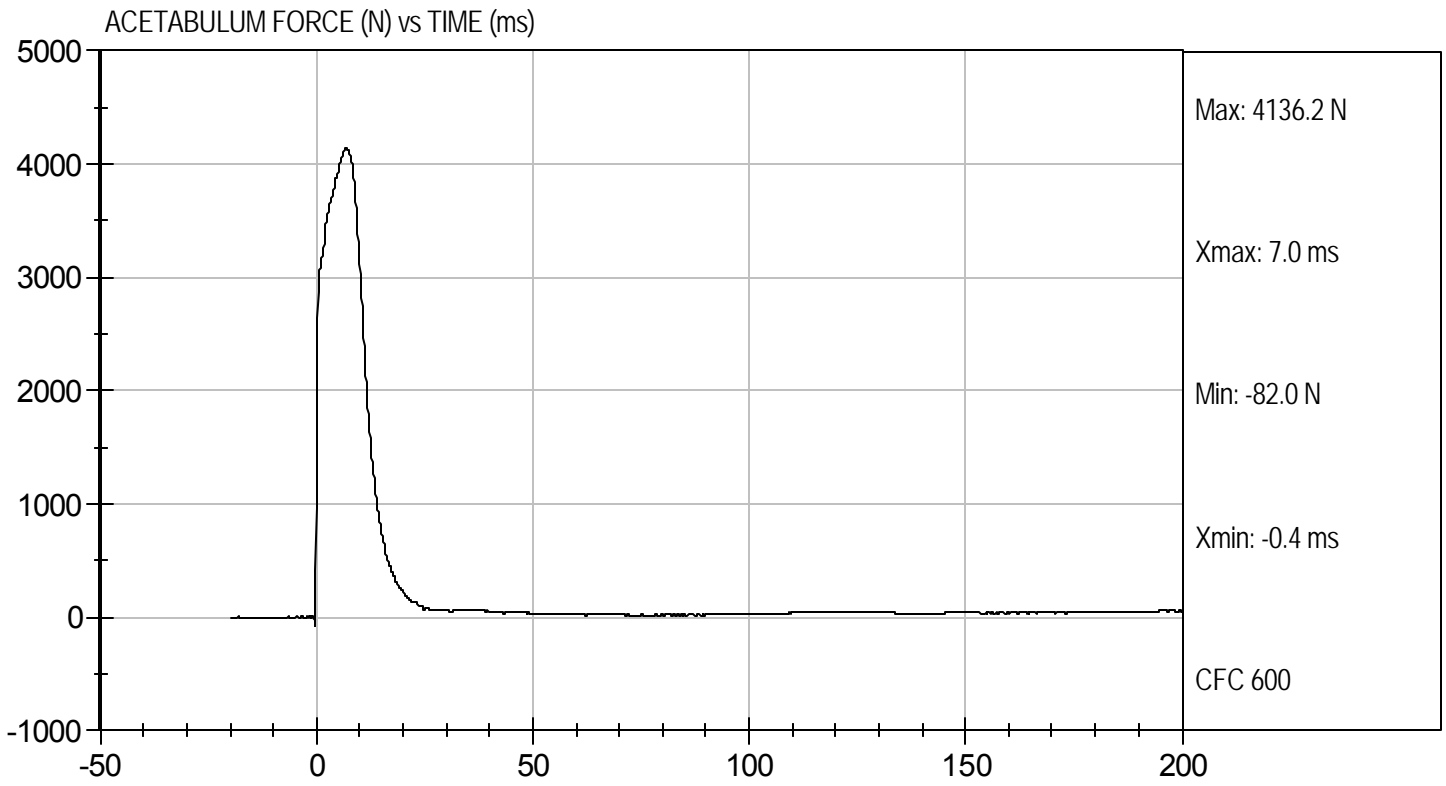
Test Desc: Pelvis Impact
Component ID: D103117

Test Date: 9/21/10
Velocity: 22.00 ft/s, 6.71 m/s

Tested Parameter	Units	Specification	Result	Pass/Fail
Temperature	deg C	20.6 to 22.2	21.9	Pass
Humidity	%	10 to 70	58	Pass
Impact Velocity	m/s	6.60 to 6.80	6.71	Pass
Peak Impactor Acceleration	G's	38 to 47	41	Pass
Pelvis Y Acceleration after 6 ms	G's	34 to 42	35	Pass
Peak Acetabulum Force	N	3600 to 4300	4136	Pass
Overall Test Results				Pass

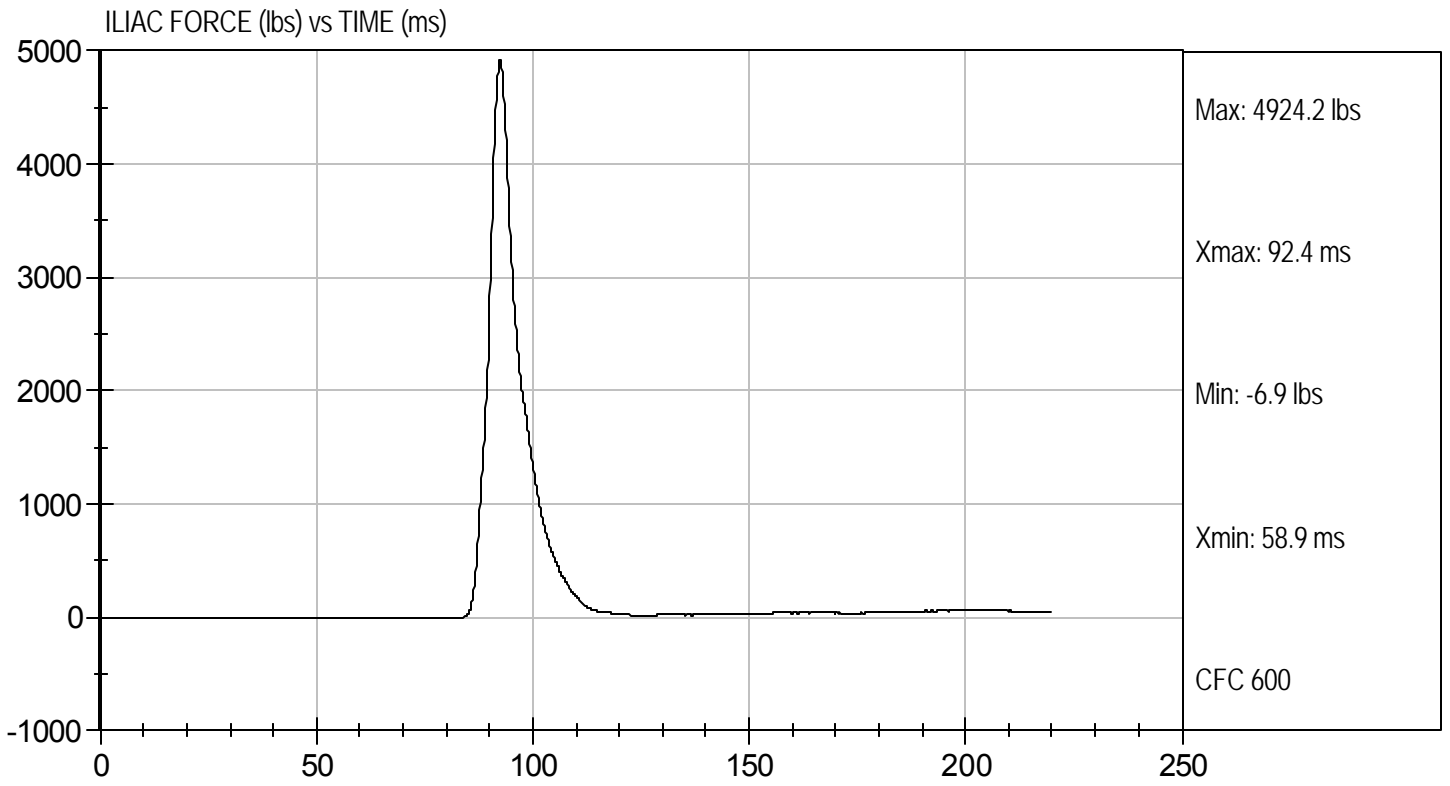
Test Desc: Iliac Impact
Component ID: D103118

Test Date: 9/21/10
Velocity: 14.36 ft/s, 4.38 m/s
