**REPORT NUMBER: NCAP-MGA-2011-023**

**NEW CAR ASSESSMENT PROGRAM (NCAP)  
Frontal Barrier Impact Test**

**GENERAL MOTORS LLC  
2011 Buick Lucerne CX 4-Dr Sedan  
NHTSA No.: MB0108**

**FINAL REPORT**

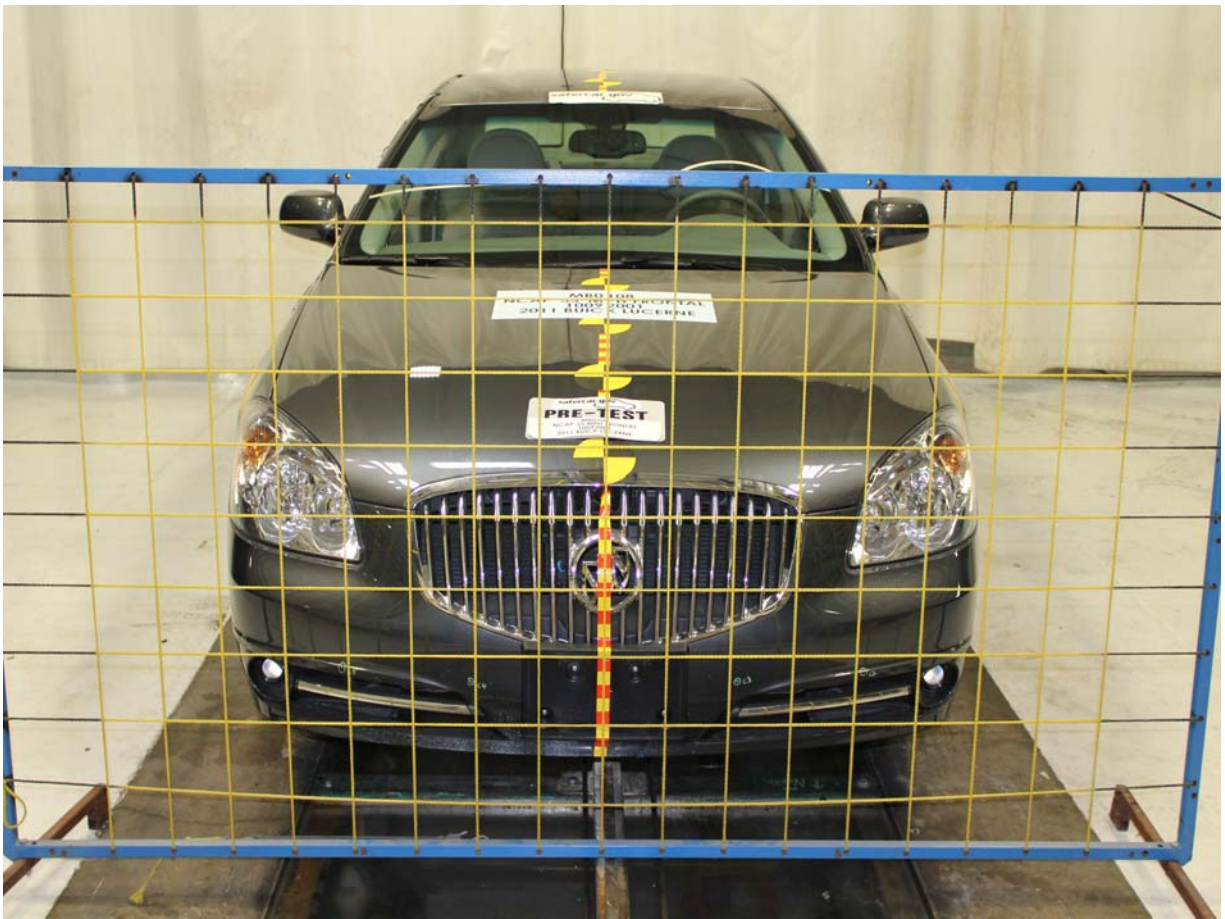
Load Cell Location

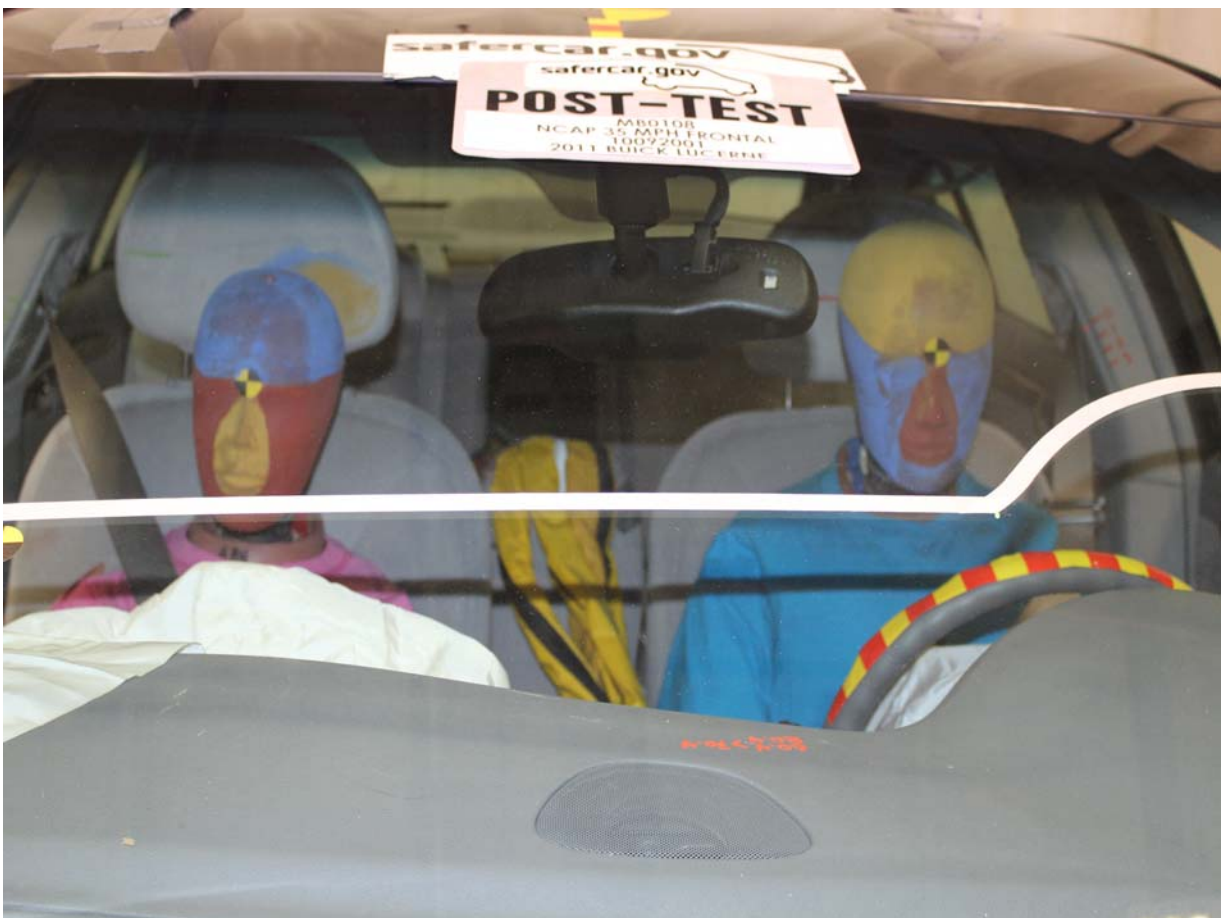
Post-Test Windshield View

There was 100 percent windshield retention and no intrusion into the protected zone of the windshield during the event. There was no Stoddard Solvent leakage after the event or during any phase of the static rollover.

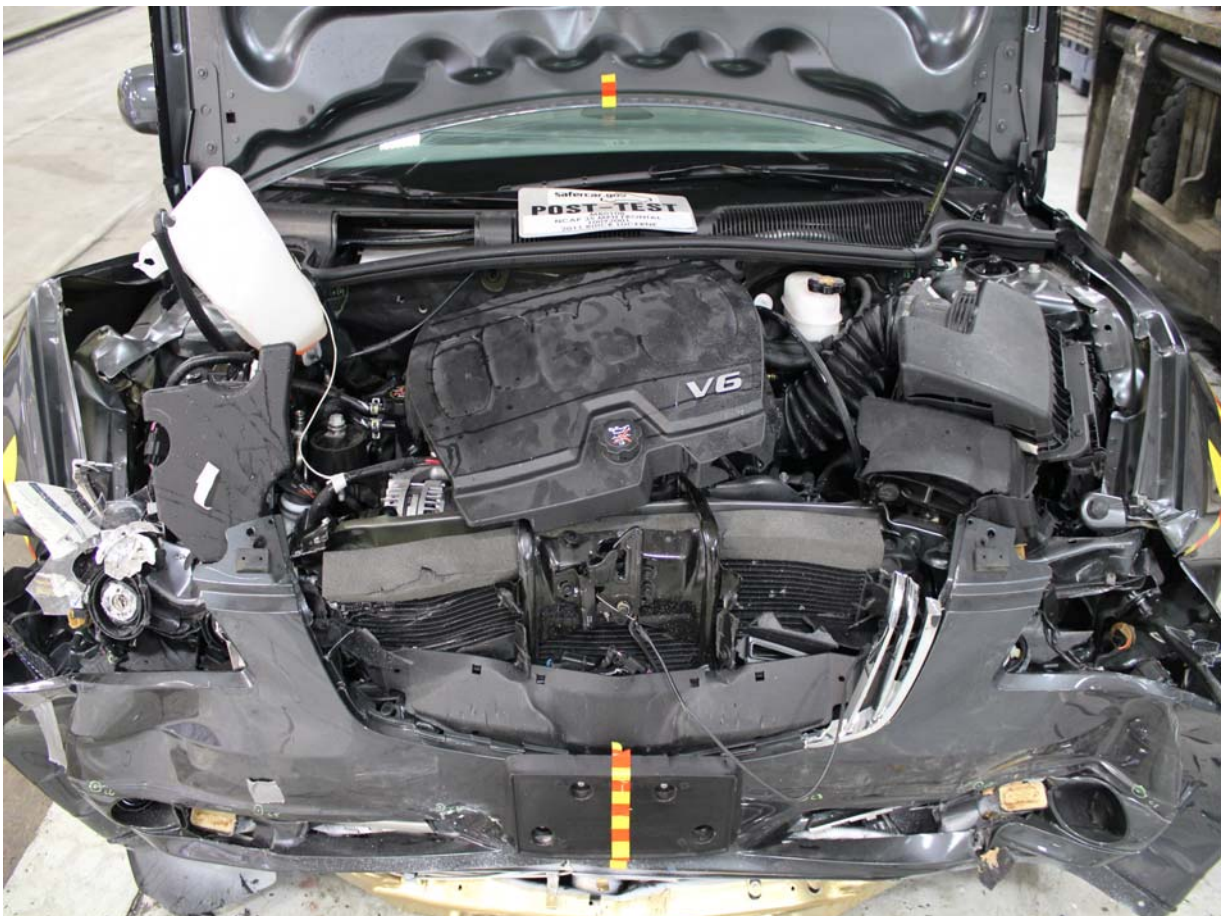
Post-Test Engine Compartment View

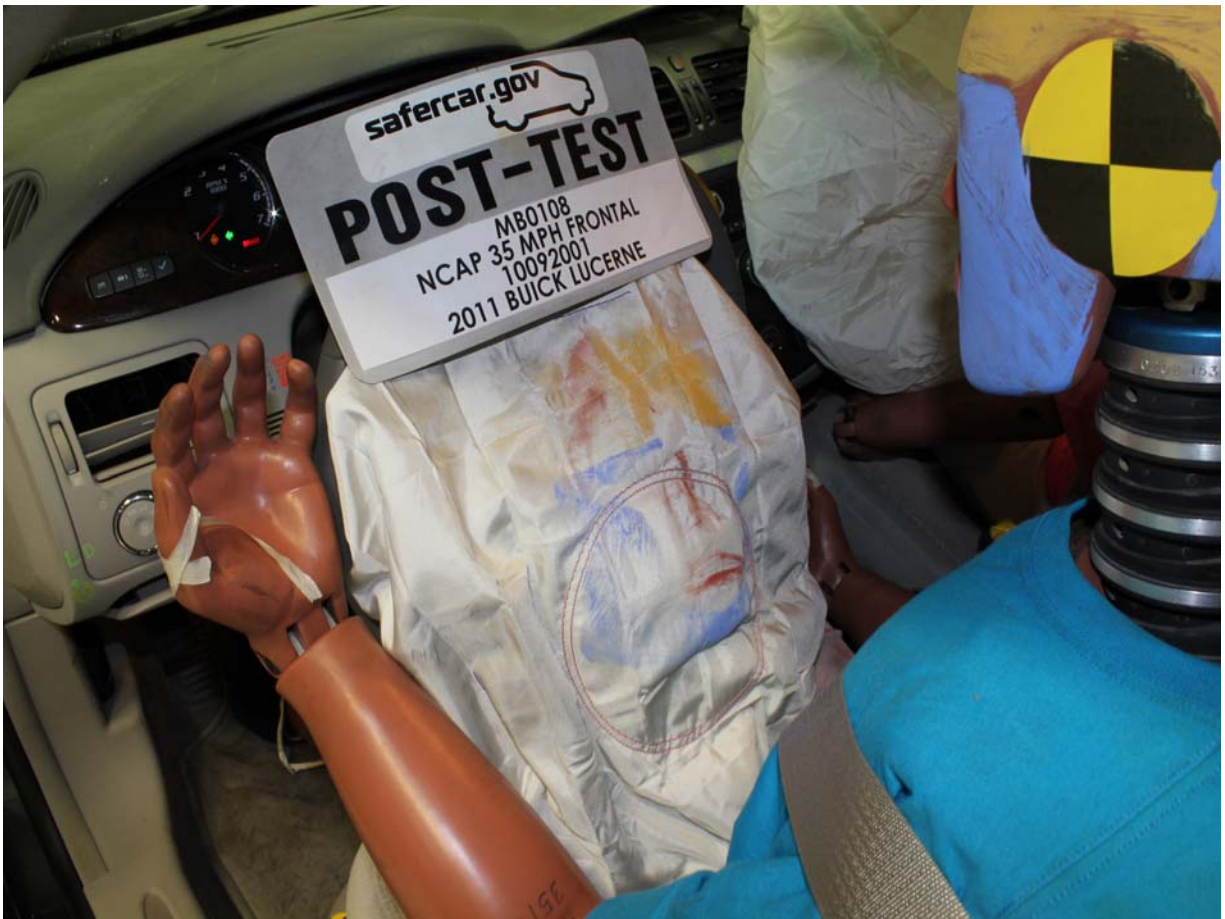
Post-Test Driver Dummy Contact with Airbag

The driver's head and chest contacted the airbag. The driver's head also contacted headrest. The driver's knees contacted the knee bolster. The passenger's head and chest contacted the airbag. The passenger's head also contacted the headrest. The passenger's knees contacted the glovebox.

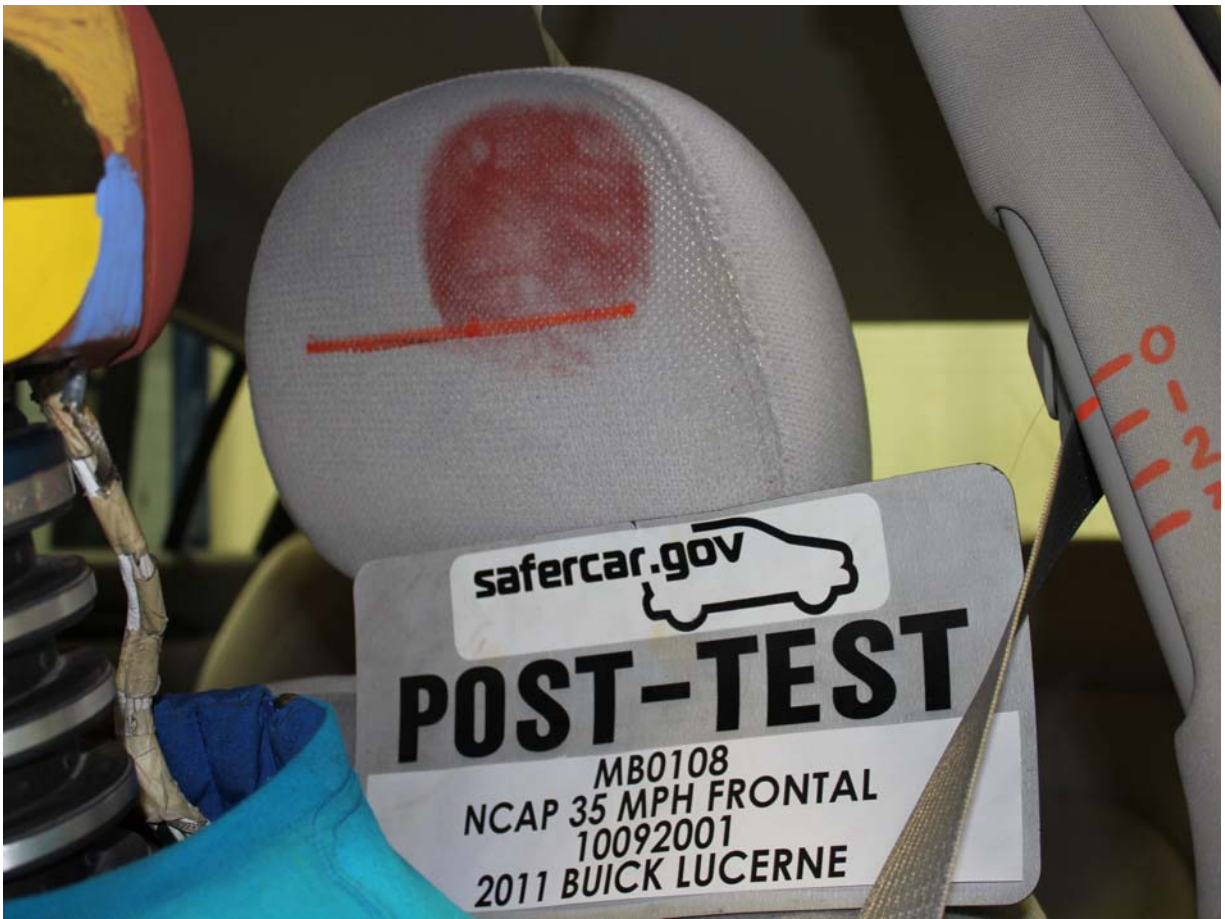
Post-Test Driver Dummy Contact with Headrest

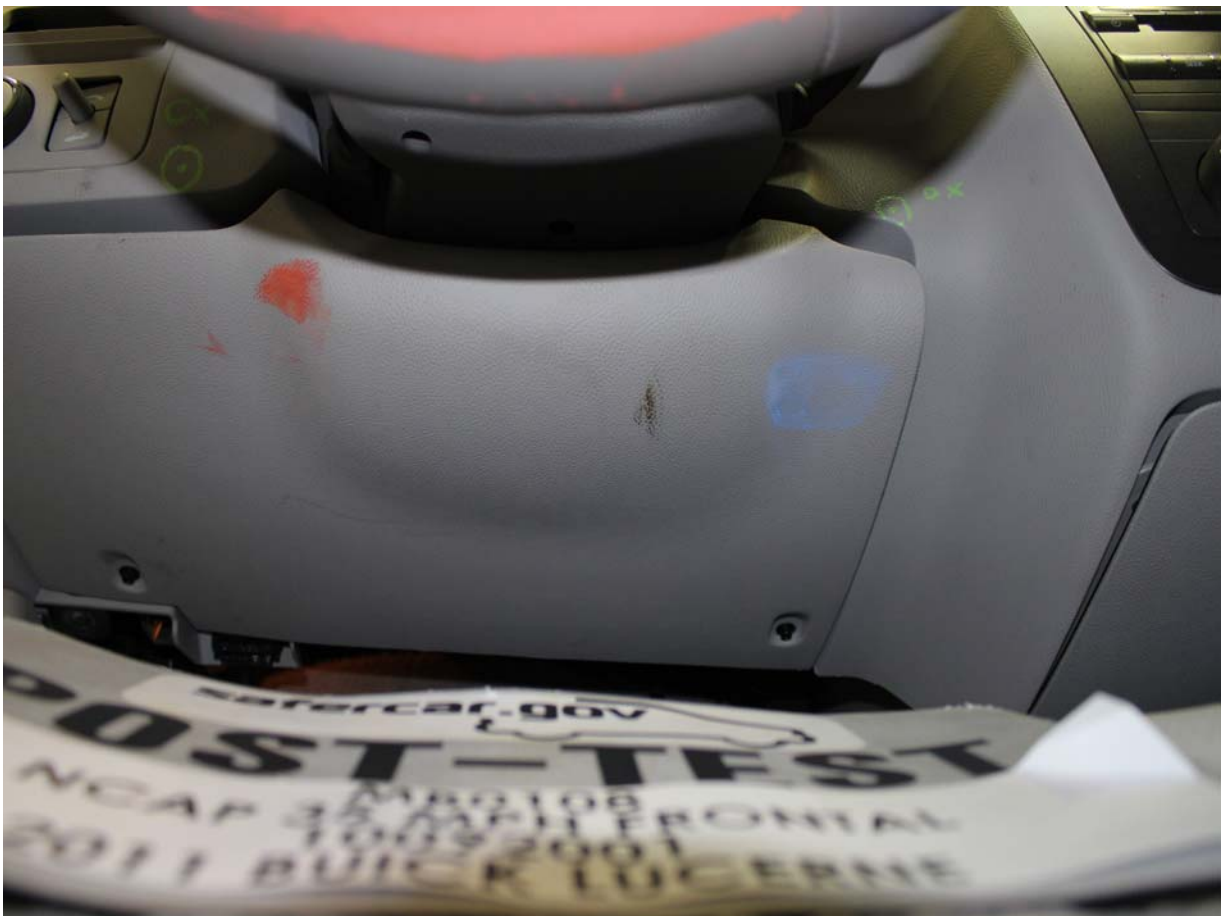
Post-Test Driver Dummy Contact with Knee Bolster

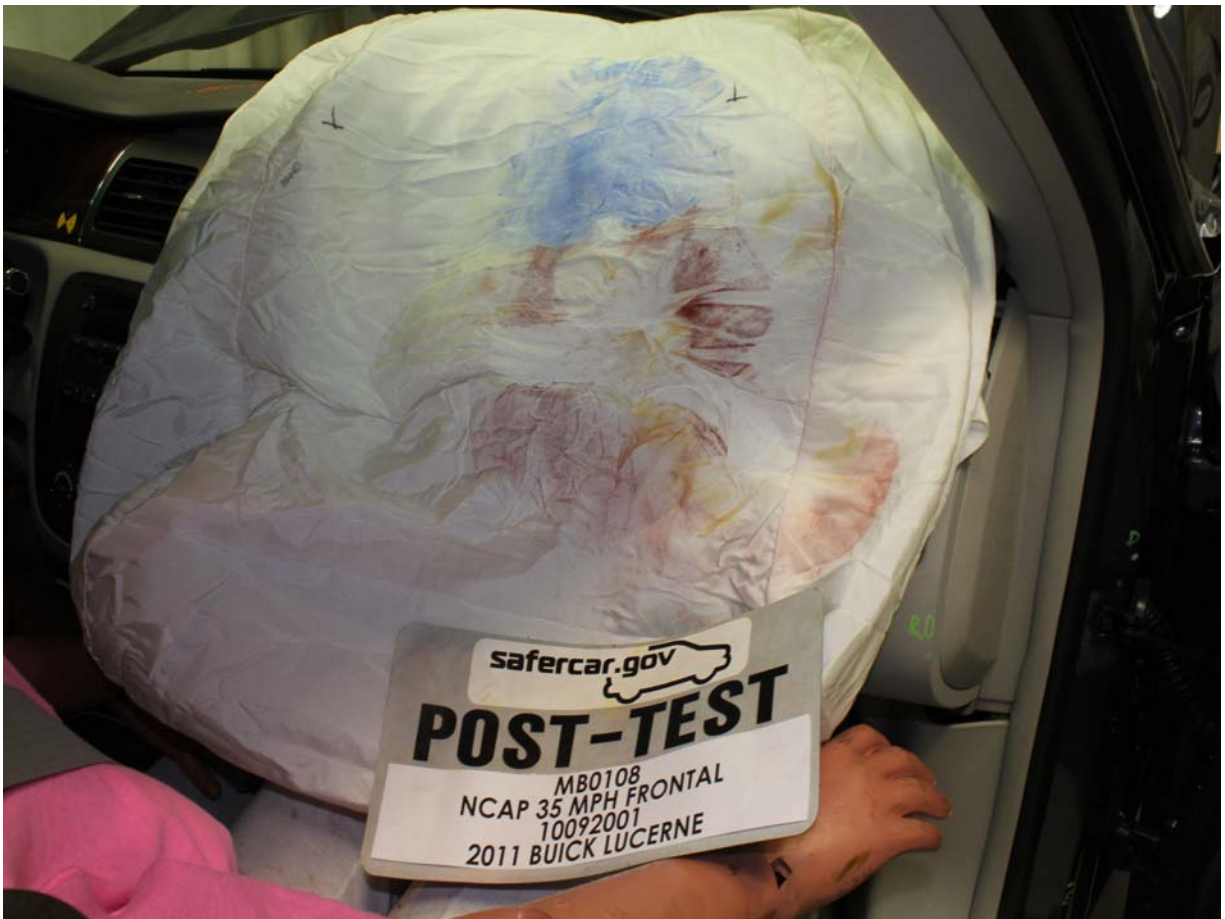
Post-Test Passenger Dummy Contact with Airbag

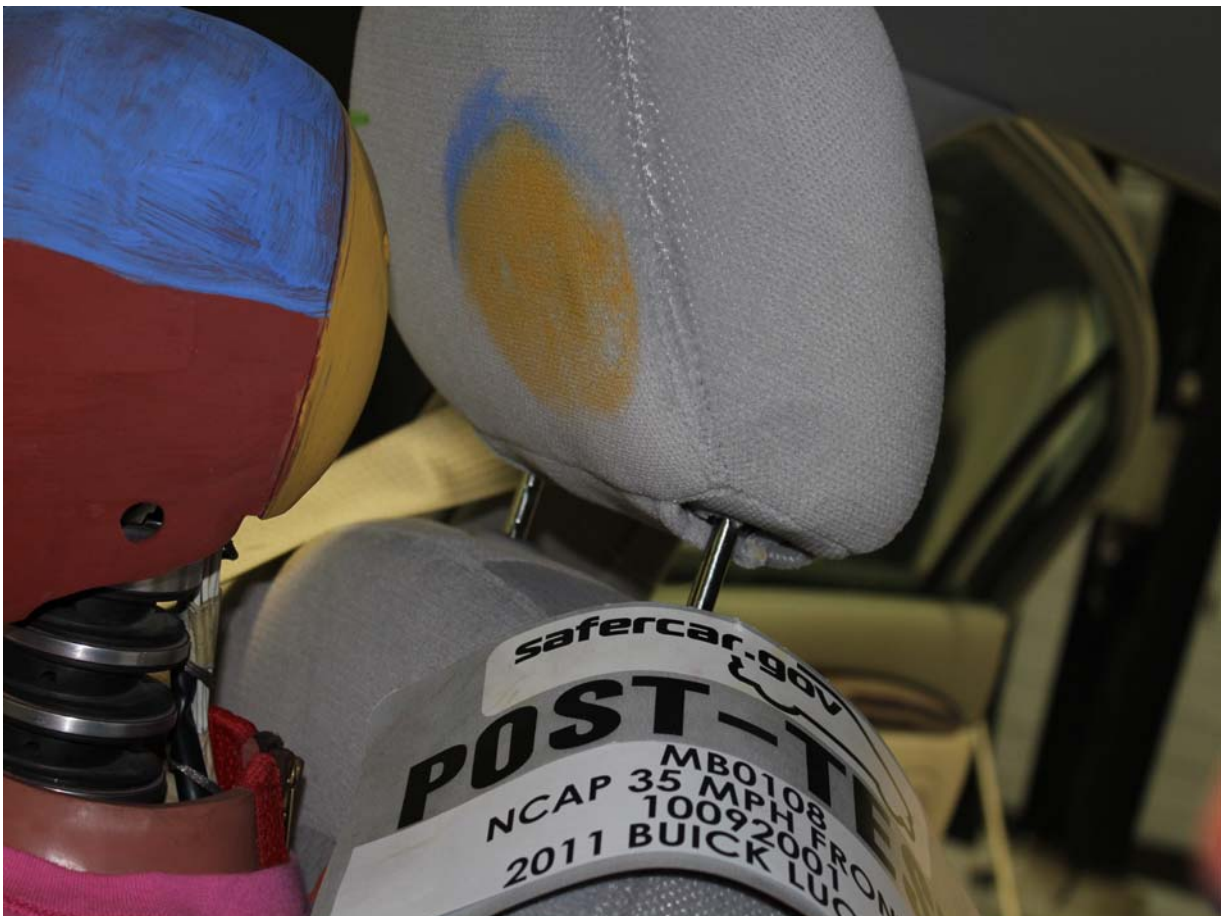
Post-Test Passenger Dummy Contact with Headrest

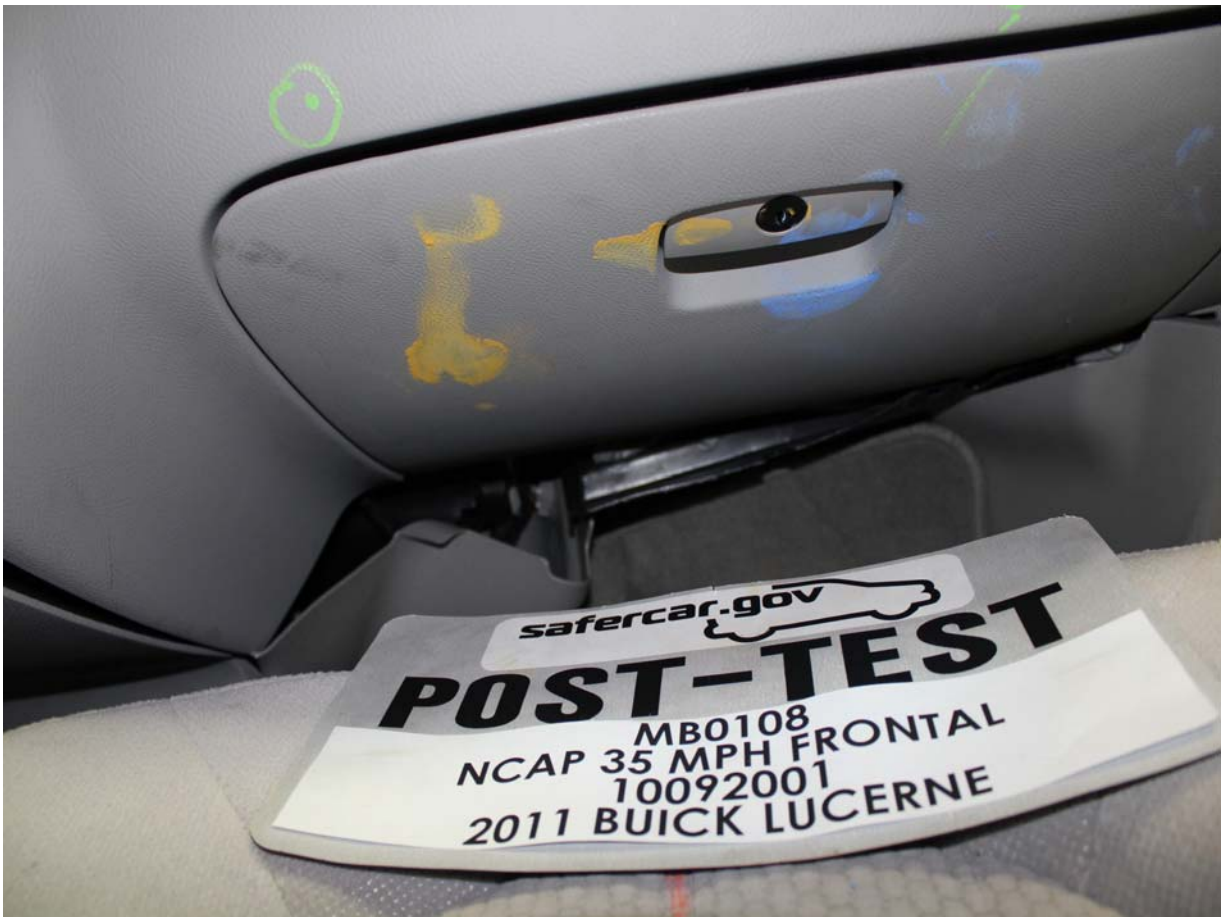
Post-Test Passenger Dummy Contact with Glovebox

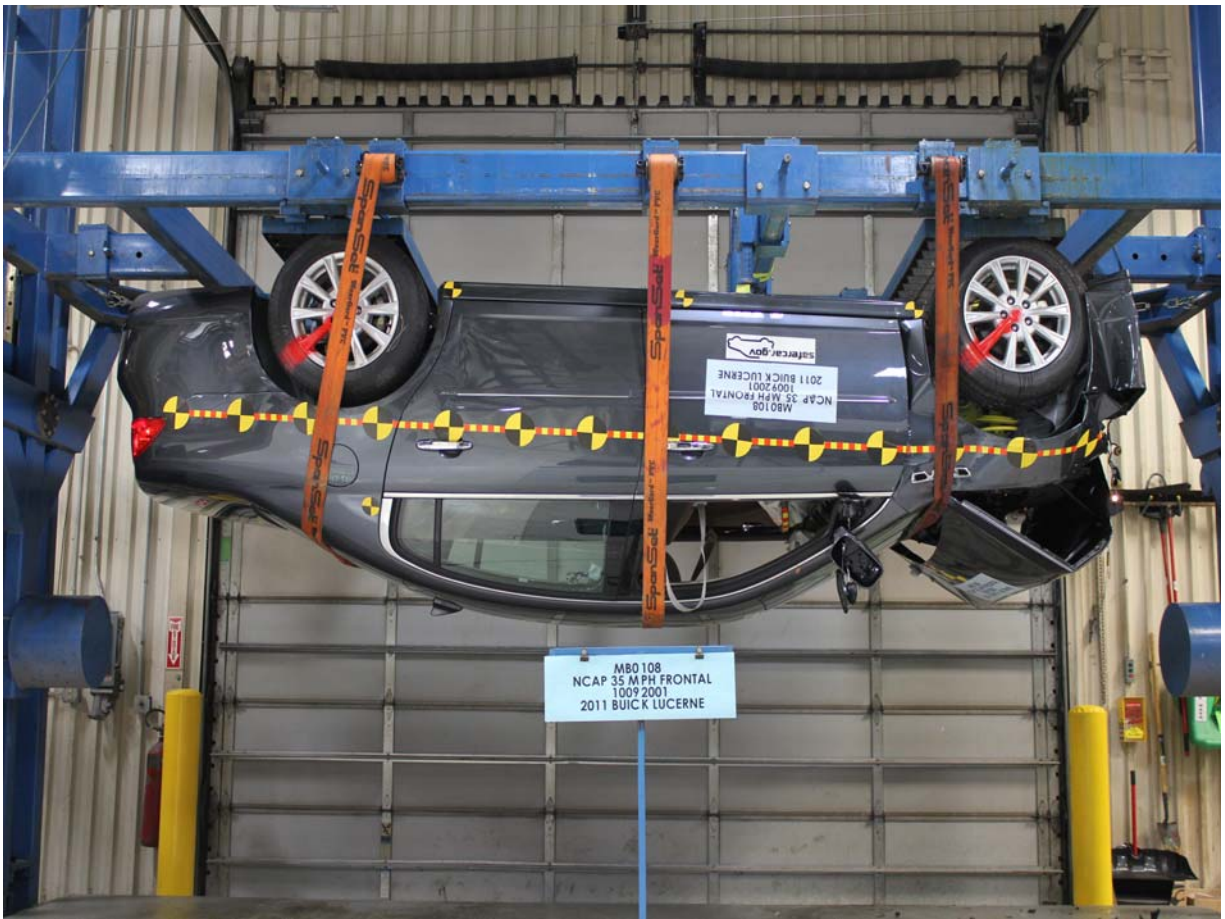
Vehicle at 180 Degrees on Static Rollover Device
