**REPORT NUMBER: SPNCAP-KAR-11-020**

**NEW CAR ASSESSMENT PROGRAM (NCAP)  
SIDE IMPACT POLE TEST**

**HONDA MOTOR CO., LTD.  
2011 HONDA CR-Z EX NAVI 3-DOOR HATCHBACK**

**FINAL REPORT**

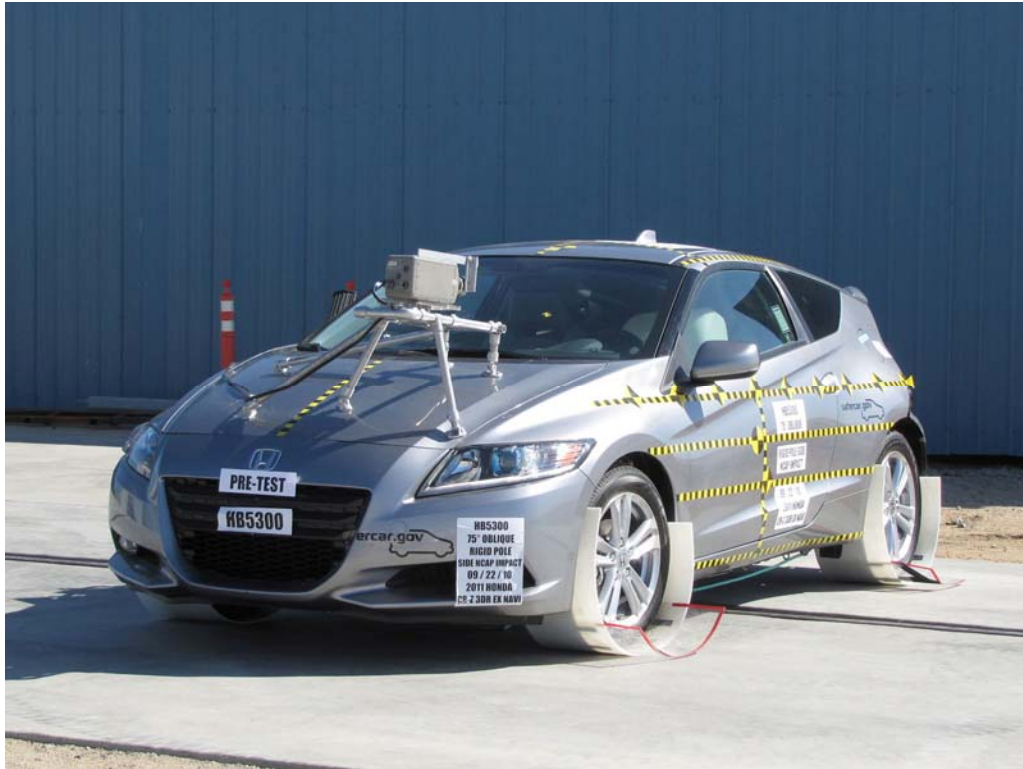
FIGURE 5. Pre-Test Left Front Three-Quarter View of Test Vehicle

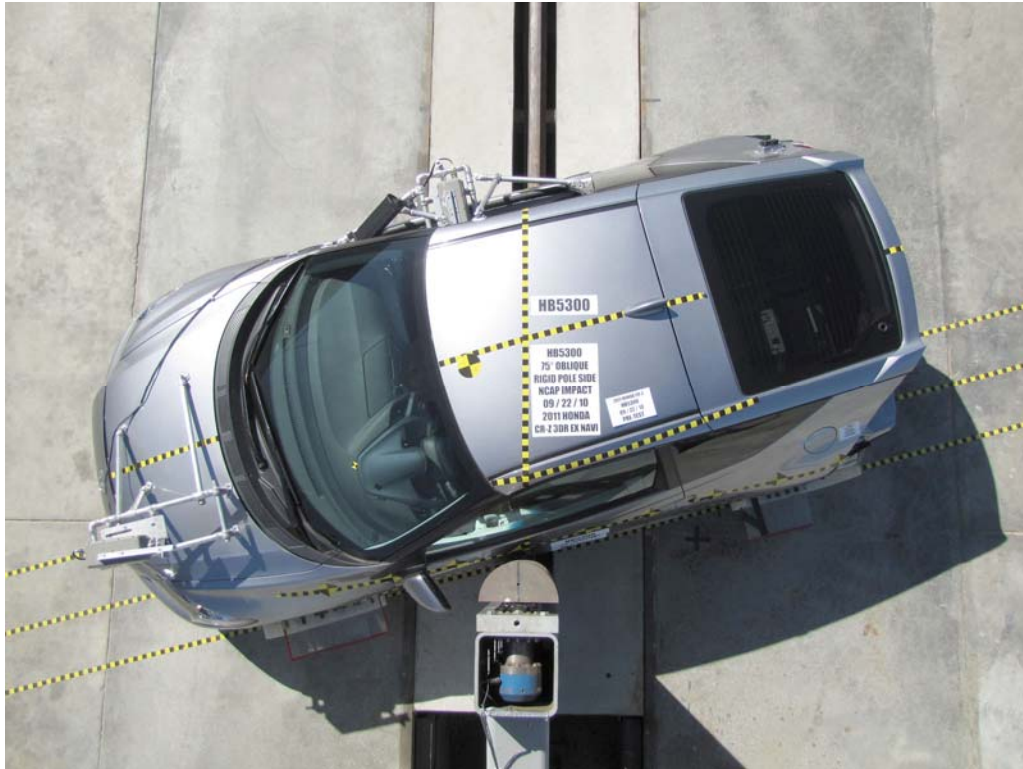
FIGURE 15. Pre-Test Overhead View of Test Vehicle and Pole

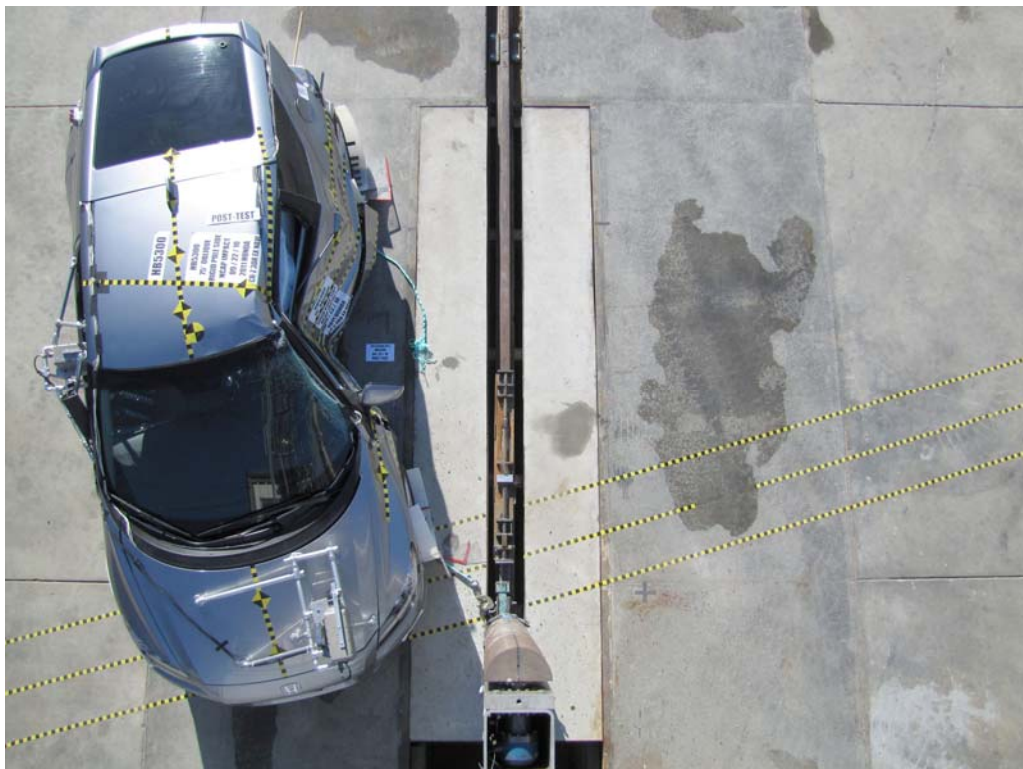
FIGURE 16. Post-Test Overhead View of Test Vehicle and Pole

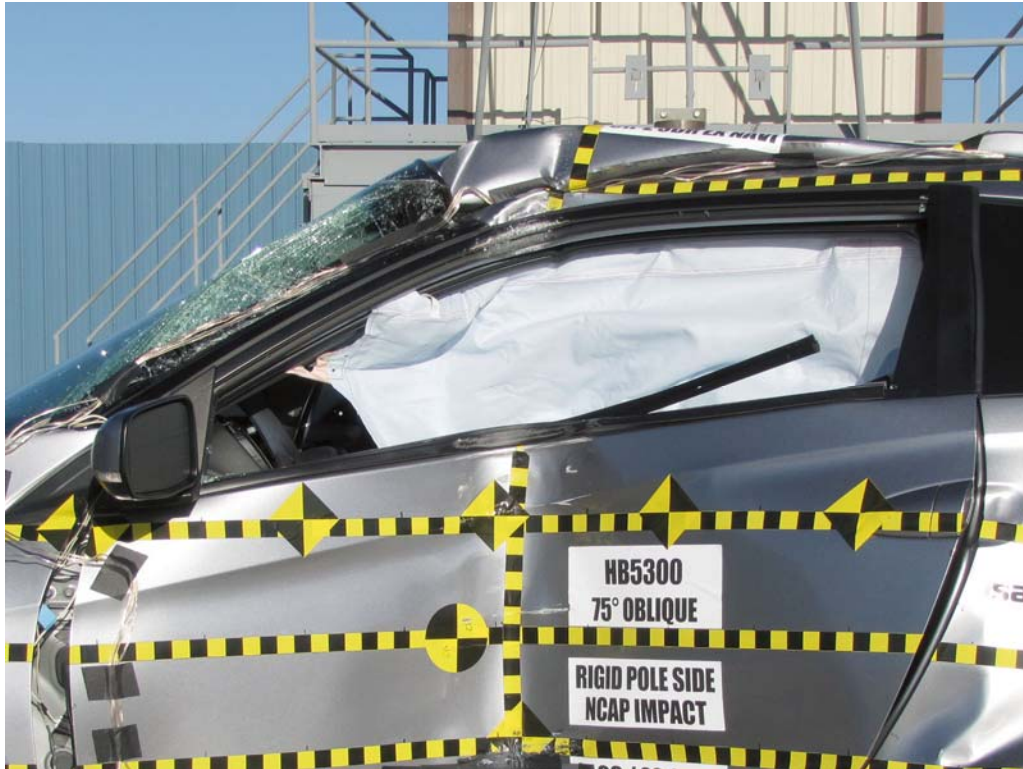
FIGURE 25. Post-Test Left Side View of Dummy Shoulder and Driver Door Top View

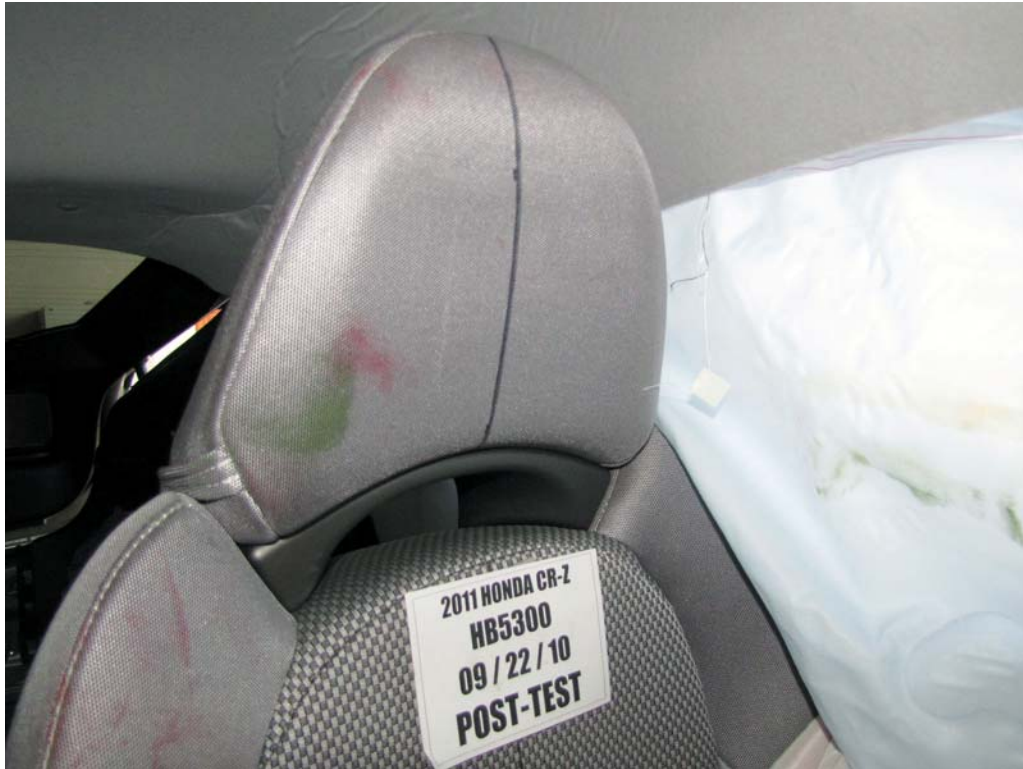
FIGURE 45. Post-Test Dummy Close-Up Head Contact with Vehicle Interior View

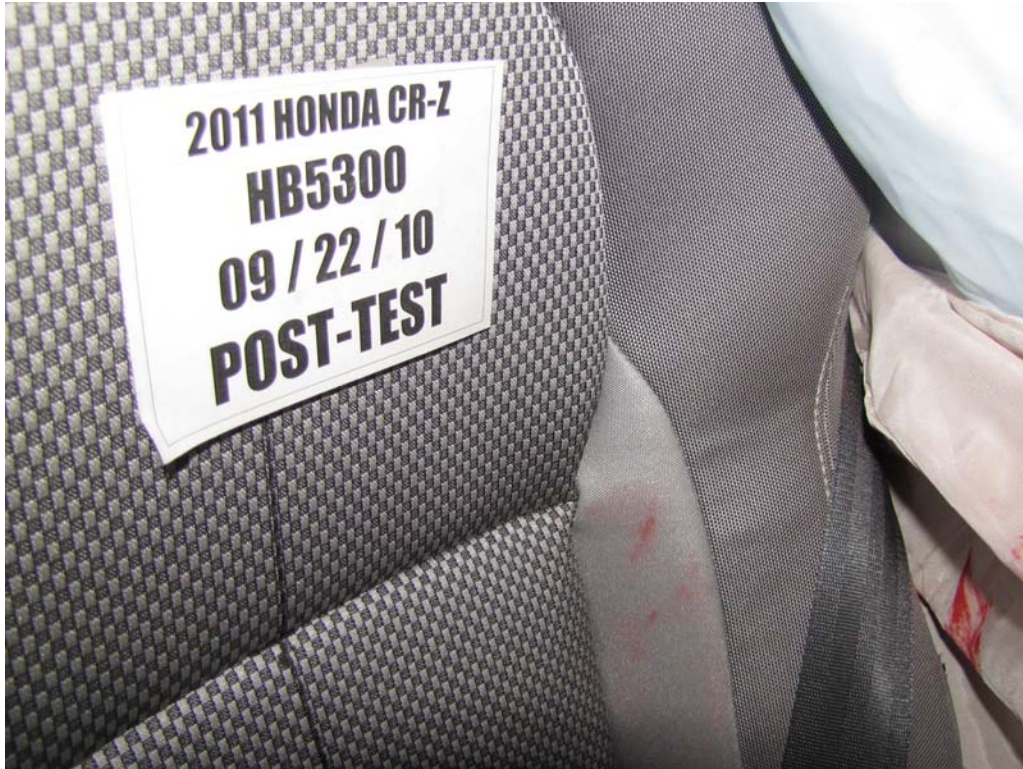
FIGURE 47. Post-Test Dummy Close-Up Torso Contact with Vehicle Interior View

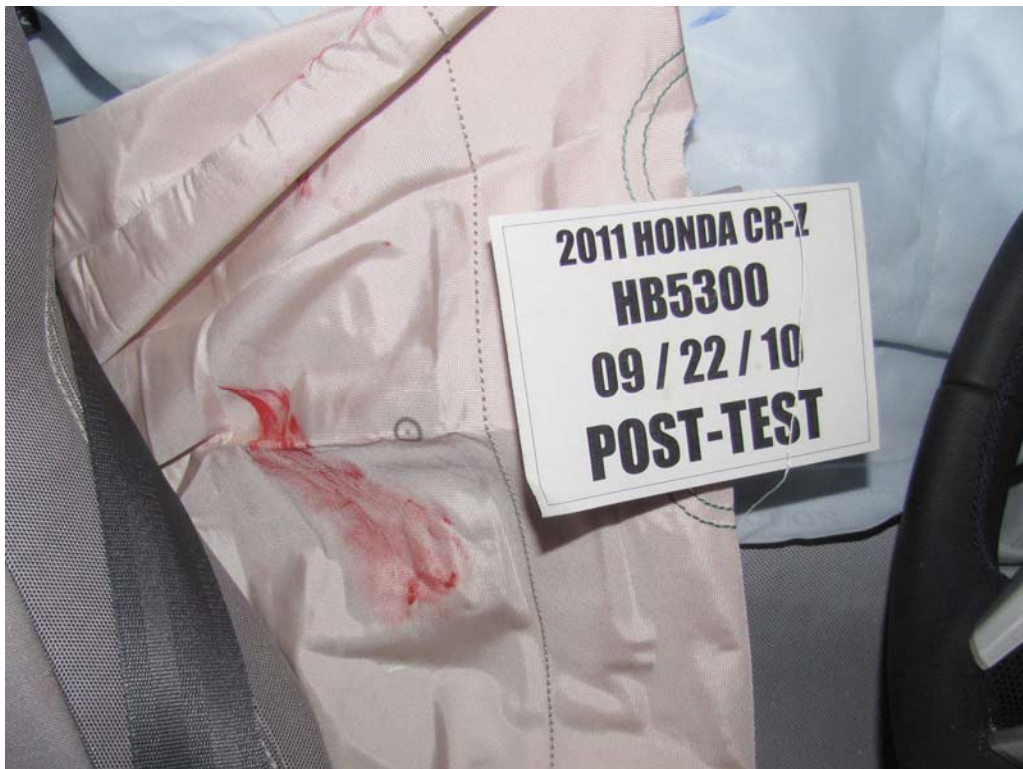
FIGURE 48. Post-Test Dummy Close-Up Torso Contact with Side Airbag View
