**REPORT NUMBER: SINCAP-MGA-2011-025**

**NEW CAR ASSESSMENT PROGRAM (NCAP)  
Moving Deformable Barrier Side Impact Test**

**GENERAL MOTORS LLC  
2011 Buick Lucerne CX 4-Dr Sedan  
NHTSA No.: MB0107**

**FINAL REPORT**

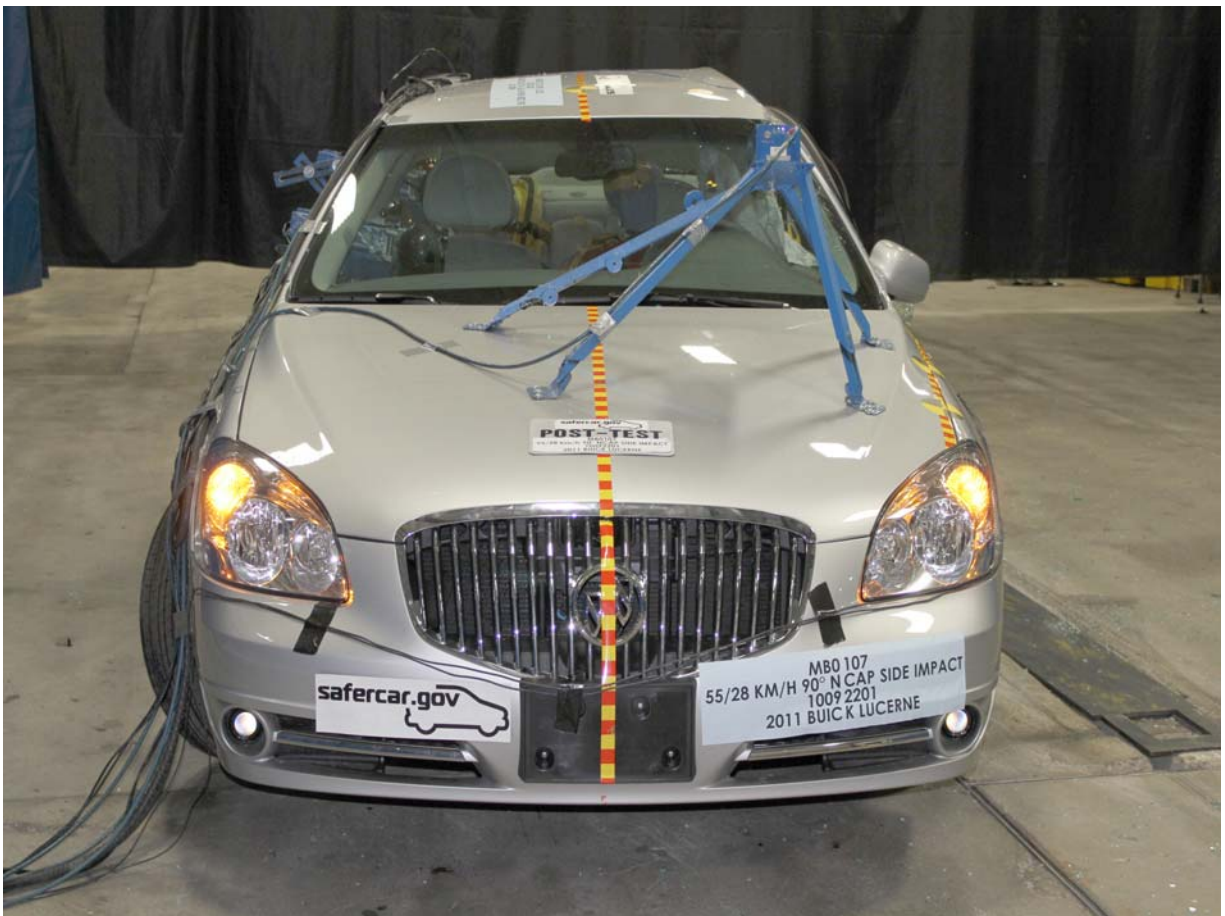
Post-Test Frontal View of Test Vehicle

| Critical Areas of Performance | Observations and Conclusions |
|---|---|
| Windshield Damage | Cracked |

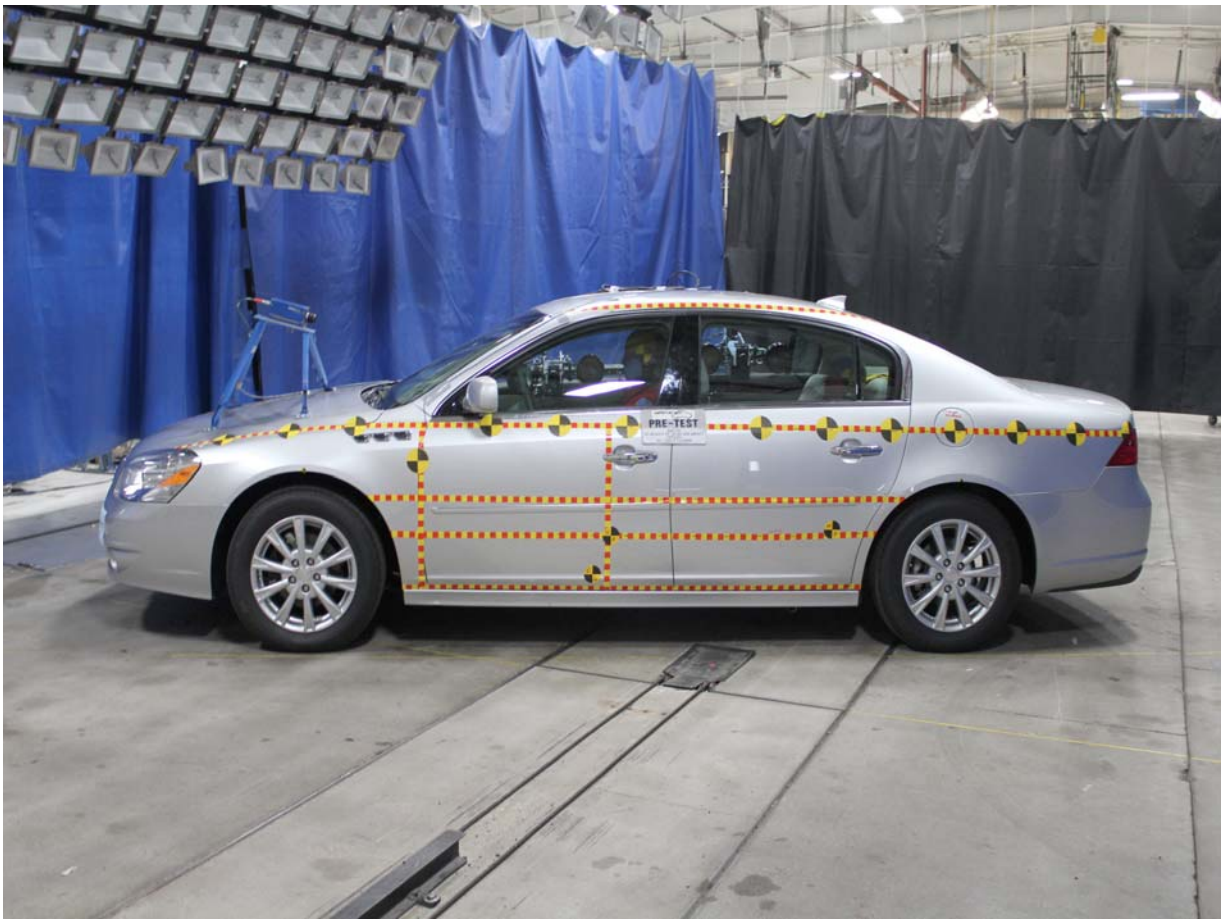
Pre-Test Left Side View of Test Vehicle

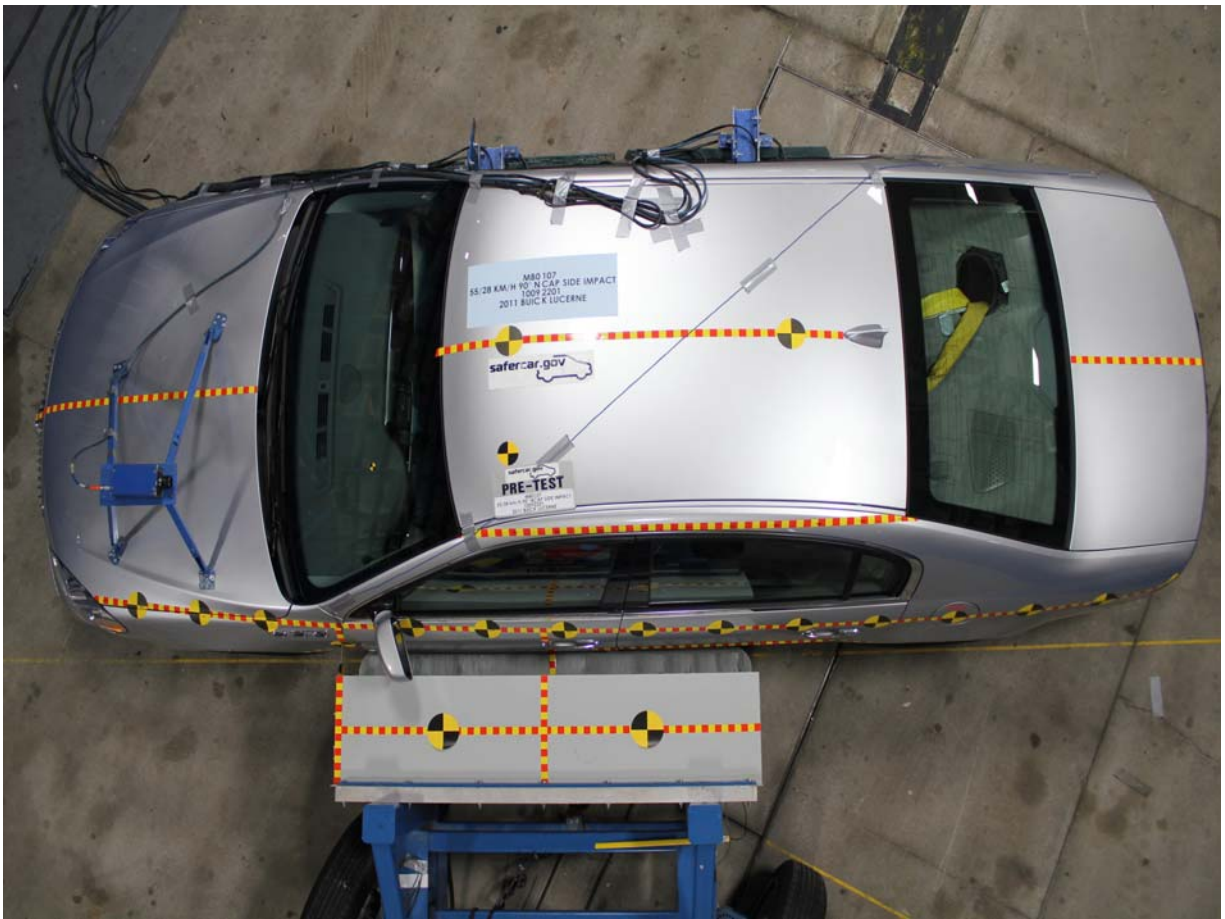
Pre-Test Overhead View of Test Vehicle with MDB Positioned Against Side of Target Vehicle

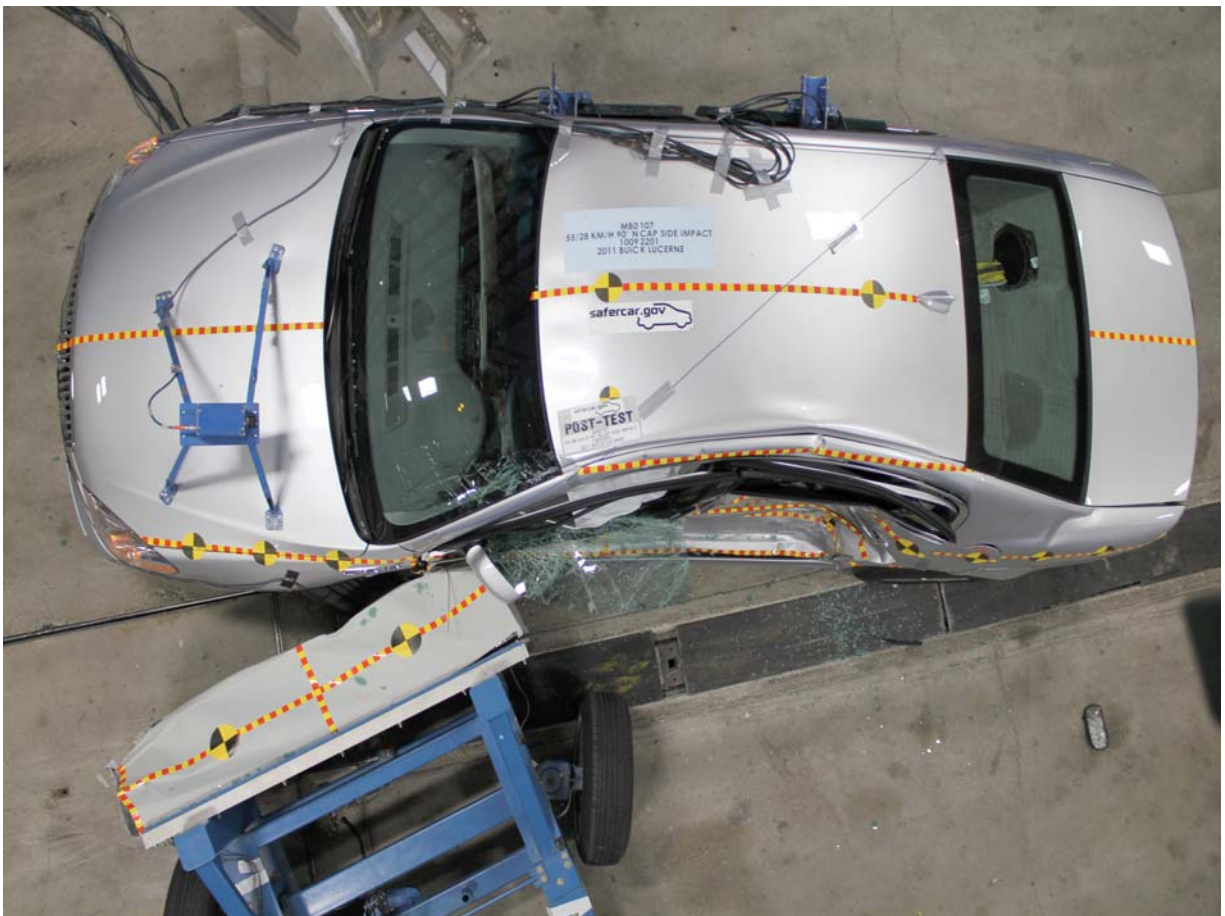
Post-Test Overhead View of Test Vehicle and MDB

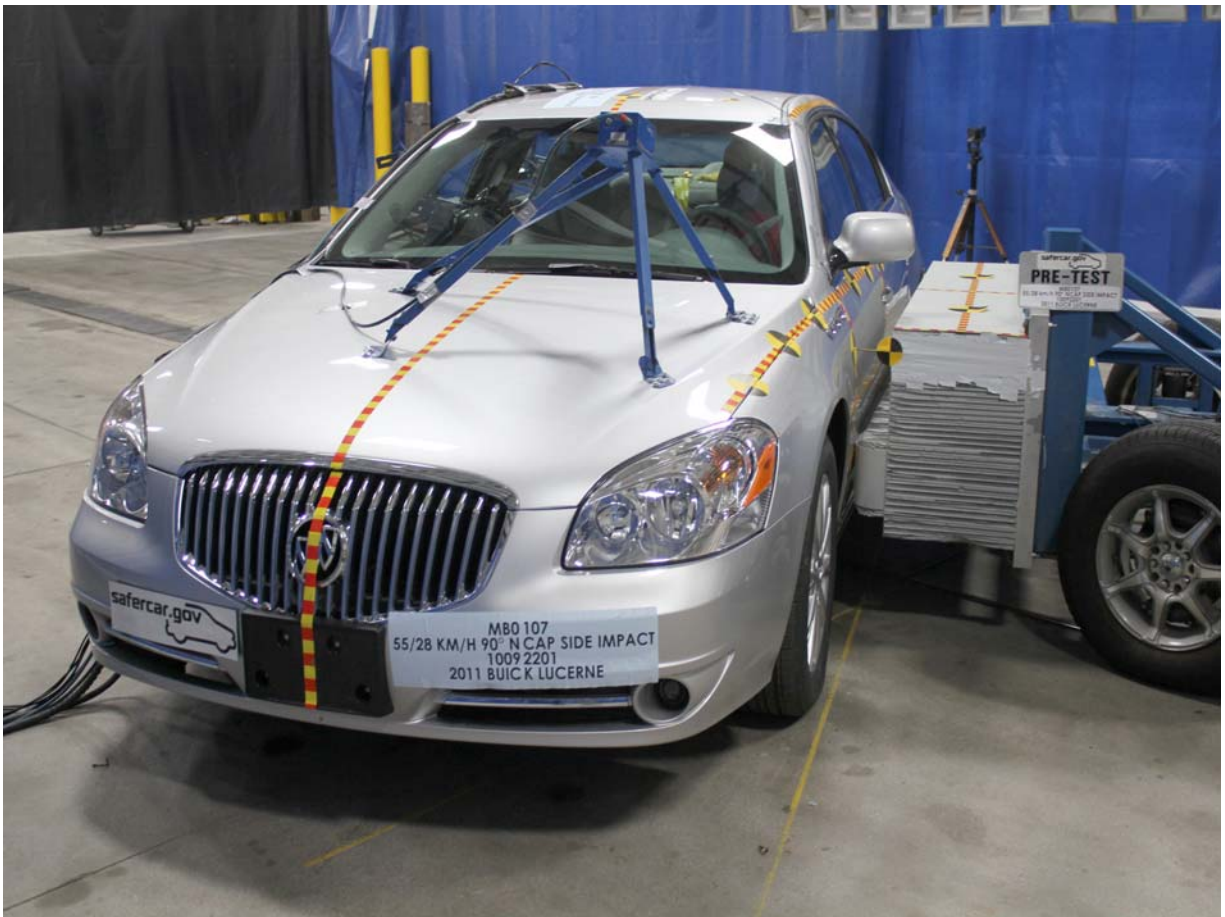
Pre-Test Left Side View of MDB Positioned Against Side of Target Vehicle

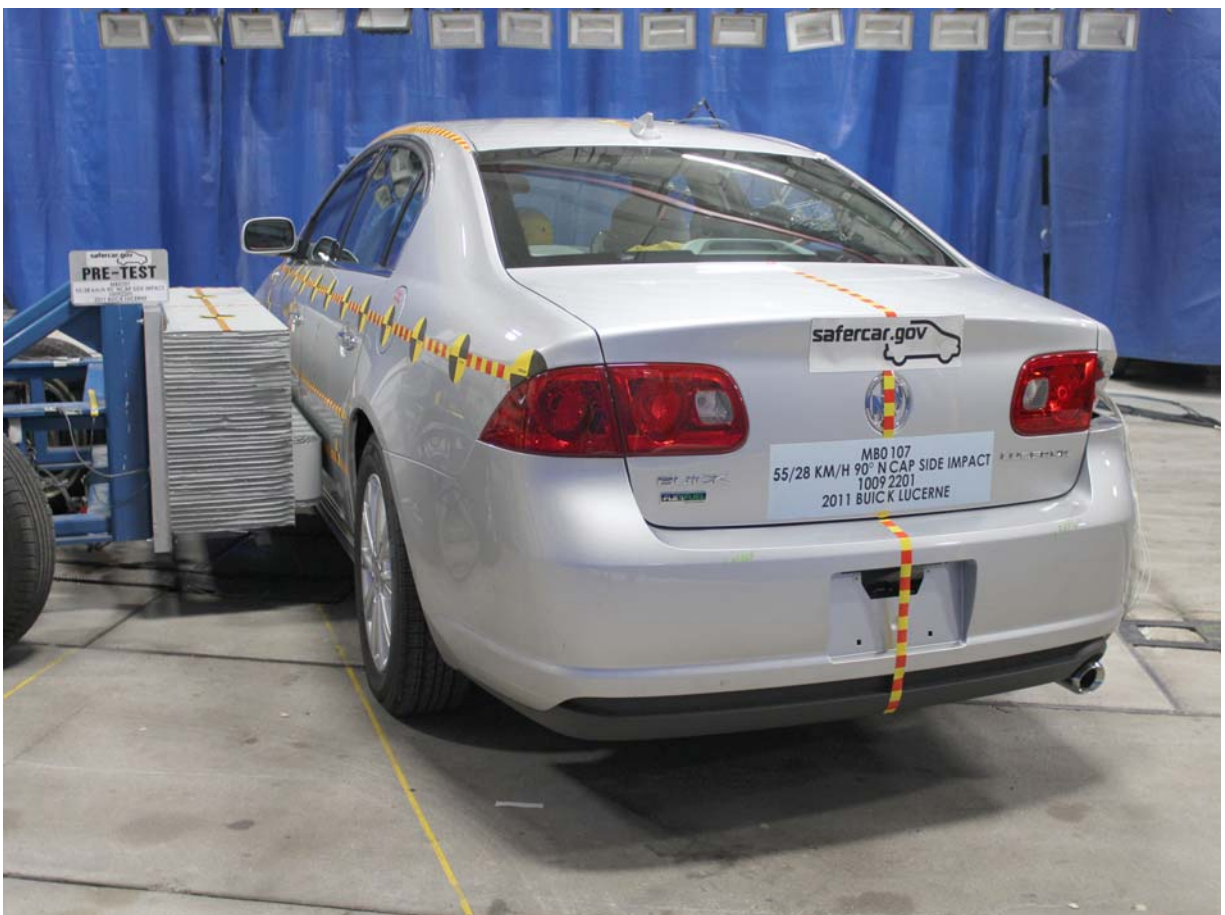
Pre-Test Right Side View of MDB Positioned Against Side of Target Vehicle

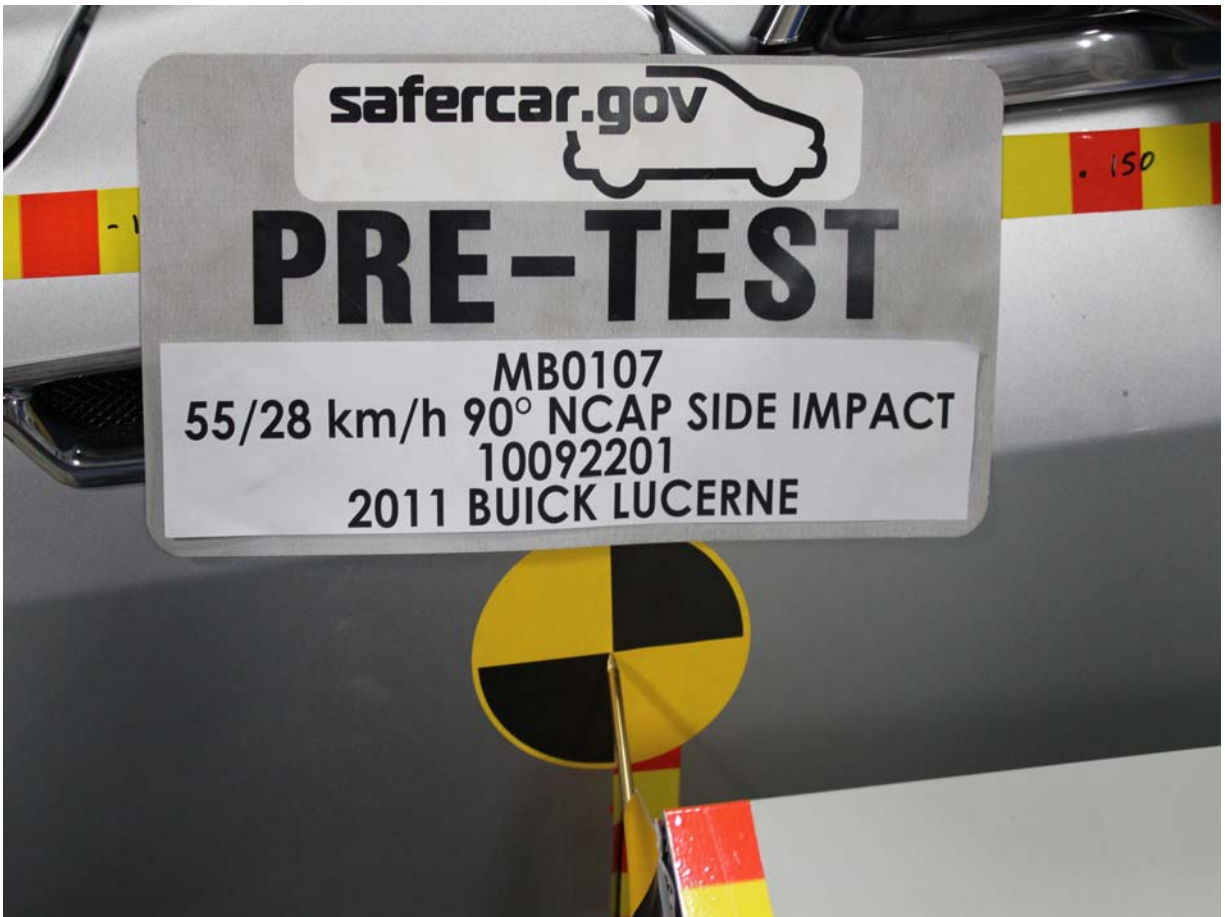
Pre-Test Close-Up View of Impact Point Target

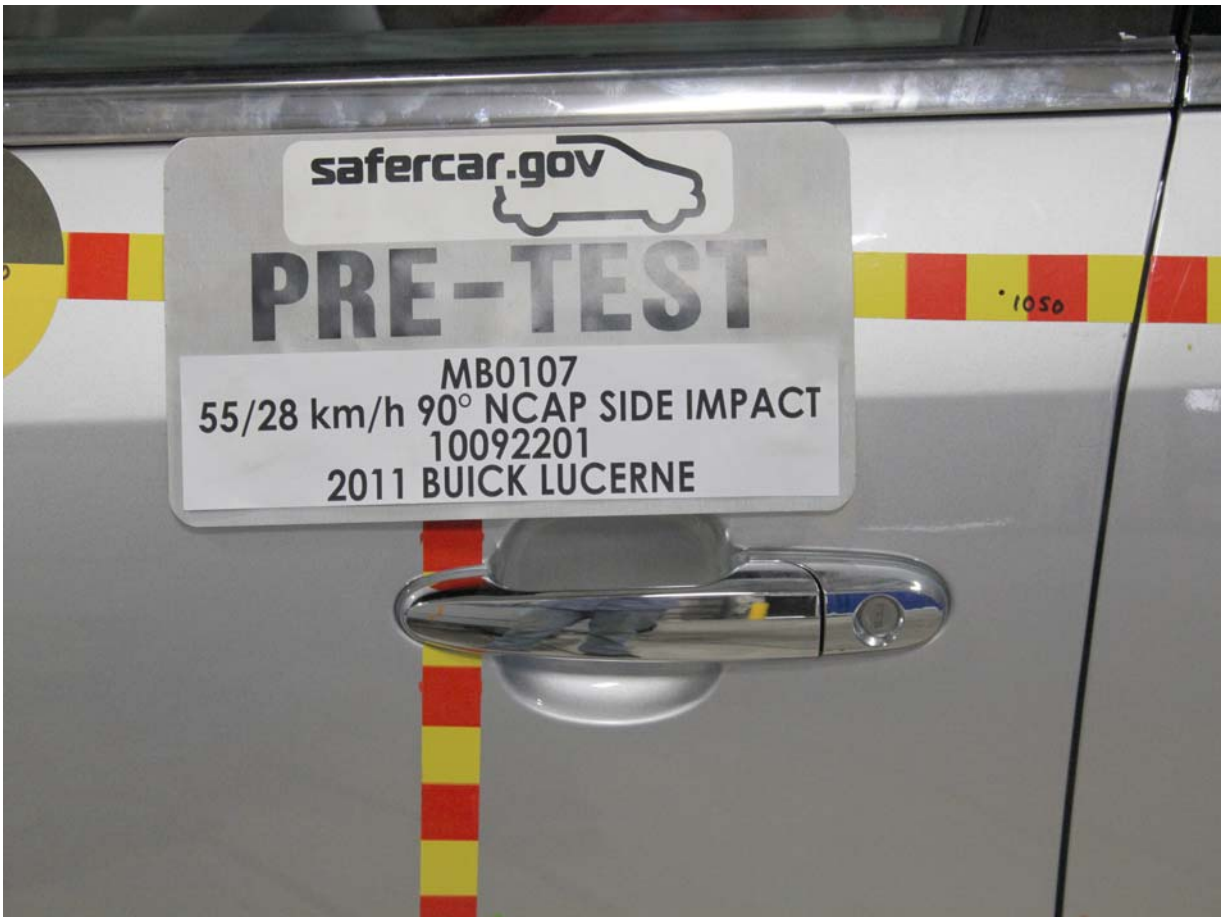
Pre-Test Left Front Door Latch Close-Up

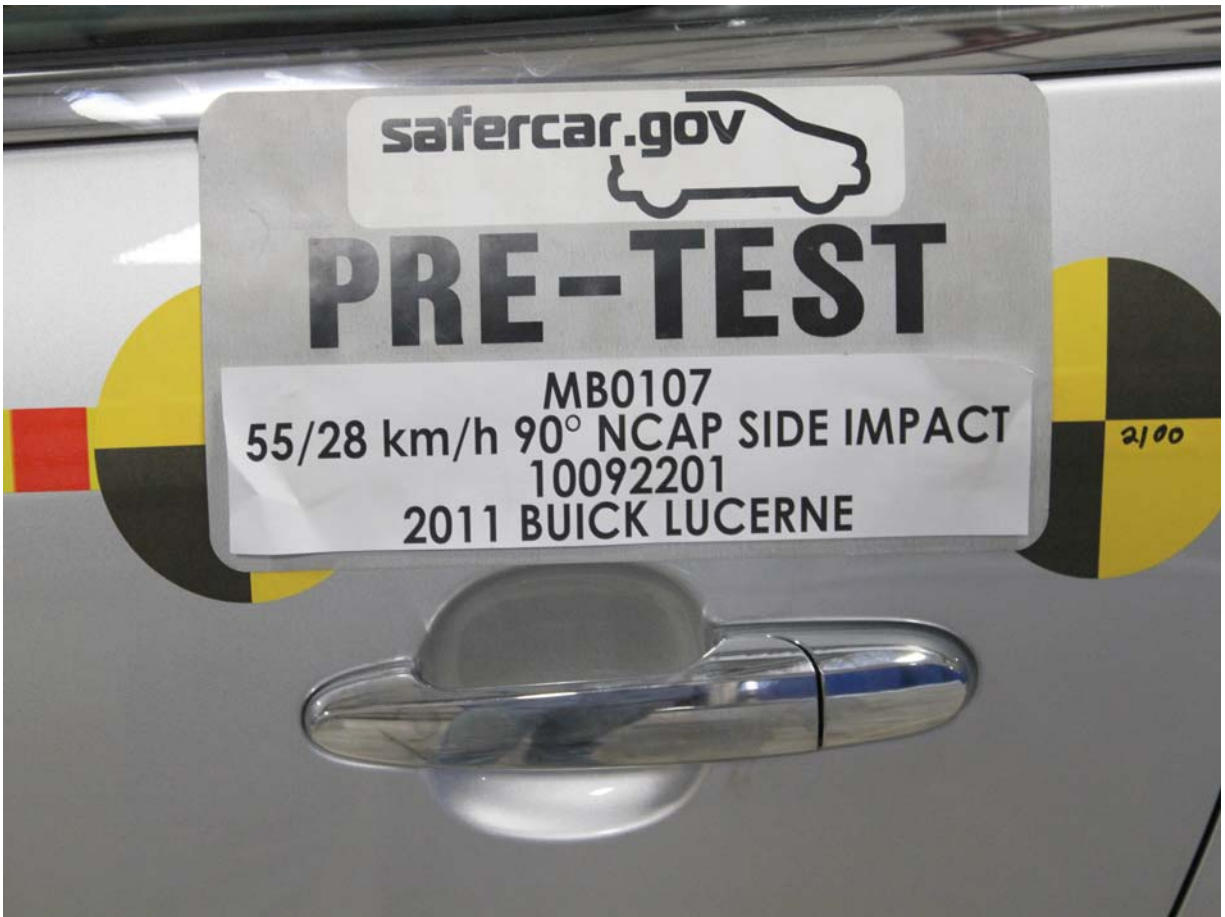
Pre-Test Left Rear Door Latch Close-Up

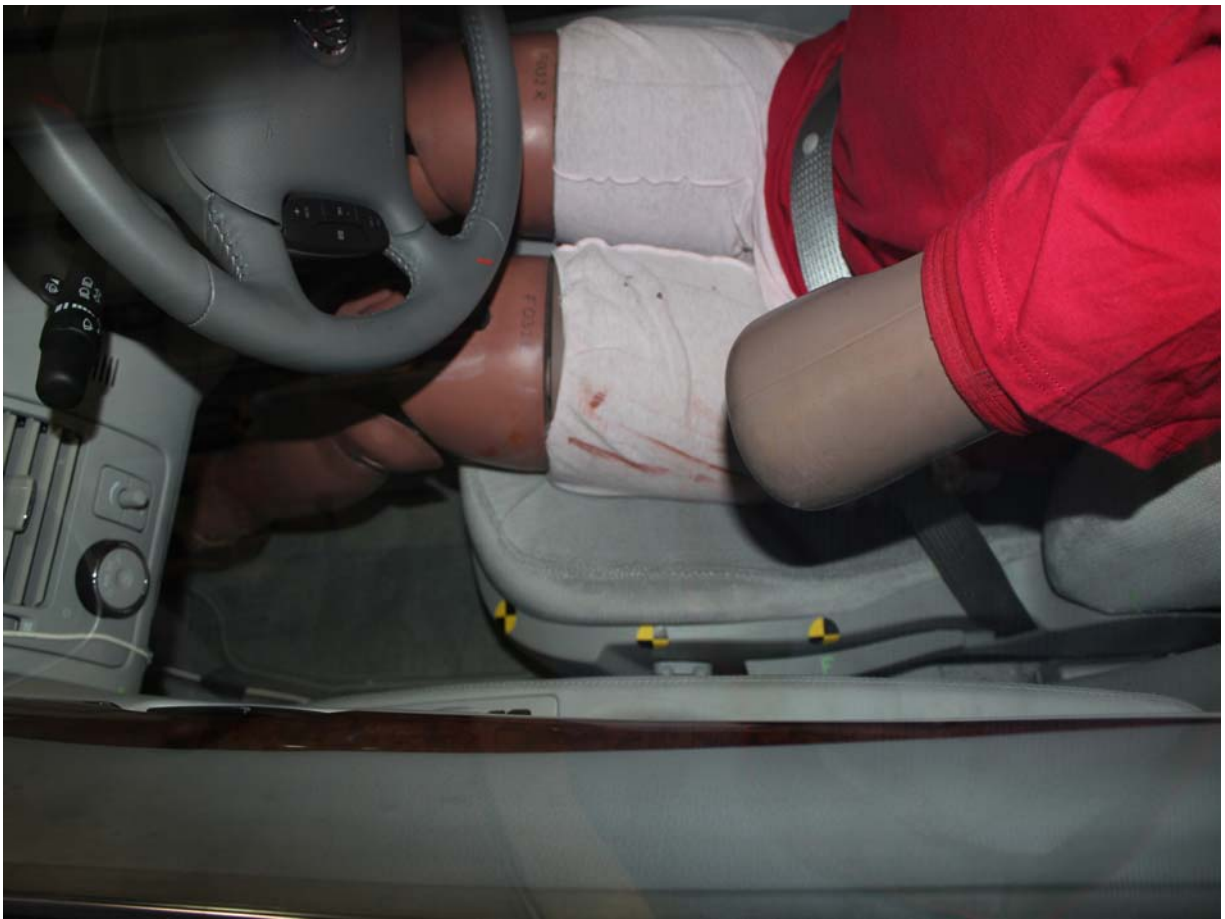
Pre-Test Driver Dummy and Door Clearance View

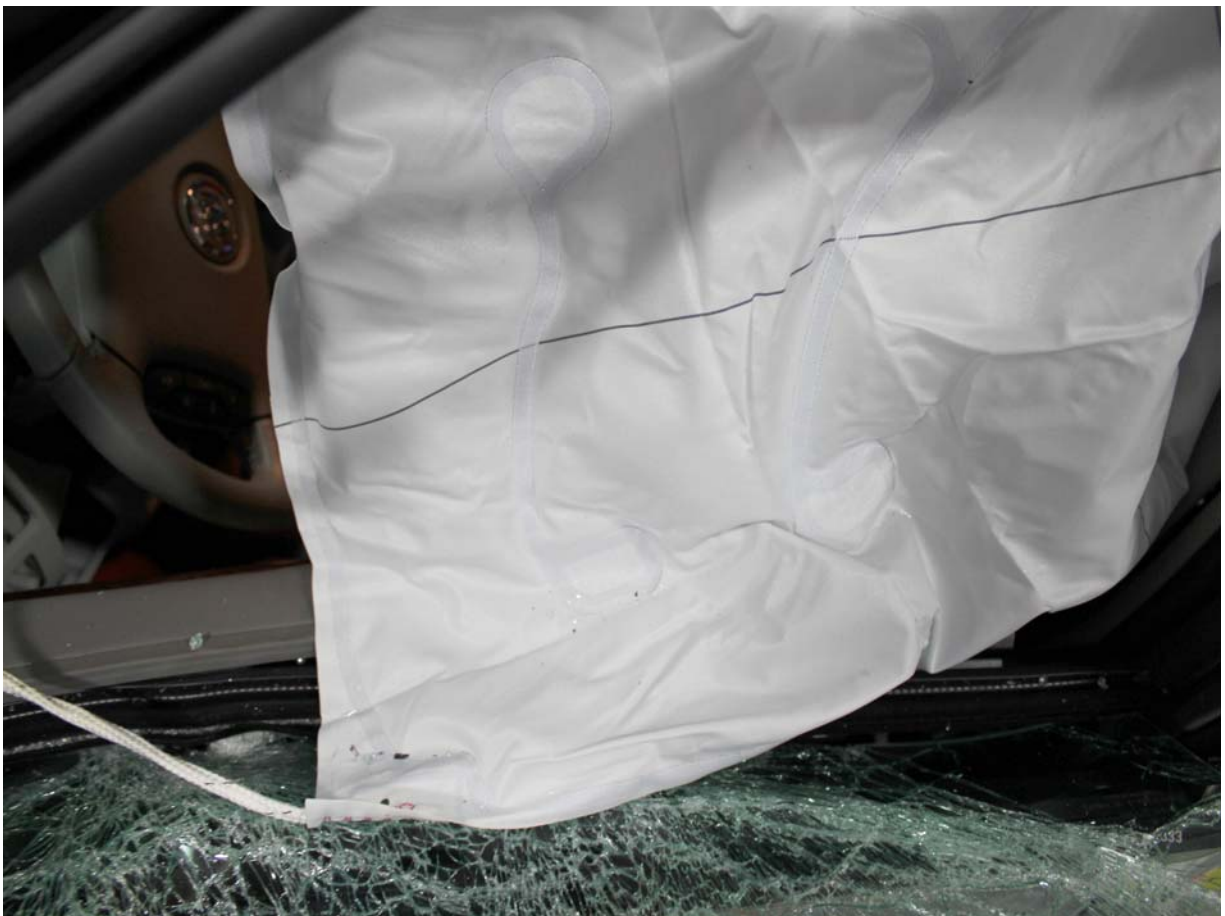
Post-Test Driver Dummy and Door Clearance View

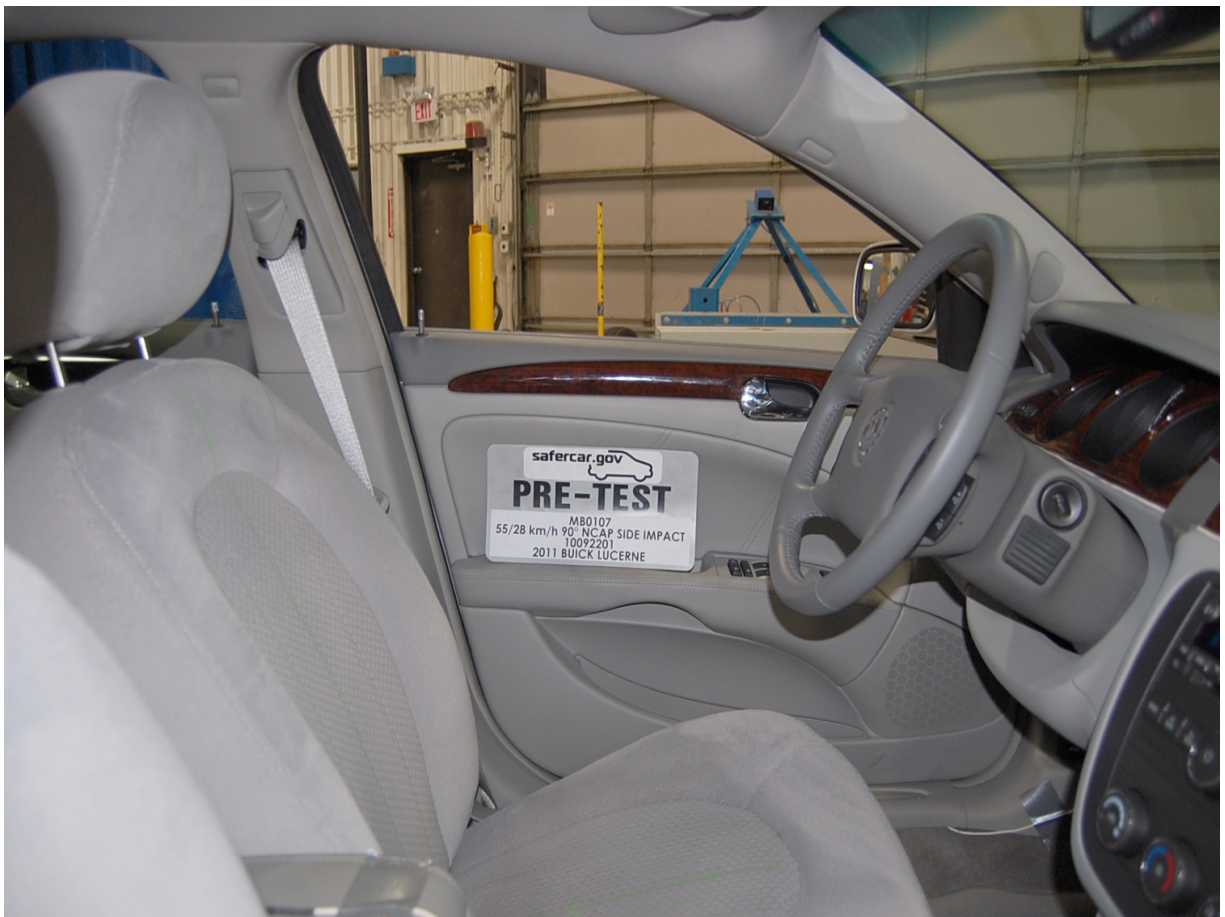
Pre-Test Driver Inner Door Panel View

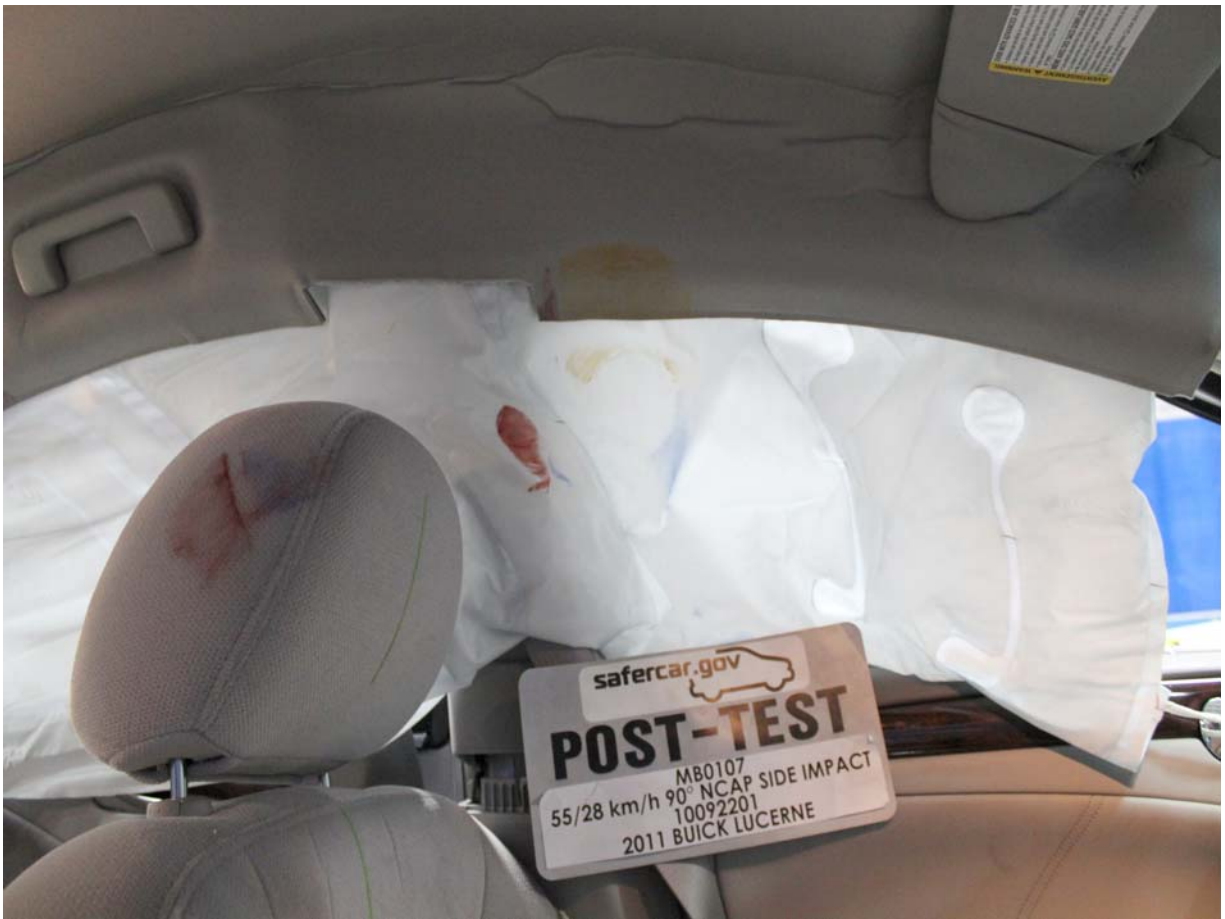
Post-Test Driver Dummy Close-up Head Contact with Vehicle View

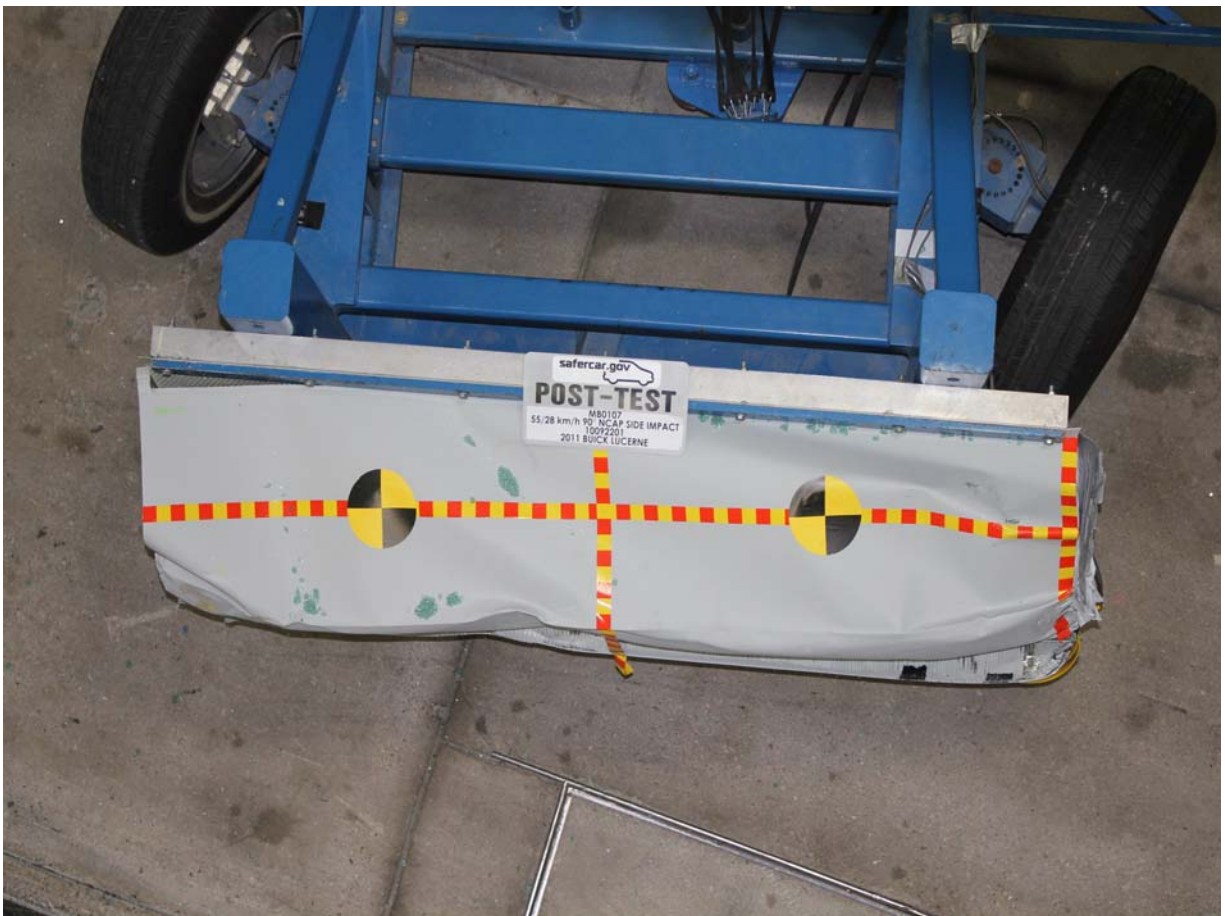
Post-Test Top View of MDB Impactor Face

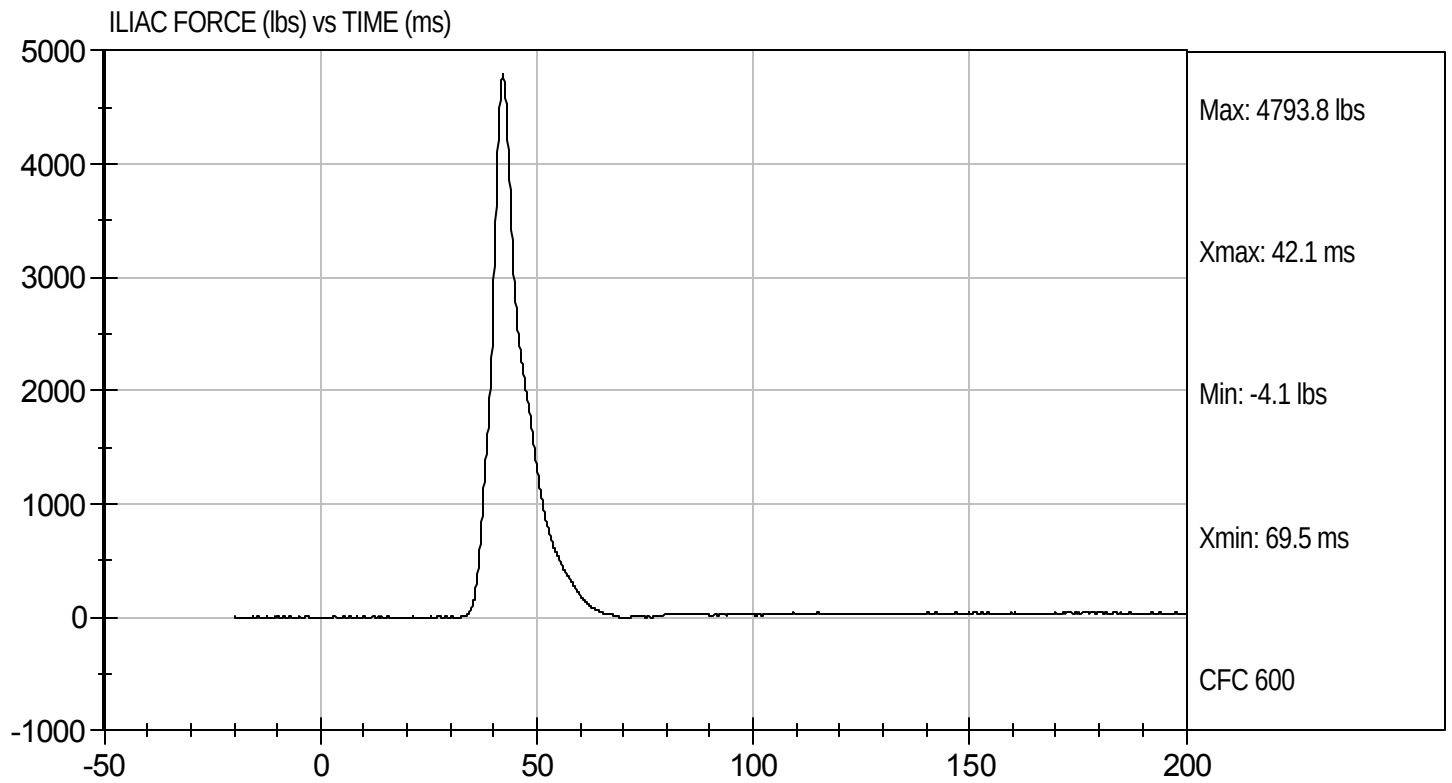
Test Desc: Iliac Impact  
Component ID: D103208

Test Date: 9/23/10  
Velocity: 14.01 ft/s, 4.27 m/s
