**REPORT NUMBER: SNCAP-KAR-11-021**

**NEW CAR ASSESSMENT PROGRAM (NCAP)  
MOVING DEFORMABLE BARRIER SIDE IMPACT TEST**

**HONDA MOTOR CO., LTD.  
2011 HONDA CR-Z EX NAVI 3-DOOR HATCHBACK**

**NHTSA No: HB5301**

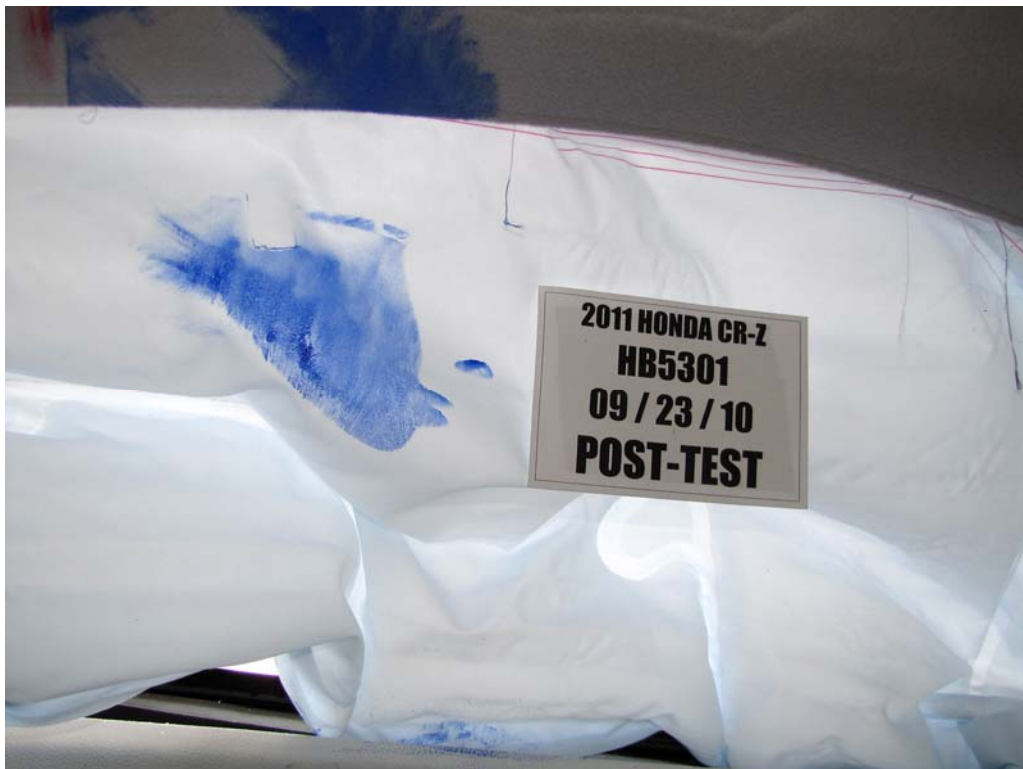
FIGURE 47. Post-Test Driver Dummy Close-Up Head Contact with Vehicle
