**REPORT NUMBER: SPNCAP-MCW-11-003**

**NEW CAR ASSESSMENT PROGRAM (NCAP)  
SIDE IMPACT POLE TEST**

**MERCEDES BENZ  
2011 MERCEDES BENZ C300 4-DOOR SEDAN**

**NHTSA NUMBER: MB 0500**

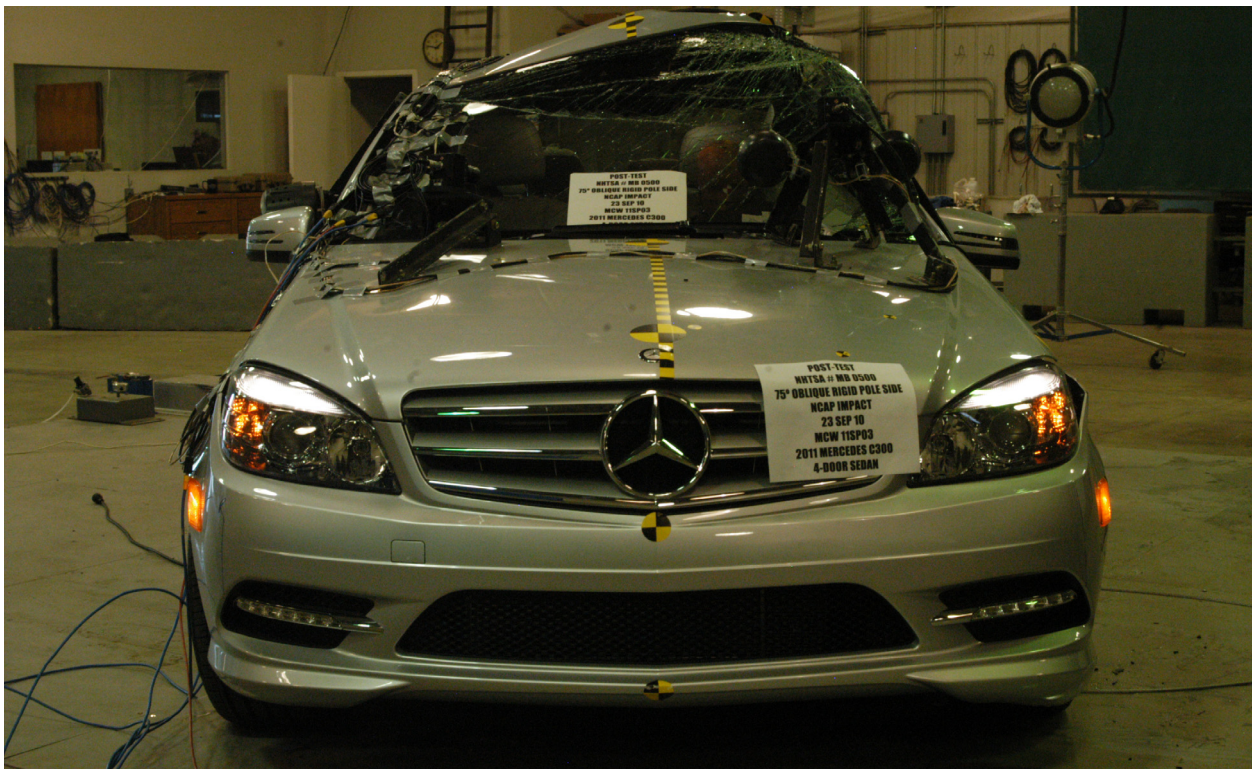
Figure 004: Post-test frontal view of test vehicle

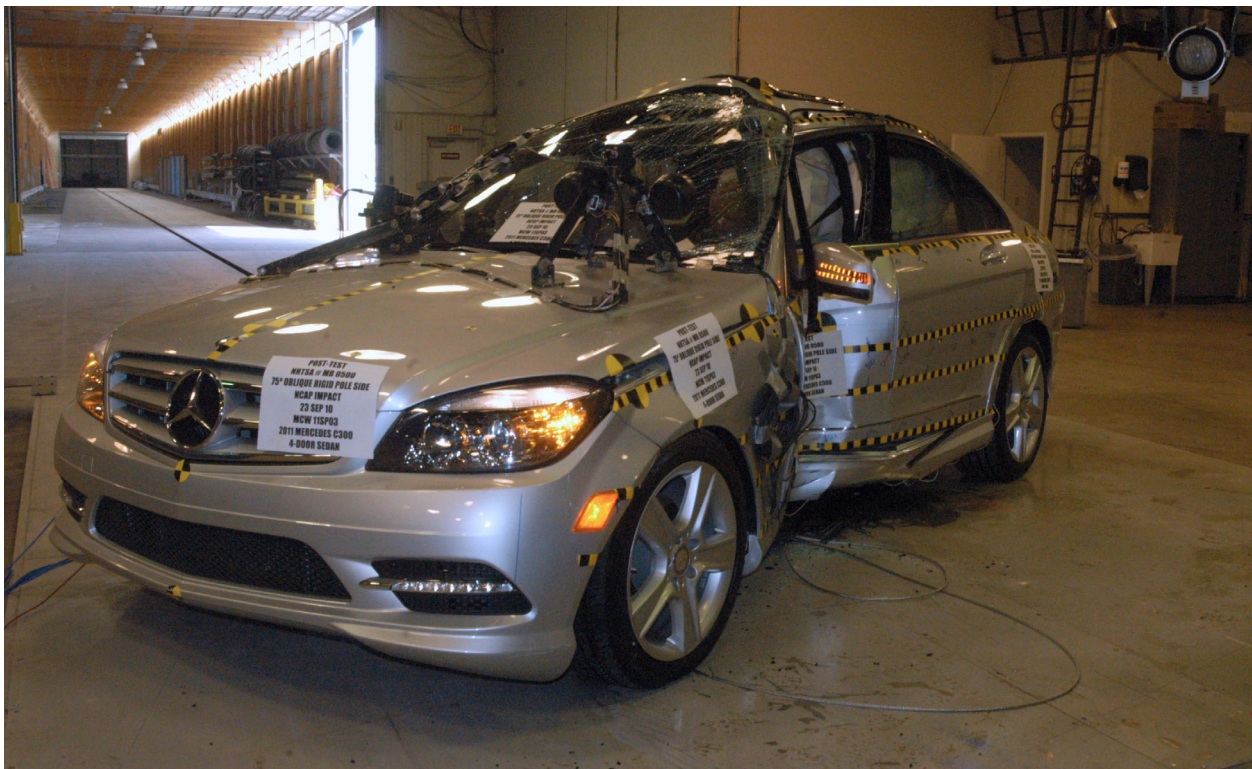
Figure 006: Post-test left front three-quarter view of test vehicle

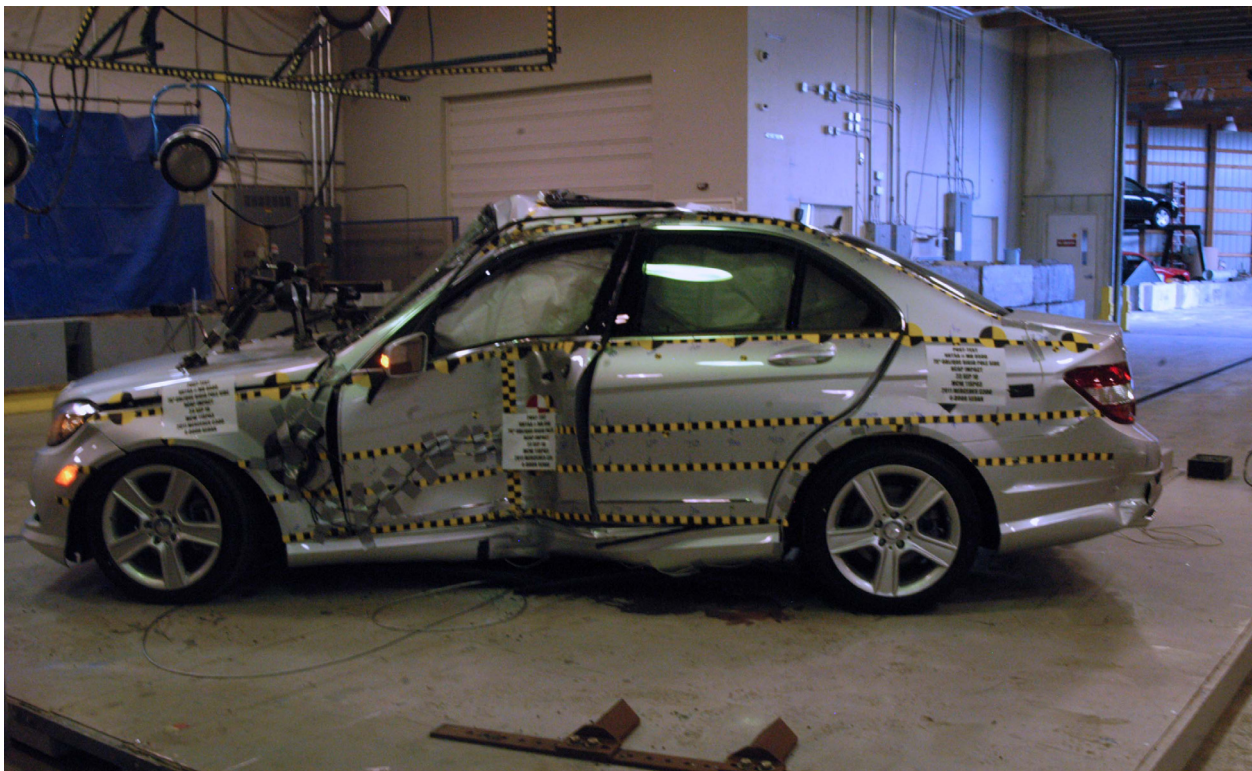
Figure 008: Post-test left side view of test vehicle

The test vehicle sustained a maximum static crush of 455 mm at level 3, 0 mm rearward of the vertical impact line.

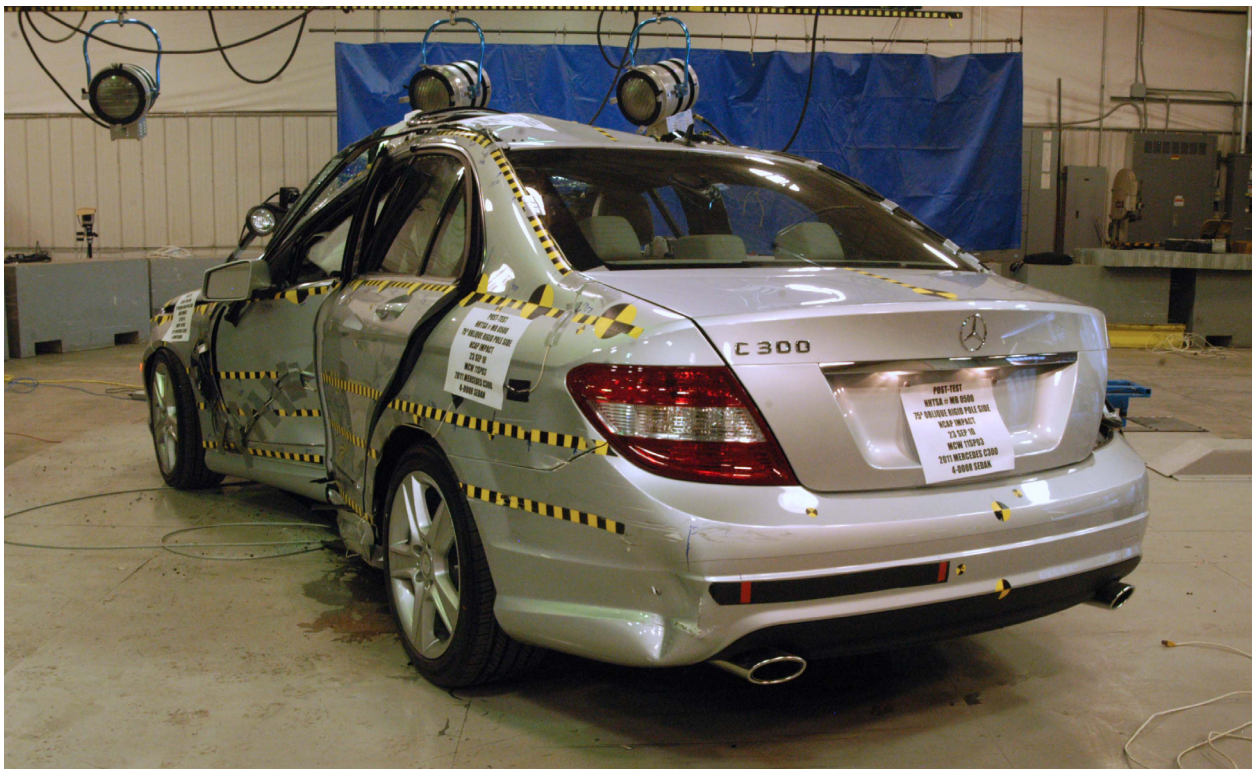
Figure 010: Post-test left rear three-quarter view of test vehicle

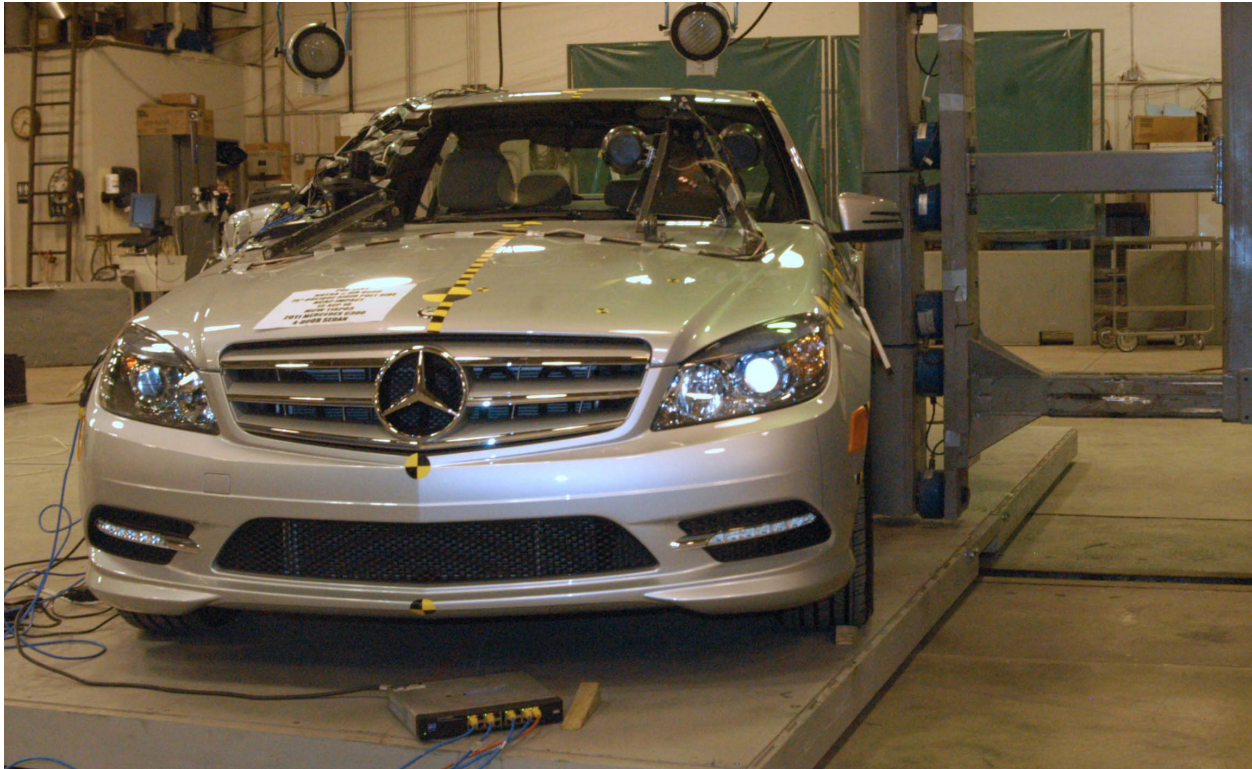
Figure 017: Pre-test left side view of pole positioned against side of vehicle at impact point

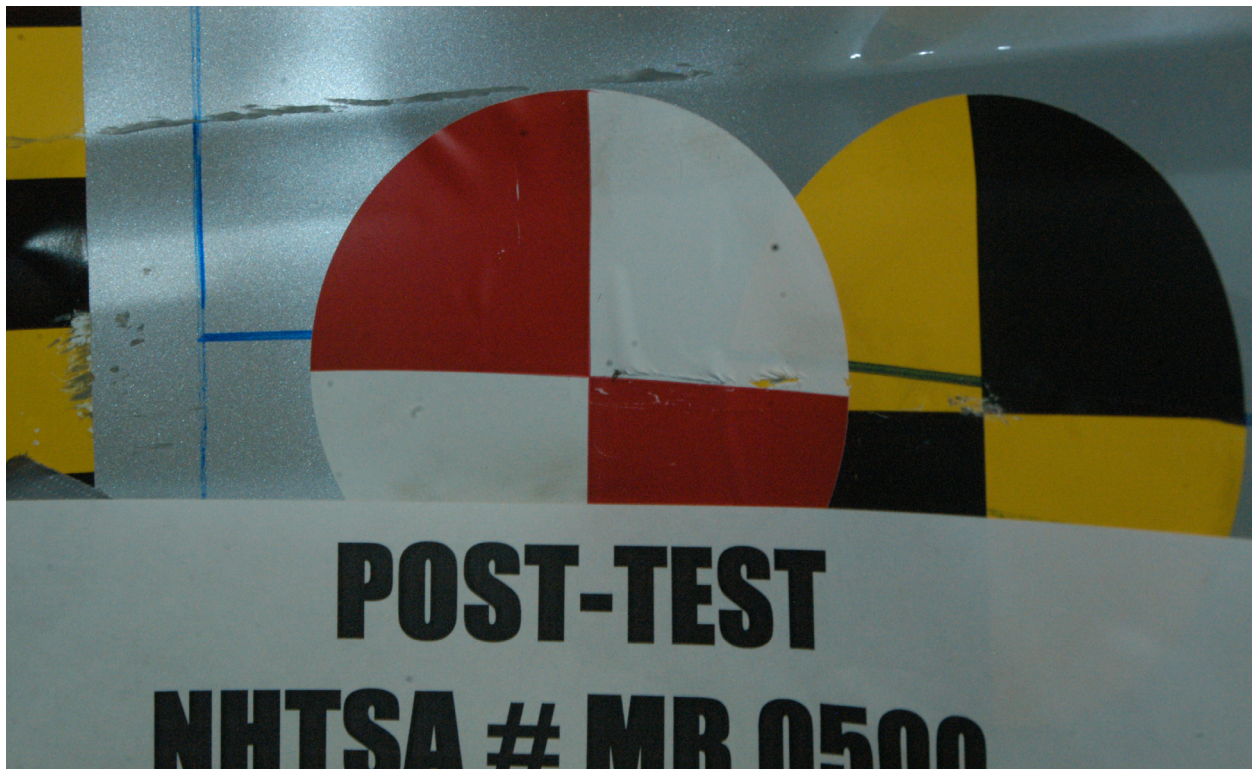
Figure 020: Post-test close-up view of impact point target showing impact location

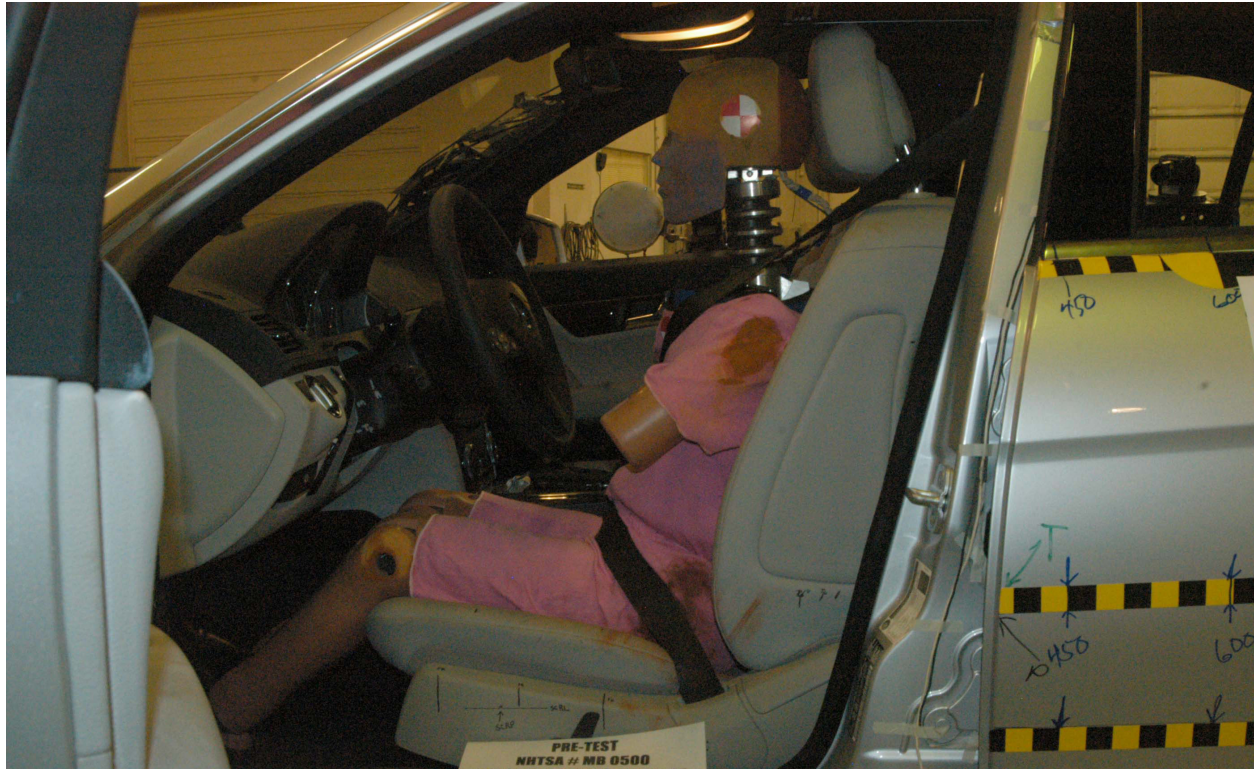
Figure 023: Pre-test left side view of dummy showing belt, chalking, and contact switches

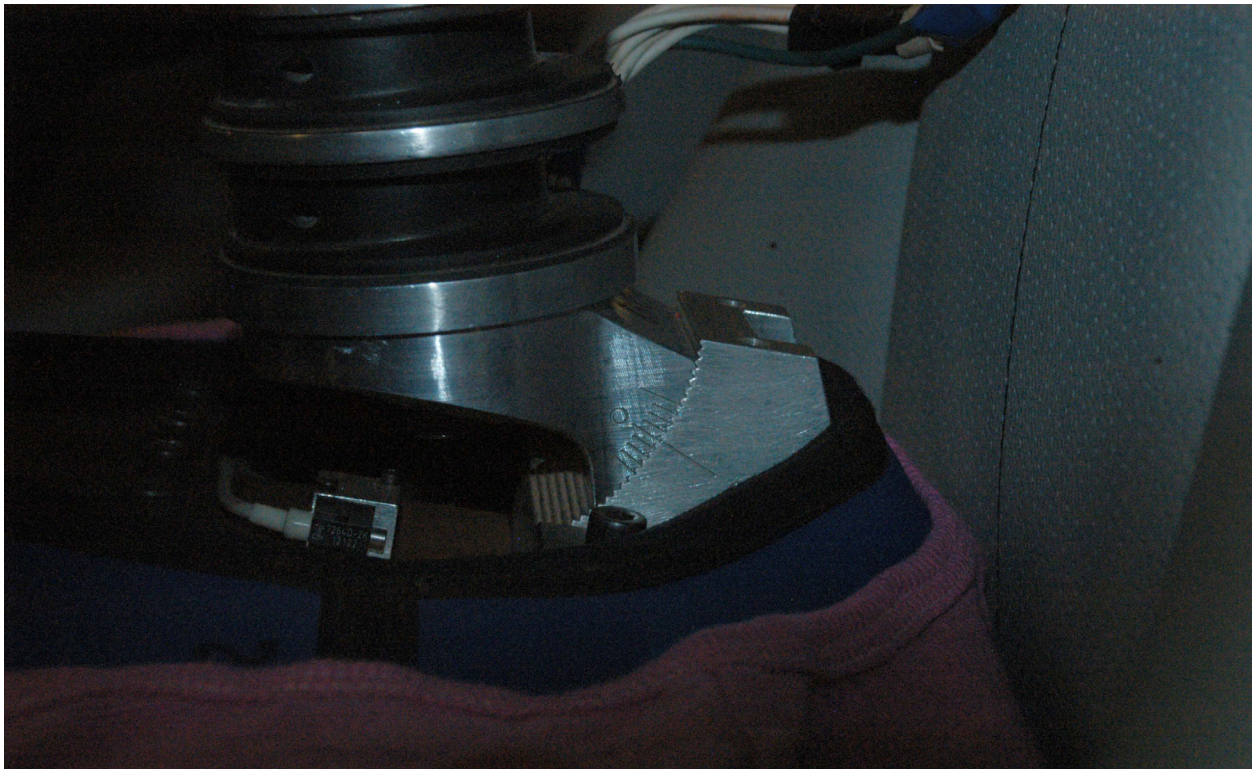
Figure 030: Pre test view of dummy's neck showing position of adjustable neck bracket

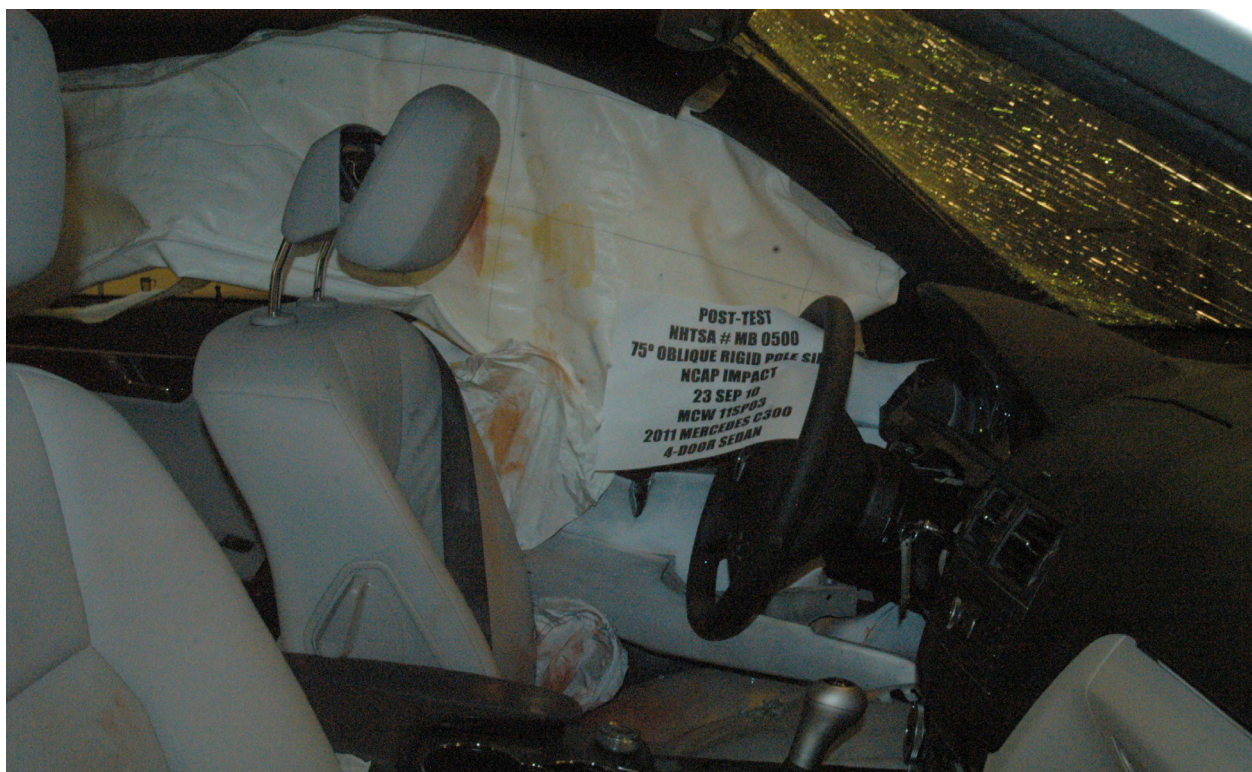
Figure 044: Post-test inner driver door panel showing dummy contact locations

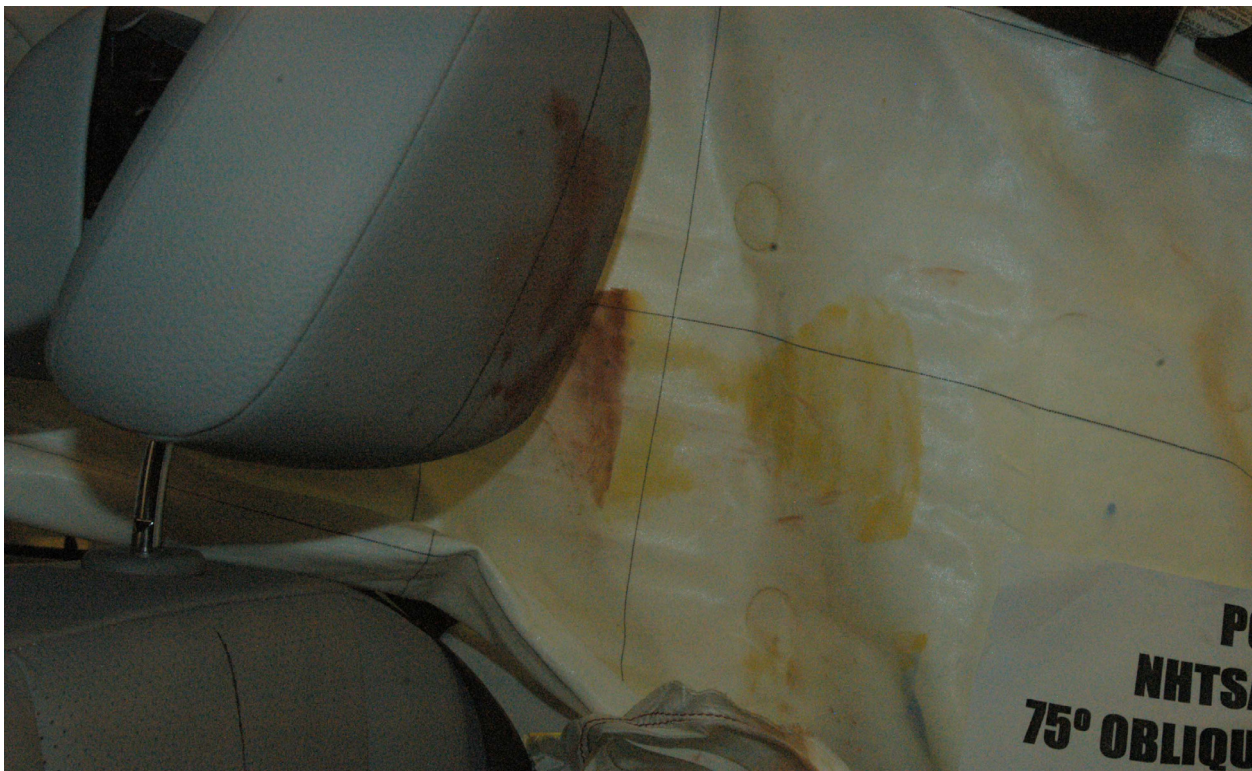
Figure 046 Post-test dummy close-up head contact with side airbag view

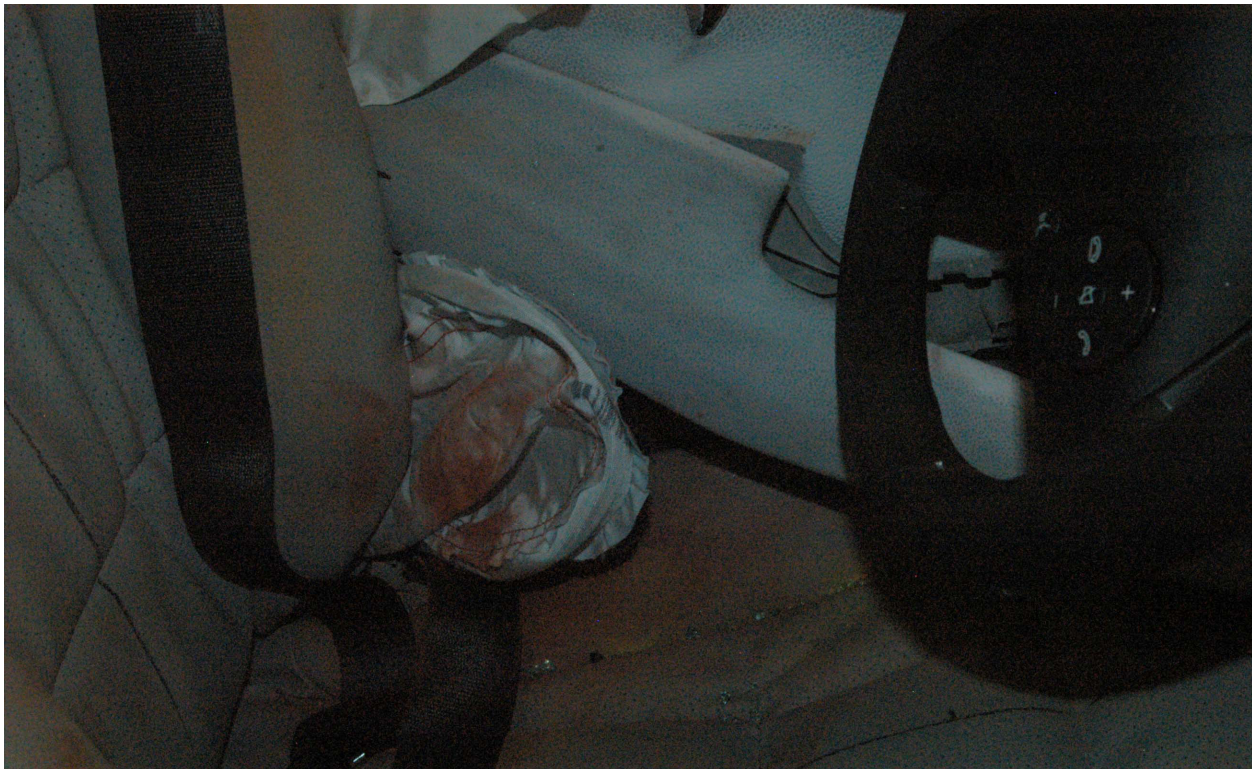
Figure 050: Post-test dummy close-up pelvis contact with side airbag view

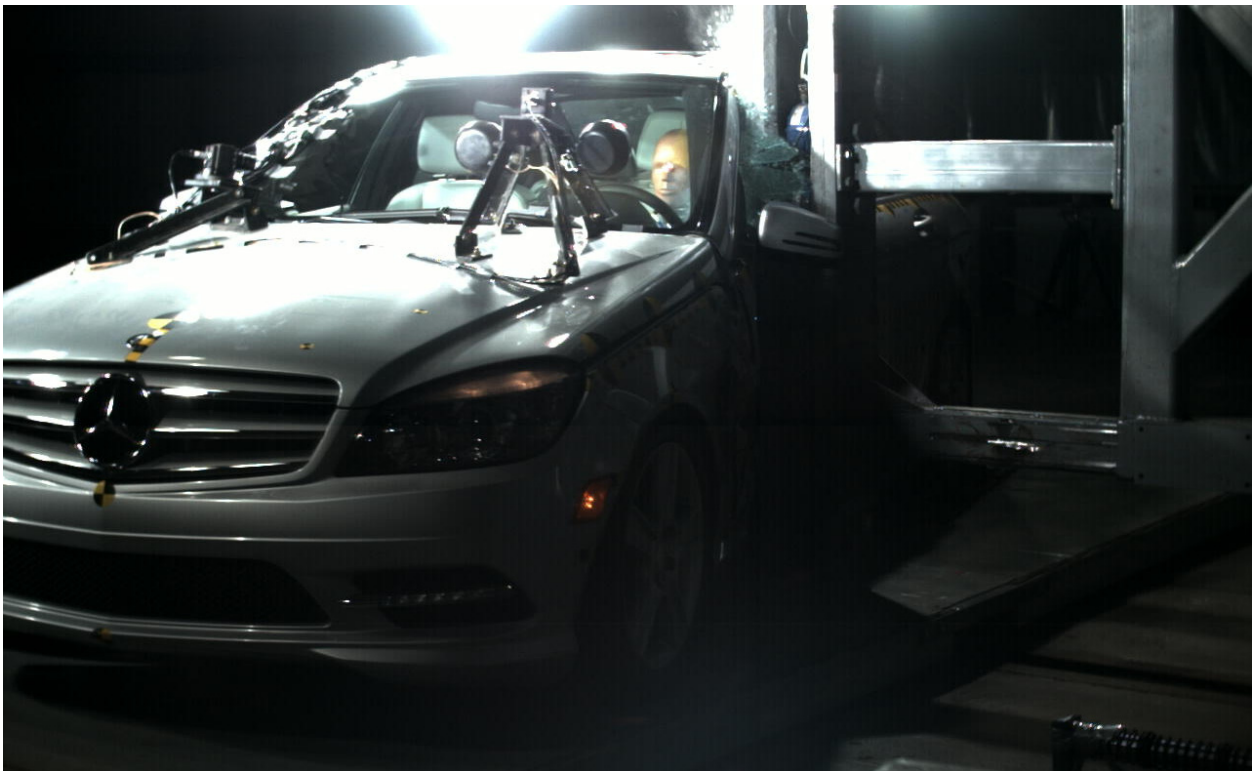
Figure 066: Impact event
