**REPORT NUMBER: NCAP-KAR-11-022**

**NEW CAR ASSESSMENT PROGRAM (NCAP)  
FRONTAL BARRIER IMPACT TEST**

**HONDA MOTOR CO., LTD.  
2011 HONDA CR-Z BASE 3-DOOR HATCHBACK**

**FINAL REPORT**

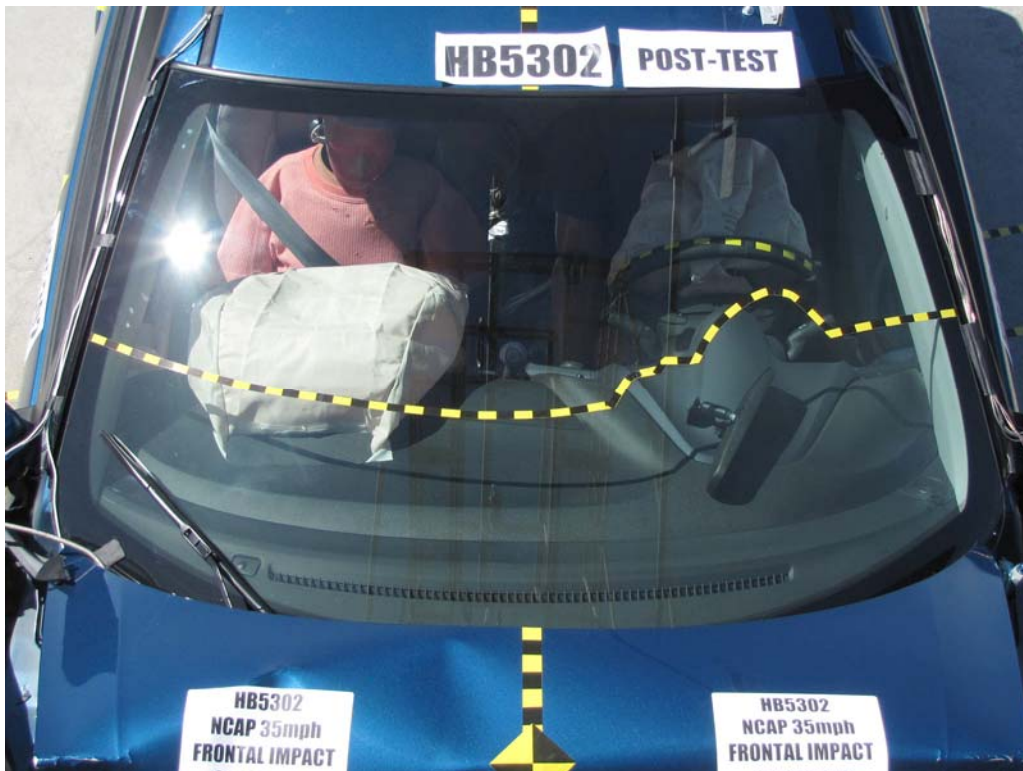
FIGURE 18. Post-Test Windshield View

There was 100% windshield retention and no intrusion into the protected zone of the windshield during the event. There was no Stoddard solvent or electrolyte leakage after the event or during any phase of the static rollover.

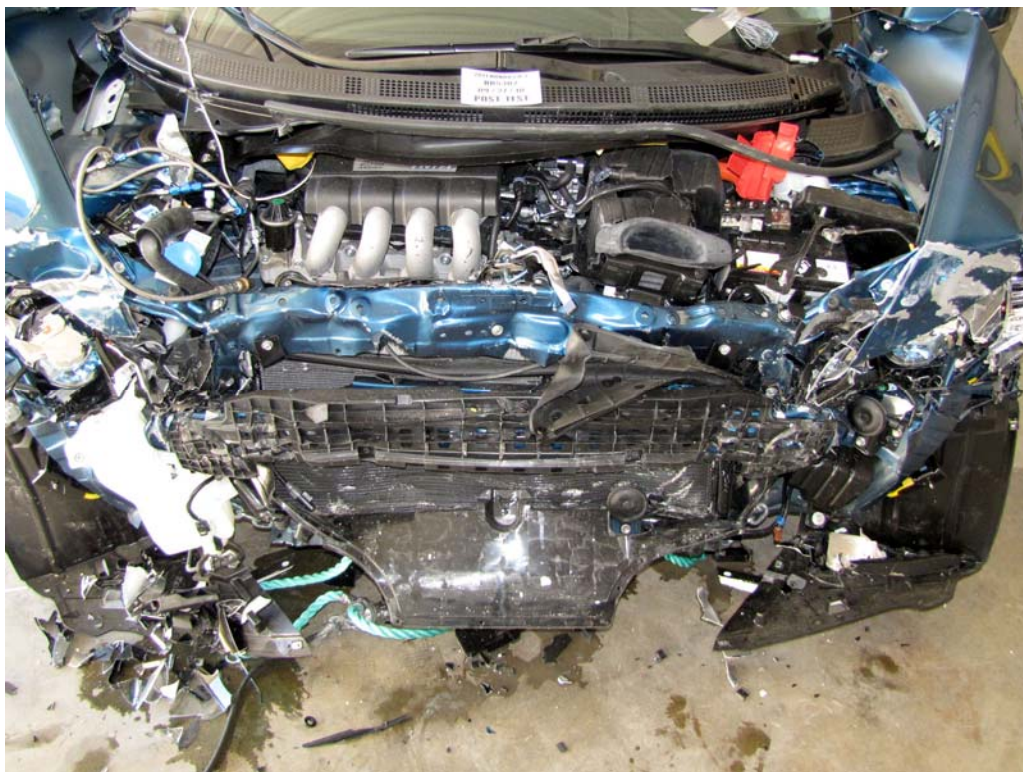
FIGURE 20. Post-Test Engine Compartment View

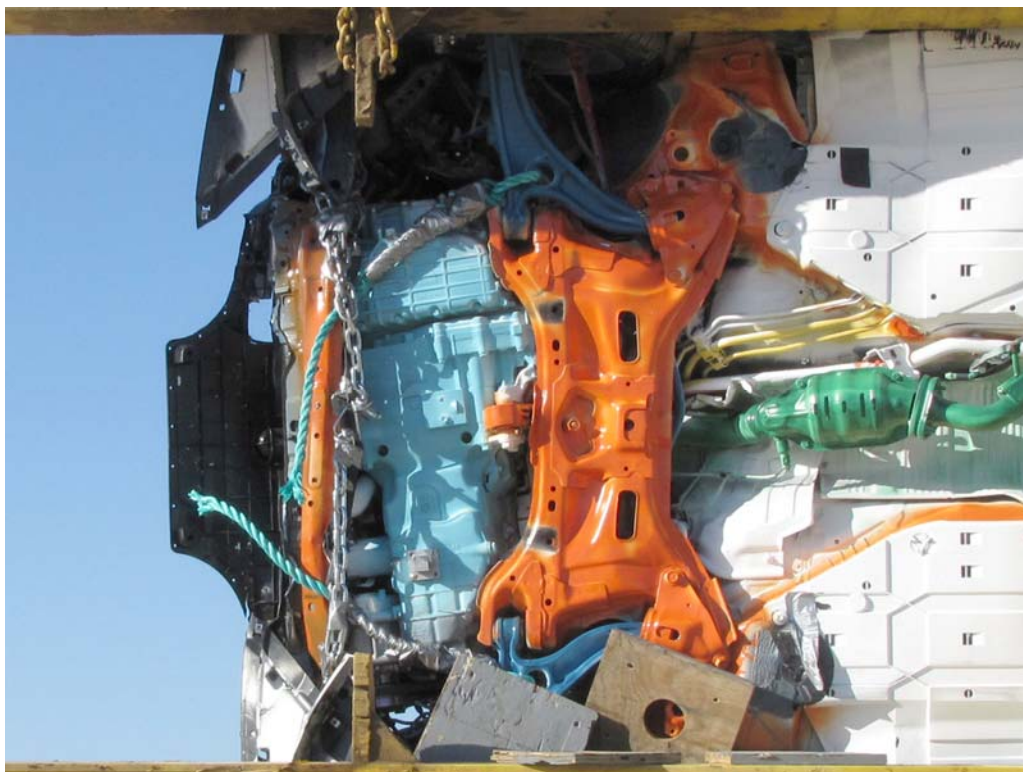
FIGURE 24. Post-Test Front Underbody View

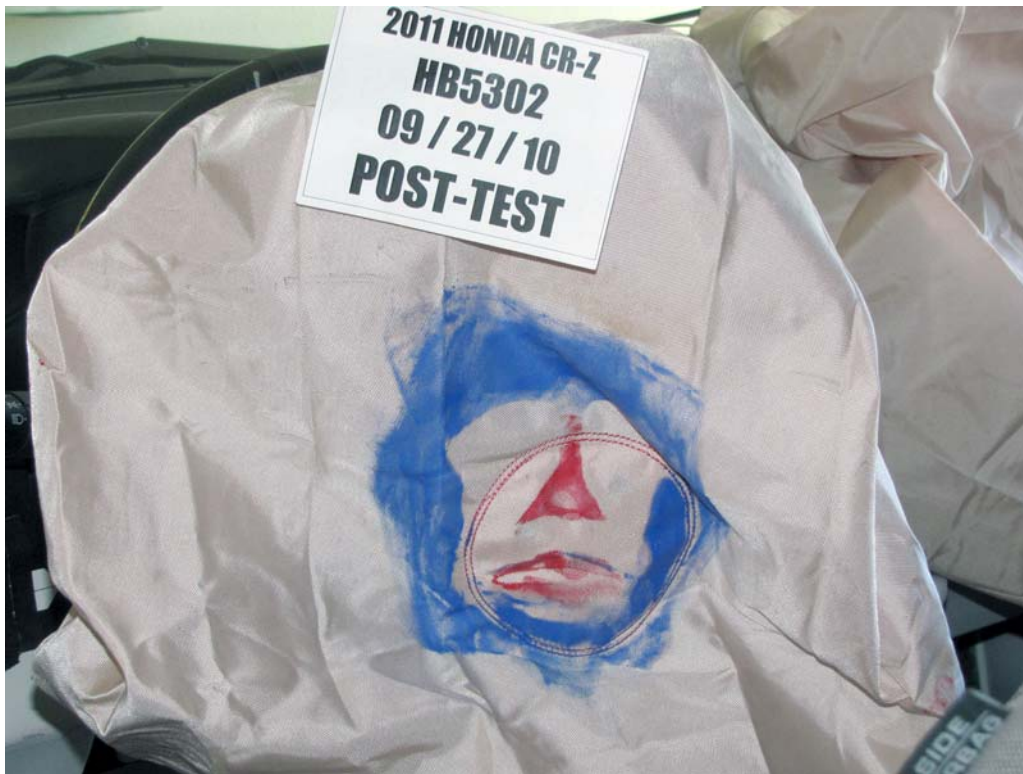
FIGURE 43. Post-Test Driver Dummy Contact With Airbag

The driver's visible contact points were as follows: The driver ATD's head contacted the airbag and headrest. The upper torso contacted the airbag. Both the left and right knees contacted the steering column, knee bolster, and steering wheel.

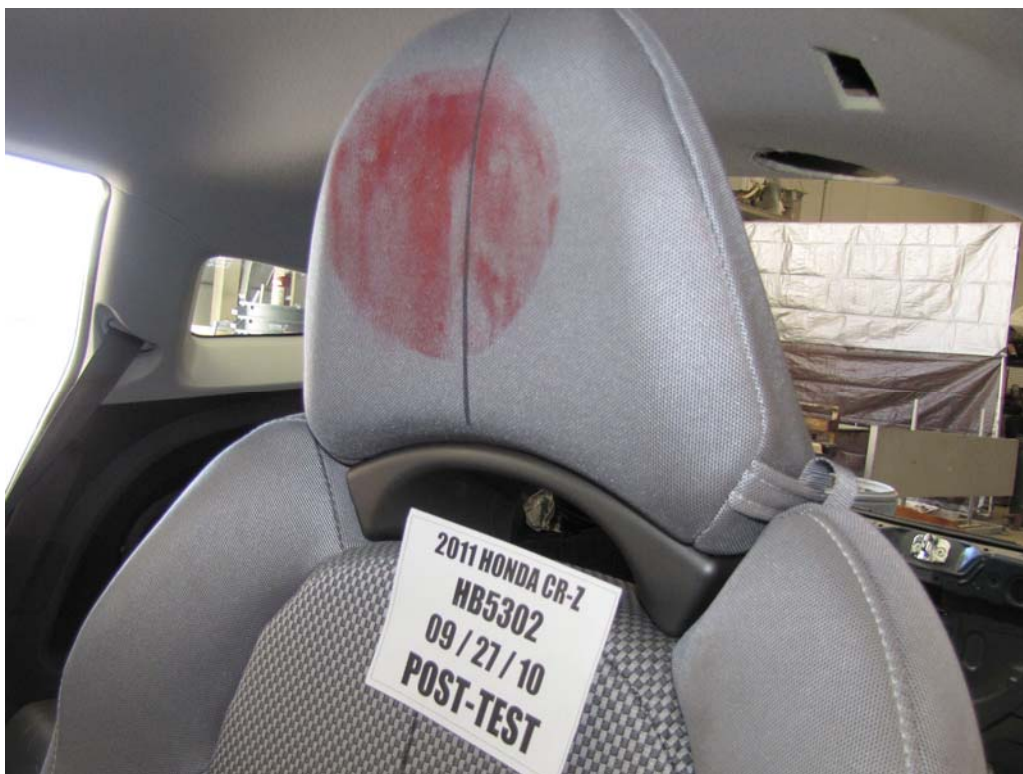
FIGURE 43a. Post-Test Driver Dummy Contact With Headrest

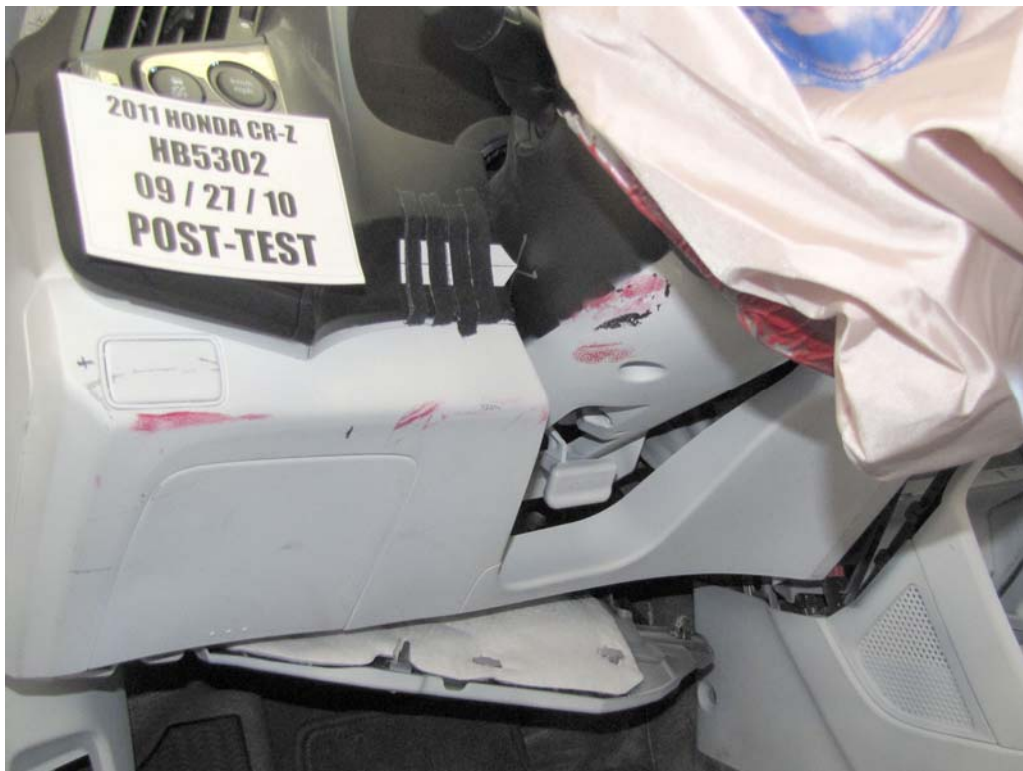
FIGURE 45. Post-Test View of Steering Column Shear Capsule

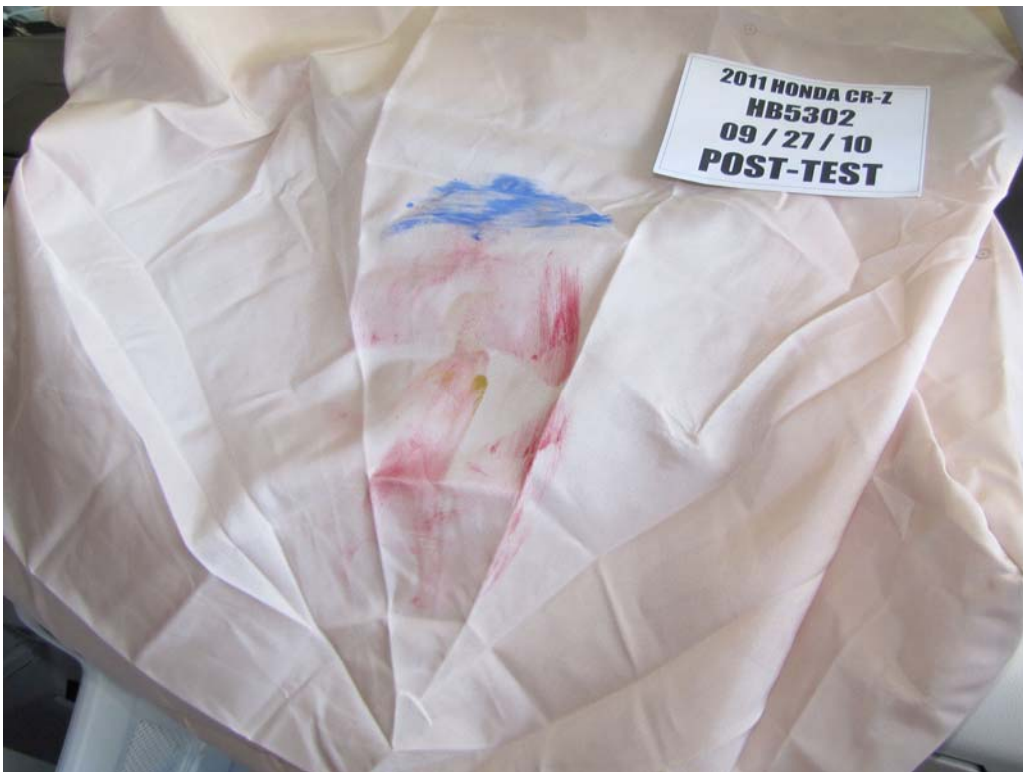
FIGURE 60. Post-Test Passenger Dummy Contact With Airbag

The passenger's visible contact points were as follows: The passenger ATD's head contacted the airbag and headrest. The upper torso contacted the airbag. Both the left and right knees contacted the glovebox.

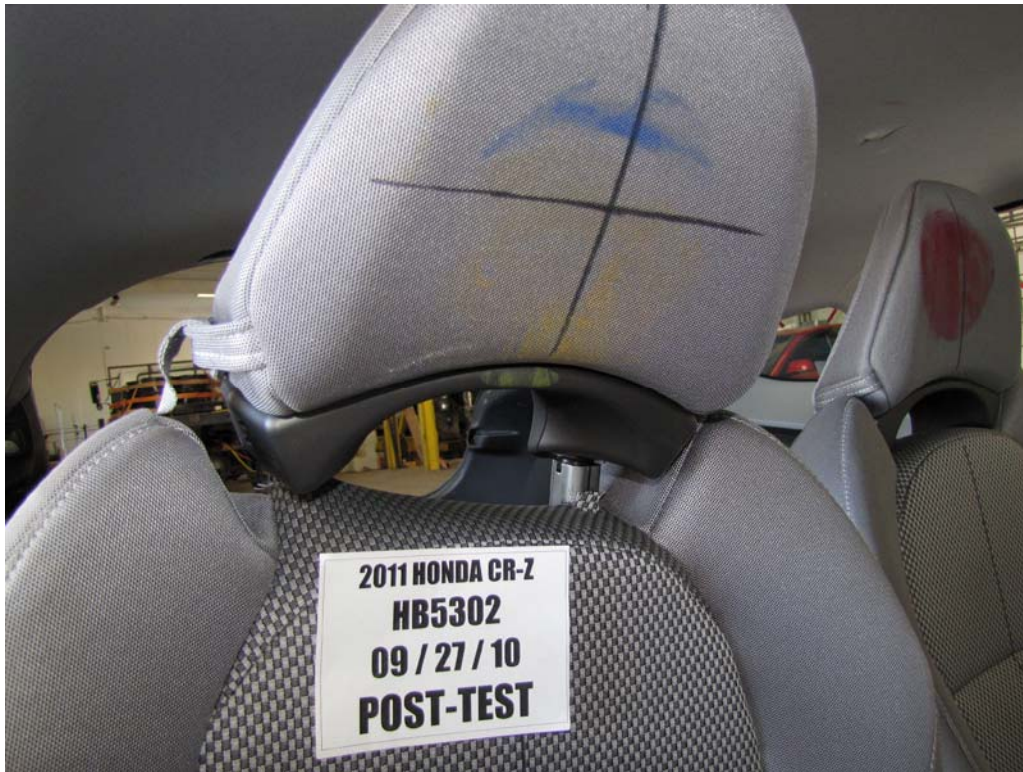
FIGURE 60a. Post-Test Passenger Dummy Contact With Headrest

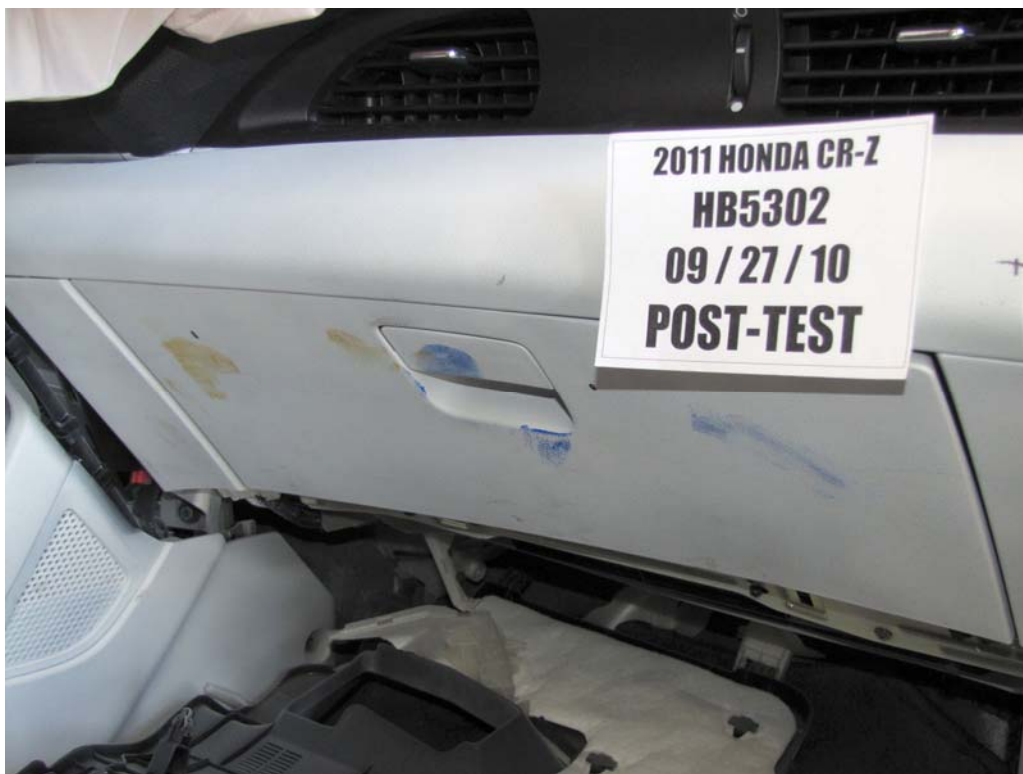
FIGURE 60b. Post-Test Passenger Dummy Contact With Knee Bolster
