**REPORT NUMBER: NCAP-MGA-2011-027**

**NEW CAR ASSESSMENT PROGRAM (NCAP)  
Frontal Barrier Impact Test**

**HONDA OF AMERICA MFG., INC.  
2011 Honda Accord LX 4-Dr Sedan  
NHTSA No.: MB5305**

**FINAL REPORT**

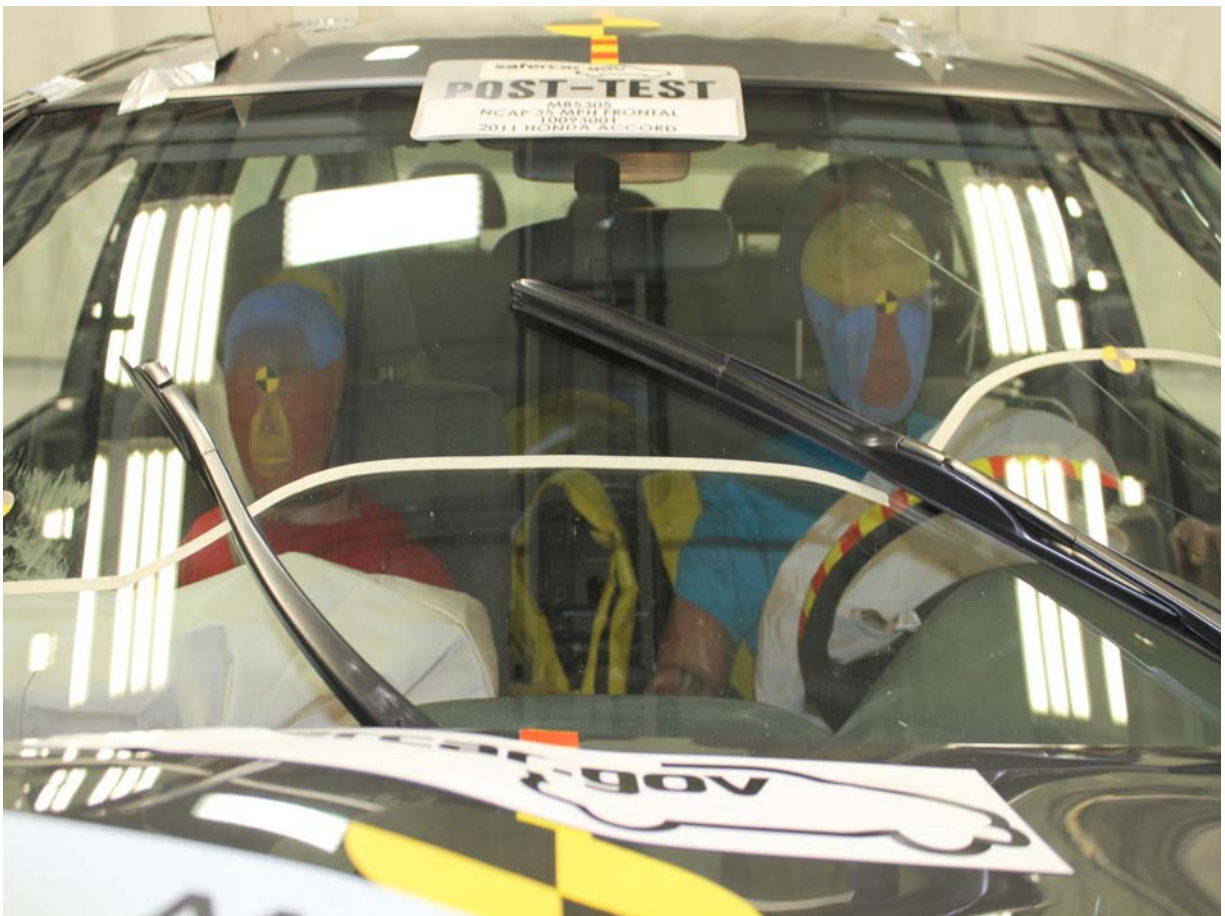
Post-Test Windshield View

There was 100 percent windshield retention and no intrusion into the protected zone of the windshield during the event. There was no Stoddard Solvent leakage after the event or during any phase of the static rollover.

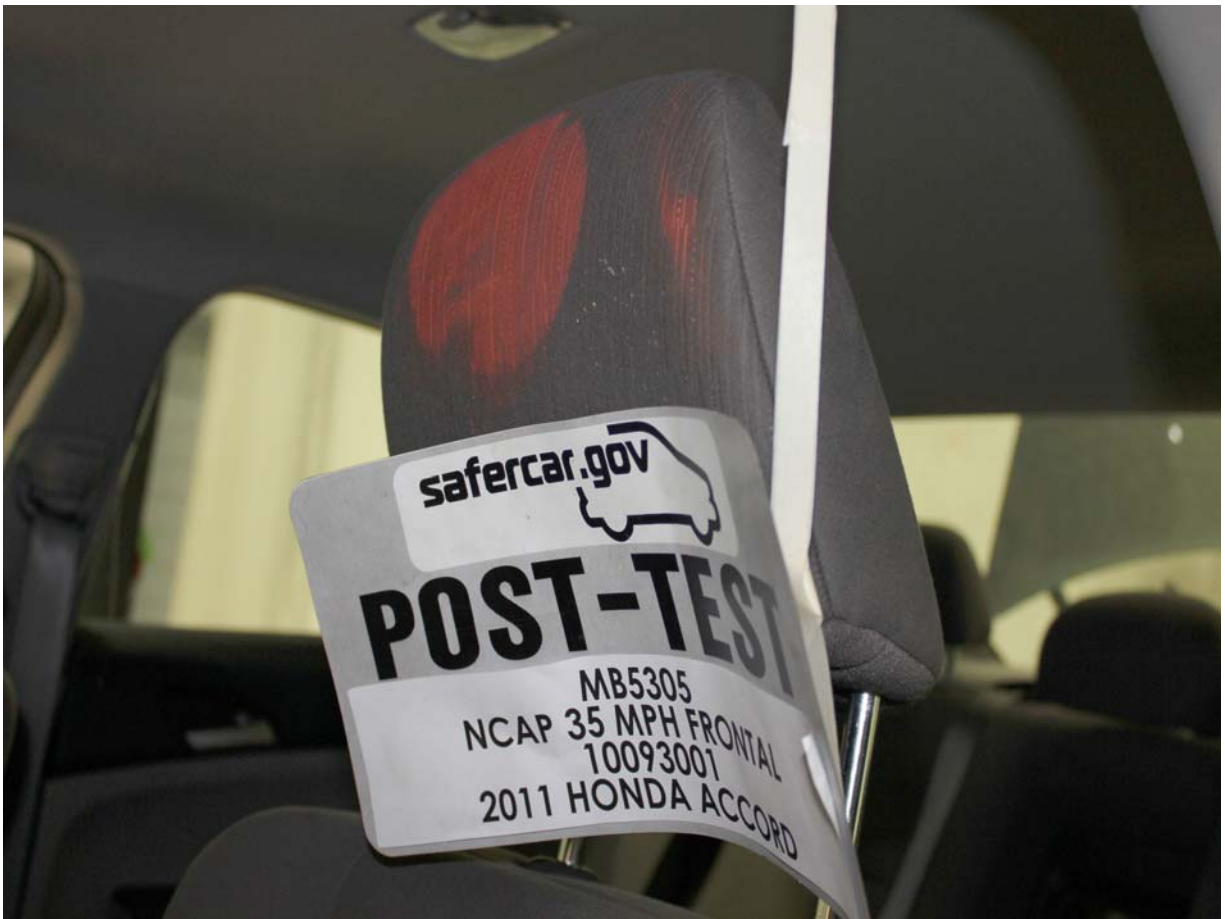
Post-Test Driver Dummy Contact with Headrest

The driver's head and chest contacted the airbag. The driver's head also contacted headrest. The driver's knees contacted the knee bolster. The passenger's head and chest contacted the airbag. The passenger's head also contacted the headrest. The passenger's knees contacted the glovebox.

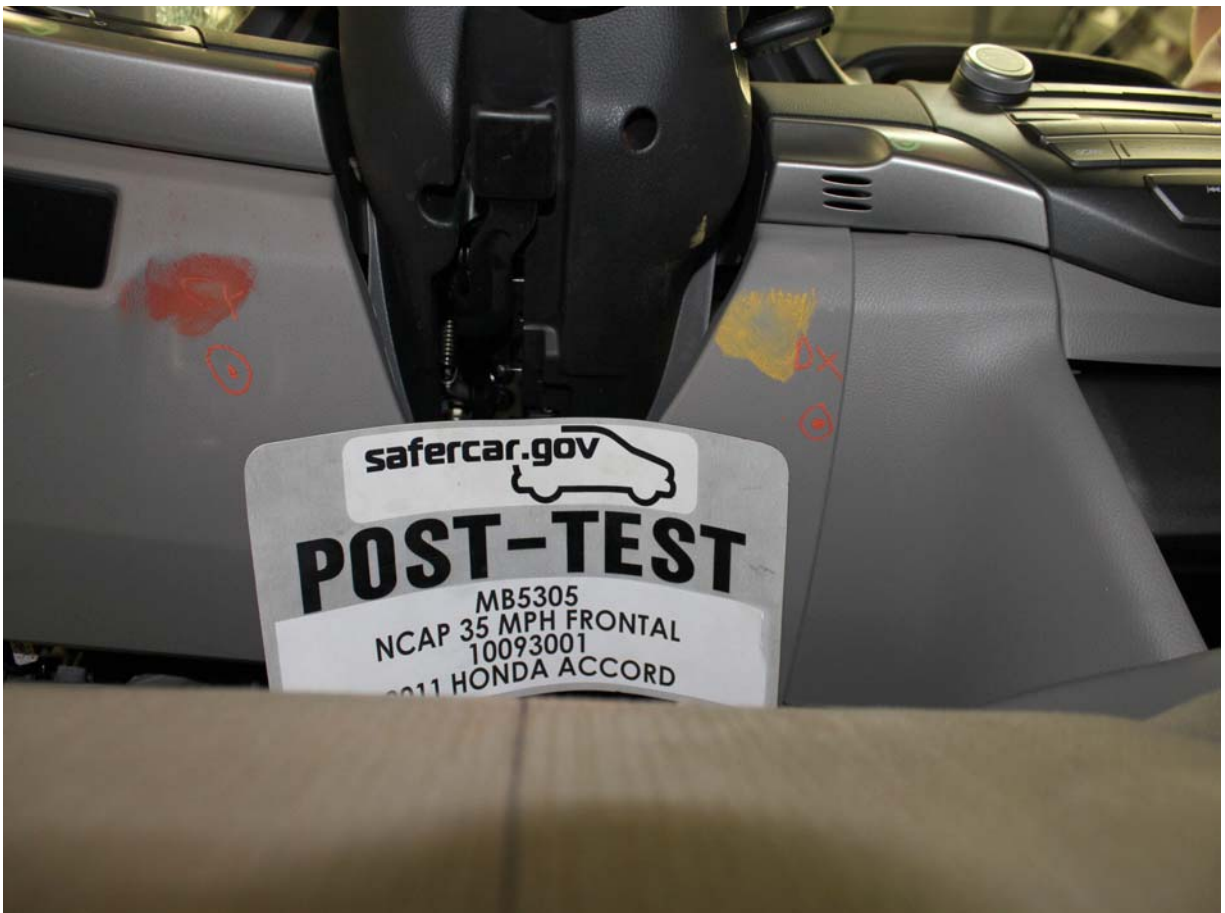
Post-Test Driver Dummy Contact with Knee Bolster

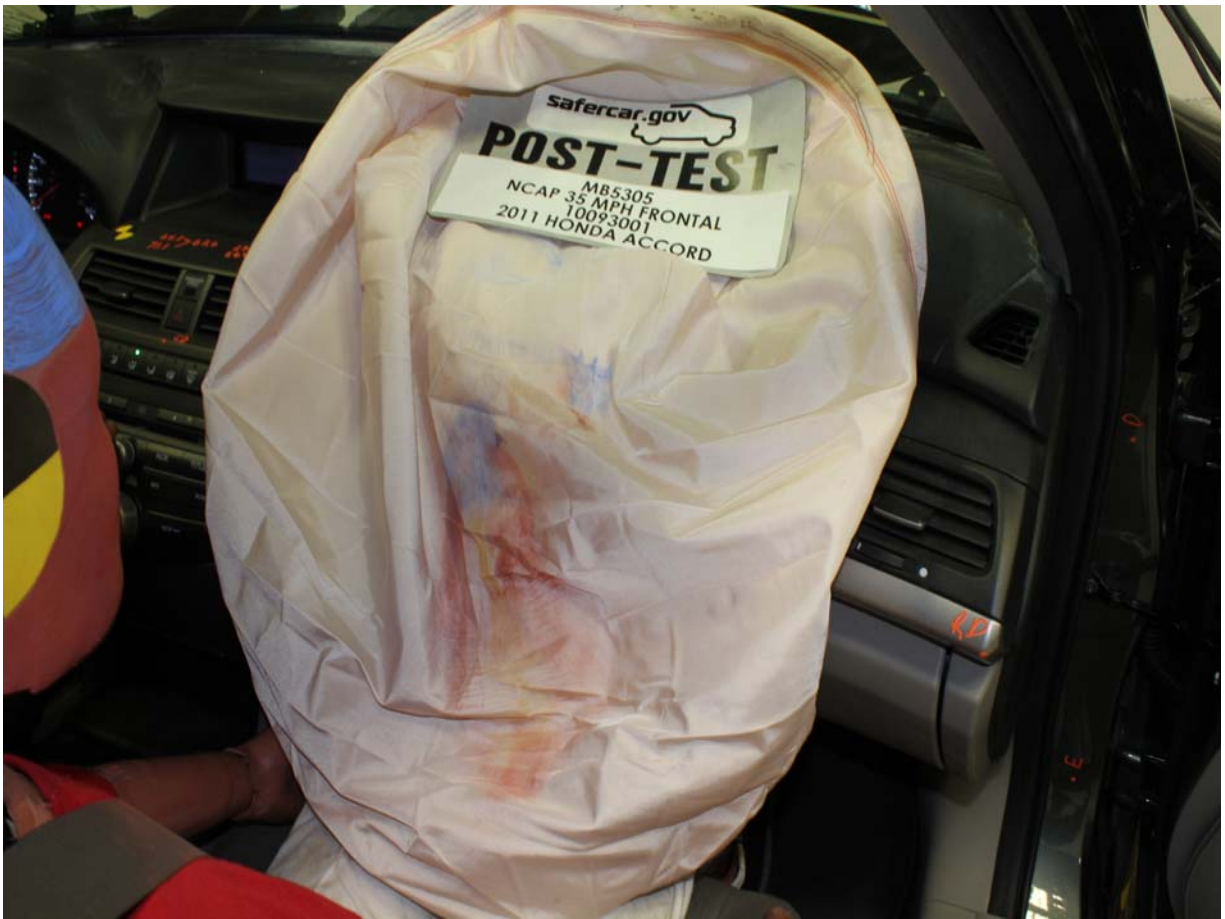
Post-Test Passenger Dummy Contact with Airbag

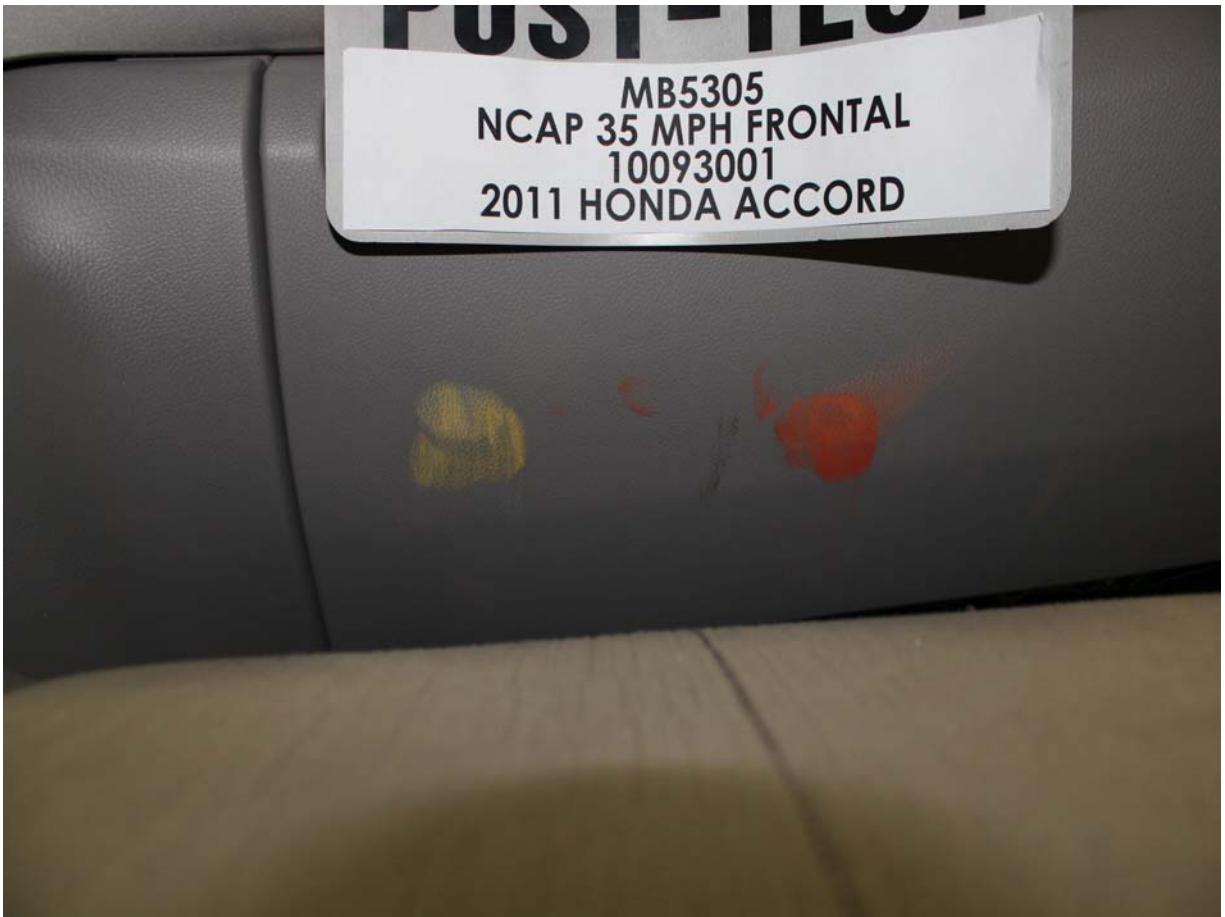
Post-Test Passenger Dummy Contact with Glovebox

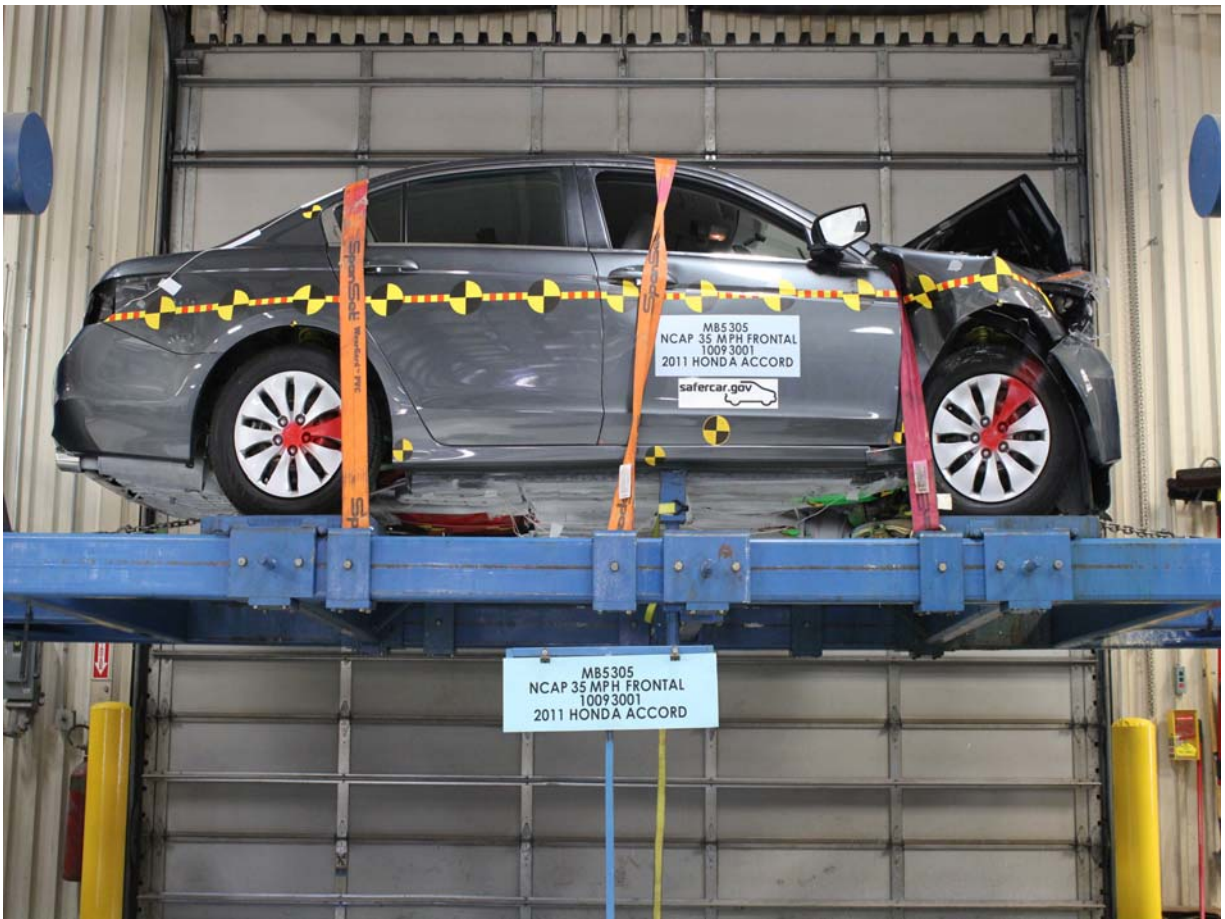
Vehicle at 0 Degrees on Static Rollover Device
