**REPORT NUMBER: NCAP-CAL-11-014**

**NEW CAR ASSESSMENT PROGRAM (NCAP)  
FRONTAL BARRIER IMPACT TEST**

**General Motors  
2011 Chevrolet Silverado  
Extended Cab**

**NHTSA NUMBER: MB0117**

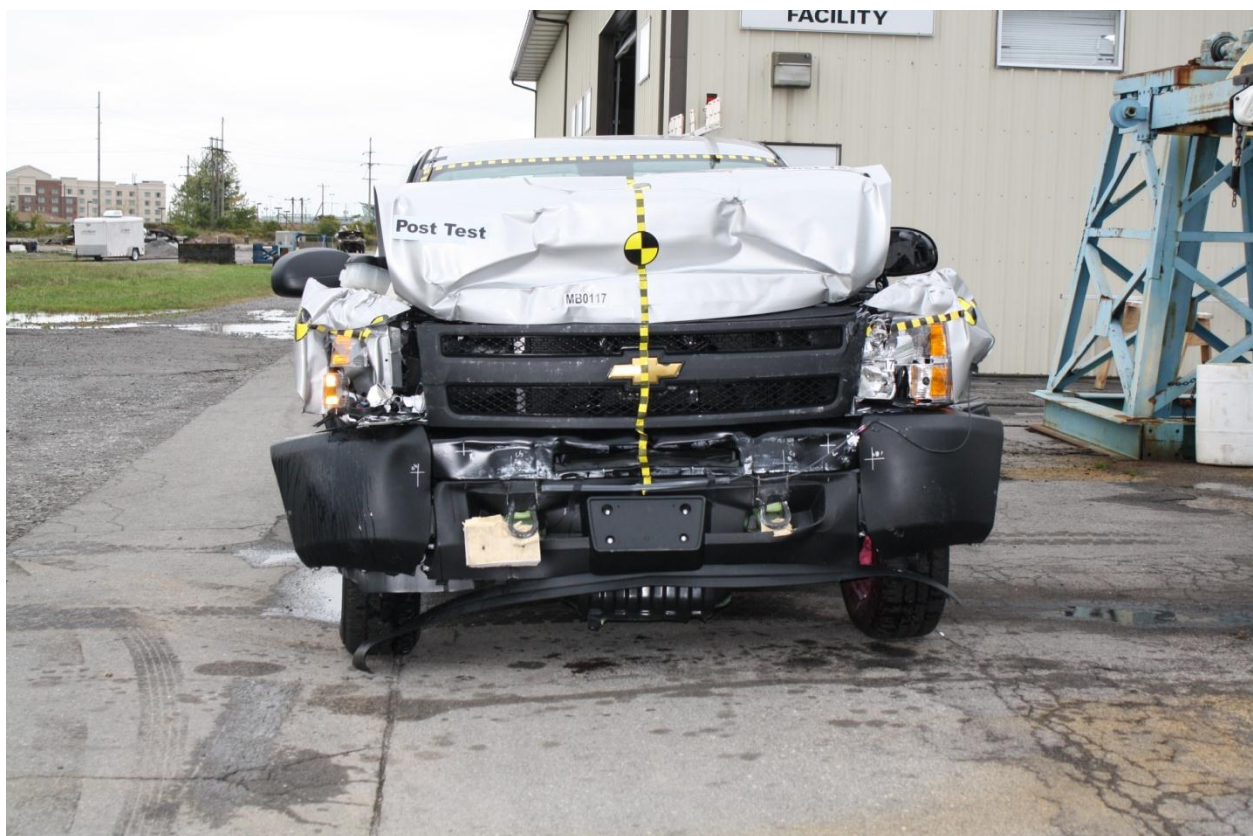
**Figure A-8: Post-Test Front View of Test Vehicle**

The maximum static crush of the vehicle was 663 mm and both the driver and passenger side doors remained closed during the impact event and were operable after the impact.
