**REPORT NUMBER: SNCAP-KAR-11-027**

**NEW CAR ASSESSMENT PROGRAM (NCAP)  
MOVING DEFORMABLE BARRIER SIDE IMPACT TEST**

**MAZDA MOTOR CORPORATION  
2011 MAZDA3 I SPORT 4-DOOR SEDAN**

**NHTSA No: MB5401**

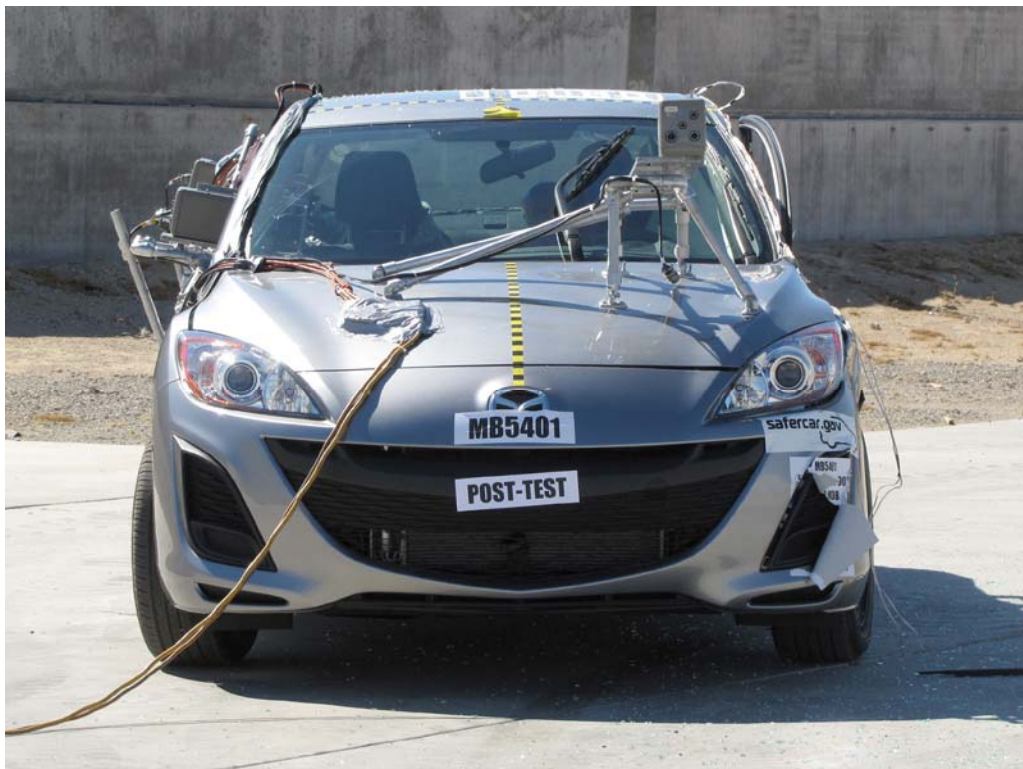
FIGURE 4. Post-Test Frontal View of Test Vehicle

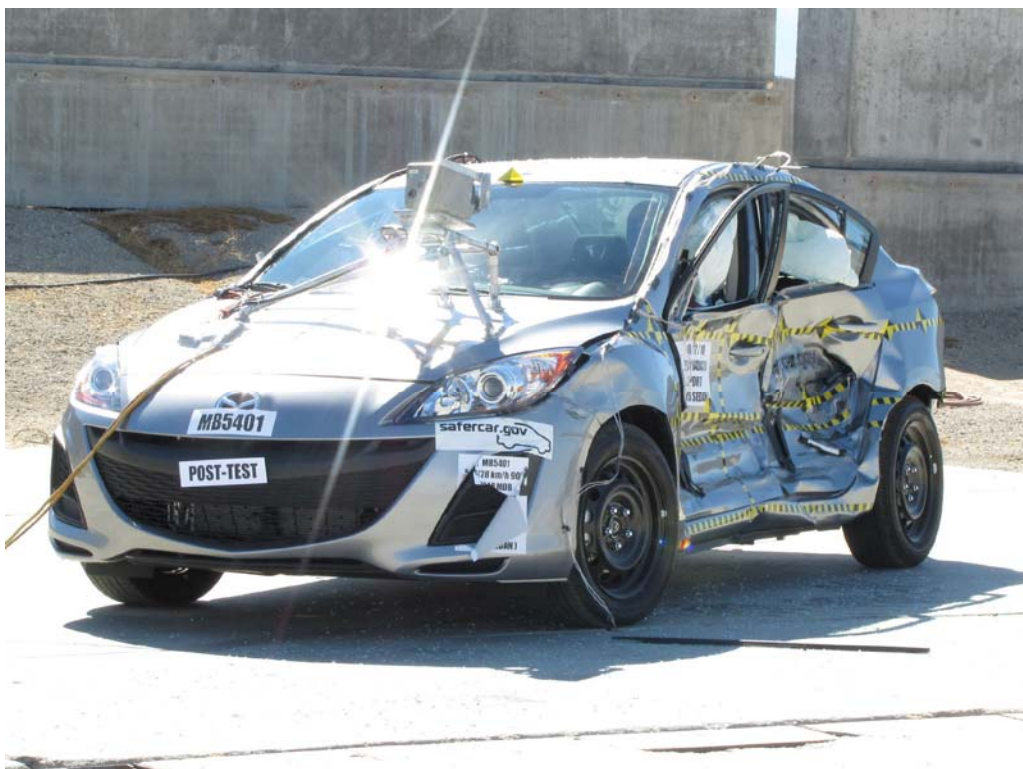
FIGURE 6. Post-Test Left Front Three-Quarter View of the Test Vehicle

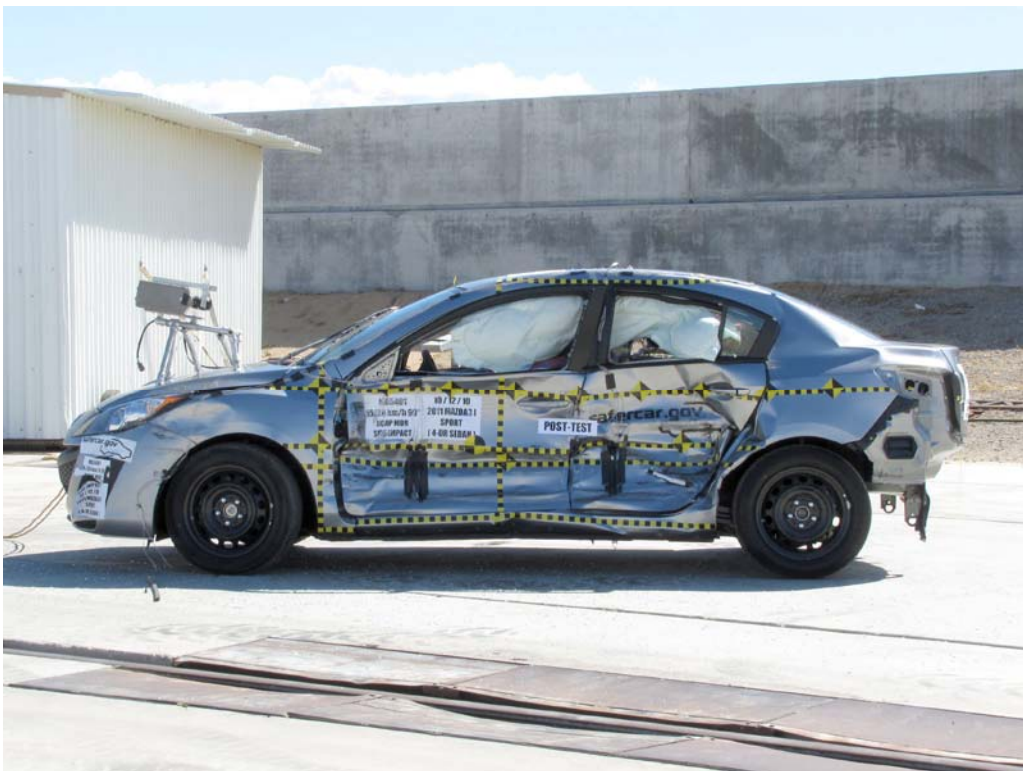
FIGURE 8. Post-Test Left Side View of Test Vehicle

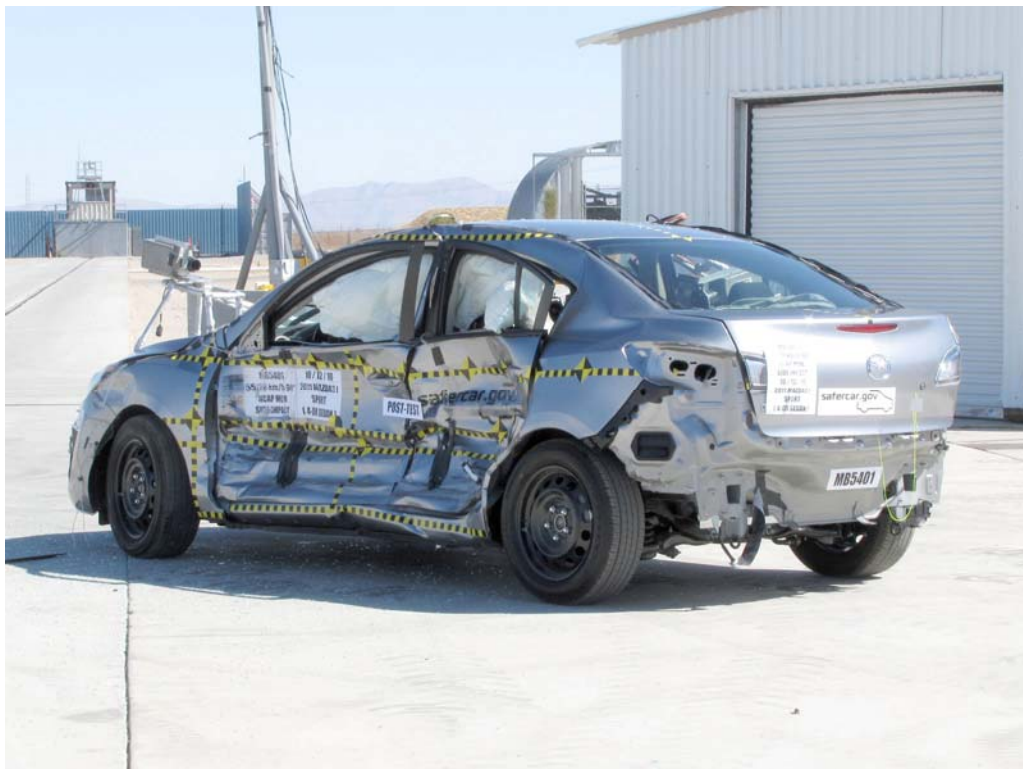
FIGURE 10. Post-Test Left Rear Three-Quarter View of Impact Zone

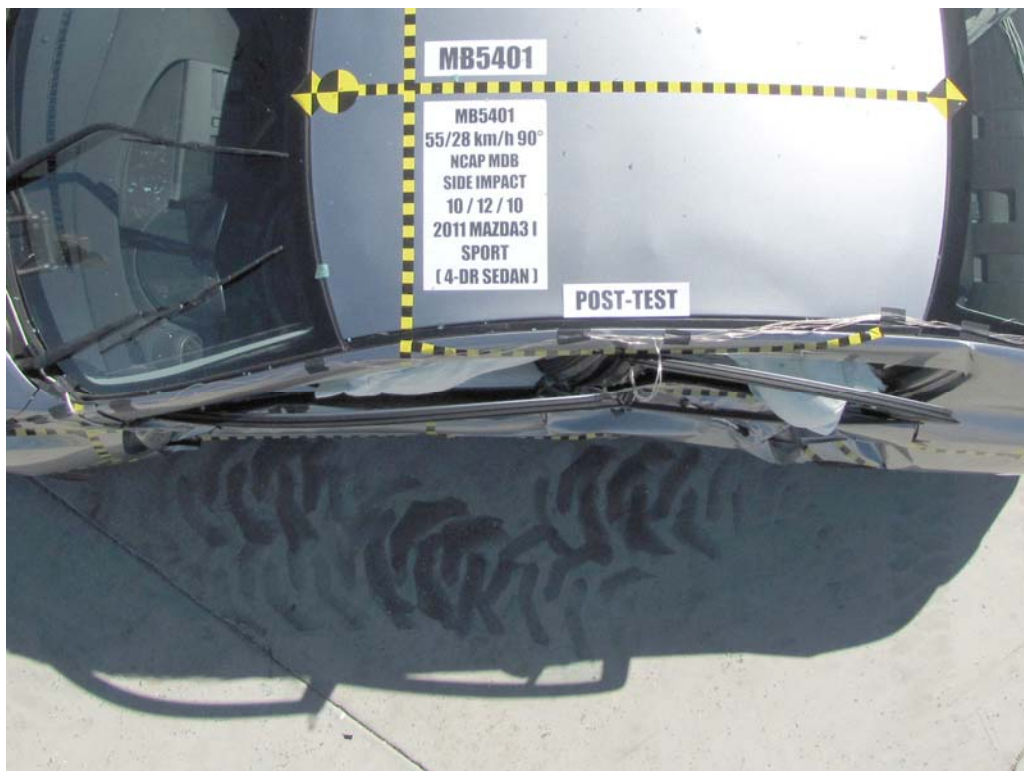
FIGURE 16. Post-Test Overhead View of Test Vehicle and MDB

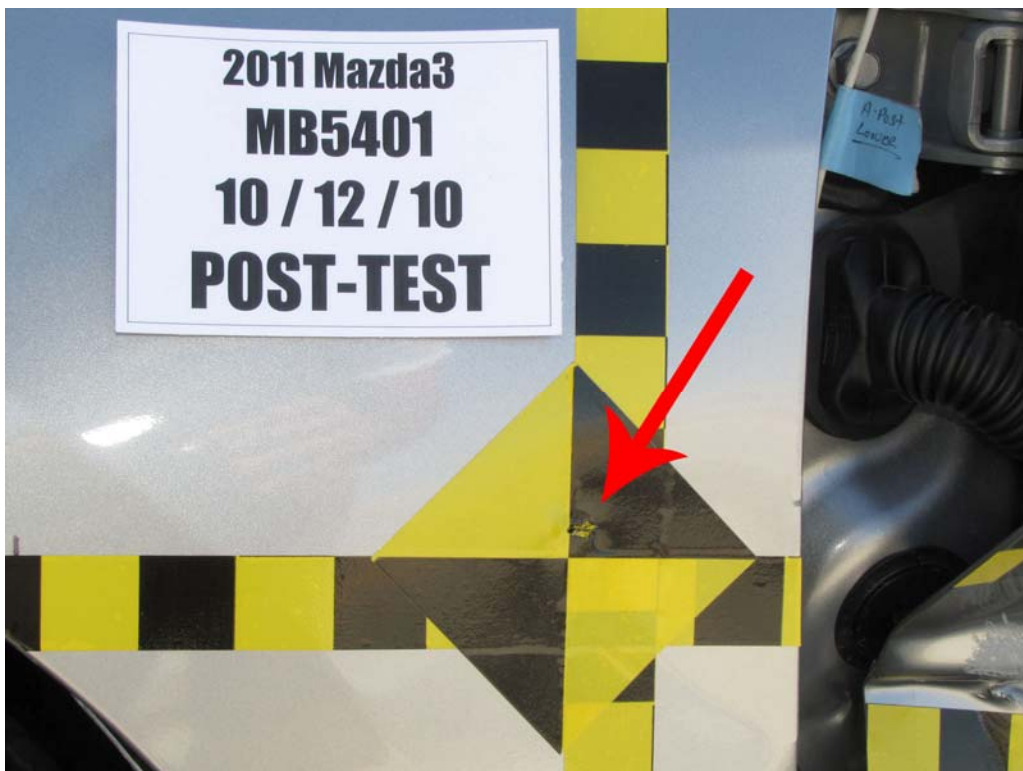
FIGURE 20. Post-Test Close-Up View of Impact Point Target  
Showing Impact Point Location

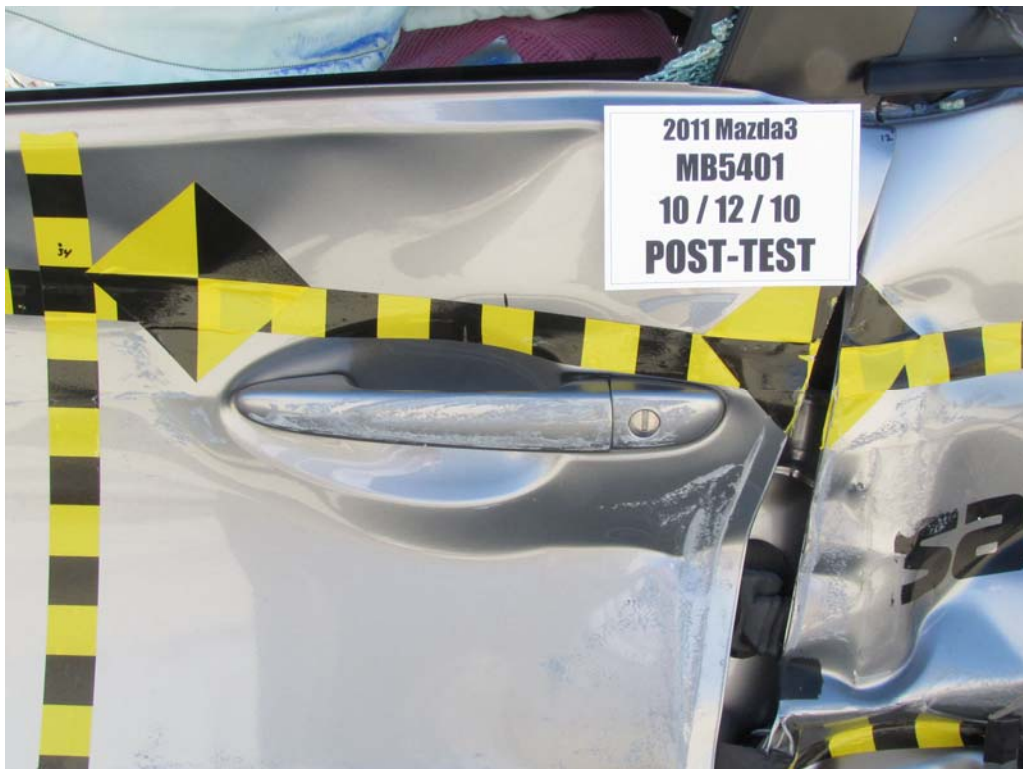
FIGURE 22. Post-Test Left Front Door Latch Close-Up

Both the front and rear doors on the struck side of the vehicle remained closed and latched. There was no separation at the hinges or latches. Both doors on the non-struck side remained closed and latched. The passenger ATD lower spine resultant acceleration and total pelvic force exceeded the maximum values.

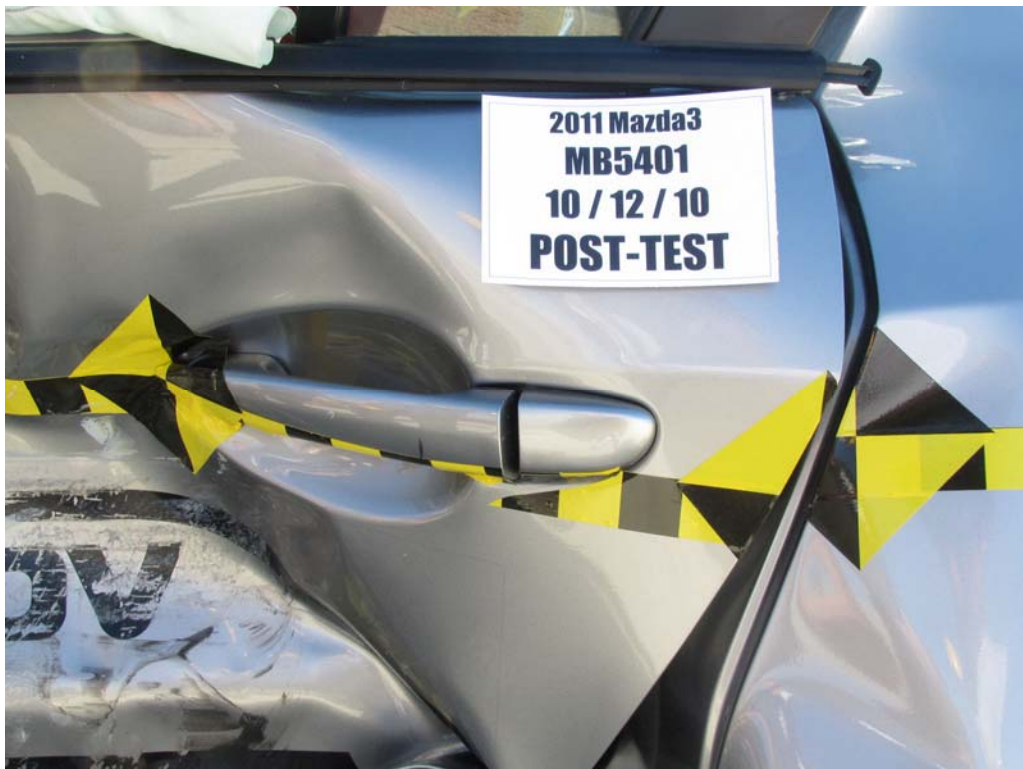
FIGURE 24. Post-Test Left Rear Door Latch Close-Up

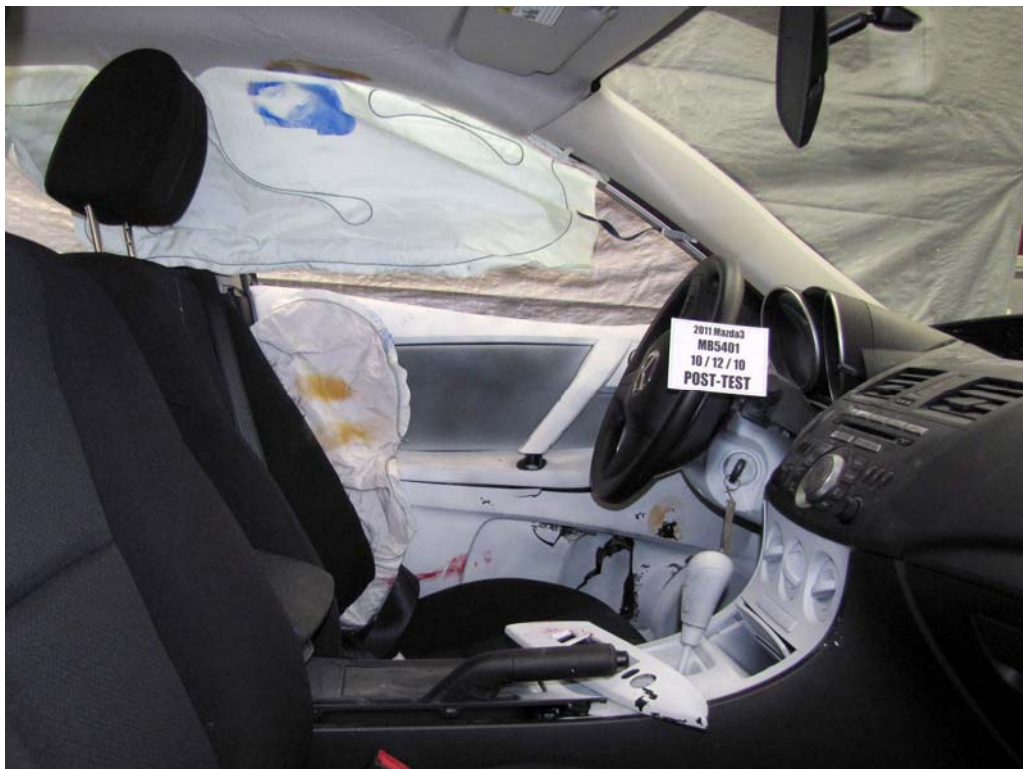
FIGURE 46. Post-Test Driver Dummy Inner Door Panel View  
Showing Driver Dummy Contact Locations

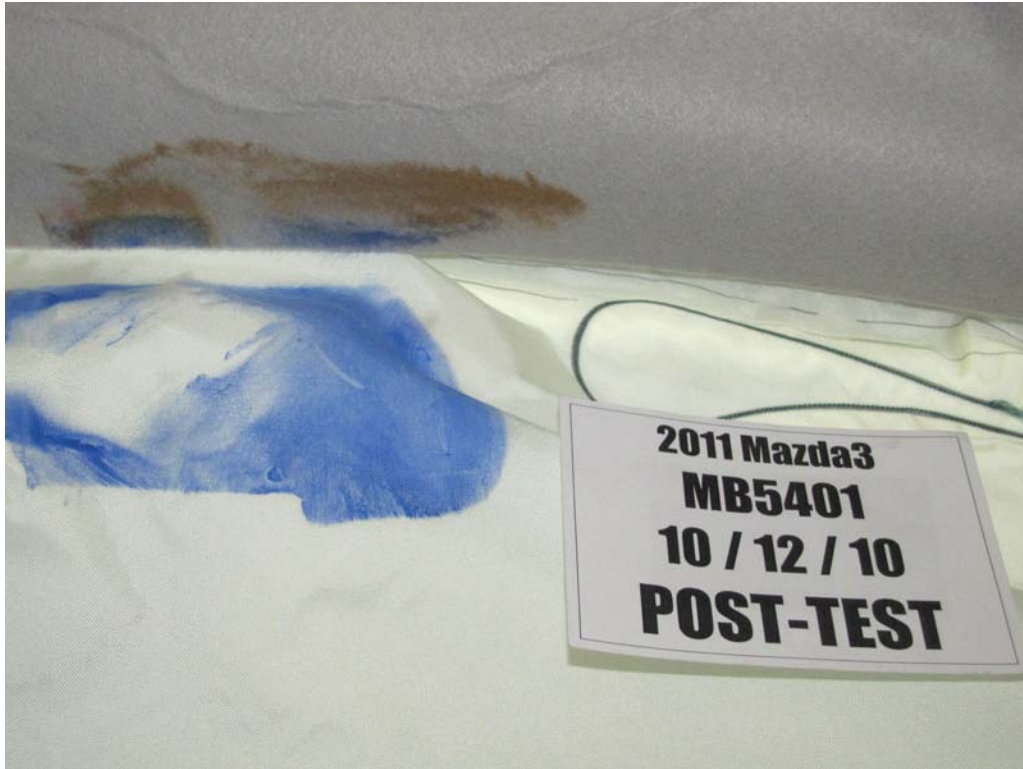
FIGURE 47. Post-Test Driver Dummy Close-Up Head Contact With Vehicle Interior View

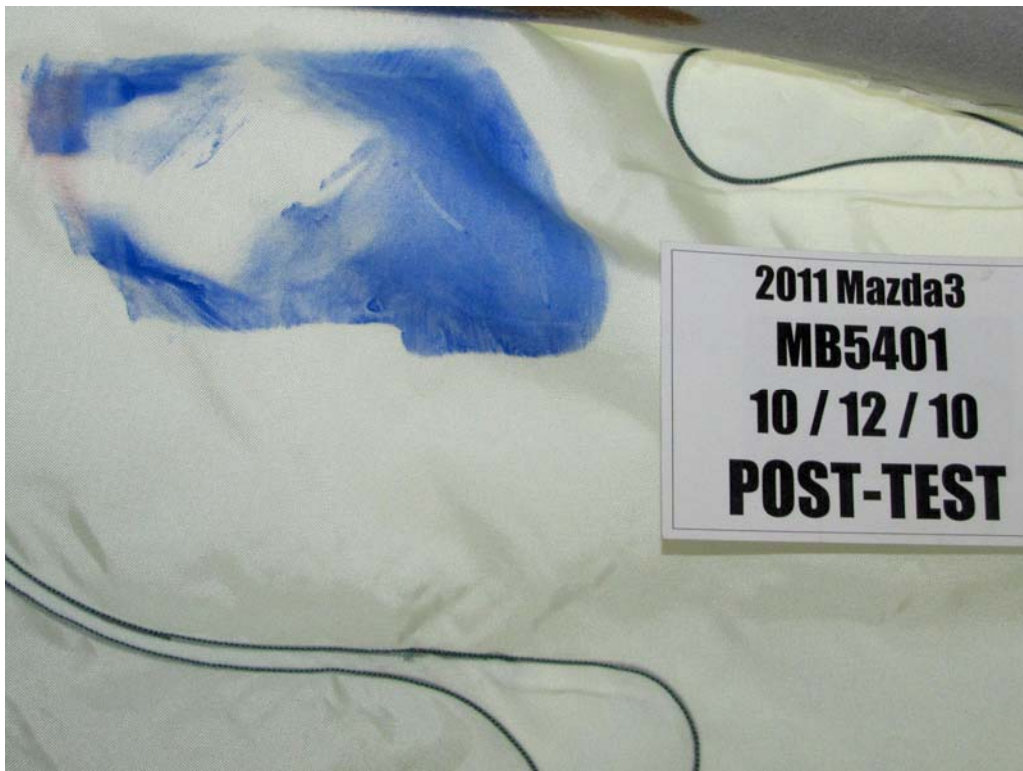
FIGURE 48. Post-Test Driver Dummy Close-Up Head Contact with Side Airbag View

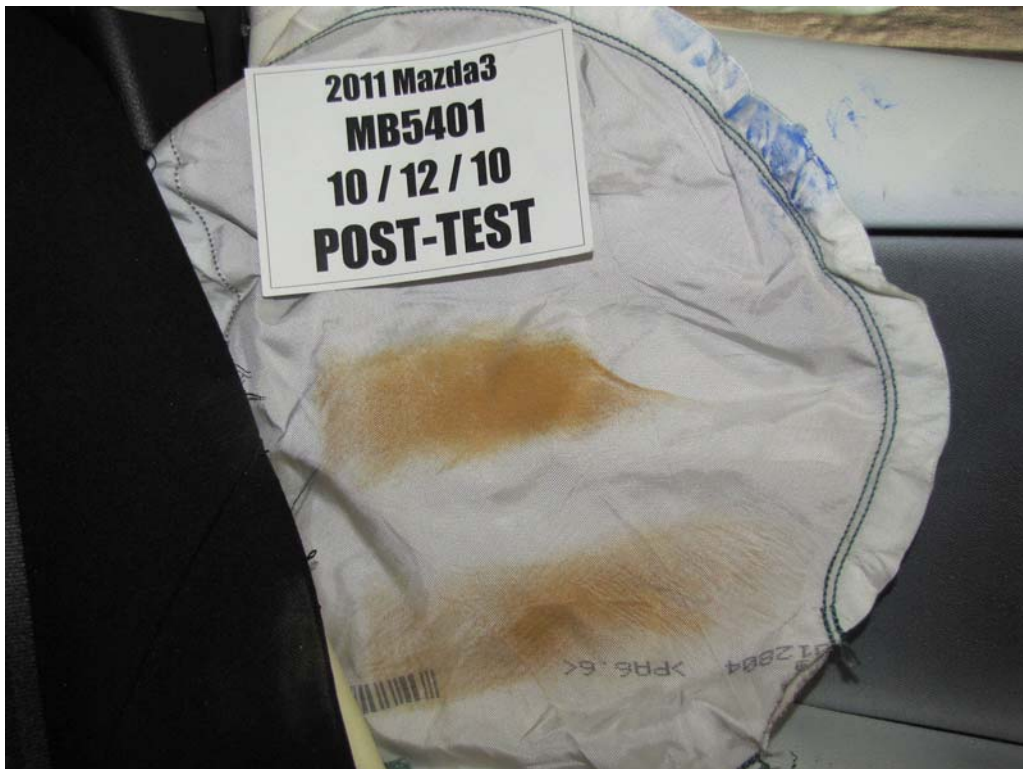
FIGURE 50. Post-Test Driver Dummy Close-Up Torso Contact with Side Airbag View

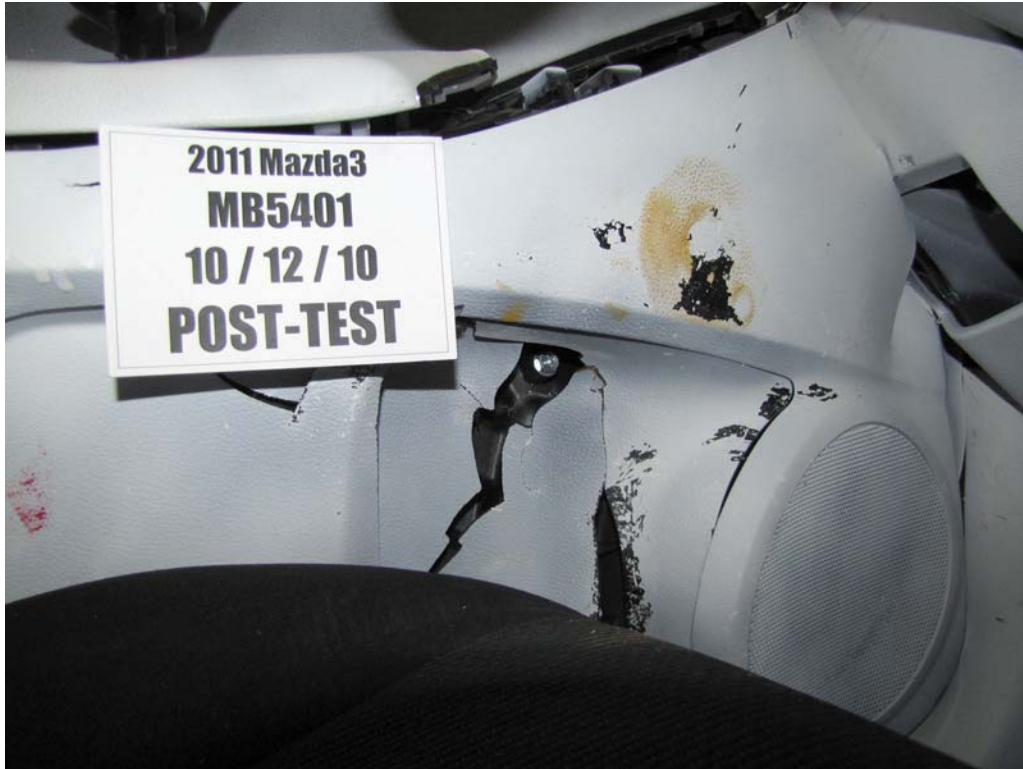
FIGURE 51. Post-Test Driver Dummy Close-Up Pelvis Contact with Vehicle Interior View

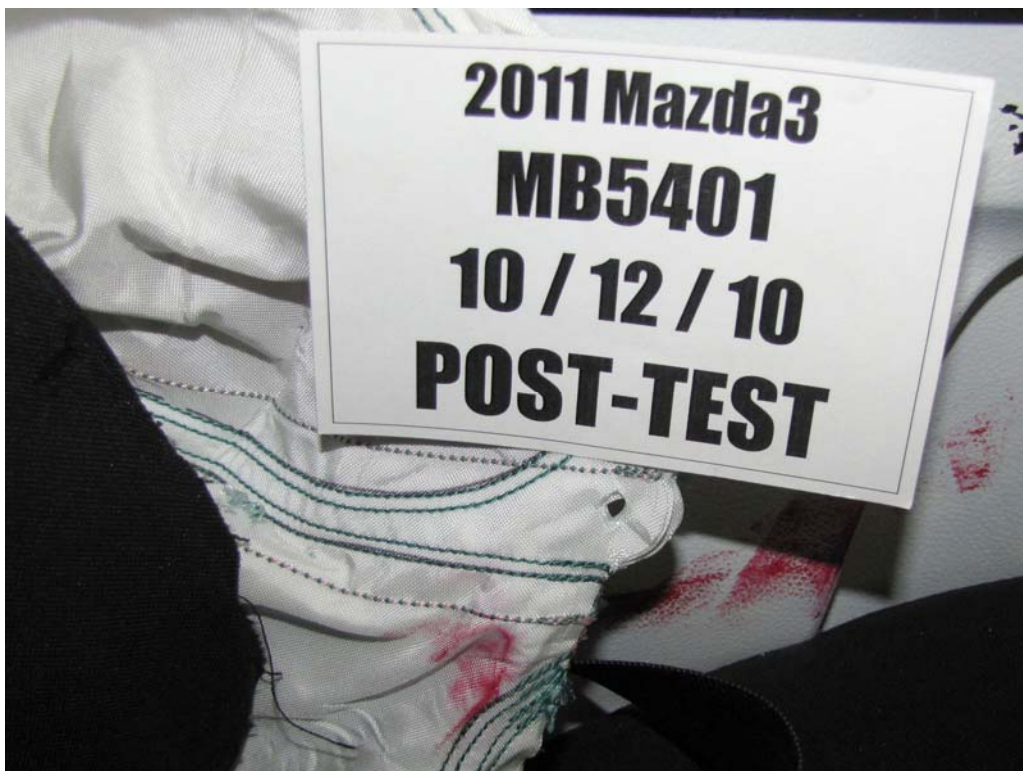
FIGURE 52. Post-Test Driver Dummy Close-Up Pelvis Contact with Side Airbag View

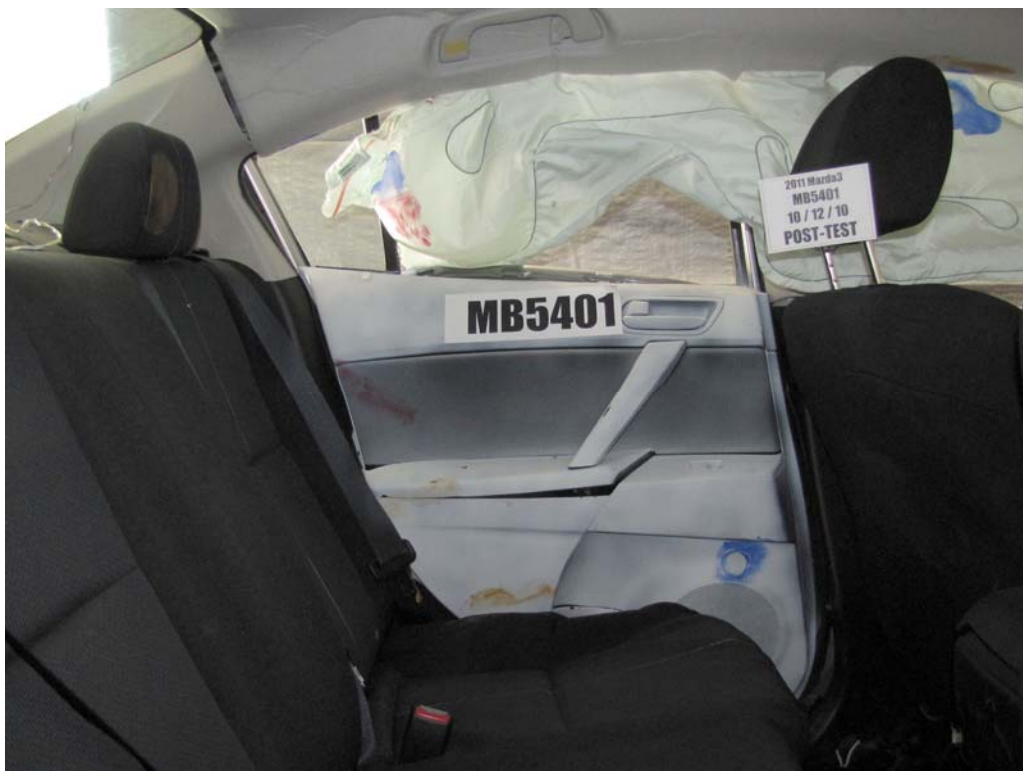
FIGURE 72. Post-Test Rear Passenger Inner Door Panel View  
Showing Rear Passenger Dummy Contact Locations

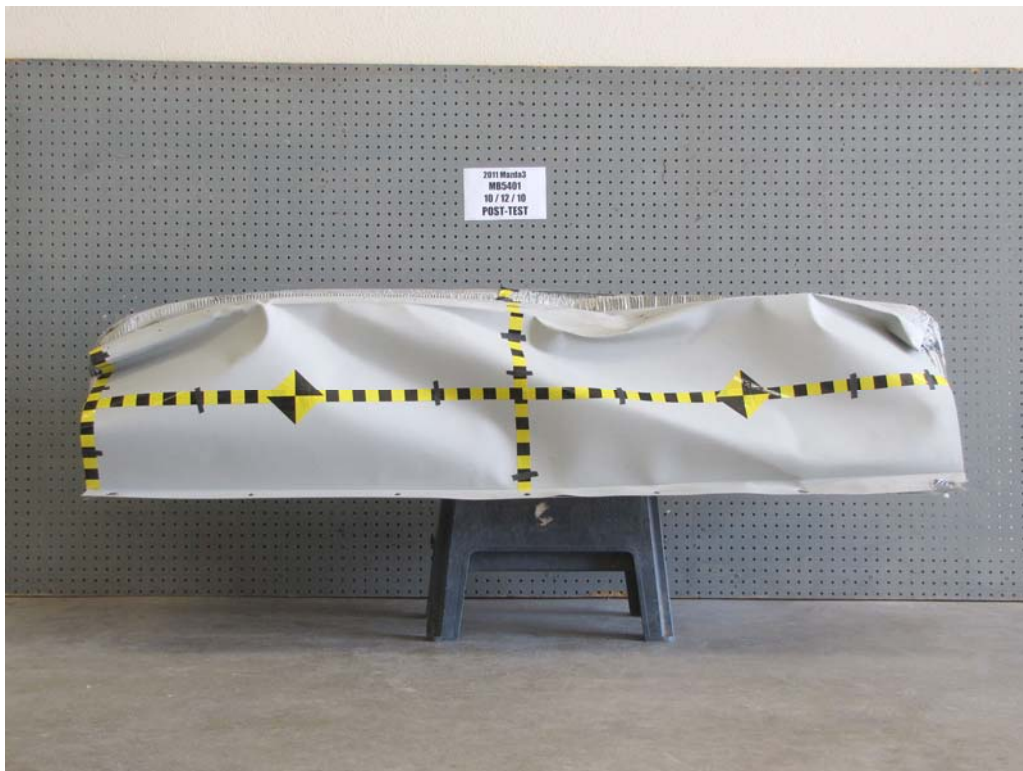
FIGURE 84. Post-Test Top View of MDB Impactor Face

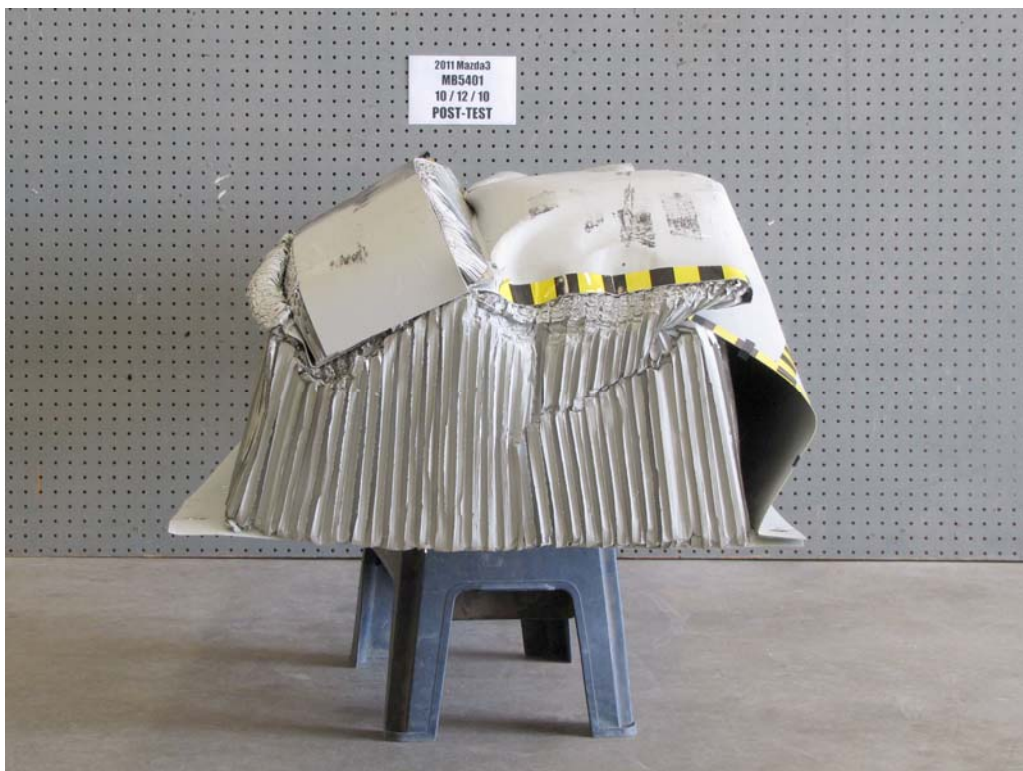
FIGURE 86. Post-Test Left Side View of MDB Impactor Face

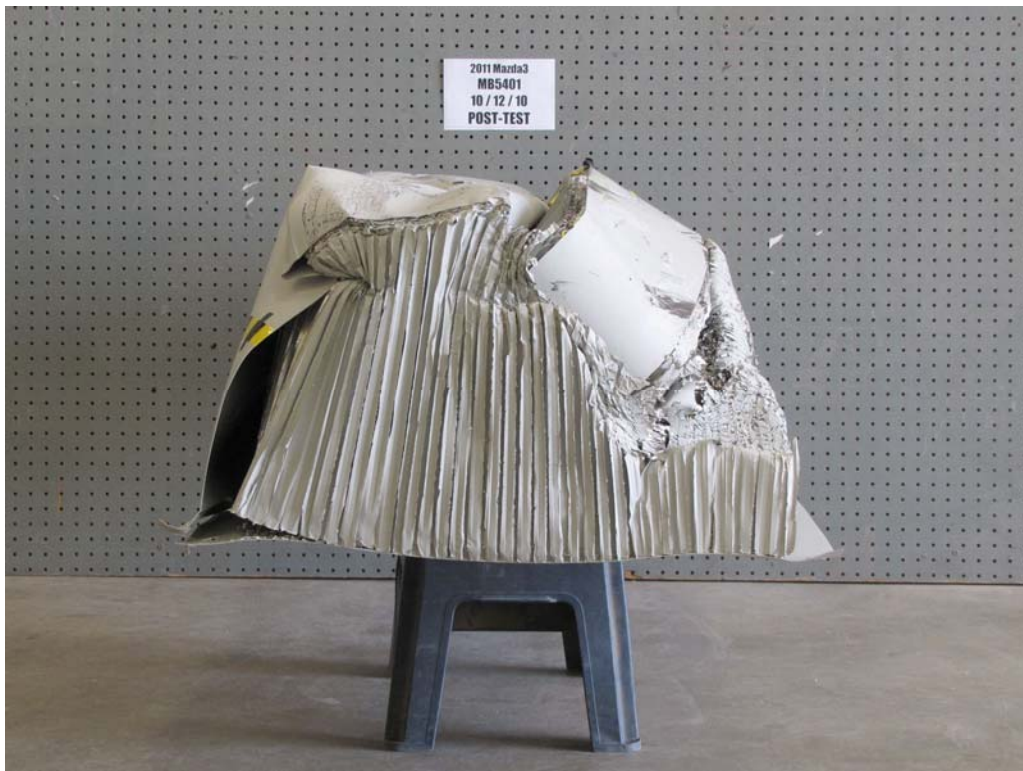
FIGURE 88. Post-Test Right Side View of MDB Impactor Face
