REPORT NUMBER: SINCAP-MGA-2011-030

**NEW CAR ASSESSMENT PROGRAM (NCAP)
Moving Deformable Barrier Side Impact Test**

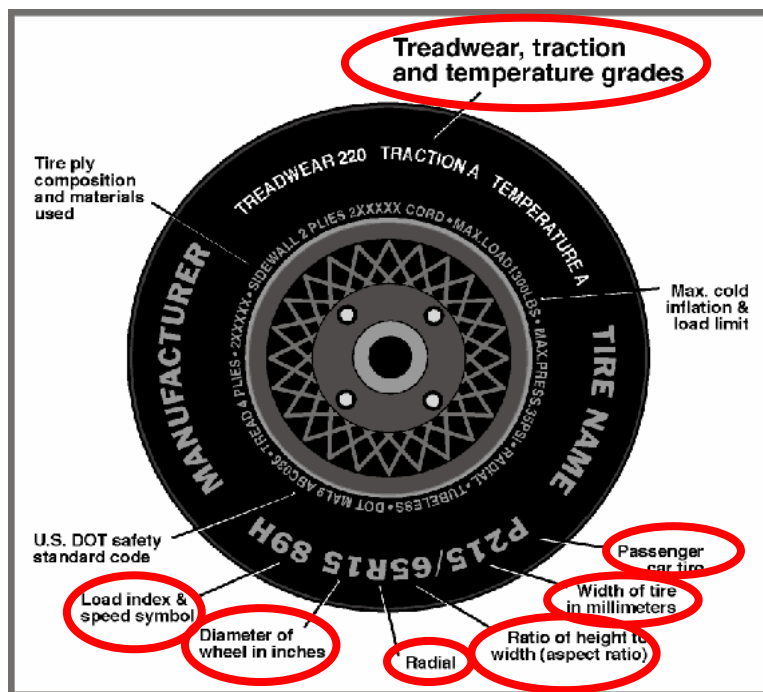
DATA FROM TIRE PLACARD

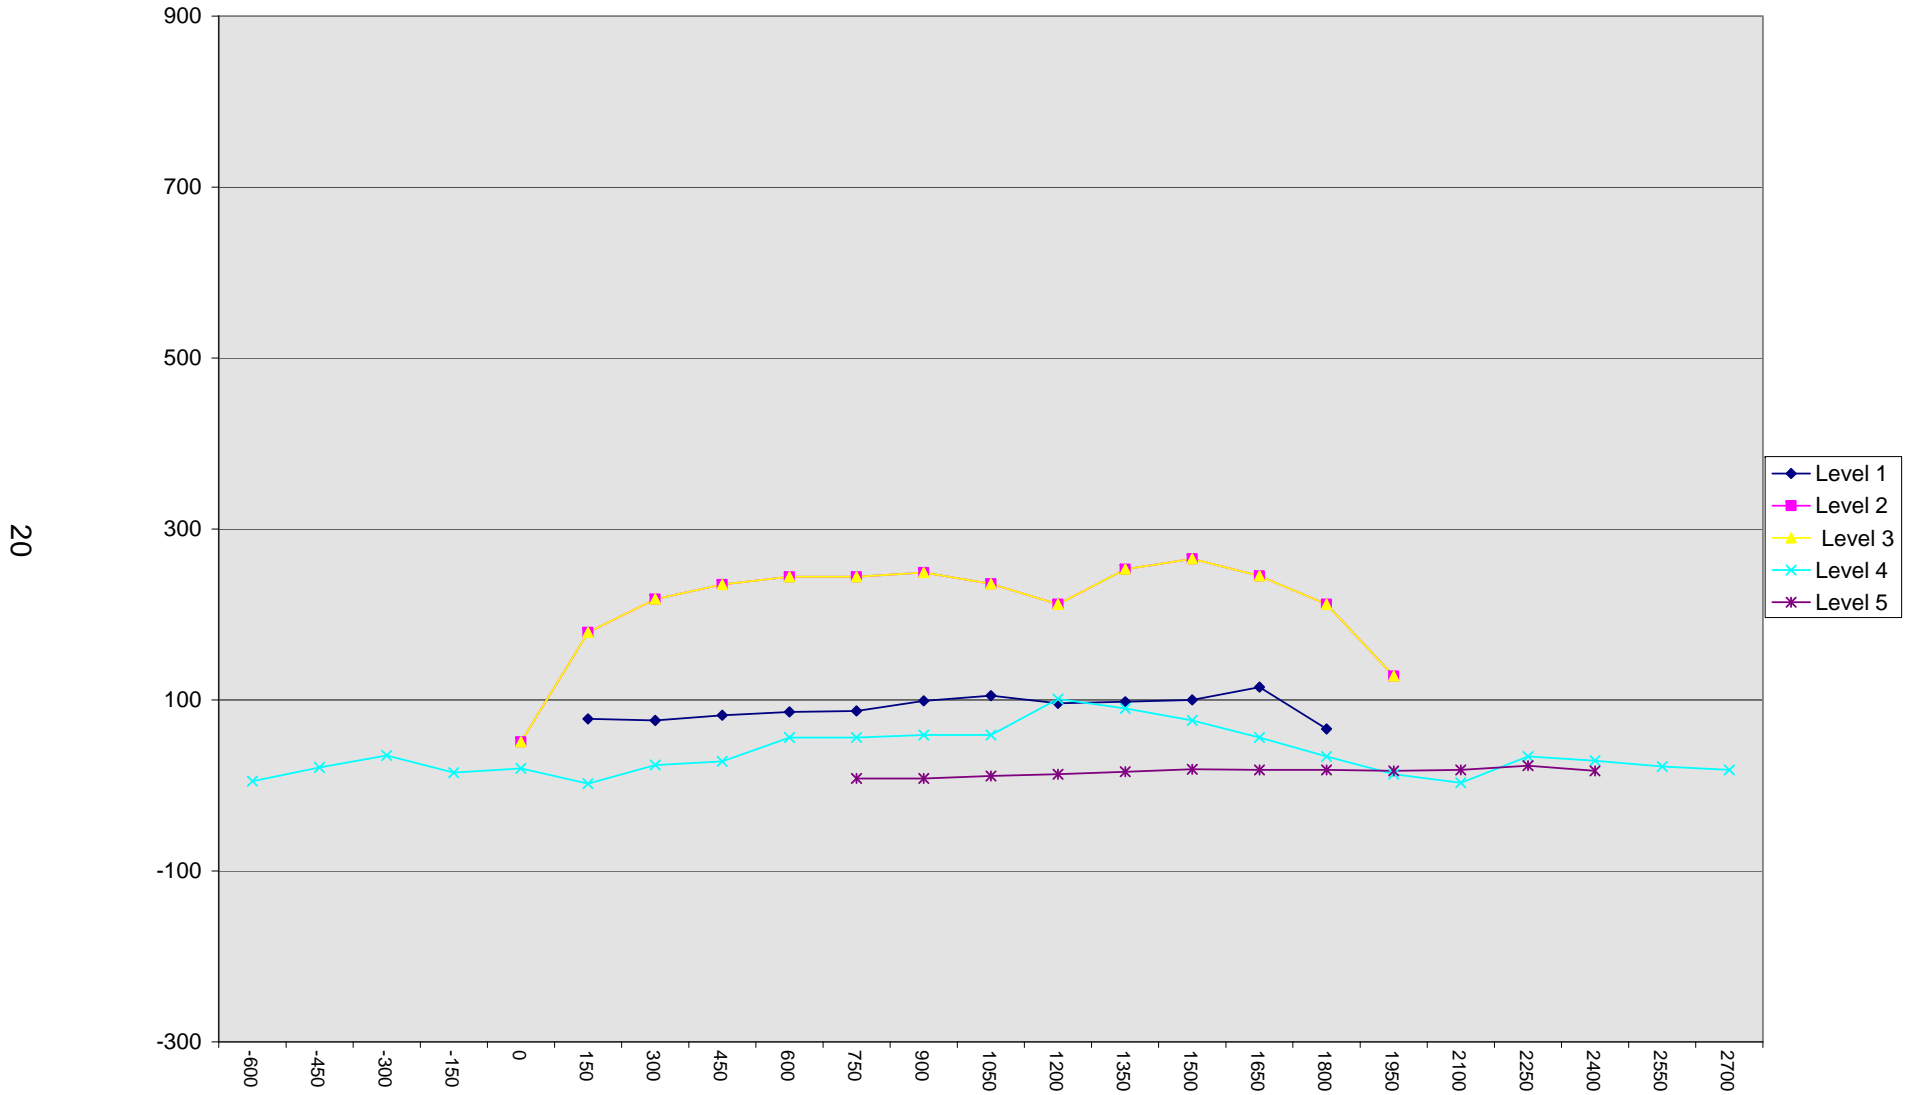
DATA SHEET NO. 13
VEHICLE DAMAGE PROFILE DISTANCES

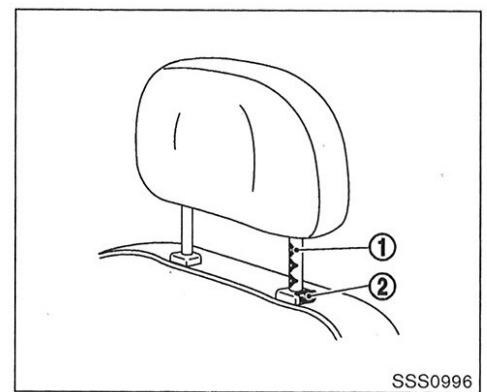
1. Pull the head restraint up to the highest position.
2. Push and hold the lock knob.
3. Remove the head restraint from the seat.
4. Store the head restraint properly in a secure place so it is not loose in the vehicle.
5. Install and properly adjust the head restraint before an occupant uses the seating position.

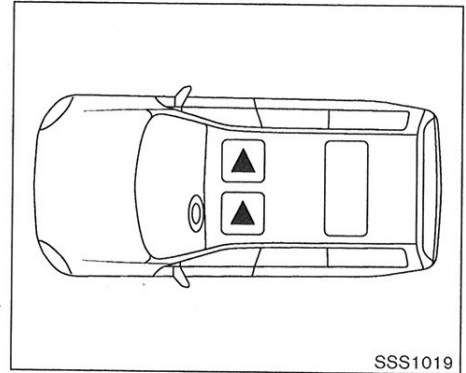
The illustration shows the seating positions equipped with head restraints. The head restraints are adjustable.
