**REPORT NUMBER: SNCAP-CAL-11-017**

**NEW CAR ASSESSMENT PROGRAM (NCAP)  
Moving Deformable Barrier Side Impact Test**

**Chrysler Group LLC  
2011 Ram 1500 Crew Cab  
Four Door Pickup**

**NHTSA NUMBER: MB0301**

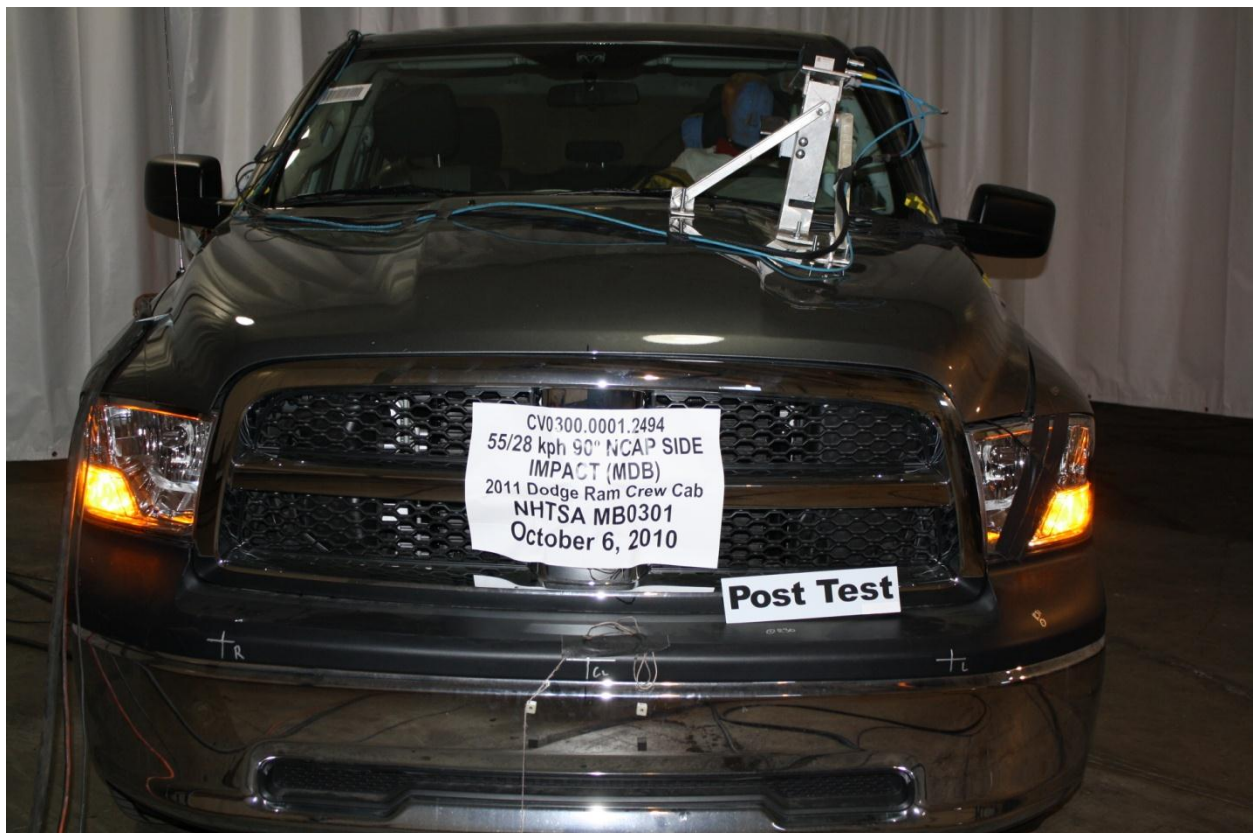
**Figure A-4: Post-Test Frontal View of Test Vehicle**

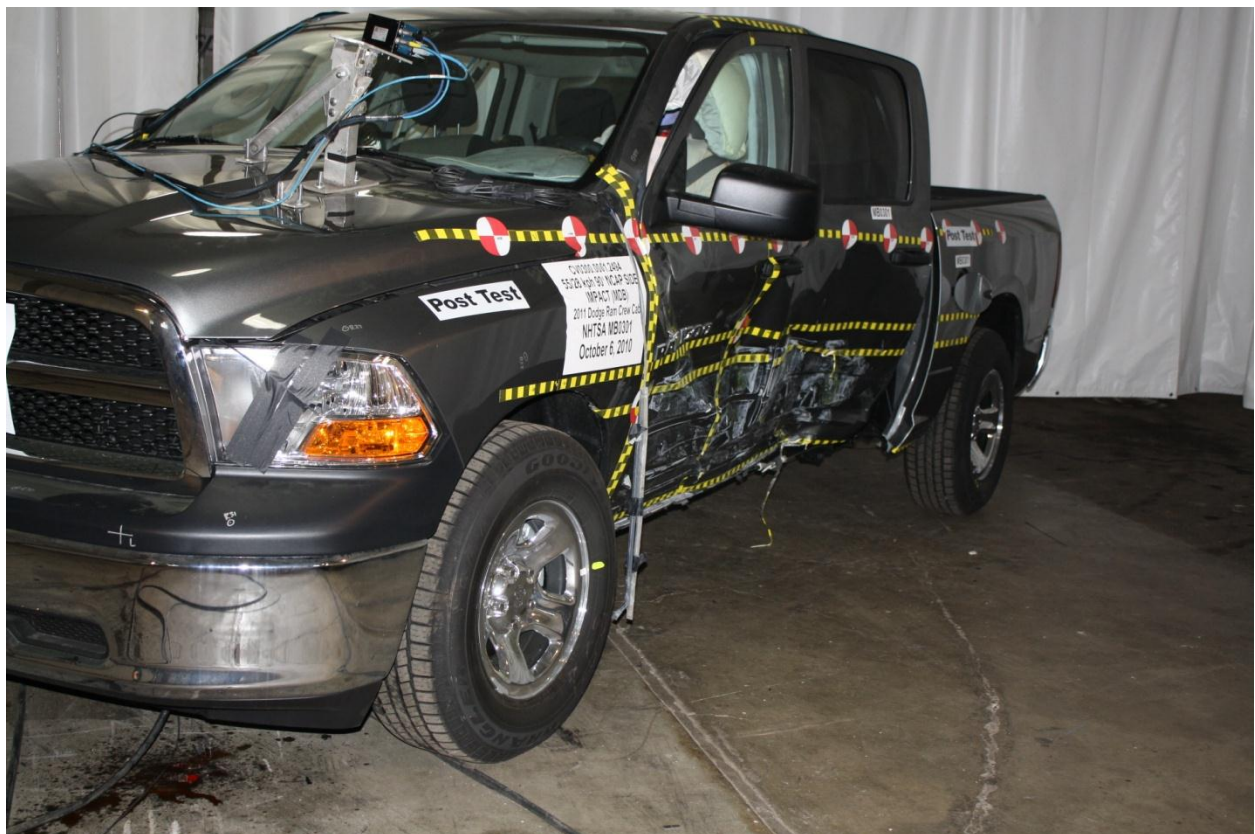
**Figure A-6: Post-Test Left Front  $\frac{3}{4}$  View of Test Vehicle**

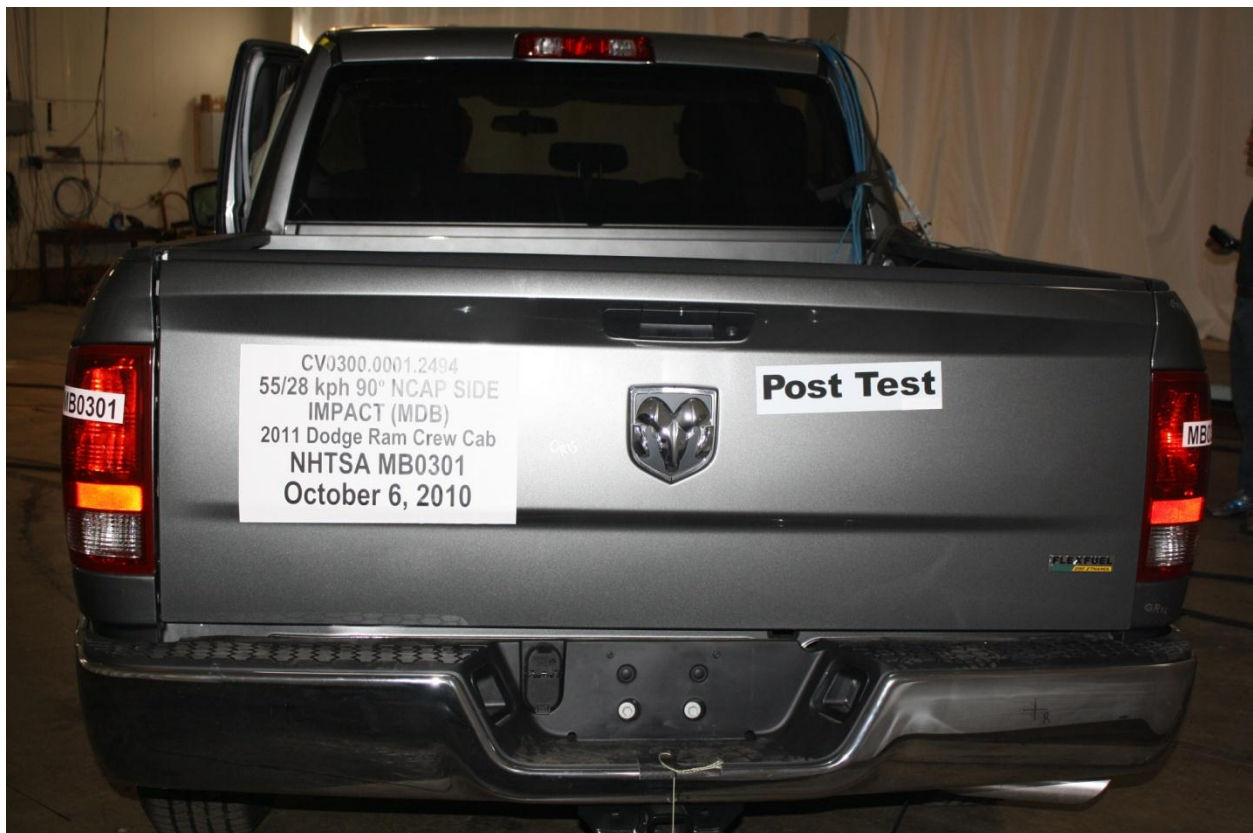
**Figure A-12: Post-Test Rear View of Test Vehicle**

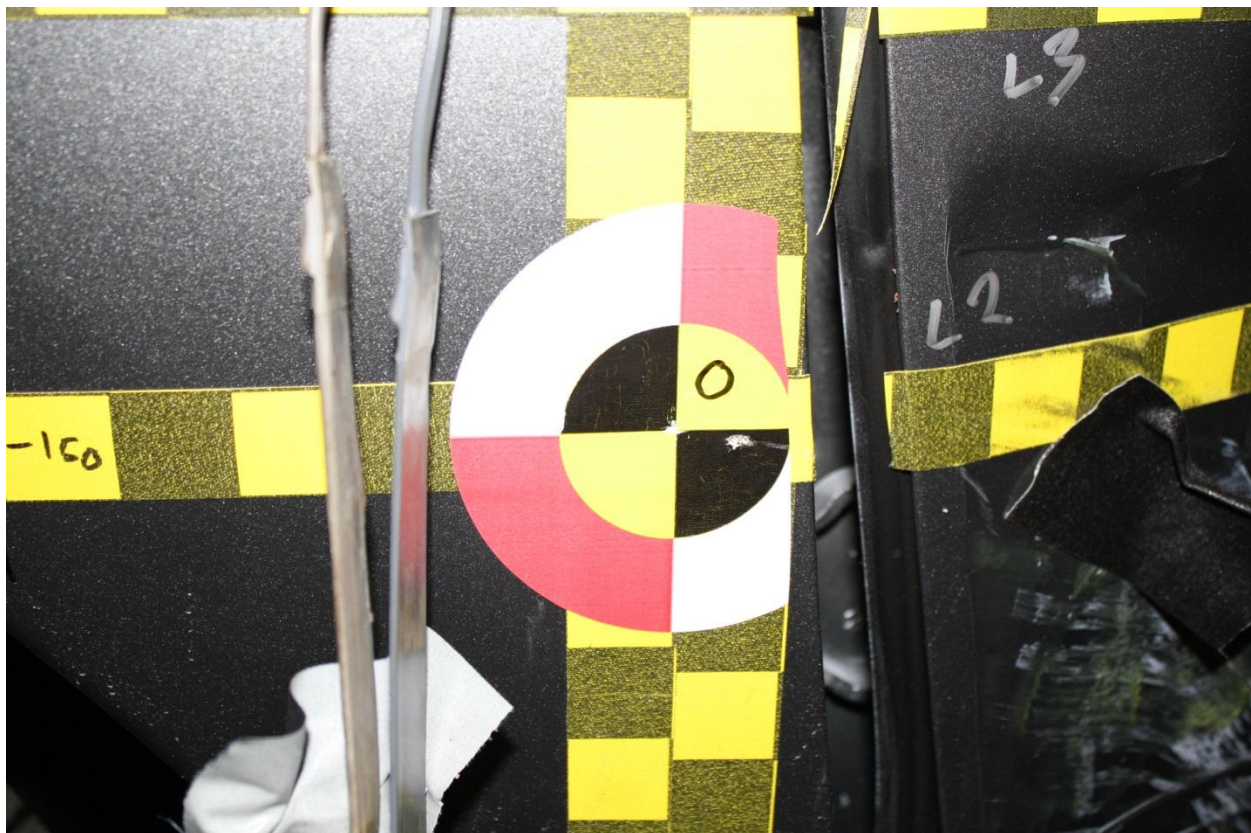
Figure A-20: Post-Test Close-up View of Impact Point Target

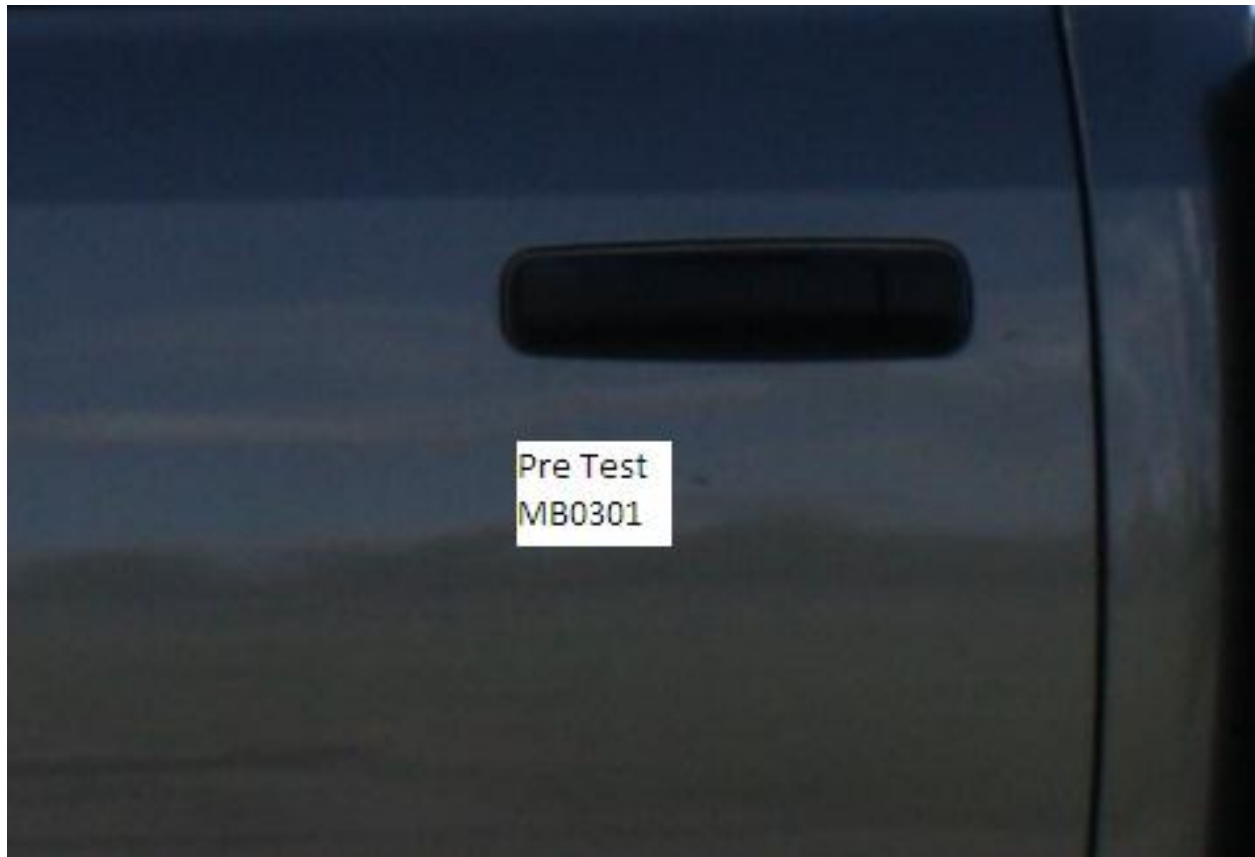
**Figure A-23: Pre-Test Left Rear Door Latch Close-up**

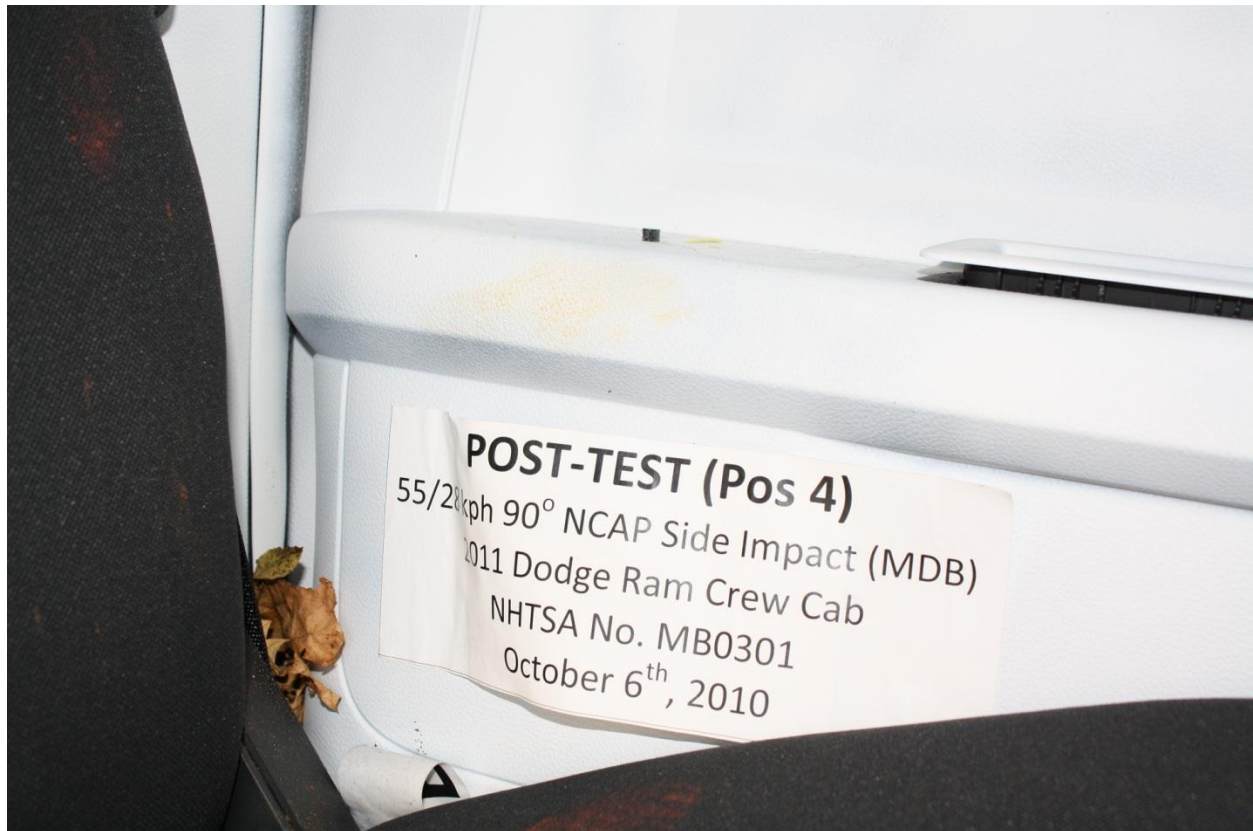
**Figure A-75: Post-Test Rear Passenger Dummy Close-Up Torso Contact with Vehicle Interior View**

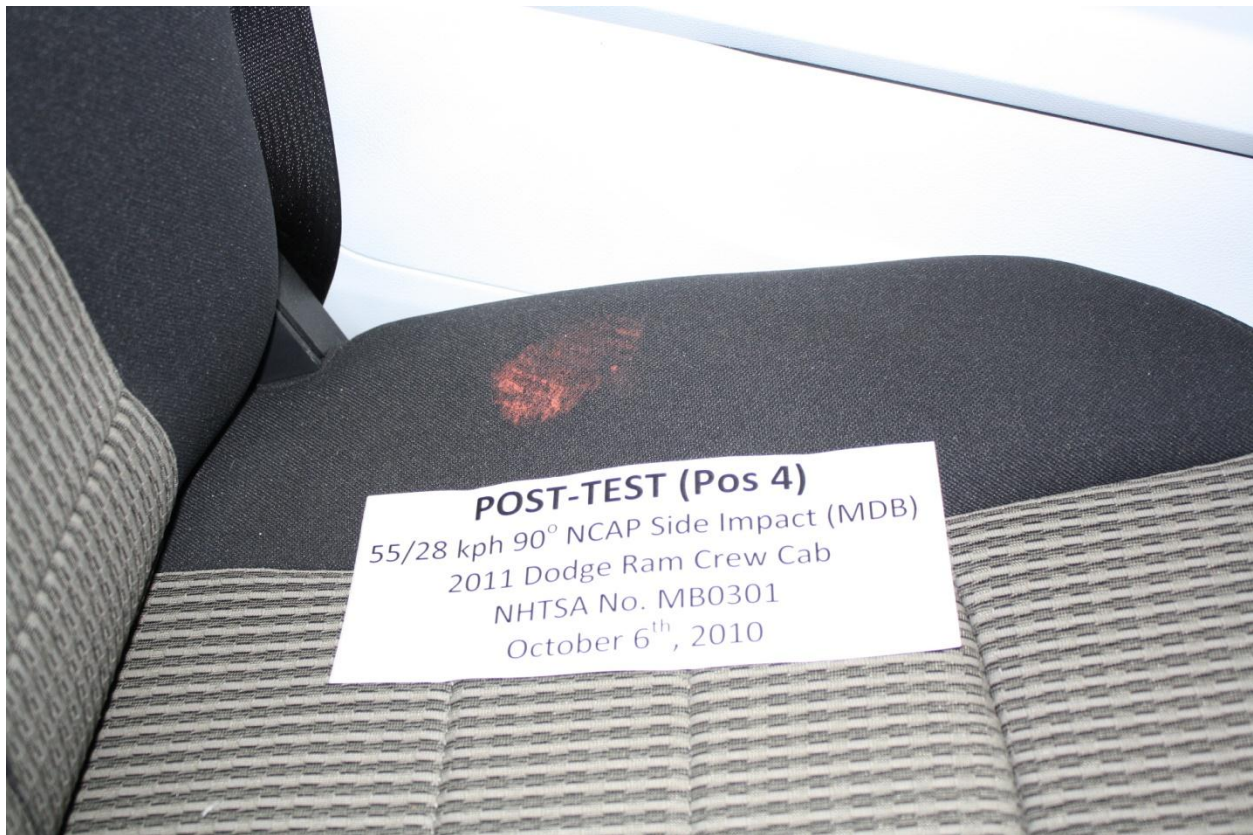
**Figure A-77: Post-Test Rear Passenger Dummy Close-Up Pelvis Contact View**

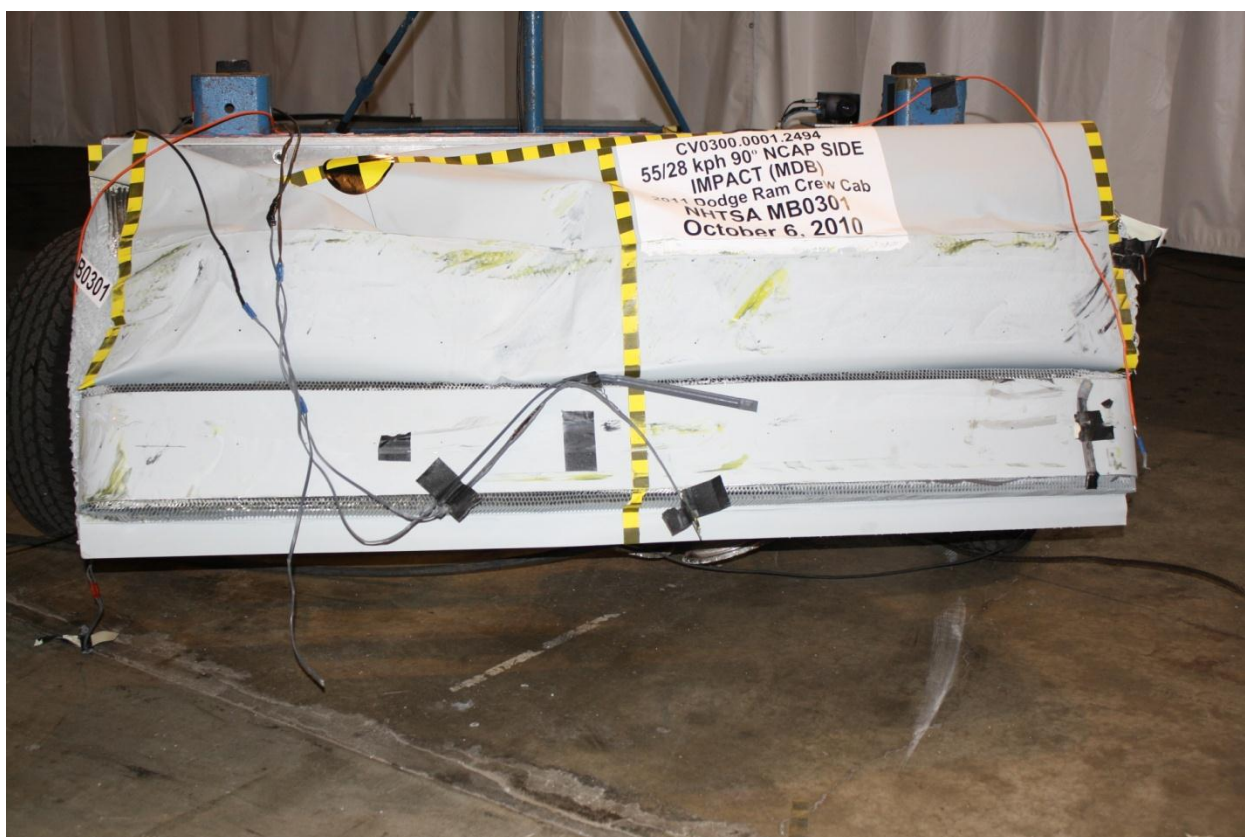
**Figure A-82: Post-Test Front View of MDB Impactor Face**

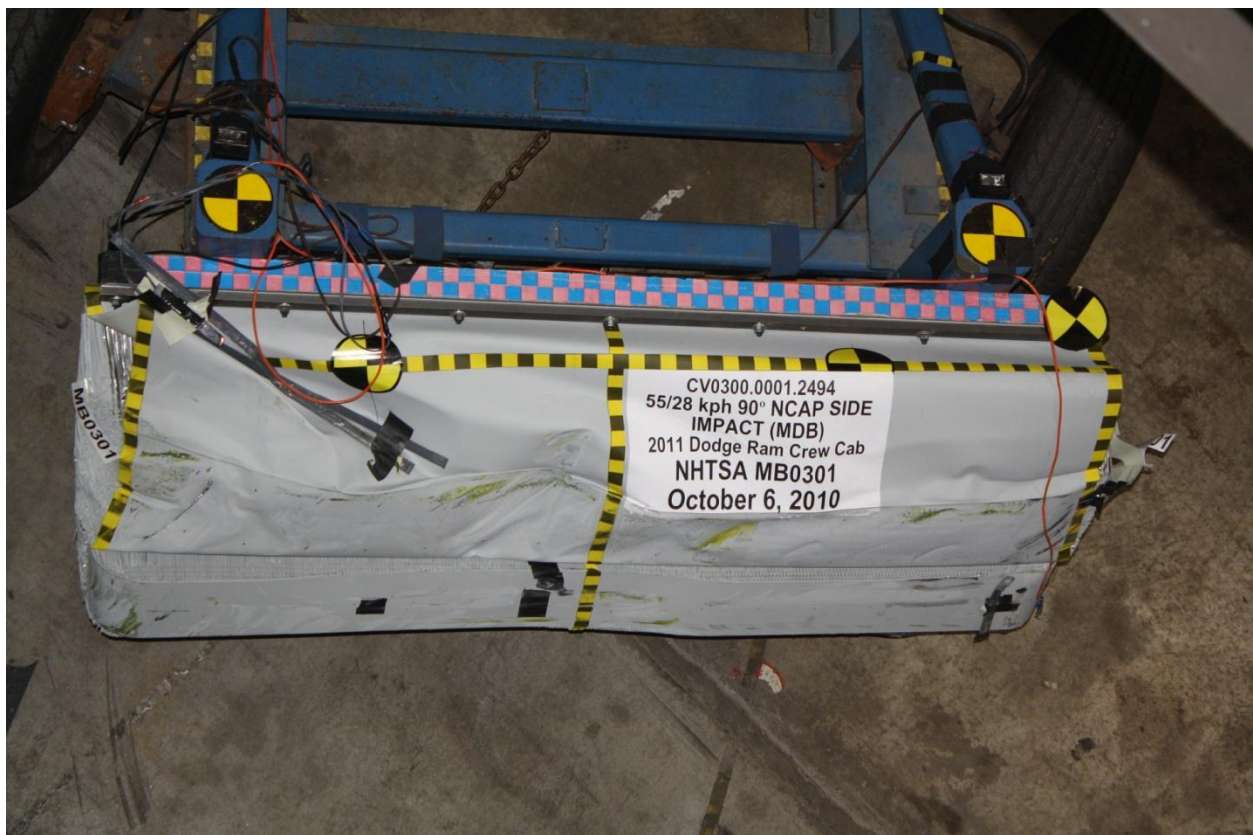
Figure A-84: Post-Test Top View of MDB Impactor Face

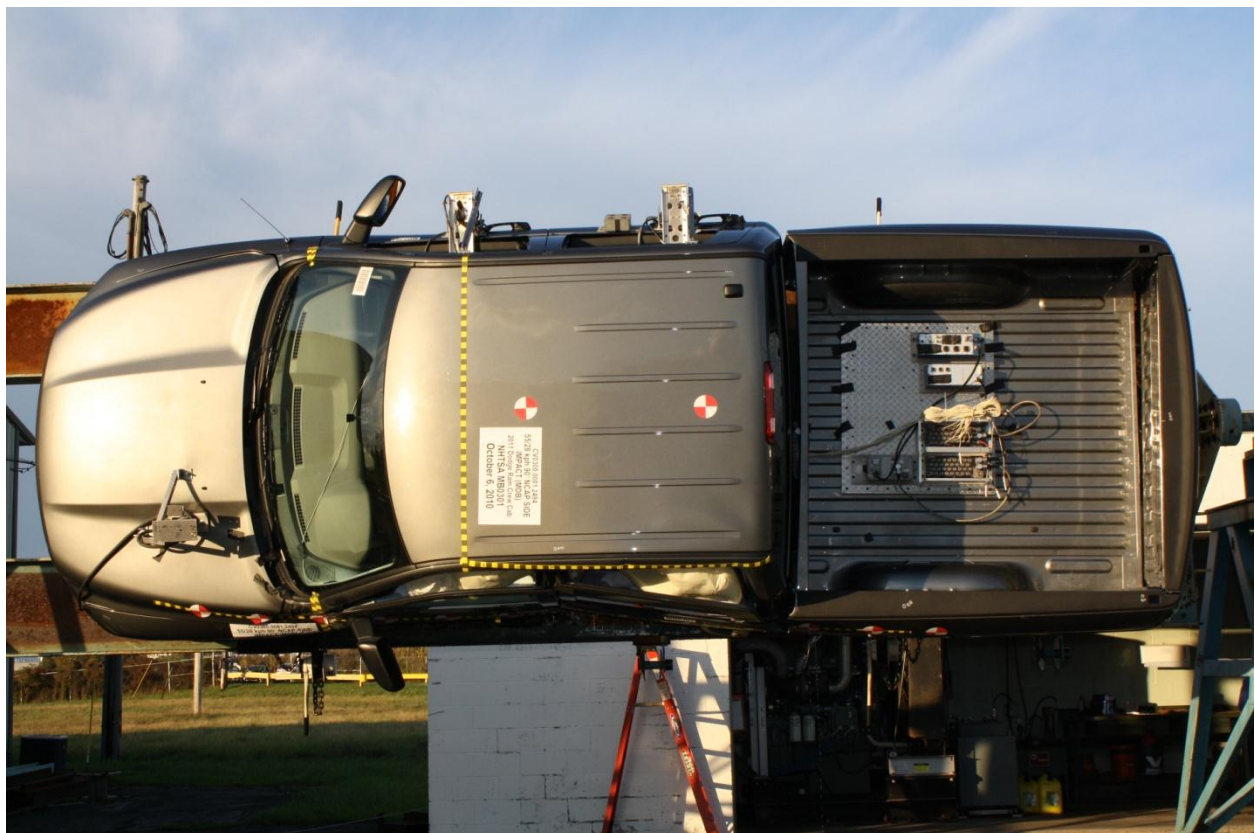
Figure A-94: FMVSS No. 301 Rollover 90°

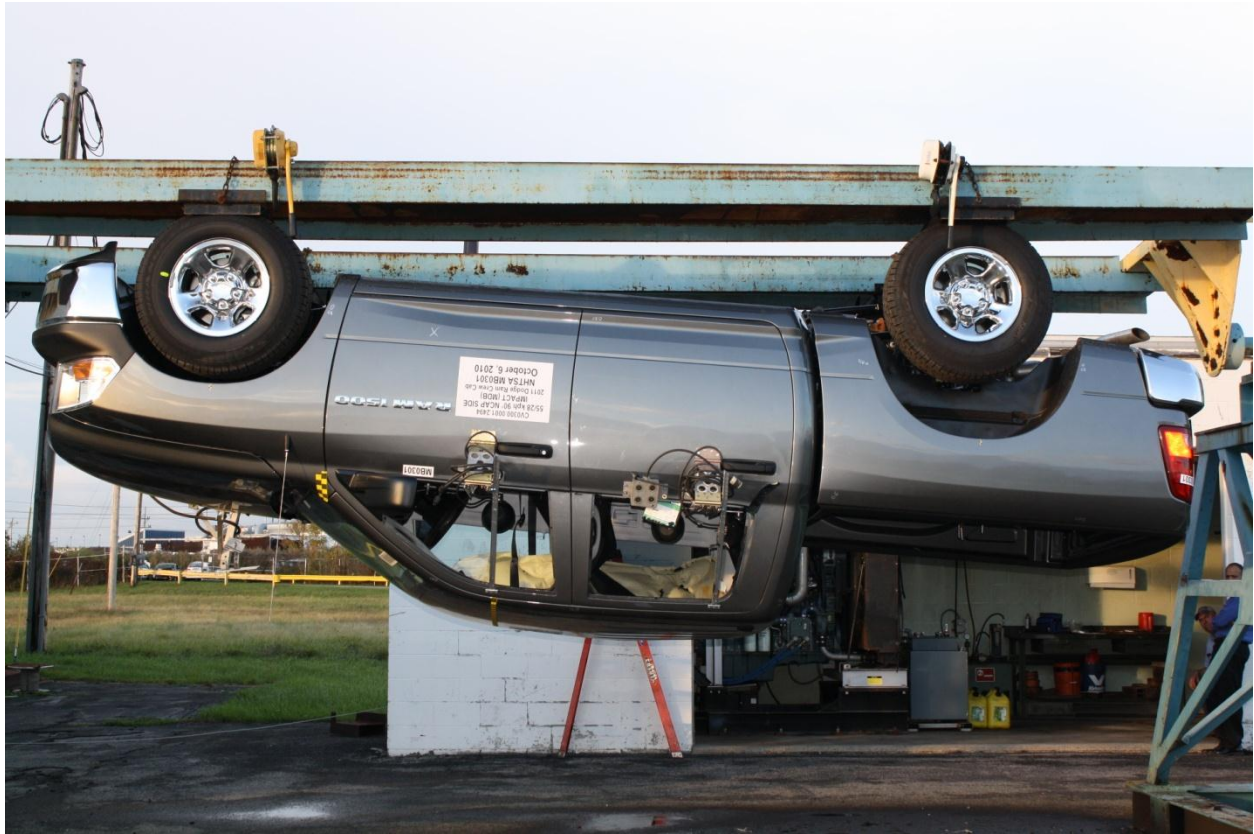
**Figure A-95: FMVSS No. 301 Rollover 180°**

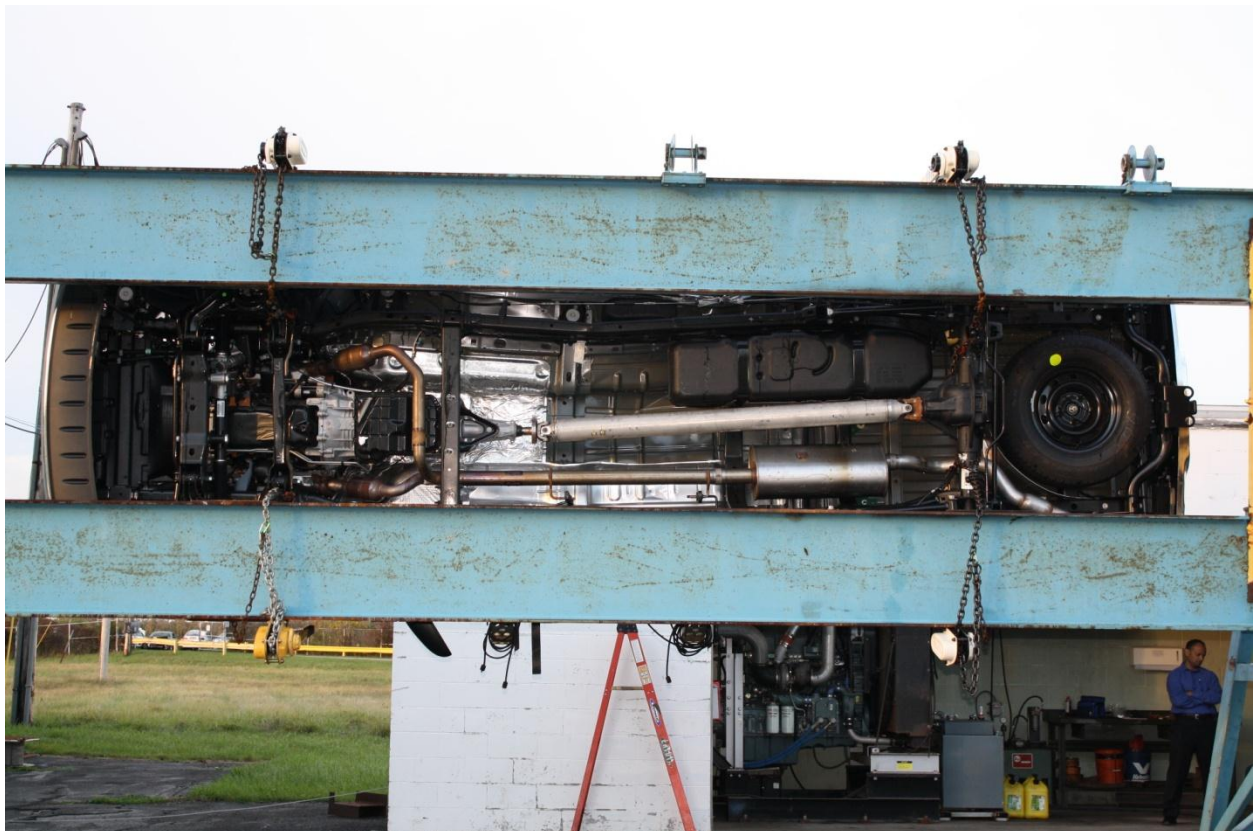
**Figure A-96: FMVSS No. 301 Rollover 270°**

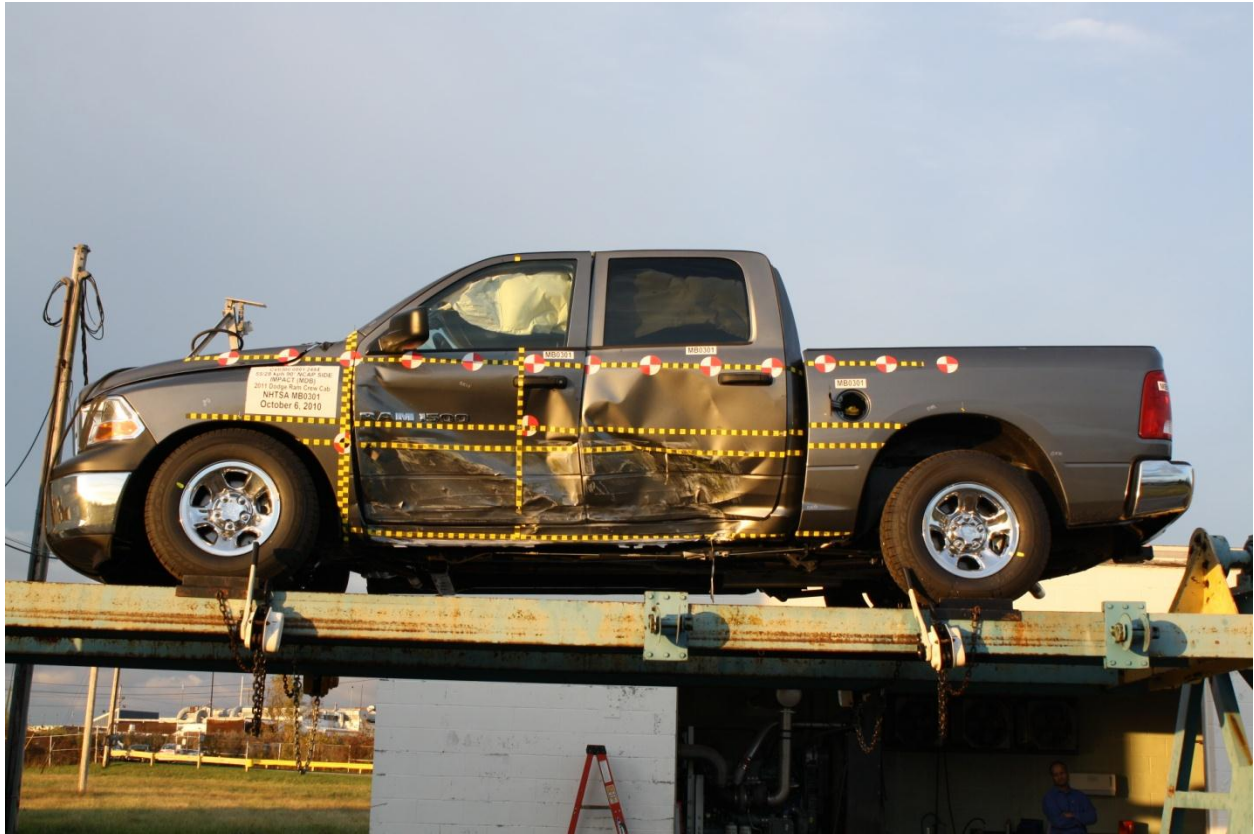
**Figure A-97: FMVSS No. 301 Rollover 360°**
