**REPORT NUMBER: NCAP-MGA-2011-031**

**NEW CAR ASSESSMENT PROGRAM (NCAP)  
Frontal Barrier Impact Test**

**NISSAN MOTOR CO., LTD.  
2011 Nissan Rogue S 5-Dr SUV  
NHTSA No.: MB5211**

**FINAL REPORT**

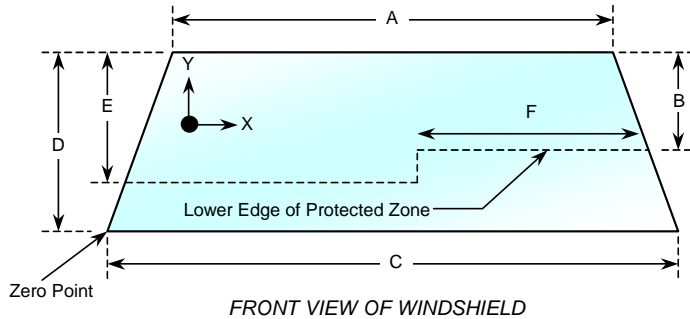
**WINDSHIELD PERIPHERY MEASUREMENTS**

Measurement	Pre-Test (mm)	Post-Test (mm)	% of Retention
Left Side	2120	2120	100
Right Side	2120	2120	100
Total	4240	4240	100

Item	Units	Value
A	mm	1190
B	mm	520
C	mm	1380
D	mm	835
E	mm	530
F	mm	460

**AREA OF PROTECTED ZONE FAILURES - NONE**

There was 100 percent windshield retention and no intrusion into the protected zone of the windshield during the event. There was no Stoddard Solvent leakage after the event or during any phase of the static rollover.

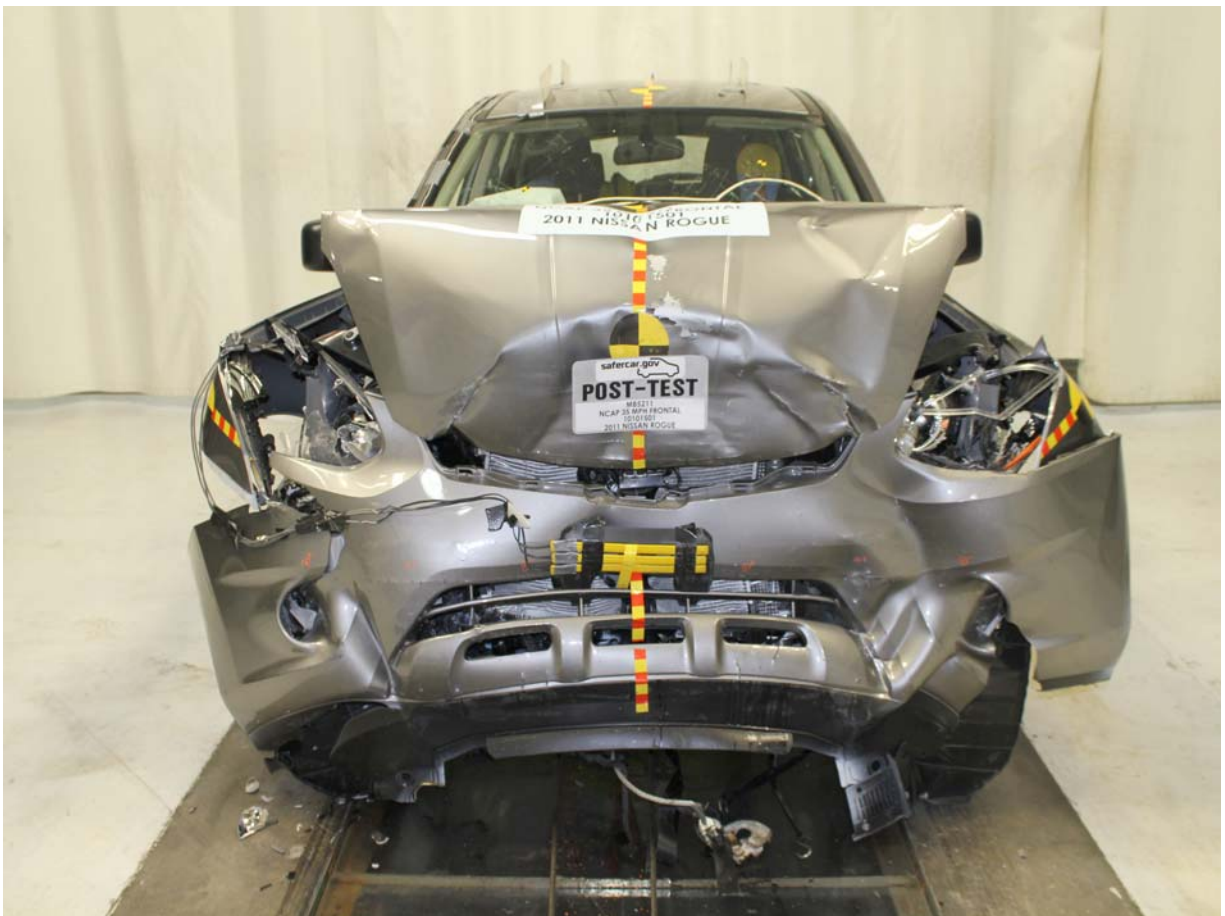
Post-Test Front View

The maximum static crush of the vehicle was 611 mm and both the driver and passenger side doors remained closed during the impact event and were operable after the impact.

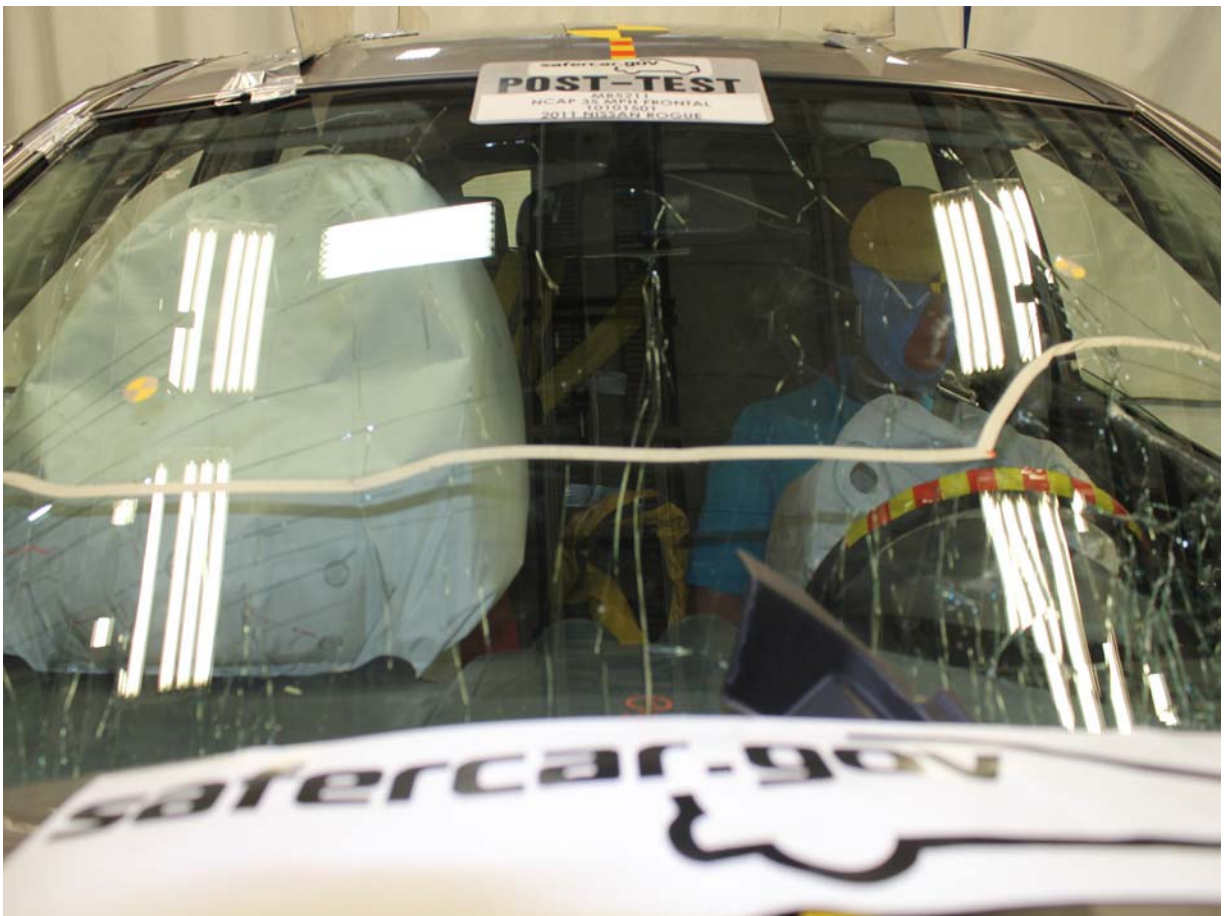
Post-Test Windshield View

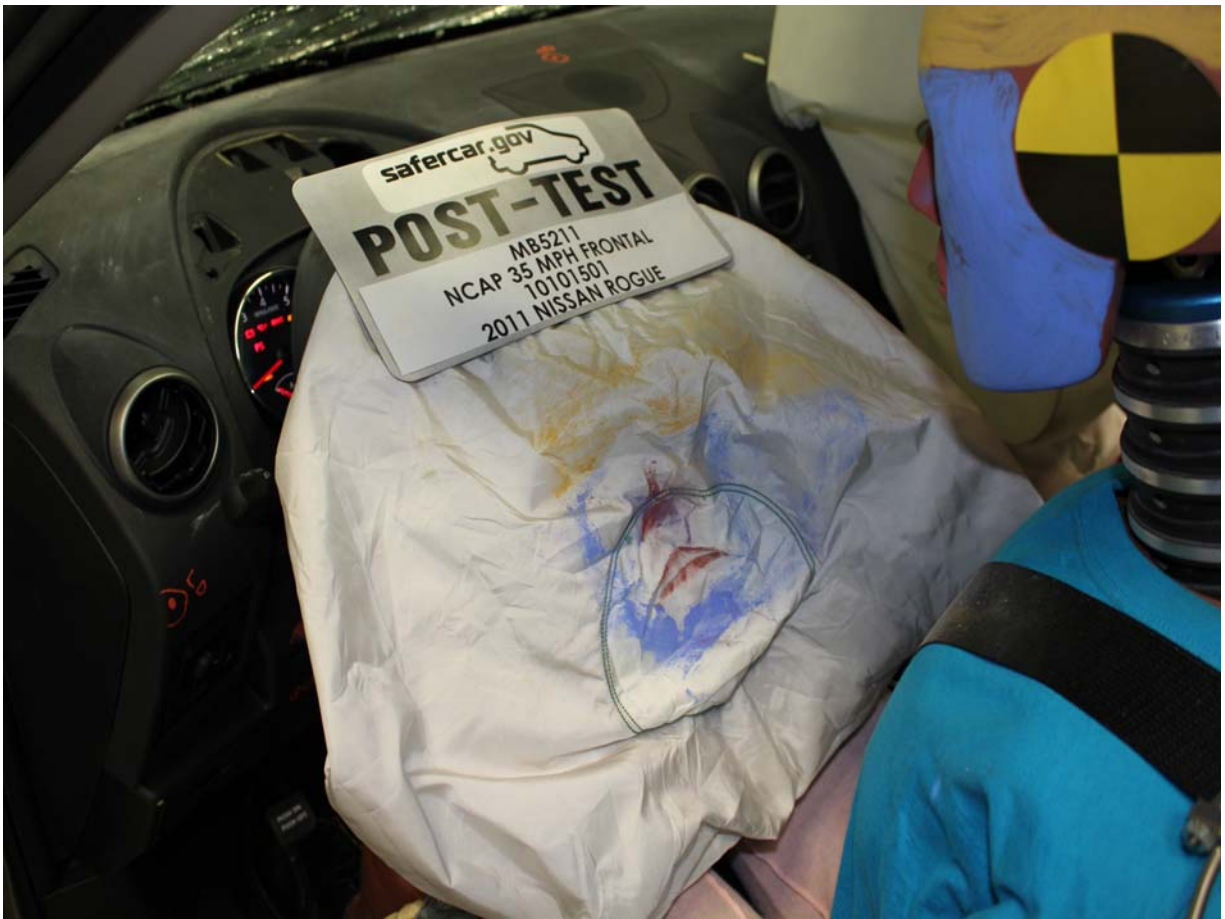
Post-Test Driver Dummy Contact with Airbag

The driver's head and chest contacted the airbag. The driver's head also contacted headrest. The driver's knees contacted the knee bolster. The passenger's head and chest contacted the airbag. The passenger's head also contacted the headrest. The passenger's knees contacted the glovebox.

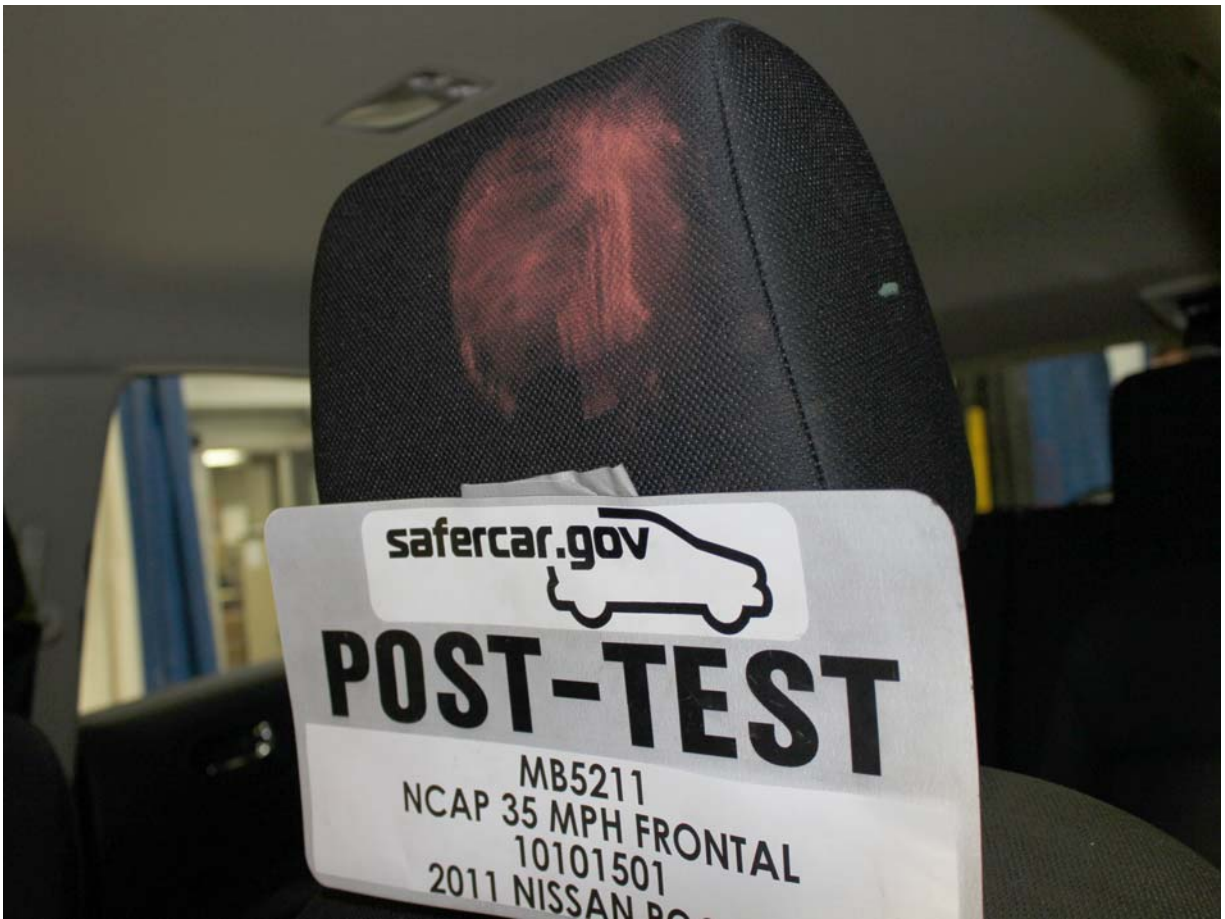
Post-Test Driver Dummy Contact with Headrest

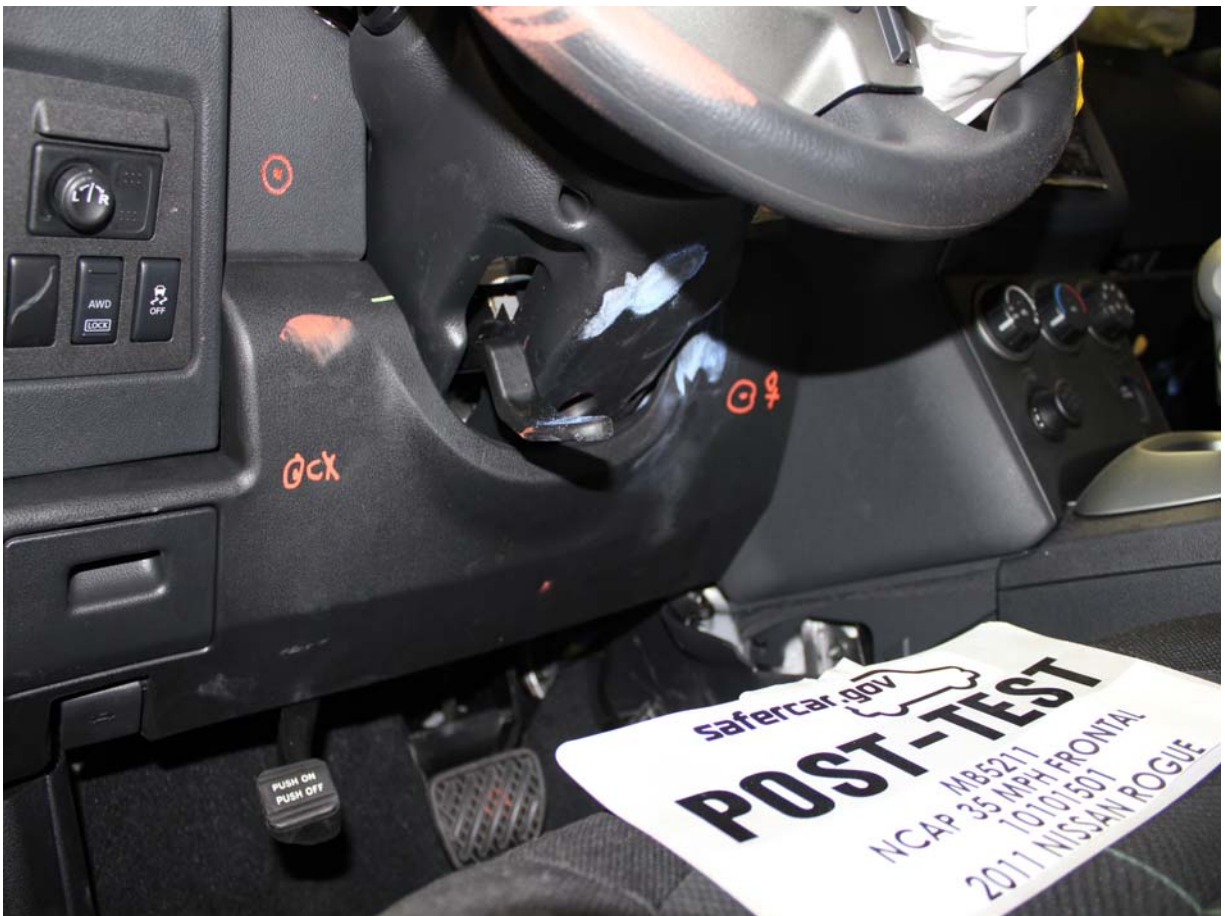
Post-Test Driver Dummy Contact with Knee Bolster

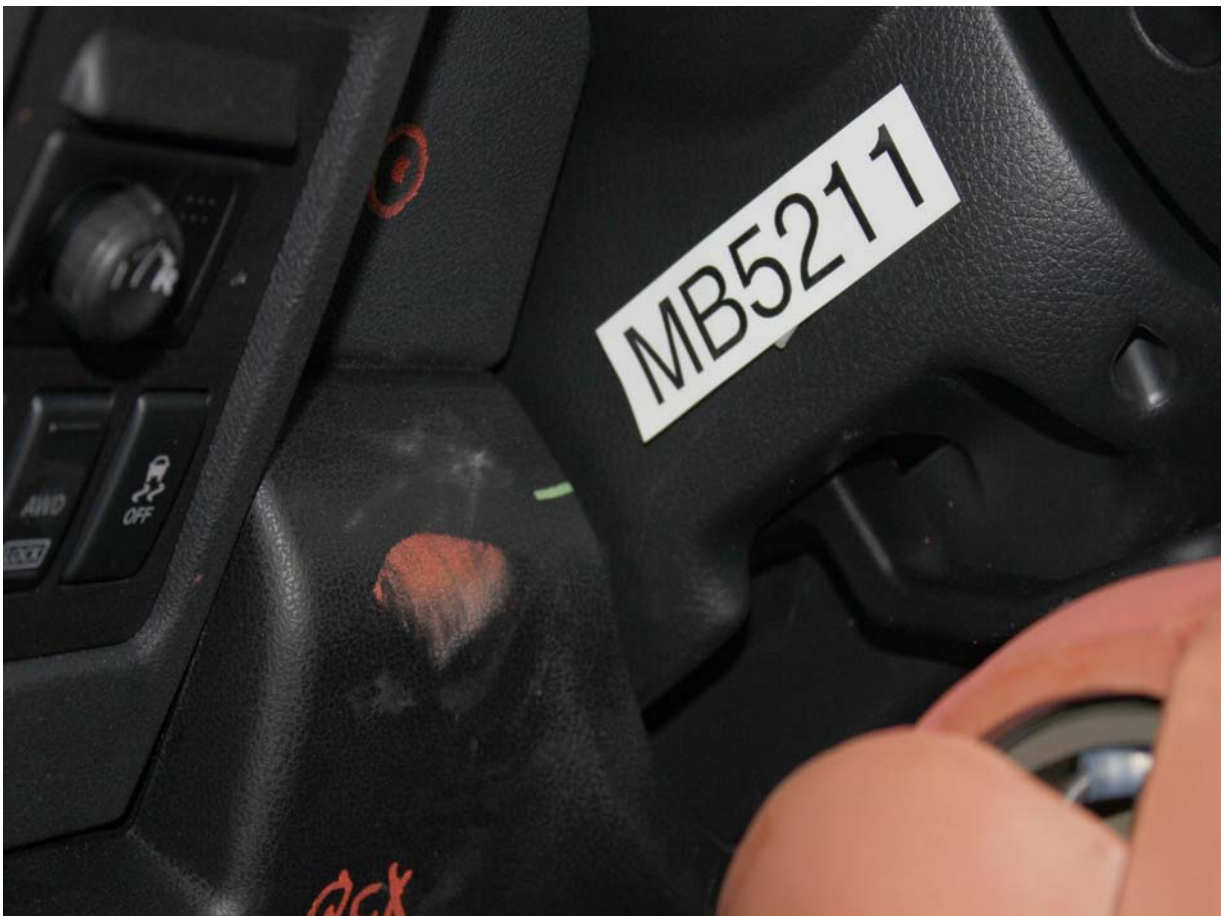
Post-Test View of Steering Column Shear Capsule

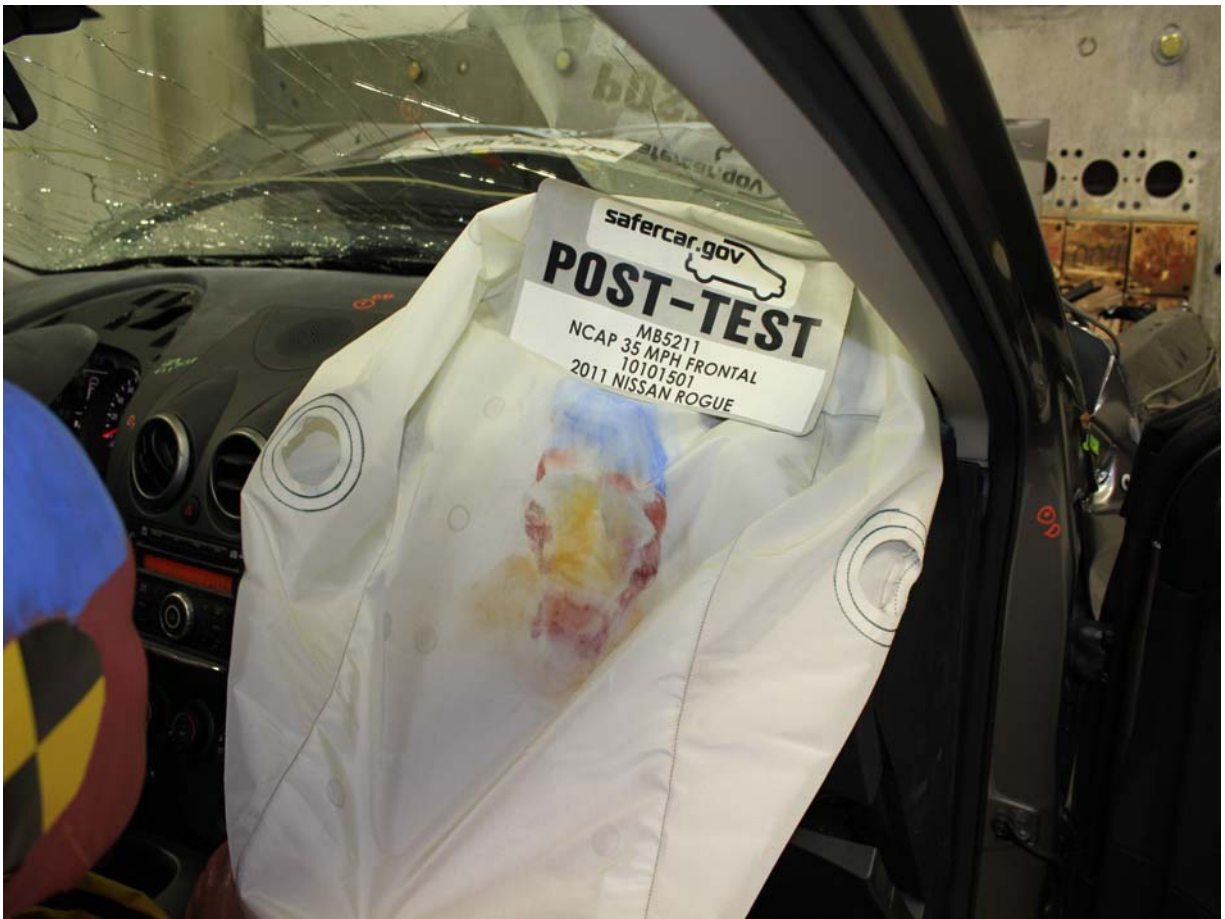
Post-Test Passenger Dummy Contact with Airbag

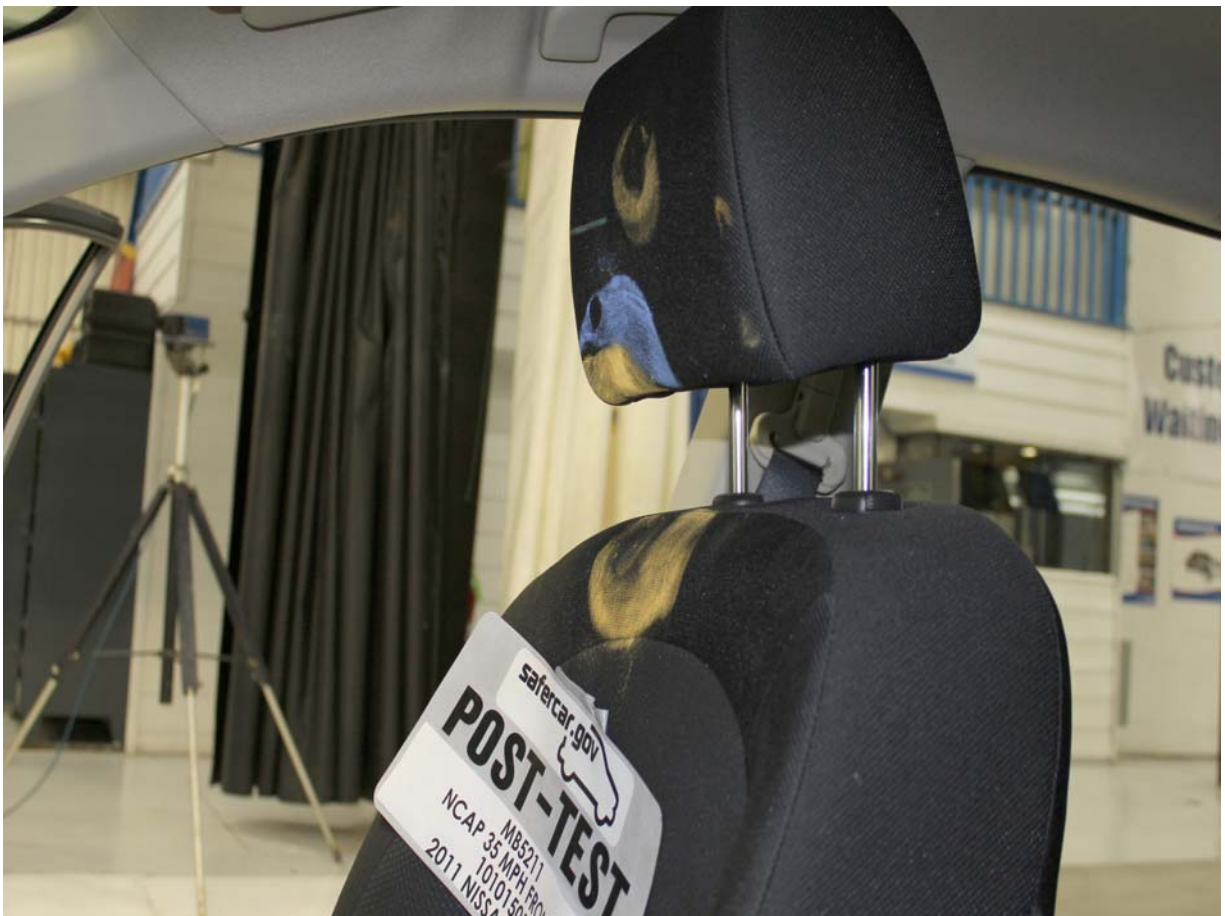
Post-Test Passenger Dummy Contact with Headrest

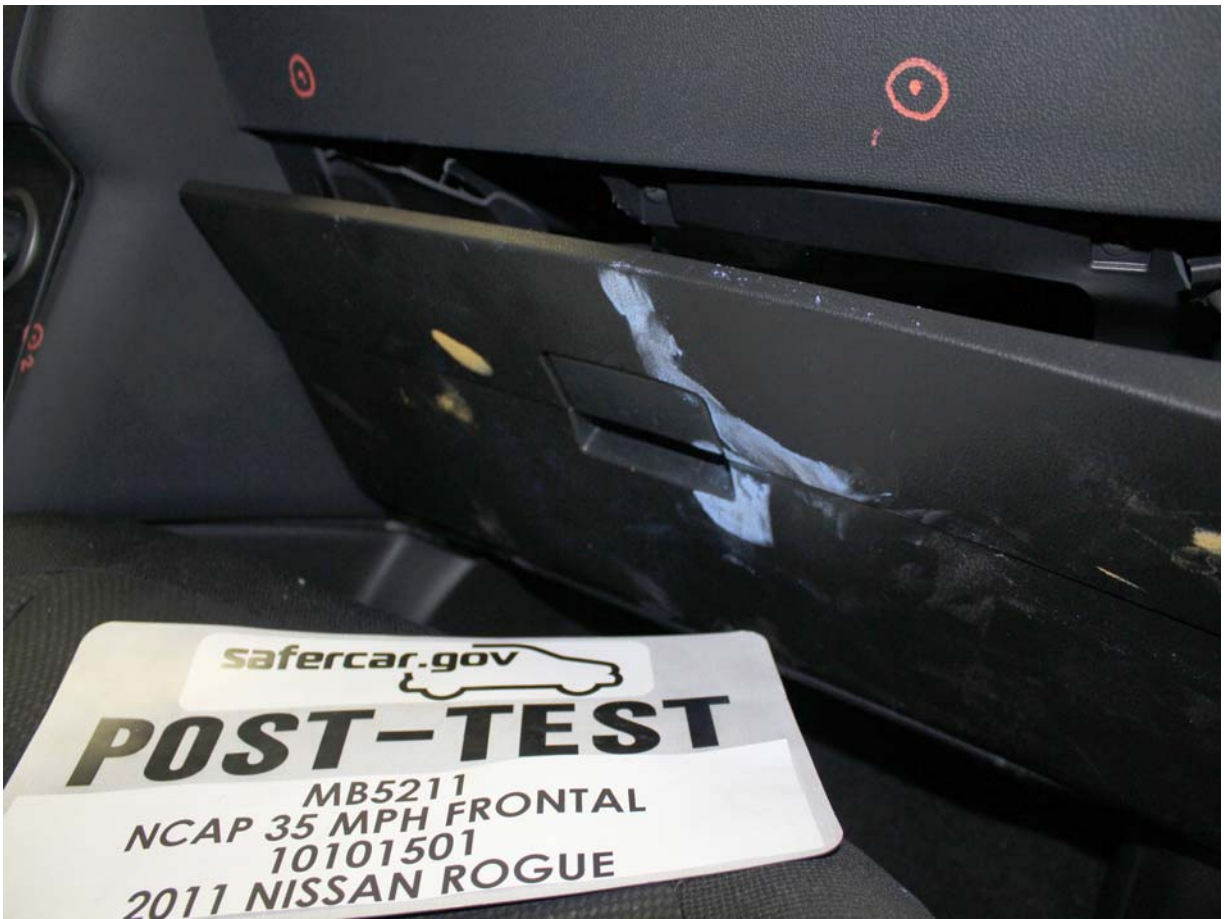
Post-Test Passenger Dummy Contact with Glovebox

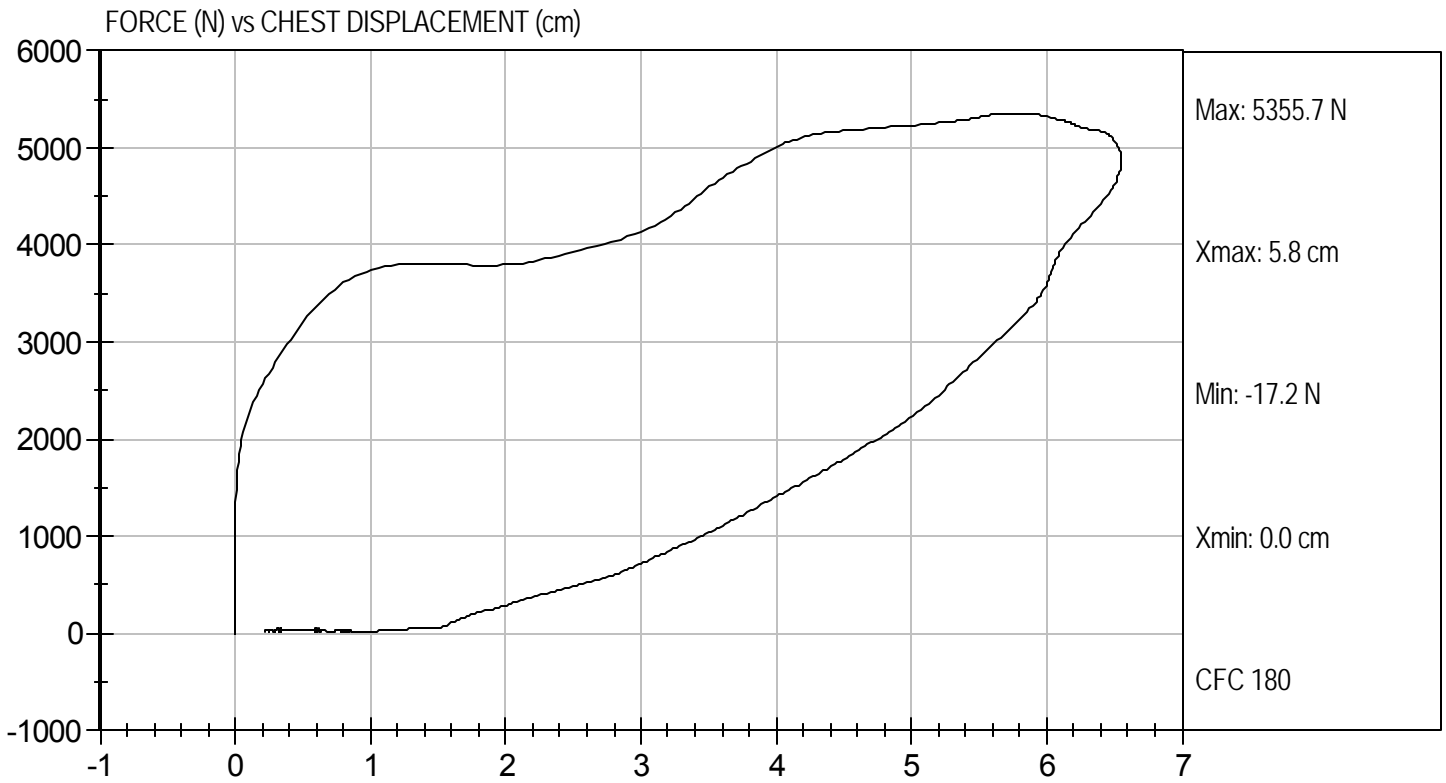
Test Desc: Thorax Impact  
Component ID: D103324

Test Date: 10/1/10  
Velocity: 22.22 ft/s, 6.77 m/s

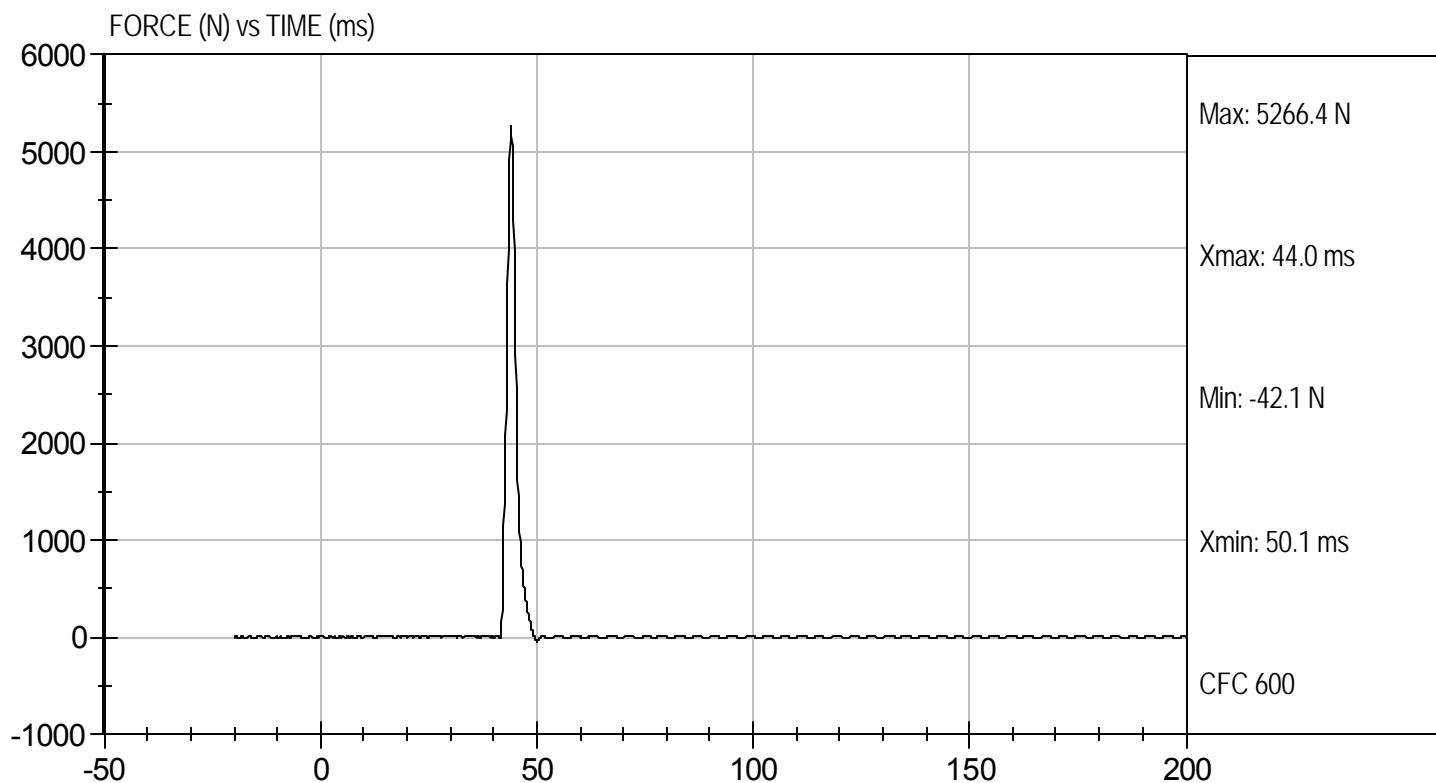
Test Desc: Right Knee  
Component ID: D103325

Test Date: 10/1/10  
Velocity: 6.92 ft/s, 2.11 m/s

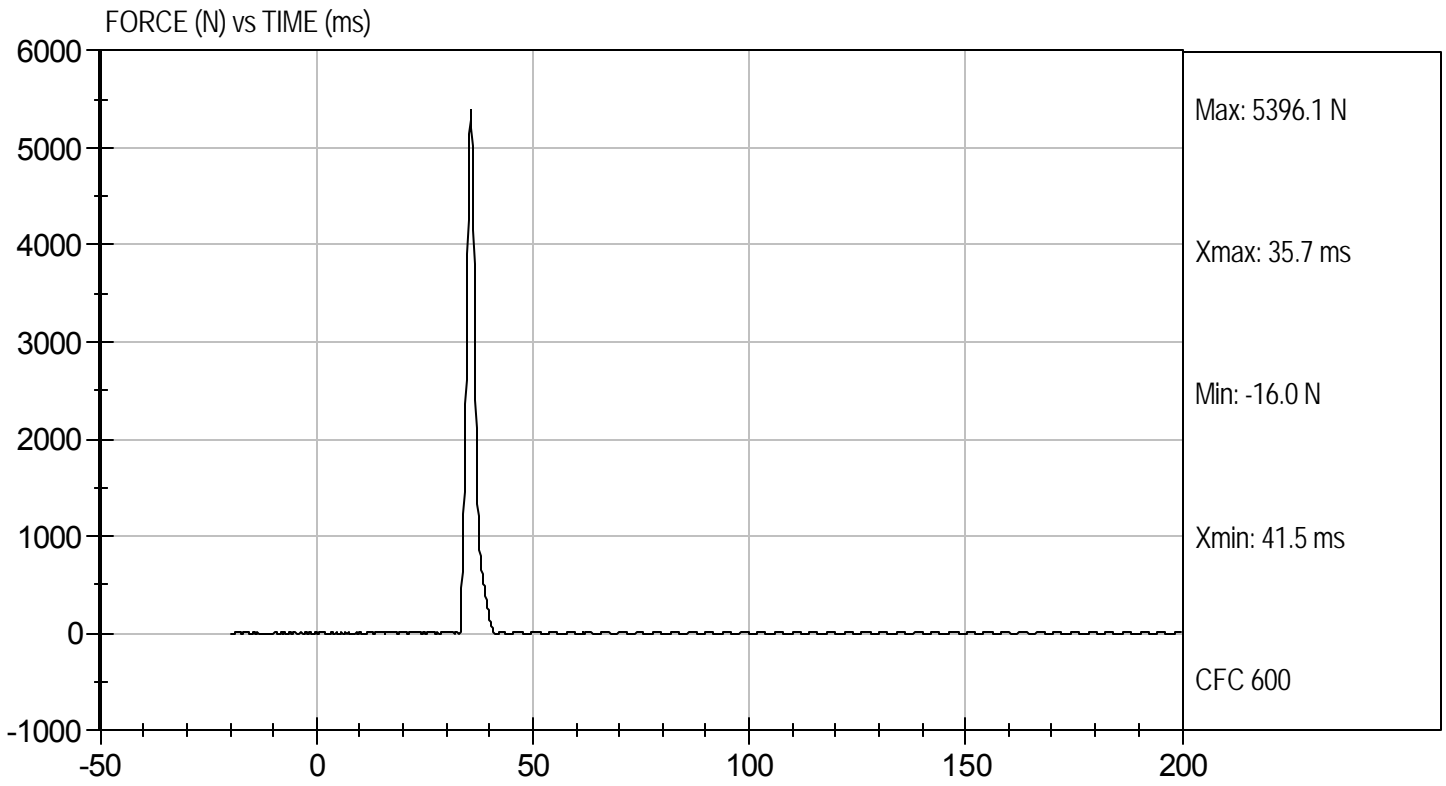
Test Desc: Left Knee  
Component ID: D103326

Test Date: 10/1/10  
Velocity: 6.83 ft/s, 2.08 m/s

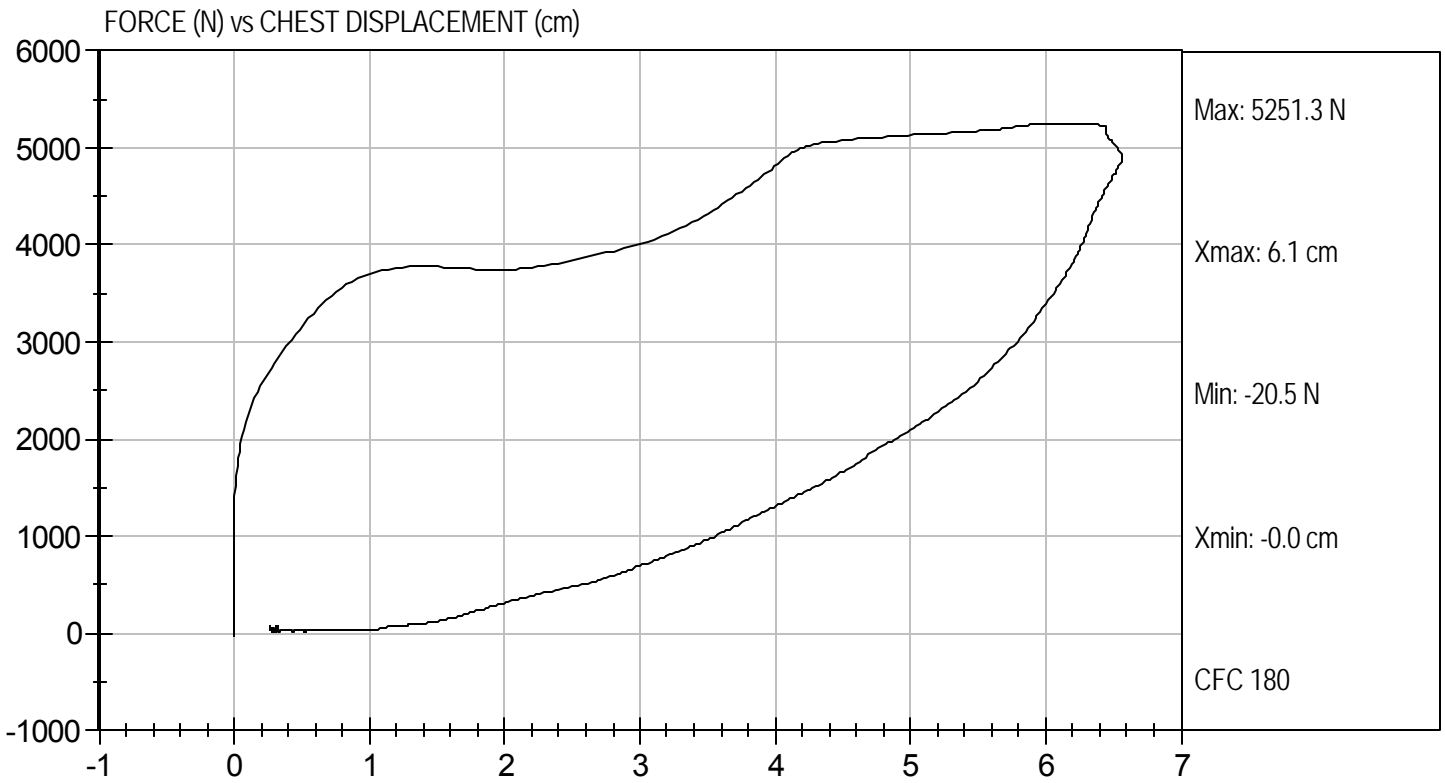
Test Desc: Thorax Impact  
Component ID: D103544

Test Date: 10/18/10  
Velocity: 21.93 ft/s, 6.68 m/s

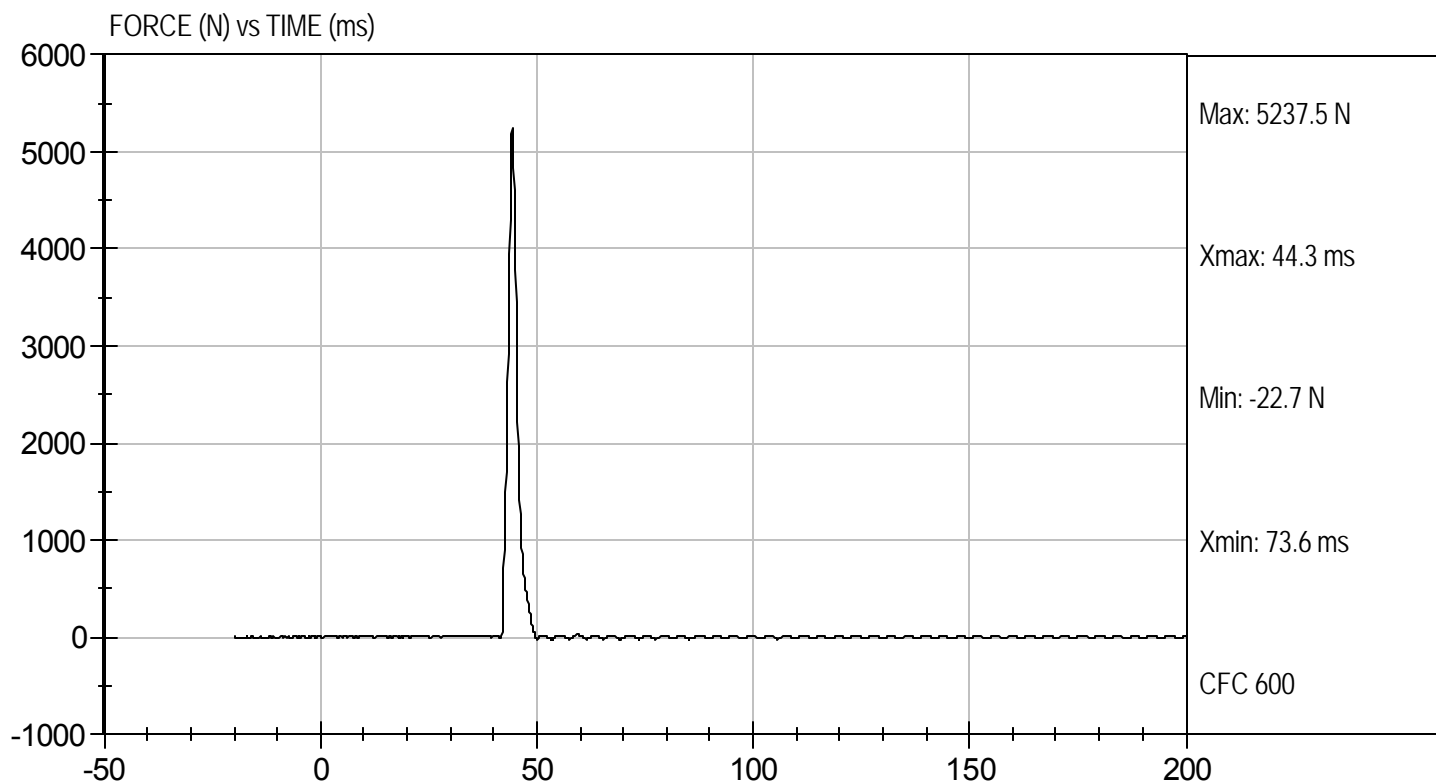
Test Desc: Right Knee  
Component ID: D103545

Test Date: 10/18/10  
Velocity: 6.92 ft/s, 2.11 m/s

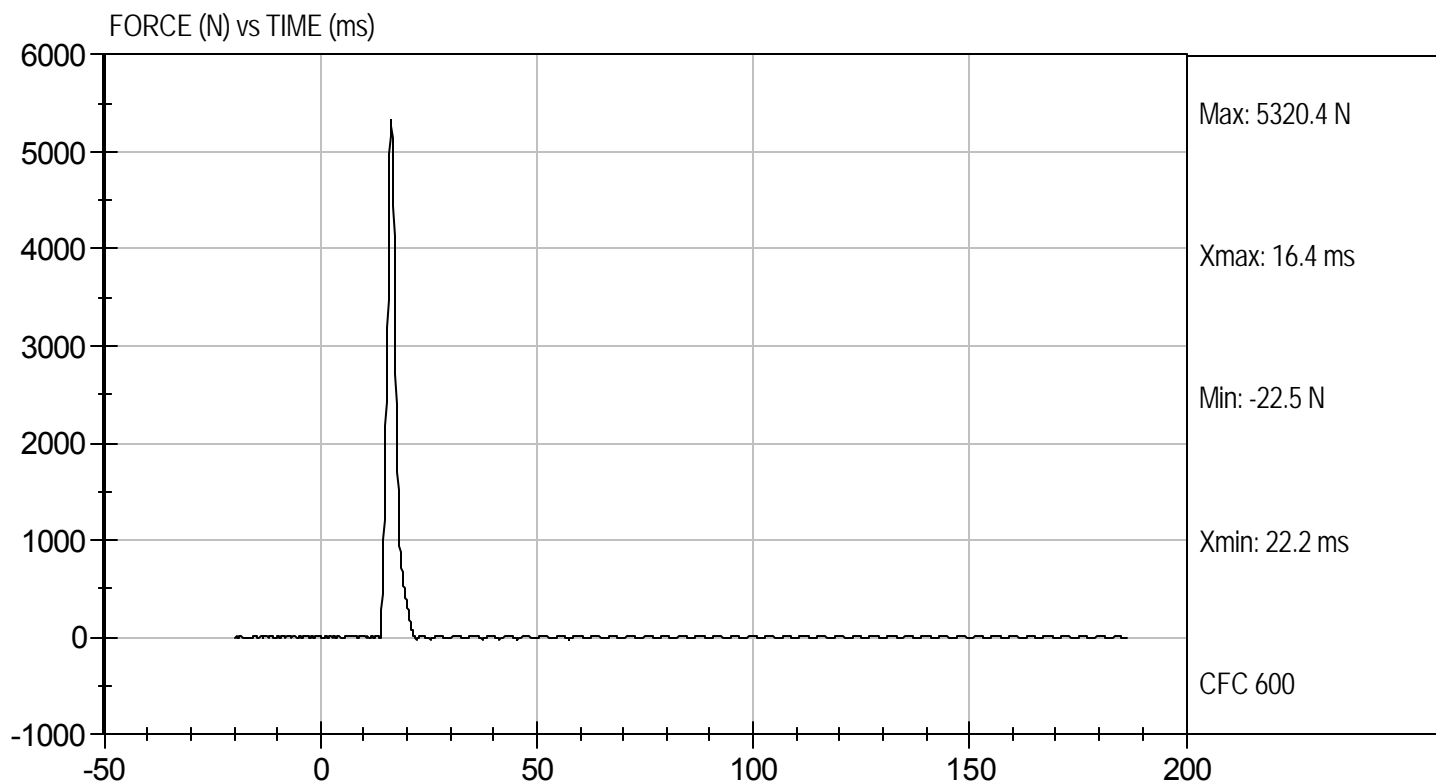
Test Desc: Left Knee  
Component ID: D103546

Test Date: 10/18/10  
Velocity: 6.80 ft/s, 2.07 m/s
