REPORT NUMBER: NCAP-CAL-11-018

**NEW CAR ASSESSMENT PROGRAM (NCAP)
FRONTAL BARRIER IMPACT TEST**

**Chrysler Group LLC
2011 Ram 1500 ST Crew Cab
4 Door Pickup**

NHTSA NUMBER: MB0302

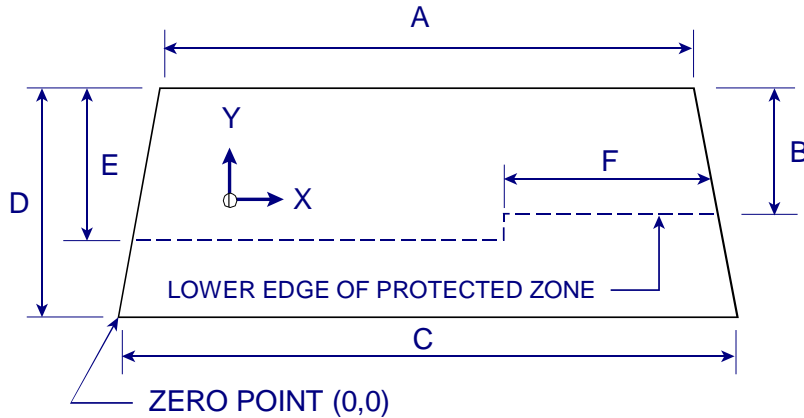
Measurement	Pre-Test (mm)	Post-Test (mm)	% Retention
Left Side	2270	2270	100%
Right Side	2270	2270	100%
Total	4539	4539	100%

Item	Units	Value
A	mm	1395
B	mm	430
C	mm	1636
D	mm	754
E	mm	498
F	mm	610

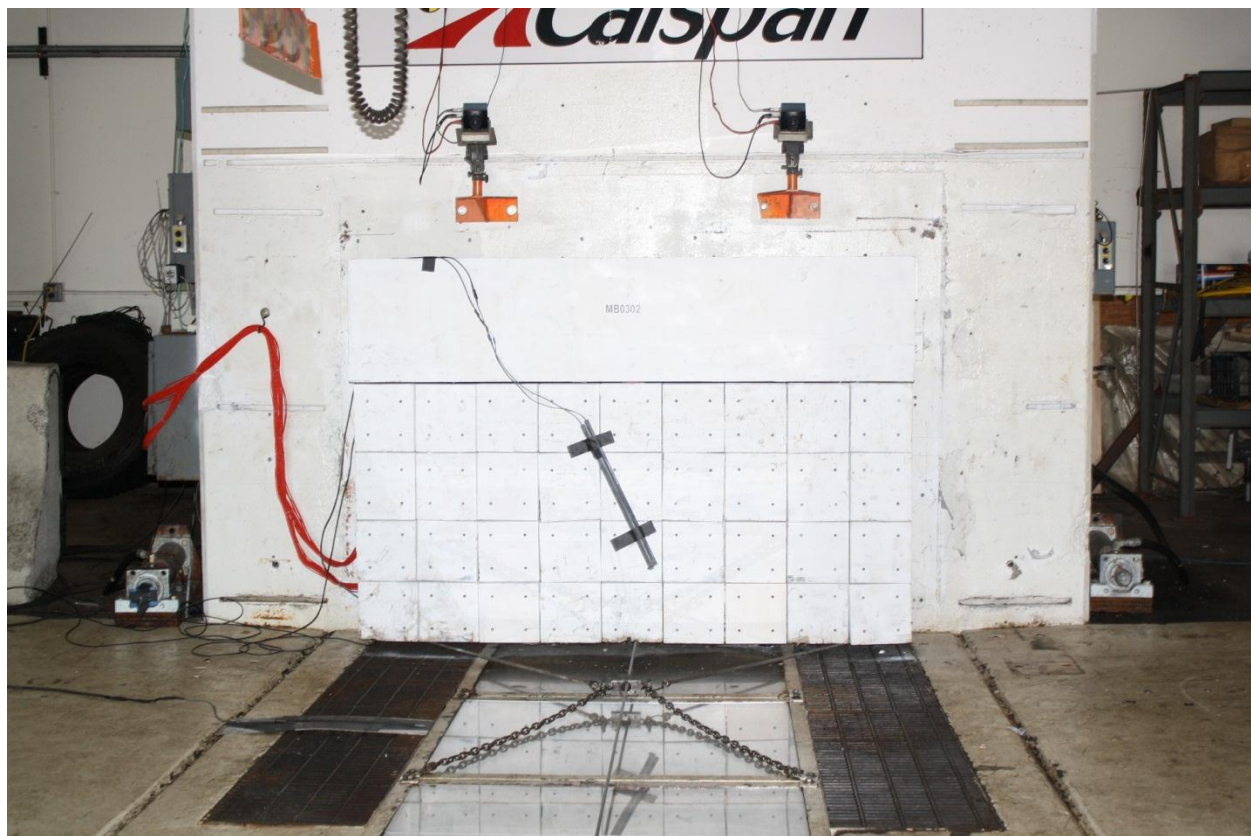
Figure A-1: Load Cell Location

A load cell barrier consisting of 36 load cells was impacted by a 2011 Ram 1500 ST Crew Cab 4 Door Pickup at a velocity of 56.1 kph. The test was performed at Calspan on 10/8/2010. Pre- and post-test photographs of the vehicle and dummies can be found in Appendix A.
