**REPORT NUMBER: SPNCAP-KAR-11-031**

**NEW CAR ASSESSMENT PROGRAM (NCAP)  
SIDE IMPACT POLE TEST**

**KIA MOTORS CORPORATION  
2011 KIA SOUL PLUS 5-DOOR MPV**

**FINAL REPORT**

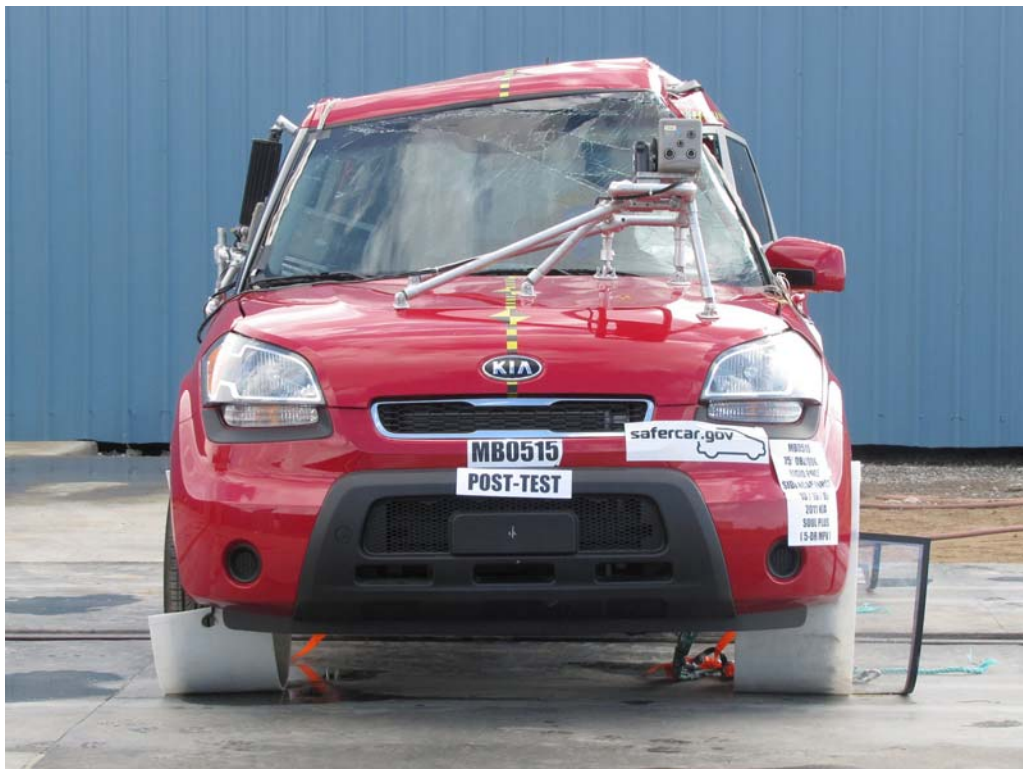
FIGURE 4. Post-Test Frontal View of Test Vehicle

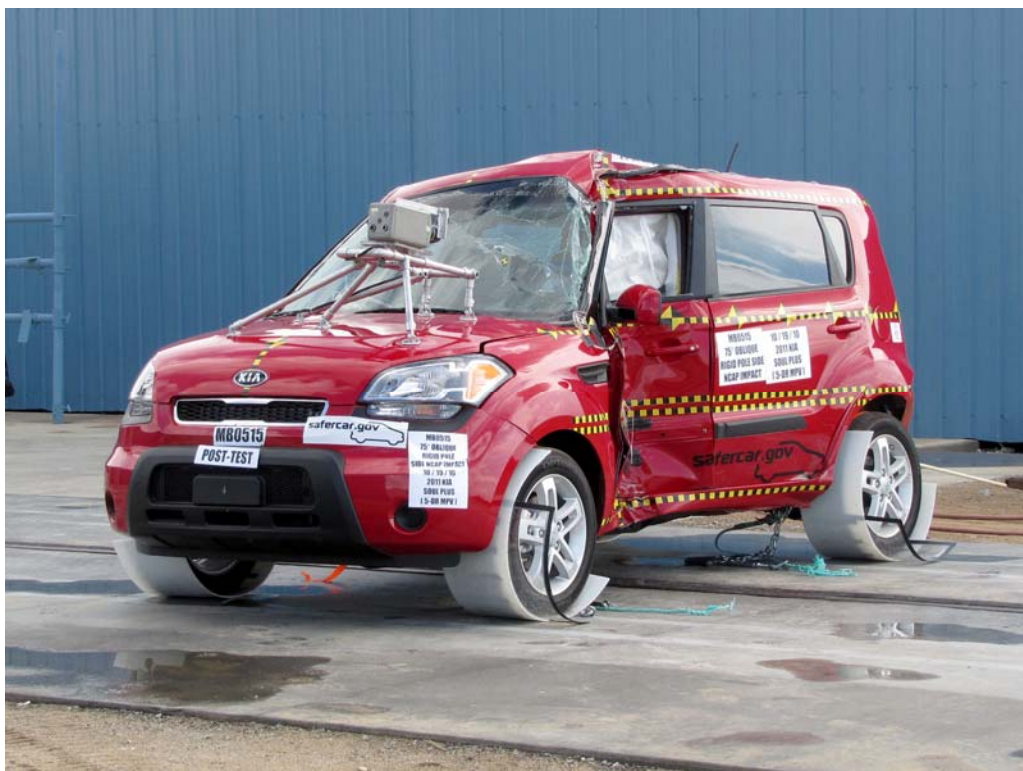
FIGURE 6. Post-Test Left Front Three-Quarter View of Test Vehicle

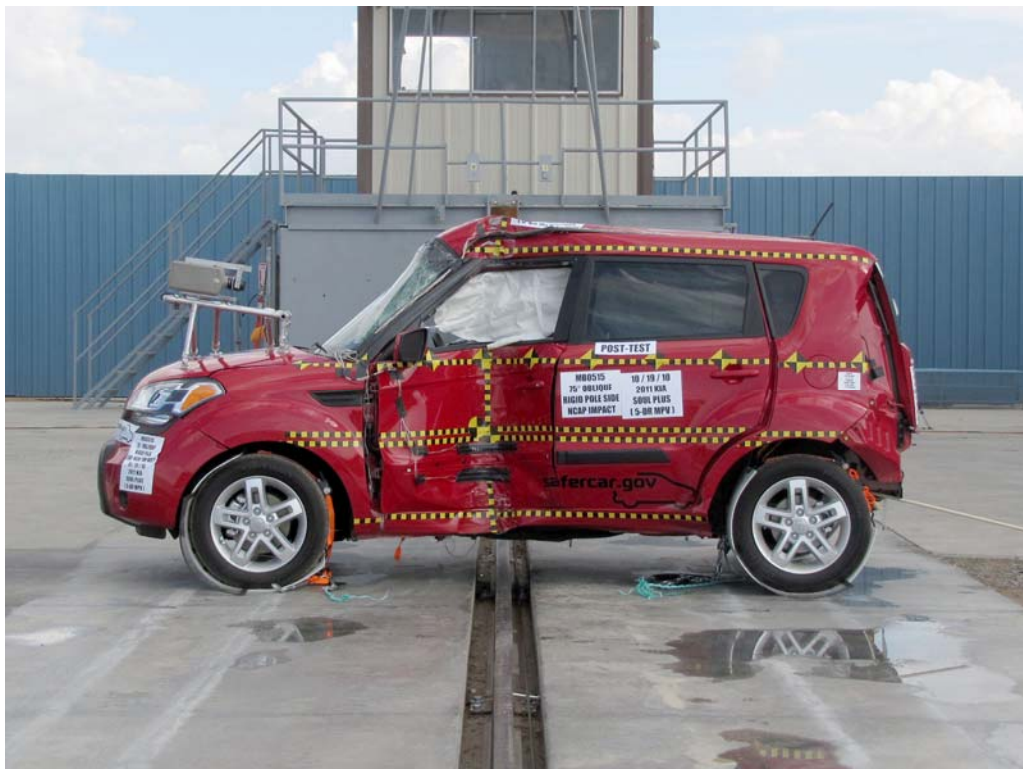
FIGURE 8. Post-Test Left Side View of Test Vehicle

Both of the struck side doors of the test vehicle remained closed and latched and were jammed shut after the impact. There was no separation at the hinges or the latches. The non-struck side doors remained closed and latched. There were no driver injury values that exceeded their limits. There was no FMVSS 301 Stoddard solvent spillage as a result of the impact.

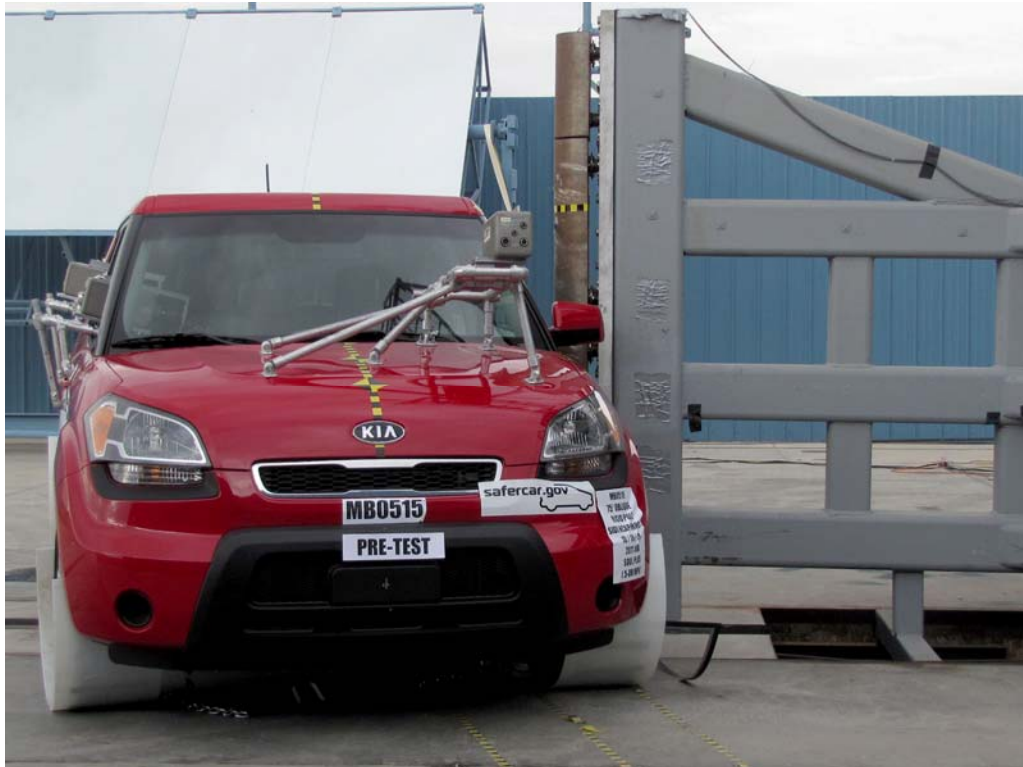
FIGURE 17. Pre-Test Left Side View of Pole  
Positioned Against Side of Vehicle at Impact Point

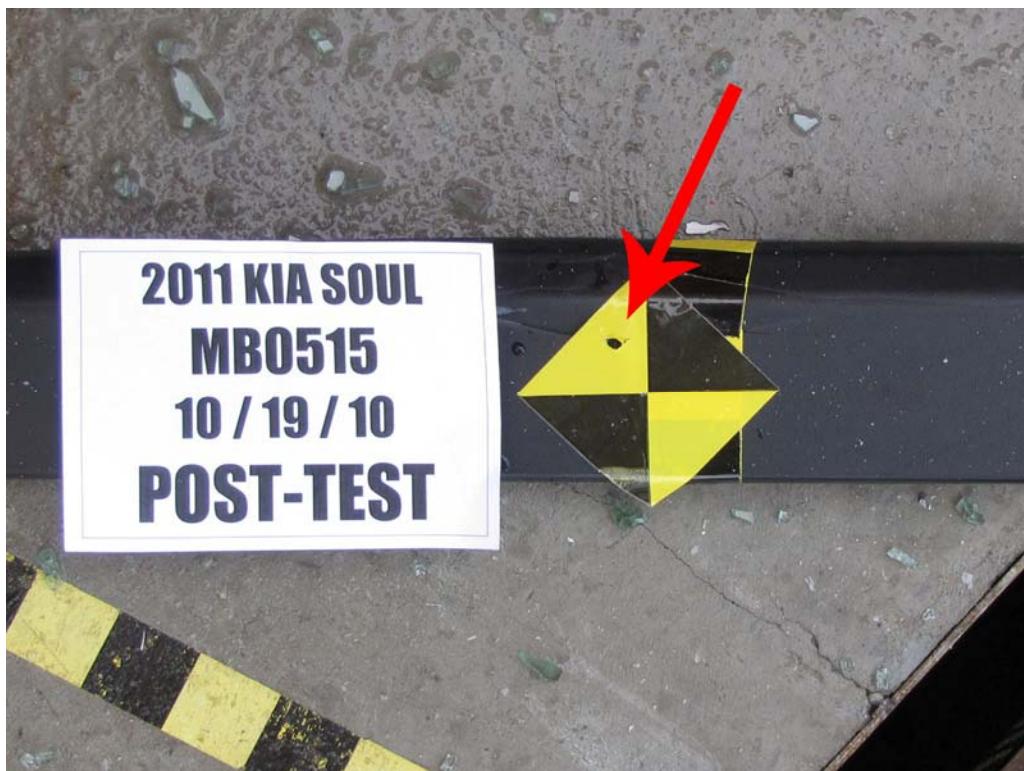
FIGURE 20. Post-Test Close-Up View of Impact Point Target Showing Impact Location

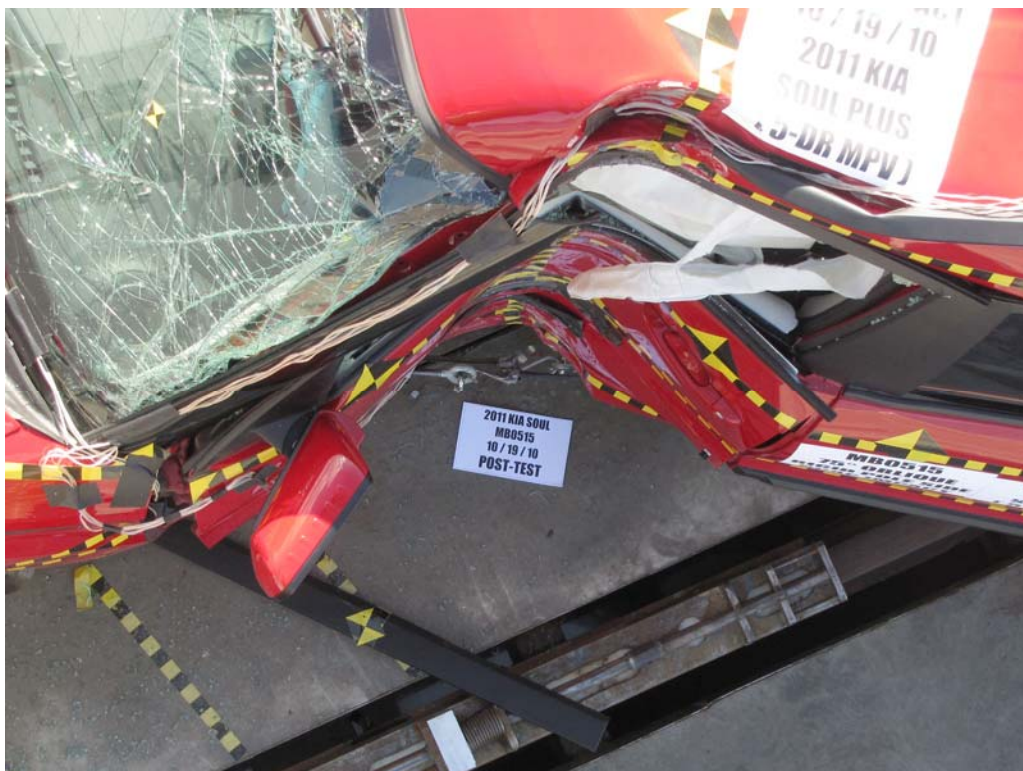
FIGURE 40. Post-Test Driver Dummy and Door Clearance

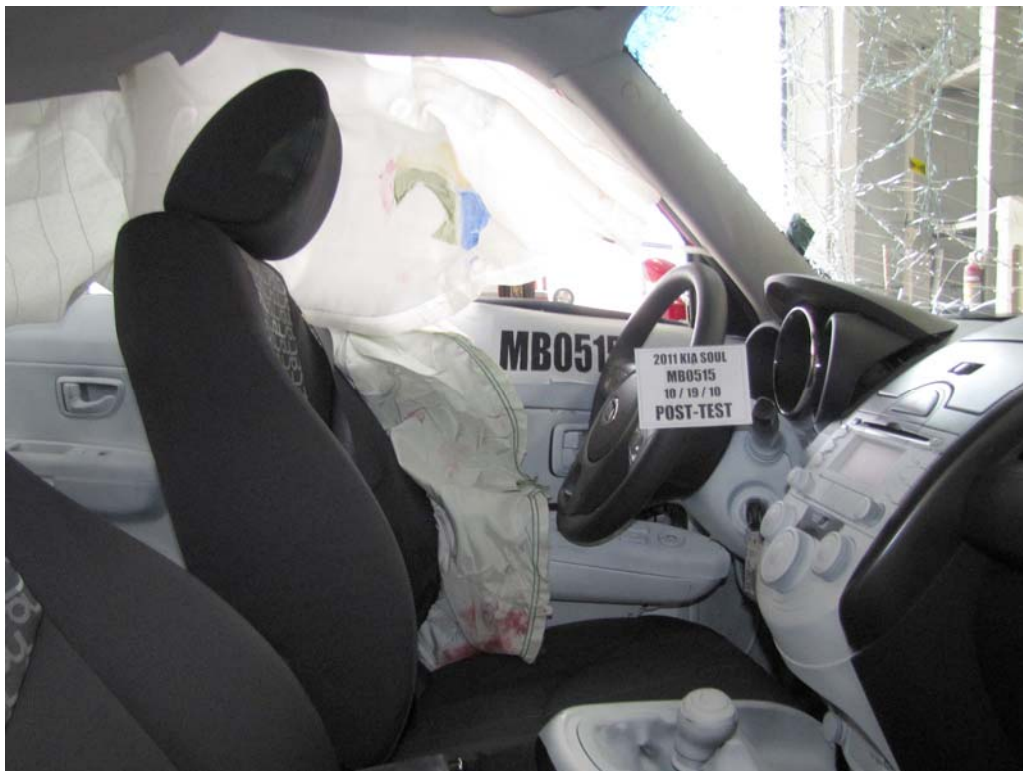
FIGURE 44. Post-Test Inner Driver Door Panel View  
Showing Dummy Contact Locations

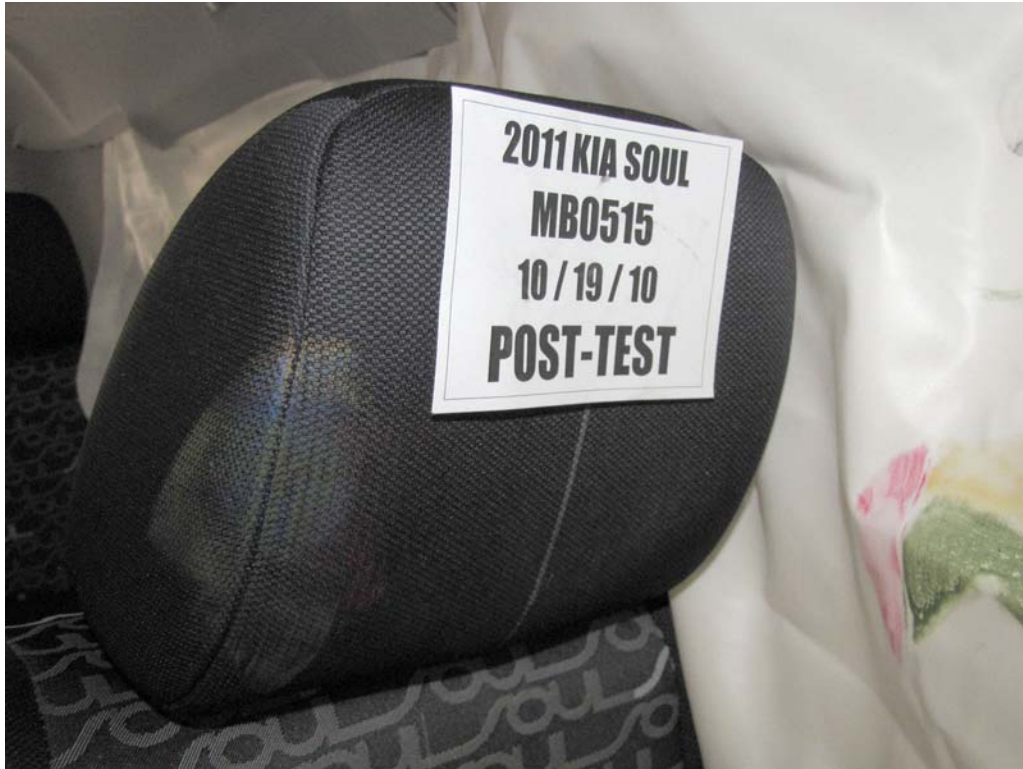
FIGURE 45. Post-Test Dummy Close-Up Head Contact with Vehicle Interior View

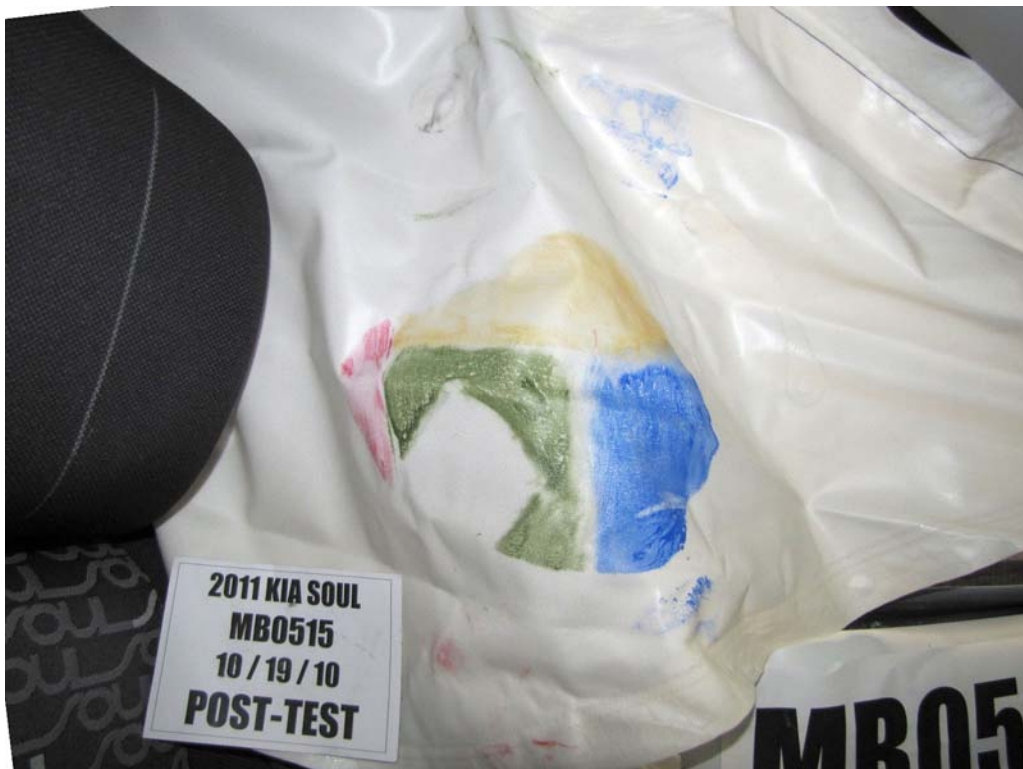
FIGURE 46. Post-Test Dummy Close-Up Head Contact with Side Airbag View

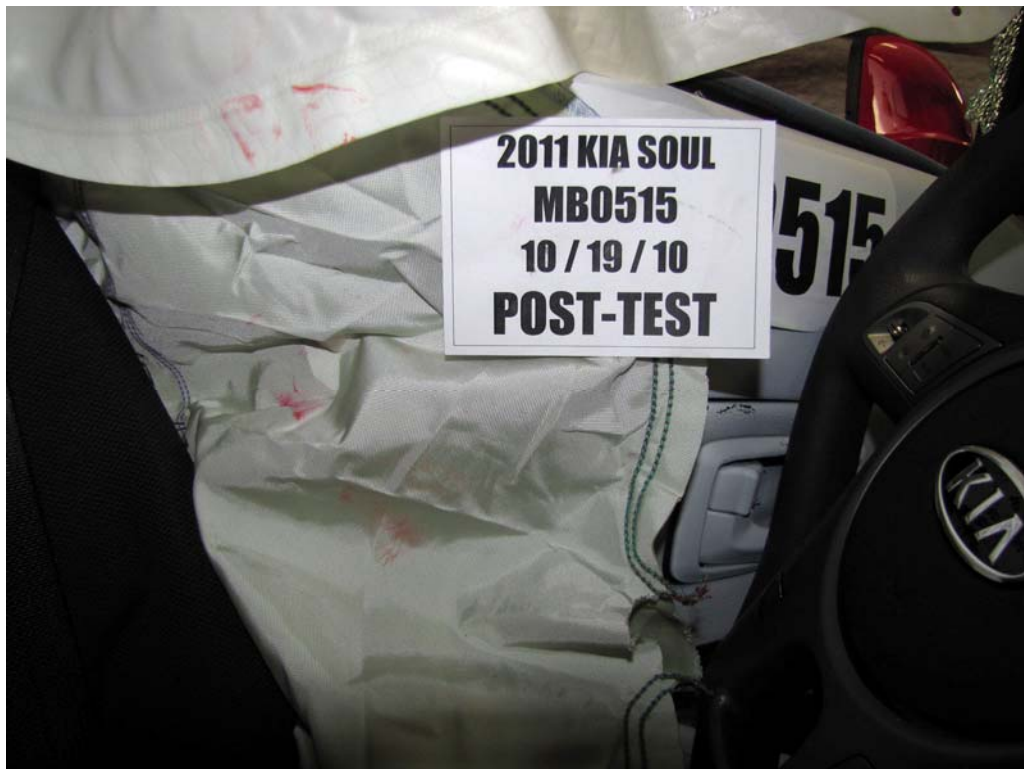
FIGURE 48. Post-Test Dummy Close-Up Torso Contact with Side Airbag View

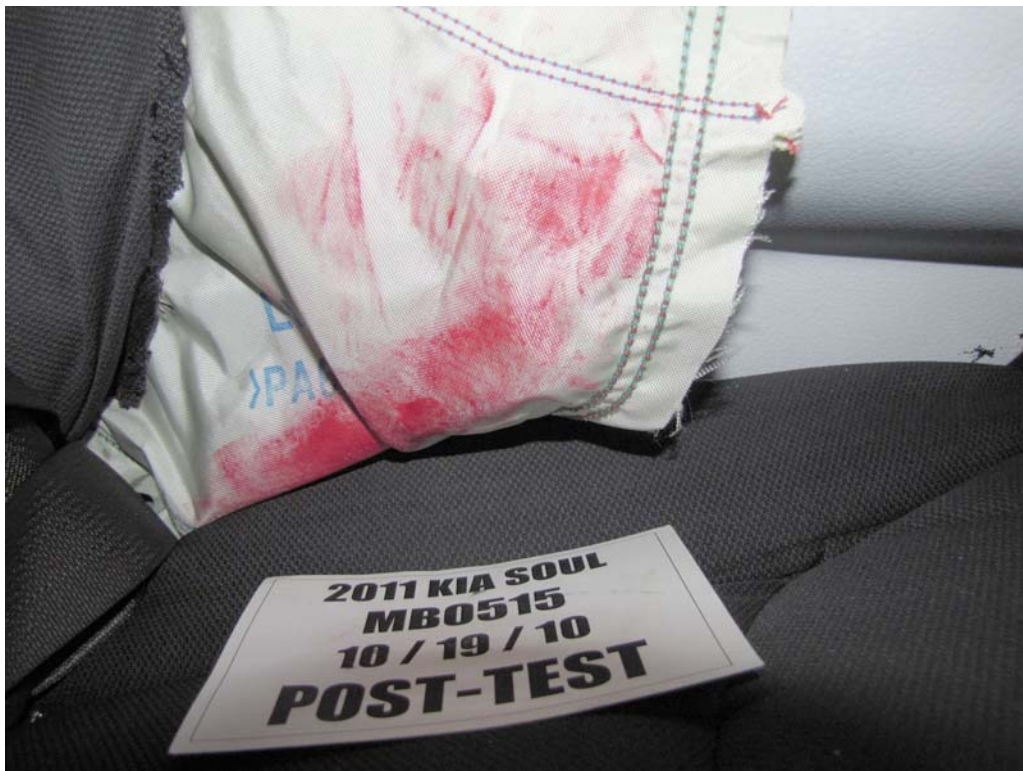
FIGURE 50. Post-Test Dummy Close-Up Pelvis Contact with Side Airbag View

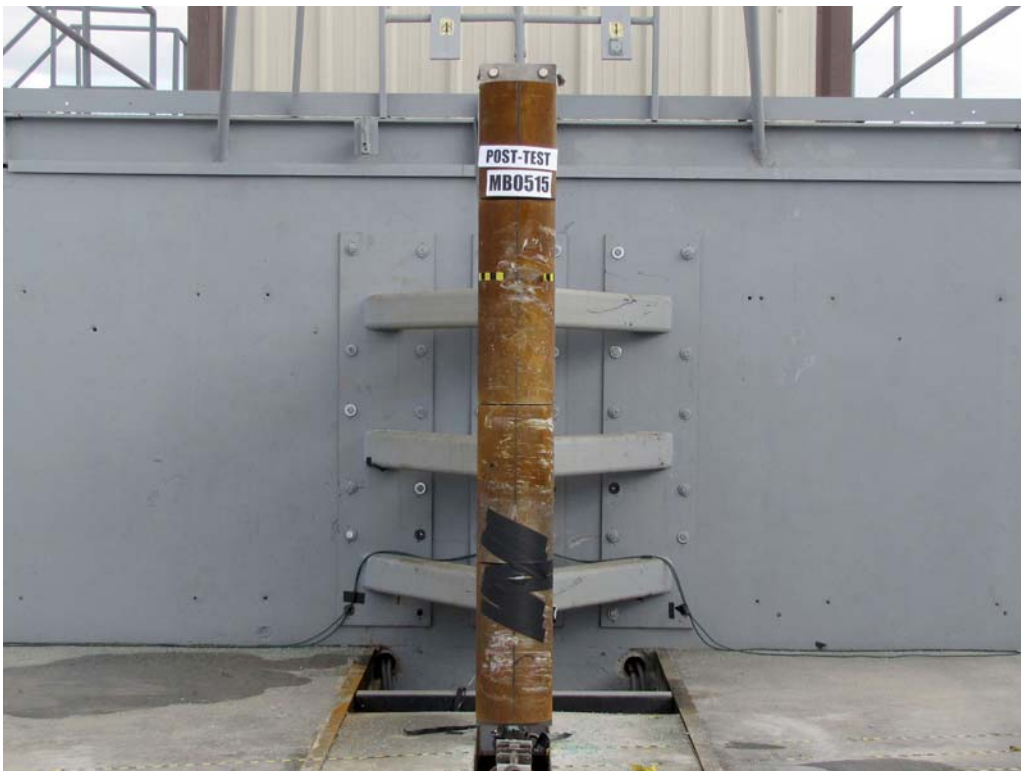
FIGURE 56. Post-Test Pole Barrier Front View

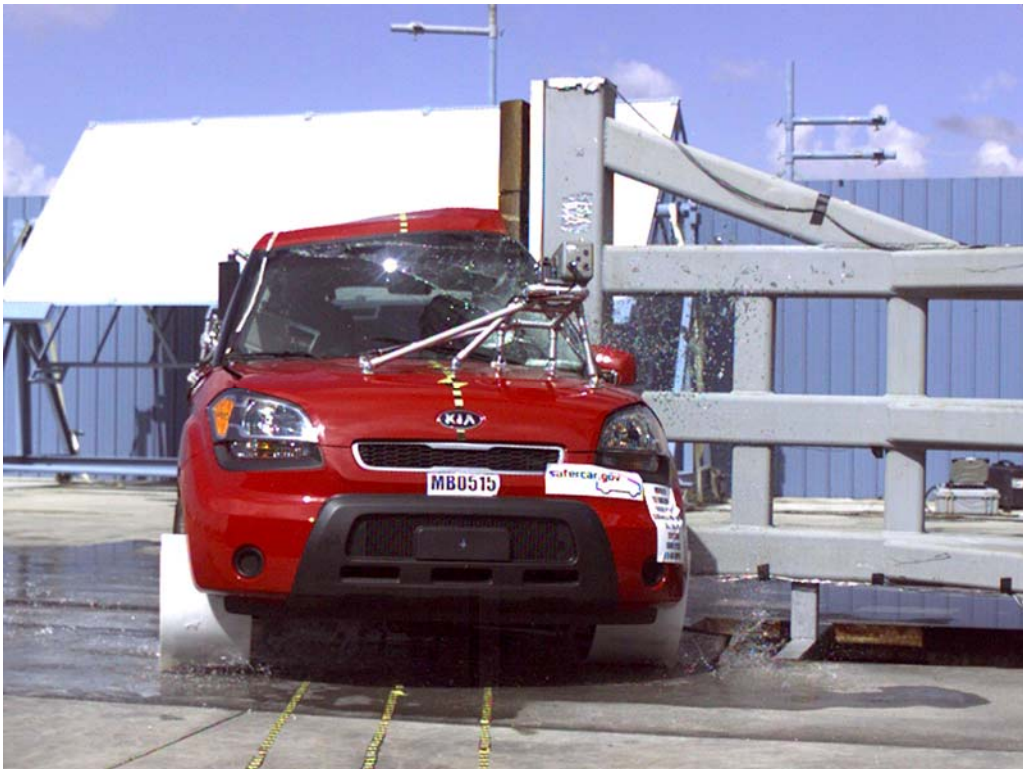
FIGURE 66. Impact Event
