**REPORT NUMBER: SINCAP-MGA-2011-033**

**NEW CAR ASSESSMENT PROGRAM (NCAP)  
Moving Deformable Barrier Side Impact Test**

**FORD MOTOR COMPANY  
2011 Ford Escape XLT FWD SUV  
NHTSA No.: MB0204**

**FINAL REPORT**

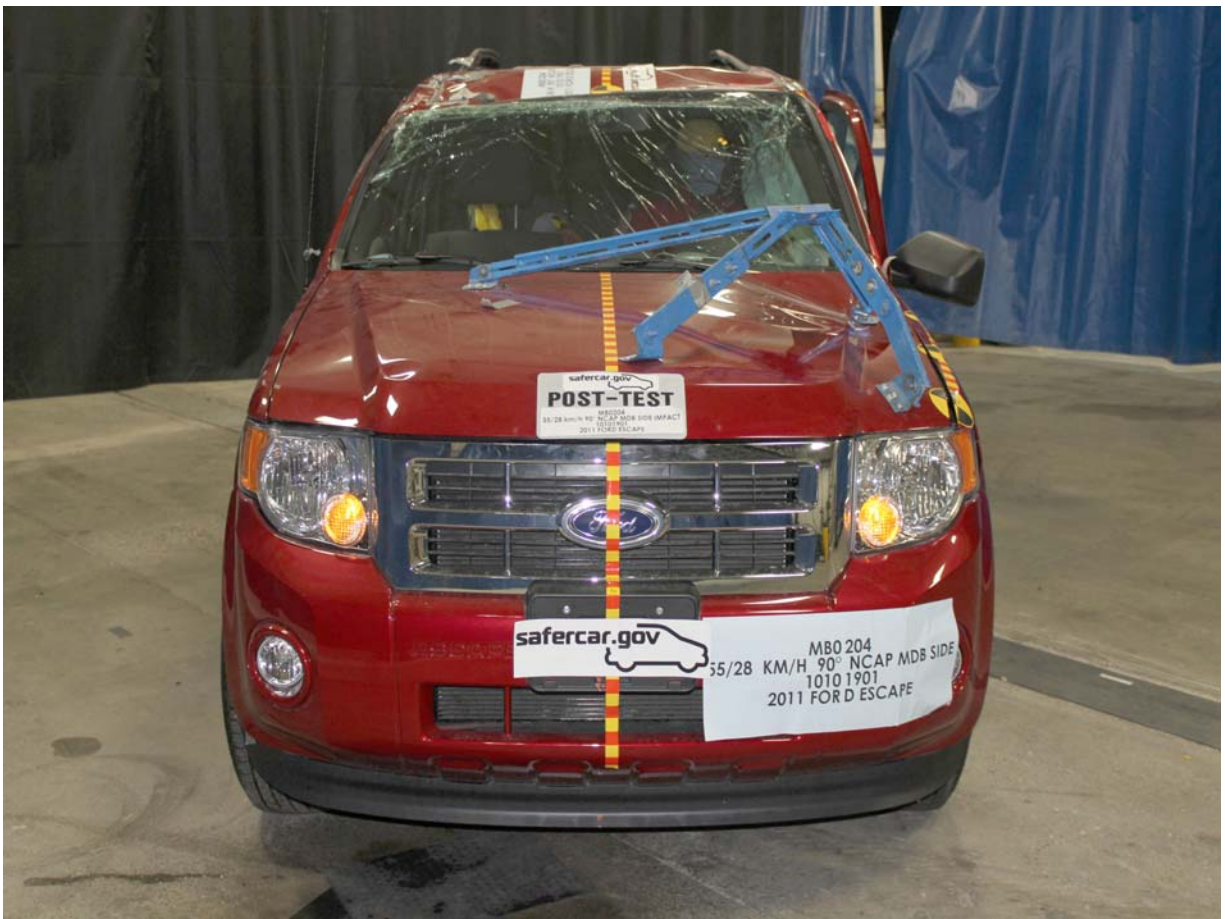
Post-Test Frontal View of Test Vehicle – Righted

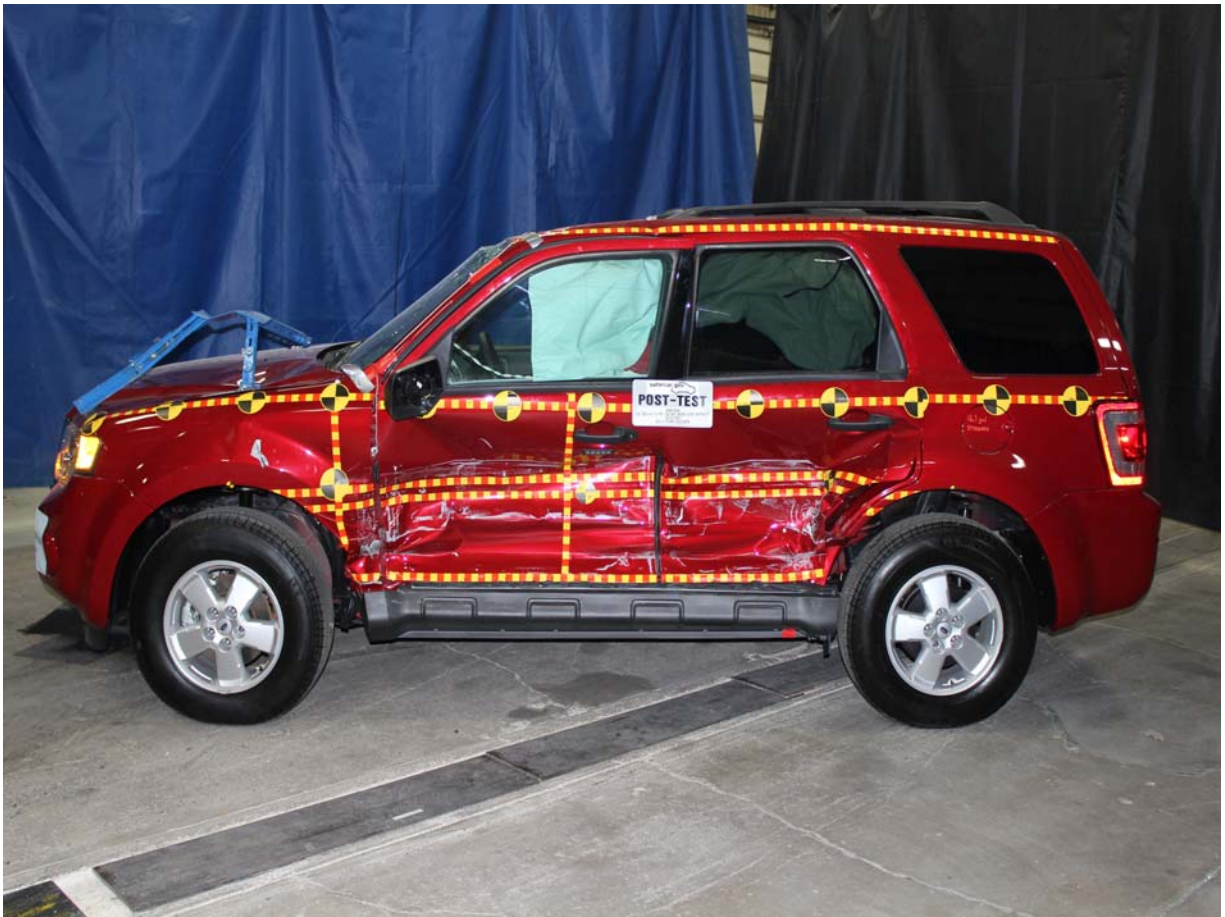
Post-Test Left Side View of Test Vehicle – Righted

| Critical Areas of Performance | Observations and Conclusions |
|---|---|
| Window Damage | Left Front Broke |

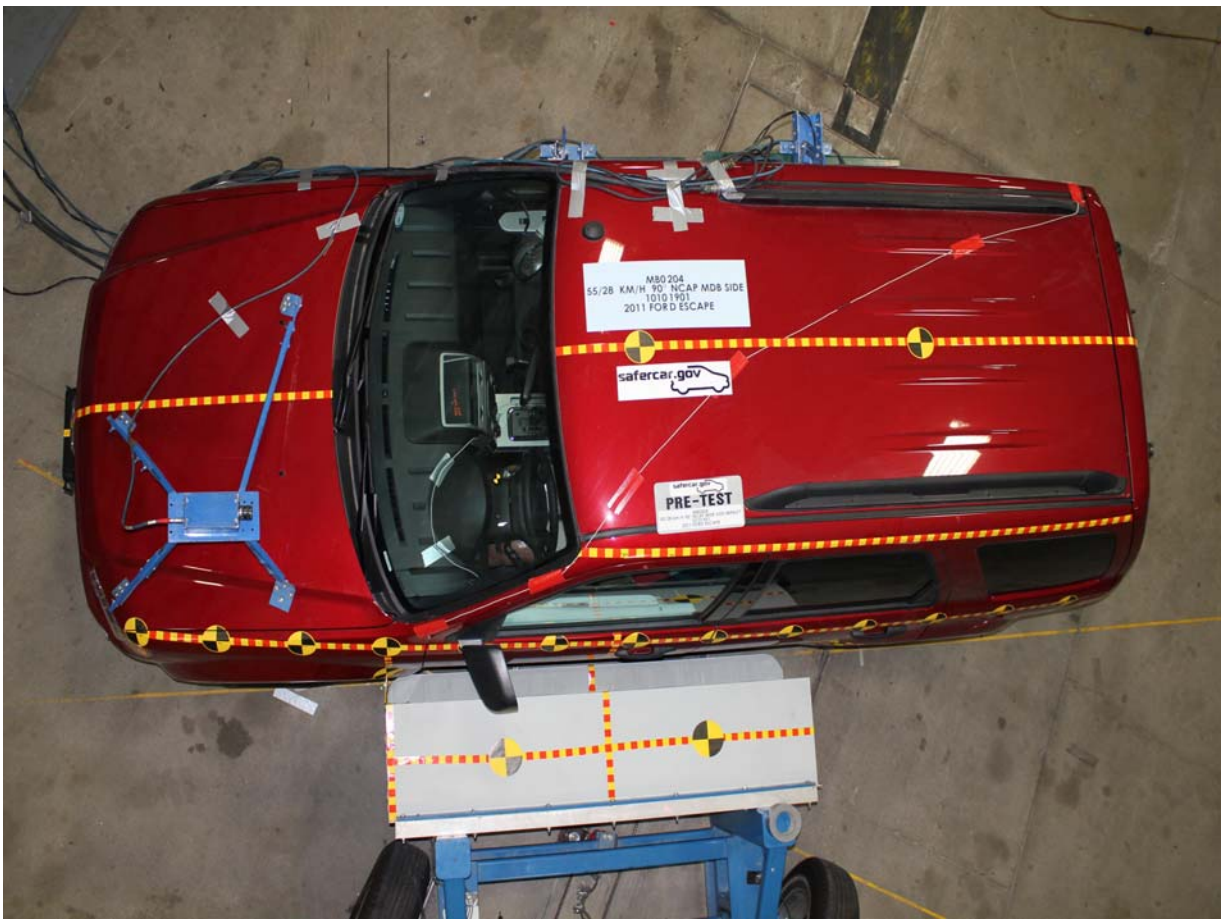
Pre-Test Overhead View of Test Vehicle with MDB Positioned Against Side of Test Vehicle

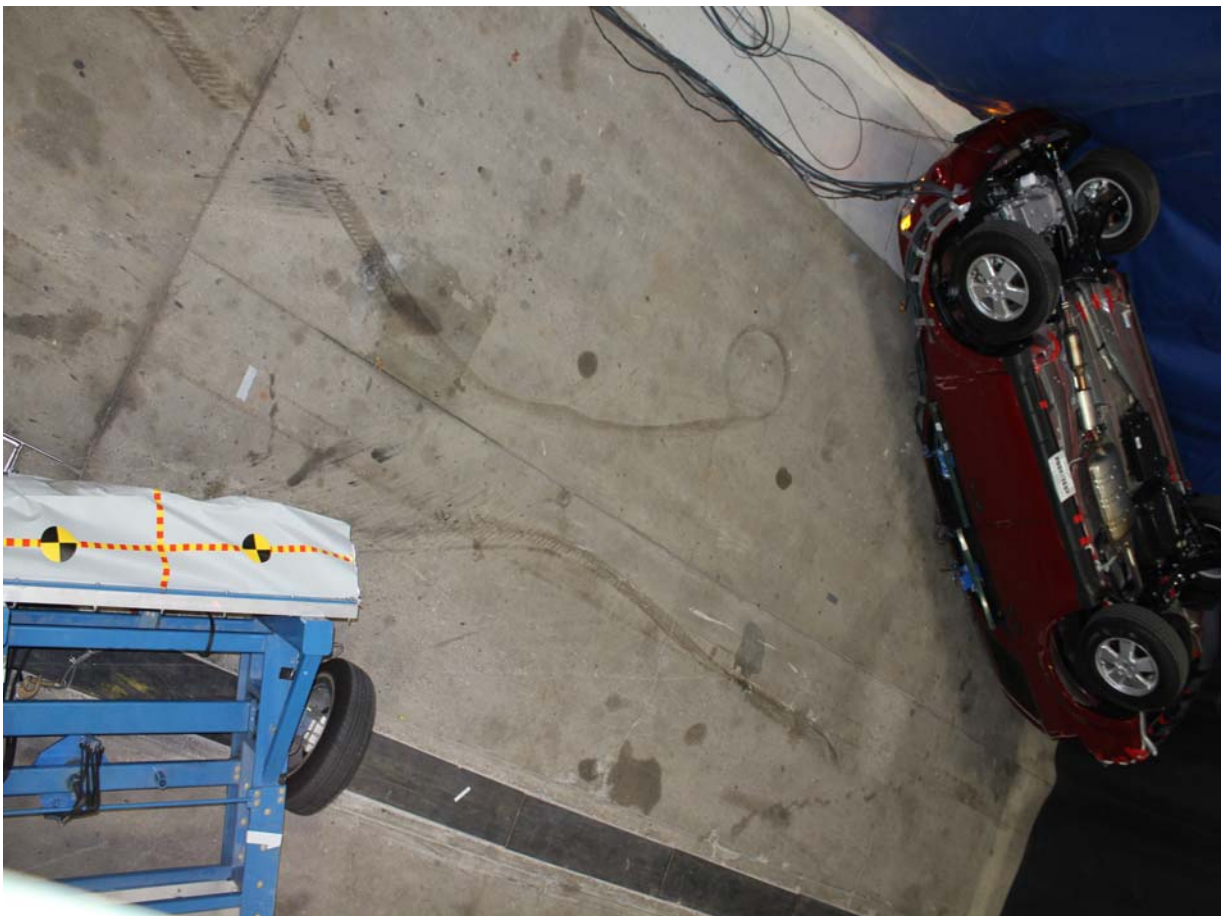
Post-Test Overhead View of Test Vehicle and MDB

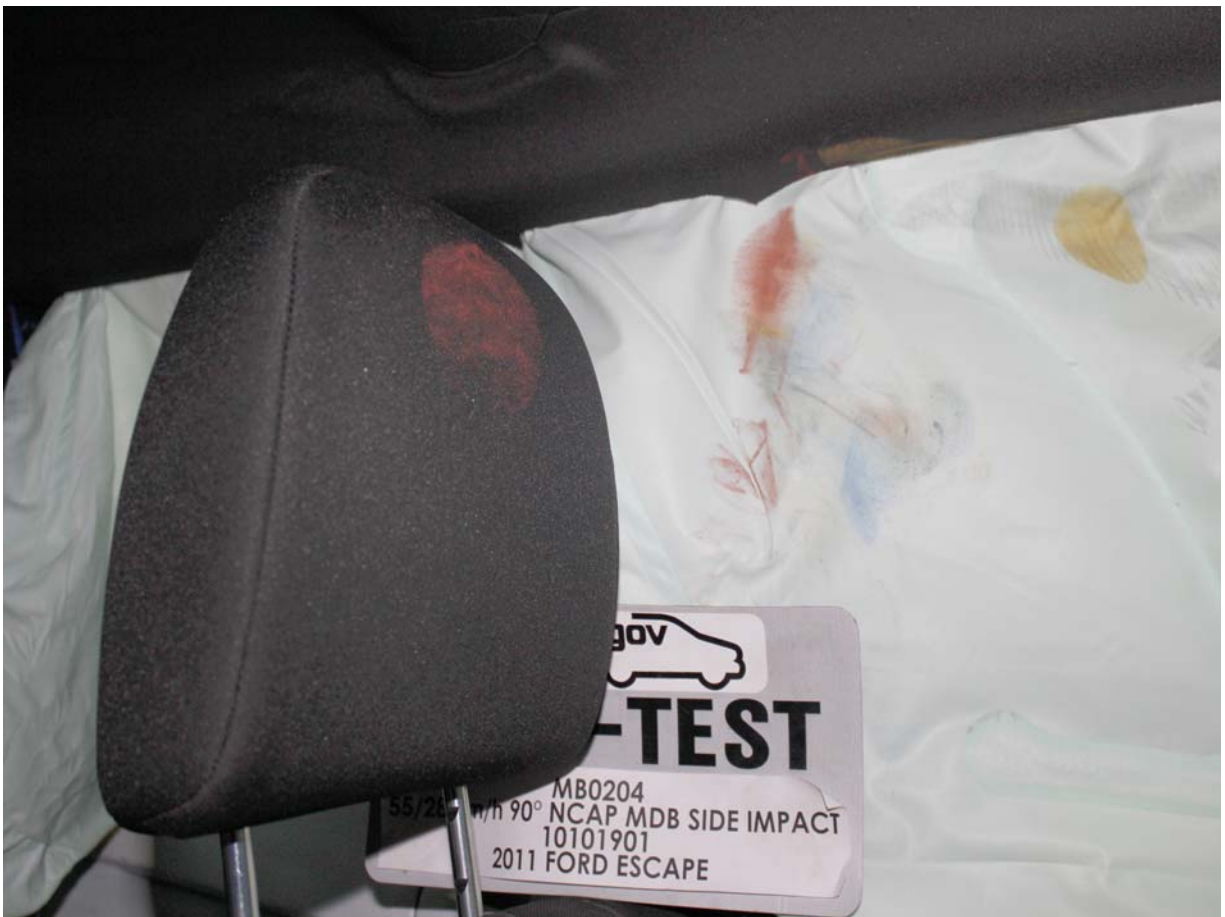
Post-Test Driver Dummy Close-up Head Contact with Vehicle View

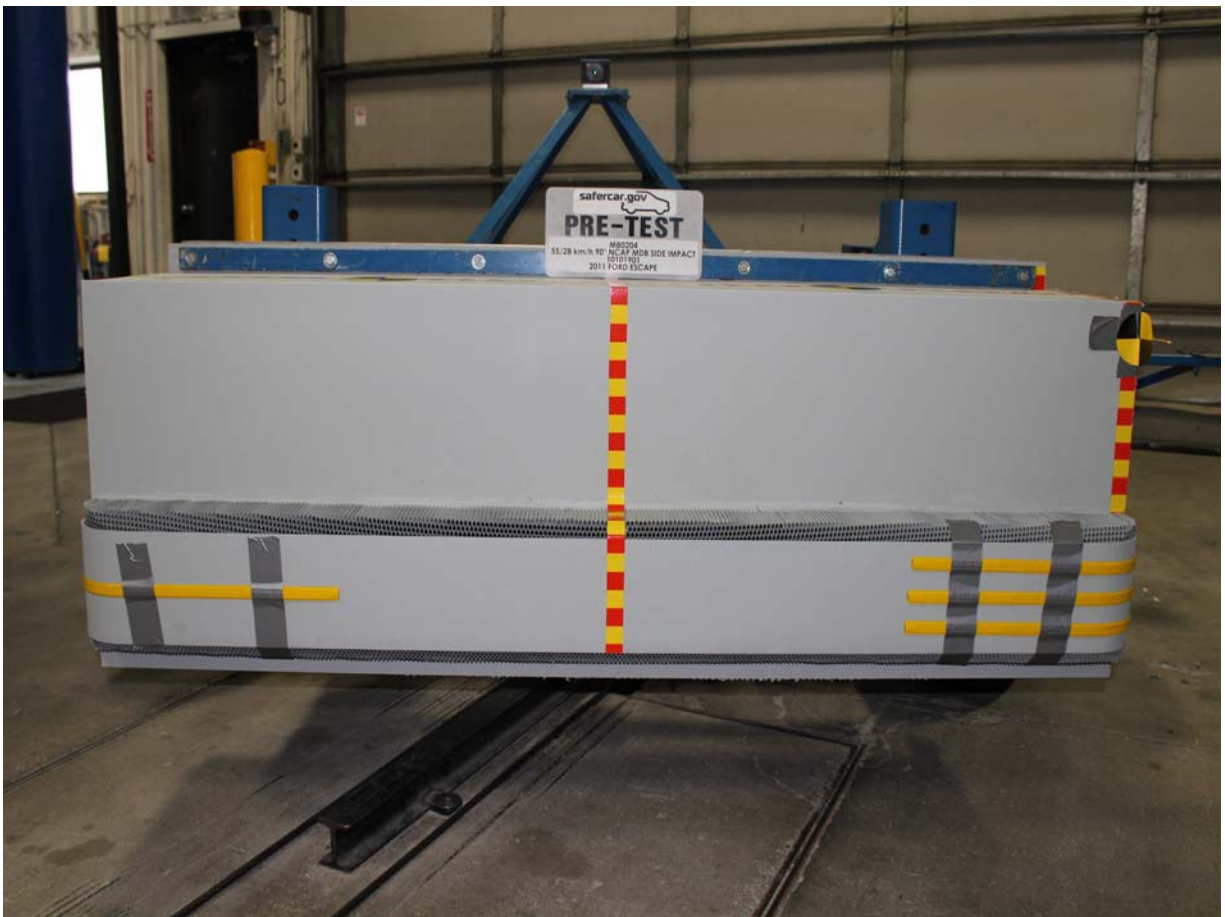
Pre-Test Front View of MDB Impactor Face
