**REPORT NUMBER: NCAP-MGA-2011-034**

**NEW CAR ASSESSMENT PROGRAM (NCAP)  
Frontal Barrier Impact Test**

**FORD MOTOR COMPANY  
2011 Ford Escape XLT 4WD SUV  
NHTSA No.: MB0205**

**FINAL REPORT**

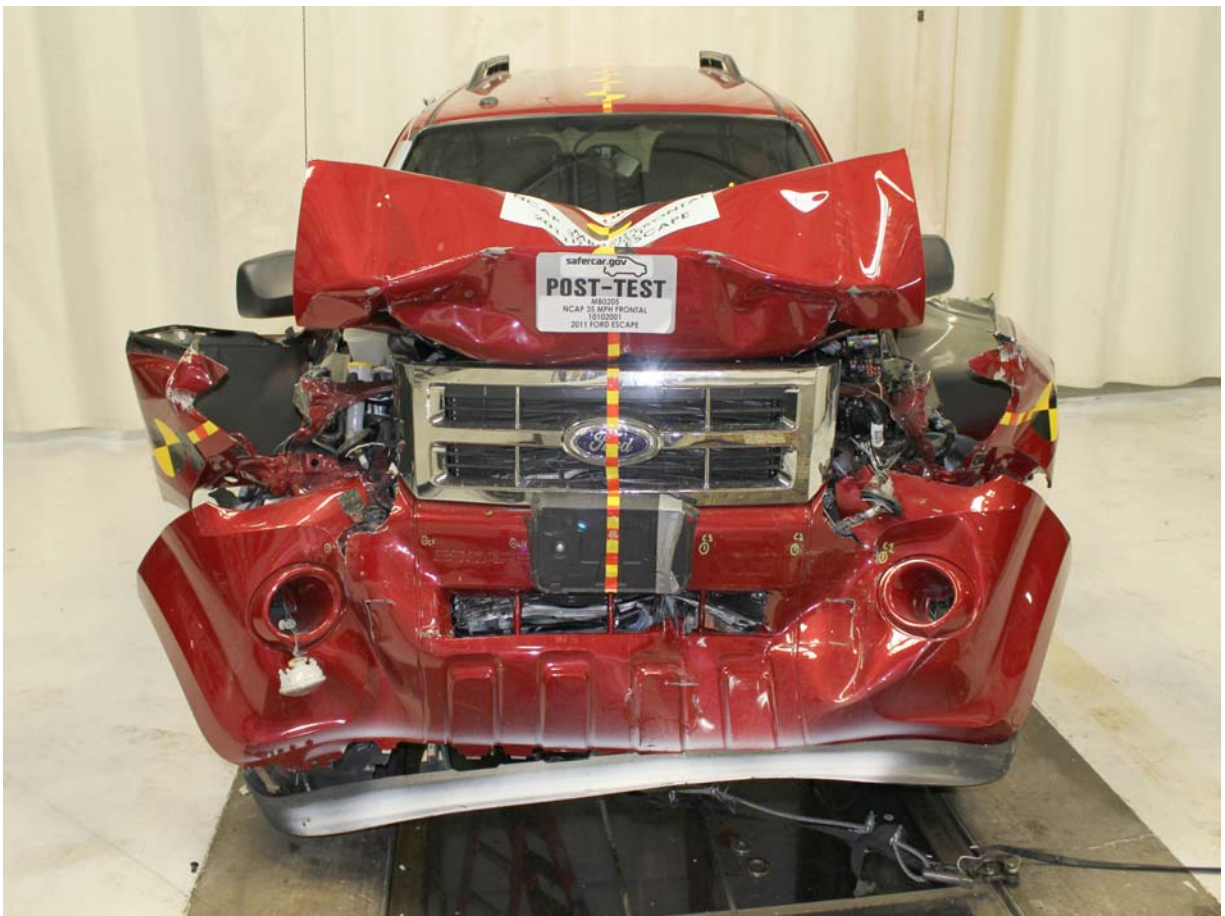
### Post-Test Front View

The maximum static crush of the vehicle was 568 mm and both the driver and passenger side doors remained closed during the impact event and were operable after the impact.

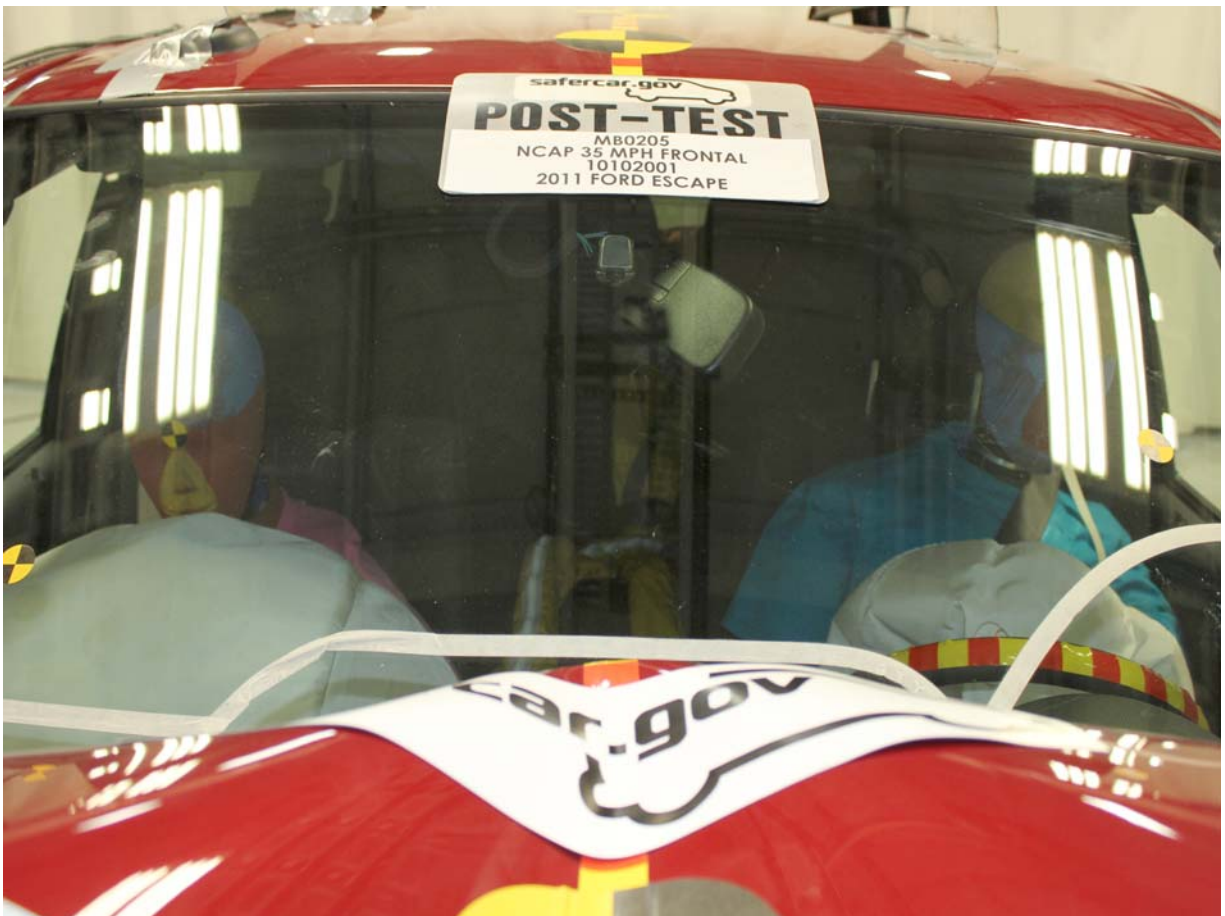
Post-Test Windshield View

There was 100 percent windshield retention and no intrusion into the protected zone of the windshield during the event. There was no Stoddard Solvent leakage after the event or during any phase of the static rollover.

| Critical Areas of Performance | Observations and Conclusions |
|---|---|
| Windshield Damage | Cracked |

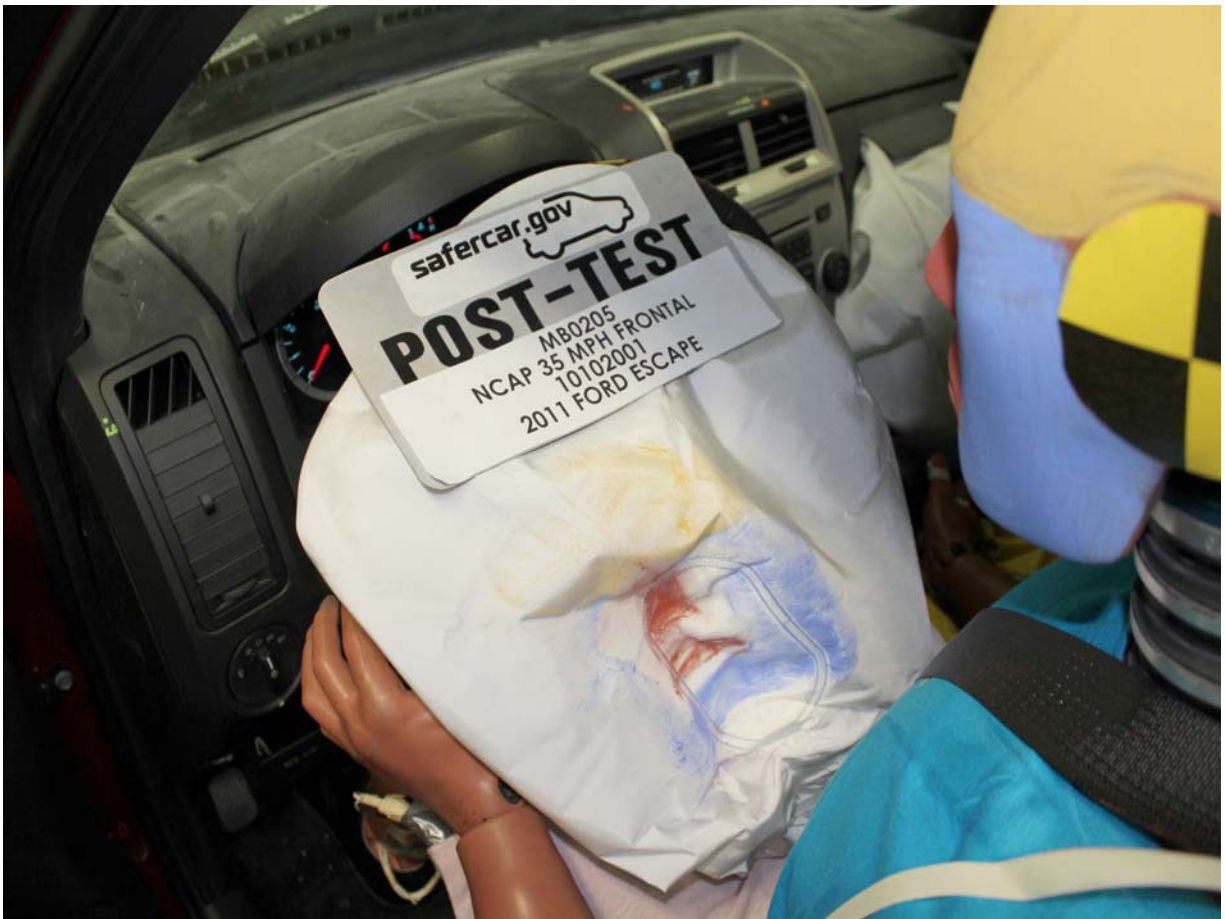
Post-Test Driver Dummy Contact with Airbag

The driver's head and chest contacted the airbag. The driver's head also contacted headrest. The driver's knees contacted the knee bolster. The passenger's head and chest contacted the airbag. The passenger's head also contacted the headrest. The passenger's knees contacted the glovebox.

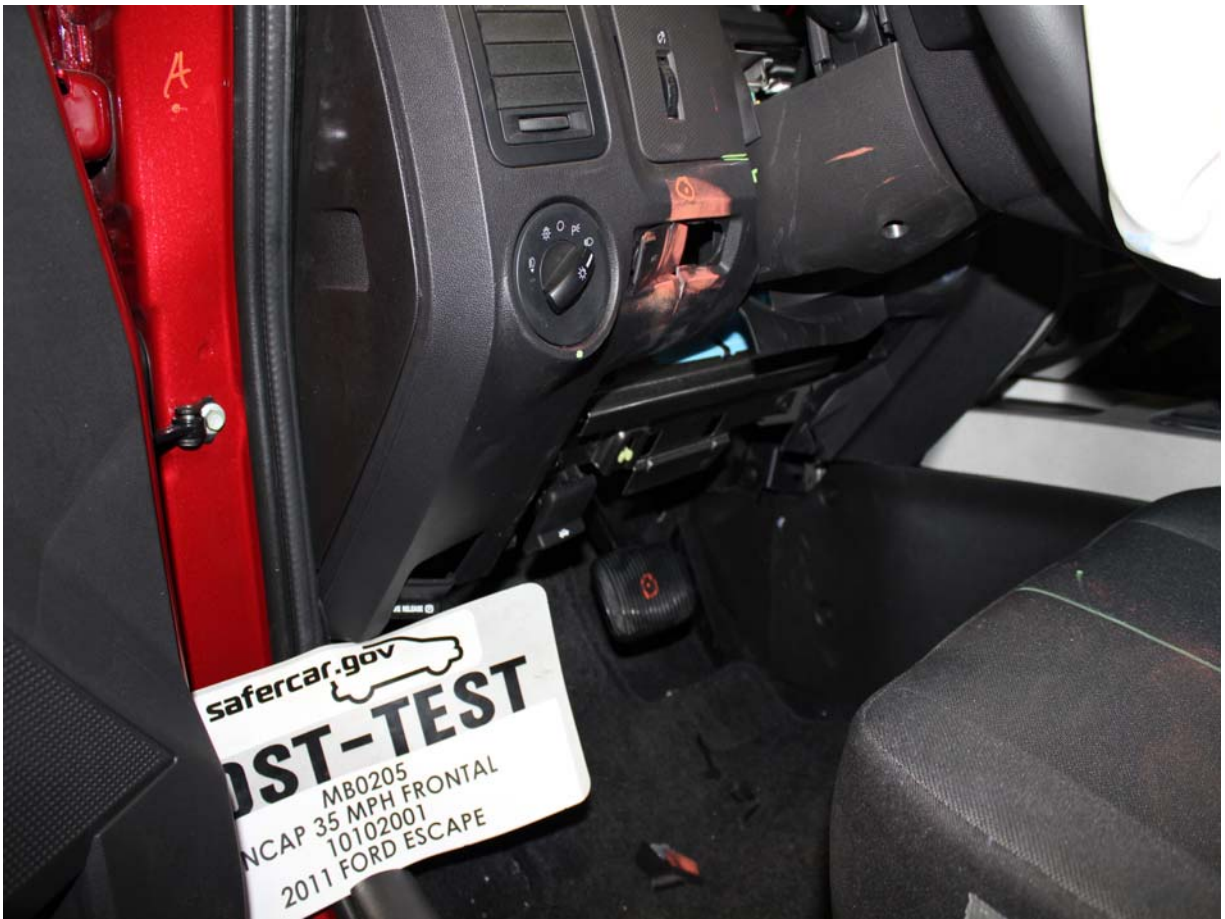
Post-Test Driver Dummy Contact with Knee Bolster - Left Knee

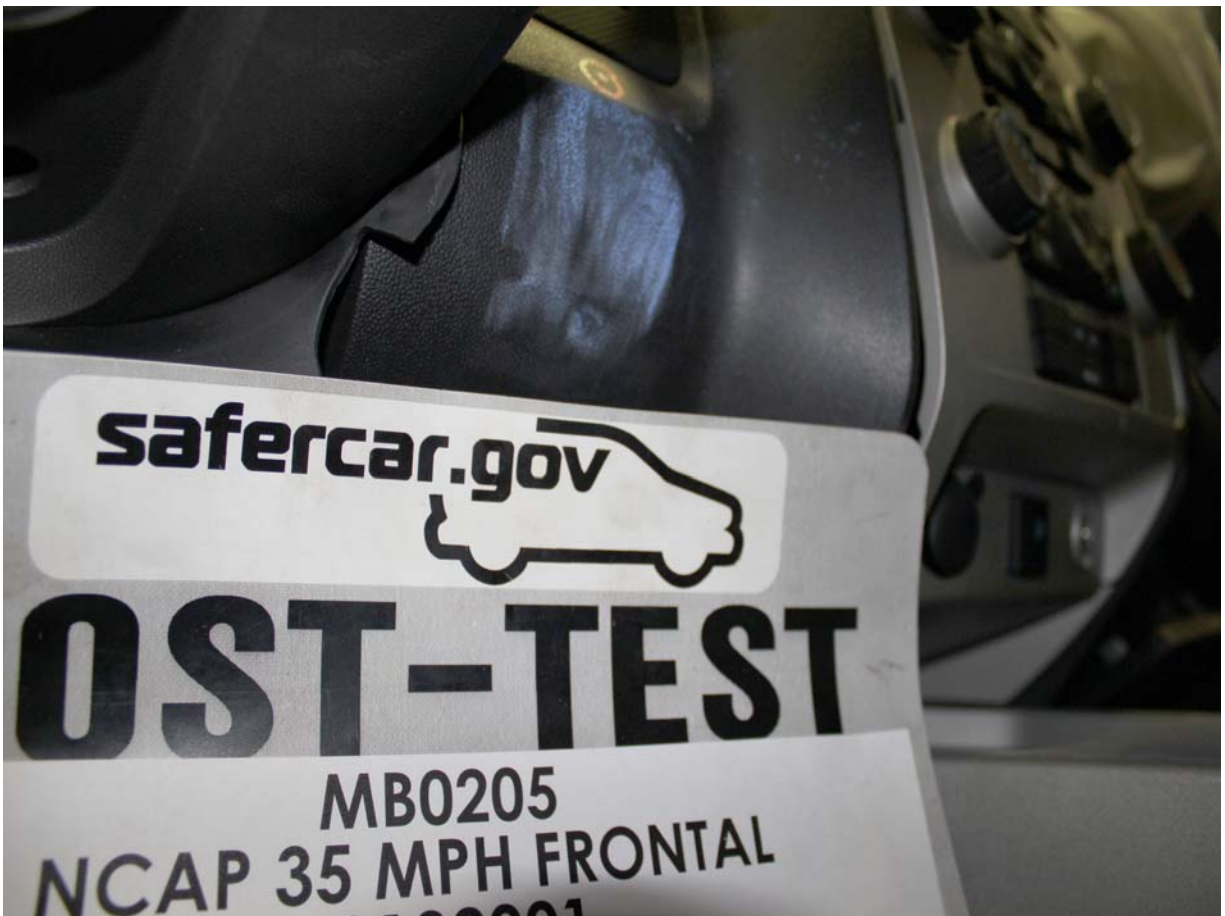
Post-Test Driver Dummy Contact with Knee Bolster - Right Knee

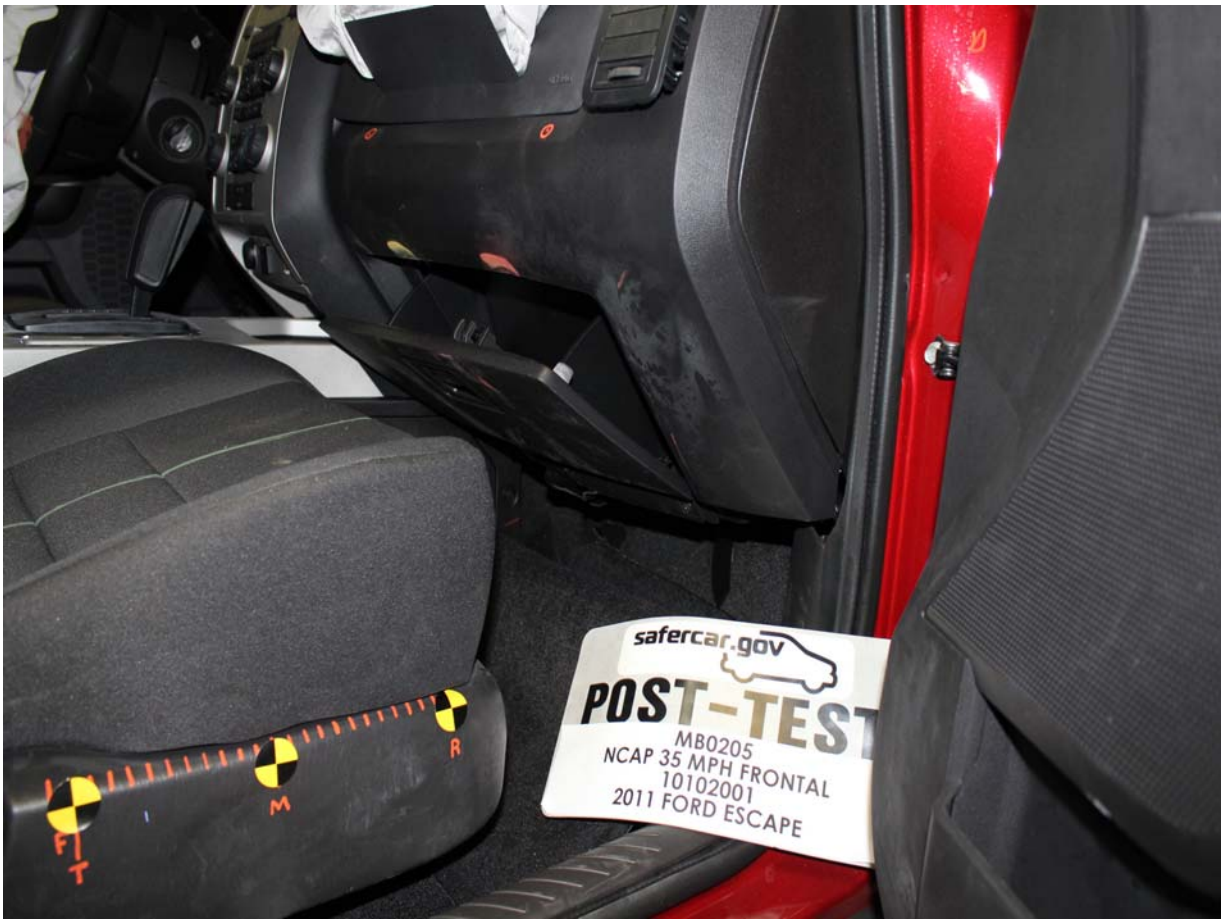
Post-Test Passenger Dummy Contact with Glovebox
