**REPORT NUMBER: NCAP-KAR-11-033**

**NEW CAR ASSESSMENT PROGRAM (NCAP)  
FRONTAL BARRIER IMPACT TEST**

**KIA MOTORS CORPORATION  
2011 KIA SOUL PLUS 5-DOOR MPV**

**FINAL REPORT**

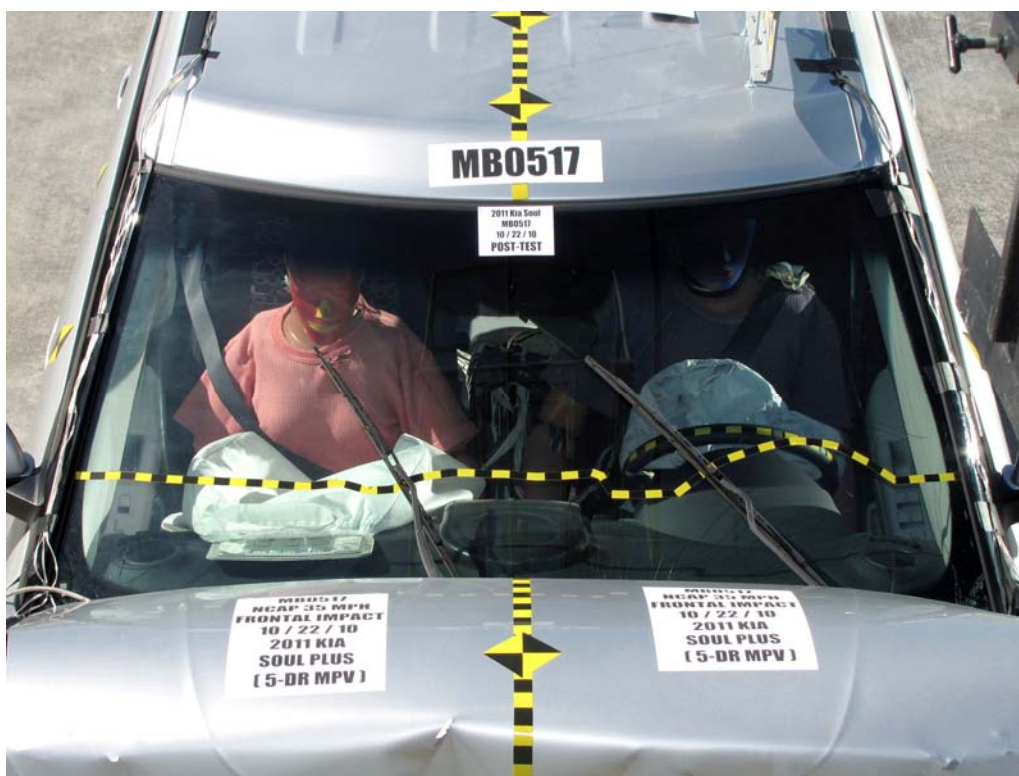
FIGURE 18. Post-Test Windshield View

There was 100% windshield retention and no intrusion into the protected zone of the windshield during the event. There was no Stoddard solvent leakage after the event or during any phase of the static rollover.

| Critical Areas of Performance | Observations and Conclusions |
|---|---|
| Windshield Damage | Cracked |

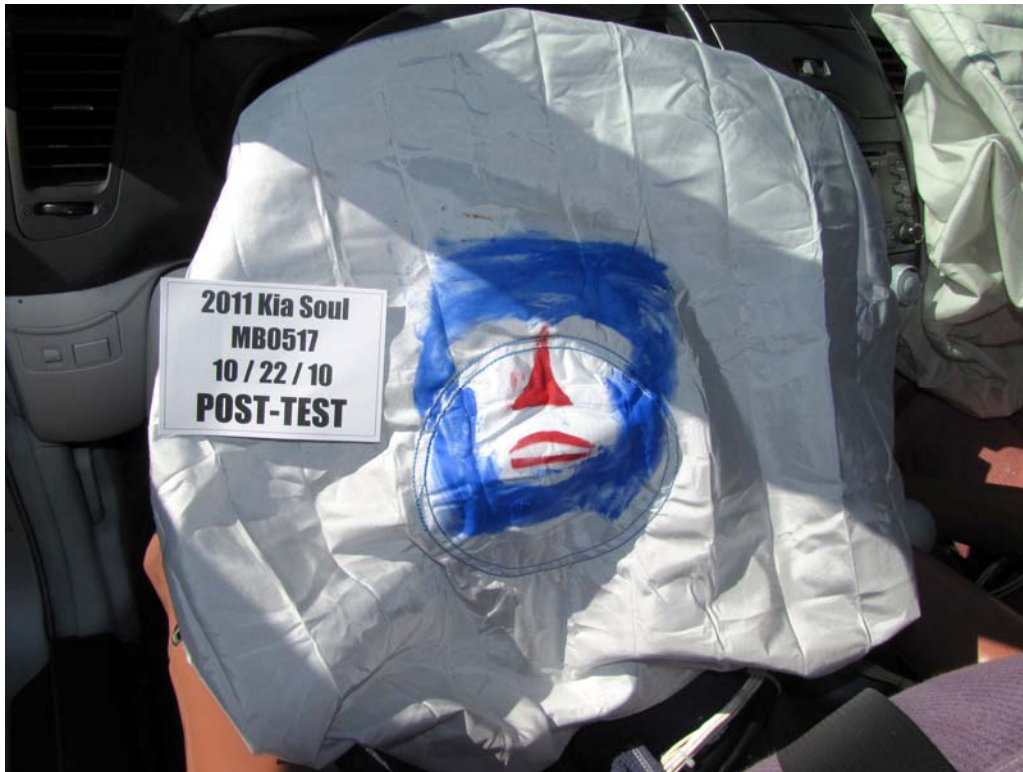
FIGURE 43. Post-Test Driver Dummy Contact With Airbag

The driver's visible contact points were as follows: The driver ATD's head contacted the airbag. The upper torso contacted the airbag. The left knee contacted the knee bolster and steering column. The right knee contacted the knee bolster.

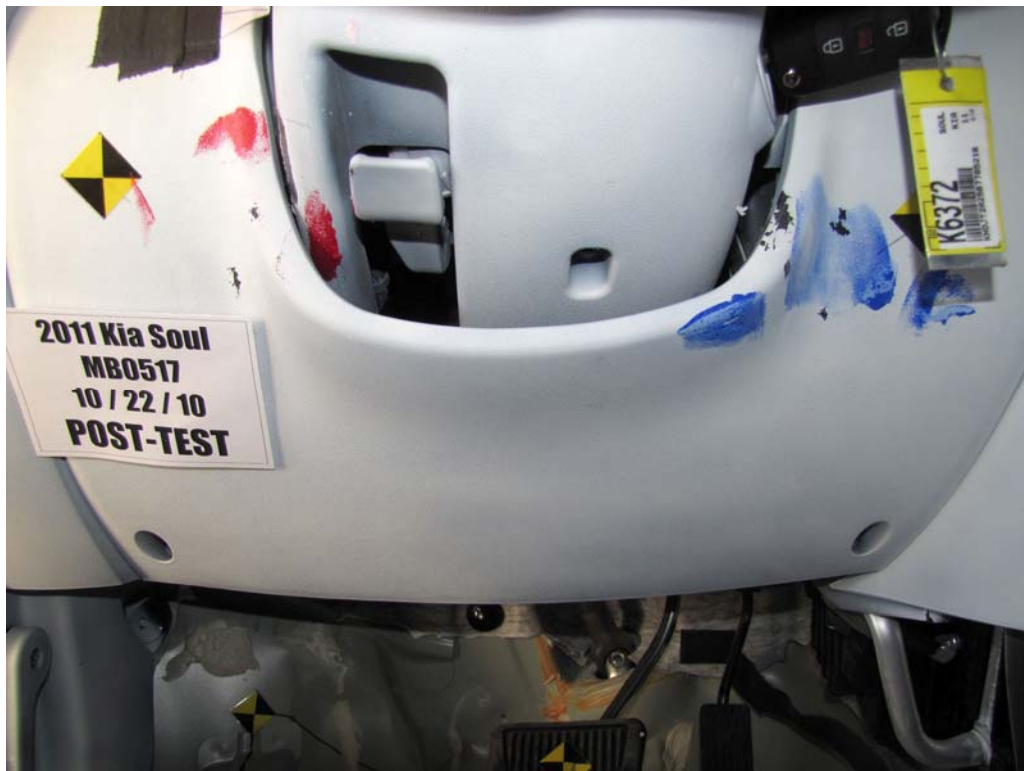
FIGURE 43b. Post-Test Driver Dummy Contact With Knee Bolster

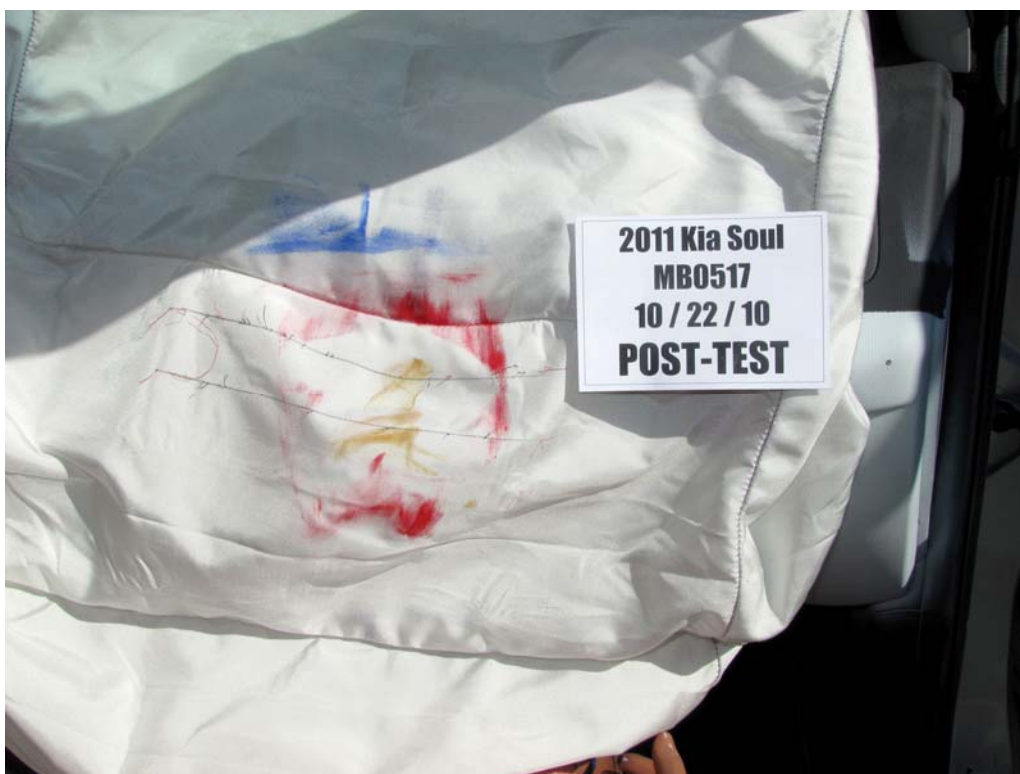
FIGURE 60. Post-Test Passenger Dummy Contact With Airbag

The passenger's visible contact points were as follows: The passenger ATD's head contacted the airbag. The upper torso contacted the airbag. The left knee contacted the glovebox. The right knee contacted the glovebox and right hand.

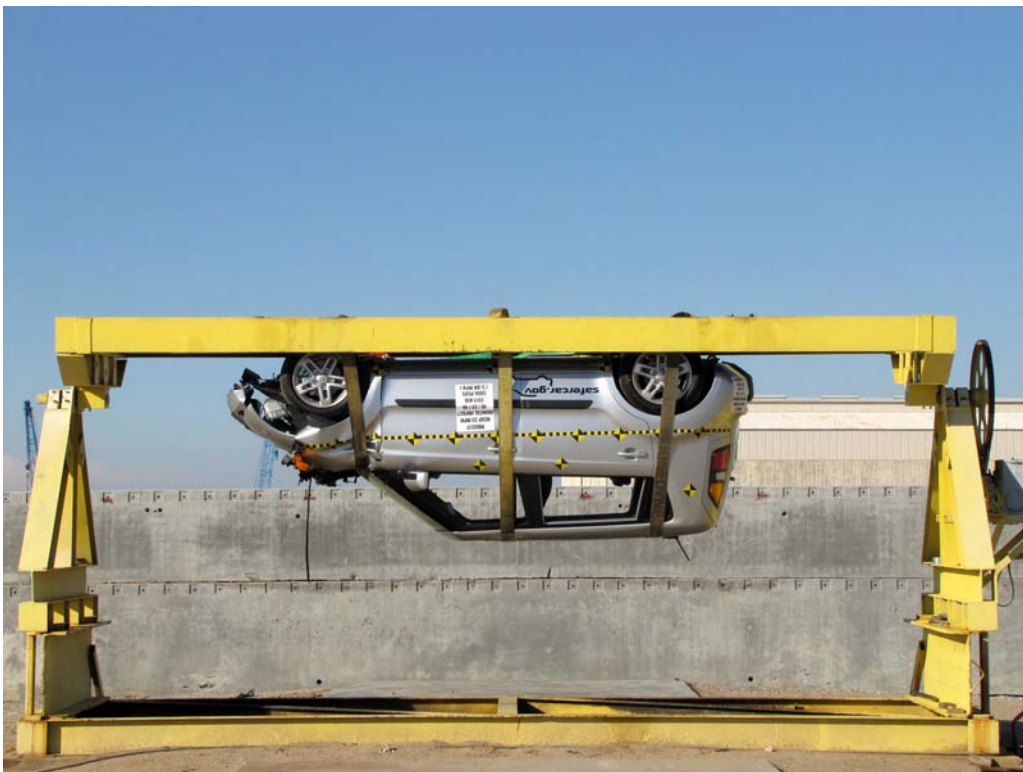
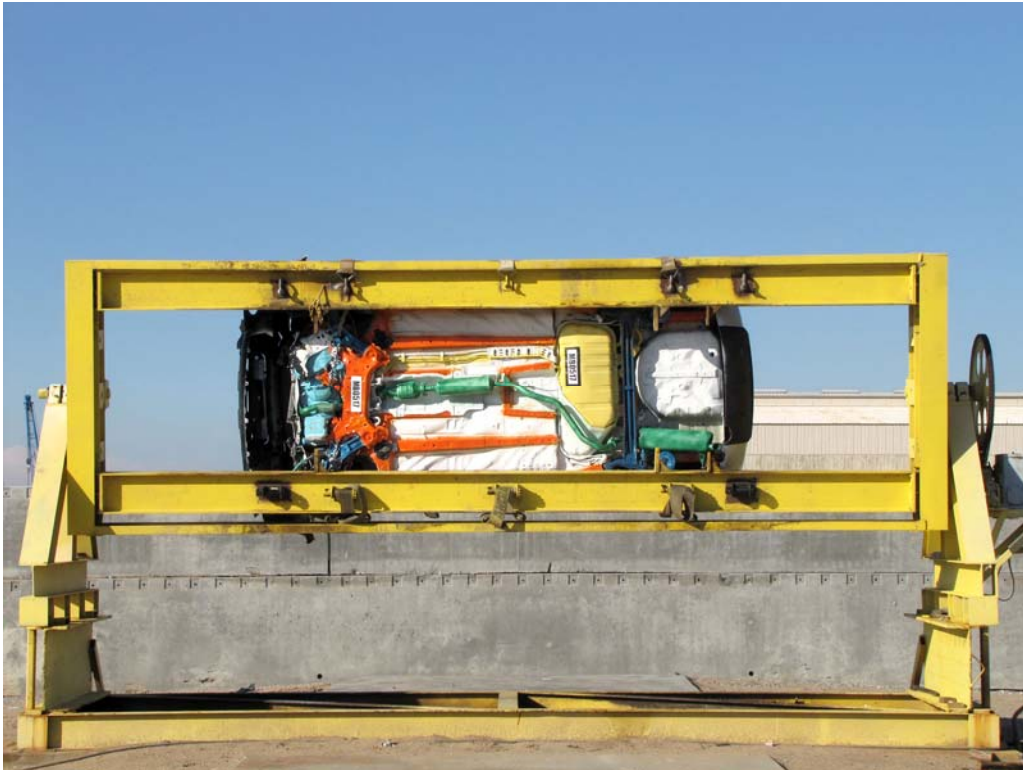
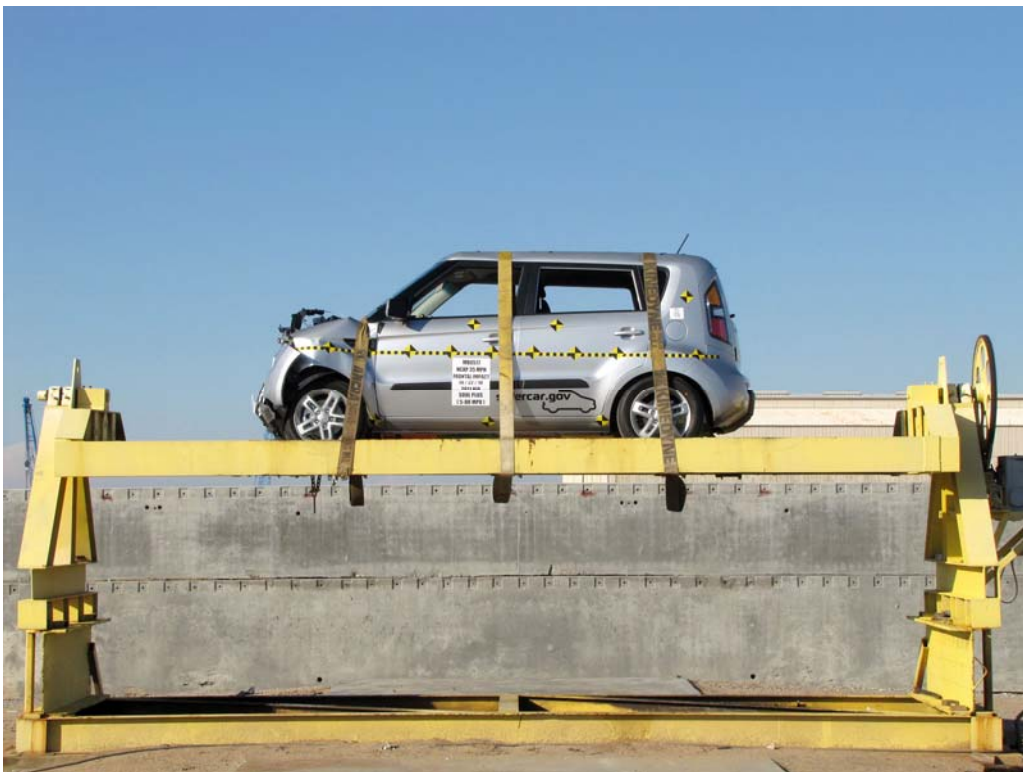
FIGURE 64. Vehicle at 0 Degrees on Static Rollover Device

FIGURE 65. Vehicle at 90 Degrees on Static Rollover Device

FIGURE 66. Vehicle at 180 Degrees on Static Rollover Device

FIGURE 67. Vehicle at 270 Degrees on Static Rollover Device

FIGURE 68. Vehicle at 360 Degrees on Static Rollover Device
