REPORT NUMBER: SNCAP-CAL-11-022

**NEW CAR ASSESSMENT PROGRAM (NCAP)
Moving Deformable Barrier Side Impact Test**

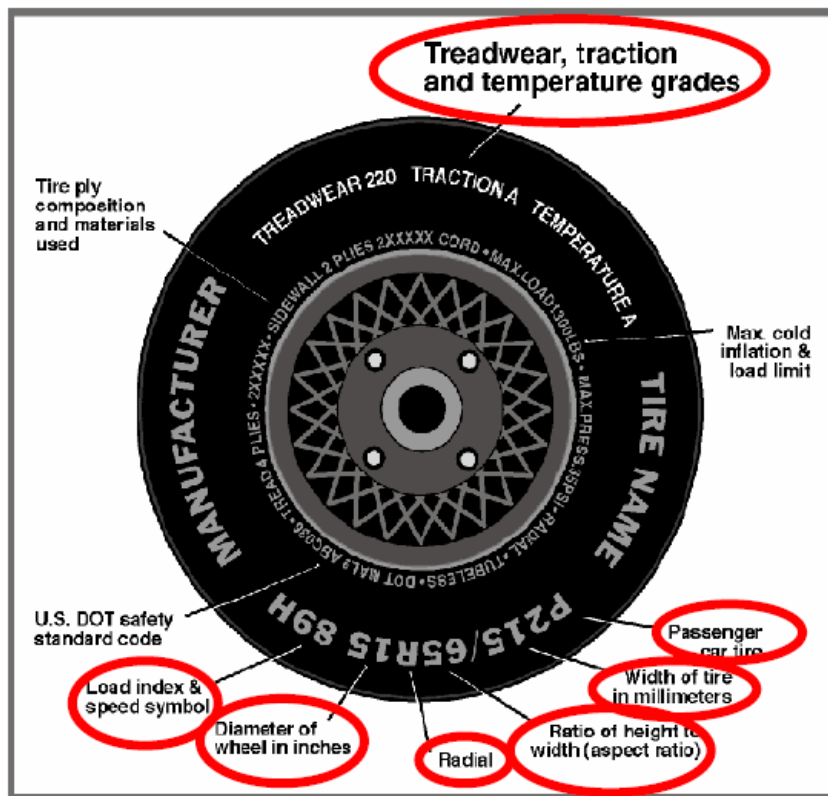
Front	Rear
Max. Tire Pressure (kPa)	350	350
Cold Pressure (kPa)	235	235
Recommended Tire Size	P205/60R16	P205/60R16
Tire Size on Vehicle	P205/60R16	P205/60R16
Tire Manufacturer	Goodyear	Goodyear
Tire Model	Assurance	Assurance
Treadwear	580	580
Traction	a	a
Temperature Grades	a	a
Tire Plies Sidewall	1 Polyester	1 Polyester
Tire Plies Body	1 Polyester, 2 Steel, 1 Nylon	1 Polyester, 2 steel, 1 Nylon
Load Index/Speed Symbol	91h	91h
Tire Material	Rubber	Rubber
DOT Safety Code Right	4BXVJA2R3010	4BXVJA2R3010
DOT Safety Code Left	4BXVJA2R3010	4BXVJA2R3010

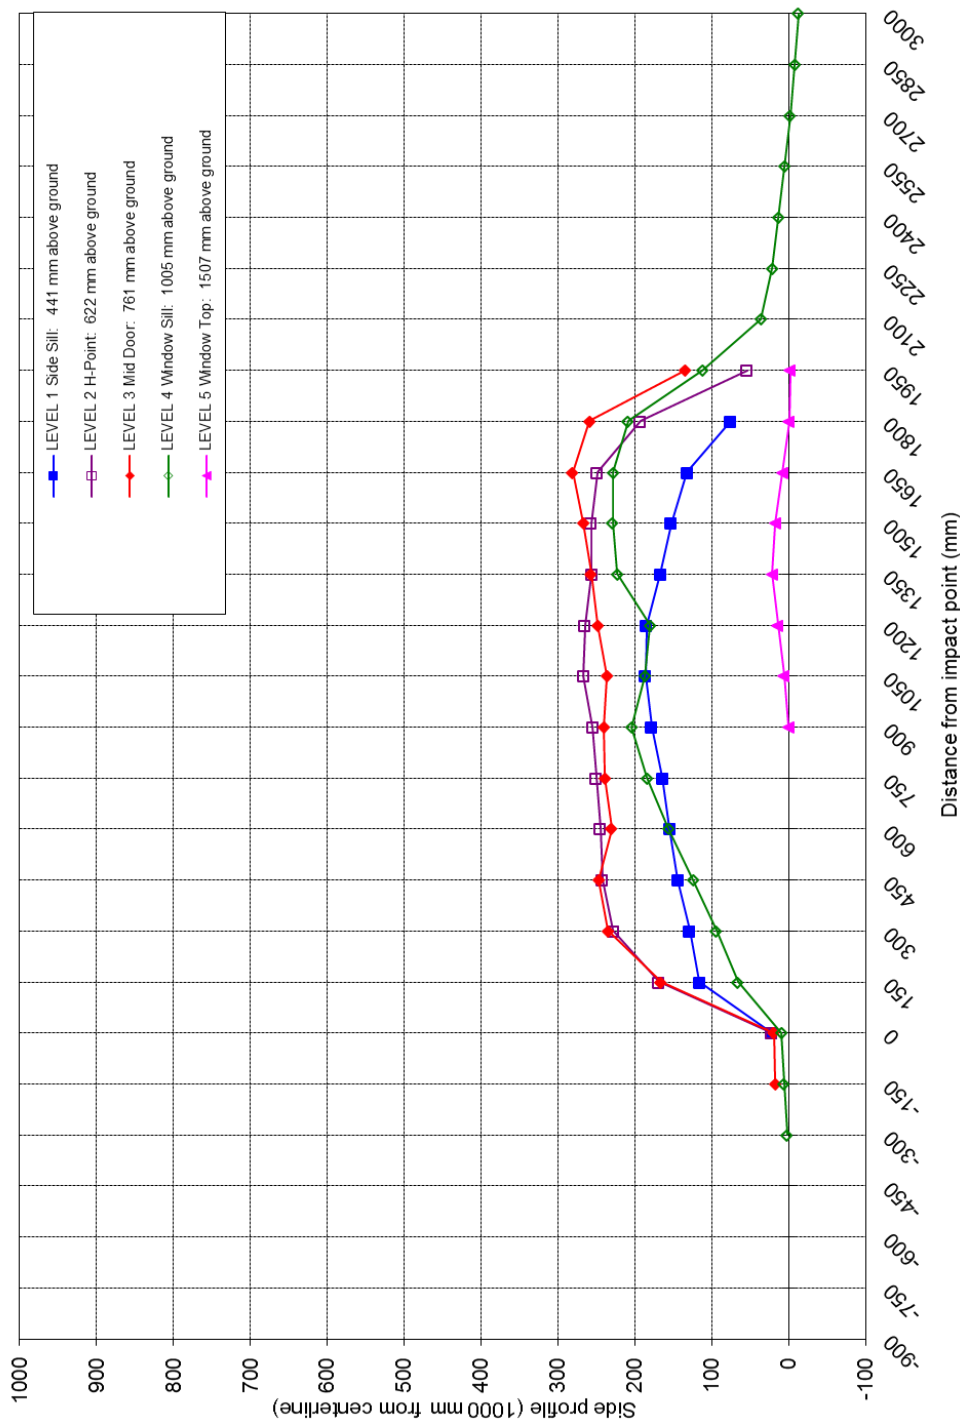
**DATA SHEET NO. 13
VEHICLE DAMAGE PROFILE DISTANCES**

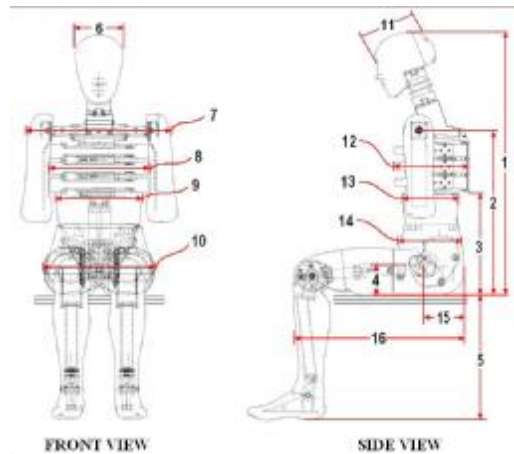
Dim. No.	Description	Specification (mm)	Result (mm)	Pass/Fail
1	Sitting Height	900-918	909	Pass
2	Seat to Shoulder Joint	558-572	565	Pass
3	Seat to Lower Face of Thoracic Spine Box	346-356	354	Pass
4	Seat to Hip Joint (center of bolt)	97-103	100	Pass
5	Sole to Seat, Sitting	433-451	444	Pass
6	Head Width	152-158	158	Pass
7	Shoulder/Arm Width	461-479	470	Pass
8	Thorax Width	322-332	323	Pass
9	Abdomen Width	273-287	282	Pass
10	Pelvis Lap Width	359-373	369	Pass
11	Head Depth	196-206	201	Pass
12	Thorax Depth	262-272	267	Pass
13	Abdomen Depth	194-204	199	Pass
14	Pelvis Depth	235-245	239	Pass
15	Back of Buttocks to Hip Joint (center of bolt)	150-160	157	Pass
16	Back of Buttocks to Front Knee	597-615	603	Pass
