**REPORT NUMBER: NCAP-KAR-11-034**

**NEW CAR ASSESSMENT PROGRAM (NCAP)  
FRONTAL BARRIER IMPACT TEST**

**NISSAN MOTOR CO., LTD.  
2011 NISSAN SENTRA 2.0 4-DOOR SEDAN**

**FINAL REPORT**

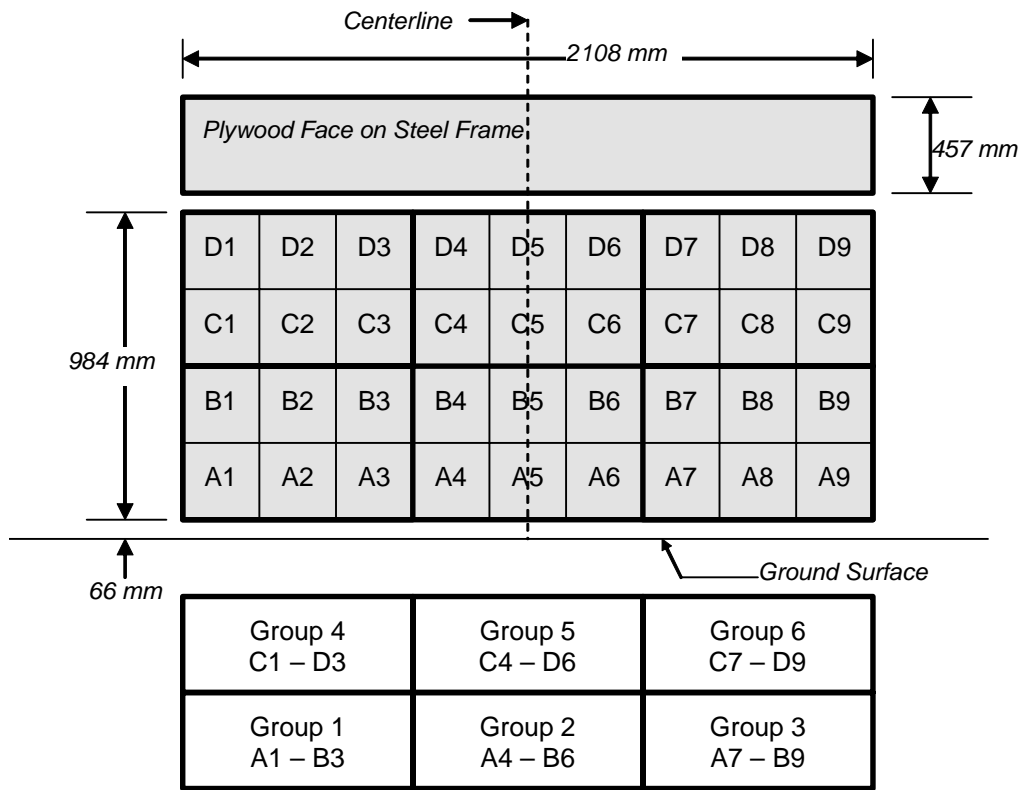
**36 Load Cell Rigid Barrier (NHTSA Standard)  
 Load Cell Locations on Fixed Barrier**

6 Groups of 6 Load Cells Each

A load cell barrier consisting of 36 load cells was impacted by a 2011 Nissan Sentra 2.0 4-Door Sedan at a velocity of 56.67 km/h. The test was performed at KARCO Engineering, LLC. on October 27, 2010. Pre- and post-test photographs of the vehicle and dummies can be found in Appendix A of this report.

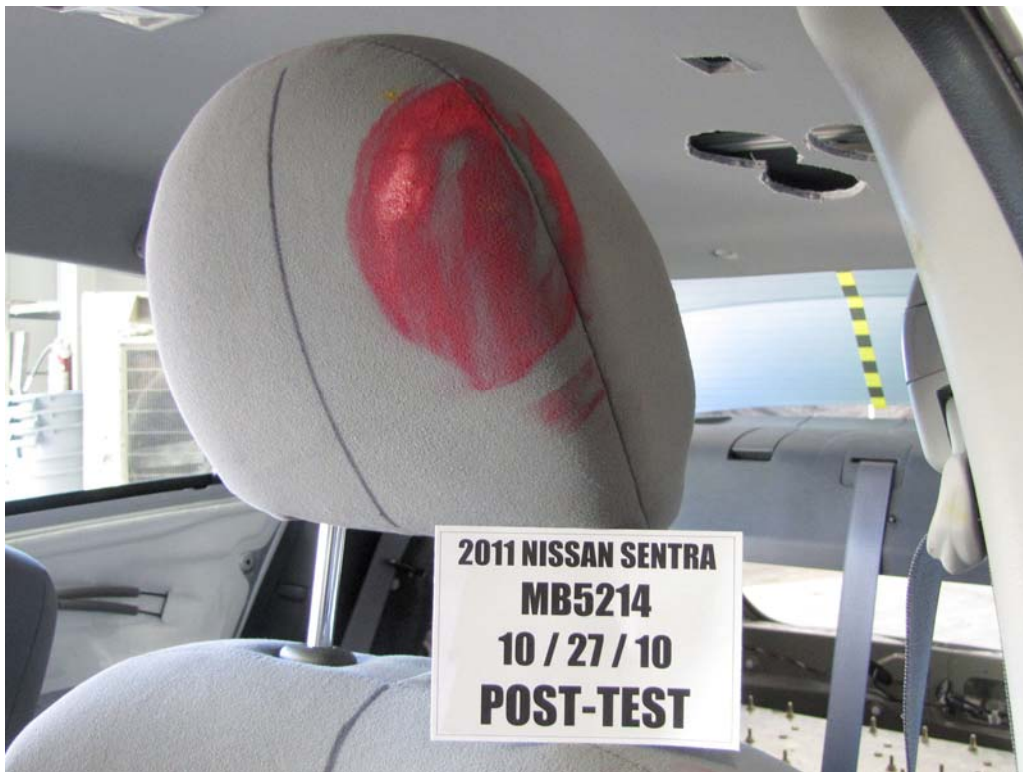
FIGURE 43. Post-Test Driver Dummy Contact With Airbag

The driver's visible contact points were as follows: The driver ATD's head contacted the airbag, side header, and headrest. The upper torso contacted the airbag. Both the left knee and right knee contacted the steering column and knee bolster.

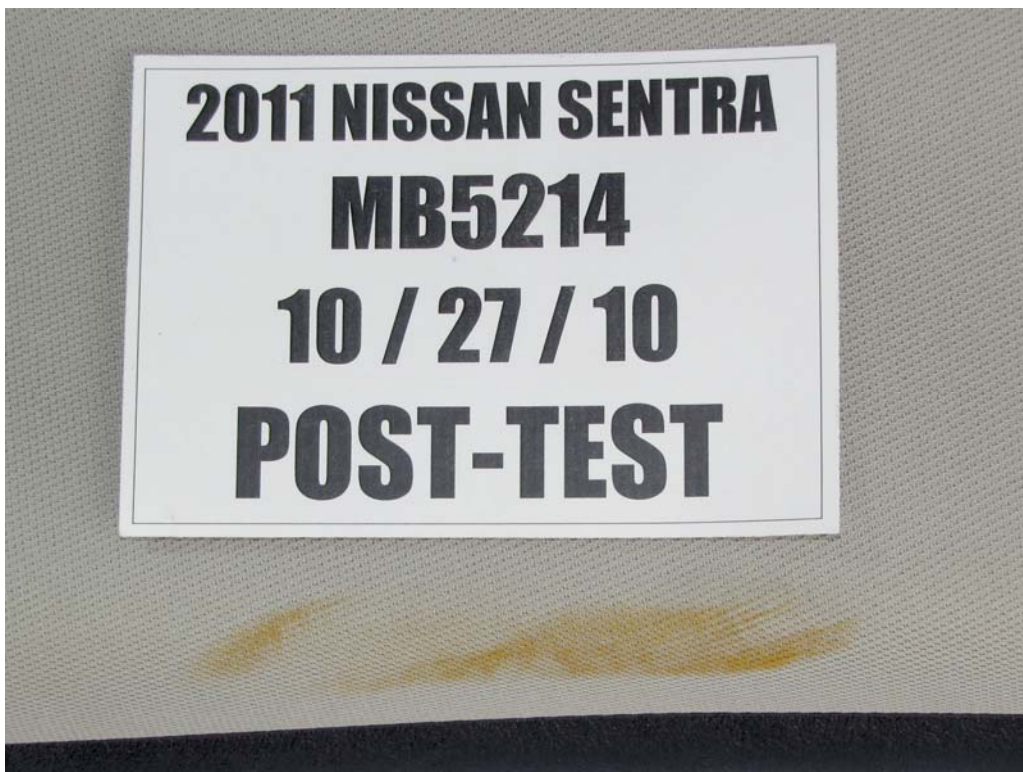
FIGURE 43b. Post-Test Driver Dummy Contact With Knee Bolster

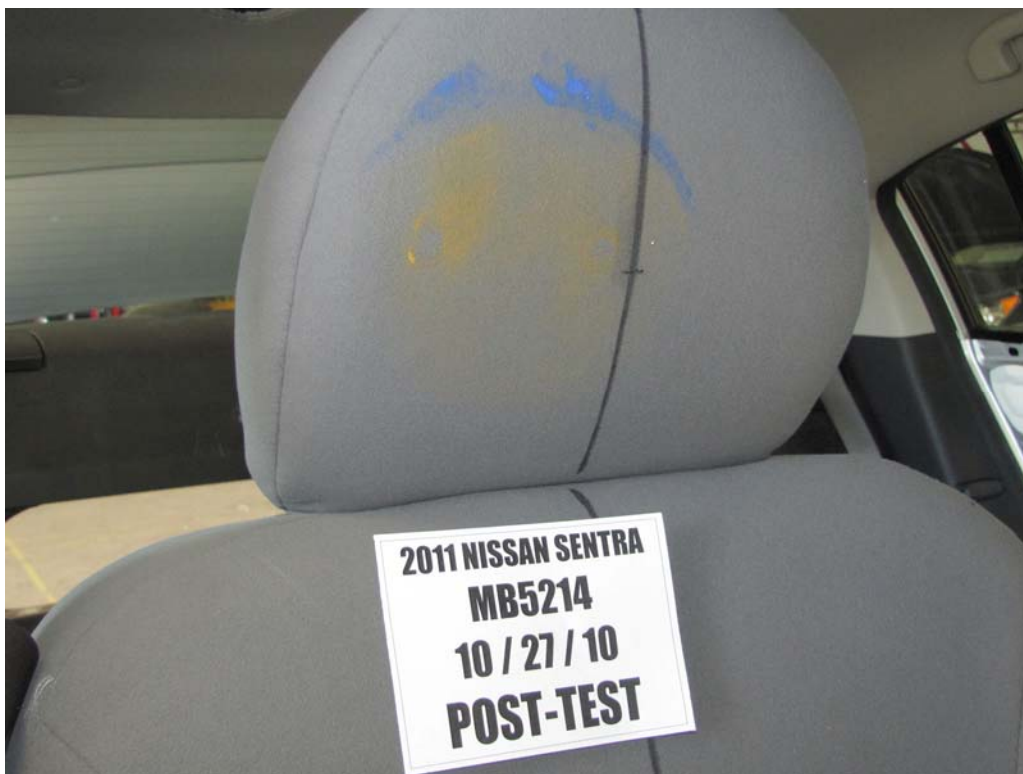
FIGURE 60. Post-Test Passenger Dummy Contact With Airbag

The passenger's visible contact points were as follows: The passenger ATD's head contacted the airbag and headrest. The upper torso contacted the airbag. Both the left knee and right knee contacted the glovebox.
