REPORT NUMBER: SPNCAP-CAL-11-021

**NEW CAR ASSESSMENT PROGRAM (NCAP)
SIDE IMPACT POLE TEST**

**Ford Motor Company
2011 Ford Fusion
Four Door Sedan**

NHTSA NUMBER: MB0215

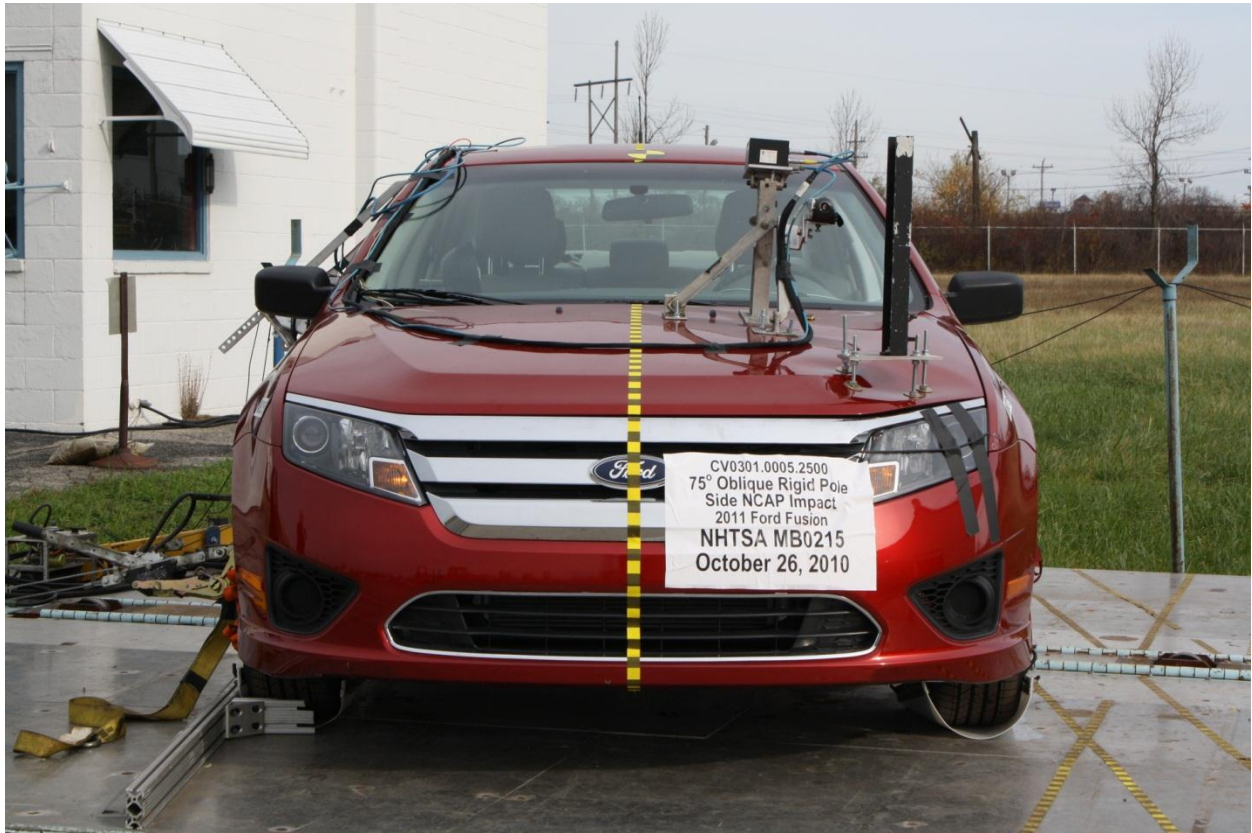
Figure A-3: Pre-Test Frontal View of Test Vehicle

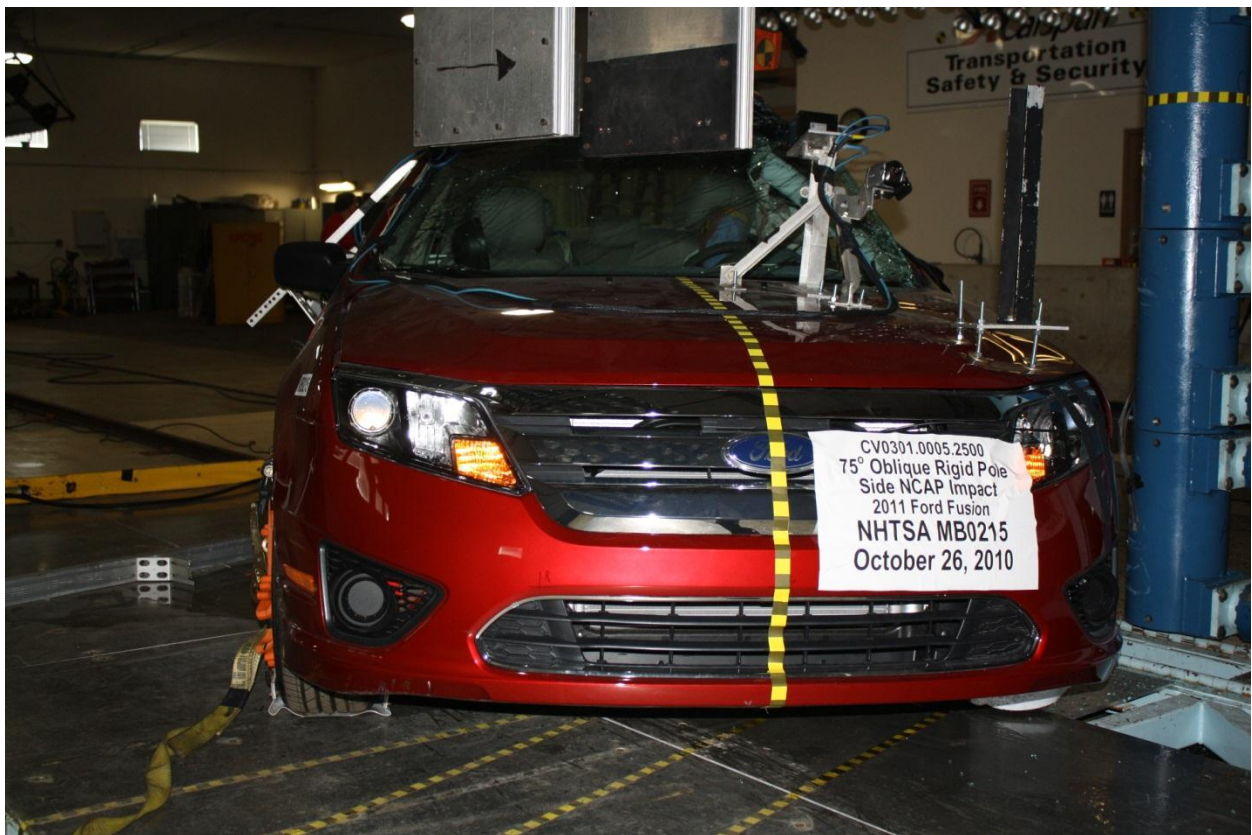
Figure A-4: Post-Test Frontal View of Test Vehicle

Critical Areas of Performance	Observations and Conclusions
Pillar Performance	b-pillar intact but intrusion occurred due to side impact
Sill Separation	none
Windshield Damage	glazing separated upper left corner of windshield
Window Damage	broken
Other Notable Effects

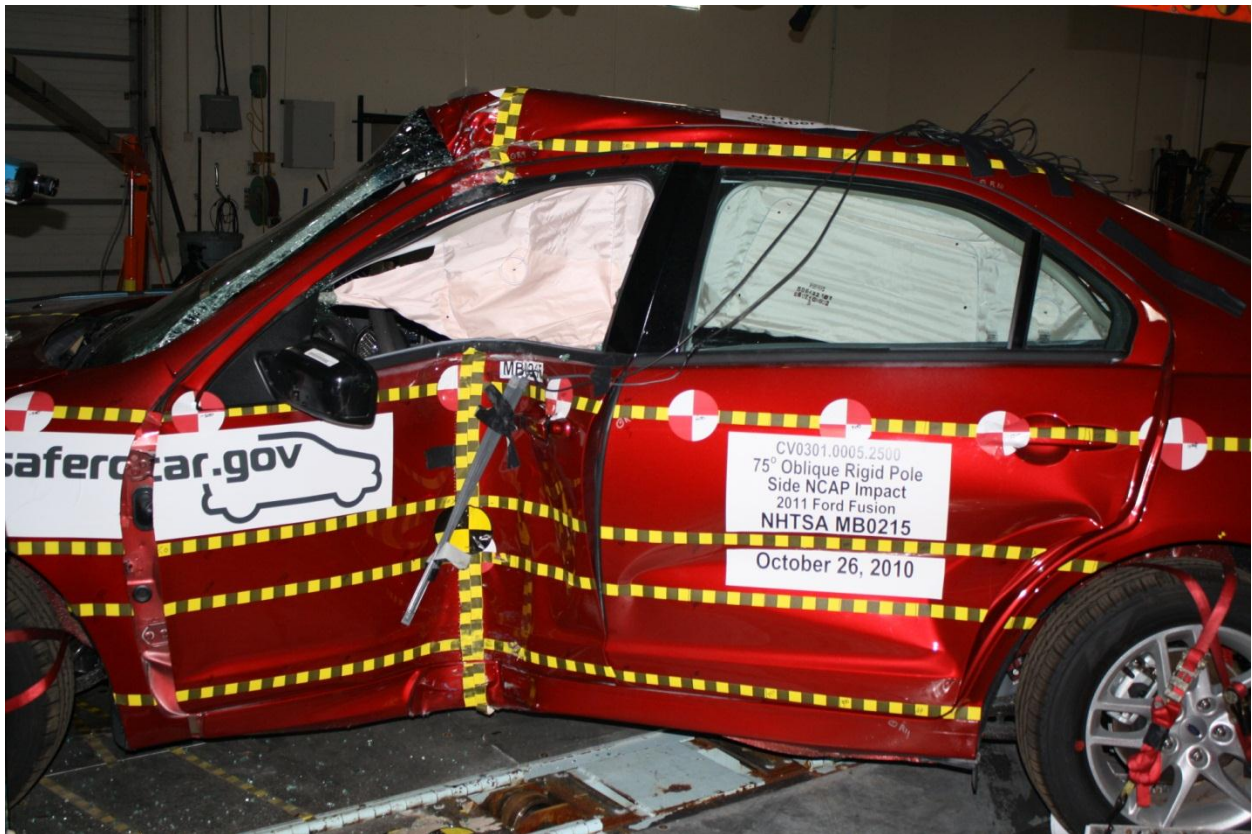
Figure A-8: Post-Test Left Side View of Test Vehicle

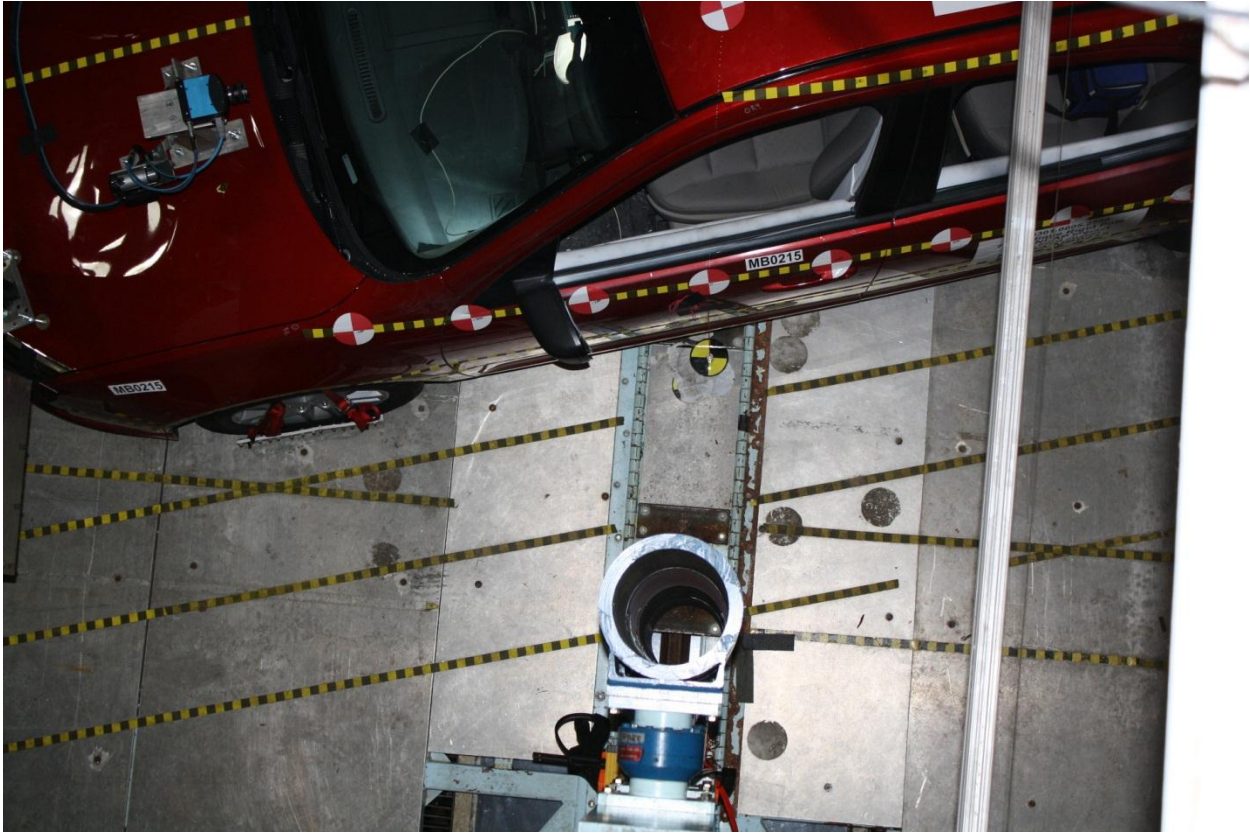
Figure A-15: Pre-Test Overhead View of Test Vehicle and Pole

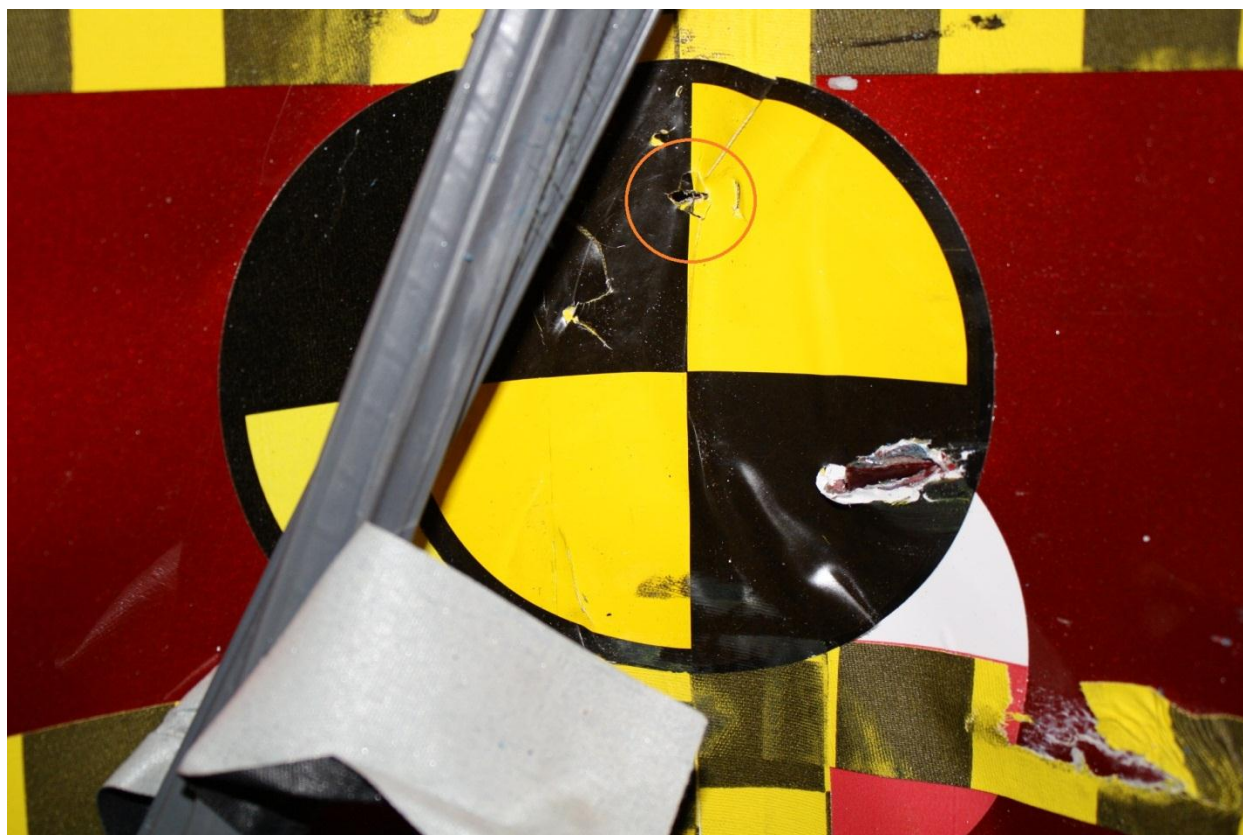
Figure A-20: Post-Test Close-Up View of Impact Point Target Showing Impact Location

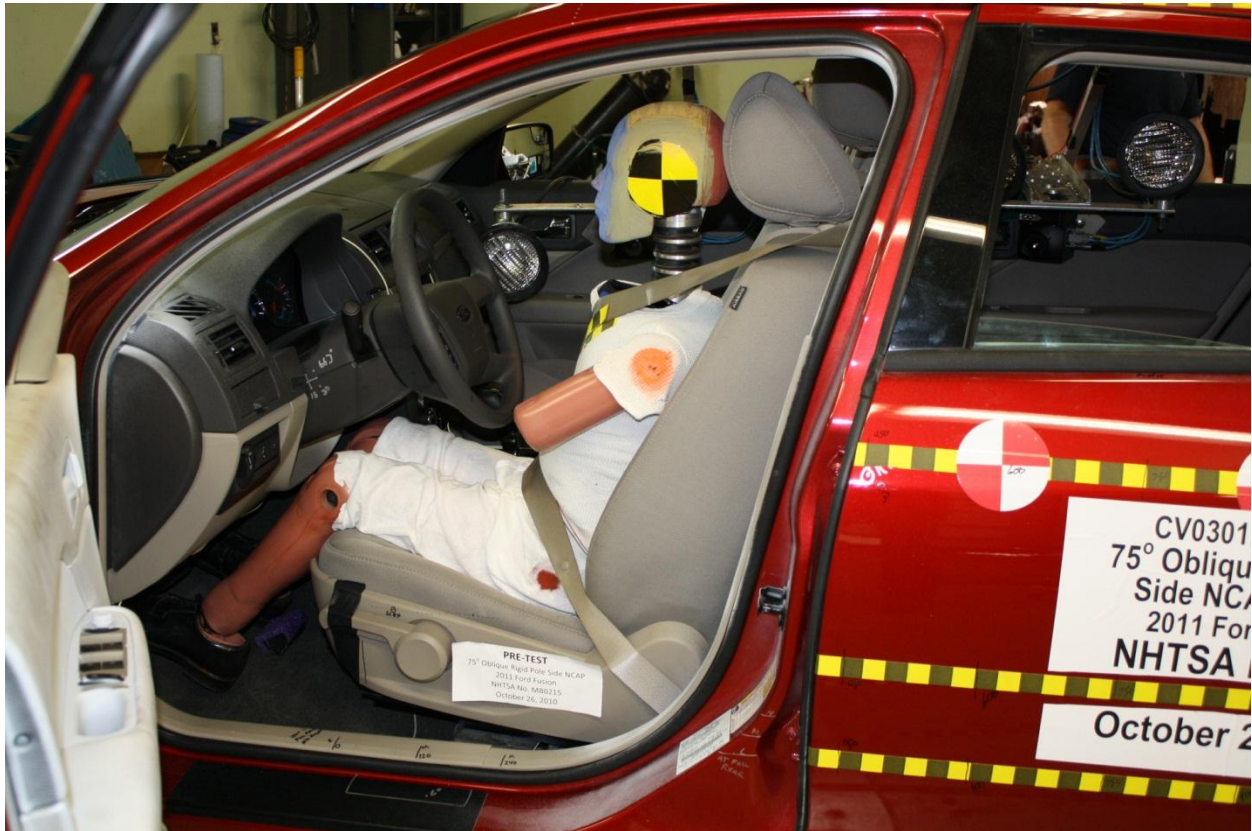
Figure A-23. Pre-Test Left Side View of Dummy Showing Belt, Chalking, and Contact Switches

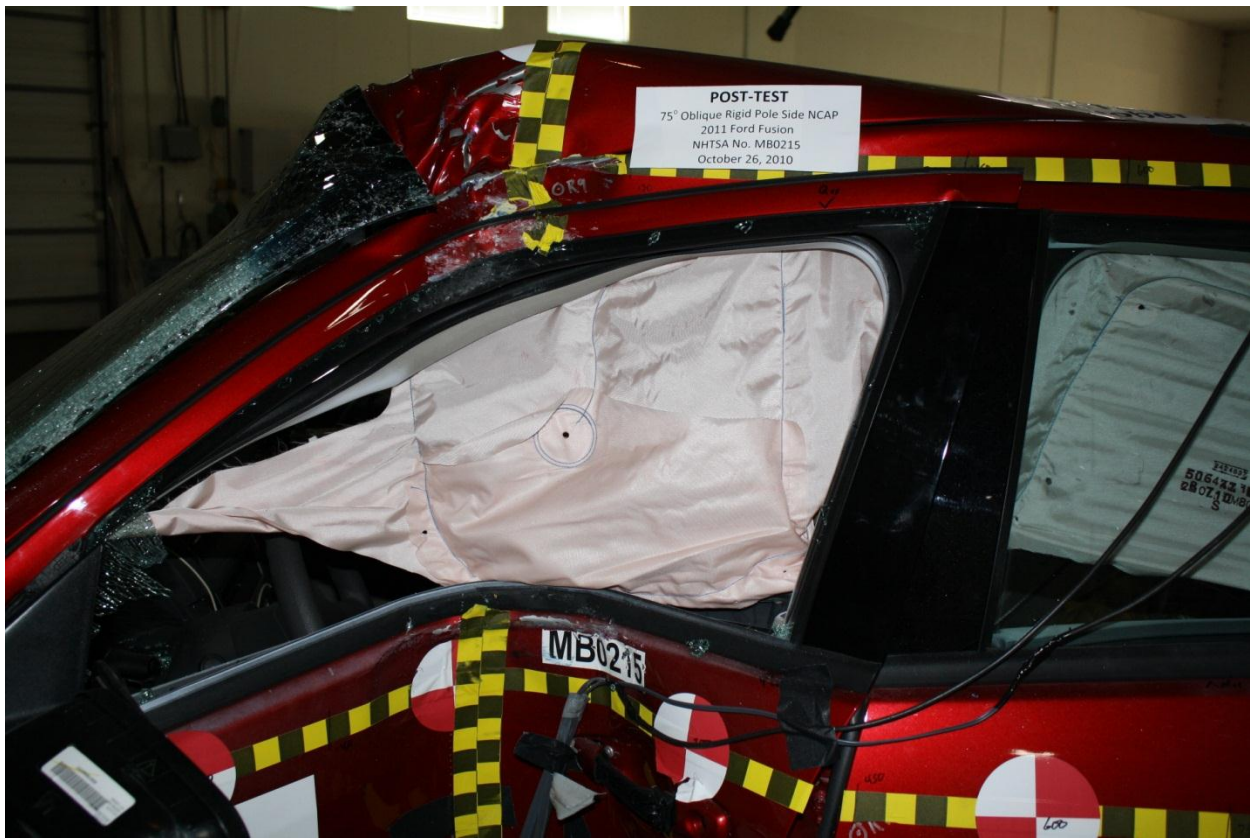
Figure A-25: Post-Test Left Side View of Dummy Shoulder and Door Top View

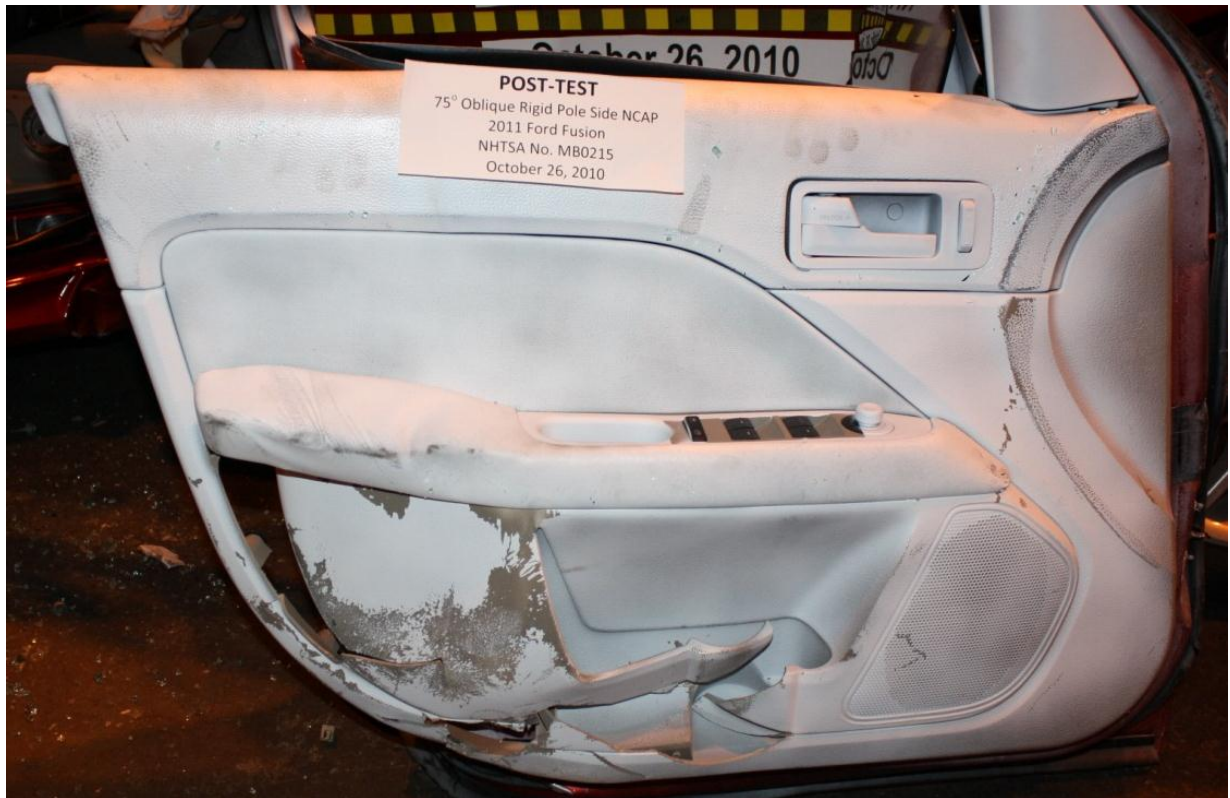
Figure A-44: Post-Test Inner Door Panel View Showing Dummy Contact Location

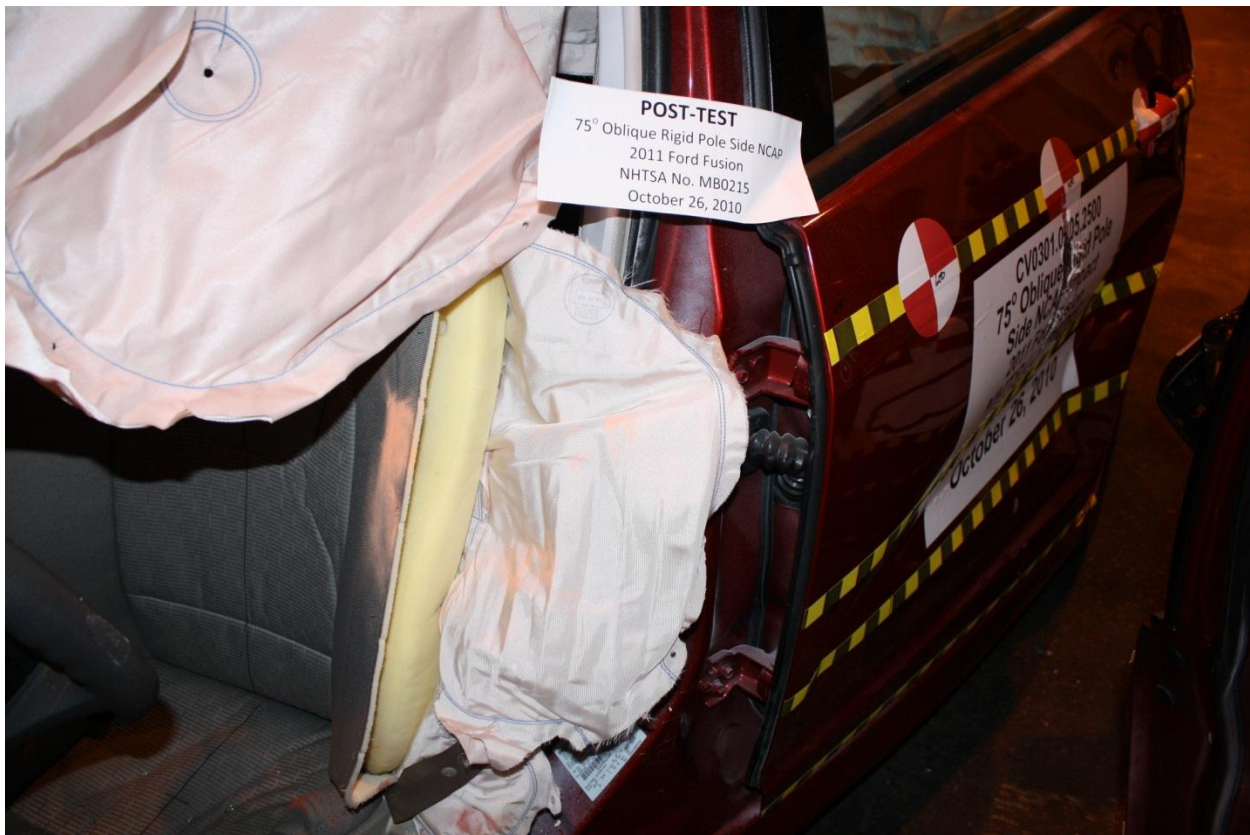
Figure A-48: Post-Test Dummy Close-Up Torso Contact with Side Airbag View

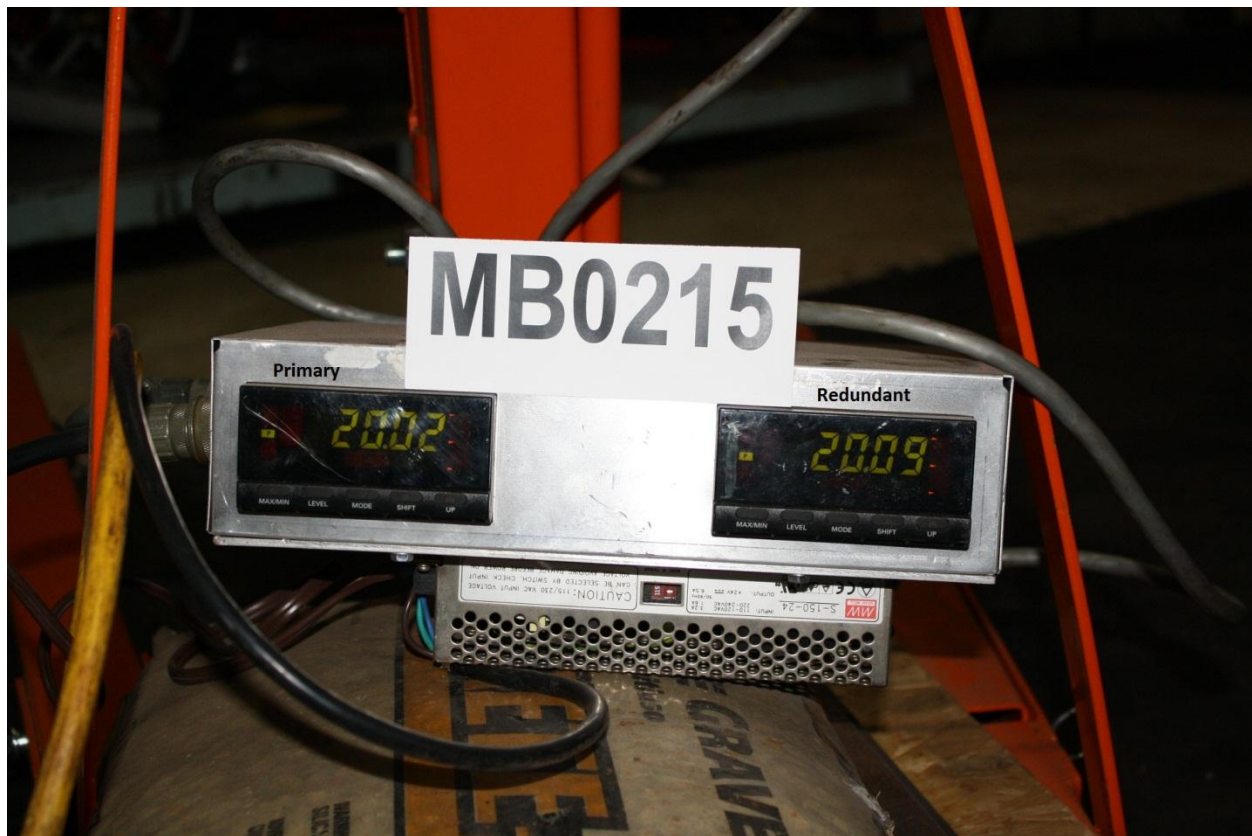
Primary **Redundant**
200.2 200.9
MAX/MIN LEVEL MODE SHIFT UP MAX/MIN LEVEL MODE SHIFT UP

Figure A-60: Post-Test Primary and Redundant Speed Trap Read-Out

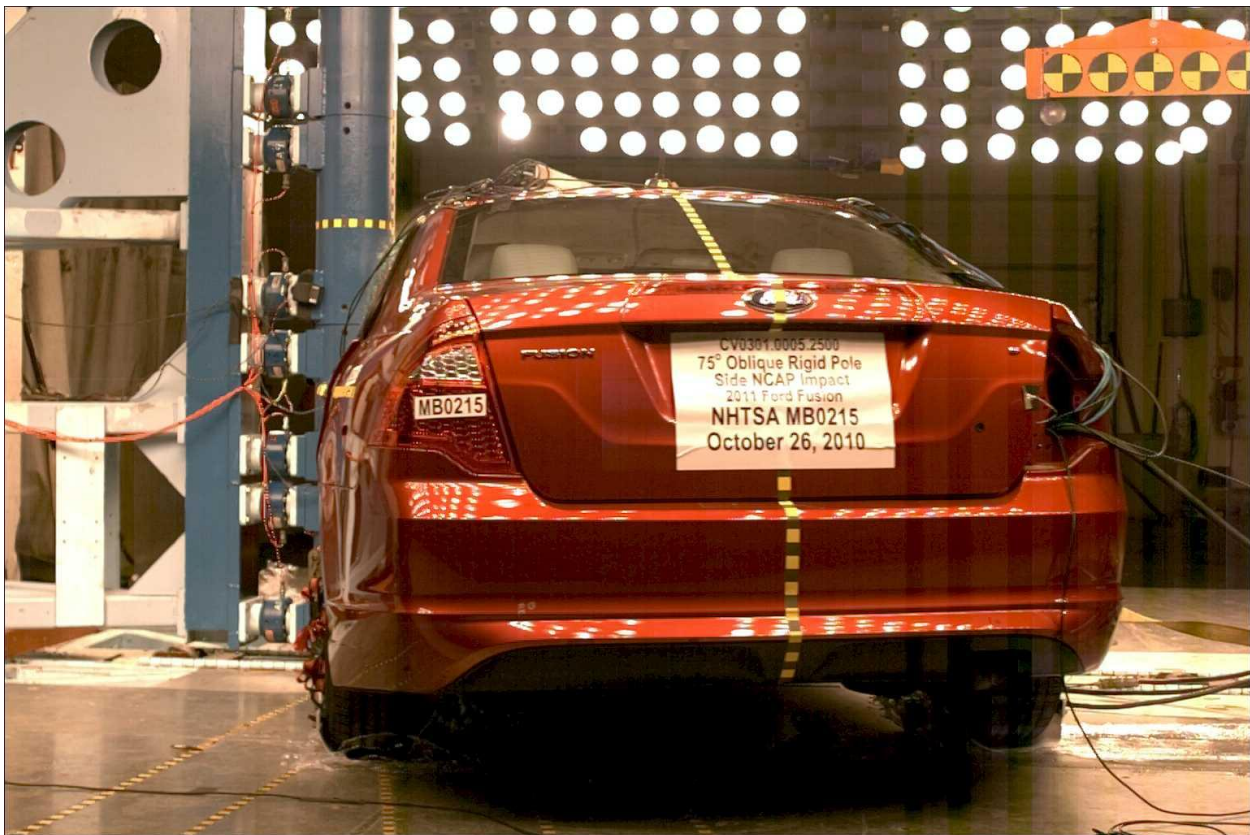
Figure A-66: Impact Event
